Archaeological Assessment

Monitoring of Ground Investigation Works

Licence No. 19E0179

Hickey's Factory

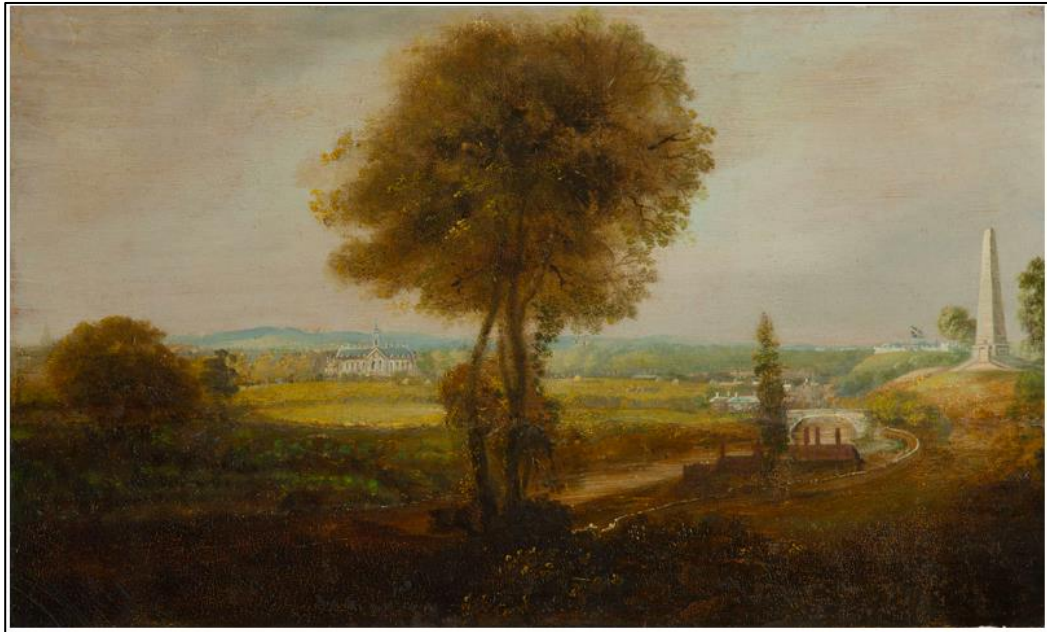
Figure 4 William Sadler (1782-1839) c.1861 A View of the Royal Hospital at Kilmainham and the Wellington Monument in Phoenix Park (Iron Works in foreground)

The proposed development site was occupied by the Royal Phoenix Iron Works, also known as Robinson’s Iron Works from the early 1800’s (Figure 4). The Iron works was located over a large area (Figures 8, 9 and 10) which extended westwards outside the proposed development area and included a dwelling house, pleasure gardens, foundry workshops, a forge, outhouses and workers cottages. The owner, Richard Robinson, a native of Hull, had settled in Dublin in 1800. His Phoenix foundry was responsible for casting King’s Bridge, designed by George Papworth to commemorate the visit of George IV to Dublin in 1823. The

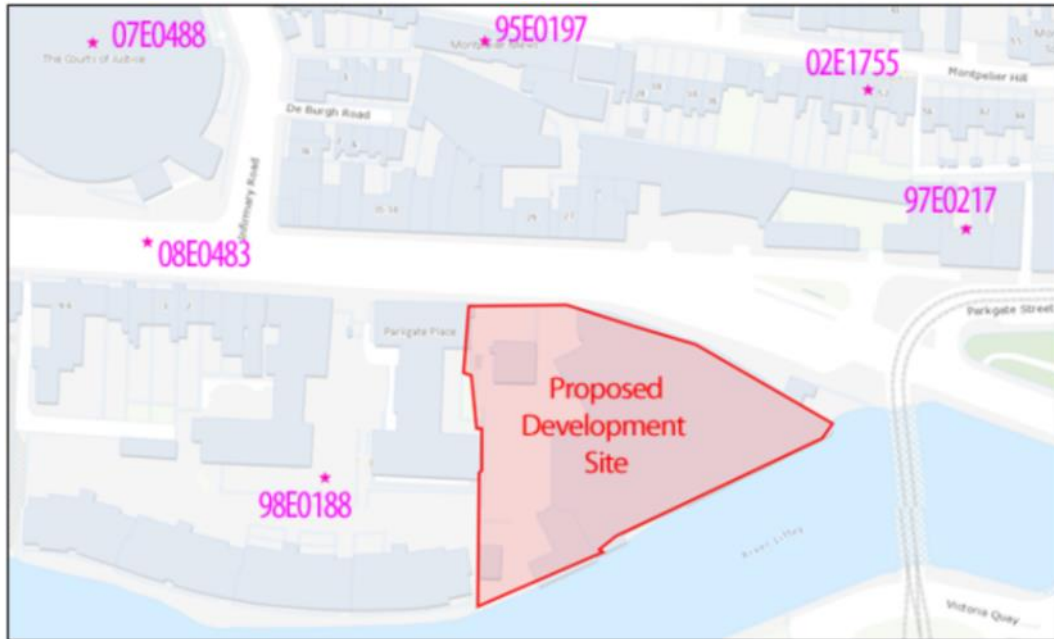
Figure 13 Archaeological investigations site locations (extracted from HeritageMaps.ie)

The proposed development site is situated within the statutory zone of archaeological potential 'Historic City of Dublin', RMP No. DU018-020. There are no specific Record of Monuments and Places (RMP) sites recorded within the subject site, however its location on the south-facing bank of the River Liffey and offers a vantage point of many of the monuments in this region of the city (Figure 13).

The Phoenix Park archaeological complex (DU018-007) is located c. 105m northwest of the development site (Figure 13). The complex is composed of a number of different sites, including the deer park (DU018-007001), a tower house (DU018-007002), a mound (DU018-007003), a house site of indeterminate date (DU018-007004), a possible well (DU018-007005), a possible enclosure (DU018-007007), a well (DU018-007008), a megalithic structure (DU018-007009), a road (DU018-007010), a cemetery mound (DU018-007011) and the star-shaped fort (DU018-007012).

No archaeological investigations have been carried out within the subject site. Some investigations have however been carried out in the environs of the site (Figure 13) but did not reveal any substantial findings that might illuminate the potential of the site.

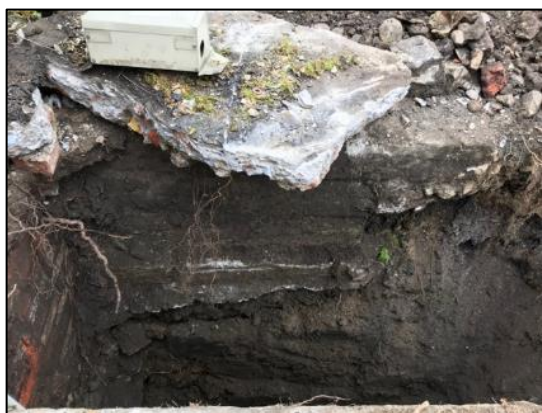
Plate 1 Concrete wall supports

TP 101 (Plates 1- 4) was excavated to a depth of 3.80m to establish the nature of the quay wall. Four phases of construction were visible. The upstanding breeze-block wall had concrete foundation supports which extended 1.80m north of the wall. Incorporated into the foundations and the backfill were two large cut-granite blocks, one of which had two mortise holes and two perforations. It is possible that these were associated with the jetty or pier, the wooden elements of which are visible on the river side of the wall.

These were probably in use when the site was an ammunitions factory. Under the breeze-block wall was a red-brick wall, 10 courses in height and set into a rubble and lime mortar foundation. These foundations lay directly on top of the remains of the limestone quay wall. The upper section of this quay wall consisted of limestone blocks to a depth of 2.20m, the lower section of the wall was constructed of irregular mudstones to a depth of 3.80m. The mudstone was visible in the section and tapered c.0.70m north from the wall.

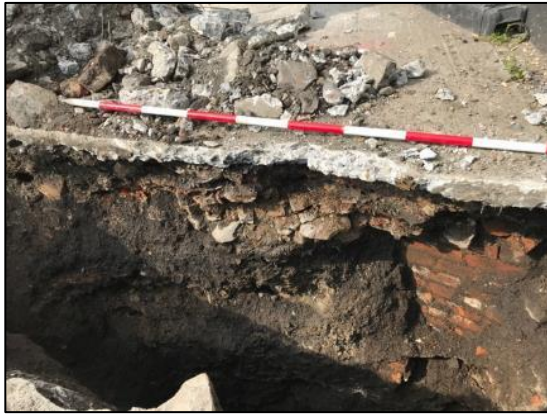
Plate 5 South-facing section of TP102

FIP 101 (Plates 5 & 6) was excavated to a depth of 4m. Beneath the concrete slab and rubble fill were industrial fills, which abutted the upstanding limestone structure, and a subsurface redbrick structure to a depth of 1.50m. The granite cornerstones of the upstanding structure were visible beneath the current ground surface and extended to 1.50m below ground surface. The wall foundations extended from 1.50m – 3.50m.

In the south-facing section, the remains of a redbrick structure were visible (seven courses in height and constructed over a drain) abutting the upstanding structure. This drain was lined with red brick, two courses deep, and capped with a layer of lime mortar. The lime mortar layer was evident across the section and possibly delineates the original ground level when the upstanding structure was constructed. The brown reclamation clays lay directly under this mortar layer.

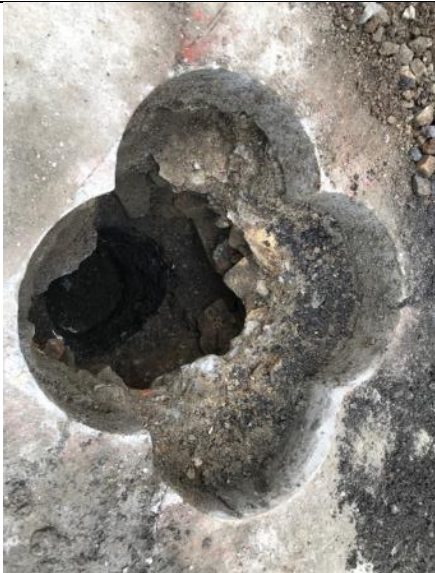
BH 101		
Depth (BGL)	Description	Interpretation
0.00 – 0.10	Concrete	Modern
0.10 – 0.60	Rubble fills, gravels with inclusions of brick, bone and mortar	Demolition material
0.60 – 1.50	Dark brown to black silty clay with inclusions of shell and slag	Industrial materials
1.50 – 2.50	Brown slightly silty clay with occasional mortar charcoal and red brick	Reclamation soils
1.50 – 3.40	Soft light brown sandy silty clay	Reclamation soils
3.40 – 4.50	Medium dense brown sandy slightly clayey sub- angular to rounded fine to medium gravel	Gravel
4.50 – 5.50	Loose sandy slightly clayey sub- angular to rounded fine to medium gravel with sub-angular to round cobbles	Gravel
5.50 – 7.10	Medium dense grey slightly clayey sandy fine to medium angular to sub-rounded gravel	Gravel
7.10 – 8.60	Weathered mudstone and limestone	Rock
8.60 – 12.60	Bedrock	Rock

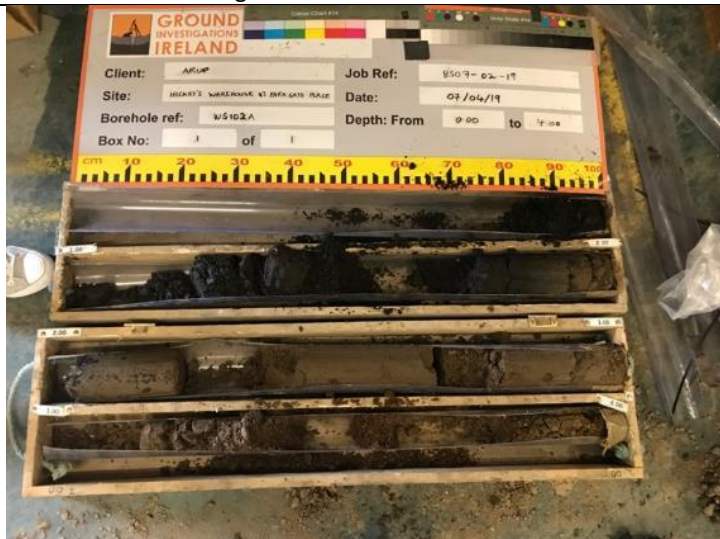
WS 102 A		
Depth (BGL)	Description	Interpretation
0.00 – 0.10	Concrete	Modern
0.10– 1.90	Black to brown sandy clay flecked with charcoal and inclusion of mortar and post medieval ceramic (0.00-0.60m - Handpit 0.60-1.00m - 40% Recovery 1.00-2.00m - 65% Recovery)	Demolition material
1.90 – 2.90	Brown clay silt with inclusions of shell and slay	Reclamation soils
2.90 – 4.00	Brown fine sand and gravels	Riverine

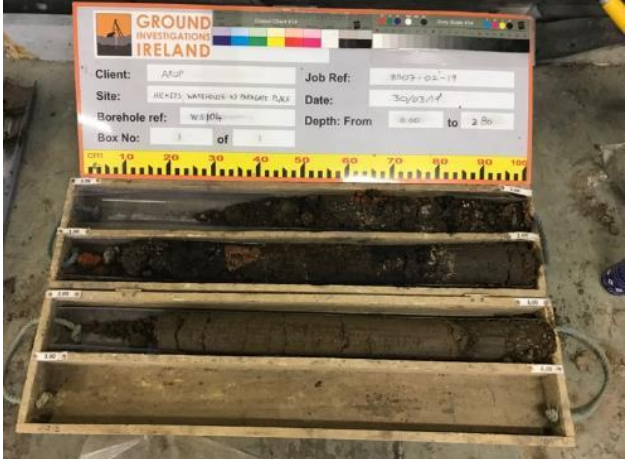
WS 104		
Depth (BGL)	Description	Interpretation
0.00 – 0.14	Concrete	Modern
0.14 – 0.84	Rubble fills, gravels with inclusions of brick, bone and mortar	Demolition material
0.84 – 1.80	Dark brown to black silty clay with inclusions of charcoal shell and slag	Industrial material
1.80 – 2.00	Brown slightly sandy slightly gravelly silty clay with occasional mortar and charcoal fragments	Reclamation soils
2.00 – 2.60	Soft brown silt clay	Reclamation soils
2.60 – 2.80	Brown sandy gravels	Obstruction 2.80 cobble/boulder

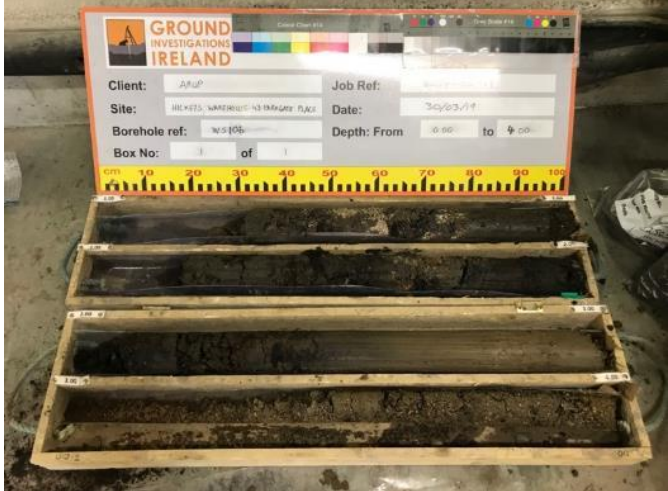
WS 106		
Depth (BGL)	Description	Interpretation
0.00 – 0.14	Concrete	Modern
0.14 – 0.65	Rubble fills, gravels with inclusions of brick, bone and mortar	Demolition material
0.65 – 1.25	Brown sandy clay with inclusions of shell and slag	Industrial material
1.25 – 2.10	Rubble fills, gravels with inclusions of brick, bone and mortar	Industrial material
2.10 – 2.50	Black sandy clay with inclusions of mortar and slag	Industrial material
2.50 – 3.00	Brown silty clay	Reclamation soils
3.00 – 4.00	Fine gravels and riverine sands	Riverine deposits

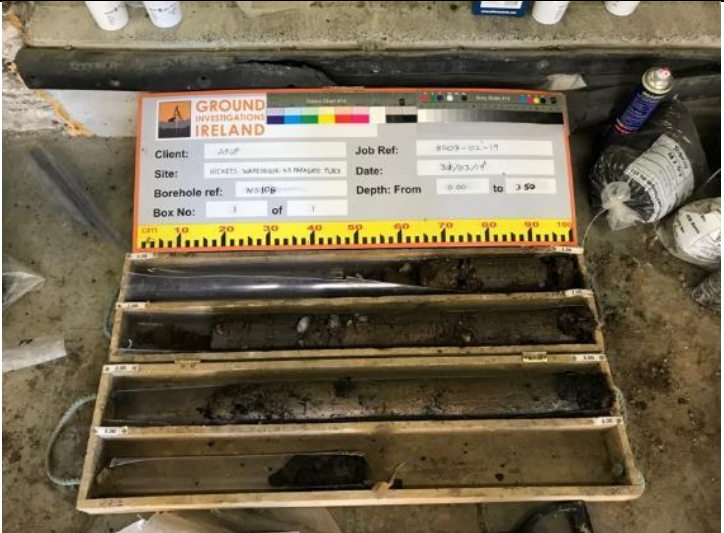
WS 108		
Depth (BGL)	Description	Interpretation
0.00 – 0.12	Concrete	Modern
0.12 – 0.70	Rubble fills, gravels with inclusions of brick and mortar	Demolition material
0.70 – 1.90	Brown silty clay with inclusions of red brick, mortar and charcoal	Industrial material
1.90 – 2.60	Brown silty clay with flecks of mortar and charcoal	Reclamation soils
2.60 – 3.50	Soft to firm brown slightly sandy gravelly clay	Reclamation soils
3.00 – 3.50	Grey brown silty clay

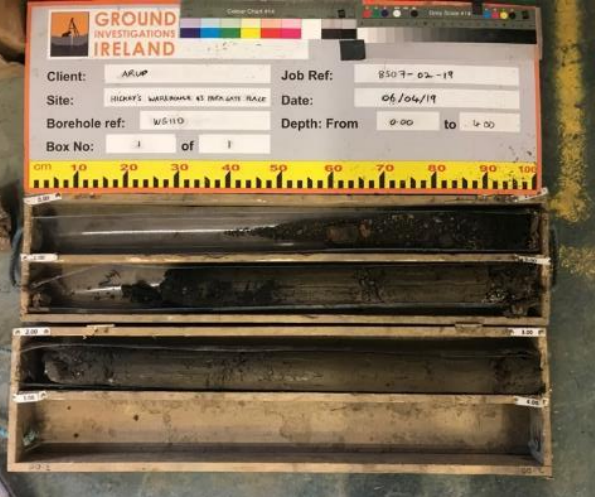
WS 110		
Depth (BGL)	Description	Interpretation
0.00 – 0.09	Concrete	Modern
0.09- 1.00	Rubble gravel fills with redbrick	Demolition material
1.00 – 2.40	Brown sandy clay flecked with charcoal and inclusion of mortar chuck and bone	Reclamation soils
2.40 – 3.30	Brown sandy clay similar to above but with a higher percentage of gravels	Reclamation soils
3.30 – 3.80	Dark grey silty clay with high percentage of gravels and sand with occasional shell. (Odorous)	Reclamation soils
3.80 – 4.00	Gravels	Riverine

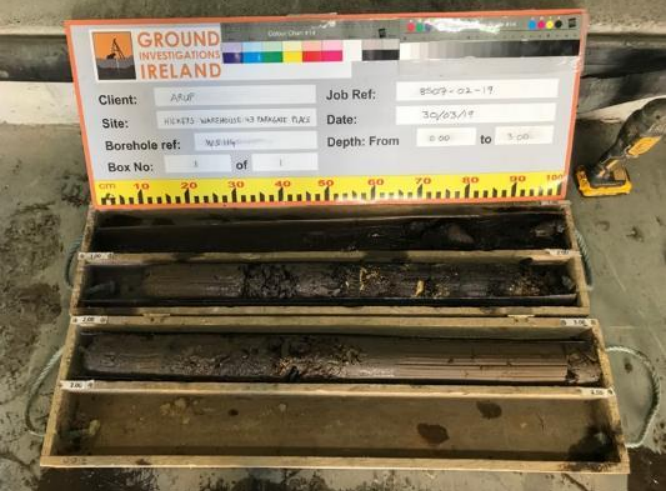
WS 114		
Depth (BGL)	Description	Interpretation
0.00 - 0.70	Concrete	Modern
0.70 - 1.00	Dark brown silty clay	Modern
1.00 - 1.30	Re-deposit brown clay with a high percentage of mica	Modern
1.30 – 2.00	Dark brown and black friable sandy clay with inclusions of rubble and brick	Industrial material
2.00 – 2.60	Brown gravelly silty clays flecked with charcoal and inclusions of mortar fragments	Industrial material
2.60 – 3.00	Brown silty clay	Reclamation soils

<p>A photograph showing soil samples in wooden boxes. A data sheet is placed on top of the boxes, and a ruler is visible below it. The data sheet includes the following information:</p> <ul style="list-style-type: none"> Client: ARUP Job Ref: 8507-02-17 Site: HICKETS WAREHOUSE-43 PARKGATE PLACE Date: 30/03/19 Borehole ref: WS 114 Depth: From 0.00 to 3.00 Box No: 1 of 1

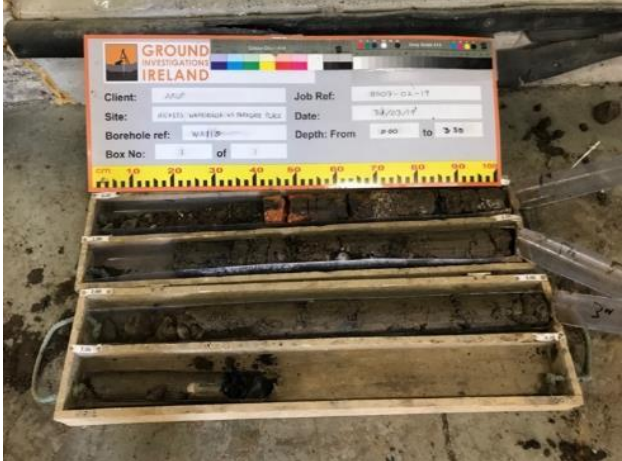
WS 115		
Depth (BGL)	Description	Interpretation
0.00 – 0.08	Modern surface	Modern
0.08 – 0.30	Rubble gravel fills with redbrick	Demolition material
0.30 – 1.80	Brown silty clay flecked with charcoal and inclusions of pebbles	Reclamation soils
1.80 – 3.30	Brown clay flecked with charcoal and inclusion of mortar flecks	Reclamation soils

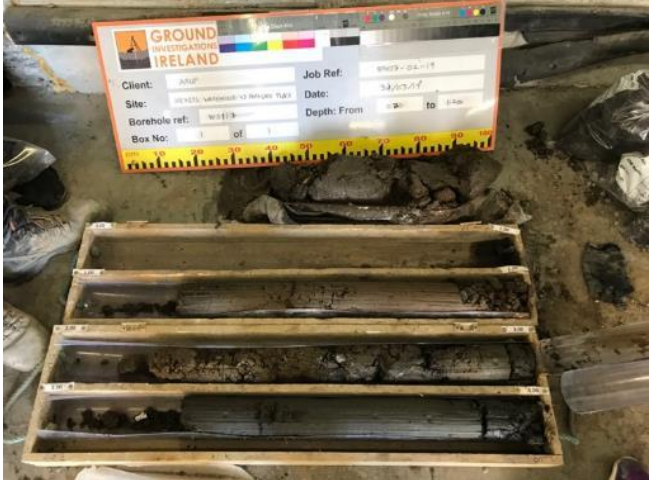
WS 116		
Depth (BGL)	Description	Interpretation
0.00 – 0.20	Concrete	Modern
0.20	Void – Wall visible beneath the concrete	Unknown

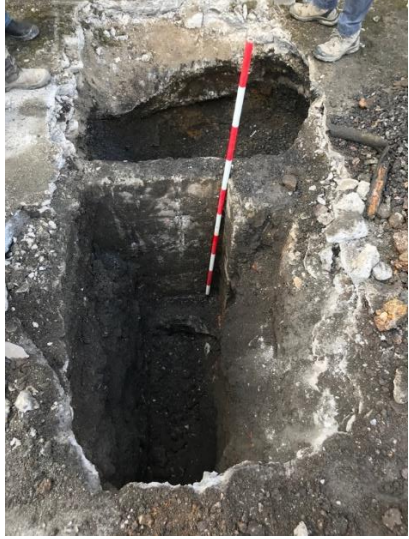
TP 04		
Depth (BGL)	Description	Interpretation
0.17 – 1.55	Brown sandy gravels with rebrick and mortar fragments East of concrete wall located directly below concrete slab and 1.30 m east of the boundary wall, orientated north south.	Industrial material
0.17 – 1.35	Dark brown black rubble fills with inclusions of redbrick slag, plastics and metal piping. Located west of concrete wall, lead piping 1.30m below ground surface.	Industrial material

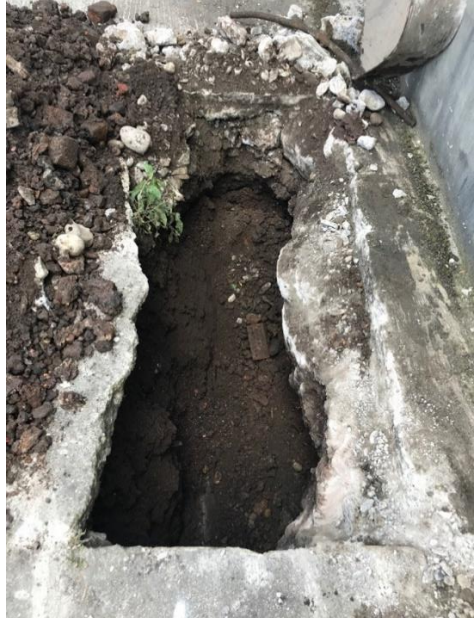
TP 05		
Depth (BGL)	Description	Interpretation
0.00 – 0.17	Concrete	Modern
0.17 – 1.40	Dark brown black rubble fills with inclusions of redbrick slag, plastics and metal piping	Industrial material
1.40	Concrete	Concrete floor of structure

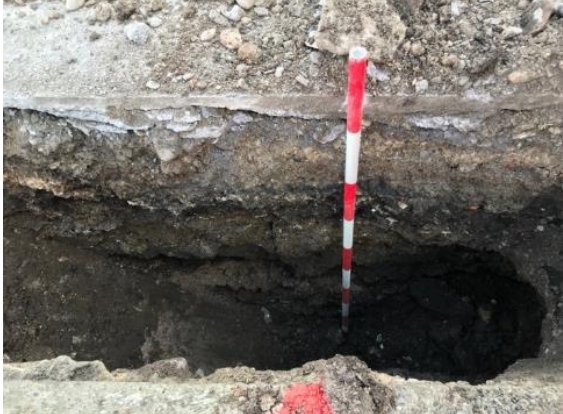
ST 01 – Slot Trench Road Side		
Depth (BGL)	Description	Interpretation
0.00 – 0.15	Concrete	Modern
0.15 – 0.35	Brown sandy gravels fills	Modern
0.35 – 0.65	Mid to dark brown sandy gravels with mortar chucks	Industrial material
0.65 – 0.95	Brown silty clay flecked with charcoal with inclusions of shell and bone	Industrial material
0.95- 1.15	Grey brown silty clays at the base of which was a higher concentration of mortar	Industrial material
1.15 – 2.50	Brown silty clay with gravels and inclusions of red brick	Reclamation soils
