Archaeological Assessment Report:

No 42A Parkgate Street

(Former Hickey's Fabric Factory)

Licence No. 19E0781

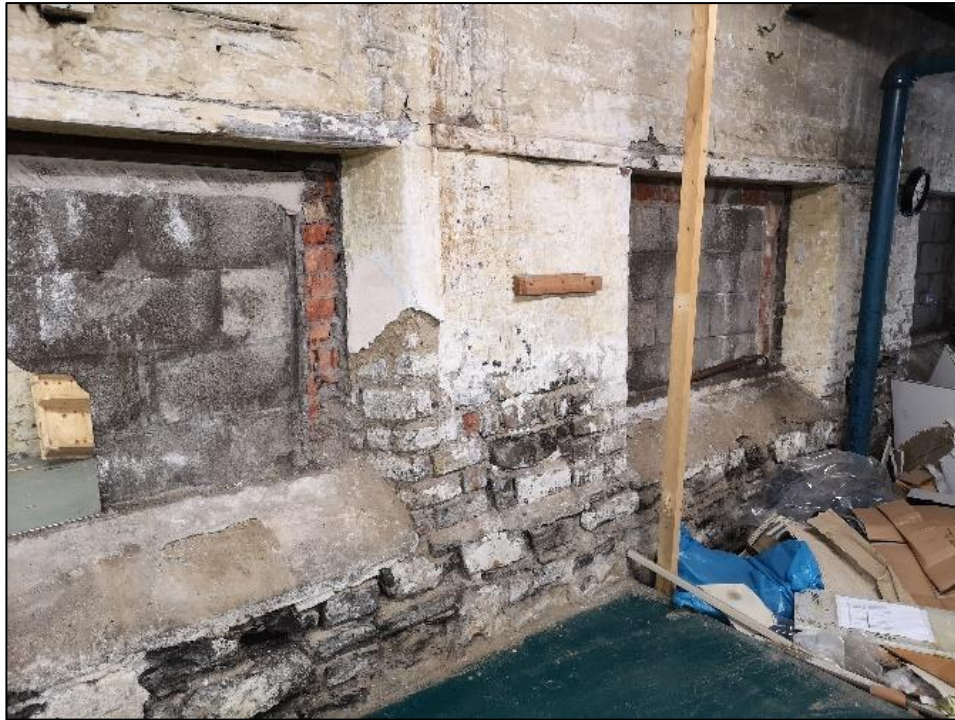
Fragmentary buildings from the iron works also survive as standing buildings (Plate 3, Plan 3 and Figures 4 and 5). During the First World War the woollen mill was converted into a bomb factory (Plate 4 and 5). From the 1920s the factory building was taken over for use as Government Stores. In the 1930s the site was used as a printing factory known as the Parkgate Printing Works (Plate 6). It was bought by the Hickey Fabric Co. in the mid-1970s until it was acquired by Chartered Land Ltd. in 2020.

Plate 3 Wall and Window opes dating to the Phoenix Iron Works

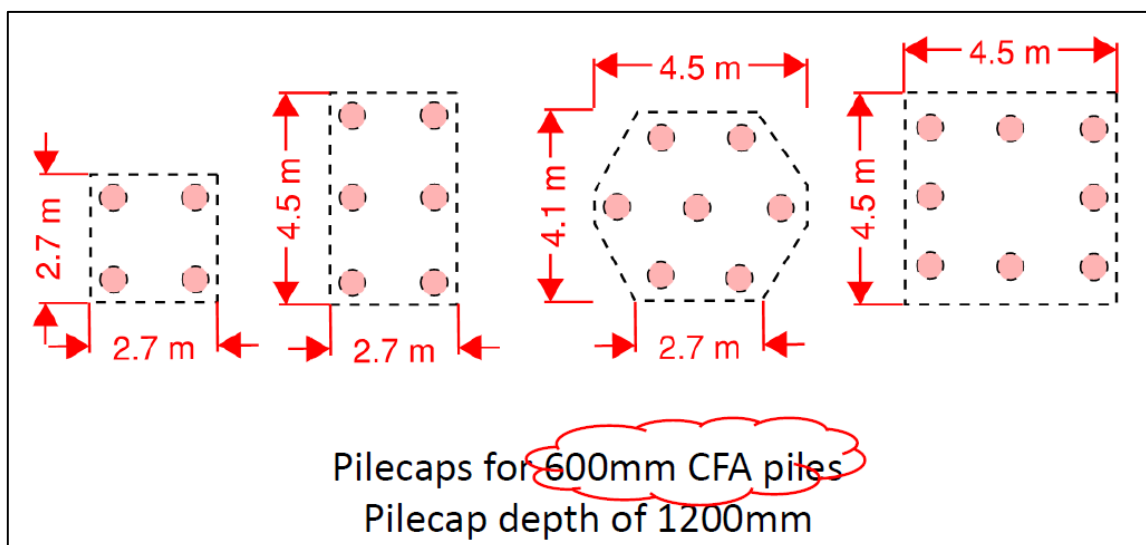
Blocks B and C form the majority of the ground works on site. The pilecaps for the 600mm CFA piles are 2.7 x 2.7m, 4.5m x 2.7m, 4.5m x 4.1m x 2.7m and 4.5m x 4.5m (Figure 16).

Figure 16 Pilecaps for Blocks B and C

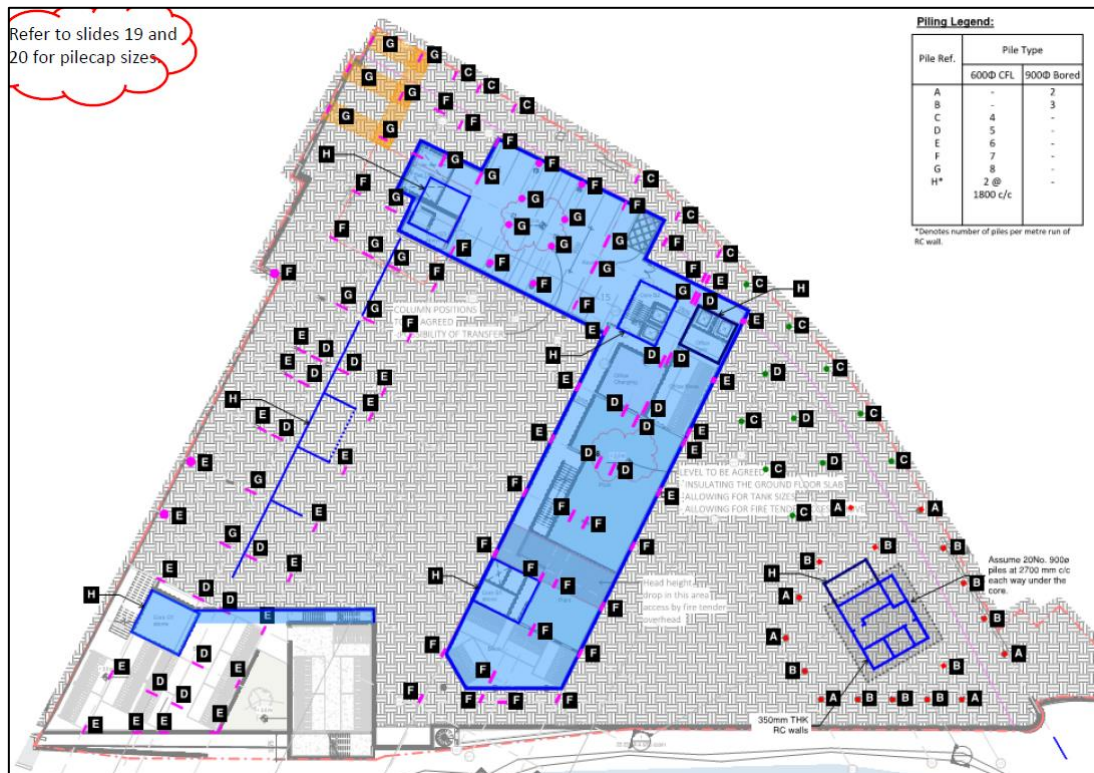
The following figures show the piling and column layout as well as the extent of the proposed basement areas on site (Figure 17 and 18). The basement layout is also overlaid with the test pit location (Figure 19). Piling will have an impact on any in-situ archaeological remains, as given their depths the piles will cut down through intact archaeological material. In addition to these interventions, there will also need to be trenches for services, utilities and drainage etc.

Figure 17 Substructure Floor Plans showing piling layout

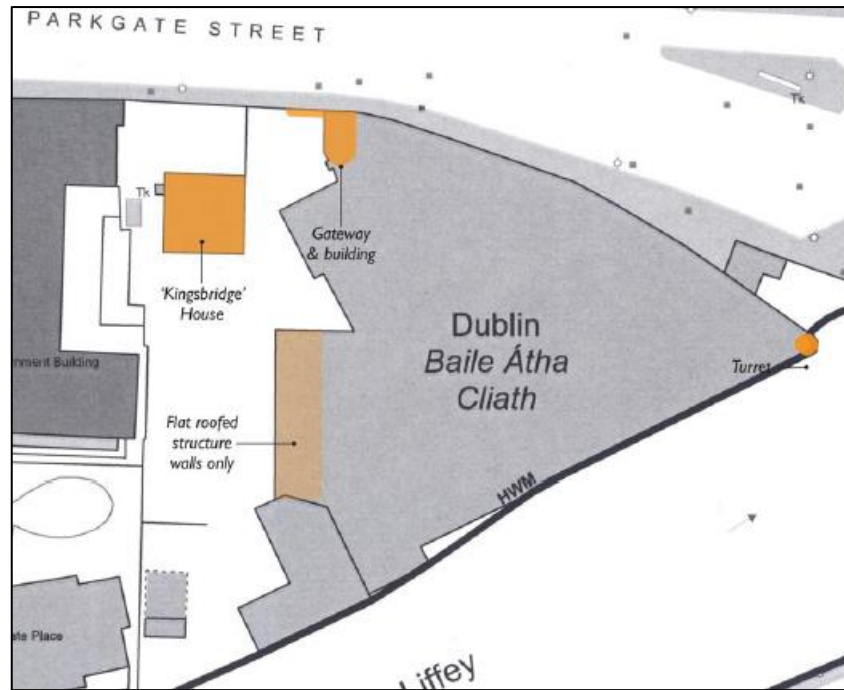
Figure 20 Mapping extract from Chapter 12 Parkgate Street EIAR Architectural Heritage, Figure 12.1 showing structures on the site that predate the 1837 First edition Ordnance Survey map. Most of the other structures date from the mid-1880s.

Prior to the demolition of existing buildings on site, a full photographic and descriptive record of the upstanding remains in relation to the Phoenix Iron Works (c. 1800-1878) and Kingsbridge Woollen Factory (1880-1890) should take place in order to add to the archaeological record and further understand the subsurface industrial remains. As part of the EIAR process, these structures have been discussed and assessed in Chapter 12 Architectural Heritage (Section 12.4.1) for the proposed development. Mapping from this chapter, shows the extent of upstanding structures that predate the 1837 First edition Ordnance Survey map (Figure 20 (Figure 12.1)).

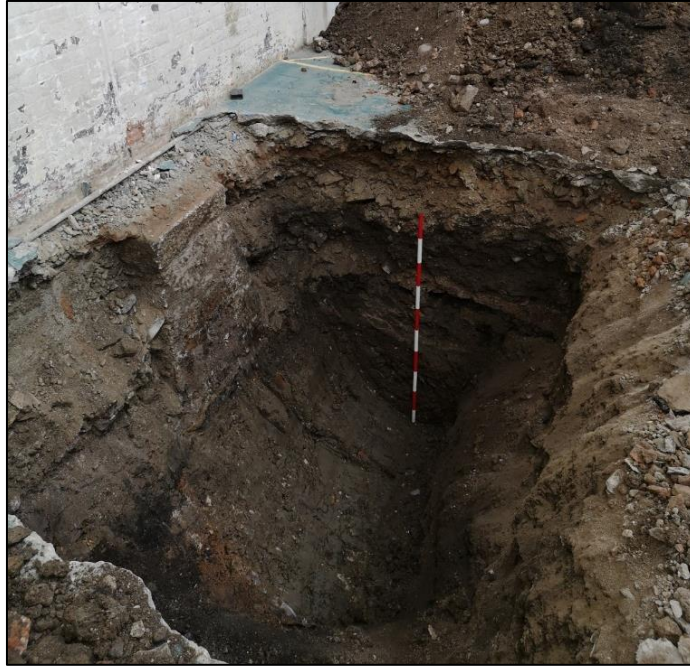
Plate 7 Test Pit 1, view to west-southwest

Test Pit	Dimensions	Findings
Test Pit 1	3m x 3m, depth 2.5m <i>Plate:7</i>	A series of 19 th century deposits were exposed, those found between depths 0.62m to 1.36m contained significant amounts of industrial waste material, the basal deposit exposed was not natural subsoil and contained 18 th to 19 th century material. Also exposed was a granite foundation plinth set into concrete possibly associated with the Knightsbridge Woollen Factory.
Test Pit 2	3m x 3.2m, depth 2.6m <i>Plate 8-9</i>	A series of 19 th and 20 th century deposits were exposed. It is likely that the identified industrial deposits are associated with the Phoenix Iron Works (c. 1800-1878). Natural subsoil was not exposed in this test pit. In the north of the pit the remnants of a rather insubstantial red brick wall oriented roughly east-west was exposed, this wall dates from the 19 th century and was constructed when the iron works was already active.

A relatively substantial foundation plinth, <C3>, was exposed, (Plate 7) acting as a support for a beam on which the current wall was laid. This concrete plinth was capped by a reused cut granite block. This plinth was bedded into deposits that contain 18th or 19th century materials and may have been associated with the Knightsbridge Woollen Factory (Figure 5). The plinth lies at 0.15m BGL and extends to approximately 1.2m deep. Natural subsoil was not reached in this test pit.

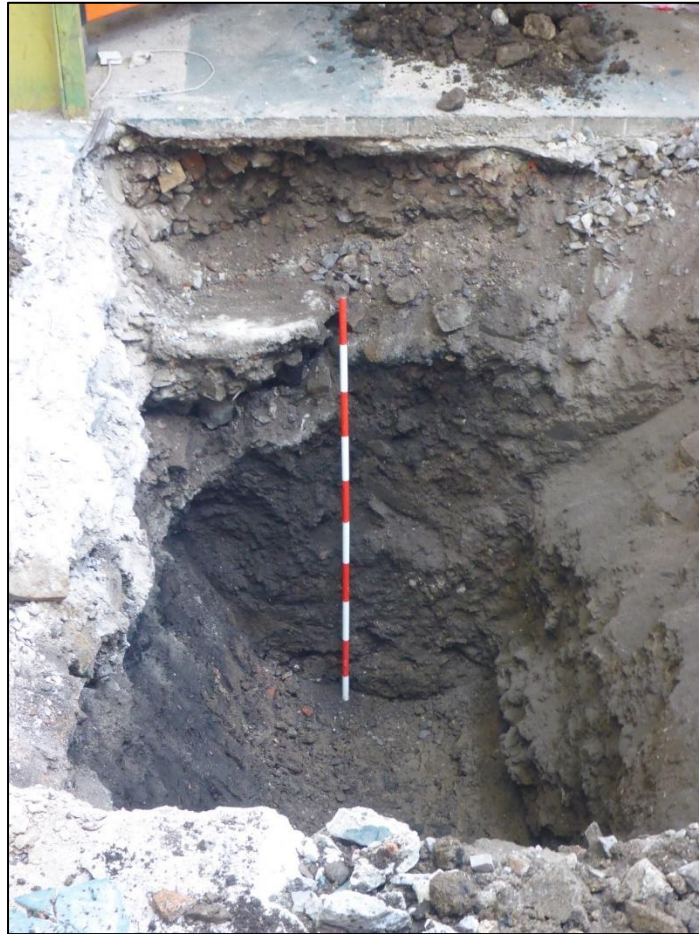
Plate 11 Test Pit 4, view to west-northwest

Test Pit	Dimensions	Findings
	<i>Plate:10</i>	inclusions of man-made material was uncovered, this may be natural subsoil.
Test Pit 4	2.97m x 3.1m, depth 2.6m <i>Plate:11</i>	A substantial loose and friable deposit was revealed which contained 18 th and 19 th materials including slag associated with the Phoenix Iron Works. Under this layer, at 2.15m below floor level, a compact sticky clay rich layer of redeposited material was uncovered. Natural subsoil was not exposed in this pit.
Test Pit 5	3m x 3m, depth 3.6m <i>Plate:12-13</i>	A 19 th century heat impacted working surface, presumably associated with the Phoenix Iron Works was revealed. Beneath this were a number of substantial layers that contained industrial waste. At a depth of 2.32m, sandy clay associated with the river began to be exposed, this deposit contained 18 th to 19 th century pottery. Under this thick layer at depth of 3.5m were river gravels, these gravels also contained occasional late post- medieval pottery fragments.

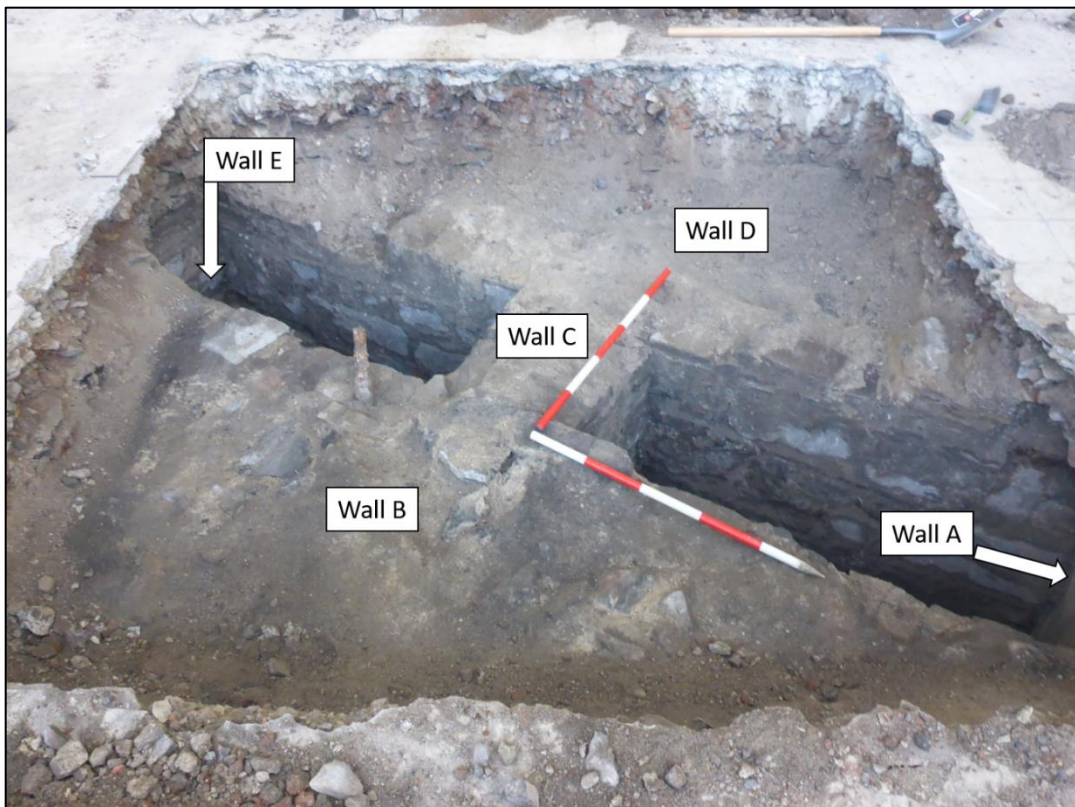
Plate 18 Test Pit 8 showing walls (A-E) and voids, view to south-southeast

Test Pit 8	2.9m x 3m, depth 2.7m <i>Plate:18-22</i> <i>Plan 4</i>	A complex of substantial stone walls were uncovered. These walls were faced with roughly hewn limestone calp blocks and cored with rubble and mortar, the walls formed two large rectangular voids that had been backfilled with demolition rubble and broken red tiles, it should be noted that the most westerly wall (Wall A) was not keyed into the abutting walls (Walls B and D) Within the northern faces of both voids were two “holes” located below metal bands bonded to the wall, the east most hand “hole” was associated with a square section metal rod that functioned as a crank for air/water flow control. Neither void was fully bottomed with the maximum depth excavated being 2.7m.
Test Pit 9	3.1m x 3m, depth 2.42m <i>Plate:23</i>	A number of 19 th century industrial waste deposits were uncovered. These overlay a heat impacted possible working surface, at a similar level, remnants of a rather thin wall that ran roughly east-west was also revealed. It can be seen that a pure black waste deposit post-dates the wall as it built up against it. The walls size and its relationship to the industrial waste indicates it may have been a non-structural division within the Phoenix Iron Works. Under the working surface, at a depth of 1.26m to 2.42m, were 18 th or 19 th century clay rich deposits. Beneath this was revealed a smooth clay which is possibly natural a natural subsoil.

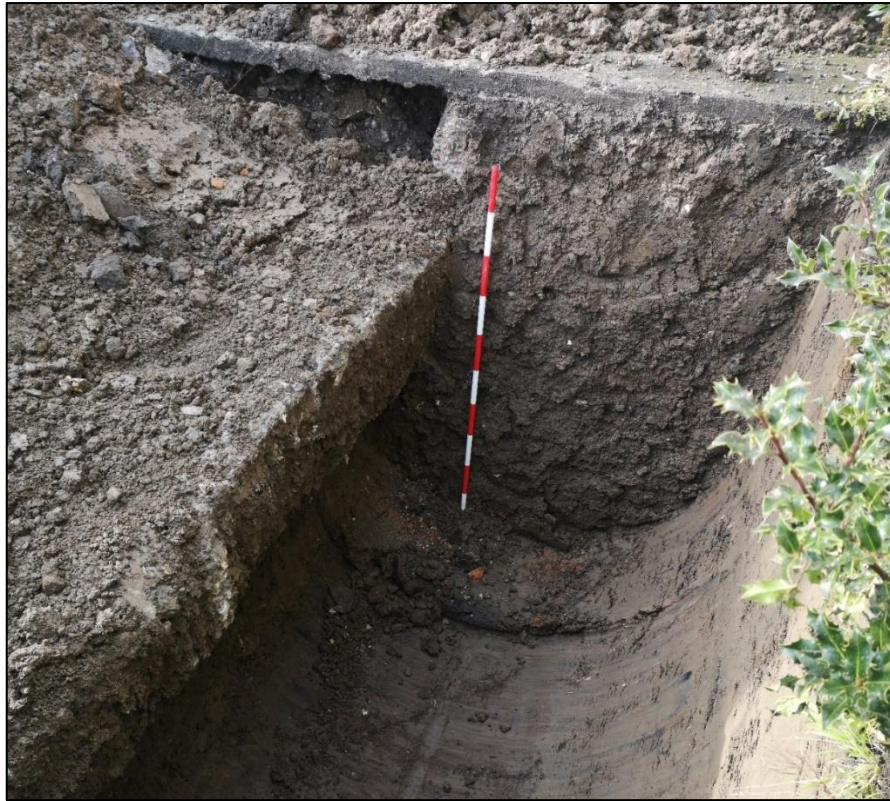
Plate 26 Test Pit 11 Section and original concrete surface, view to west

Test Pit	Dimensions	Findings
Test Pit 11	3m x 3m, depth 2.8m <i>Plate:26</i>	Approximately half of this test pit was taken up by a substantial modern concrete pad that follows the line of the current yard and associated red brick and concrete wall. In the north half of the test pit deposits excavated were the typical 19 th century, clay rich, slag free deposits found typically at lower levels throughout the site. The lack of industrial waste and working surfaces points to this area not being used for intensive industrial activity. Natural subsoil was not uncovered in this test pit.
Test Pit 12	3.5m x 4.2m, depth 3.3m <i>Plate:27</i>	A working surface that may be associated with the similar surface found in test pit 5, was revealed at 0.95m below ground level. Beneath this layer, more 19 th century industrial waste deposits were removed, a stained clay rich redeposit containing 18 th to 19 th century material was revealed at 1.7m deep, as well as a deposit of red brick occurred at a depth of 2.4m. A layer of possible natural clay subsoil that was odious was uncovered to a depth of 2.95m. Between 2.95m and 3.3m, highly odious, sandy river gravel was exposed. Overall the sequence of the deposits in this test pit resembles those found in pit 5, however the appearance and strong odour of the lowest deposits may indicate contamination.
