HOLY CROSS COLLEGE SHD

ENVIRONMENTAL IMPACT ASSESSMENT REPORT (EIAR) VOLUME 3 (APPENDICES)

Wintering Bird Survey Report
For a Proposed Strategic Housing Development
Lands at Clonliffe College, Clonliffe Road, Drumcondra, Dublin 3

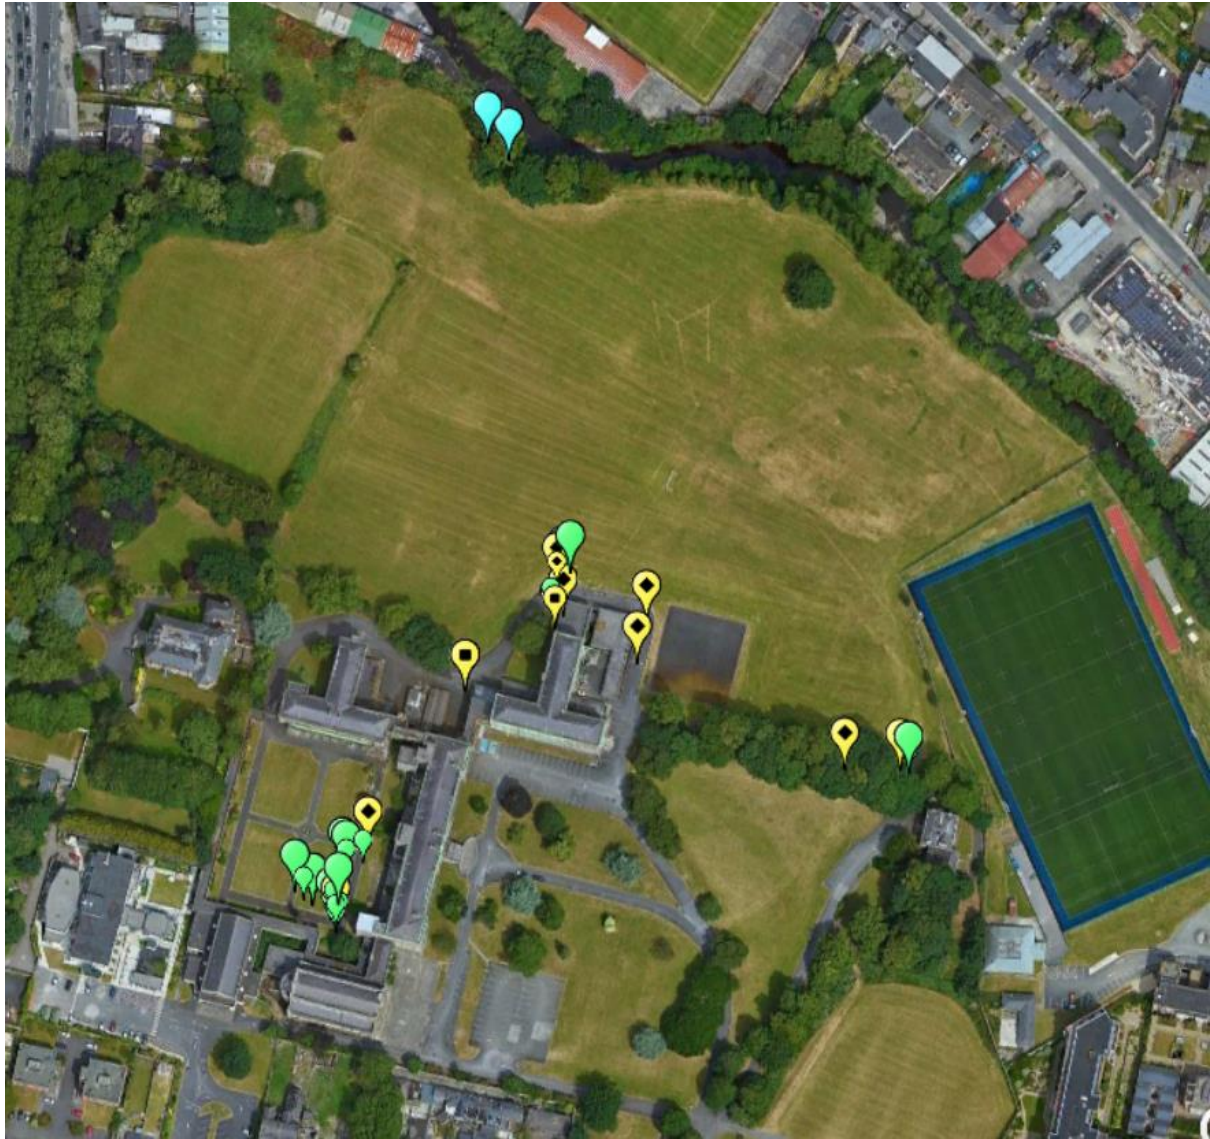
Common pipistrelle feeding route

Bat activity at Clonliffe College 30th June to 1st July 2020

Leisler's bats and common pipistrelles were noted in the area of the cloister primarily during the night but Leisler's bats were noted prior to sunrise at the northern buildings but were not seen to enter any building
