HOLY CROSS COLLEGE - STAGE 1 ROAD SAFETY AUDIT PREPARED BY BARRY TRANSPORTATION

Clonliffe Lands Development Access Junctions

Stage 1 Road Safety Audit

February 2021

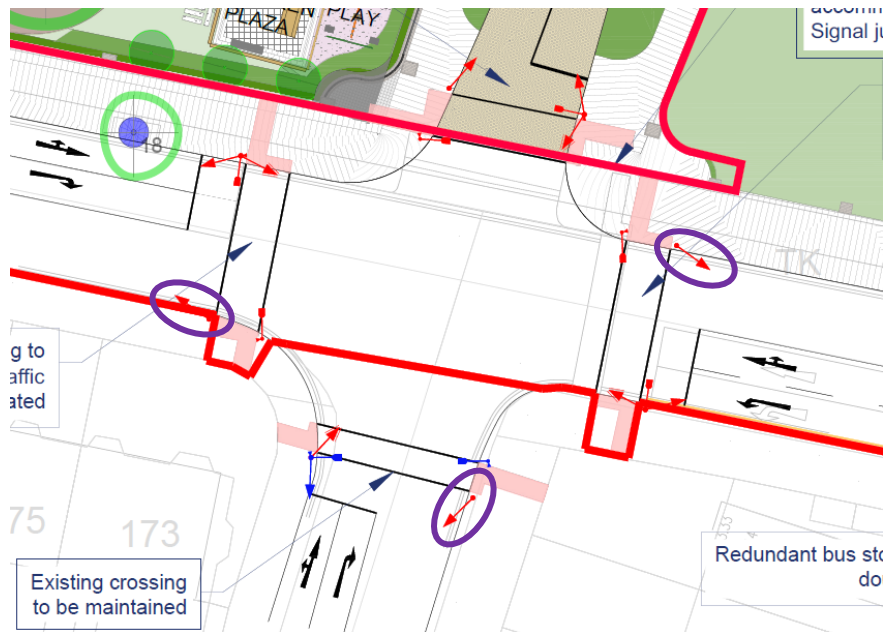
Figure 2.1: Secondary Primary Heads

2.1 Problem: Traffic Signals on Clonliffe Road and Jones Road

The proposed traffic signals at the Clonliffe Road / Jones' Road junction with the development are inconsistent with the traffic signal arrangement at similar nearby junctions within Dublin City Council. The proposed arrangement includes a primary head, secondary head and a second primary head for each arm. The second primary head is not required at a junction of this nature. See Figure 2.1 of the proposed arrangement and Figure 2.2 for examples of similar junctions near Clonliffe Road with no secondary primary head.

Recommendation

Remove the second primary head at the junction.

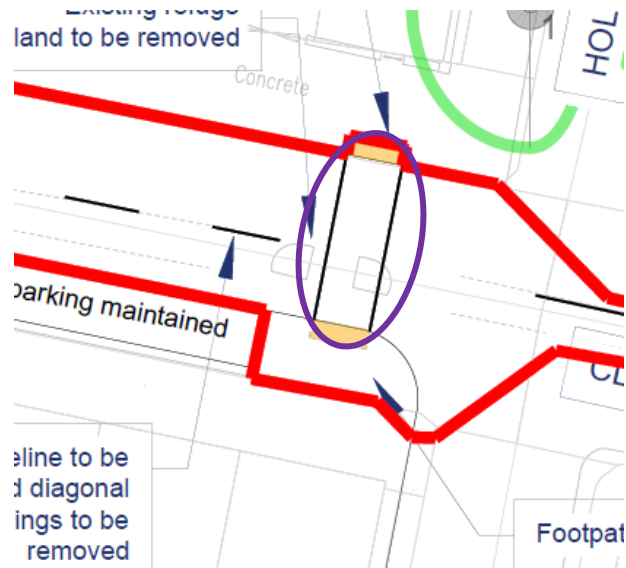
Figure 2.3: Incorrect Road Markings

2.5 Comment: Uncontrolled Crossing

Transverse road markings at the uncontrolled pedestrian crossing should be omitted in accordance with normal practice.

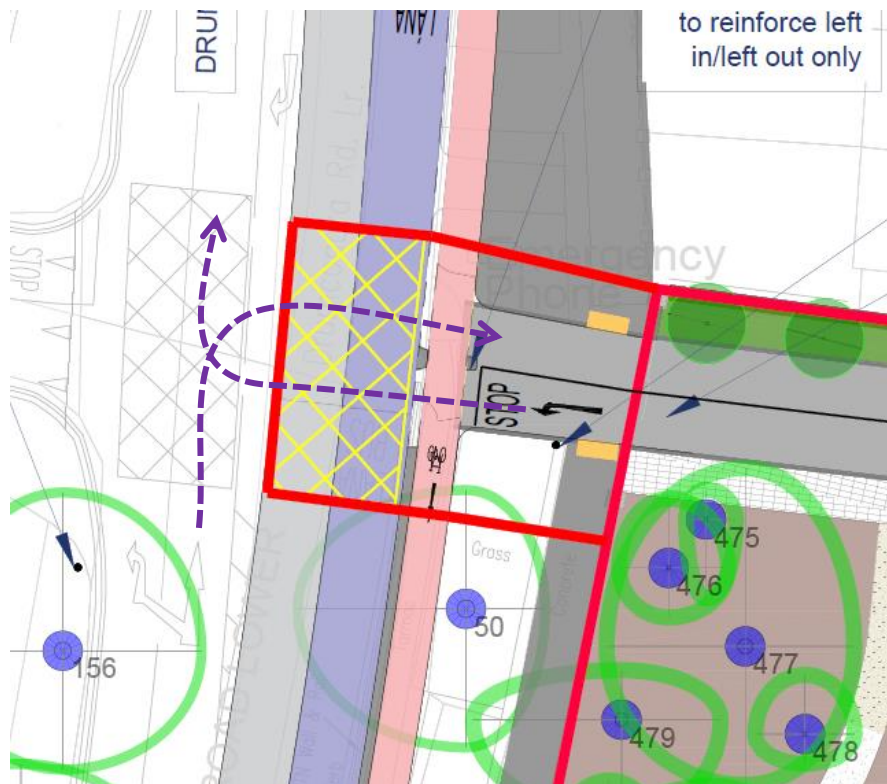
Figure 3.1: No secondary

3.1 Problem: Left In / Left Out

The proposed Left In and Left Out mountable island arrangement at Drumcondra Road does not make it obvious to drivers that they cannot turn right into or out of the development. Furthermore, the deflection island is not a sufficient physical deterrent for these movements. Drivers may disobey (or miss entirely) the signage and turn right in/out of the development or go straight across the junction to and from Hollybank Road with a subsequent high risk of vehicle conflicts.

Recommendation

Provide a larger deflection island, physically forcing vehicles to turn left out of the development, preventing vehicles from turning right or traversing to and from Hollybank Road. Alternatively, provision of a signalised junction would resolve safety issues here.

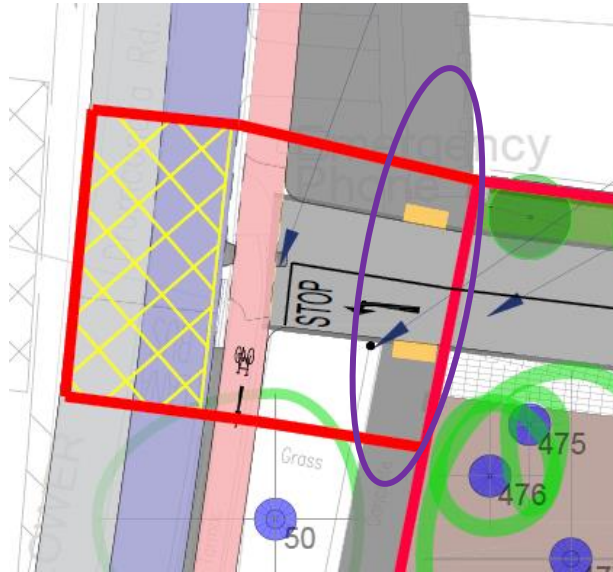
Figure 3.2: Restricted visibility on both sides.

3.2 Problem: Pedestrian Visibility

There will be restricted visibility of the Drumcondra Road Lower footpath due to the boundary walls for drivers exiting the development and this could lead to vehicle/pedestrian collisions. Additionally, there is no traffic calming proposed as part of the access road.

Recommendation

While it is acknowledged that there are restrictions in widening the existing wall opening at the junction to improve visibility, therefore an alternative acceptable solution would be to provide a pedestrian crossing ramp in the form of an entry treatment at the access. This would reinforce pedestrian priority and slow vehicles down. A lower height/slope kerb can be used so that the ramp is gentle and can facilitate a stop line.
