Arboricultural Assessment, Arboricultural Impact and Tree Protection Strategy Report

**Milltown Park,
Sandford Road,
Dublin 6**

Project No.	TSAN001	Date	24/08/21
Project Name	Proposed Residential Development, Milltown Park, Dublin 6	Revision	F

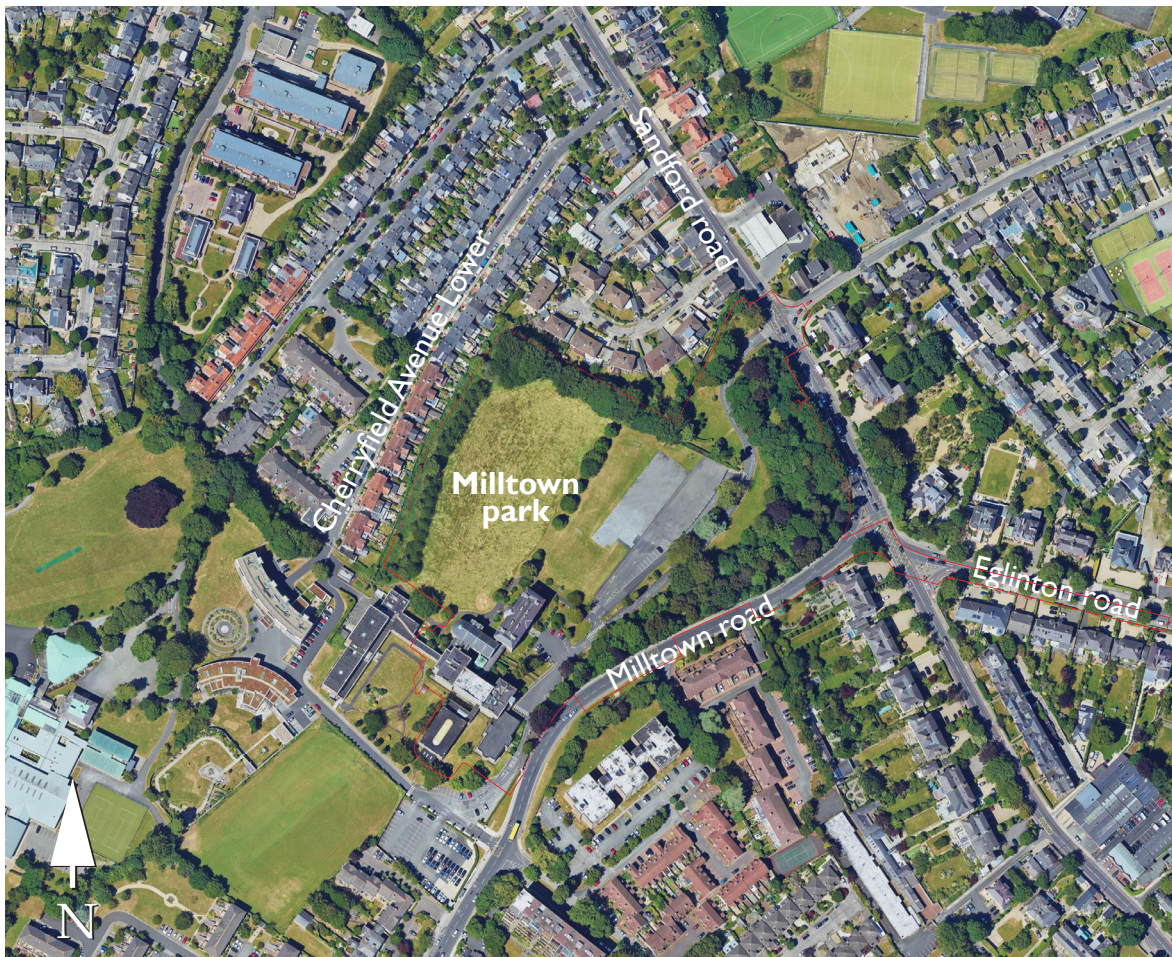
Image 1. Site overview with red line outline of survey boundary located at Milltown Park, Sandford Road, Dublin 6.

The site is located on part of the grounds of a former Jesuit college on Sandford Road, Dublin 6 (see image 1).

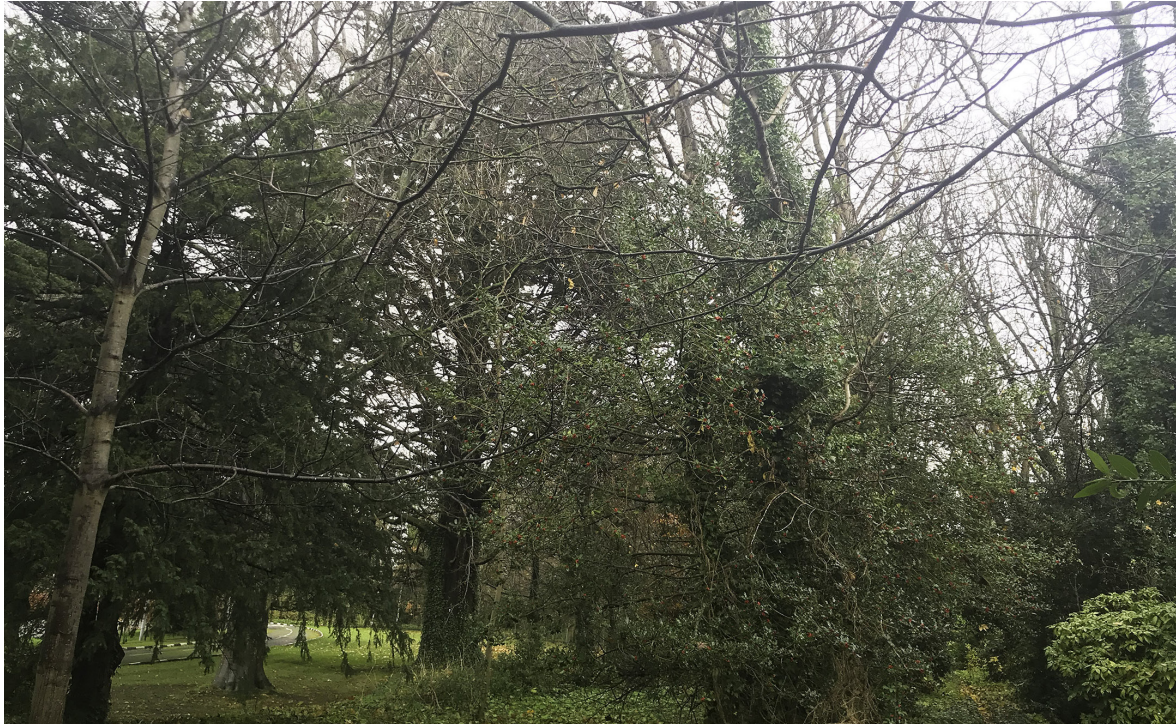
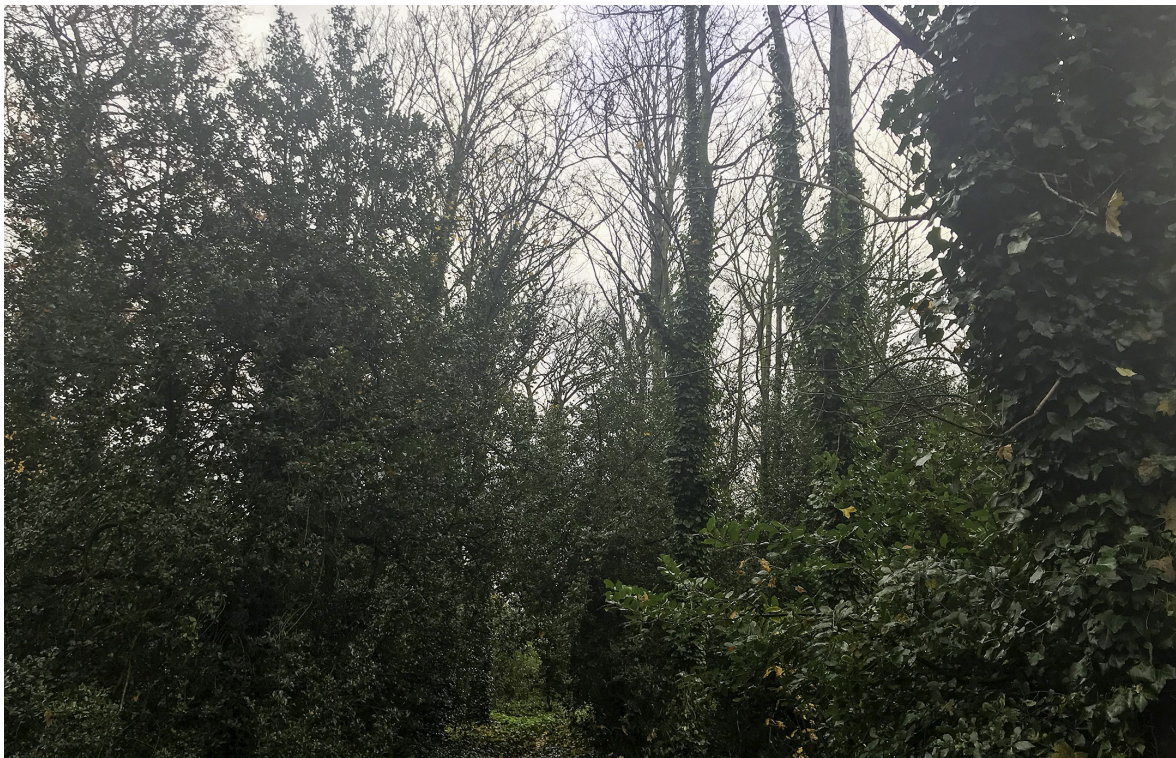
Image 2b & 2c. Wooded area of mixed age structure with a range of native, naturalised and exotic species present including ash, sycamore, birch, copper beech and coniferous species. General condition of trees good however thinning of trees could improve access and overall structure of planting, light permeability and ecological value.

Light is also restricted to the under-story with the result that the ground flora is mainly dominated by ivy (*Hedra helix*).

The sylvan quality of this section of the site would be greatly improved by the removal of the poorer specimen trees. This would allow more light to penetrate the canopy thereby increasing the biodiversity value of this area. The structure of the tree group as a whole would also be more robust following the removal of the poorer specimens.

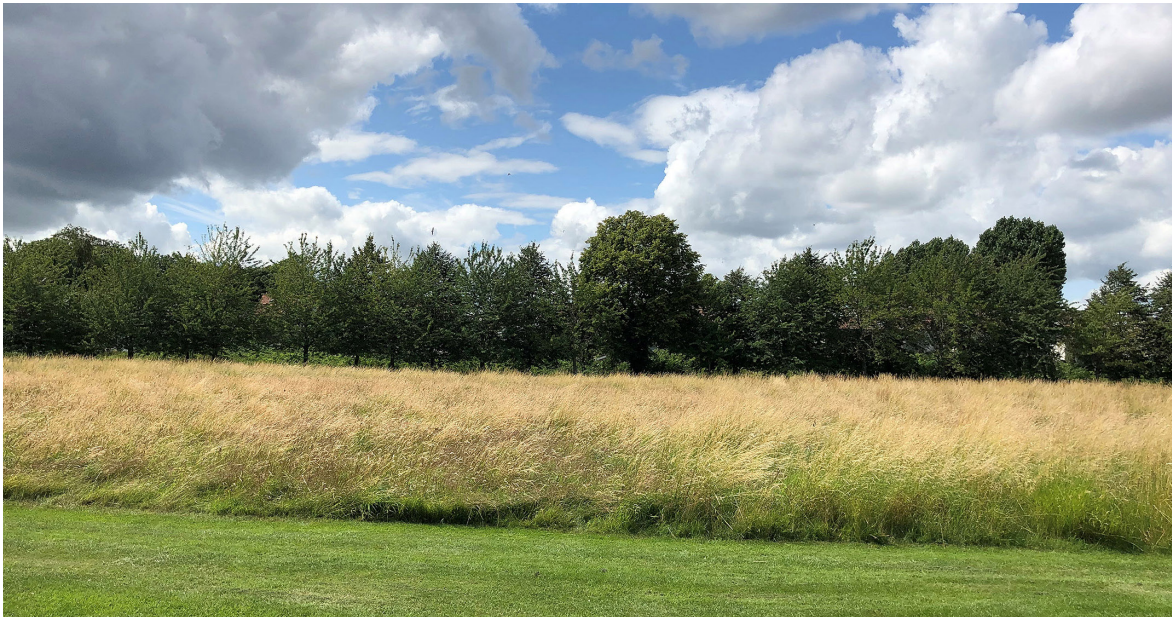
Image 3a. A double line of alternating limes and cherry cultivars providing screening to the rear of properties on Cherryfield Avenue Lower.

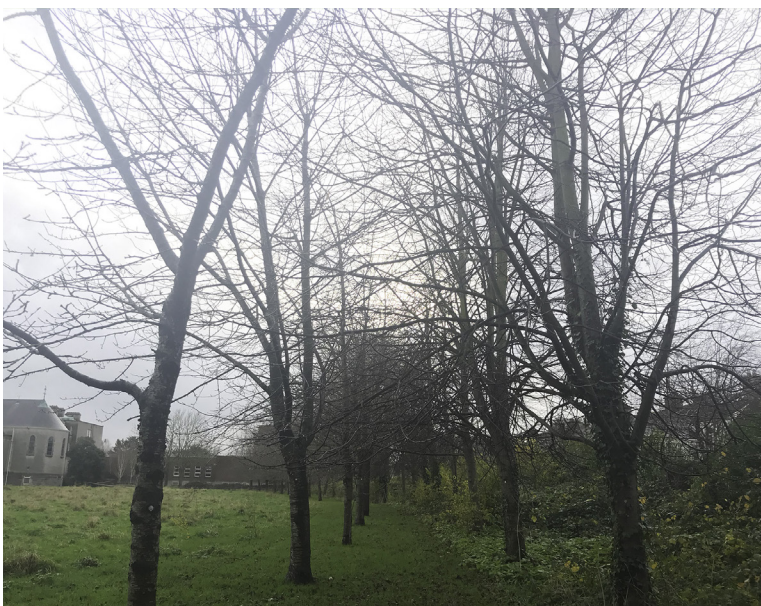
Image 3b. The same trees as above, in autumn. Many of these trees have suffered mower damage to roots which will limit their long-term potential.

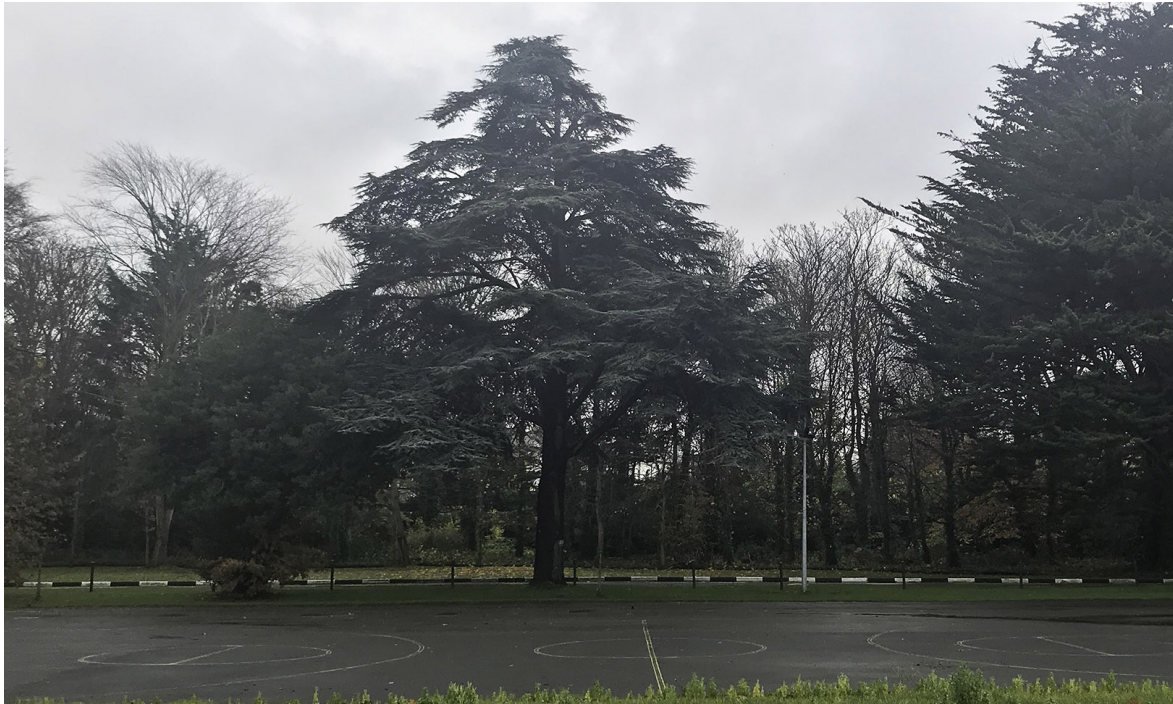
Image 4 Atlantic blue cedar (#110).

Some of the high value trees of note are the Atlantic blue cedar (*Cedrus atlantica* 'Glauca') which is located adjacent to the internal road near the centre of the site (image 4).

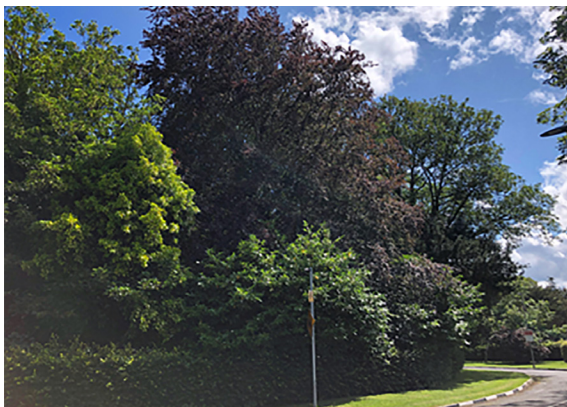
A number of mature sycamore, copper beech (*Fagus sylvatica* 'Purpurea') and lime trees at the entrance from Sandford Road provide a strong silvicultural setting at the entrance to the site (image 5).

Image 5. Mature high value trees at the entrance from Sandford Road.

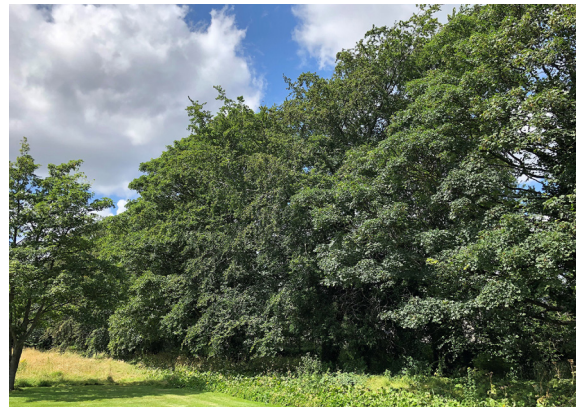
Of note are trees within the screen planting to the rear of Norwood Park. The planting includes a mixture of native and naturalised species including sycamore and beech (*Fagus sylvatica*) (image 6). The mature beech here are of high landscape value and are particularly valuable as a screen to and from the site.

Image 6. Mature beech and sycamore to the rear of Norwood Park properties.

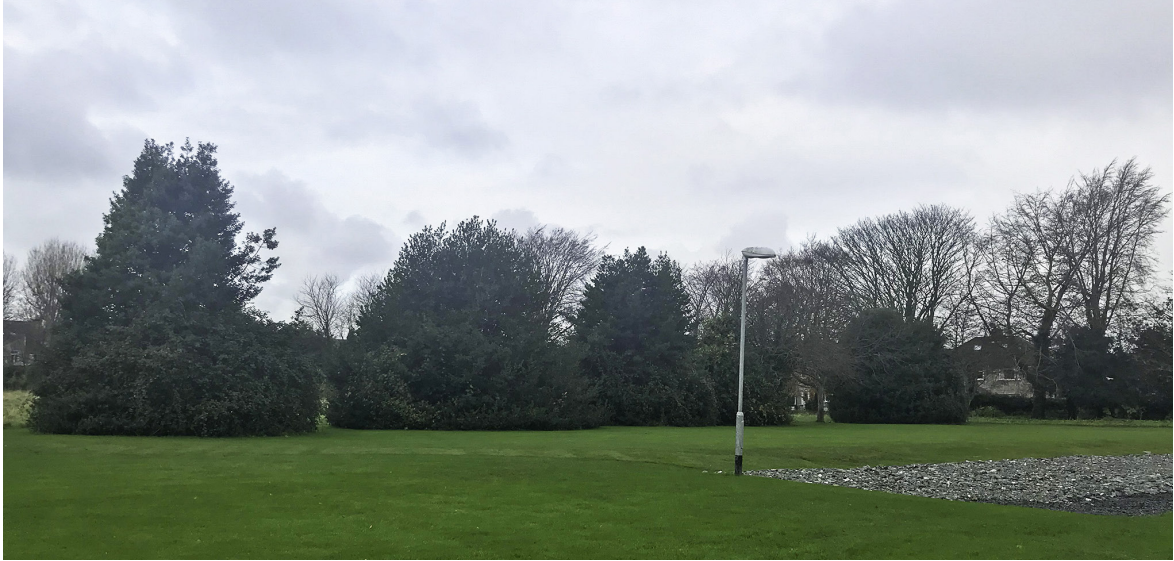
Image 7. A line of holly and lime within the lawn area are of moderate to low landscape value.

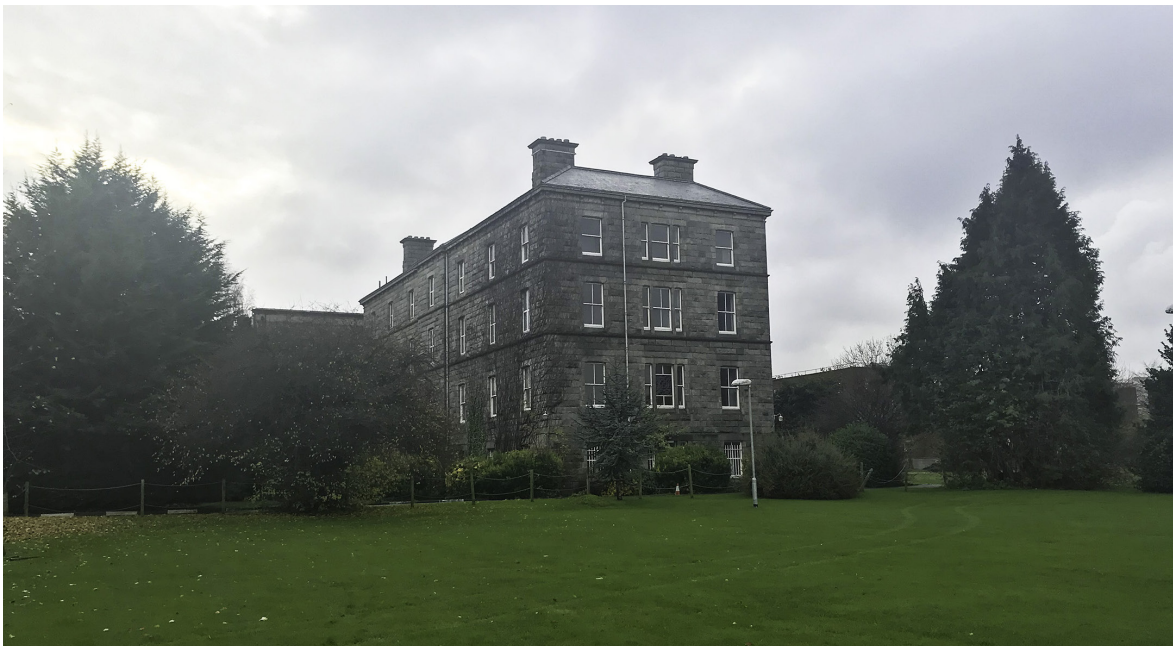
Image 8. Tabor House with mature Lawson cypress (#408) pictured right.

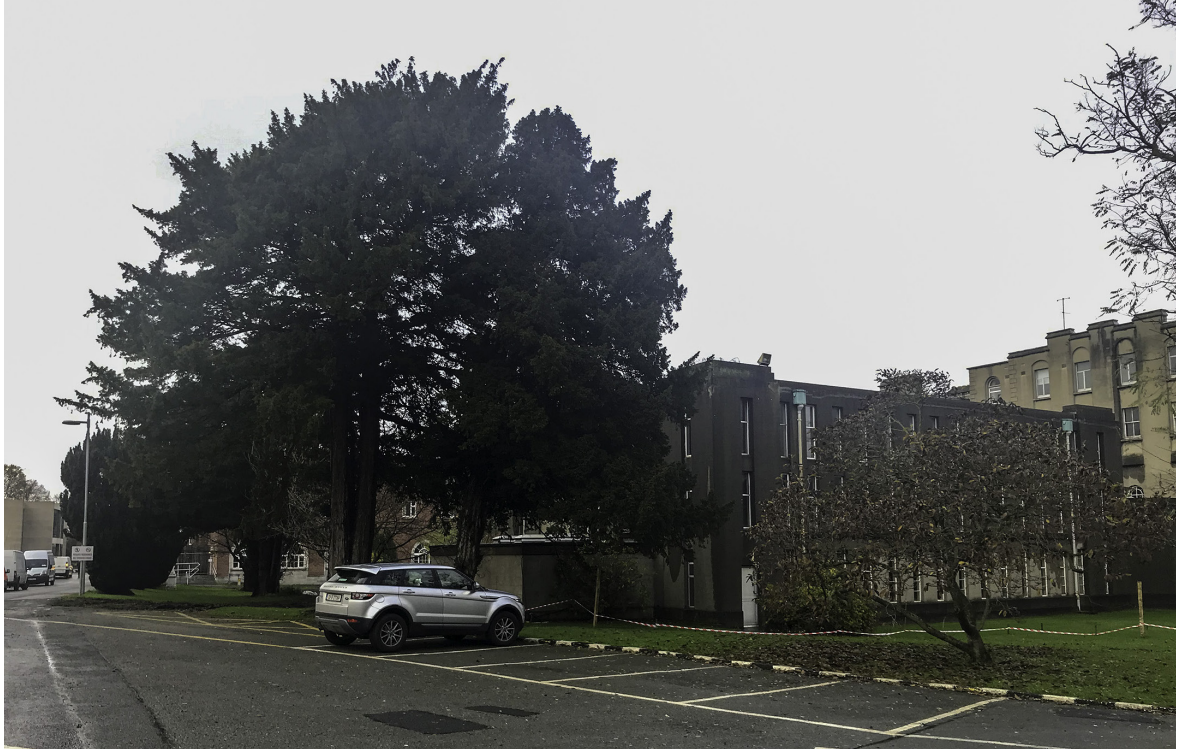
Image 9. Mature Yew pictured left adjacent to car park inside the entrance from Milltown Road, outside the southern site boundary.

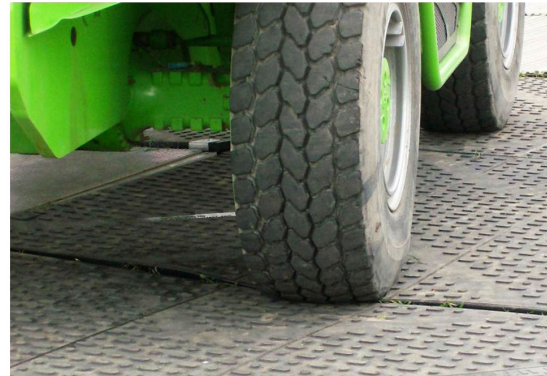
Image 10 Rola-Trac™ protective matting.

Protective matting such as Rola-Trac™ (image 10) will be placed over the initial work zone areas near tree root systems to mitigate any adverse effects from the presence of heavy machinery. These also have the benefit of protecting the soil from any potential works contaminants.

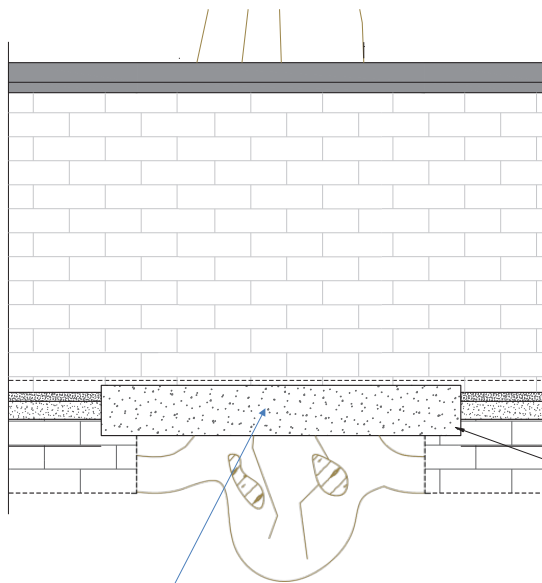
Concrete lintel over tree roots allows them to grow underneath it reducing damage to wall and roots system

Precast lintel with min. 1000mm length and min. 100mm bearing each side to be placed at level to suit a min. 50mm clearance to existing tree roots.

The ash trees #78, 79, hawthorn #81, False acacia #414, yew trees #416, 417, birch #421, 422, 424 & cherry #418 which have roots systems in proximity to proposed works. In consultation with site engineers, the proposed separation wall will be bridged to minimise root disturbance (example image 11). A preliminary investigation using hand tools/ AirSpade will be undertaken to identify root systems extents and locate optimal positions for bridging the separation wall. Refer to TSAN001 tree protection 107-109 for proposed locations.

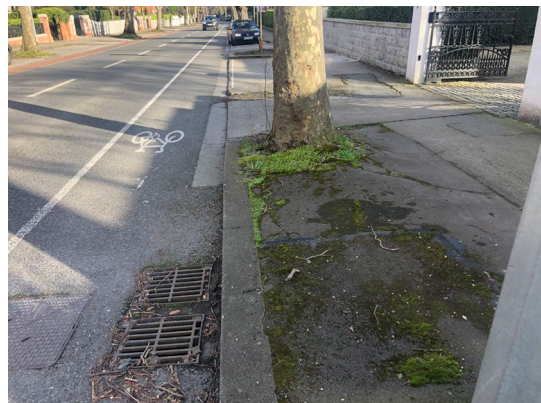
Image 3. Base of tree #607. Note bulging to tarmac from surface roots.

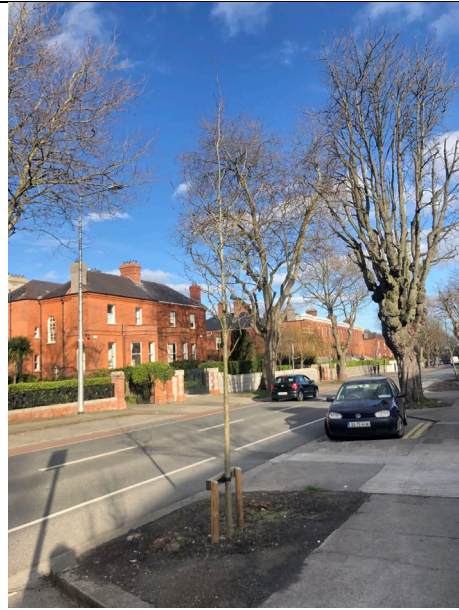
Tree number: 606A
Species: London plane
Age: Young
Height m: 4.5
Dbh mm: 100
Spread n,e,s,w. m: 0.45,0.45,0.45,0.45
Clear stem m: 6n
Commentary: Raised paving to east, south and west. Slight heave to kerb toward north but not significant.
Impact of proposed works: None
Recommendations: No actions necessary

Image 4. Recently planted untagged tree.

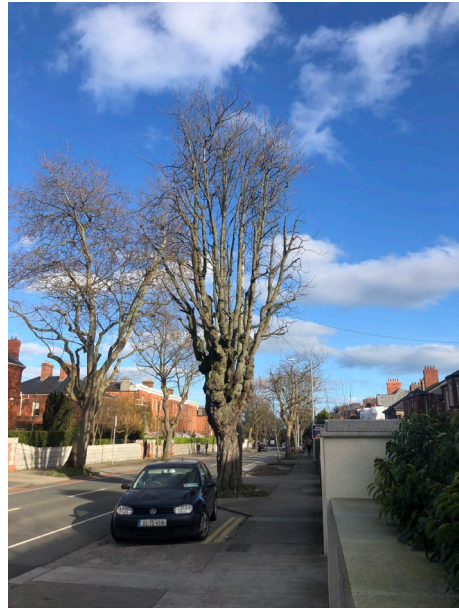
Image 5. Tree #605. Note high canopy clearance over road.

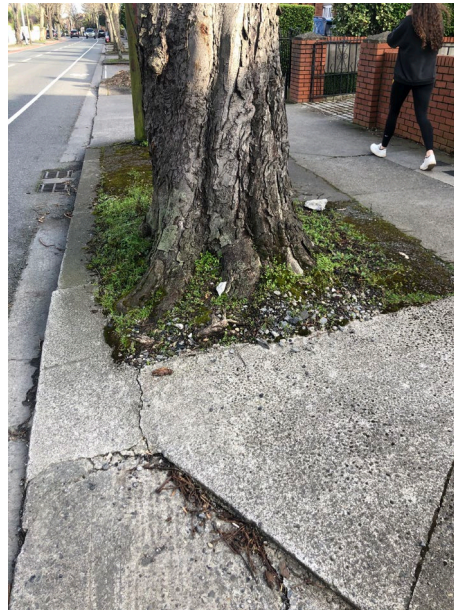
Image 6. Tree #605. Note bulging to paving and kerb

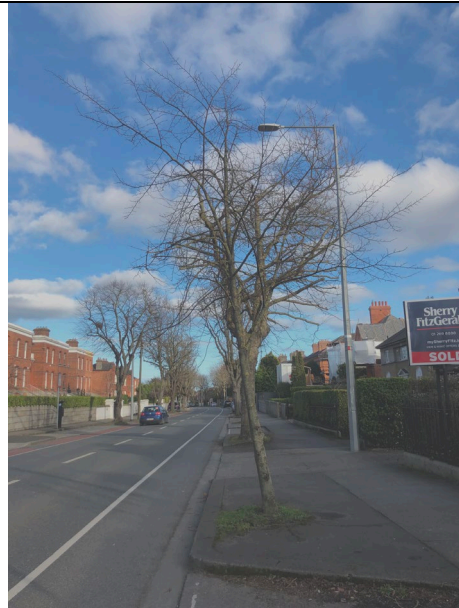
Tree number: 604
Species: Lime cultivar
Age: Young
Height m: 6
Dbh mm: 140
Spread n,e,s,w. m: 3,3,3,3
Clear stem m: 2n
Commentary: Set back 90cm from kerb. Possible root impact to tarmac to east & south west. Very unlikely roots under road.
Impact of proposed works: None
Recommendations: No actions necessary

Image 7. Tree #604 Note limited canopy spread over road.

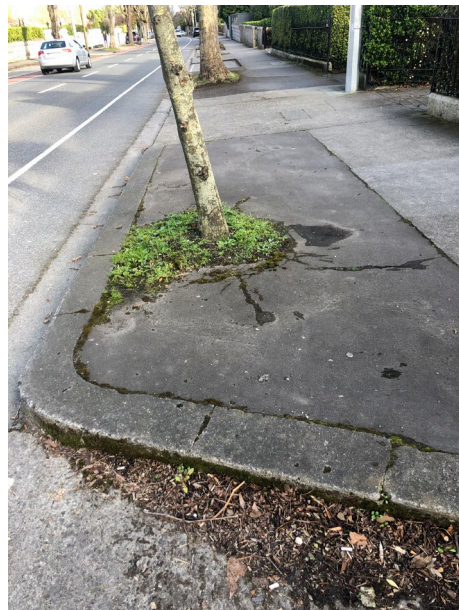
Image 8. Tree #604. Note bulging to tarmac surface.

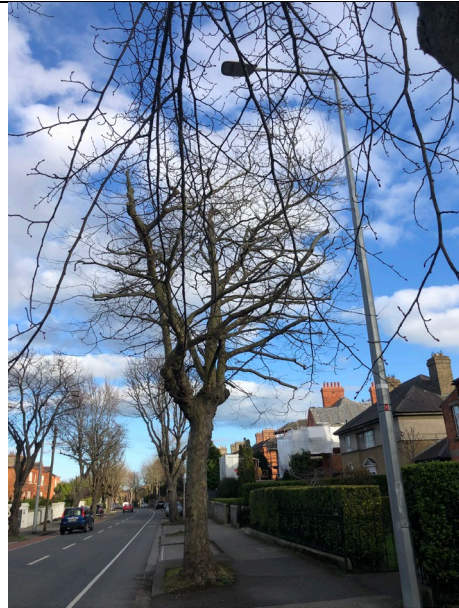
Tree number: 603
Species: London plane
Age: Mature
Height m: 11
Dbh mm: 340
Spread n,e,s,w. m: 5,7,7,5
Clear stem m: 7n
Commentary: Crown reduced to north. Kerb raised at base of tree to north very slightly. Tarmac bulging at base to south and west.
Impact of proposed works: None
Recommendations: No actions necessary

Image 9. Tree #603. Note crown reduction over road

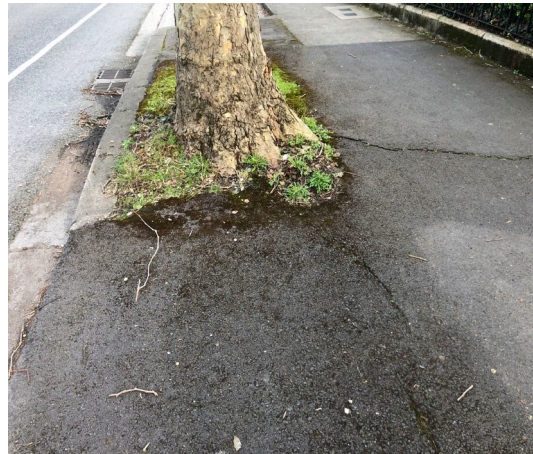
Image 10. Tree #603. Note bulging to tarmac from surface roots.

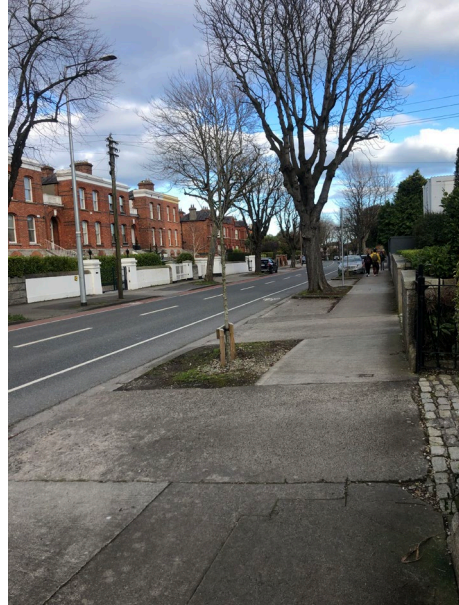
Tree number: 606B
Species: London plane
Age: Young
Height m: 5
Dbh mm: 50
Spread n,e,s,w. m: 0.5,0.5,0.5,0.5
Clear stem m: 2n
Commentary: Crown reduced to north. Kerb raised at base of tree to north very slightly. Tarmac bulging at base to south and west.
Impact of proposed works: None
Recommendations: No actions necessary

Image 11. Untagged young tree

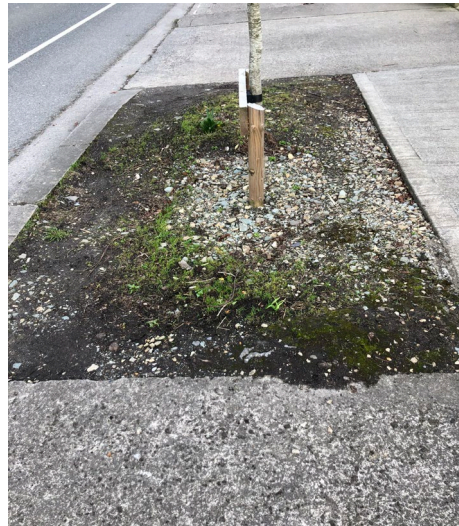
Image 12. Base of tree untagged tree. Note clearance from edge of road.

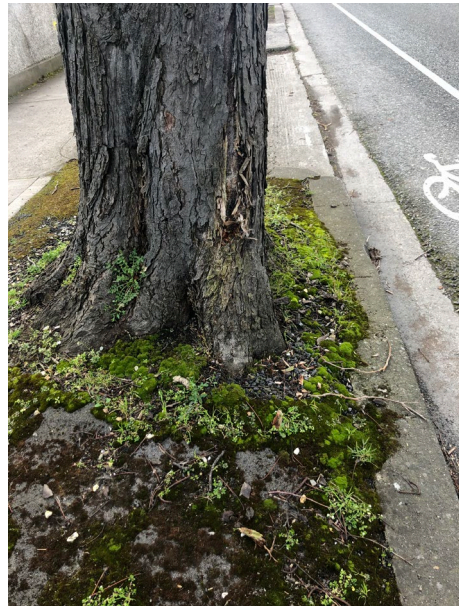
Image 14. Tree #601. Note bark damage at base of trunk.

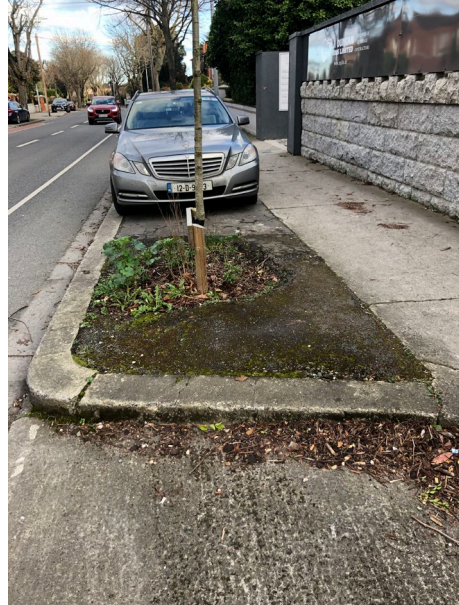
Tree number: 606C
Species: London plane
Age: Young
Height m: 5
Dbh mm: 50
Spread n,e,s,w. m: 0.5,0.5,0.5,0.5
Clear stem m: 2n
Commentary: A young specimen with no impact on surrounding paving.
Impact of proposed works: None
Recommendations: No actions necessary

Image 15. Untagged tree.

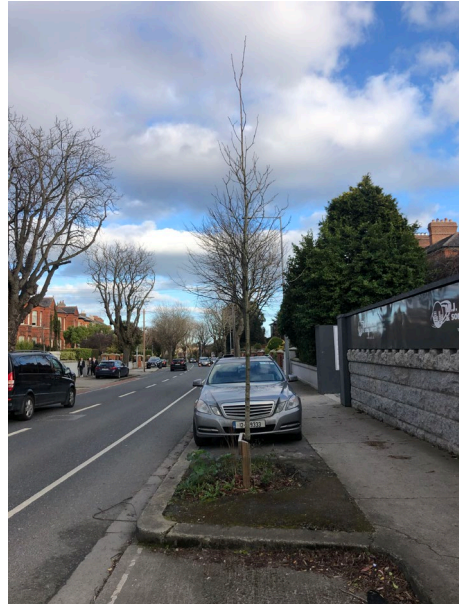
Image 16. Untagged young tree. Note distance from road edge.

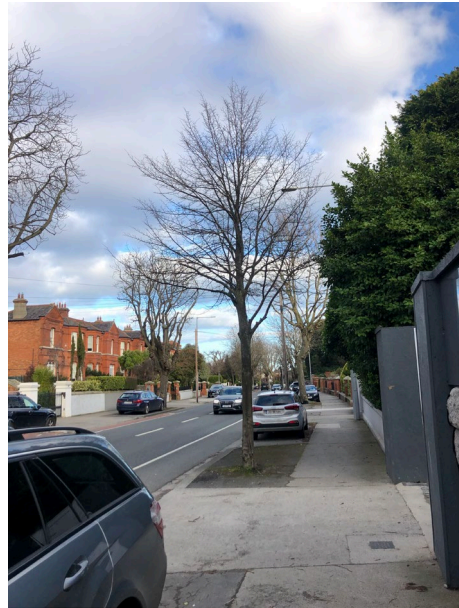
Tree number: 599
Species: Elm cultivar
Age: early-mature
Height m: 8
Dbh mm: 200
Spread n,e,s,w. m: 8,3,2,2
Clear stem m: 2n

Image 17. Tree #599. Note lower limbs over road.

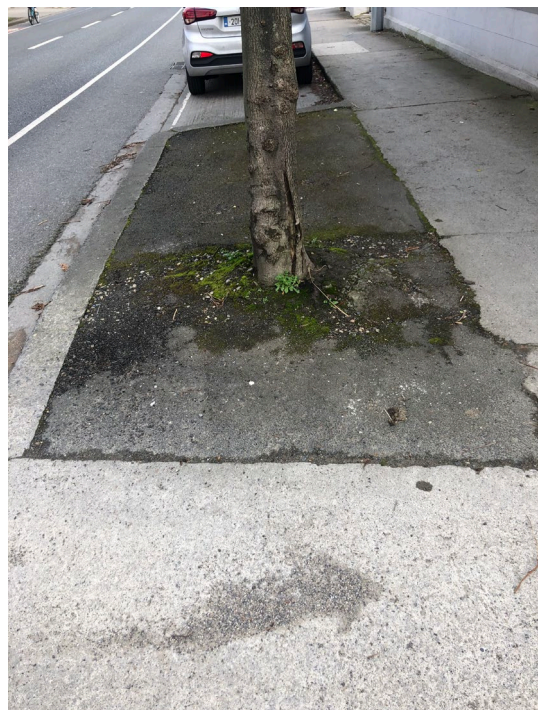
Image 18. Tree #599. Note bark damage as base of trunk.

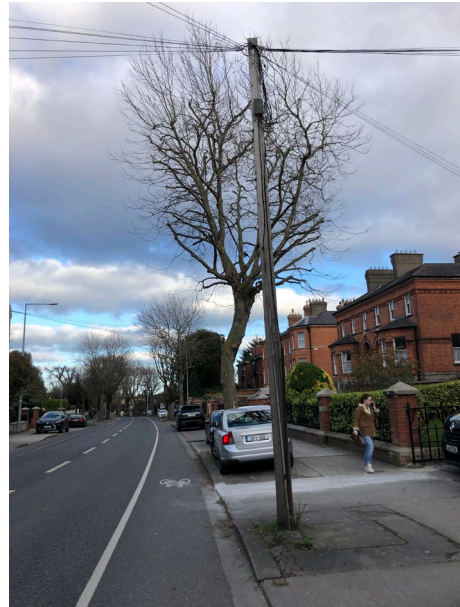
Tree number: 598
Species: London plane
Age: Mature
Height m: 15
Dbh mm: 470
Spread n,e,s,w. m: 4,6,6,5
Clear stem m: 6n
Commentary: Kerb raised very slightly to north.
No further impact on surrounding paving.
Impact of proposed works: None
Recommendations: No action necessary

Image 19. Tree #598. Note very high branch clearance over road.
