**Arboricultural Report
BS5837:2012 Trees in Relation to
Design, Demolition and Construction
-Recommendations**

Proposed Site: Huntstown, Dublin
Client: Huntstown Power Company

Job Reference: Mooretown Substation
Prepared by: Rik Pannett, C&G Arboriculture
Date: 21st July 2021

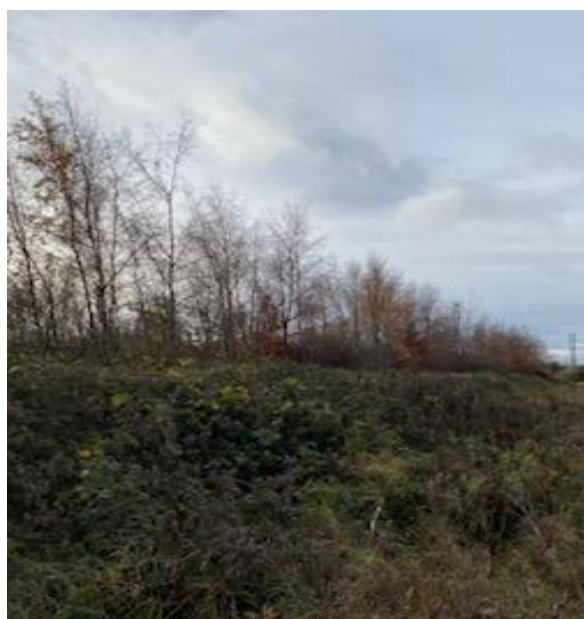
Fig 1. Shelter belt, South-Eastern corner

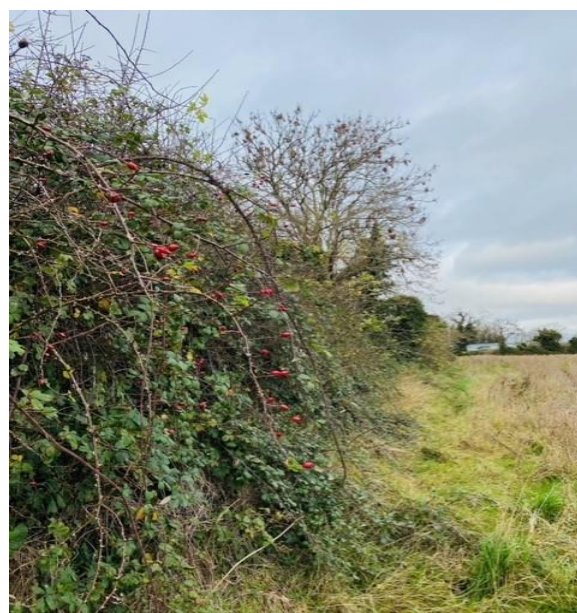
Fig 2. Hedgerow including ash T7

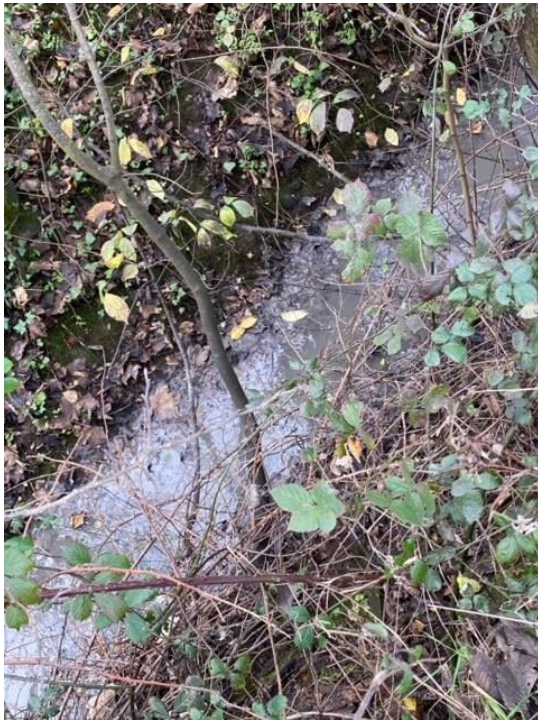
Fig 3. Drainage ditch

3.1 The survey area comprises broadly level arable land bordered and intersected by drainage ditches (Fig 4) adjoined by hedgerows of varying character. There are a number of native hedgerows (Fig 2), comprising an overstorey of Ash (*Fraxinus excelsior*), Wych Elm (*Ulmus glabra*) and Sycamore (*Acer pseudoplatanus*), with an understorey of Hawthorn (*Crataegus monogyna*), Blackthorn (*Prunus spinosa*), and Elder (*Sambucus nigra*). Bramble

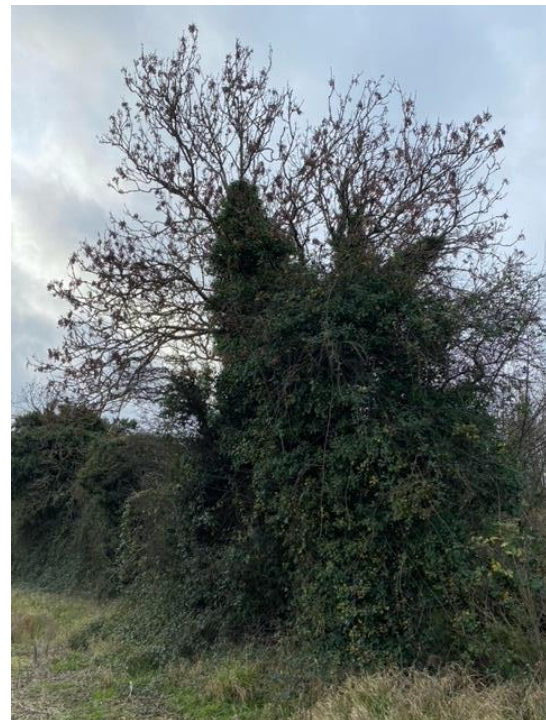
Fig 4. Ash, typical of many on site

There is limited visibility of the site from public roads. The trees are generally of small stature (Fig 4), and as such they offer minimal visual importance. The planned replanting of a wide variety of native trees and hedgerows will mitigate losses sustained during the development of the site as well as mitigating expected future losses due to ash dieback. The impact on retained trees, tree groups and hedgerows will be minimal if the development plans are carefully implemented according to the arboricultural method statement.

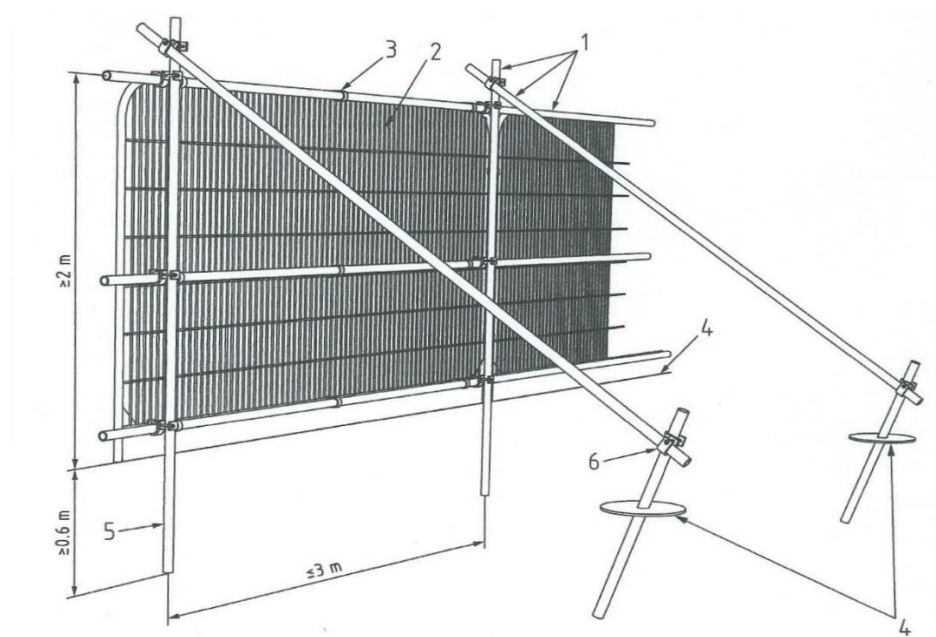
- 1 Standard scaffold poles
- 2 Heavy gauge 2m tall, galvanised tube & welded mesh infill panels
- 3 Panels secured to uprights & cross members with wire ties
- 4 Ground level
- 5 Uprights driven into the ground until secure (minimum depth 0.6m)
- 6 Standard scaffold clamps

Fig. 5: Protective barrier specifications

On completion of the tree works, protective fencing should be erected where required, as specified in the tree protection plan, in accordance with BS5837:2012 (fig. 5). Fencing is intended as a precaution to prevent accidental damage to the rooting area of retained trees. Hedgerows, and trees remote from construction can be protected using a lower specification of barrier such as Euromesh (fig. 6). The positioning of any fencing at the edge of the RPA is shown in the TPP as a pink line.

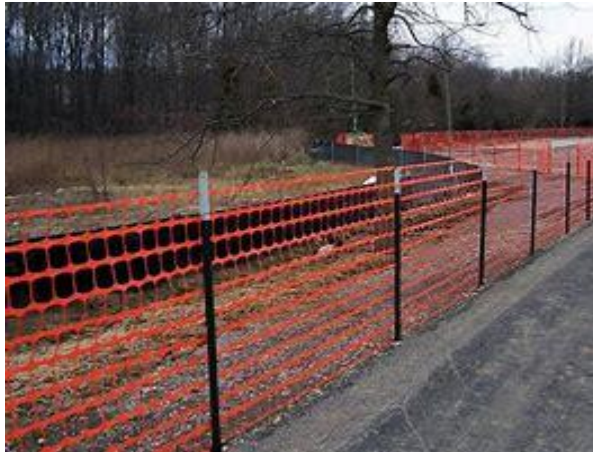
Fig. 6: Euromesh type fencing

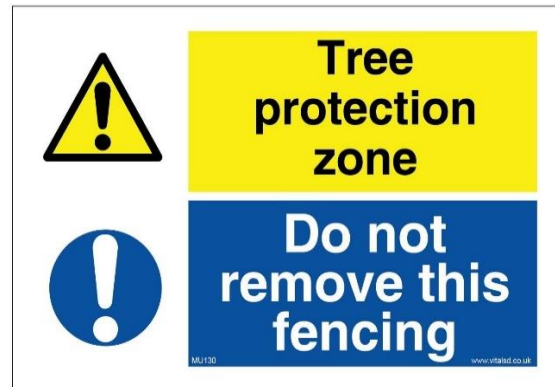
Fig. 7: signage to be affixed to fencing

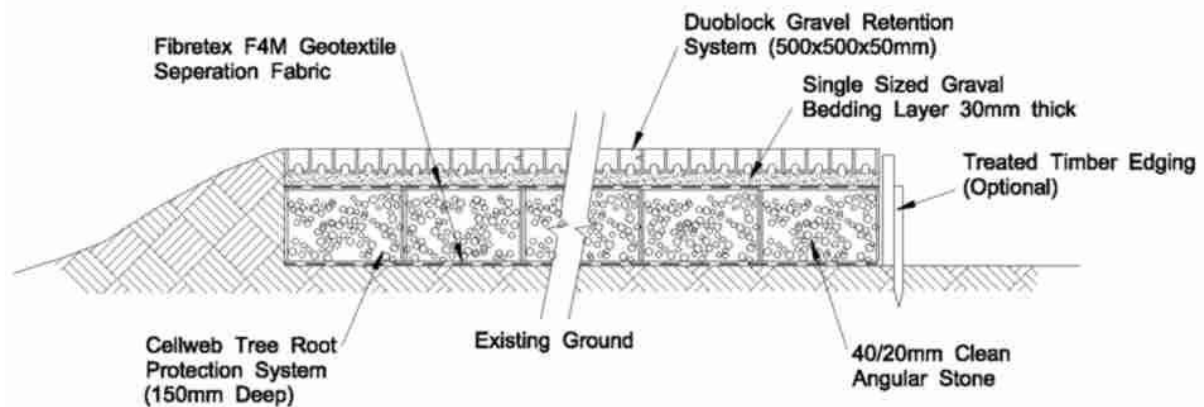
Construction of hard surfaces will incorporate a cellular no-dig solution such as Cellweb tree root protection (fig. 8) which will ensure that loads placed upon it are laterally dissipated rather than being transferred to the soil and root systems below ground.

The walls of the cellular structure are perforated and must be combined with the infill of clean angular stone, preferably of a single size (20-40mm) which will enable the passage of water and oxygen to the tree roots, ensuring their continued functioning and health.

Fig. 8: example of cellular no dig construction method.
