Title: **Stage 1 Road Safety Audit**

**Proposed Strategic Housing Development, Greenpark
Housing.**

Report reference: **1153R01**

Bruton Consulting Engineers Ltd

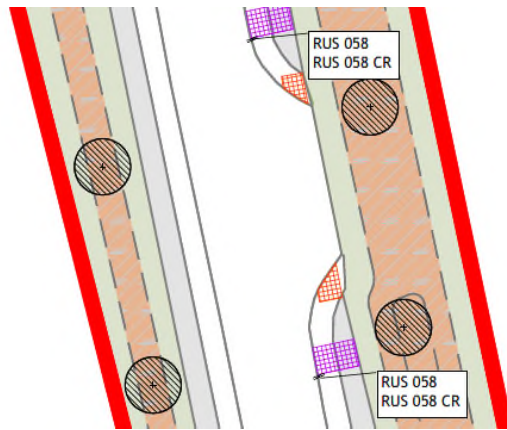
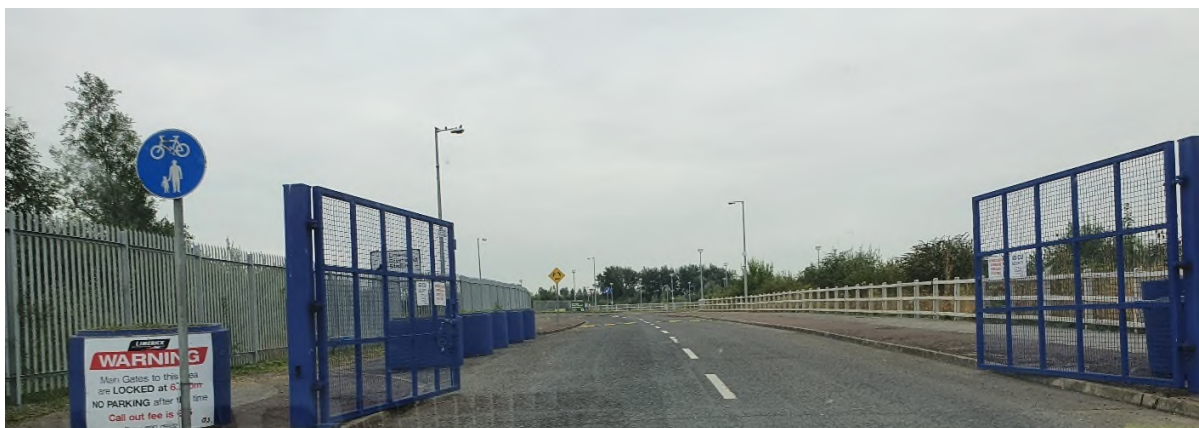
Drawing 191325- PUNCH-XX-XX-DR-C-0450 Rev PLO, Link Road.

The footpath and cycle track merge into a single shared use crossing point at the potential future access on the Link Road southbound between the Greenpark Roundabout and the Greyhound stadium roundabout. This could lead to collisions between cyclists and pedestrians as they have to share a narrow space.

It is recommended that the cycle track be brought on-road across the junction without a shared area for pedestrians.

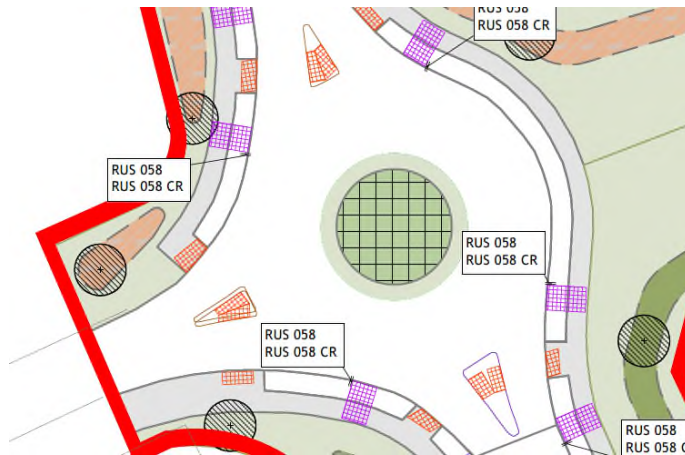
Drawing 191325- PUNCH-XX-XX-DR-C-0450 Rev PLO, Link Road.

Two of the splitter islands at the greyhound stadium roundabout appear to be too small to be able to provide safe refuge for cyclists and pedestrians. If the islands are not wide enough, pedestrians with bicycles or those pushing buggies may be struck by passing vehicles.

It is recommended that the traffic islands be made sufficiently large to cater for vulnerable road users.

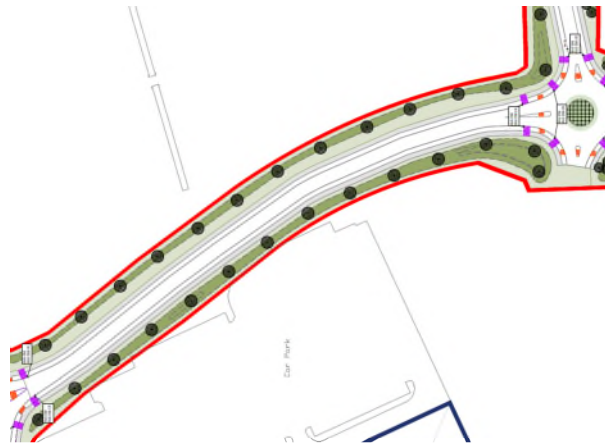
Drawing 191325- PUNCH-XX-XX-DR-C-0451 Rev PLO, Link Road.

There is a relatively long distance between the greyhound stadium roundabout and the proposed roundabout leading to the proposed residential development. This link also has a relatively straight alignment. There is a risk that drivers will travel at excessive speed along this section which could lead to high injury severity if a vulnerable road user is struck.

It is recommended that traffic calming be provided along this section of the Link Road.

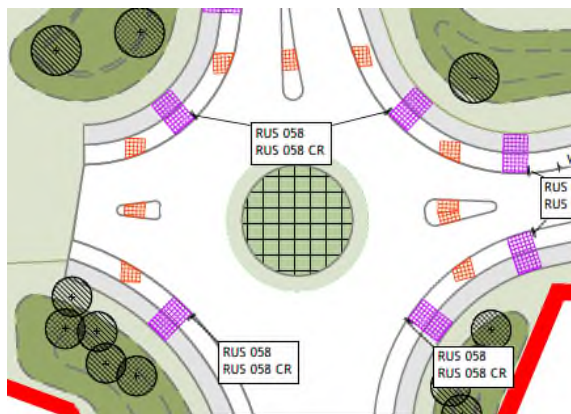
Drawing 191325- PUNCH-XX-XX-DR-C-0451 Rev PL0, Link Road.

The splitter islands at the proposed new roundabout appear to be too small to be able to provide safe refuge for cyclists and pedestrians. If the islands are not wide enough, pedestrians with bicycles or those pushing buggies may be struck by passing vehicles.

It is recommended that the splitter islands be made sufficiently large to cater for vulnerable road users.

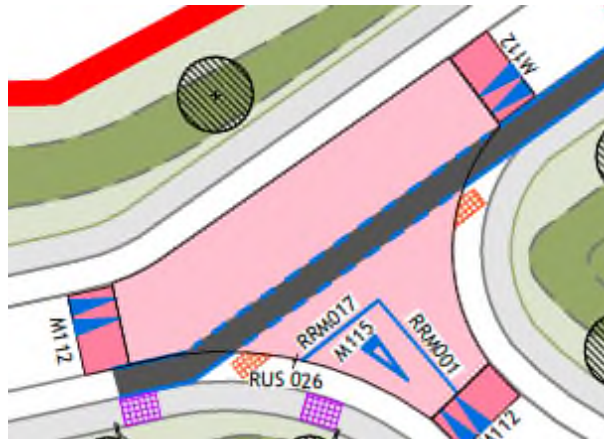
Drawing 191325- PUNCH-XX-XX-DR-C-0451 Rev PL0, Development Access from Link Road.

The corner radii at the junction into the proposed residential area are high. This could lead to high turning speeds and possible collisions with pedestrians and cyclists. It is also proposed to provide a yield control which would also lead to higher turning speeds.

It is recommended that tighter corner radii are provided in accordance with the guidance in DMURS and that a stop control is provided.

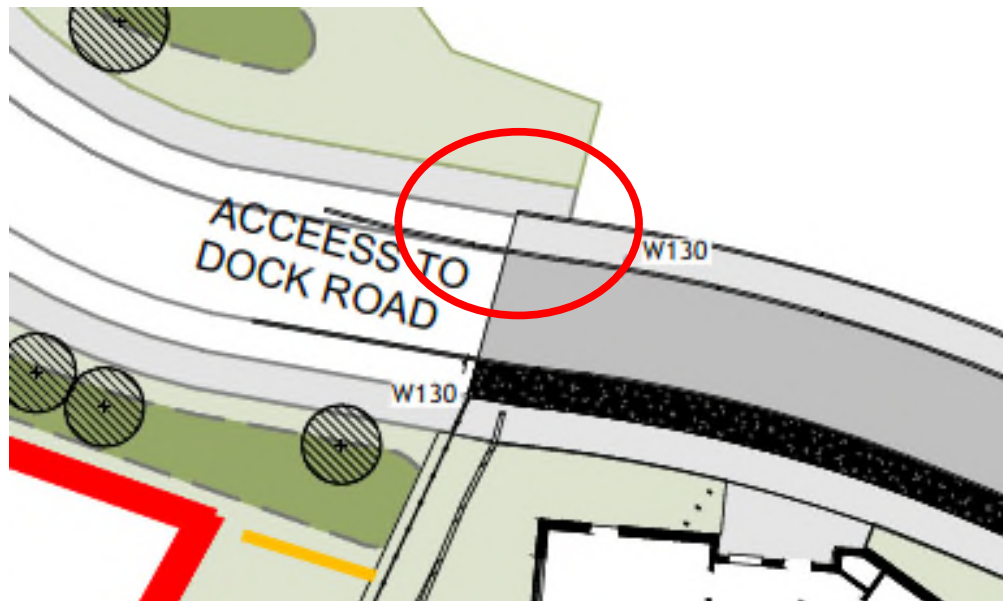
Drawing 191325- PUNCH-XX-XX-DR-C-0451 Rev PL0, cycle track provision in residential area.

There is a change in cross section at the main access road outside the creche. The cycle track terminates suddenly. This could lead to cyclists sharing the footpath with pedestrians which may lead to collisions between those two user groups due to a lack of space for both.

It is recommended that a consistent cross section to be provided along the main access road.

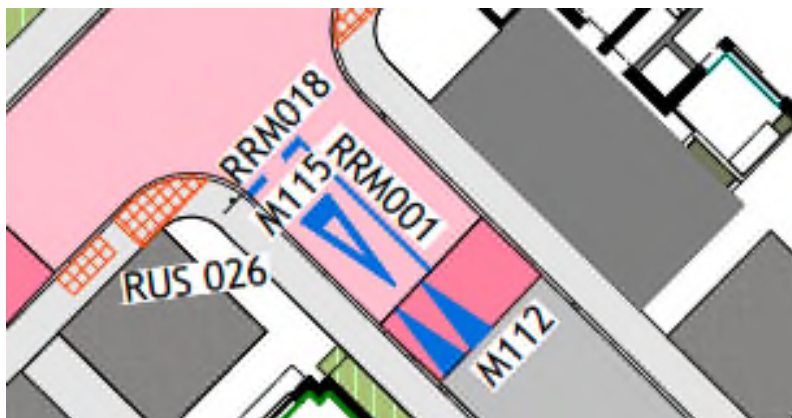
Drawing 191325- PUNCH-XX-XX-DR-C-0452 Rev PL0, throughout the scheme, yield control junctions.

It is proposed to provide yield control junctions throughout the scheme. This could lead to higher turning speeds and in turn higher injury severity if vulnerable road users are struck.

It is recommended that stop control be provided in lieu of yield control.

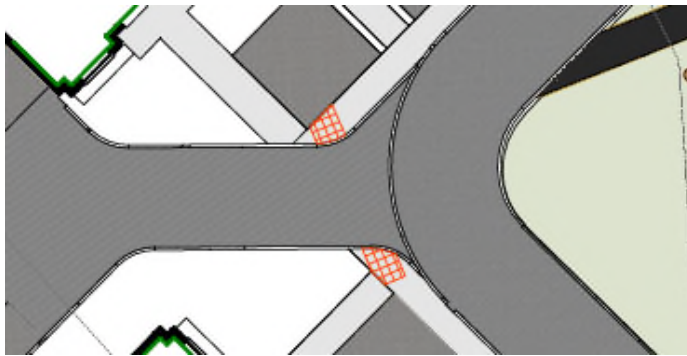
Drawing 191325- PUNCH-XX-XX-DR-C-0452 Rev PLO, The Paddocks.

It is proposed to provide vehicle access to 2 no. residential units at five of the corners of The Paddocks. At these accesses points the footpath is to be terminated and dropped kerbs and tactile paving provided. This gives priority to vehicular traffic which would be infrequent. It is anticipated that this area will be used regularly by children playing. Drivers may not anticipate pedestrians to cross and this may lead to a higher likelihood of a collision.

It is recommended that pedestrians be given priority and that the footpaths be made continuous with drivers having to stop and check for crossing pedestrians.

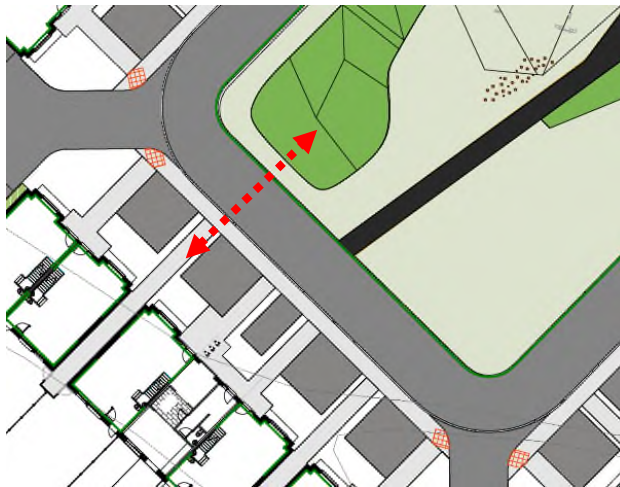
Drawing 191325- PUNCH-XX-XX-DR-C-0452 Rev PLO, The Paddocks.

There is no provision for pedestrians to cross into the green areas at The Paddocks. The high kerbs may lead to accessibility for some mobility impaired pedestrians and may lead to trips and falls for others.

It is recommended that uncontrolled pedestrian crossing points be provided from the surrounding footpaths to the green areas.

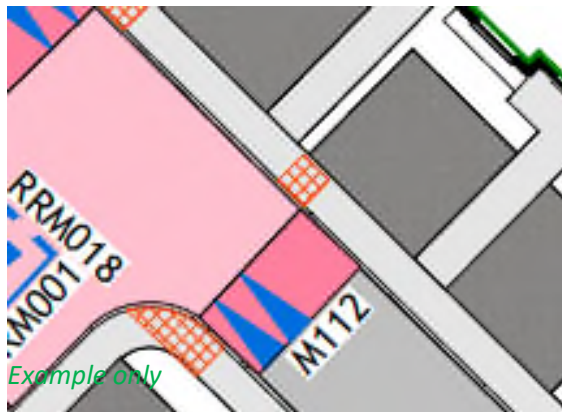
Drawing 191325- PUNCH-XX-XX-DR-C-0452 Rev PL0, General Item, uncontrolled crossing areas.

There are uncontrolled pedestrian crossings at each of the raised tables at internal junctions within the development. At some locations the uncontrolled crossings are where vehicles will be reversing out of curtilage parking spaces. This may lead to collisions with small children who attempt to cross at the crossing point and vehicles whose drivers cannot see them in their mirrors. In addition, the tactile paving may not be capable of taking vehicular loading and may crack in time leading to trip hazards for pedestrians.

It is recommended that the crossing points be away from area where drivers will be reversing.

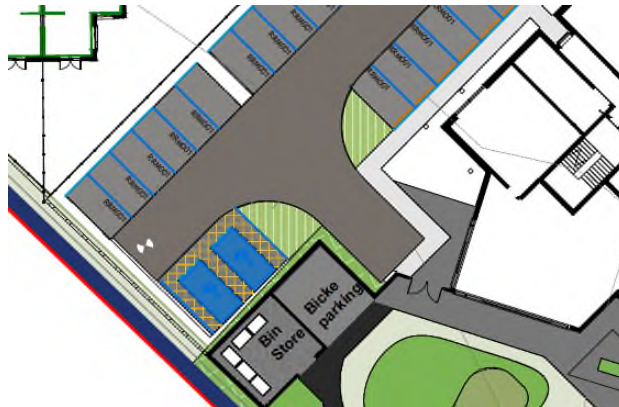
Drawing 191325- PUNCH-XX-XX-DR-C-0452 Rev PLO, Disabled parking spaces at the apartment block.

There are 2 no. disabled parking spaces at the turning head along the apartment block. It is unclear if the occupants of those spaces will have a route without kerbs or hard surfacing to get to the main access of the apartment block. Without a suitable route for the mobility impaired drivers may have to park elsewhere which may block pedestrian routes.

It is recommended that access to the apartment block from the disabled parking spaces be provided as per the guidance in Technical Guidance Document of Part M of the Building Regulations.

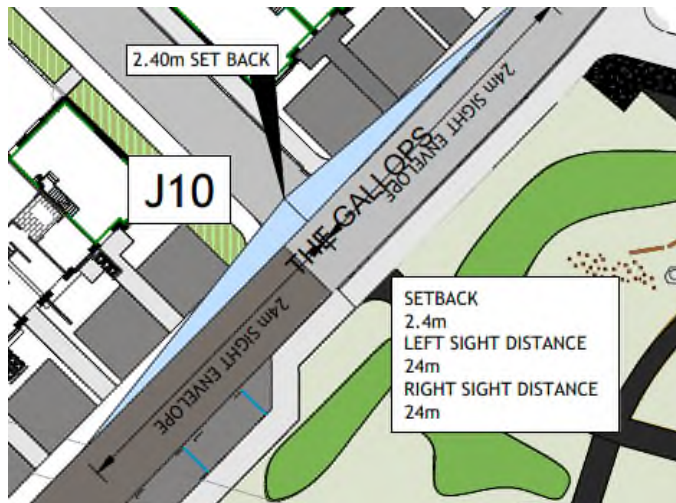
Drawing 191325- PUNCH-XX-XX-DR-C-0750 Rev PLO, J10 Sightlines.

The visibility envelope at J10 intersects with the curtilage parking spaces for the residential unit to the left. This could lead to a lack of visibility for exiting drivers if the parking spaces are occupied by high vehicles such as vans or hatchback SUVs.

It is recommended that the visibility envelope be kept clear of obstructions.

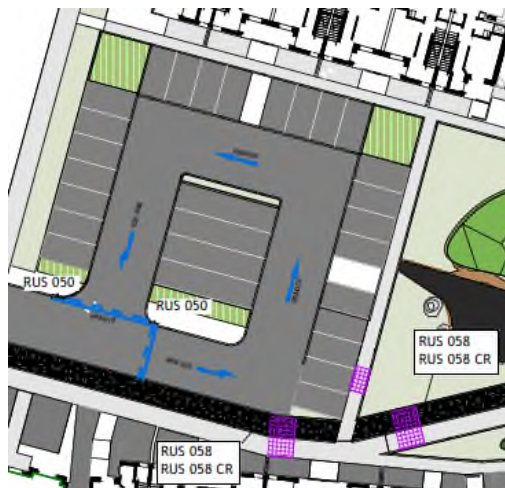
Drawing 191325- PUNCH-XX-XX-DR-C-0453 Rev PL0, Parking area adjacent to Greenpark Avenue.

There is a proposed one way circulatory route around the car park close to the Greenpark Avenue connection. There is a high likelihood that drivers will enter the wrong way leading to head-on collisions as the natural instinct would be to turn at the first access point and travel clockwise.

It is recommended that one way system be reversed.

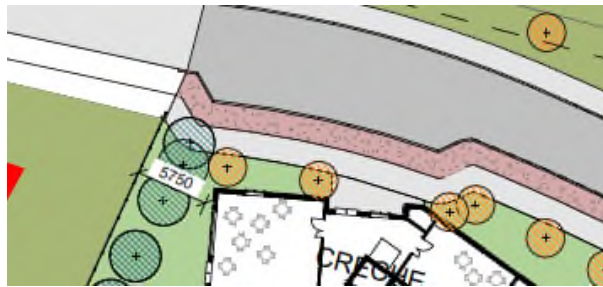
Drawing20133-RAU-ZZ-ZZ-DR-A-02.1004 Rev A

This drawing shows a set down area outside the creche. The set down area is along the cycle track. There could be collisions between cyclists and opening doors from parked cars.

It is recommended that a shared area be provided along the set down and that a buffer zone be provided between the parked cars and the shared use area.

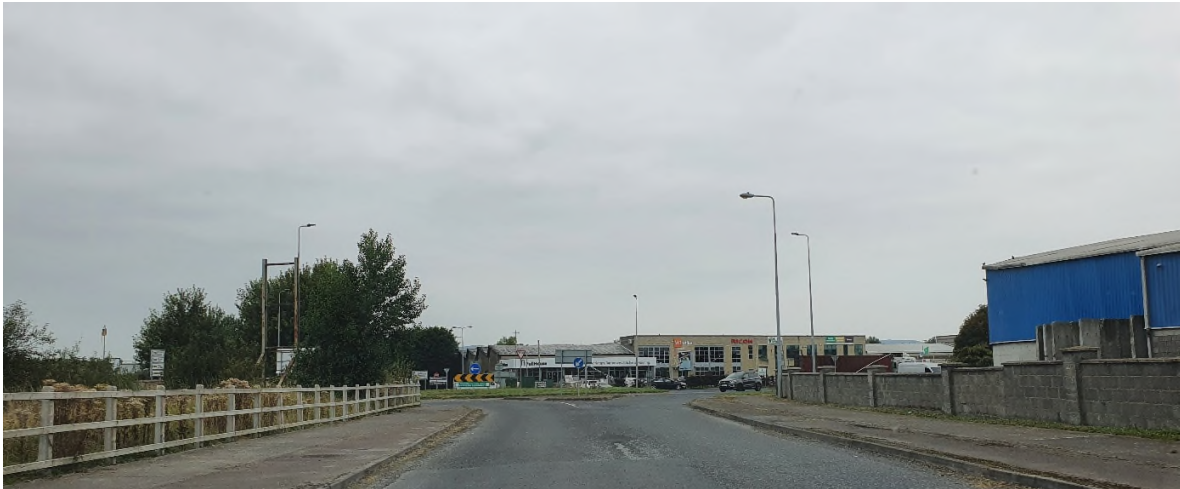
Site visit observation, existing road from Greenpark roundabout.

The quality of the existing road/footway and cycle track from the Greenpark roundabout to the gates is relatively poor including settlement at chambers and trip hazards for vulnerable road users. The skid resistance of the surfacing course may not be adequate which could lead to overshoot of the roundabout or failure to stop in time if brakes have to be applied suddenly.

It is recommended that suitable repairs and resurfacing be carried out along this section.
