rEiAR Non-Technical Summary

**FOR
SAND AND GRAVEL QUARRY
AT
Maplestown, Co. Carlow**

NOVEMBER 2021

**ON BEHALF OF
MARK PHELAN**

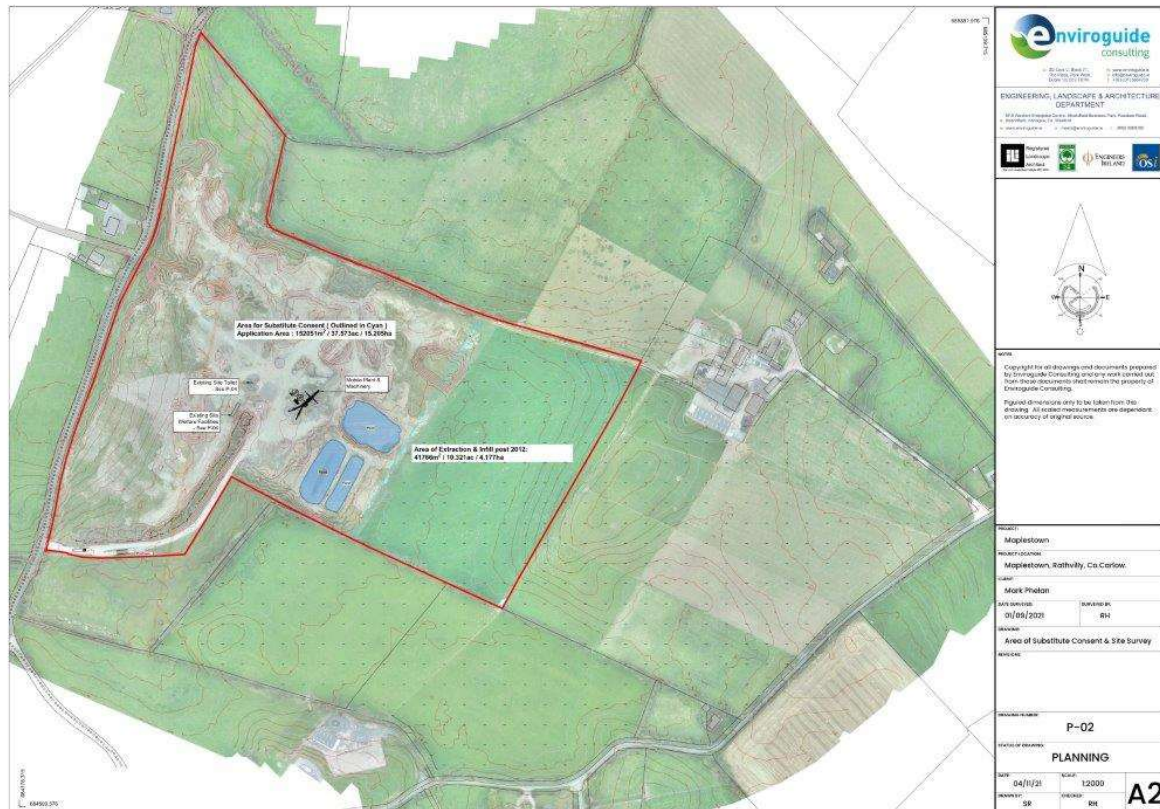
Figure 3-2: Area of Unauthorised Development for which Substitute Consent is Required (Drawing No. P-02)

The proposed area of extraction occupied an inverted L-shaped area measuring approximately 454 m east to west by 355m and 255 m north to south at its maximum and minimum respectively. The area is shown in Figure 3-2 below outlined in Cyan:

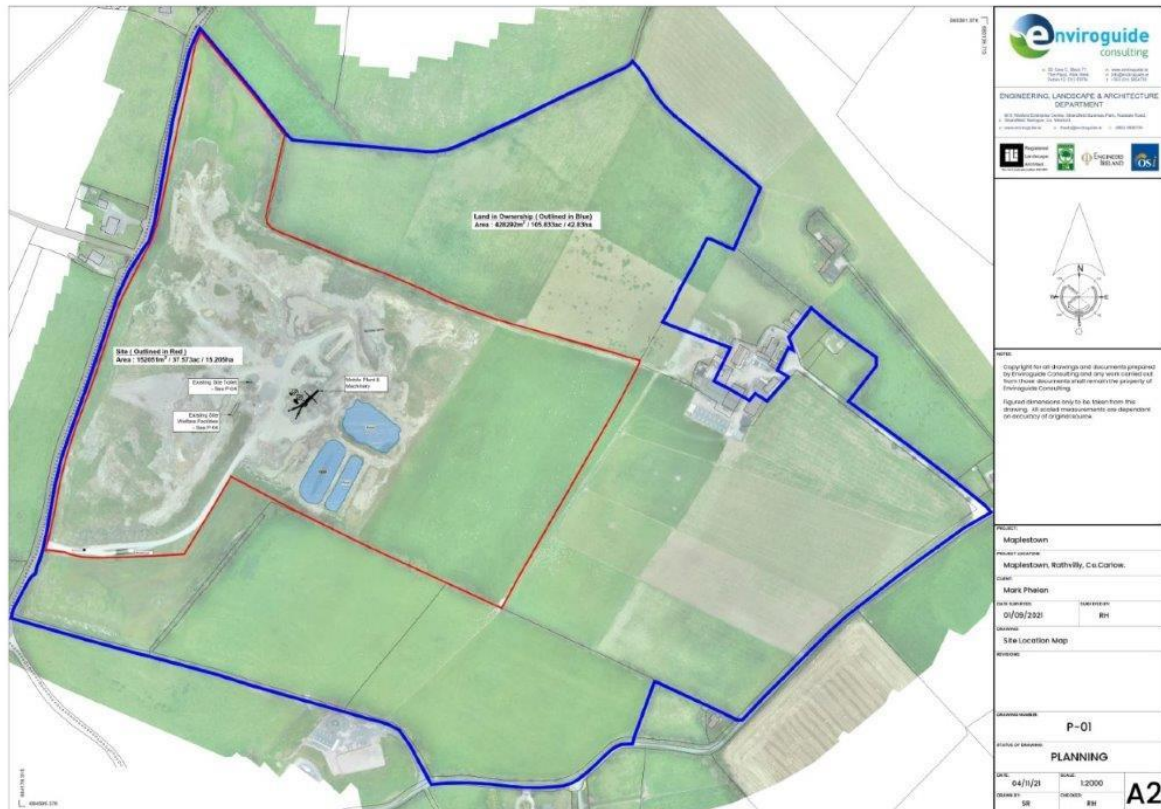
Figure 5-2: Overall Site Layout (Drawing No. P-01)

The overall Site area is 15.21 hectares (ha) and is shown on Figure 2-2 outlined in Red which contains an area of land which was quarried and infilled outside of the granted planning permission period (4.18 ha) for which substitute consent is being sought (refer to Figure 2-3).

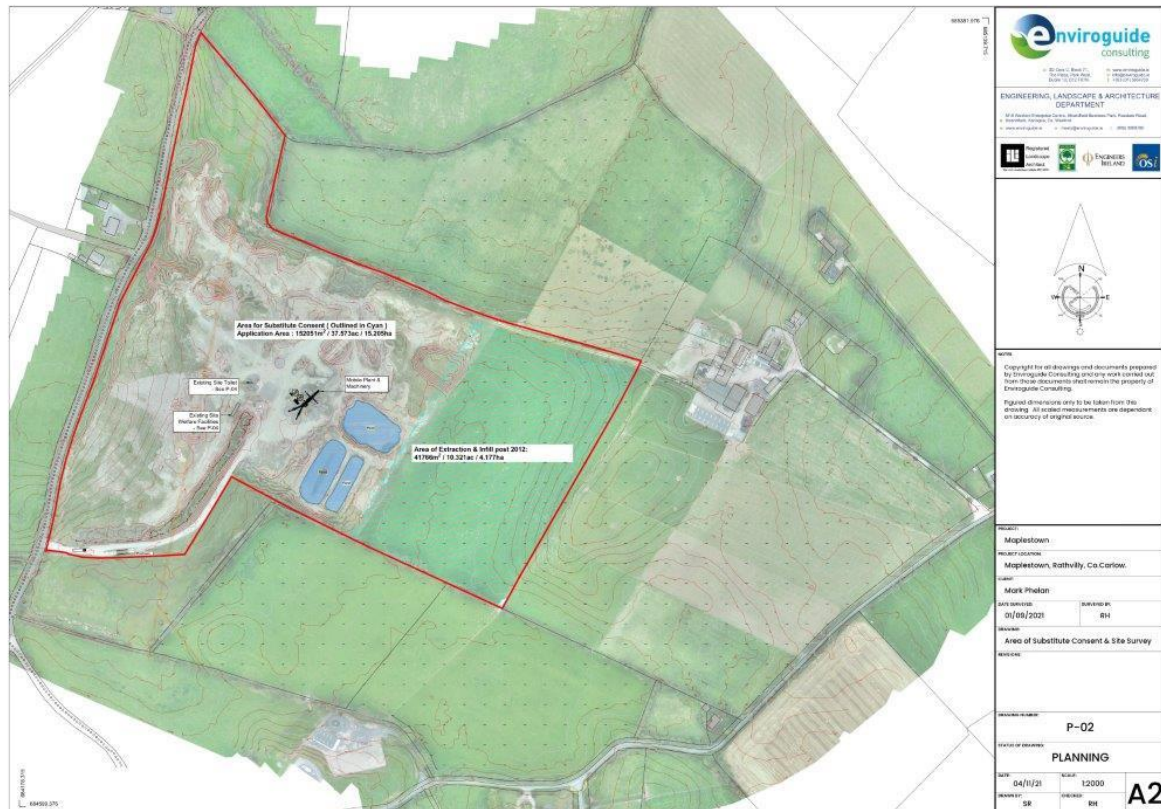
Figure 5-3: Area of Unauthorised Development for which Substitute Consent is Required (Drawing No. P-02)

The proposed area of extraction occupied an inverted L-shaped area measuring approximately 454 m east to west by 355m and 255 m north to south at its maximum and minimum respectively. The area is shown in Fig. 2-3 below outlined in Cyan:

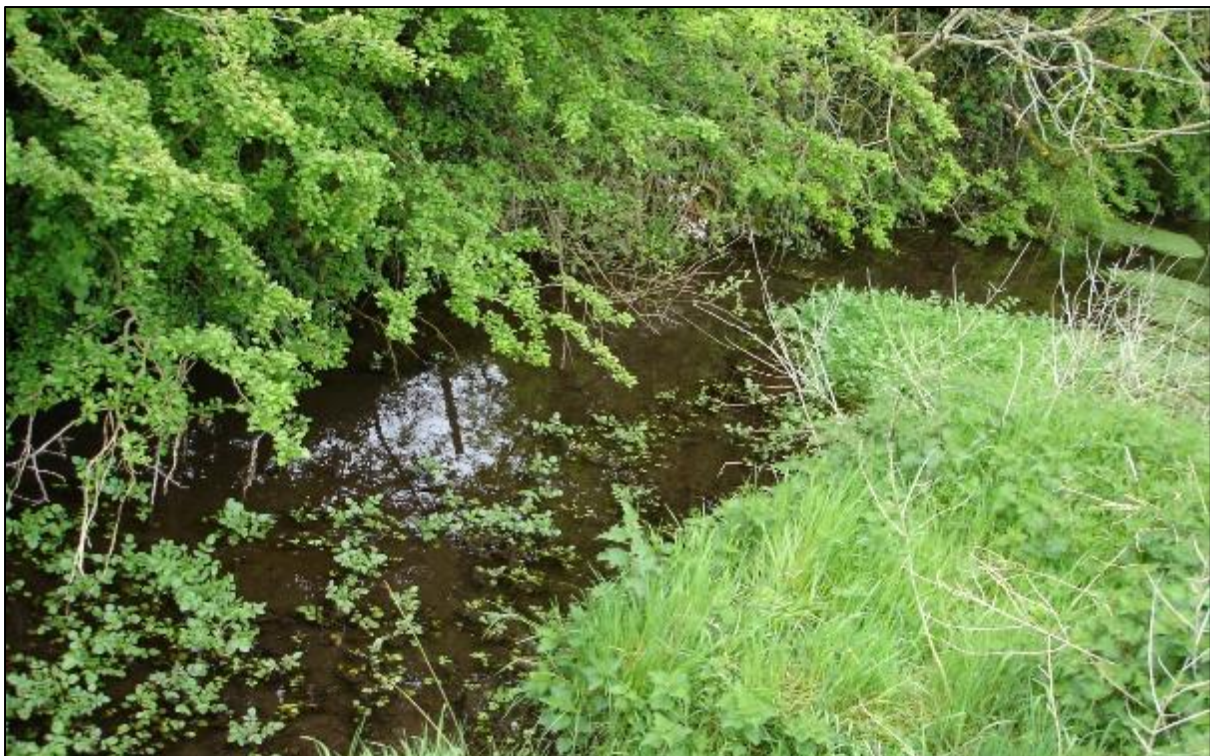
Figure 5-4: Broadstown stream at the Historic site southern boundary flowing westward (Image: EssGee Consultants).

The BROADSTOWN 1st order watercourse is a slit rich slow flowing stream that runs along a 150m stretch of the southern boundary of the historic site. This stream flows to the west into the Graney watercourse which joins the river Lerr before entering the river Barrow 13.5 km to the southwest. Both sides of the bank along this stretch of the watercourse are steep and are flanked by hedgerows (on the southern bank) and dry meadows and grassy verges (on the northern bank). Bank vegetation consisted of Lady's Smock (*Cardamine pratensis*) Willowherb (*Epilobium hirsutum*), Pink Water Speedwell (*Veronica catenate*), Common Nettle (*Urtica dioica*), Cleaver (*Galium aparine*), Dandelion (*Taraxacum officinale*), Groundsel (*Senecio vulgaris*), Creeping Thistle (*Cirsium arvense*), Common Daisy (*Bellis perennis*) and Creeping Buttercup (*Ranunculus repens*). Aquatic vegetation was dominated by Common Duckweed (*Lemna minor*), Greater Tussock Sedge (*Carex paniculate*) and Common Bulrush (*Typha latifolia*). Cattle drinking access point is also present along this stretch of watercourse.

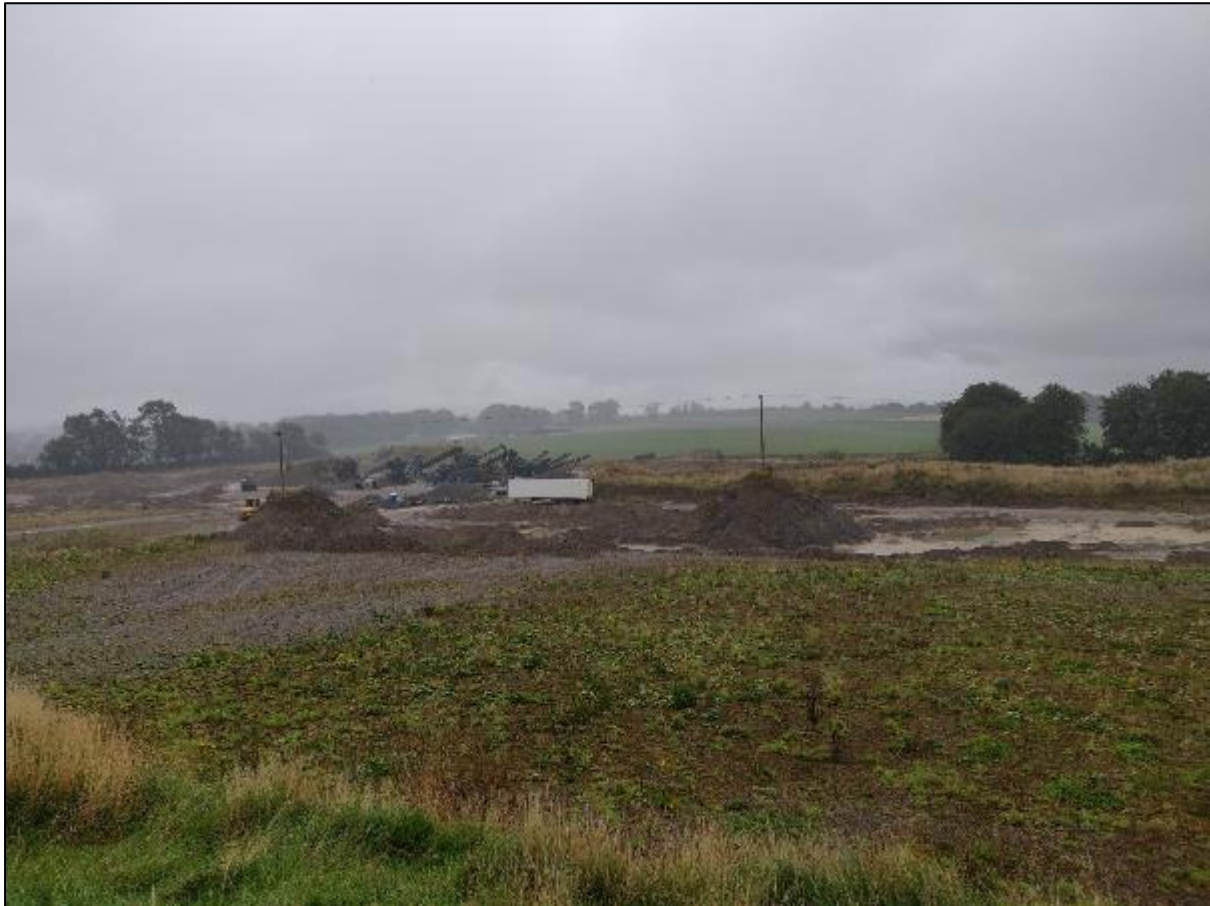
Figure 5-5: Example of active quarry habitat (ED4) that covers majority of the western side of the site

During site visits in August 2021, this habitat type makes up the majority of the central and western sections of the Site of the Historic Development, where ongoing extraction activities and infrastructure are located. This habitat type interchanges with sections of *Recolonising bare ground (ED3)*, particularly in the northwestern and southwestern boundaries of the site where vehicular and excavation activity has not occurred for periods of time.

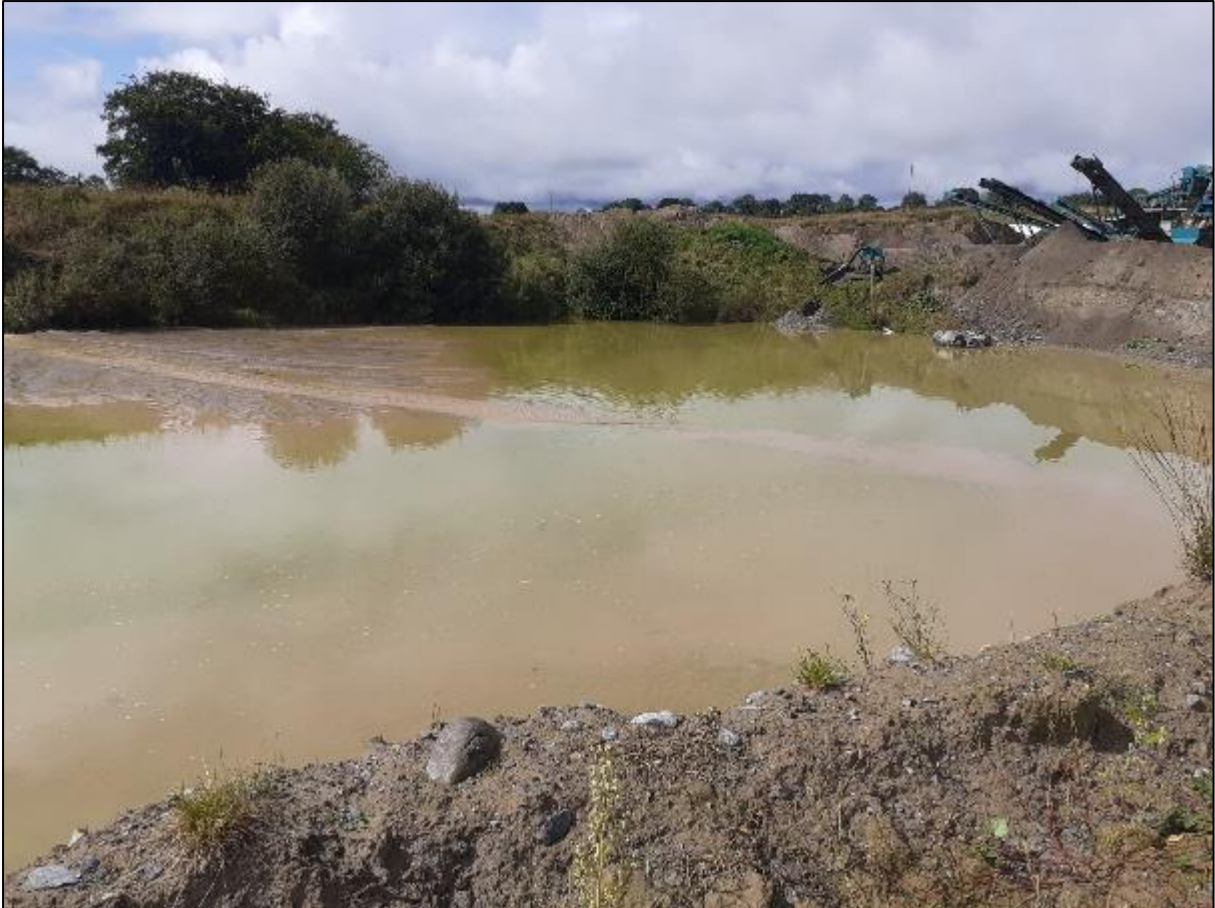
Figure 5-10: Extraction/settling pond located within the active quarry

Three settling ponds were recorded surrounded in bare disturbed earth for the most part likely due to recent machinery activity within the active quarry. The largest settlement pond was the only pond in use at the time of the site visit with the other two smaller ponds appearing to be out of use for some time. Species located on the banks surrounding these waterbodies included: White Willow (*Salix alba*) Coltsfoot (*Tussilago farfara*) Bitter Dock (*Rumex obtusifolius*) Ragwort (*Jacobaea vulgaris*) and Horsetails (*Equisetaceae*).

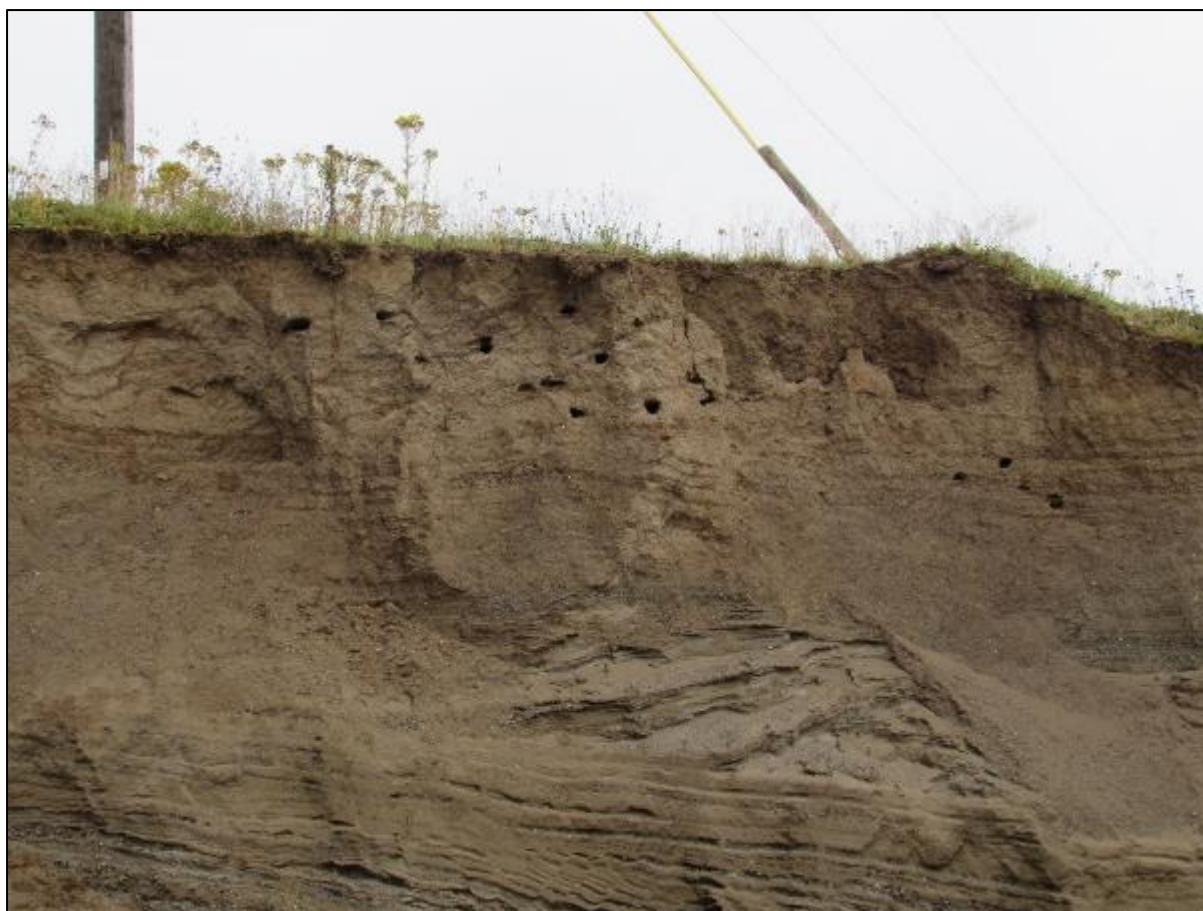
Figure 5-12: Example of exposed cliff face habitats at limits of current extraction works (ED1).

Typical species recorded here include Dandelion (*Taraxacum*) Redshank (*Persicaria maculosa*) Marsh thistle (*Cirsium palustre*), and Rosebay Willowherb (*Chamaenerion angustifolium*).

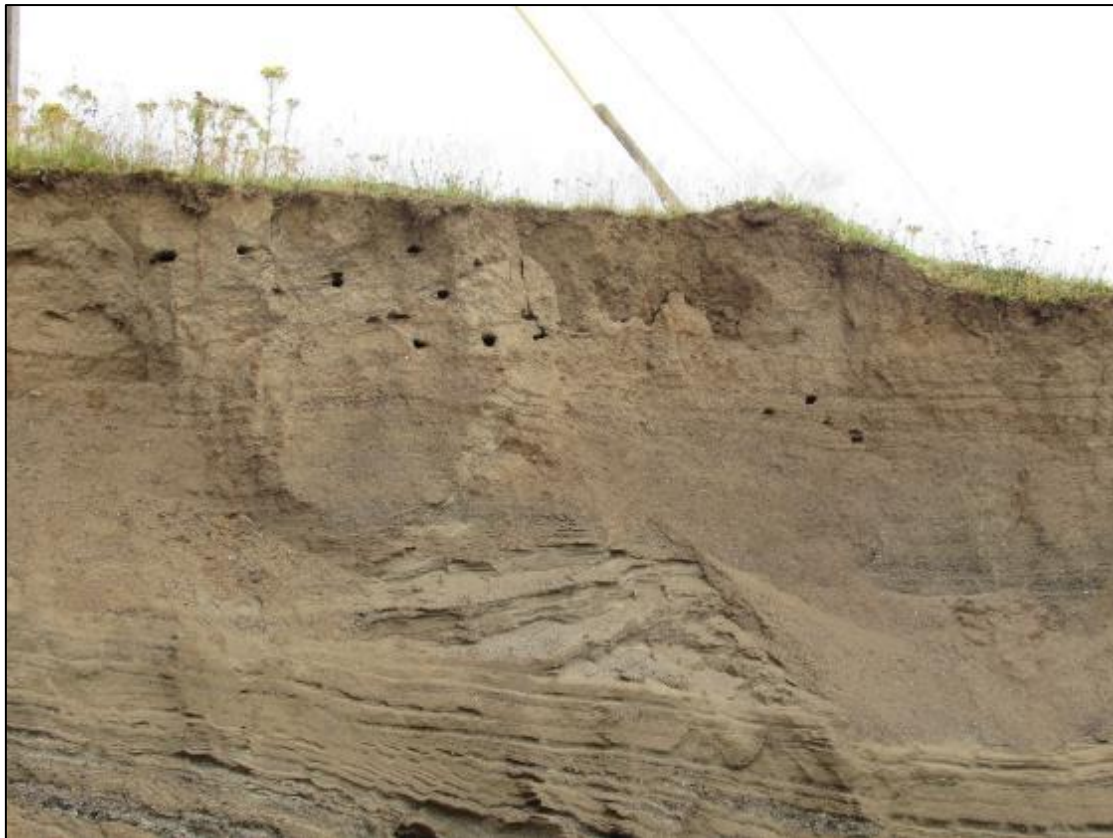
Figure 5-16: Example of cliff faces supporting Sand martin nesting burrows at the proposed infill site.

As there was no loss of hedgerow habitat and a 5m buffer was maintained between historic extraction and infill works, it is considered that these works did not result in habitat loss for other bird species.

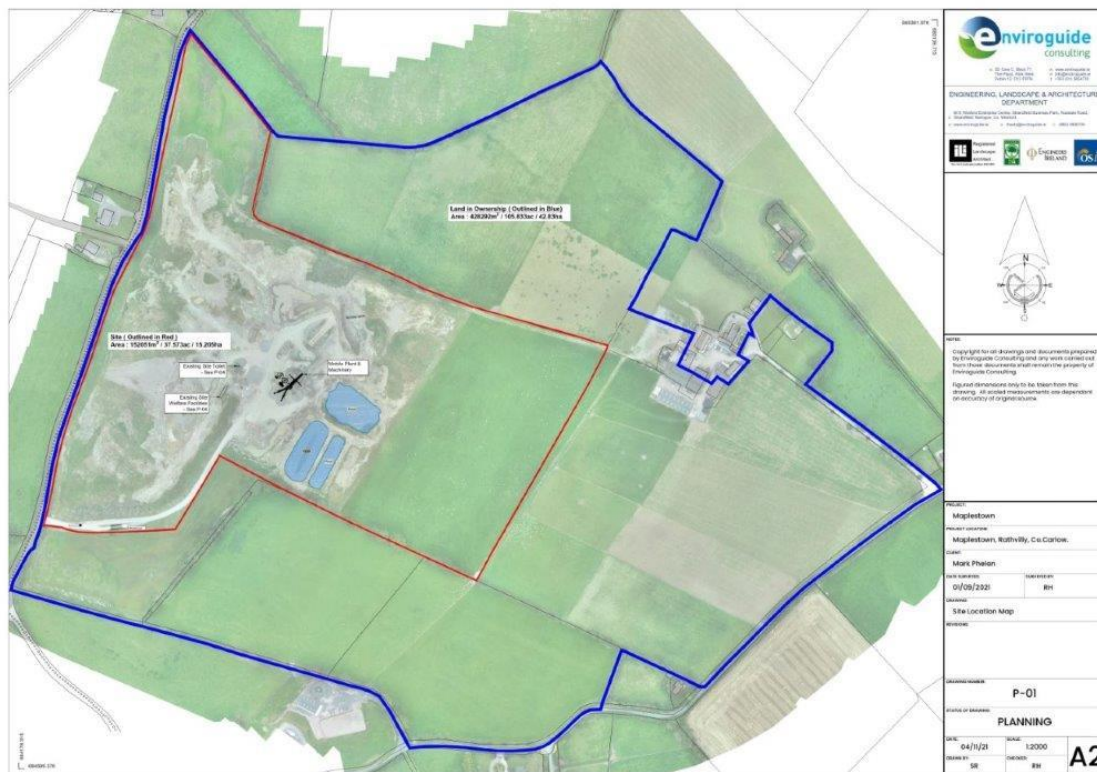
Figure 6-1: Unauthorised Development and Development Site Layout

- Application for substitute consent for the Unauthorised Development at the site since 2012 when planning permission expired in 2012 (An Bord Pleanála Planning Ref. 221741);
 - Approximately 192,240 tonnes of sand and gravel including 75,060 tonnes of overburden was extracted over an area of 4.177Ha since 2012;
 - Approximately 4.177Ha of the existing quarry was subsequently restored using surplus materials already on Site;

The overall Development Site Layout is presented in *Figure 6-1* (refer to Drawings P-01 through P-04 included as part of this application).

- The existing quarry and restored area, for which substitute consent is required, measuring approximately 15.21Ha (refer to *Figure 6-1* and Drawing No. P-02 included as part of this application). It is noted that the restored area, measuring 4.177Ha, was covered with grass and being used for grazing of livestock;

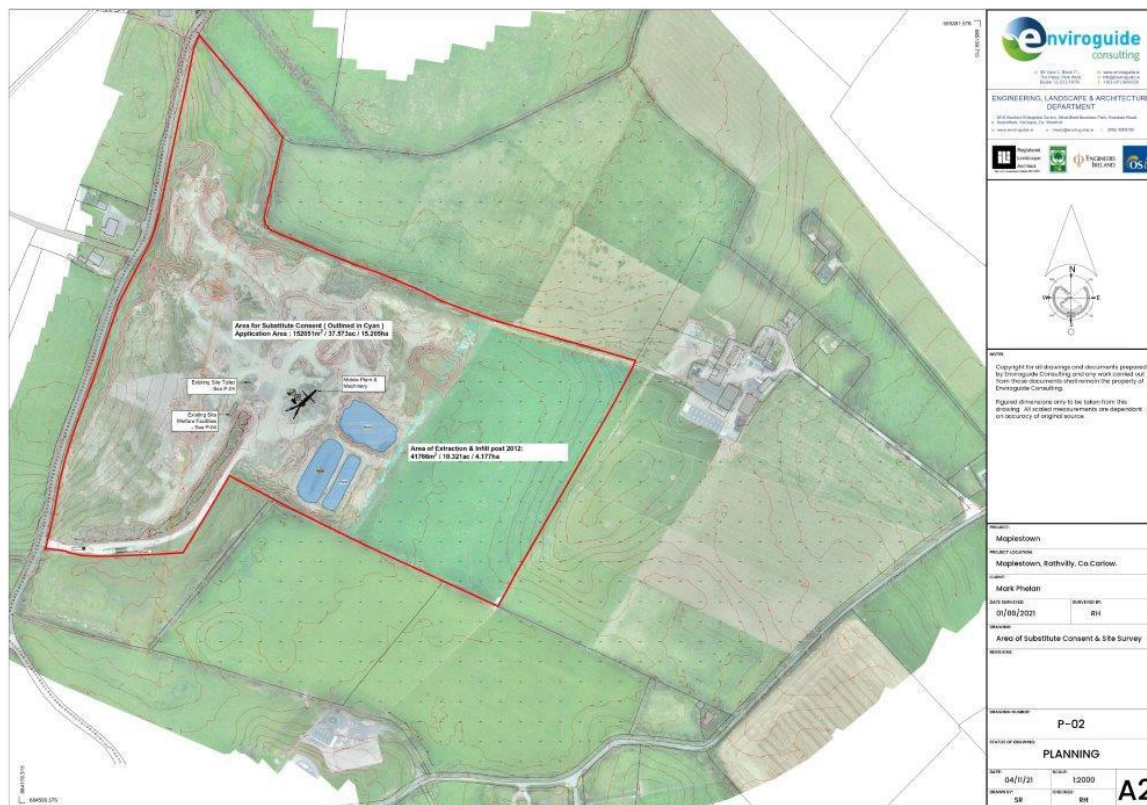
Figure 6-4: Topographical Survey (Drawing No. P-01)

The topographical survey for the Site is presented in Figure 6-4 (refer to Drawing No. P-01 included as part of this application).

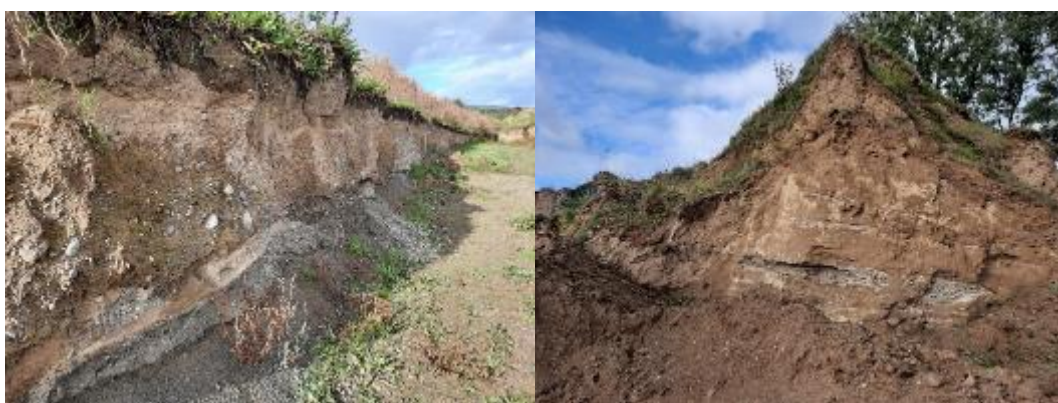
Photograph 6-1. Exposed Soils along the West and North Boundary of the Existing Extraction Area

It is noted that the subsoils encountered along the western boundary of the proposed infill area (MW6) comprised brown sands and gravels to 10.1mbGL (112.53mOD) underlain by clayey SILT to the final depth of drilling at 14mbGL (108mbGL).

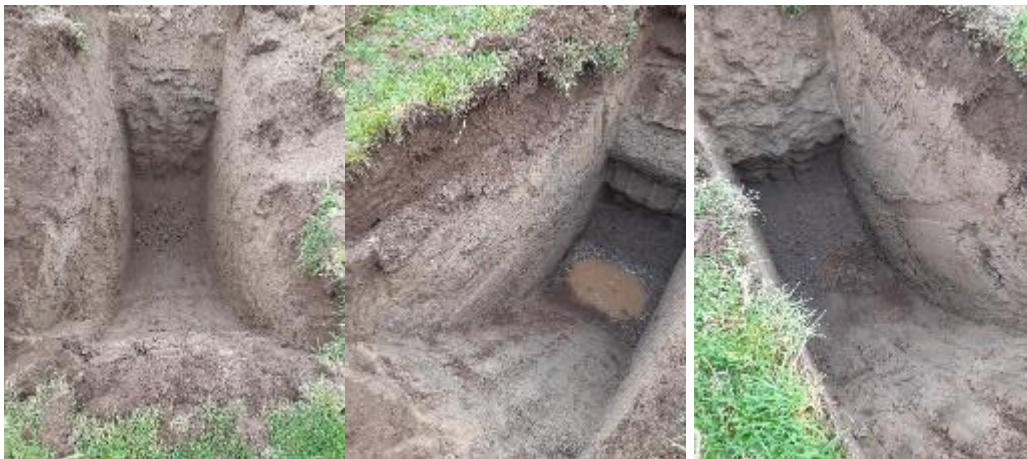
Photograph 6-2. Photos of TP2, TP3 and TP4 (left to right)

The soil encountered within the existing infill area are presented in shown in Photograph 6-2.

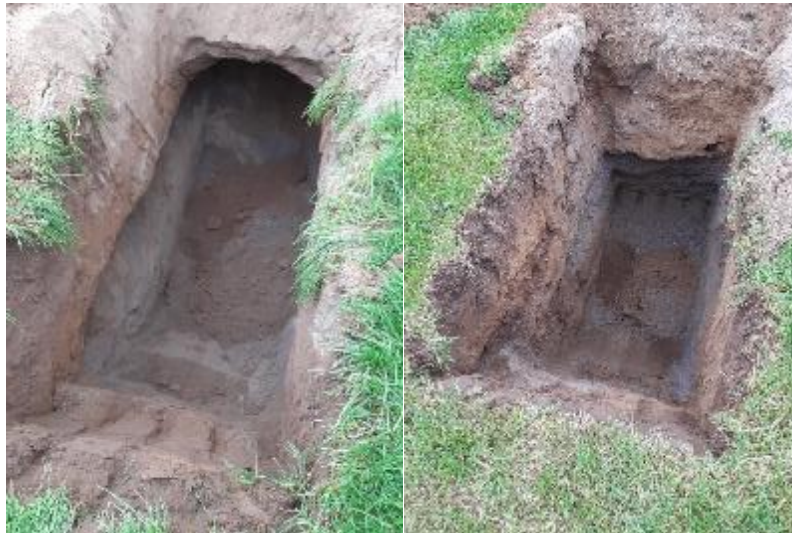
Photograph 6-3. Photos of Soil and Subsoil (TP5 and TP10)

The soils encountered within the proposed quarry area of the Site (TP5, TP9 and TP10) are summarised as brown, slightly gravelly, silty fine to medium grained sand with frequent rootlets between 0.1mbGL and 0.3mbGL. The subsoils encountered (TP5, TP9 and TP10) comprised light brown to orange, fine sand with varying silt and gravel content to maximum depth of 1.1mbGL. The fine sand was underlain sandy gravel and gravelly sand with varying inclusions of assorted cobbles of limestone and granite between 1.4mbGL and the maximum depth of excavation at 2.6mbGL. Outside of the proposed quarry area (MW5 to the north and MW3 to the south) the sands and gravels with varying silt content extended to a maximum depth of 16.2mbGL (98.832mOD) (MW3) where bedrock was encountered however, brown slightly gravelly silty clay was encountered at downgradient location MW3 between 8.5mbGL (106.553mOD) and 13.0mbGL (102.053mOD).

Typical subsoil deposits encountered are shown in Photograph 6-3.

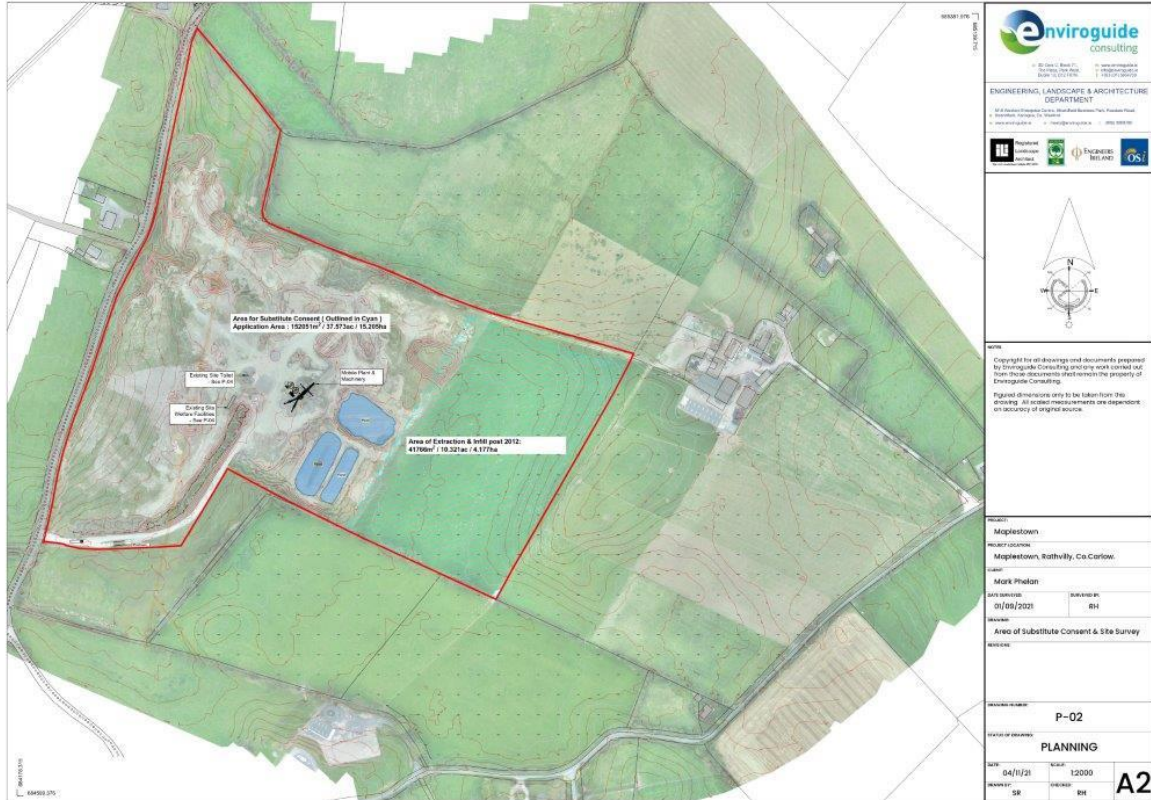
Figure 7-4: Topographical Survey (Drawing No. P-01)

The topographical survey for the Site is presented in Figure 6-4 (refer to Drawing No. P-01 included as part of this application).

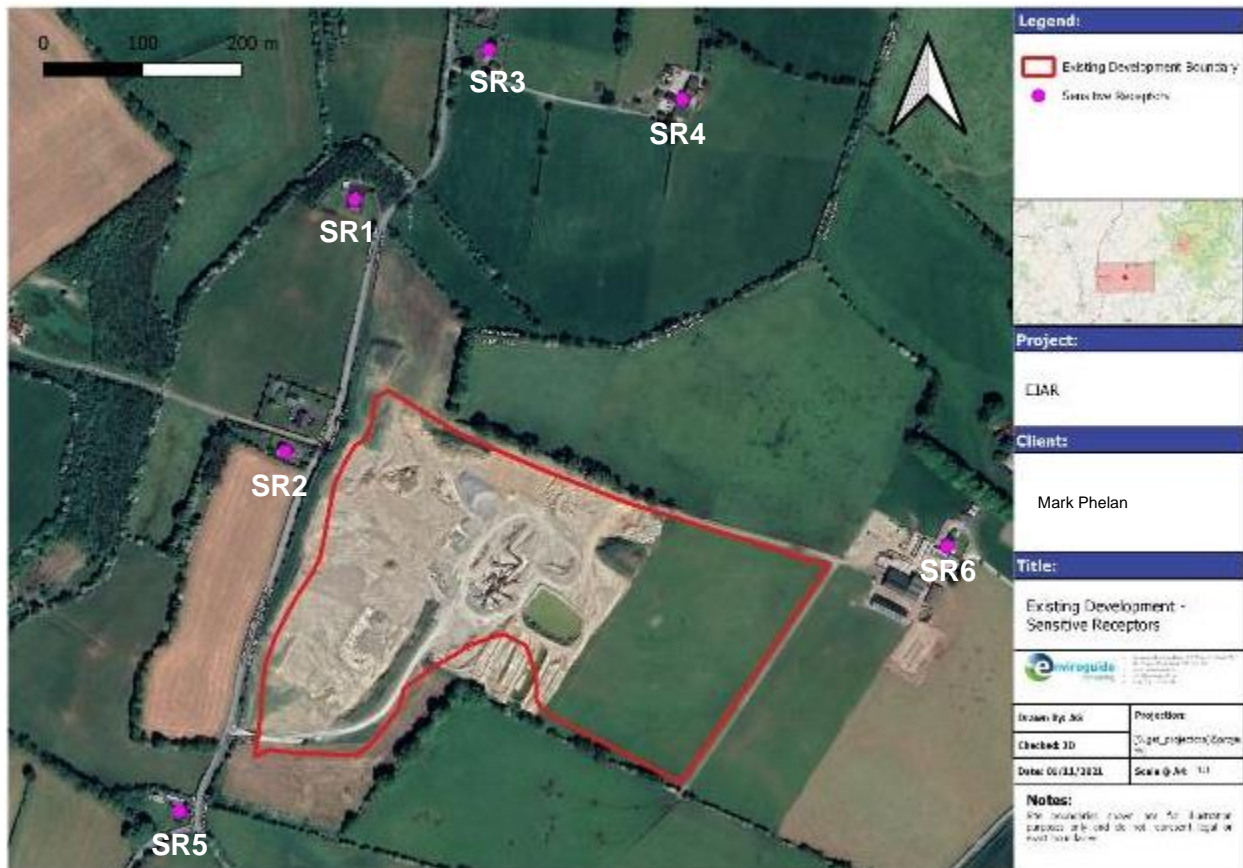
Figure 8-4: Area of unauthorised development – Sensitive Receptors

The extraction and infilling operations had the potential for an increased temporary impact on air quality. This would have increased or decreased depending on local weather conditions, the level of activity, the location of the works within the site and the mitigation measures employed. Dust deposition typically occurs in close proximity to the dust-generating source. Only a small number of sensitive locations were identified as being potentially affected by dust deposition in the previous EIS and these are presented in Figure 8-4. The proposed location of the facility was in an area with a low population density and the nearest sensitive locations beyond the site boundary were generally greater than 60m from the extract and processing of material. The following Figure 8-4 identifies the sensitive receptors which were included in this assessment:

Generally, the potential for severe dust impacts is greatest within 100m of dust generating activities, though residual impacts can occur for distances beyond 100m. The nearest residential receptors have previously been considered as low sensitivity locations within the historical EIS, whereas high sensitivity locations were classified as a hospital, high density residential, school or crèche. Bigstone National School, which is located approximately 0.25 km southwest of the plant area, was considered a high sensitivity receptor. However, due to the distance from the dust generating sources, there has been no impact on this receptor.

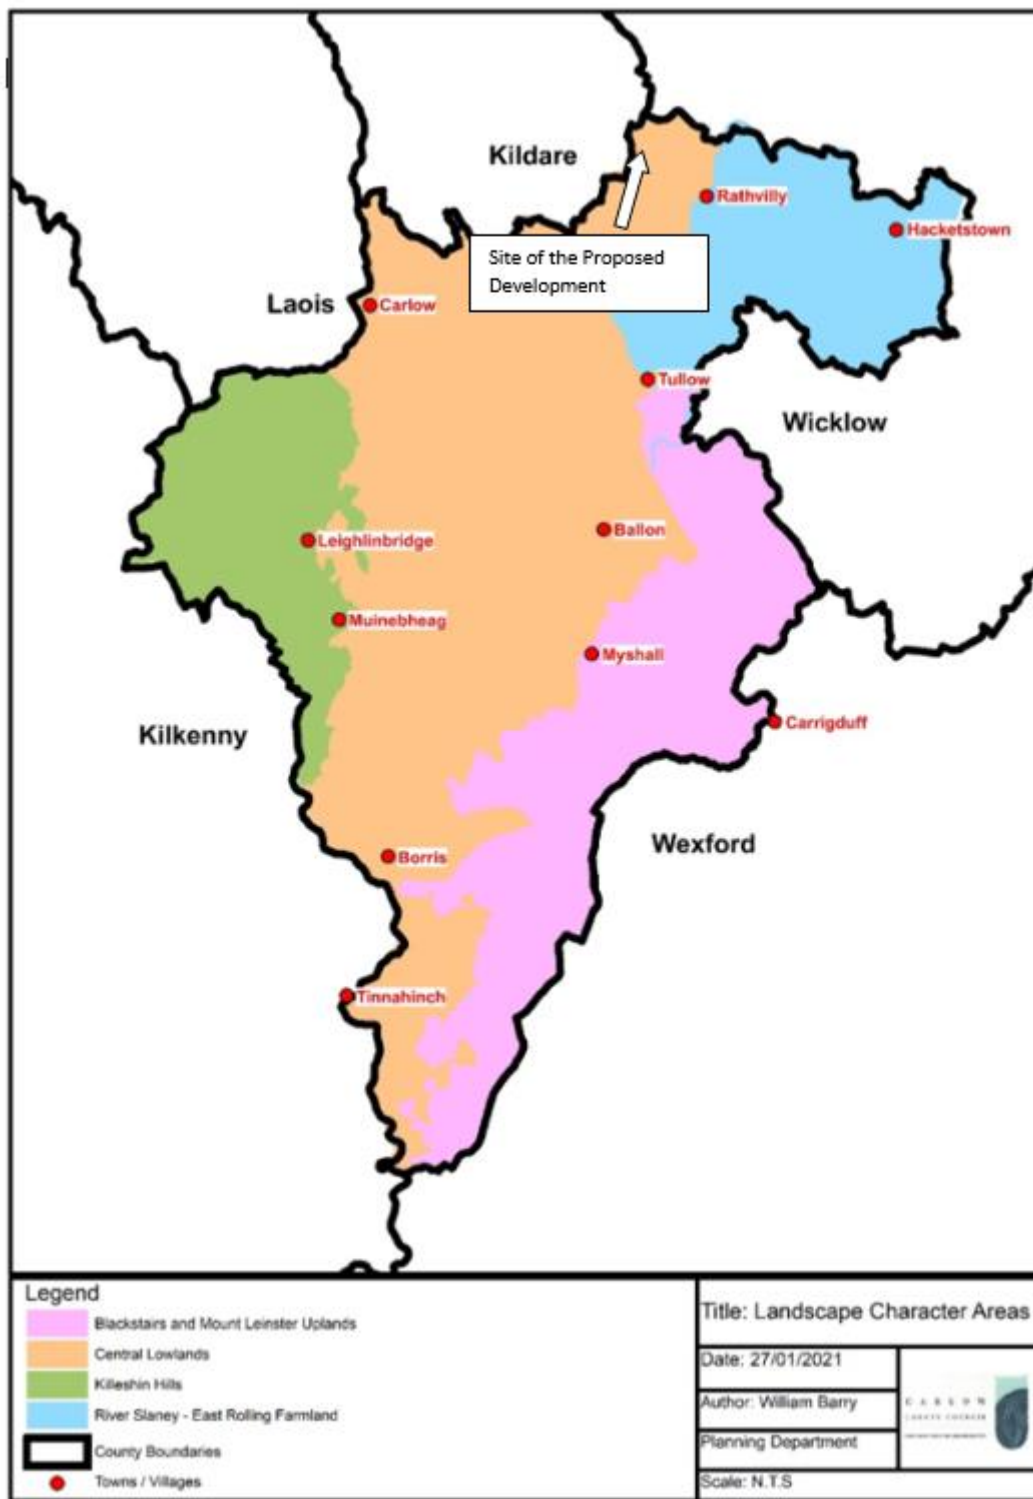
Figure 10-4: Landscape Character Areas

- *Blackstairs and Mount Leinster Uplands*
- *Central Lowlands*

- *River Slaney/East Rolling Farmland*
- *Killeshin Hills*

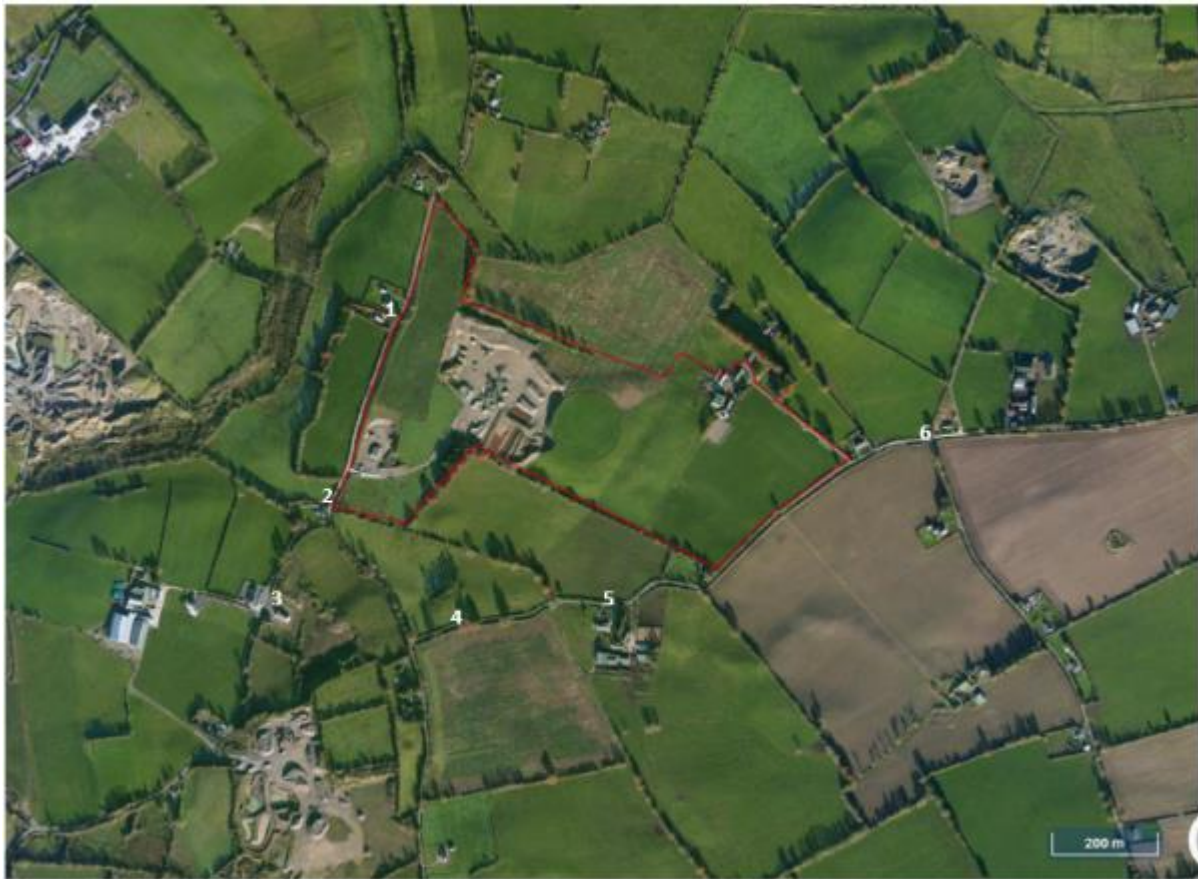
Figure 10-8: Visual Reference Points

The selected viewpoints for the Development are depicted in Figure 10-8.

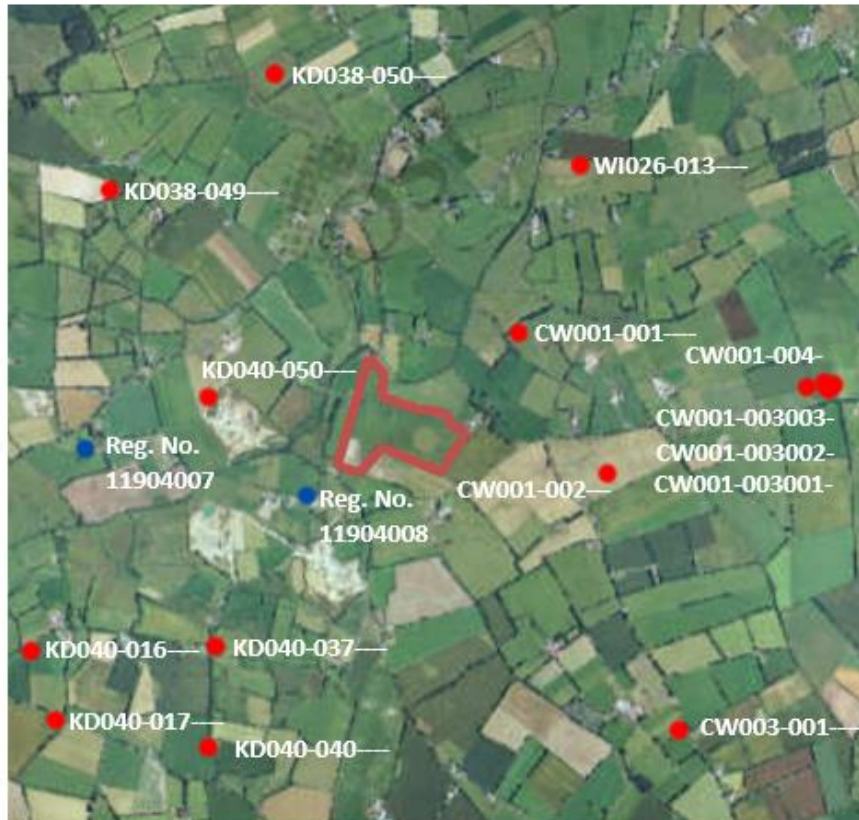
Figure 11-1: Location of the area applying for Substitute Consent and the area applying for Consent in relation to archaeological monuments and architectural features (red and blue dots)

Ringforts and enclosures are undoubtedly the most common field monuments within the Irish landscape and there are no. 3 ringforts and no. 6 enclosures located within a 2km radius of the Unauthorised Development. A ringfort is a space surrounded by an earthen bank formed by material thrown up from a fosse or ditch located immediately outside the earthen bank. Generally, ringforts vary in size from 25–50 metres in diameter and are usually circular in plan but can also be oval or D-shaped. Figure 11-1 below indicates the location of the site in relation to archaeological monuments and architectural features.

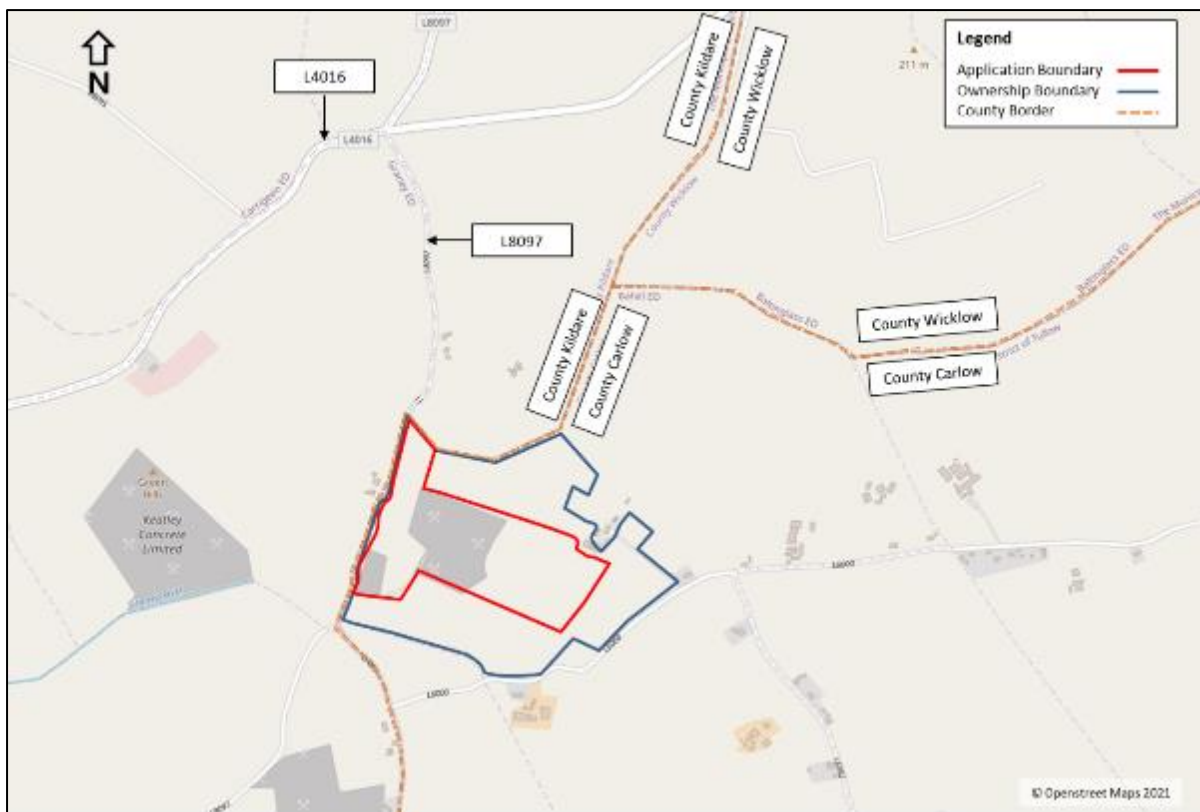
Figure 12-1: Development Site Location

The unauthorised development site is located to the east of L8097 at Maplestown, Co. Carlow. The site is currently accessed via a 3-arm priority-controlled junction with L8097 at the western side of the site. The site is bounded by agricultural lands to the north, east and south of the proposed site, and L8097 to the west of the site. The site is located within County Carlow, however, is adjacent to the border with County Kildare (located immediately to the west of the site).

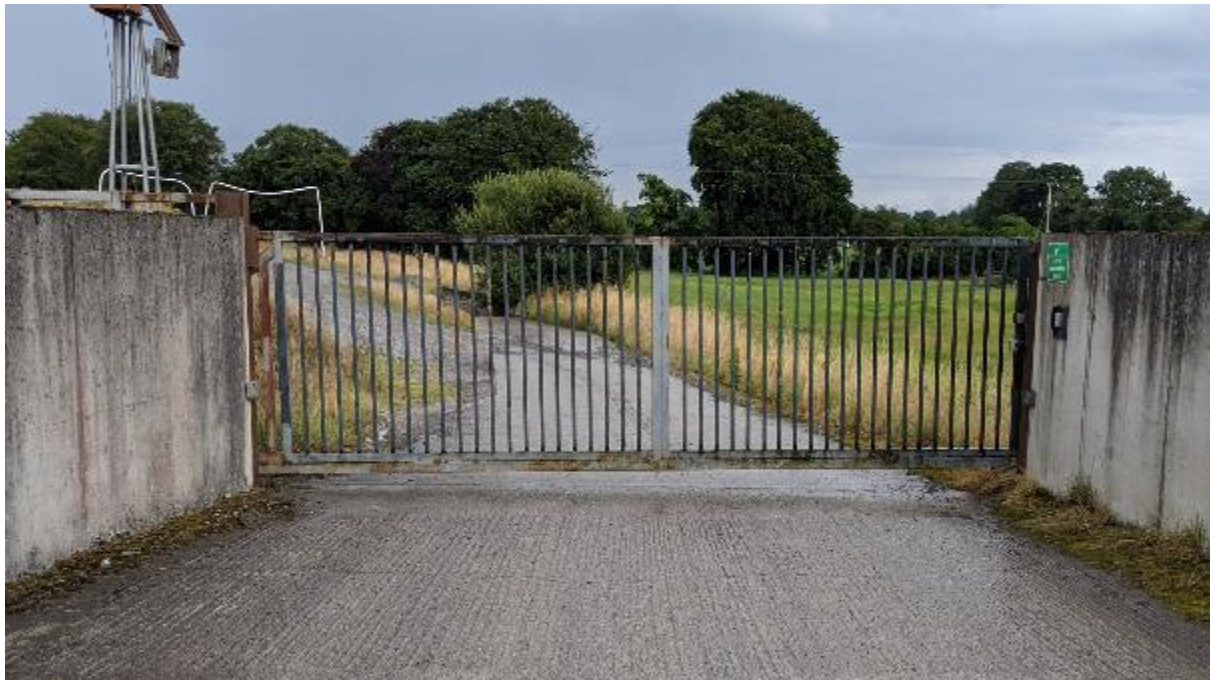
Figure 12-2: Existing Site Access

The site is accessed exclusively via a priority-controlled junction with L8097 to the west of the site. The site access junction measures ca. 8.5-metres wide, with the existing site access gate set-back ca. 22 metres from the road edge. The existing layout is capable of simultaneously accommodating two-way traffic flows.

The site access road is ca. 70 metres in length and connects the L8097 with the remainder of the site. A wheel wash is located along the access road, ca. 35 metres from L8097. The access road is generally straight, with a bend ca. 45 metres from the L8097. The location of this existing site access is illustrated in Figure 12-2 which follows.

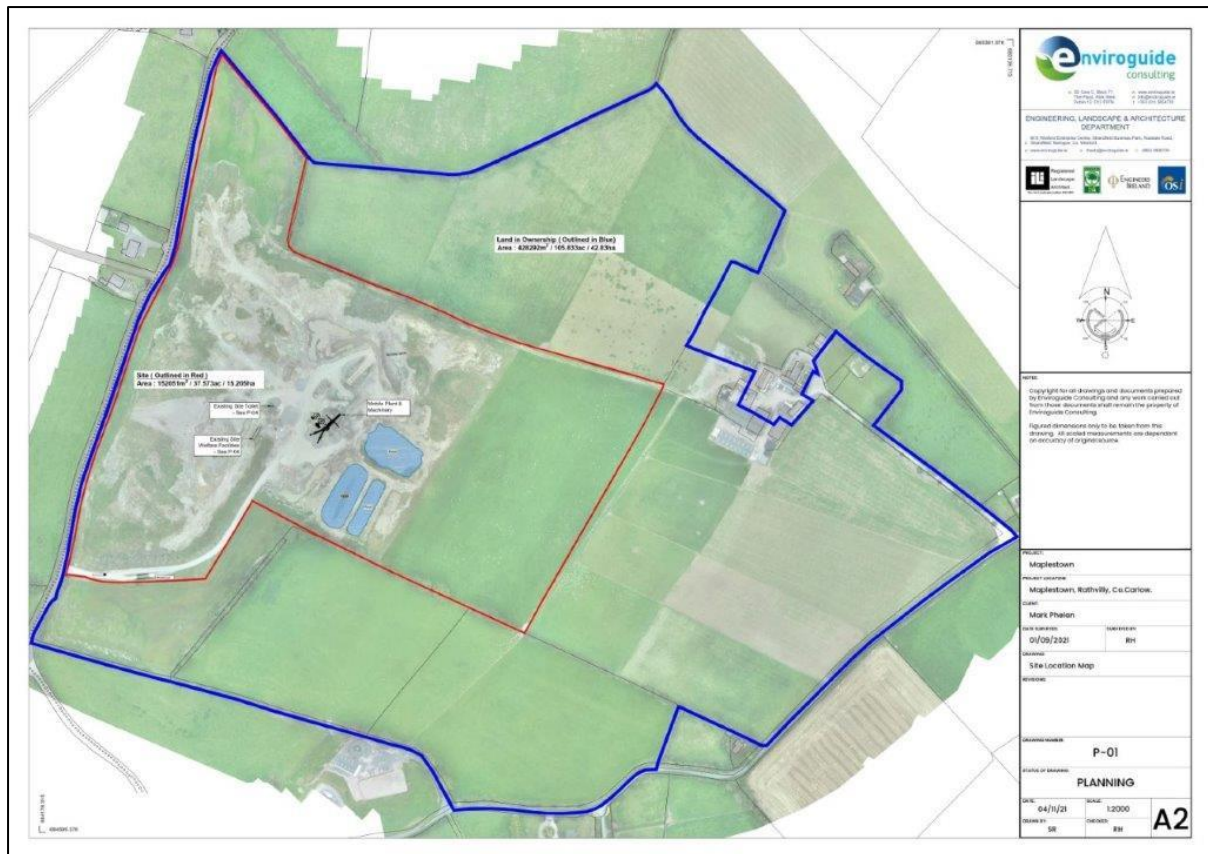
Figure 12-3: Existing Site Layout

The internal site layout is characterised by a series of unpaved internal haul roads, providing access to the various parts of the quarry. Within the site there are a number of set-down areas that connect the internal haul roads, allowing for machinery and vehicles to park if required.

As can be seen from Figure 12-3, the existing site layout features a site access road which provides access to the mobile plant and machinery. An office and toilet are located directly to the east of the weighbridge and a wheelwash is provided for vehicles egressing the site.
