rEiAR Non-Technical Summary

**FOR
SAND AND GRAVEL QUARRY
AT
Maplestown, Co. Carlow**

NOVEMBER 2021

**ON BEHALF OF
MARK PHELAN**

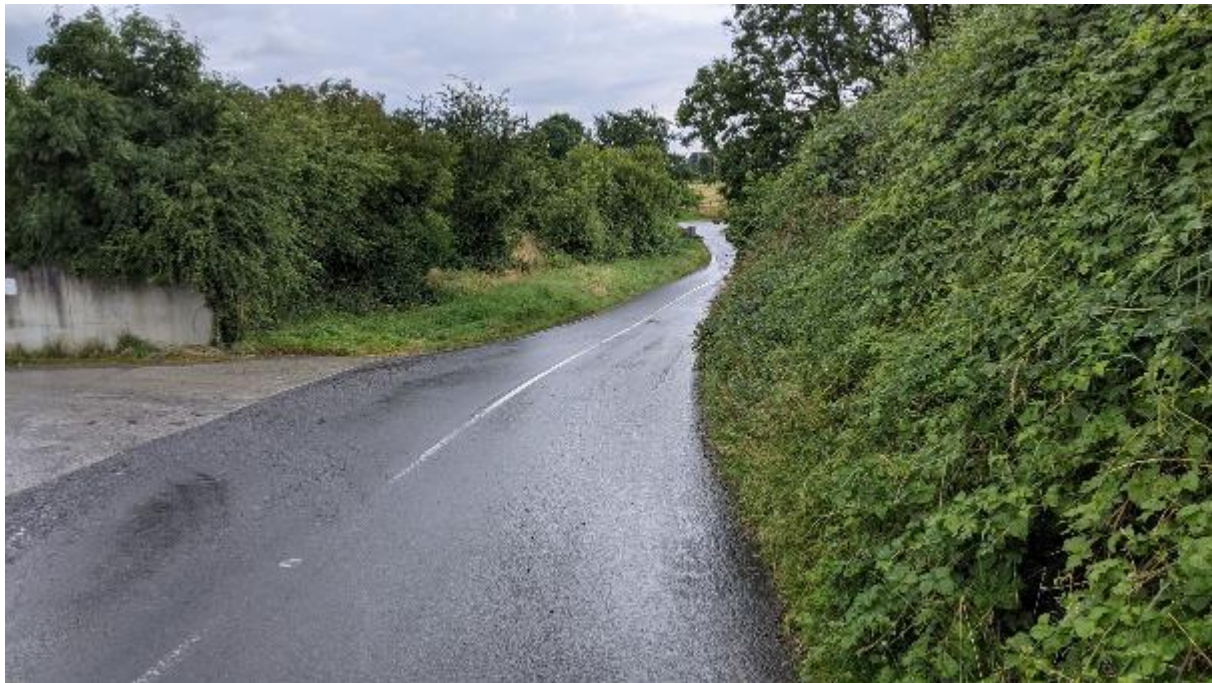
Figure 12-4: L8097 (directly outside site access)

carriageway is ca. 5.3 metres wide, with numerous changes to the road's horizontal and vertical alignment noted (illustrated in Figure 12.3).

A speed limit of 80 km/ h is in operation on L8097 in the vicinity of the site access, however due to the road's layout and alignment traffic speeds are noted to be substantially lower than the maximum speed limit. As a local rural road, no footpaths or street lighting are present.

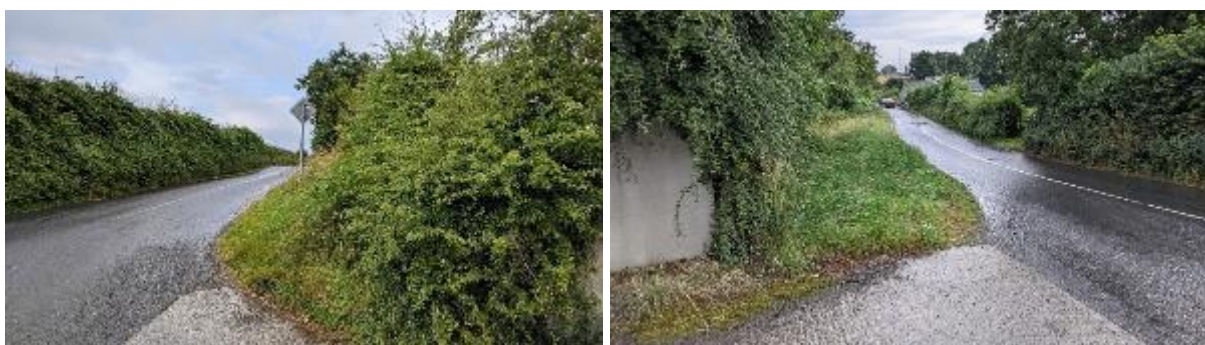
Figure 12-5: L8097/ Site Access Junction (Northbound and Southbound Visibility)

The site is accessed via an internal access road that intersects with the L8097 and operates as a priority-controlled junction. There are no road markings or signage located at the site access junction.

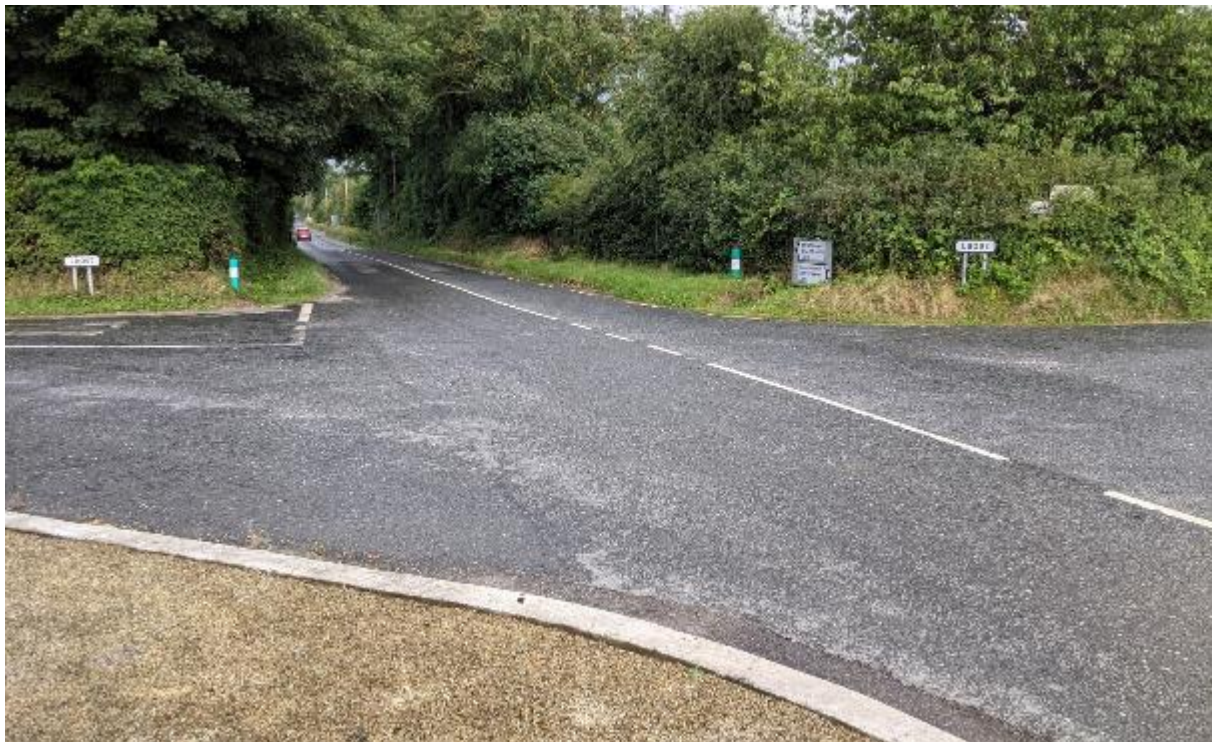
Figure 12-6: L4016/ L8097 junction (looking northeast on L4016)

The 4-arm stop-controlled L4016/ L8097 junction is located ca. 1.4 kilometres to the north of Development site, and all development traffic is noted to pass through this junction.

The pavement surface of all arms at the junction was noted to be in good condition, with the junction layout incorporating suitable turning radii to allow for satisfactory vehicle movements through all arms of the junction.

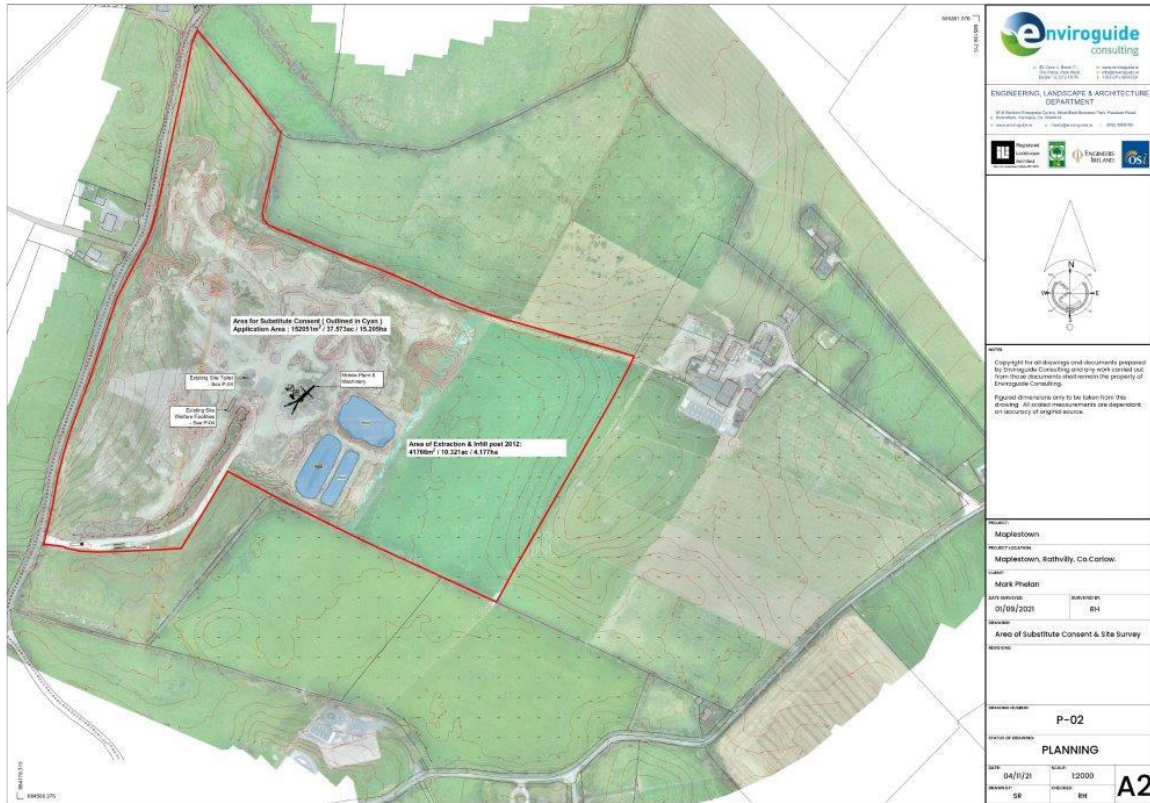
Figure 12-9: Proposed Site Layout (Area of Substitute Consent)

The general site layout is illustrated in Figures 12-9 (area of Substitute Consent) overleaf. The Development served commercial customers only.
