GREATER DUBLIN DRAINAGE PROJECT

EIAR Addendum Chapter 11A (Biodiversity (Terrestrial and Freshwater Aquatic))
Appendix A11.1 Terrestrial Baseline Survey Report
Confidential Badger Survey 2023 Report

IE000258
S4P01
17 July 2023

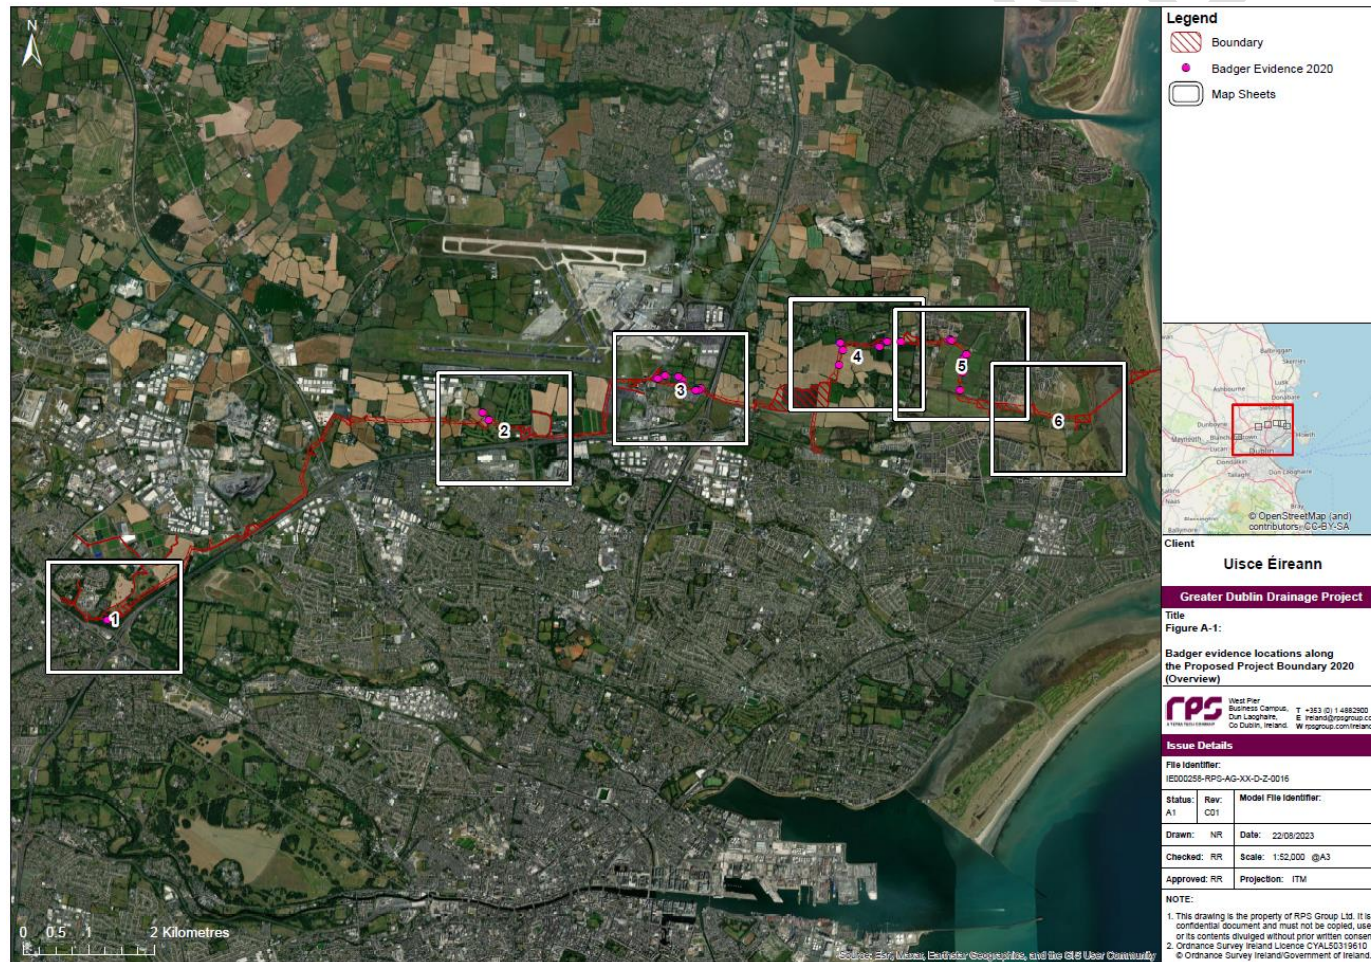
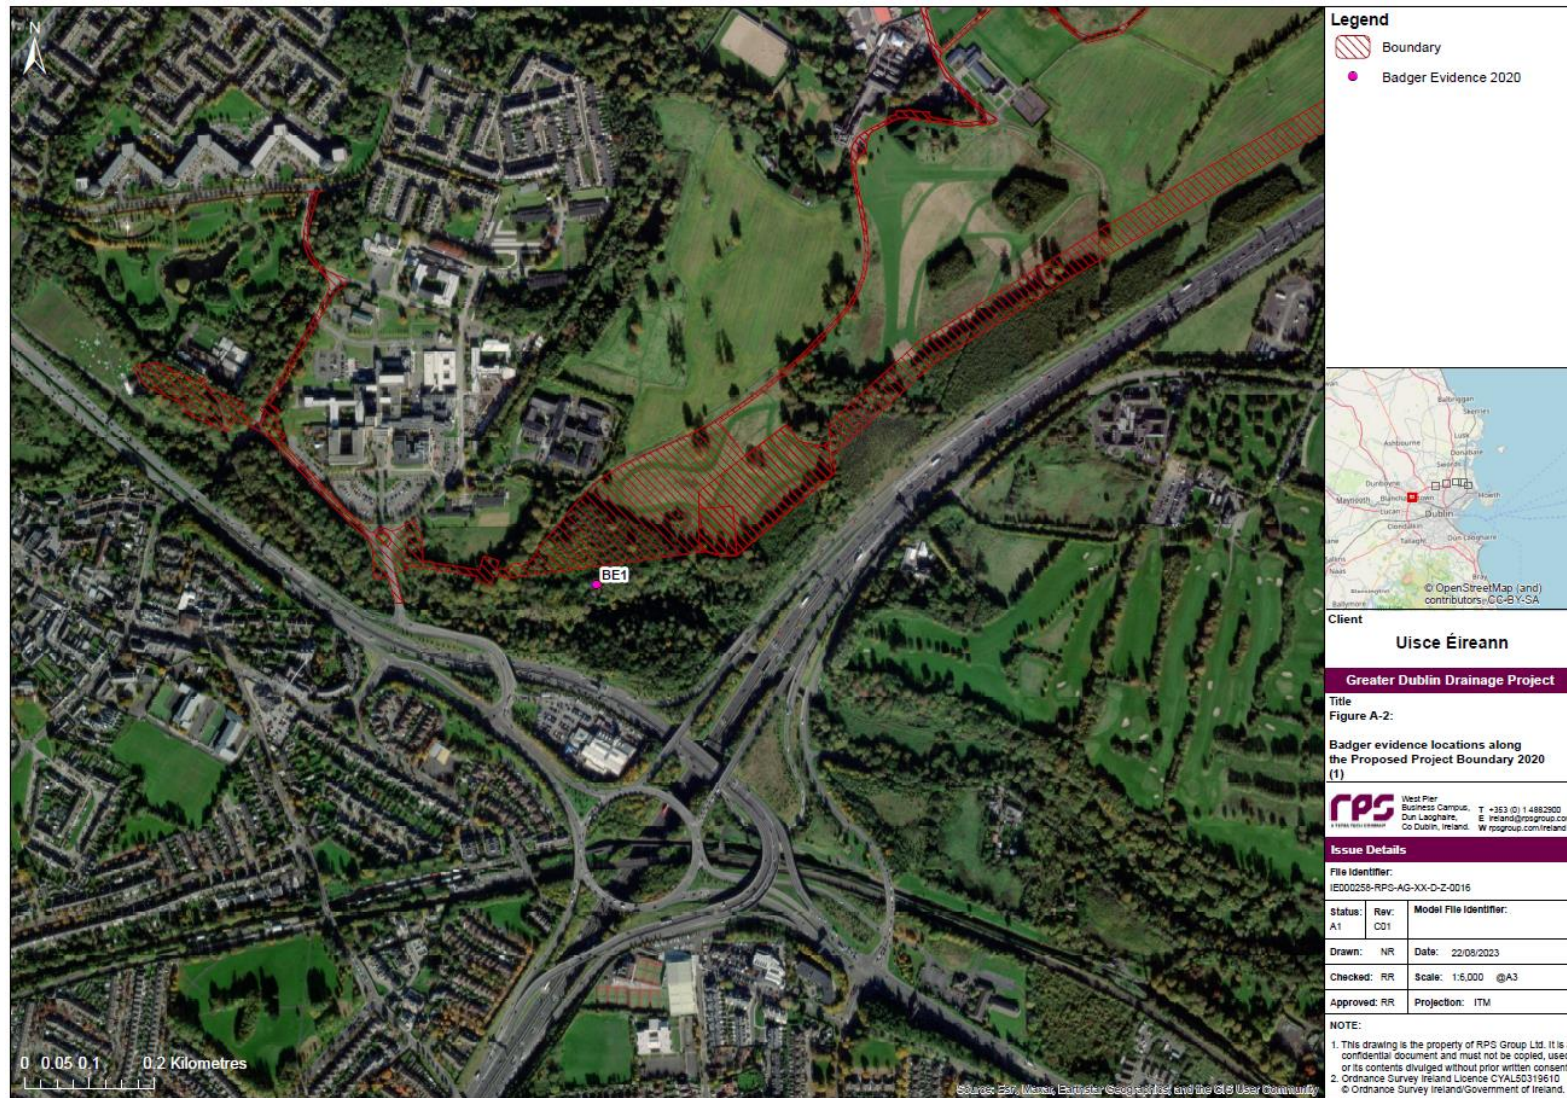
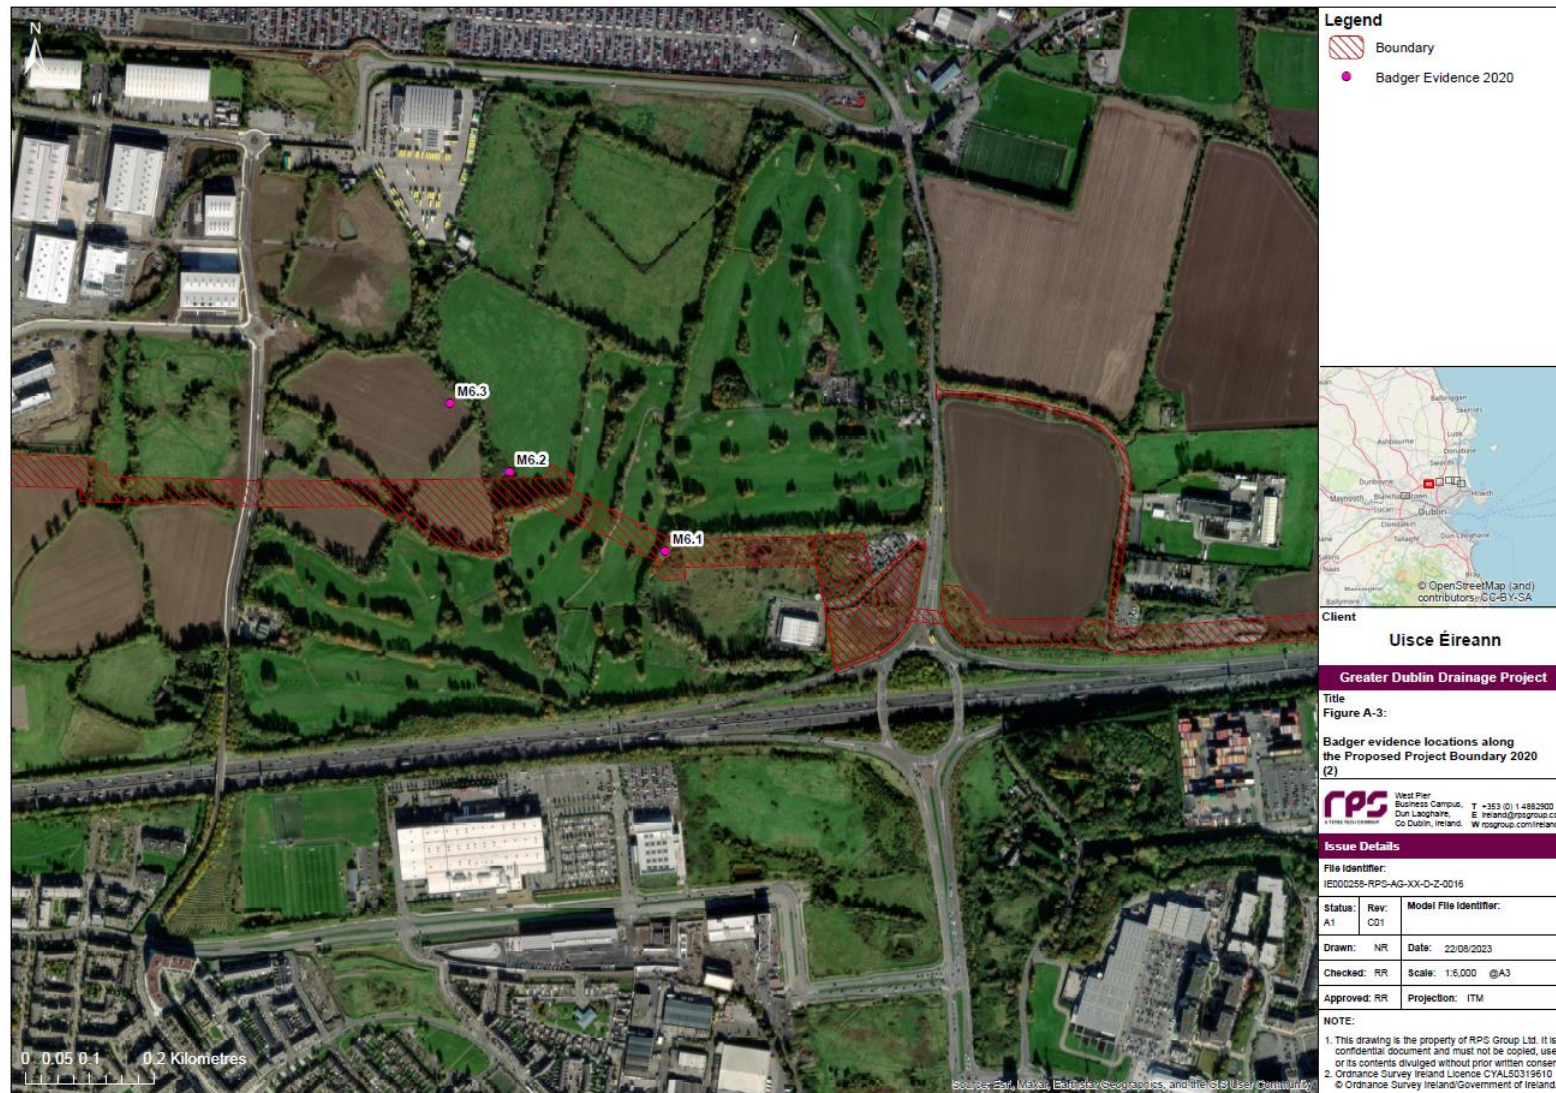
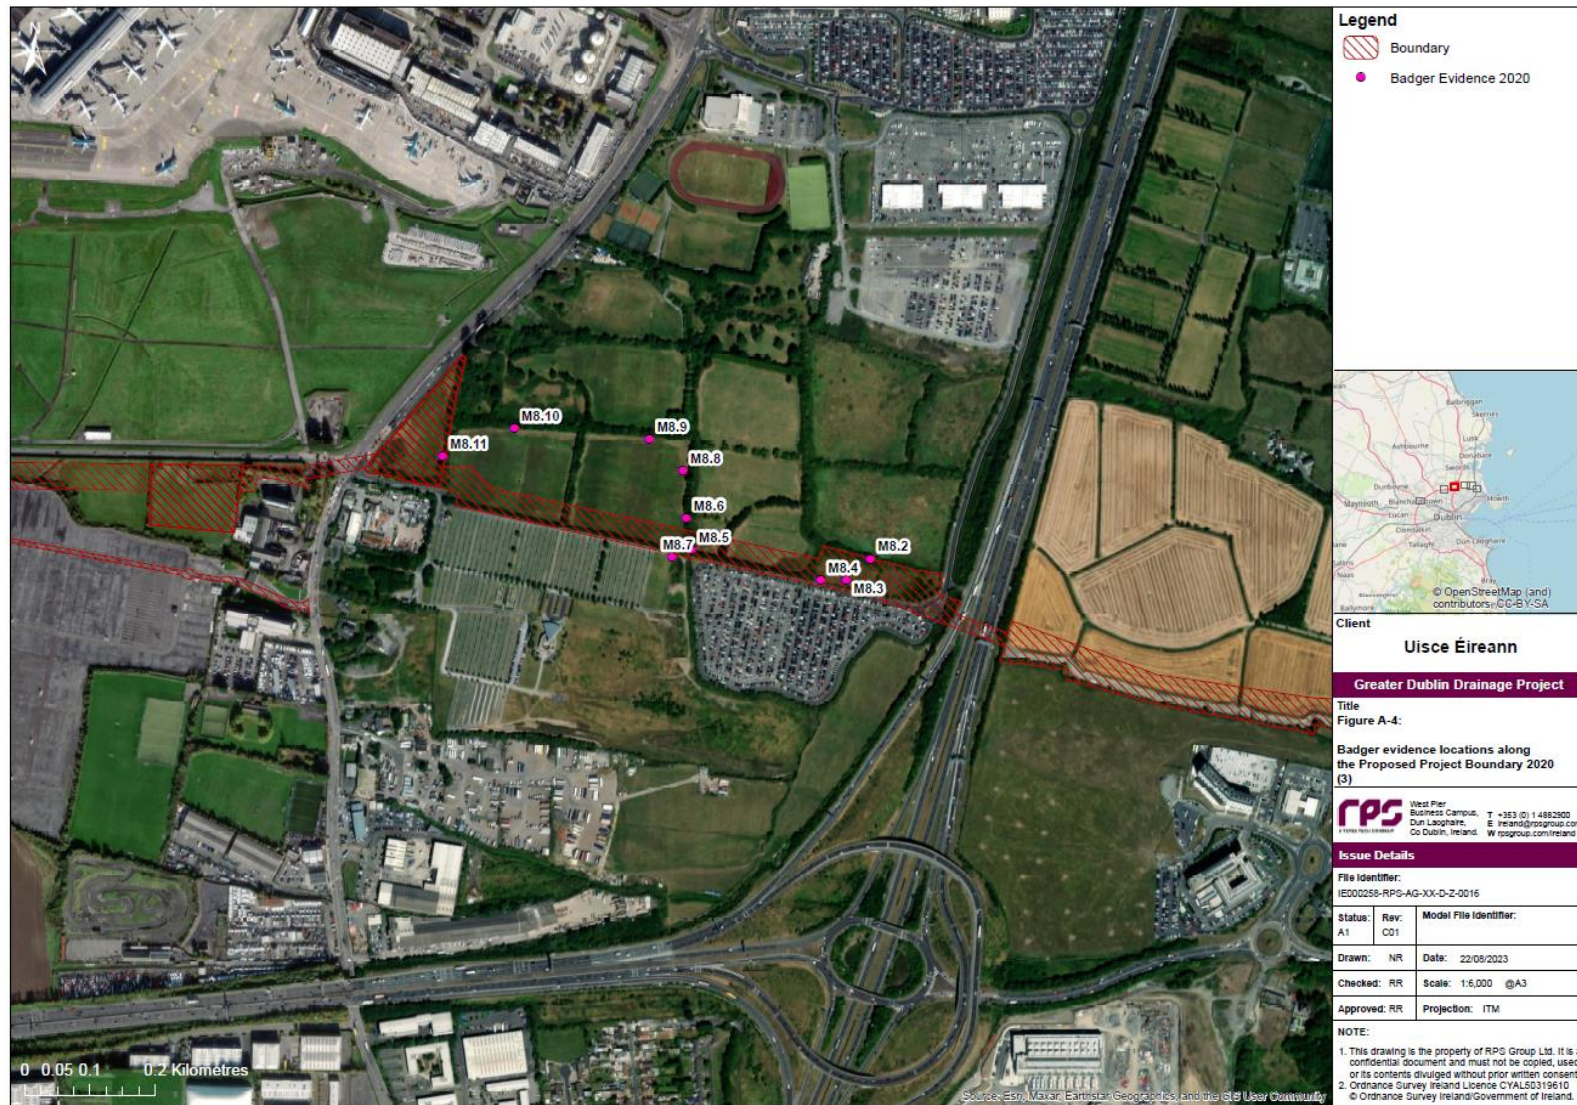
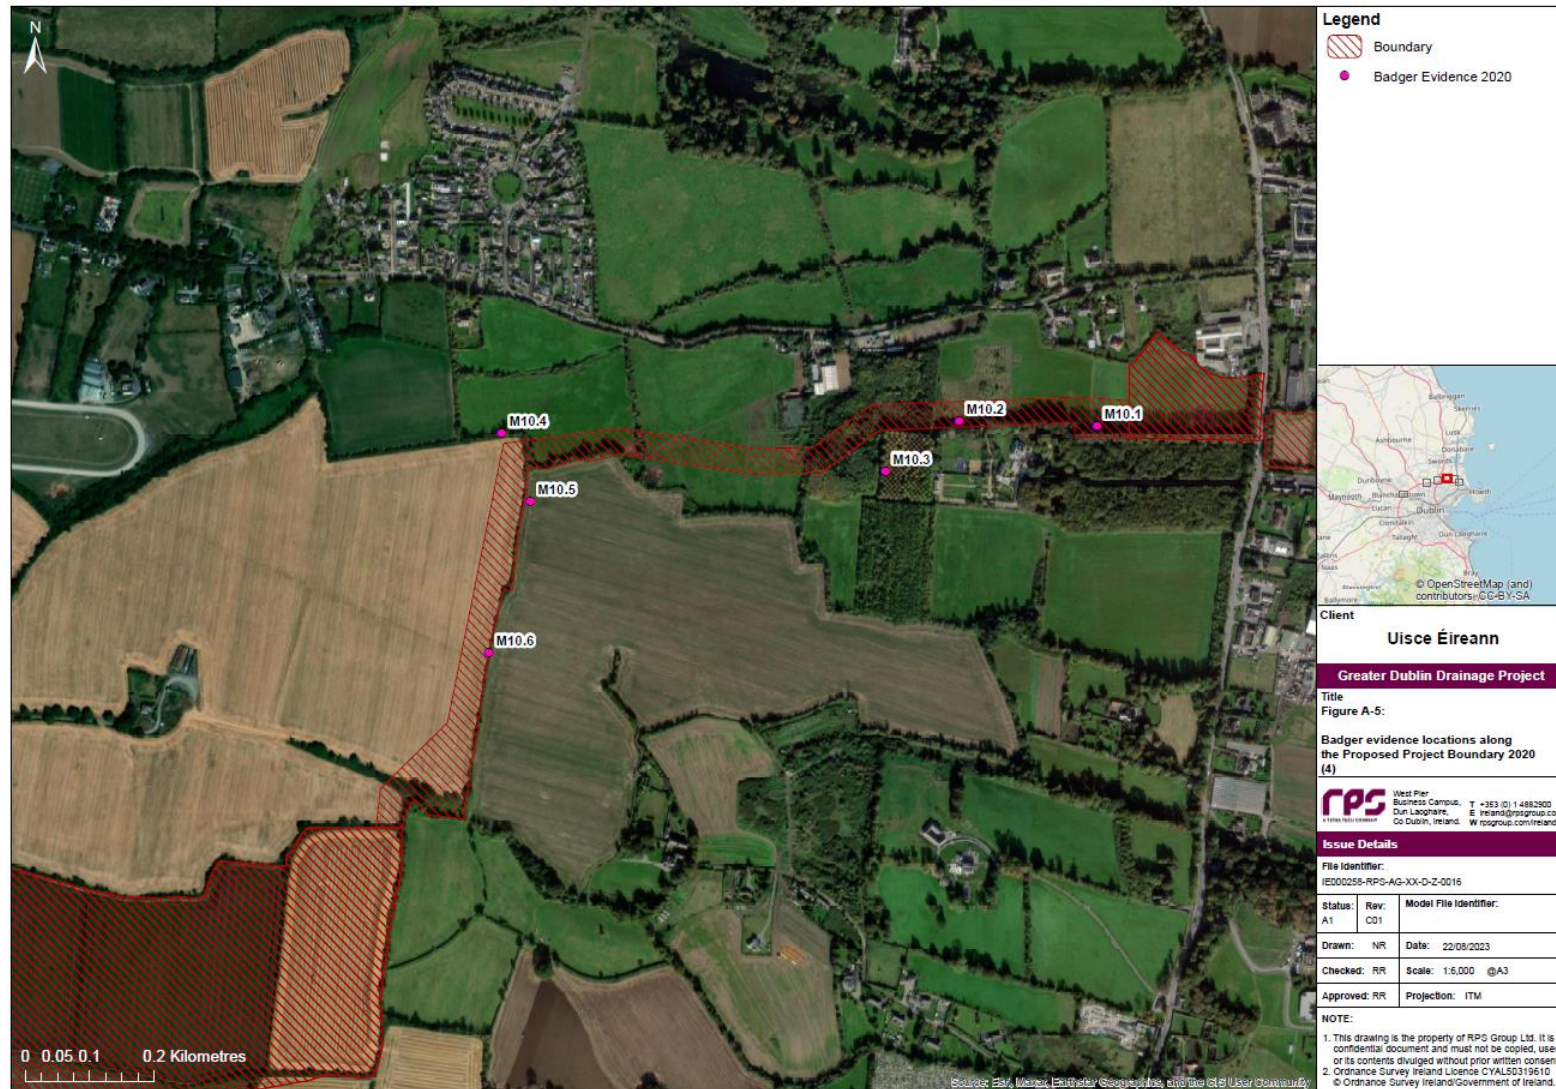
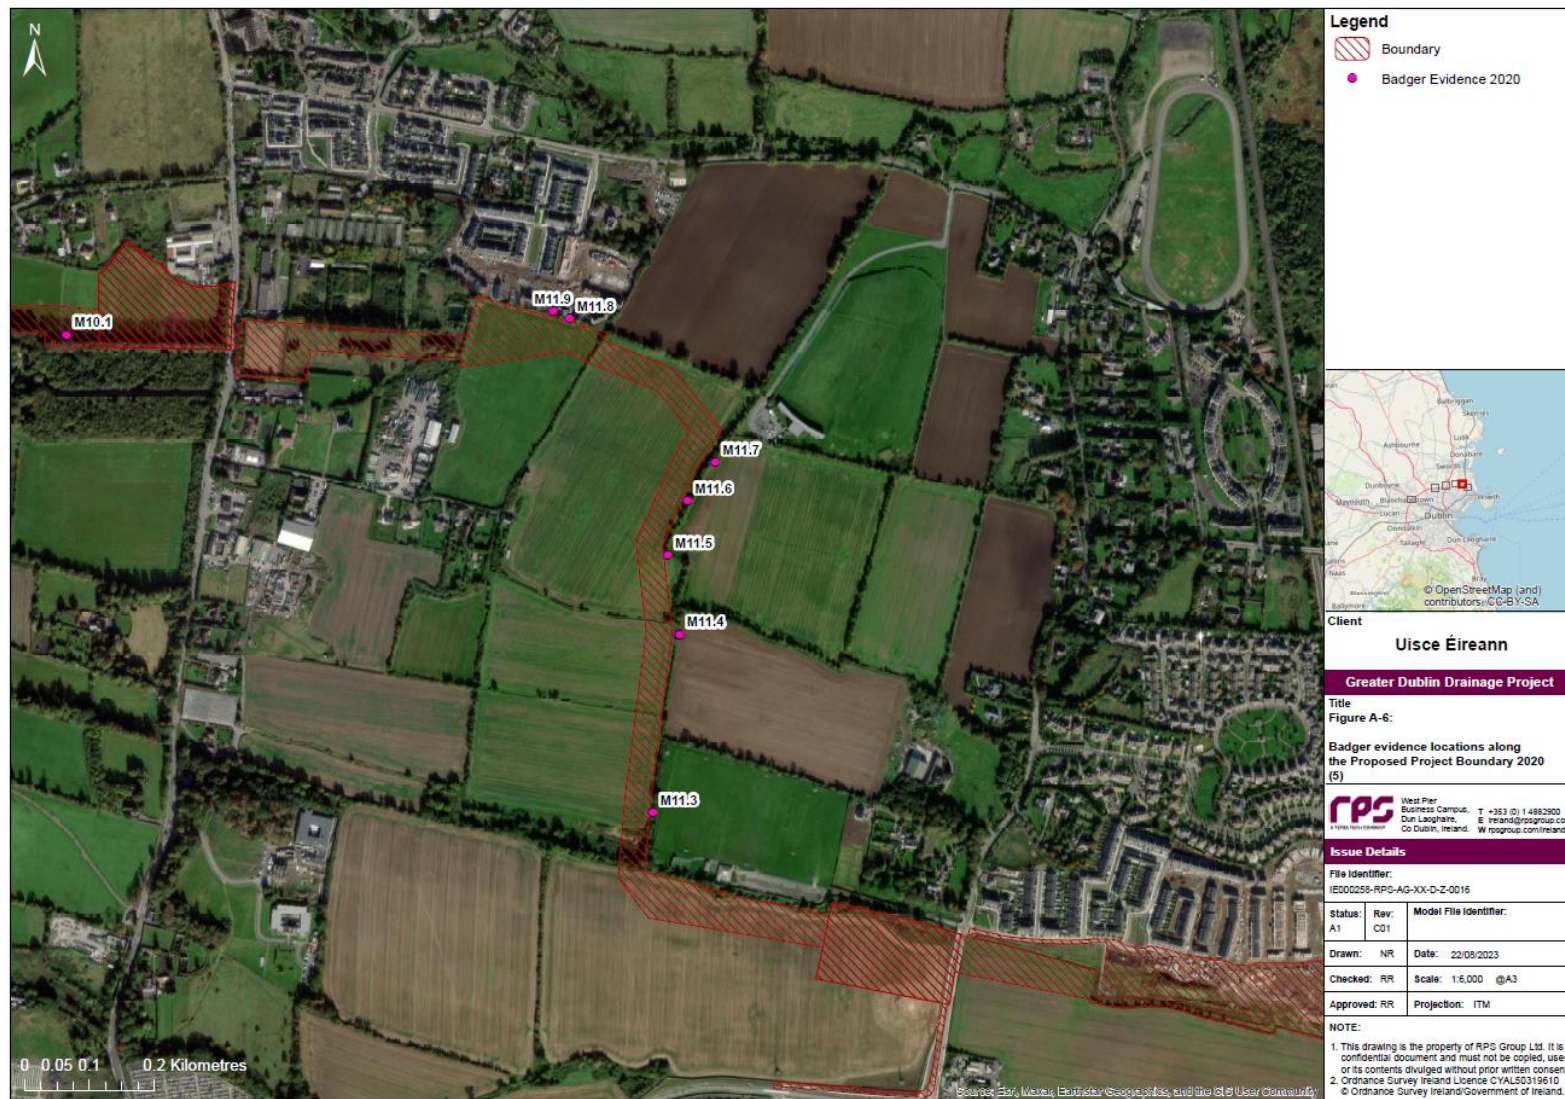
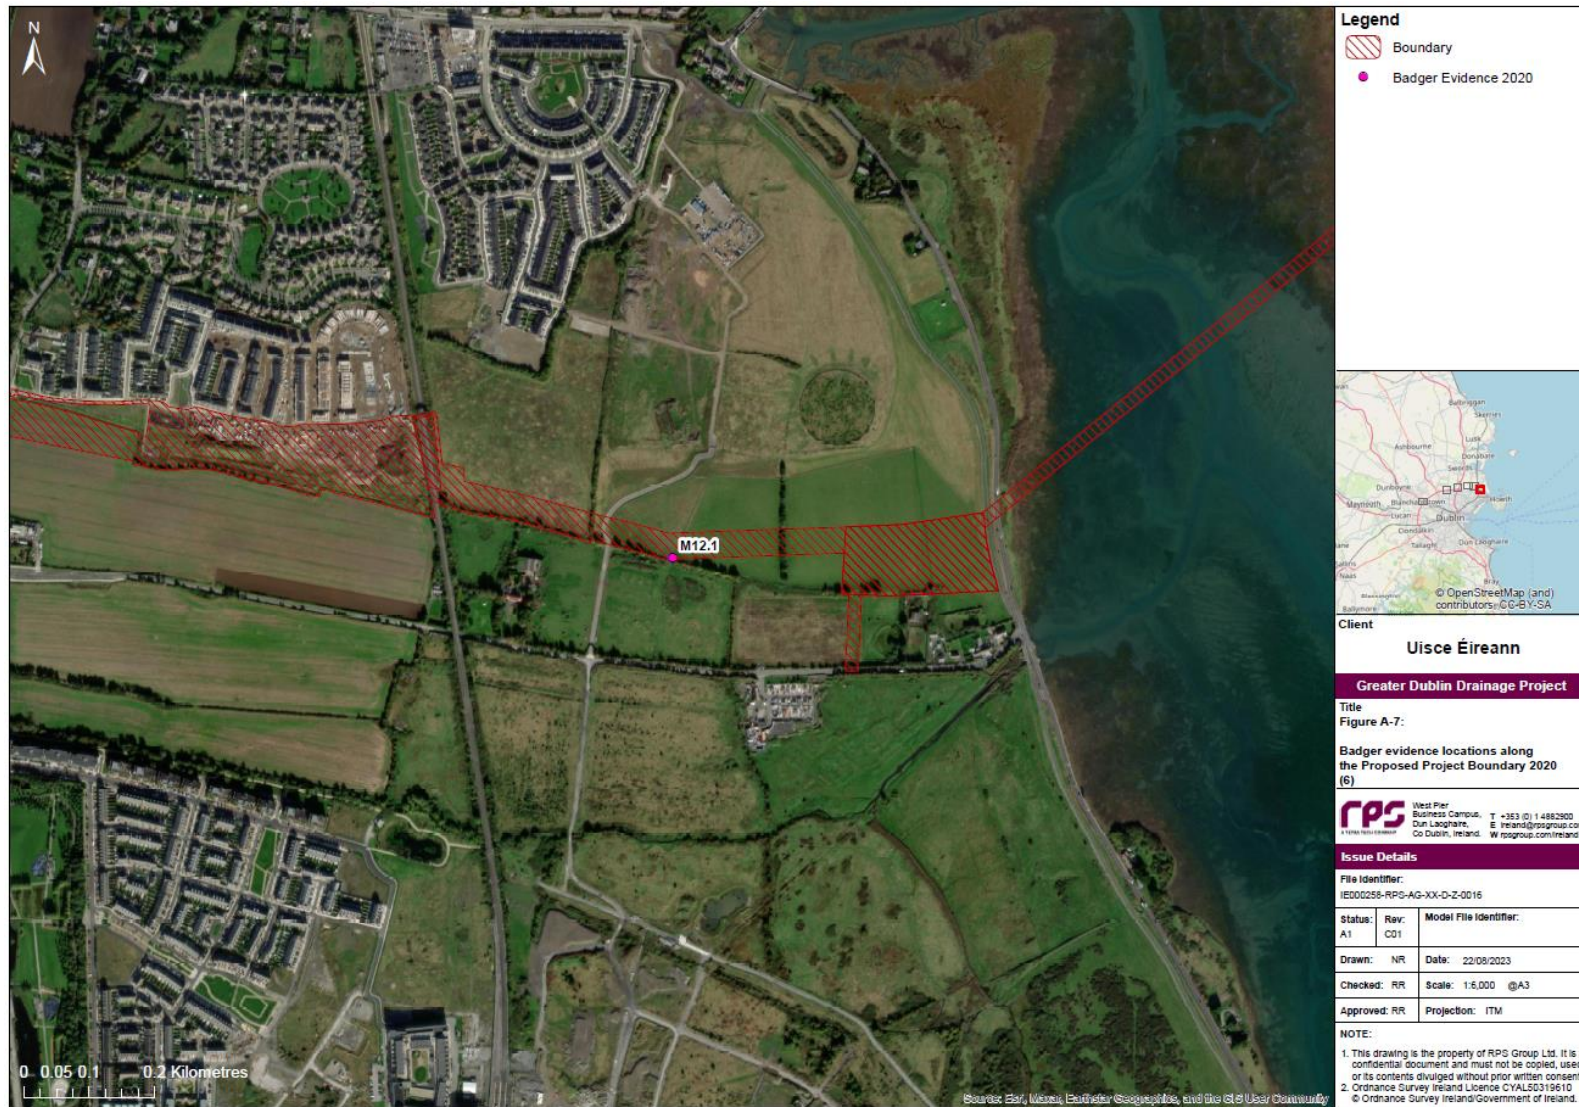
Figure A-1 Badger evidence locations along the Proposed Project Boundary 2020 (Overview)

Figure A-2 Badger evidence locations along the Proposed Project Boundary 2020 (1)

Figure A-3 Badger evidence locations along the Proposed Project Boundary 2020 (2)

Figure A-4 Badger evidence locations along the Proposed Project Boundary 2020 (3)

Figure A-5 Badger evidence locations along the Proposed Project Boundary 2020 (4)

Figure A-6 Badger evidence locations along the Proposed Project Boundary 2020 (5)

Figure A-7 Badger evidence locations along the Proposed Project Boundary 2020 (6)

In 2020 badger evidence such as snuffle holes, excavations, trails, prints, and latrines were recorded either close to or within the redline boundary of Proposed Project. The badger evidence is mapped in GIS and shown in **Figure A-1 to A-7 of Appendix A** and detailed within (**Table B-1, Appendix B**). The majority of this evidence was recorded in the eastern section of the Proposed Project route.

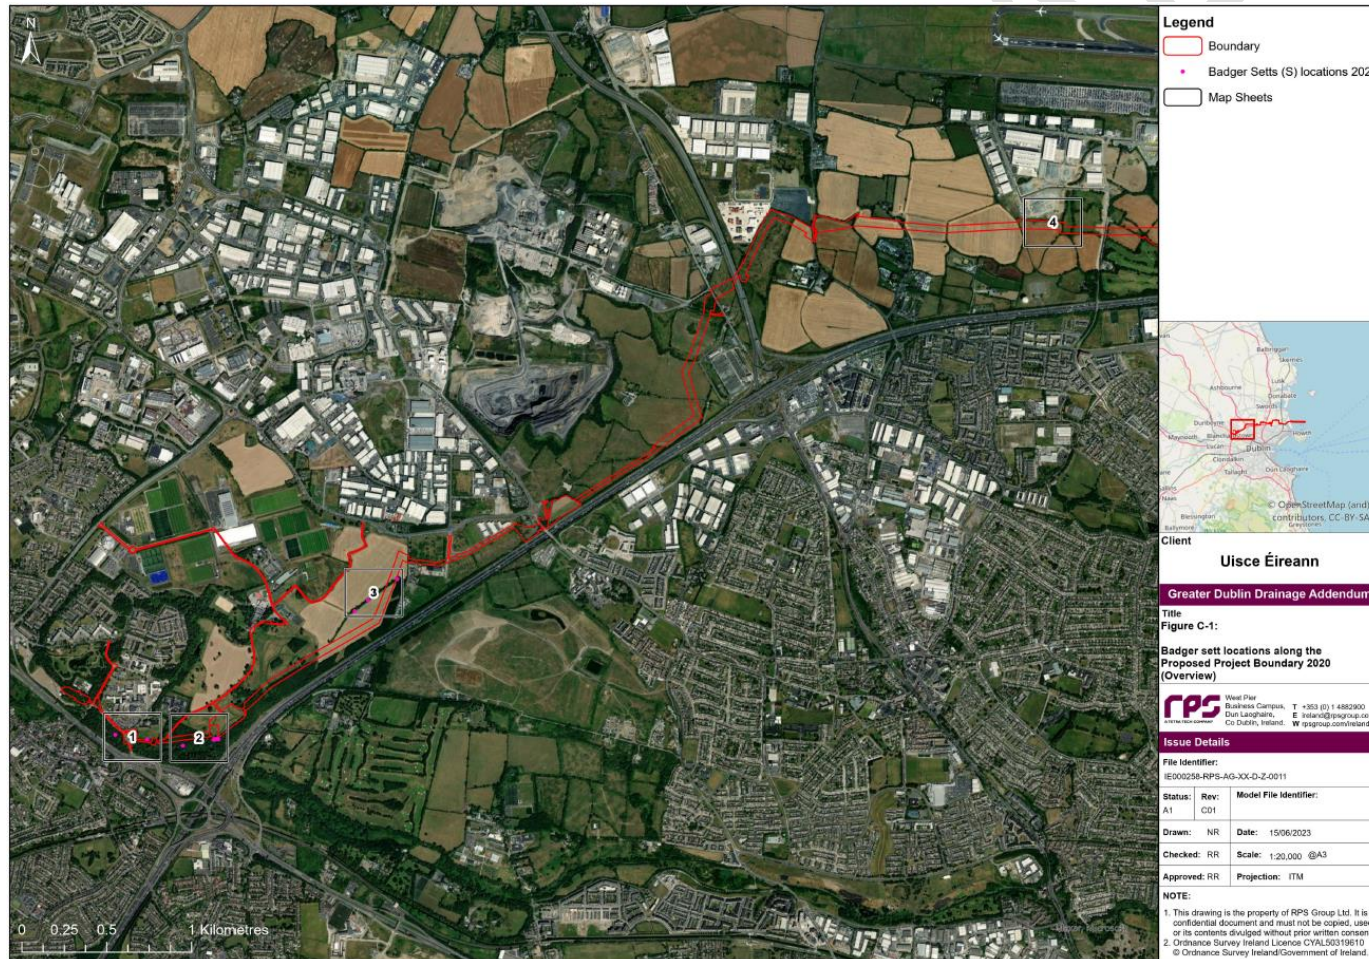
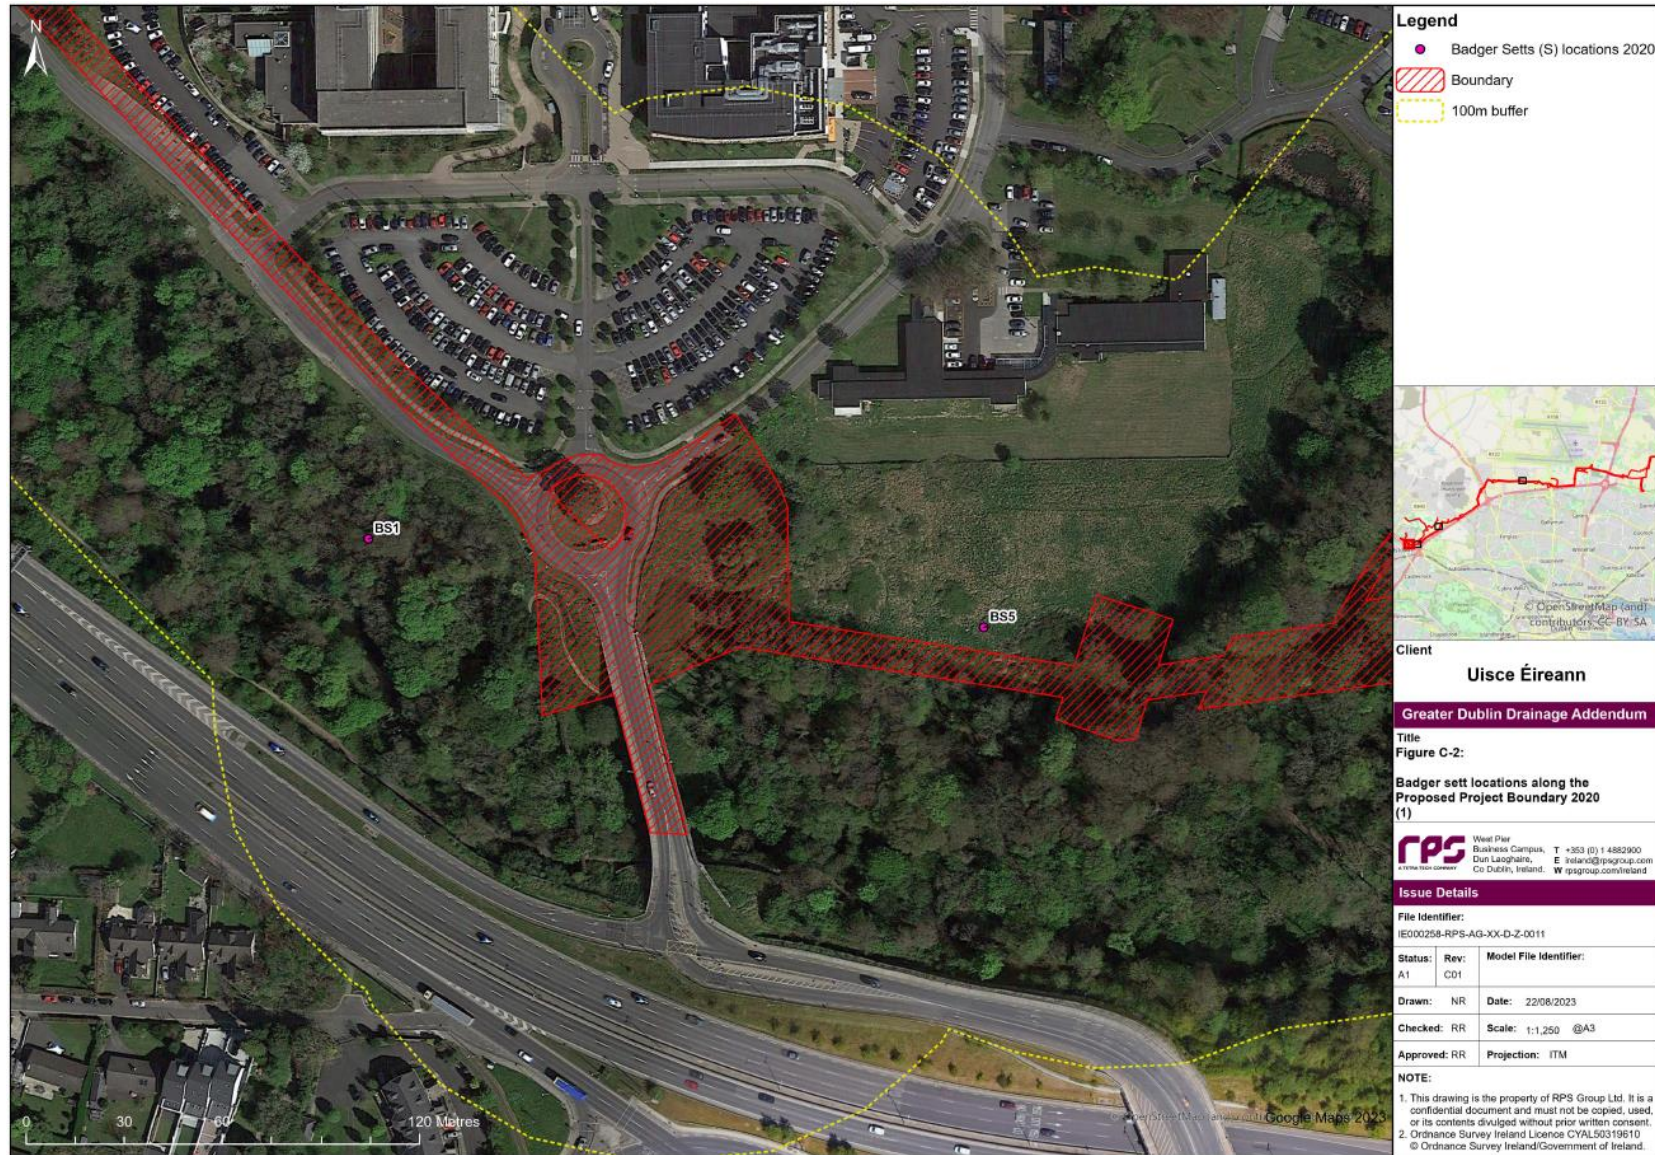
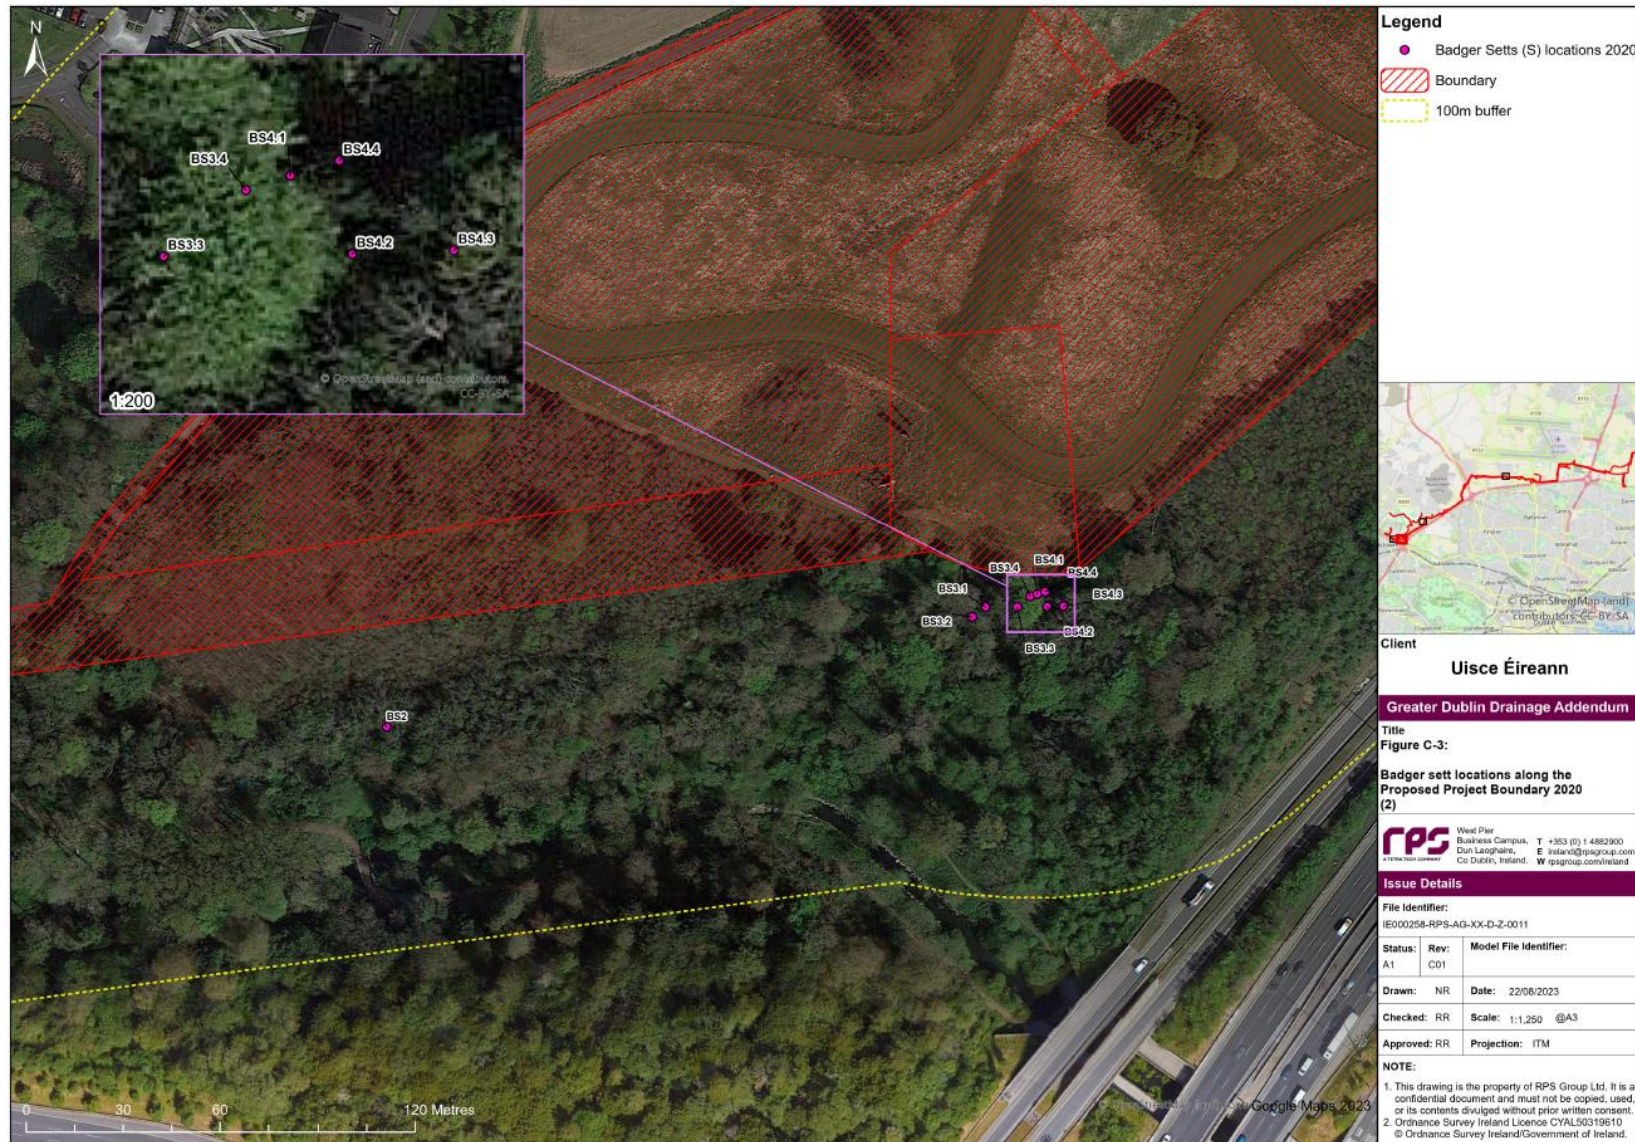
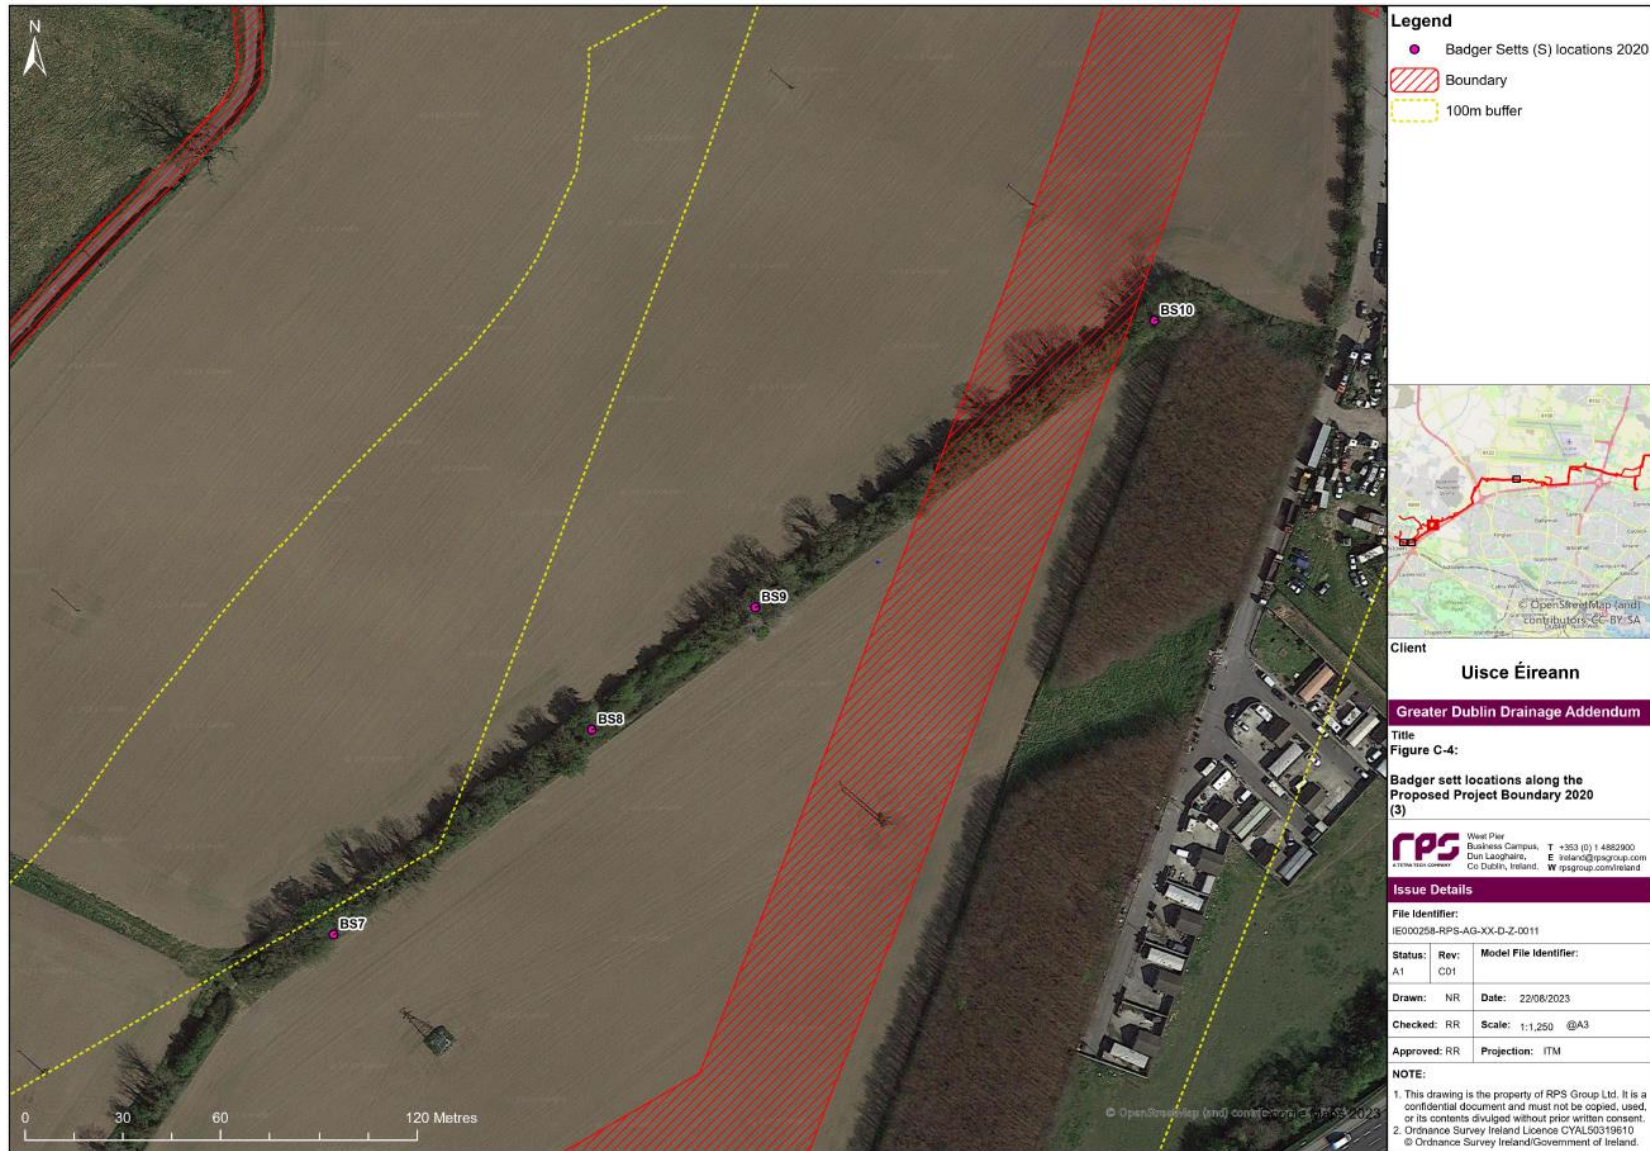
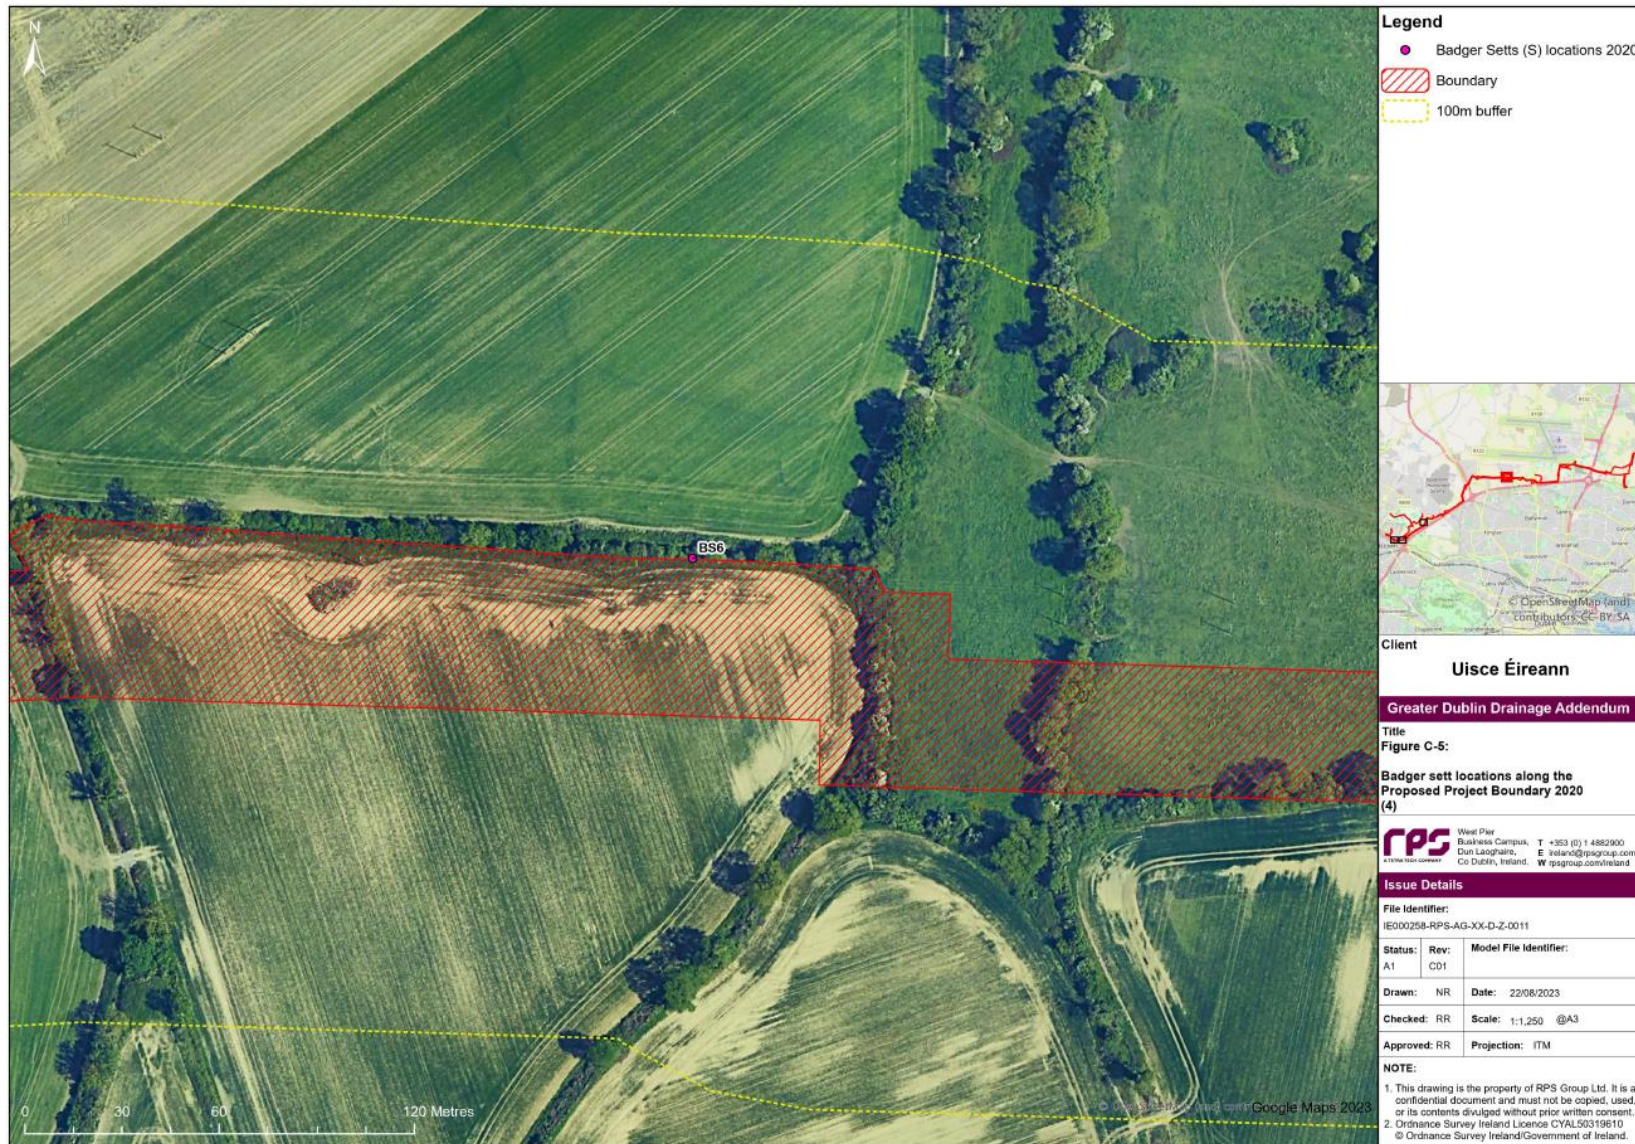
Figure C-1 Badger sett locations along the Proposed Project Boundary 2020 (Overview)

Figure C-2 Badger sett locations along the Proposed Project Boundary 2020 (1)

Figure C-3 Badger sett locations along the Proposed Project Boundary 2020 (2)

Figure C-4 Badger sett locations along the Proposed Project Boundary 2020 (3)

Figure C-5 Badger sett locations along the Proposed Project Boundary 2020 (4)

In 2020, ten badger setts were identified. Eight badger setts (BS1, BS2, BS3, BS4, BS5, BS6, BS9 and BS10) were identified outside of the redline boundary but within 50m of the redline boundary of the Proposed Project. Another two setts (BS7 and BS8) were identified outside of the redline boundary but within 100m of the redline boundary of the Proposed Project. Four of the 10 setts (BS7, BS8, BS9 and BS10) were also recorded in the 2017 survey. Therefore, the six extra setts recorded in 2020 are new setts and represent a material change. Ten setts were also recorded in 2017. Six of which were not re-recorded in 2020. It is not considered that such fluctuations in sett activity, particularly for setts which are not main setts, is unusual, given that badgers are mobile with sett activity able to change during and between years. The location of these setts and further details are provided in the **Figures C-1 to C-5 of Appendix C and Table D-1 of Appendix D**
