GREATER DUBLIN DRAINAGE PROJECT

EIAR Addendum Chapter 11A (Biodiversity (Terrestrial and Freshwater Aquatic))
Appendix A11.1 Terrestrial Baseline Survey Report
Confidential Badger Survey 2023 Report

IE000258
S4P01
17 July 2023

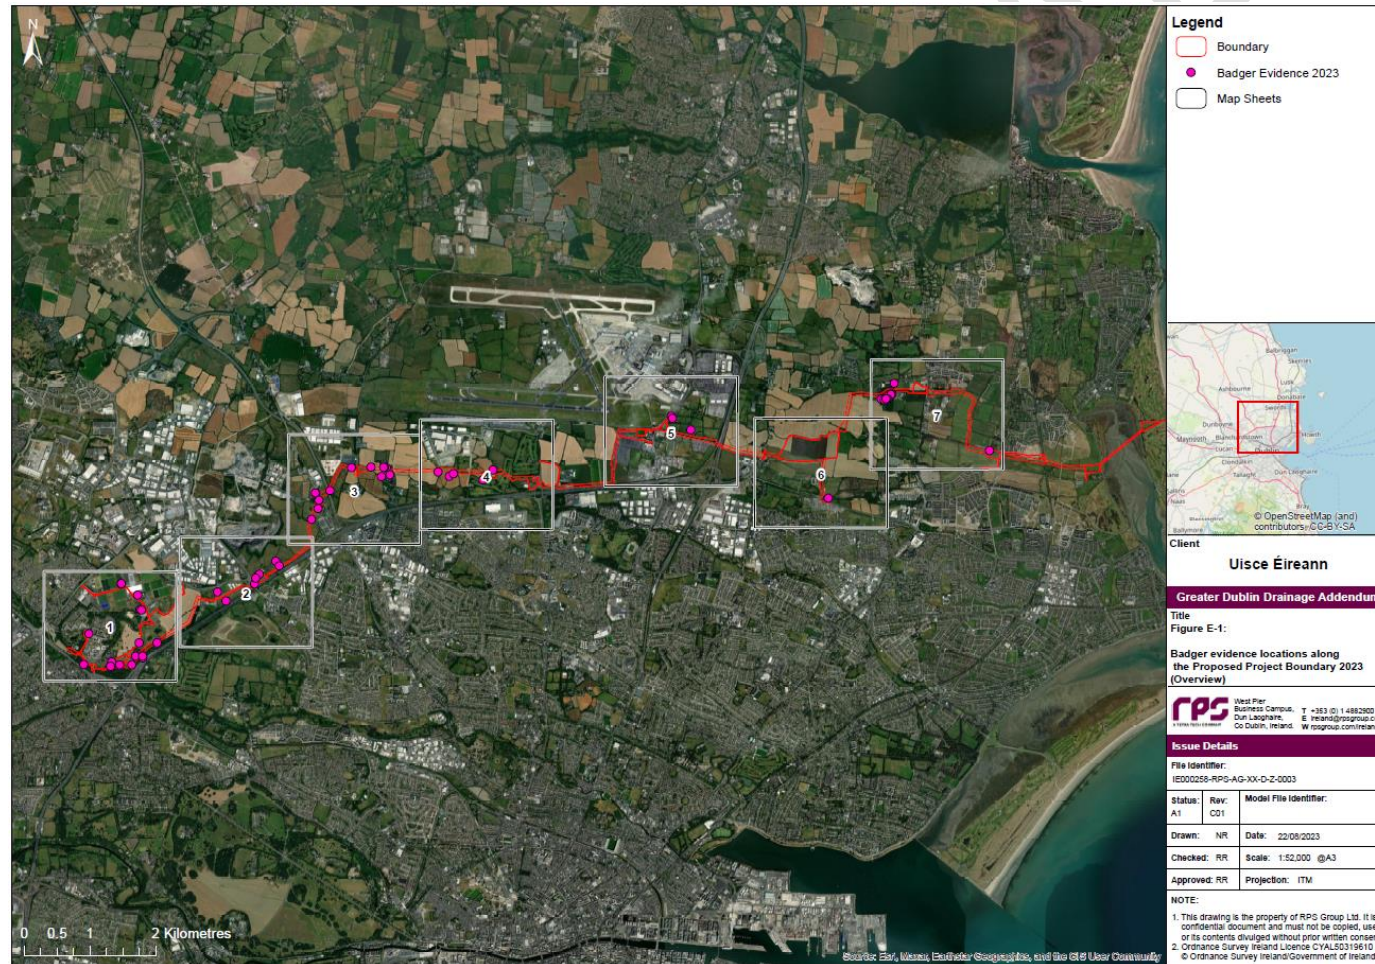
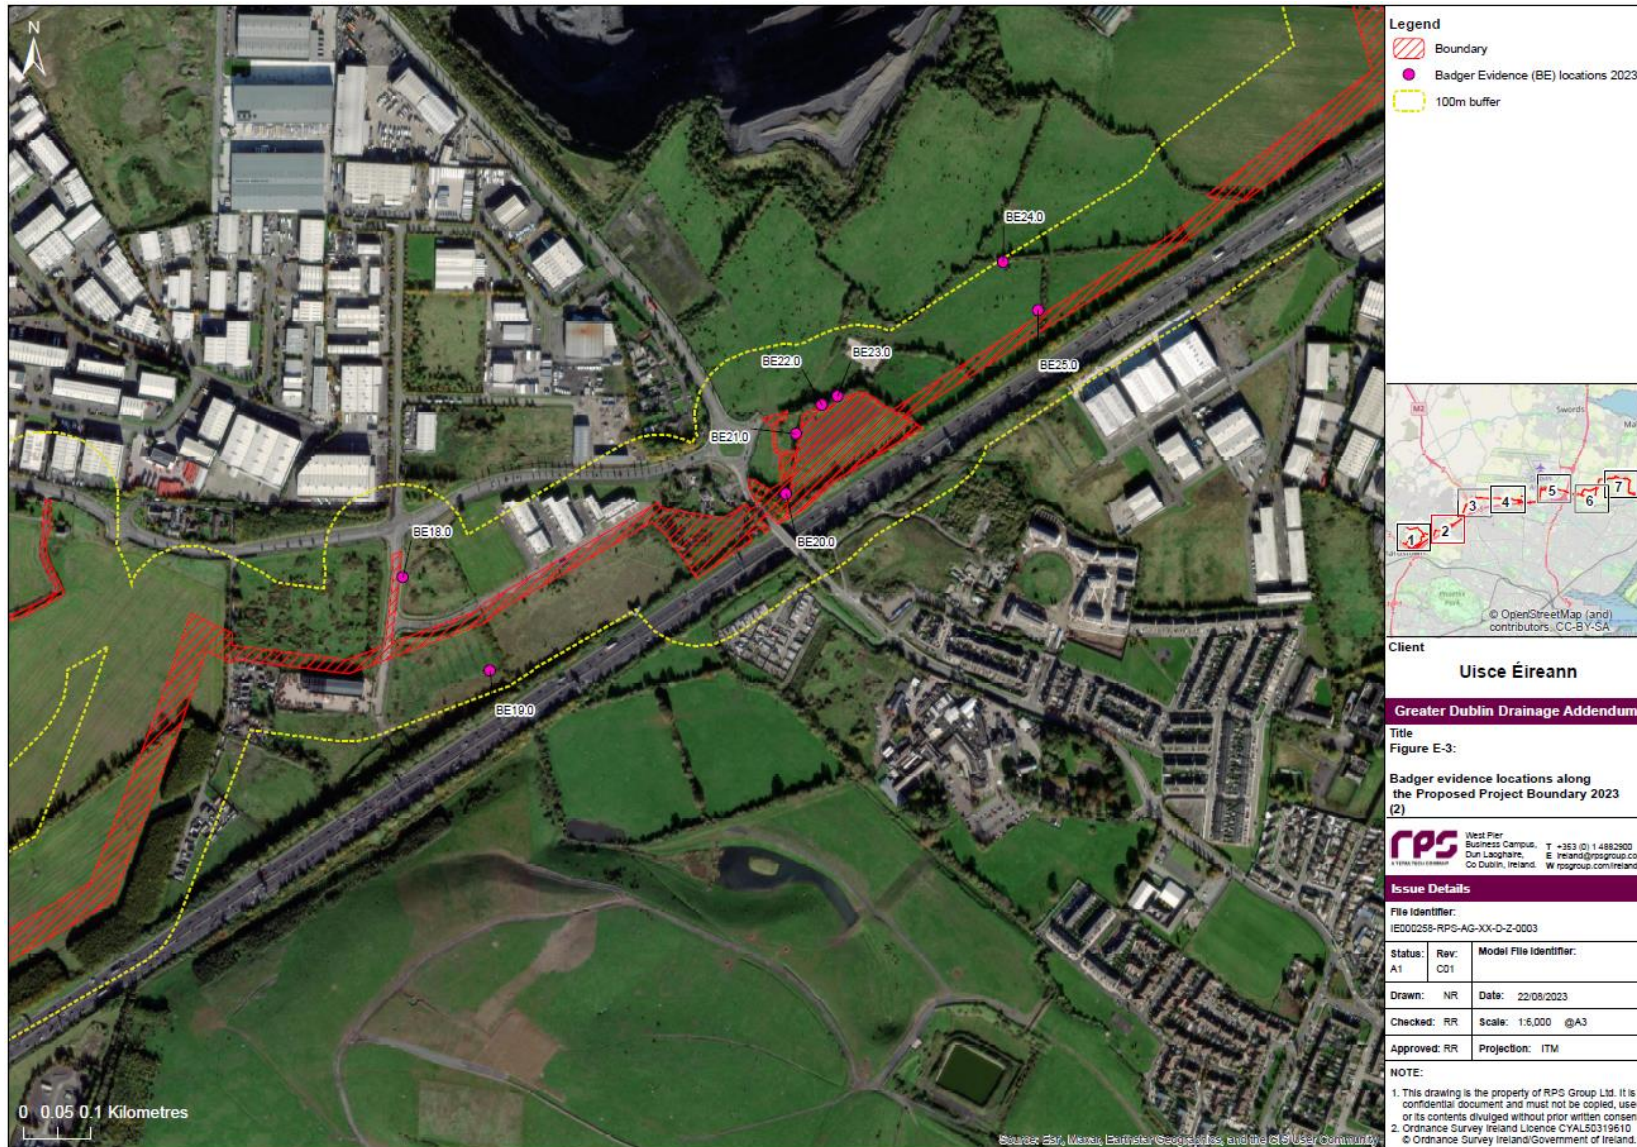
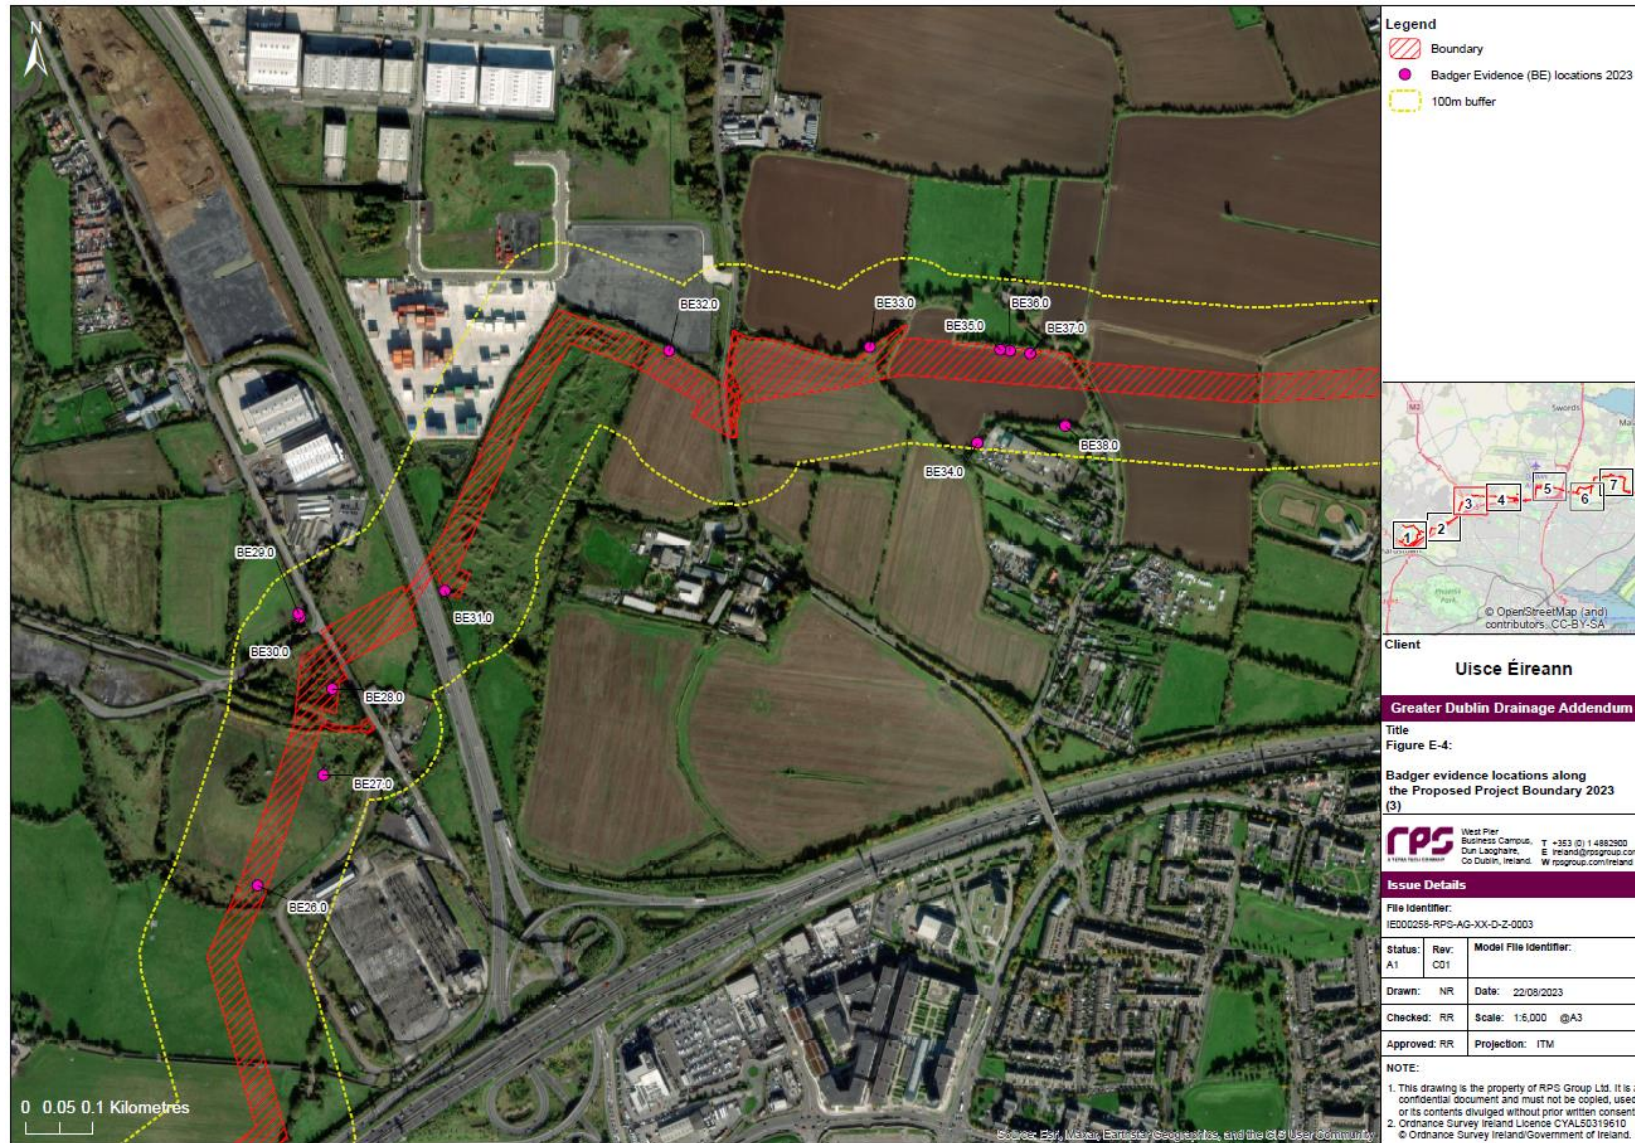
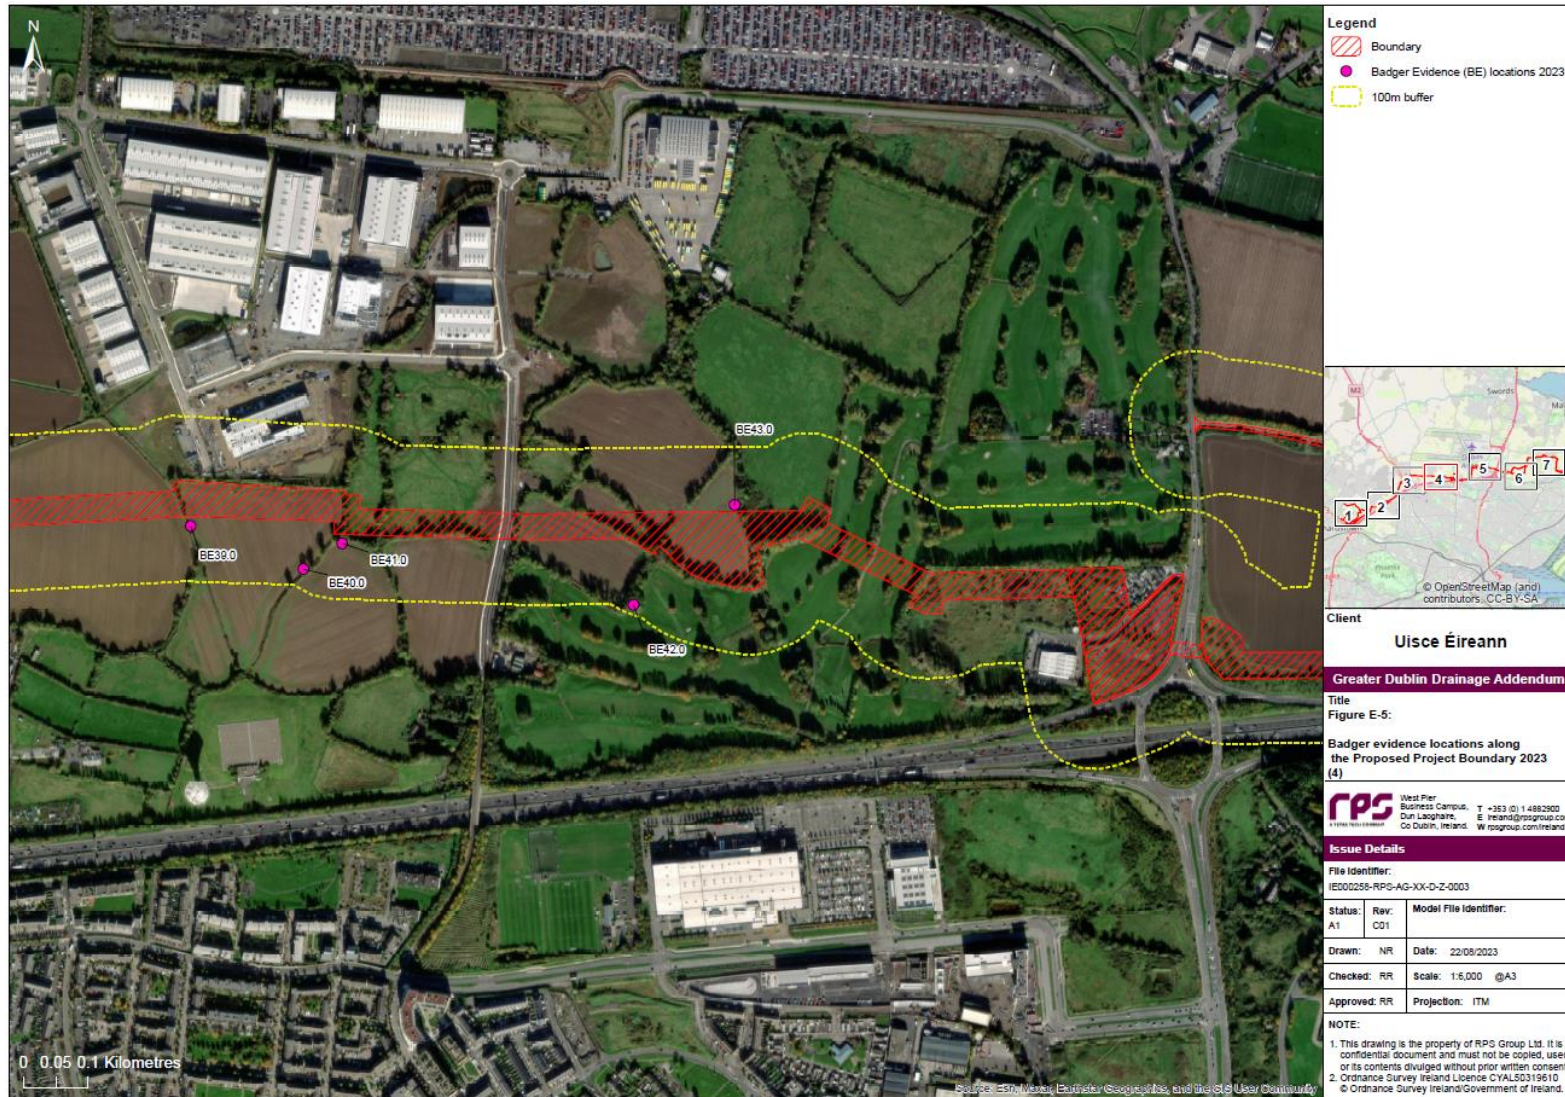
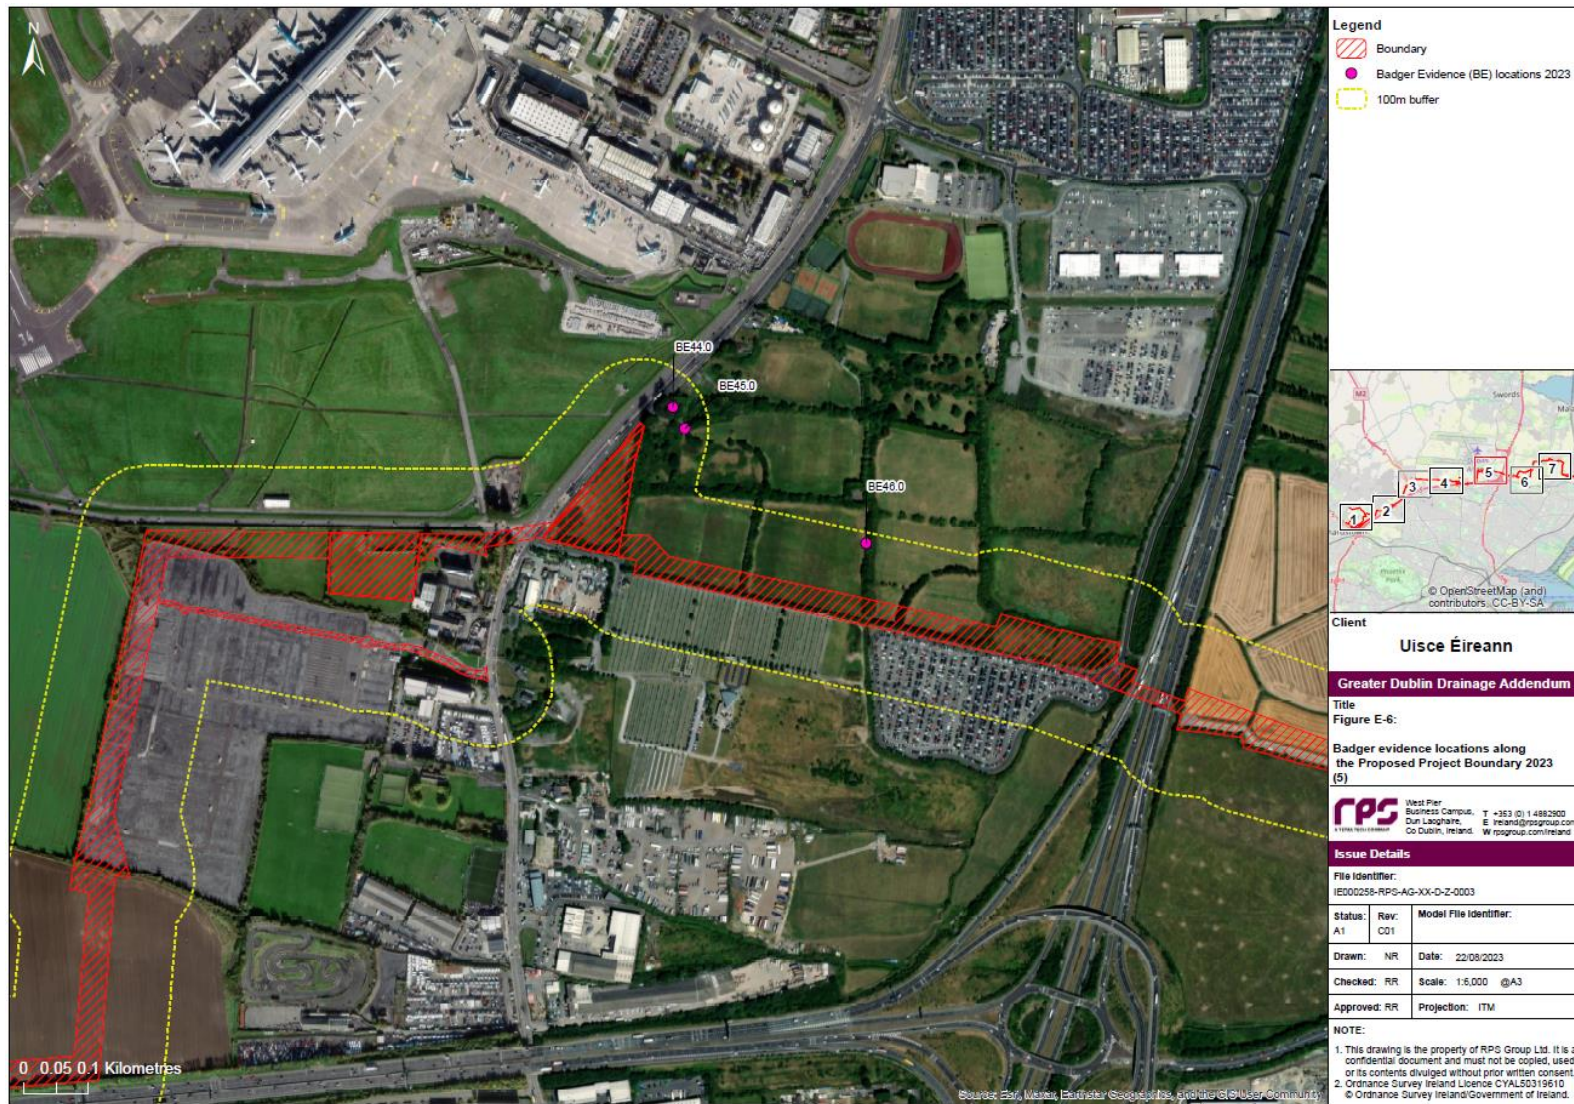
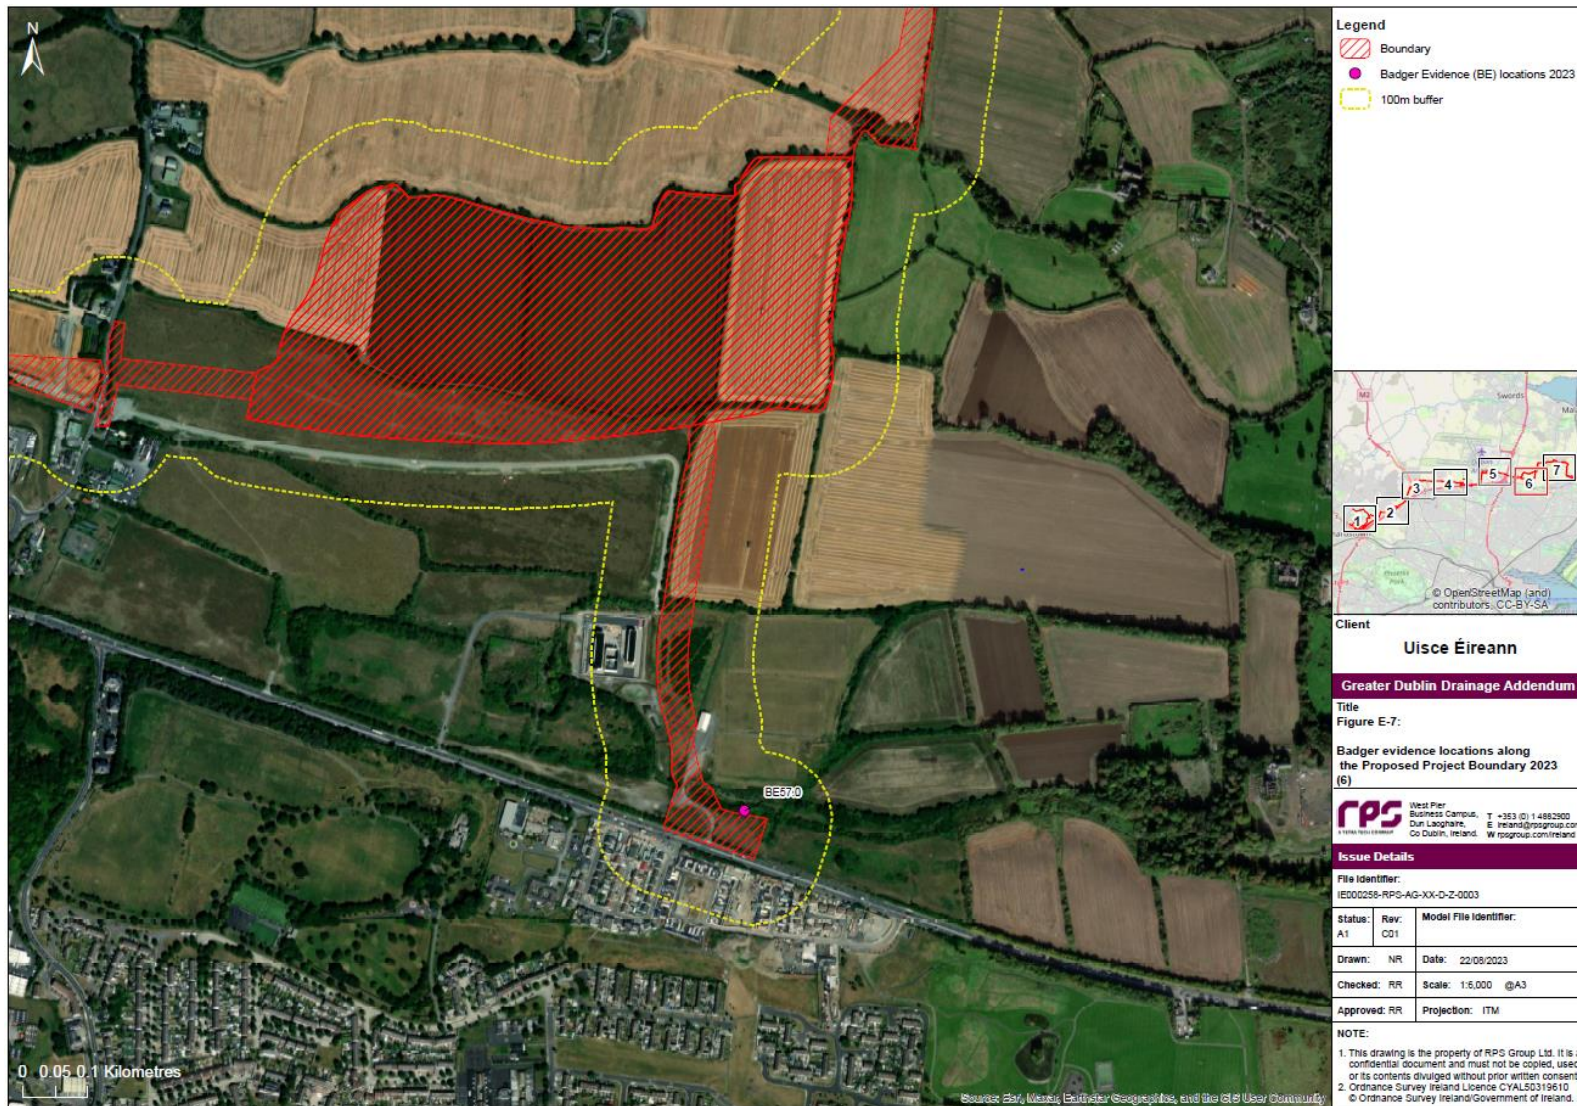
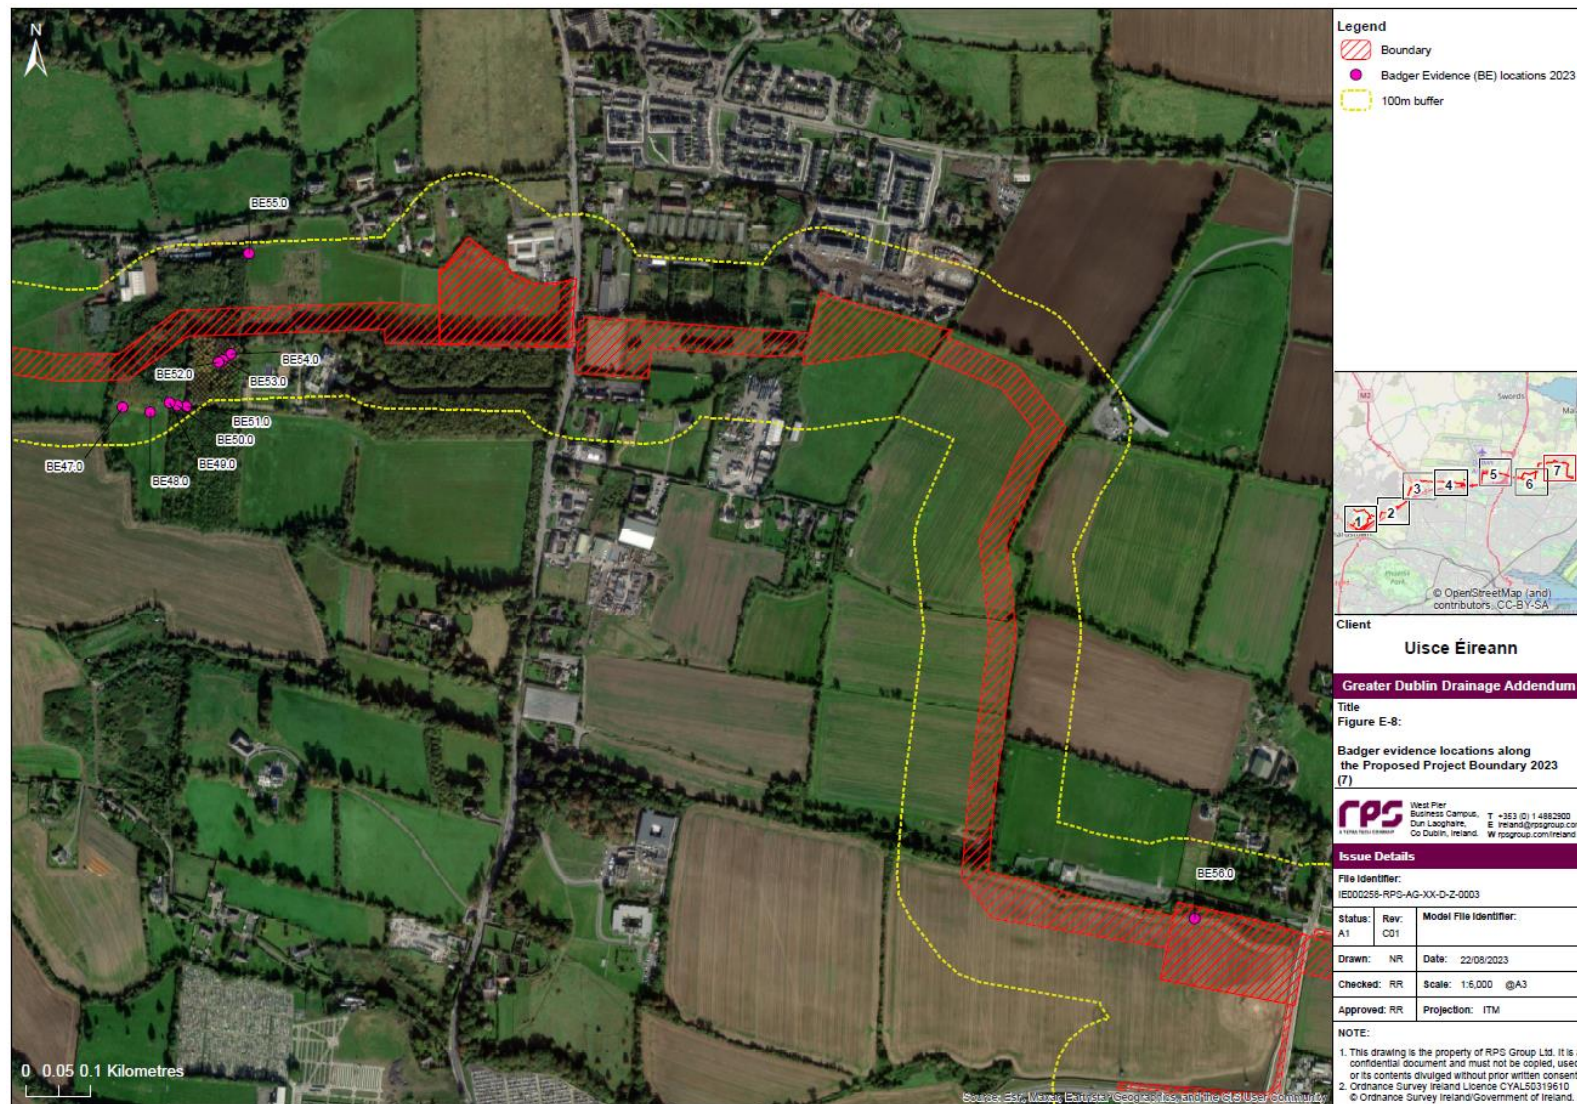
Figure E-1 Badger evidence locations along the Proposed Project Boundary 2023 (Overview)

Figure E-2 Badger evidence locations along the Proposed Project Boundary 2023 (1)

Figure E-3 Badger evidence locations along the Proposed Project Boundary 2023 (2)

Figure E-4 Badger evidence locations along the Proposed Project Boundary 2023 (3)

Figure E-5 Badger evidence locations along the Proposed Project Boundary 2023 (4)

Figure E-6 Badger evidence locations along the Proposed Project Boundary 2023 (5)

Figure E-7 Badger evidence locations along the Proposed Project Boundary 2023 (6)

Figure E-8 Badger evidence locations along the Proposed Project Boundary 2023 (7)

In 2023 badger evidence such as snuffle holes, hair, trails, prints, and latrines were recorded either close to or within the footprint of the Proposed Project Boundary (**Table F1 of Appendix F**). The badger evidence is also mapped in GIS and shown in **Figures E-1 to E-8 of Appendix E**. The majority of this evidence was recorded in the western section of the Proposed Project route.
