GREATER DUBLIN DRAINAGE PROJECT

EIAR Addendum Chapter 11A (Biodiversity (Terrestrial and Freshwater Aquatic))
Appendix A11.1 Terrestrial Baseline Survey Report
Confidential Badger Survey 2023 Report

IE000258
S4P01
17 July 2023

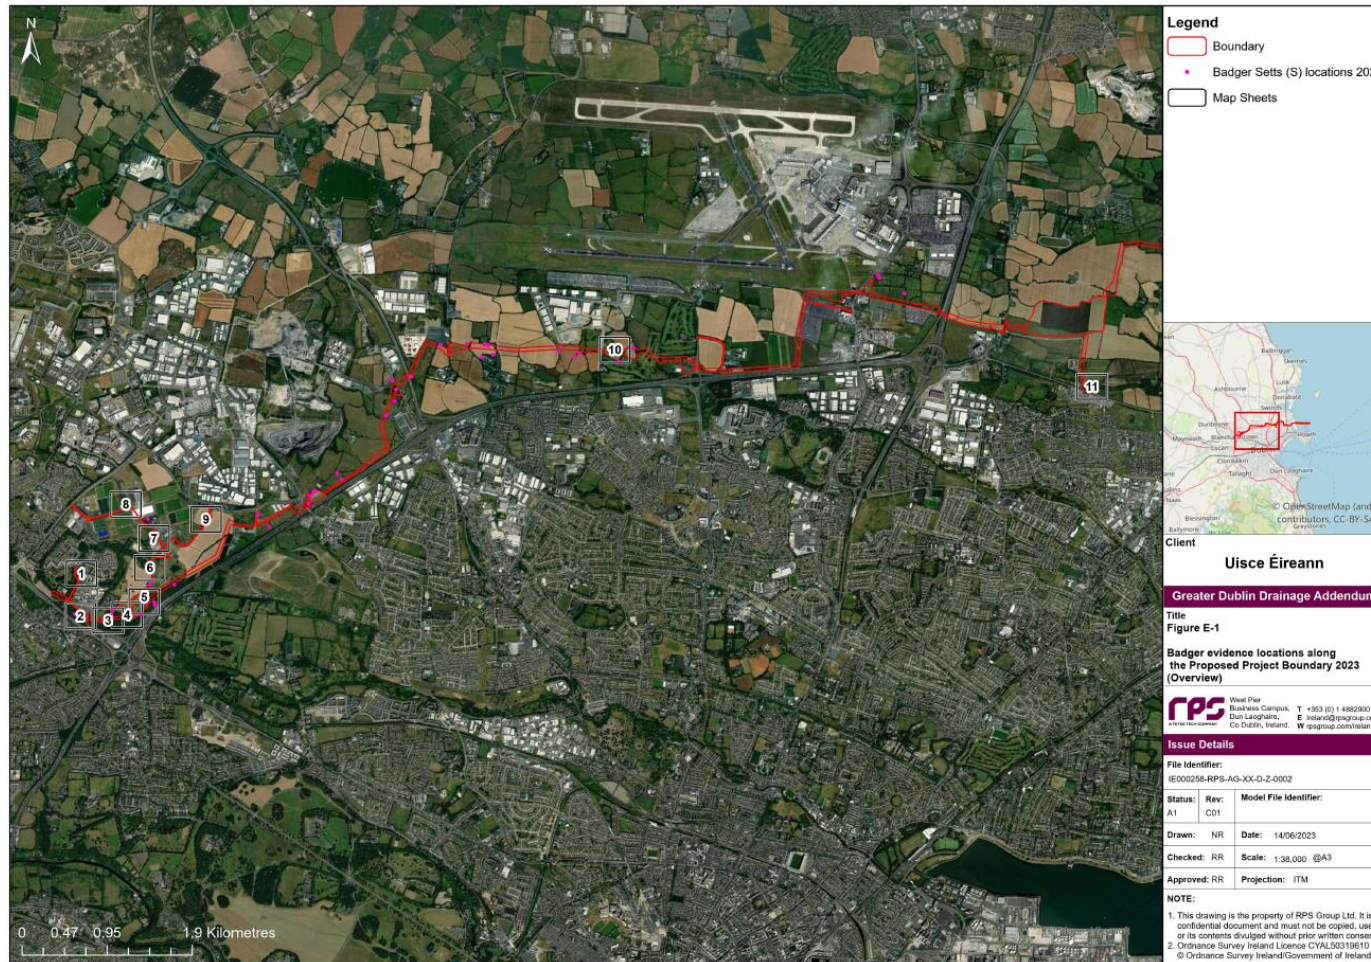
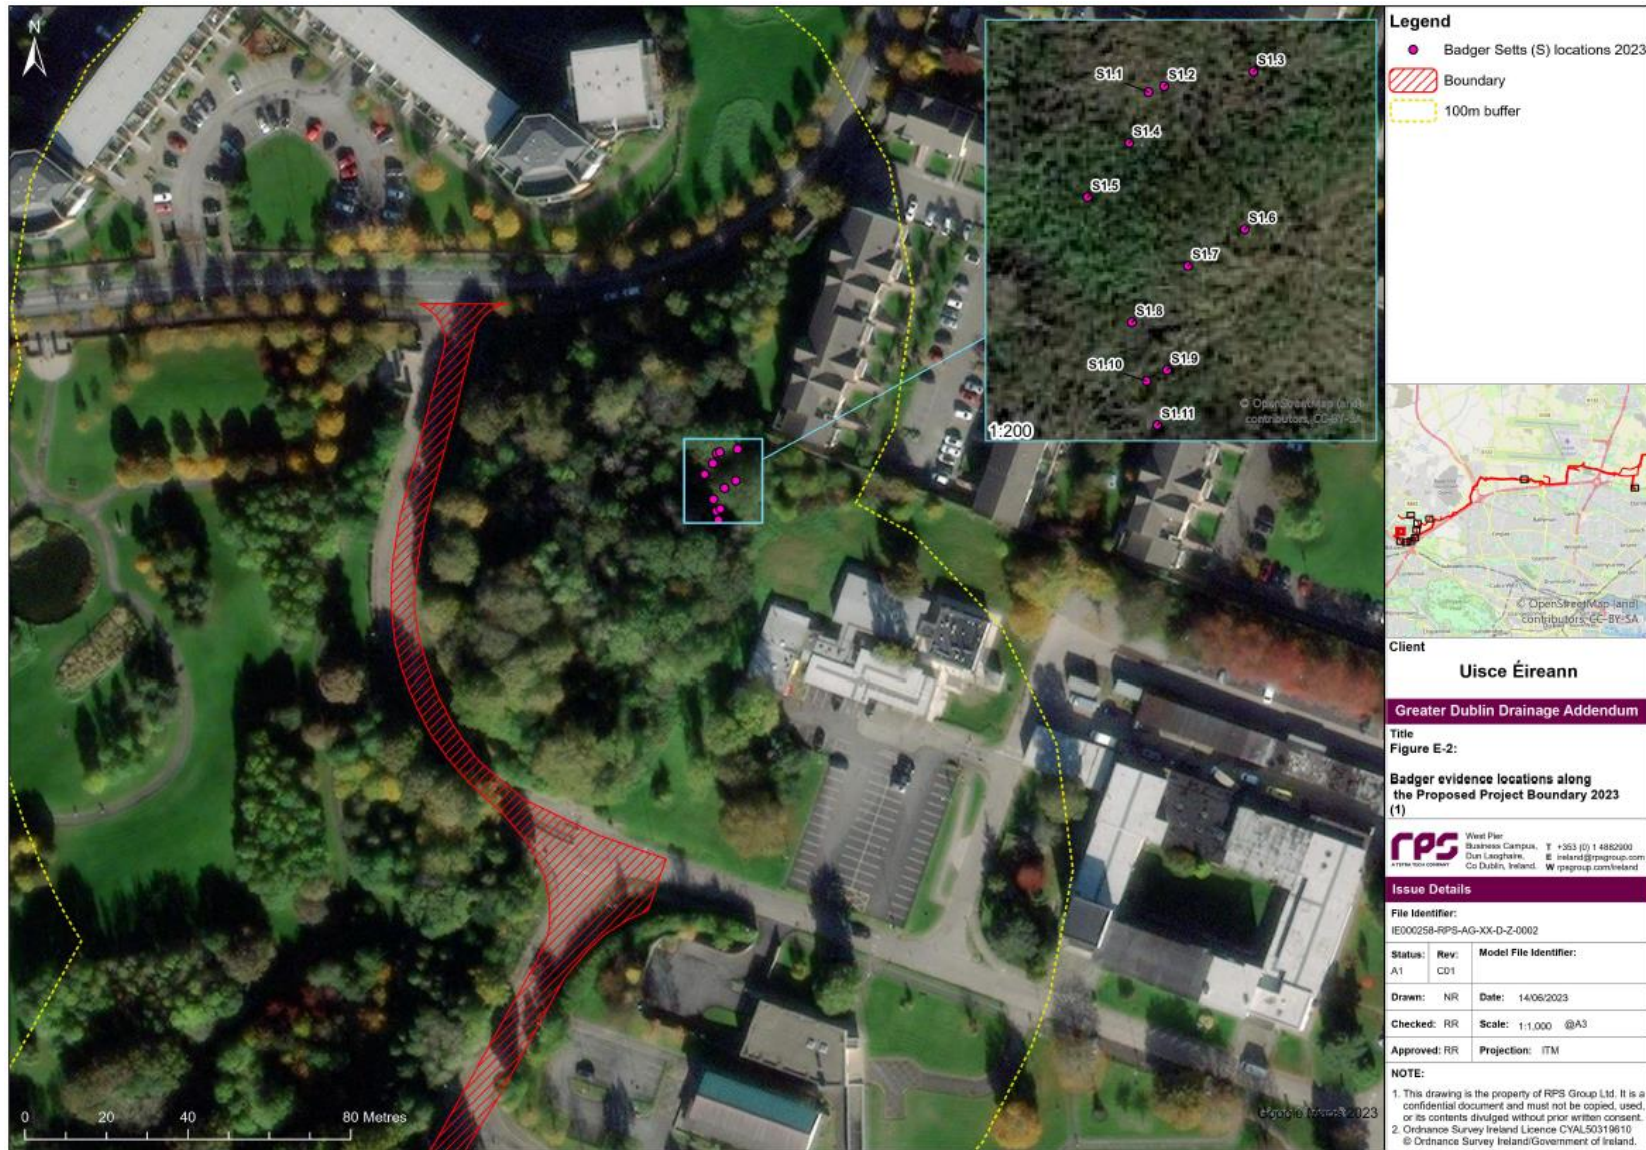
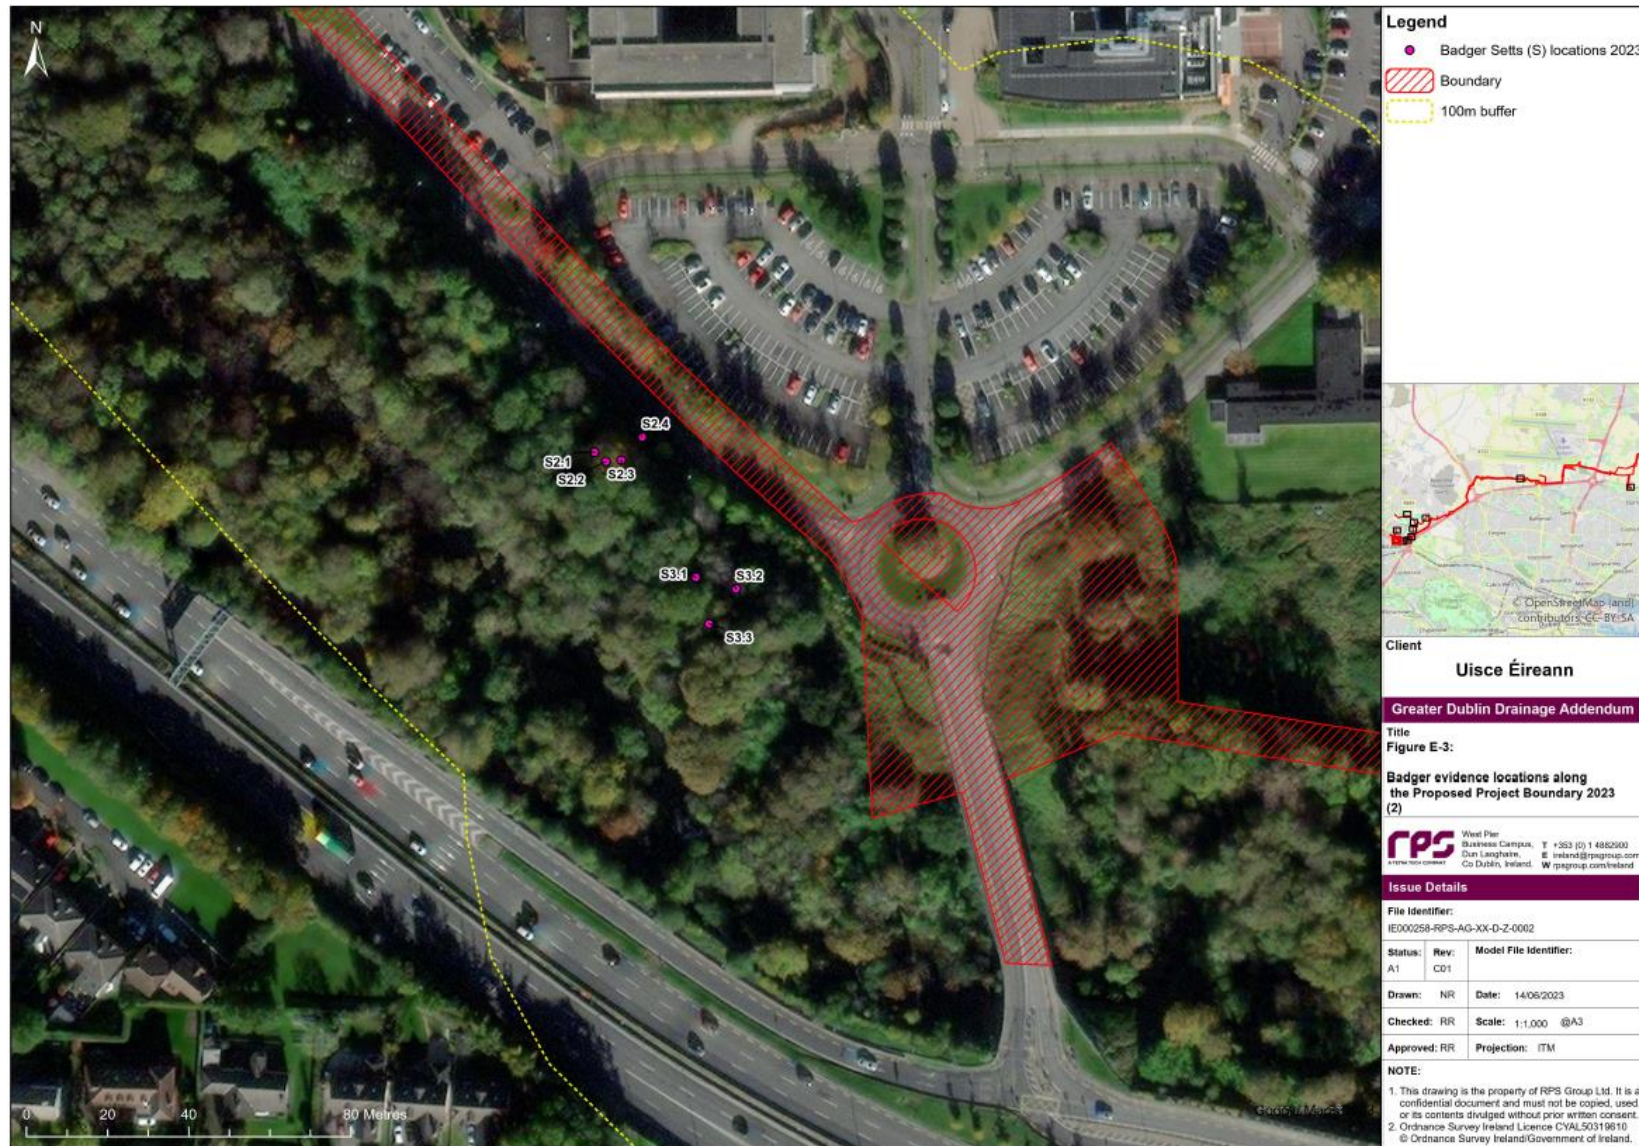
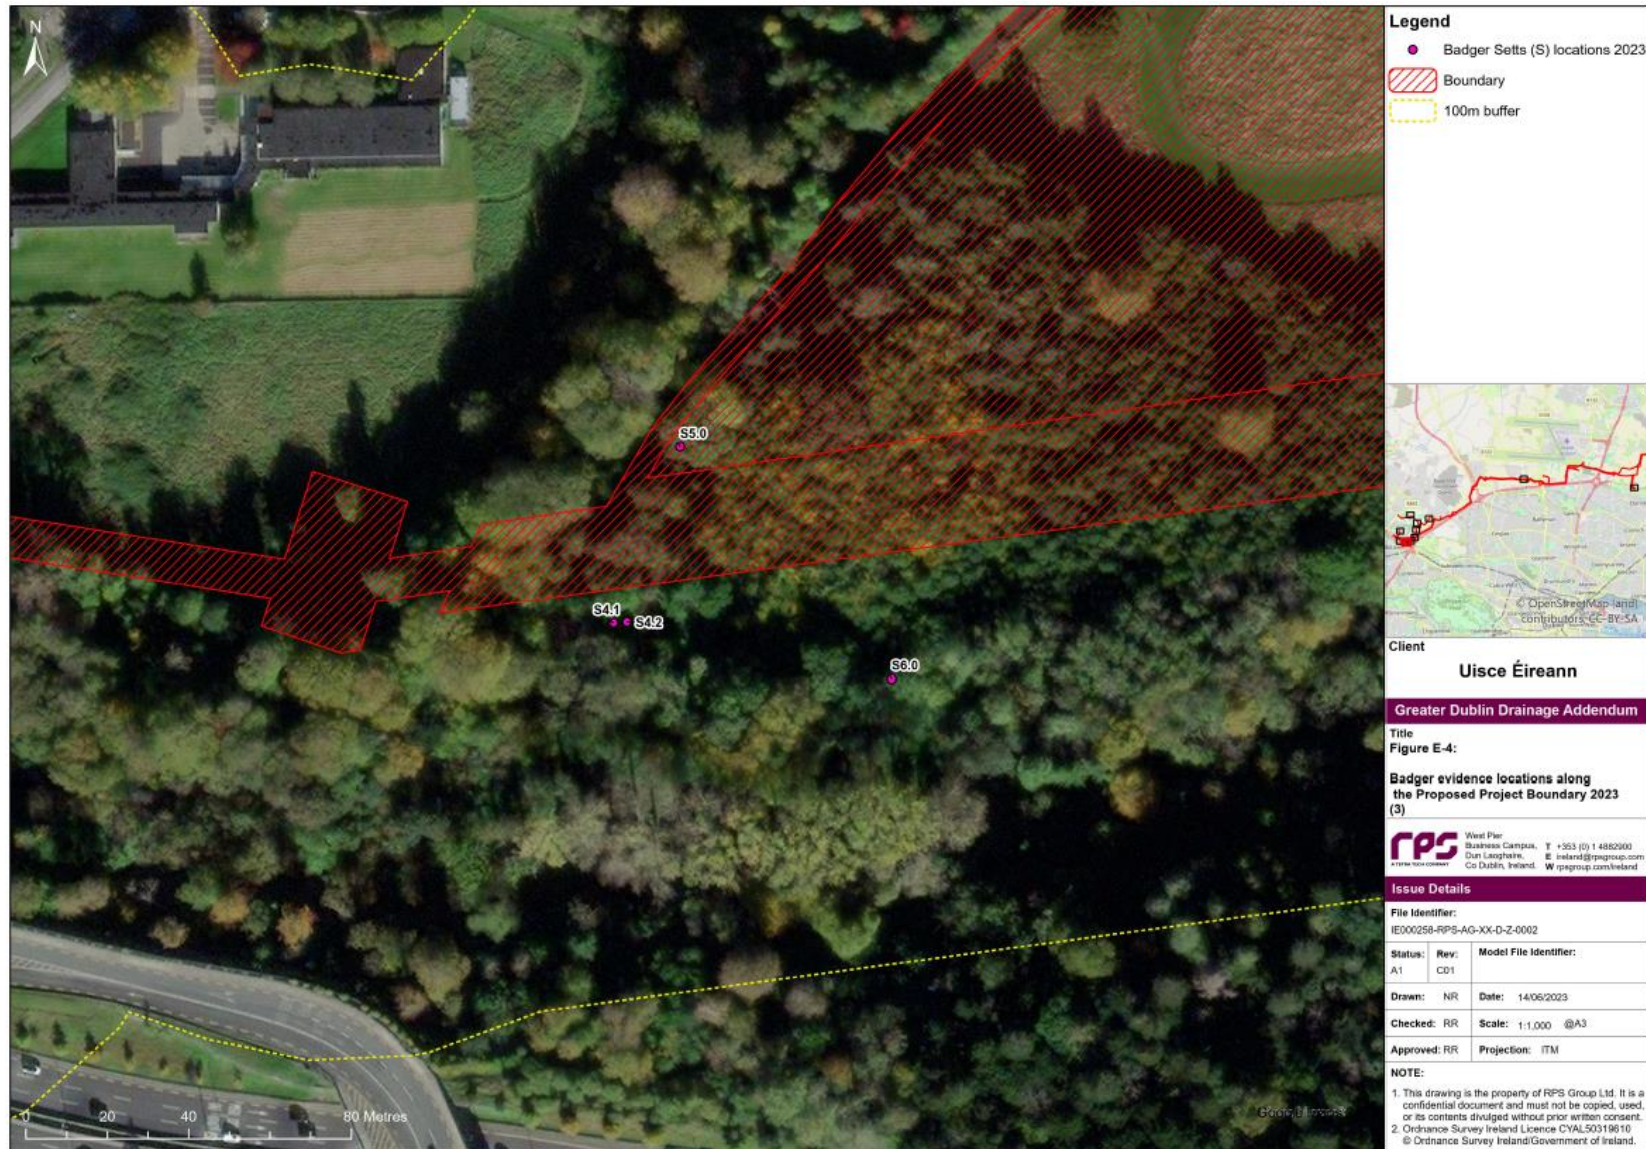
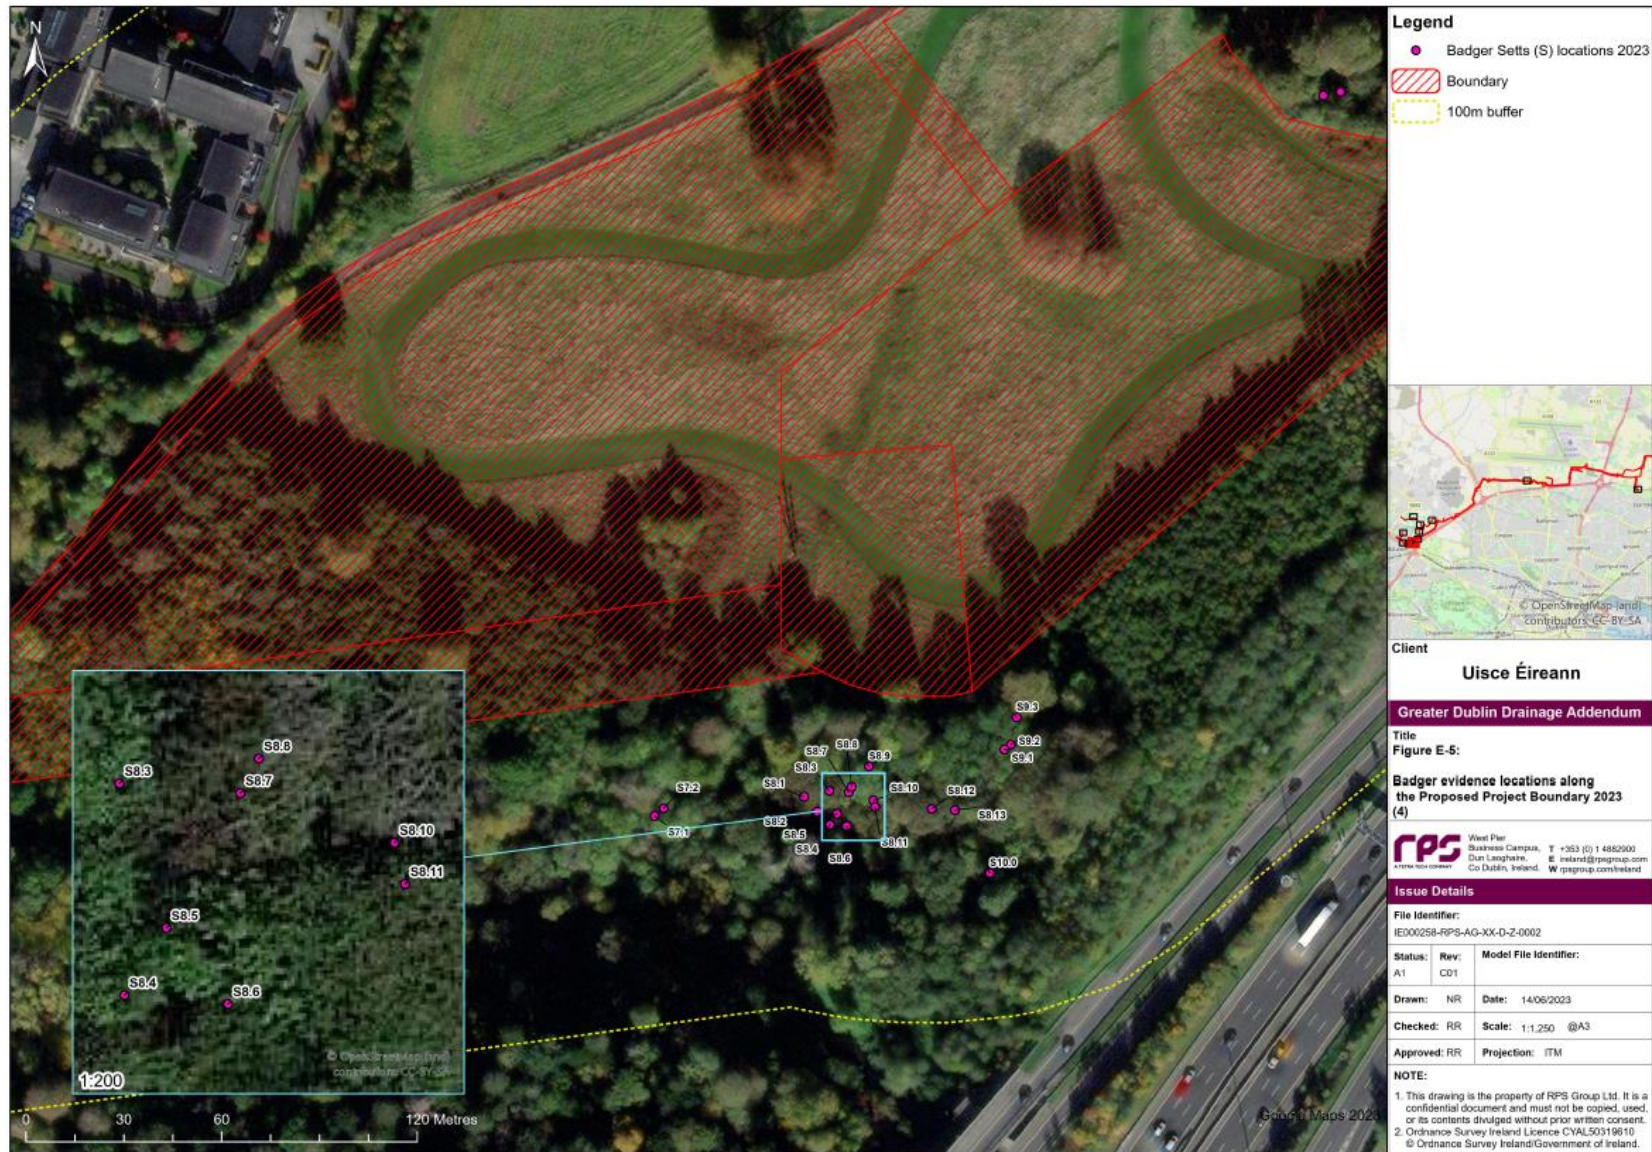
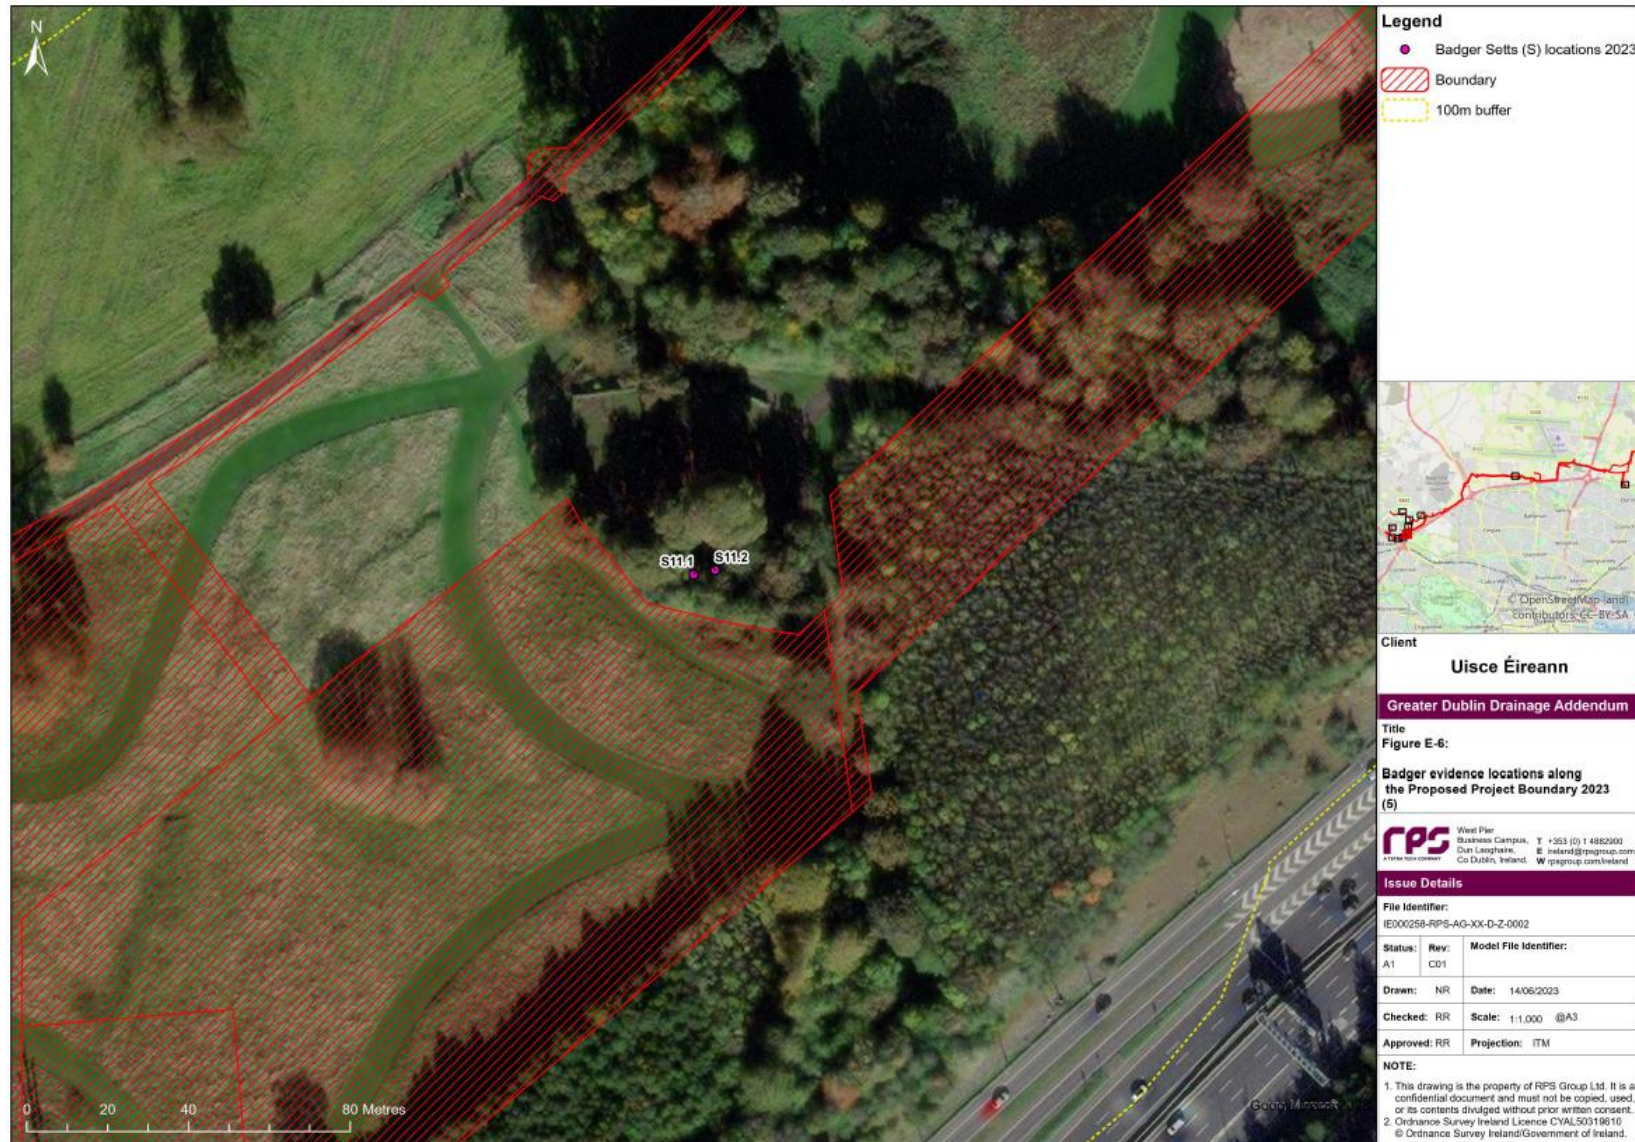
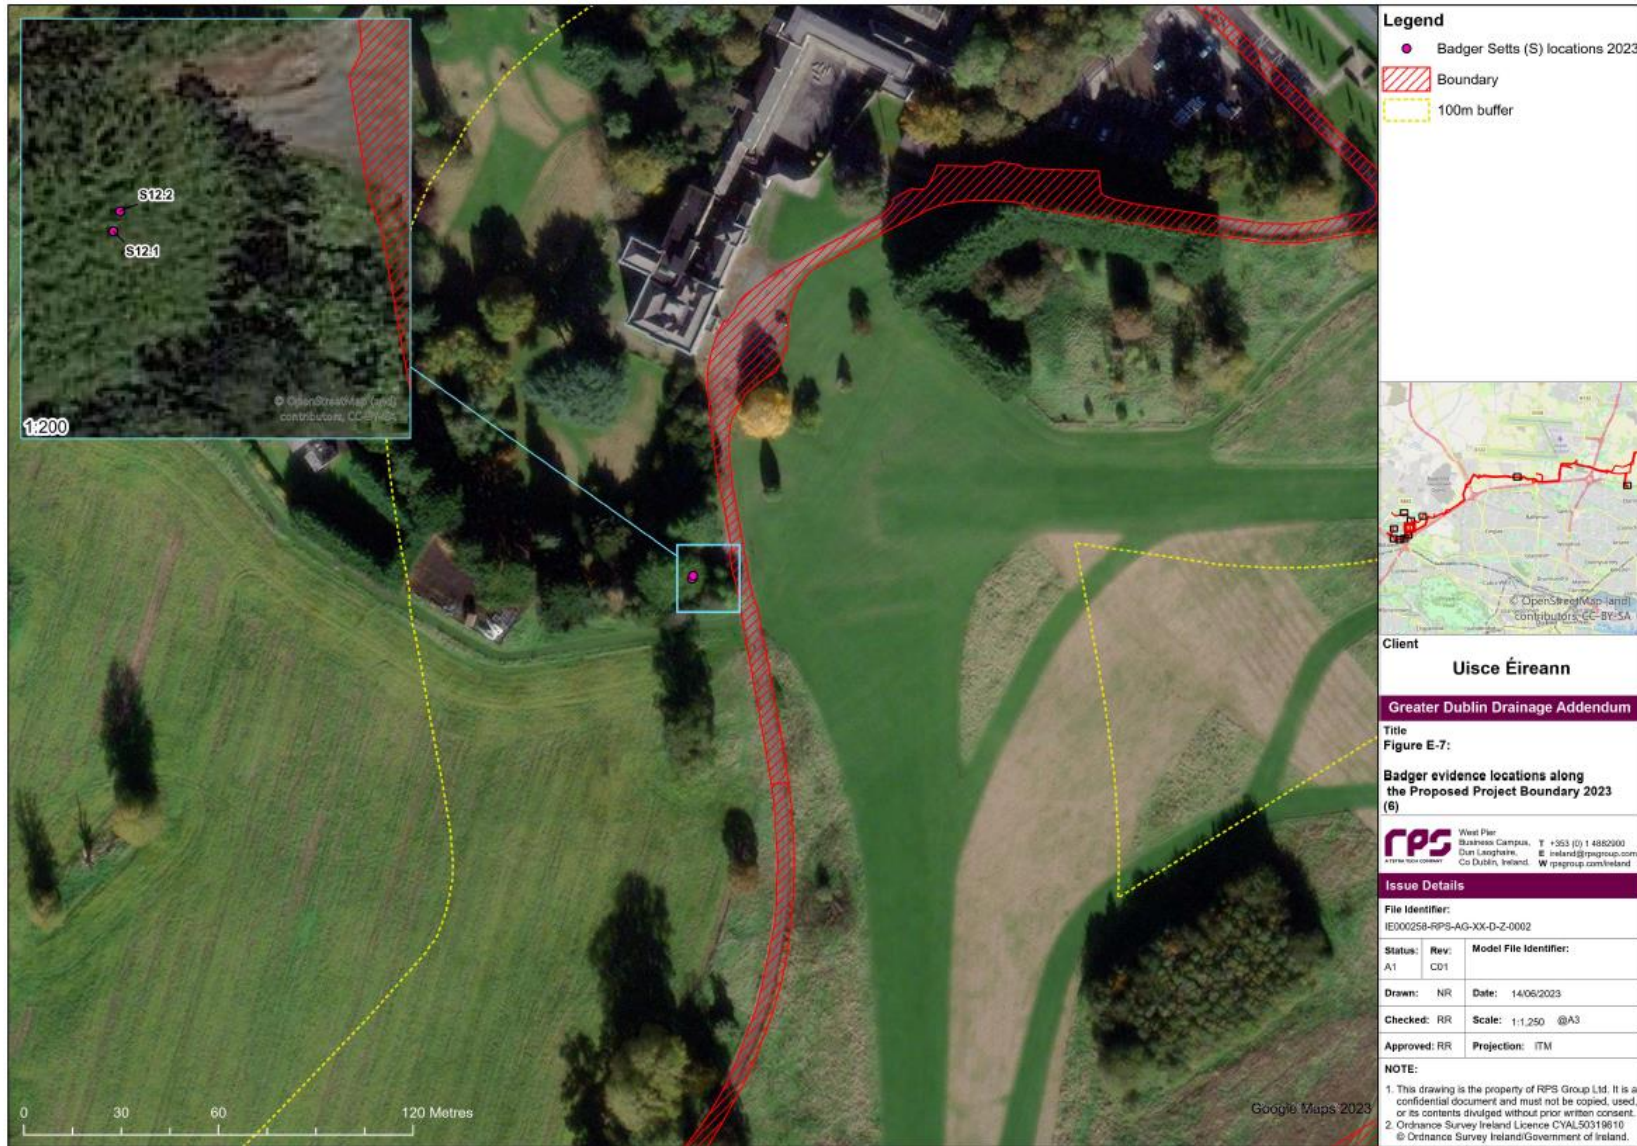
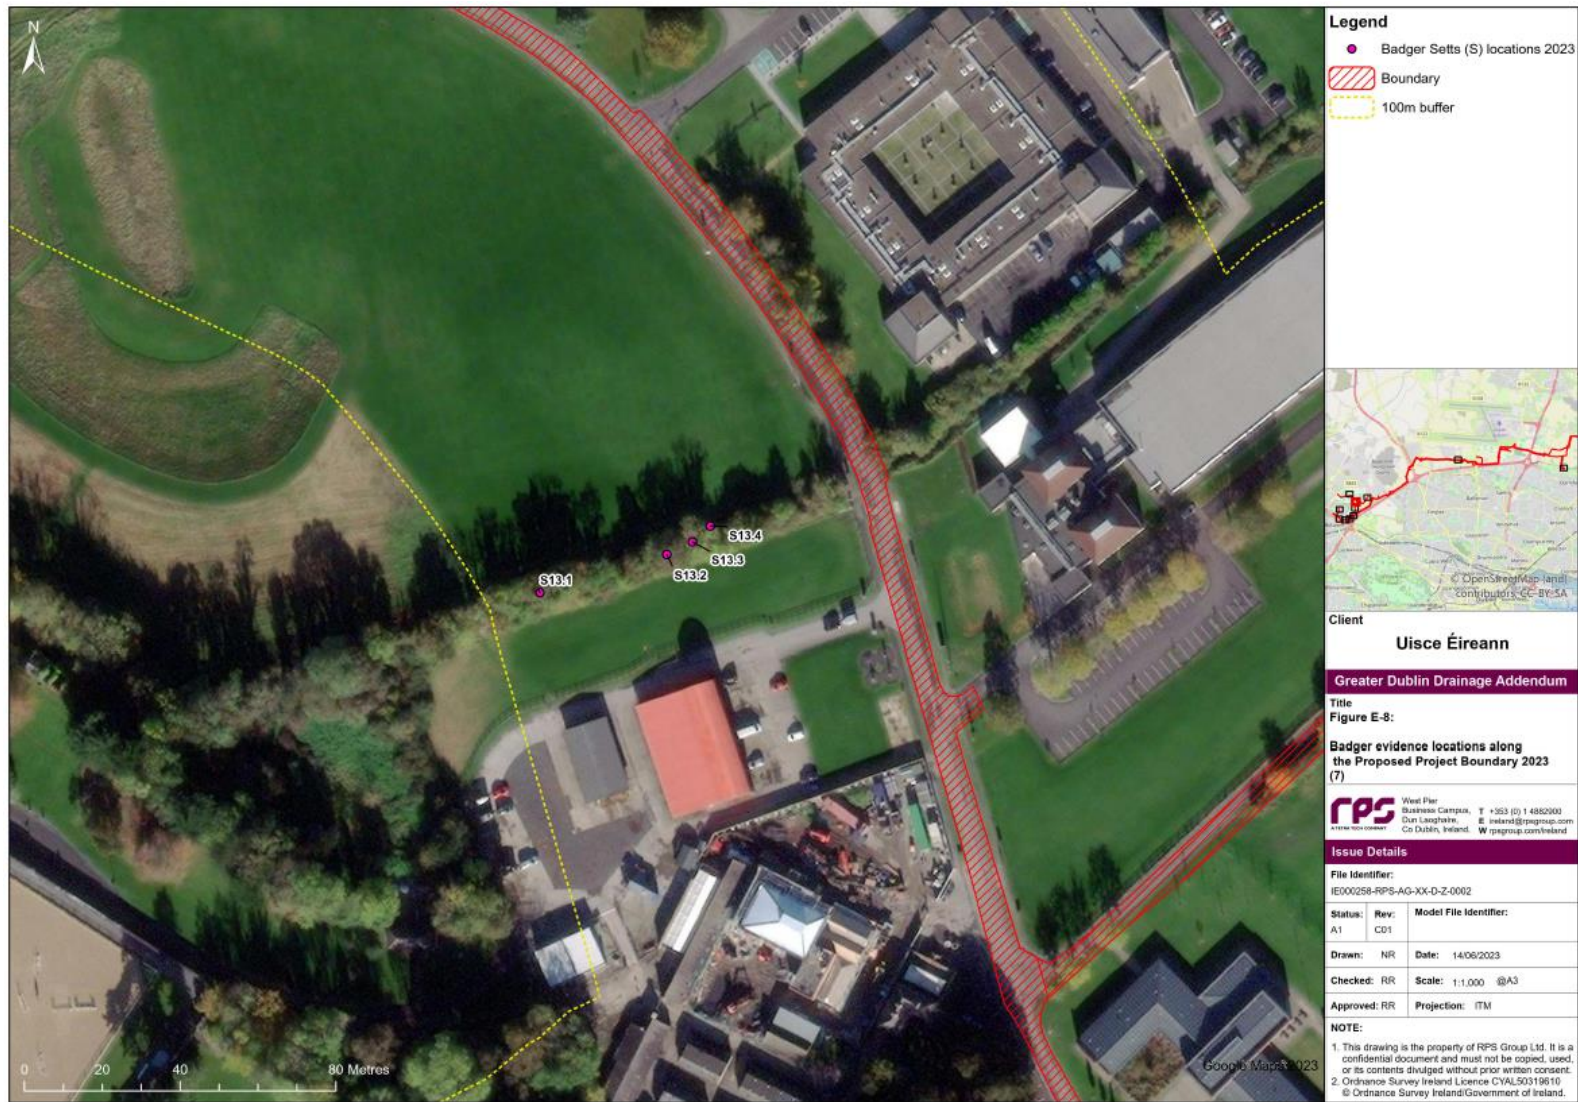
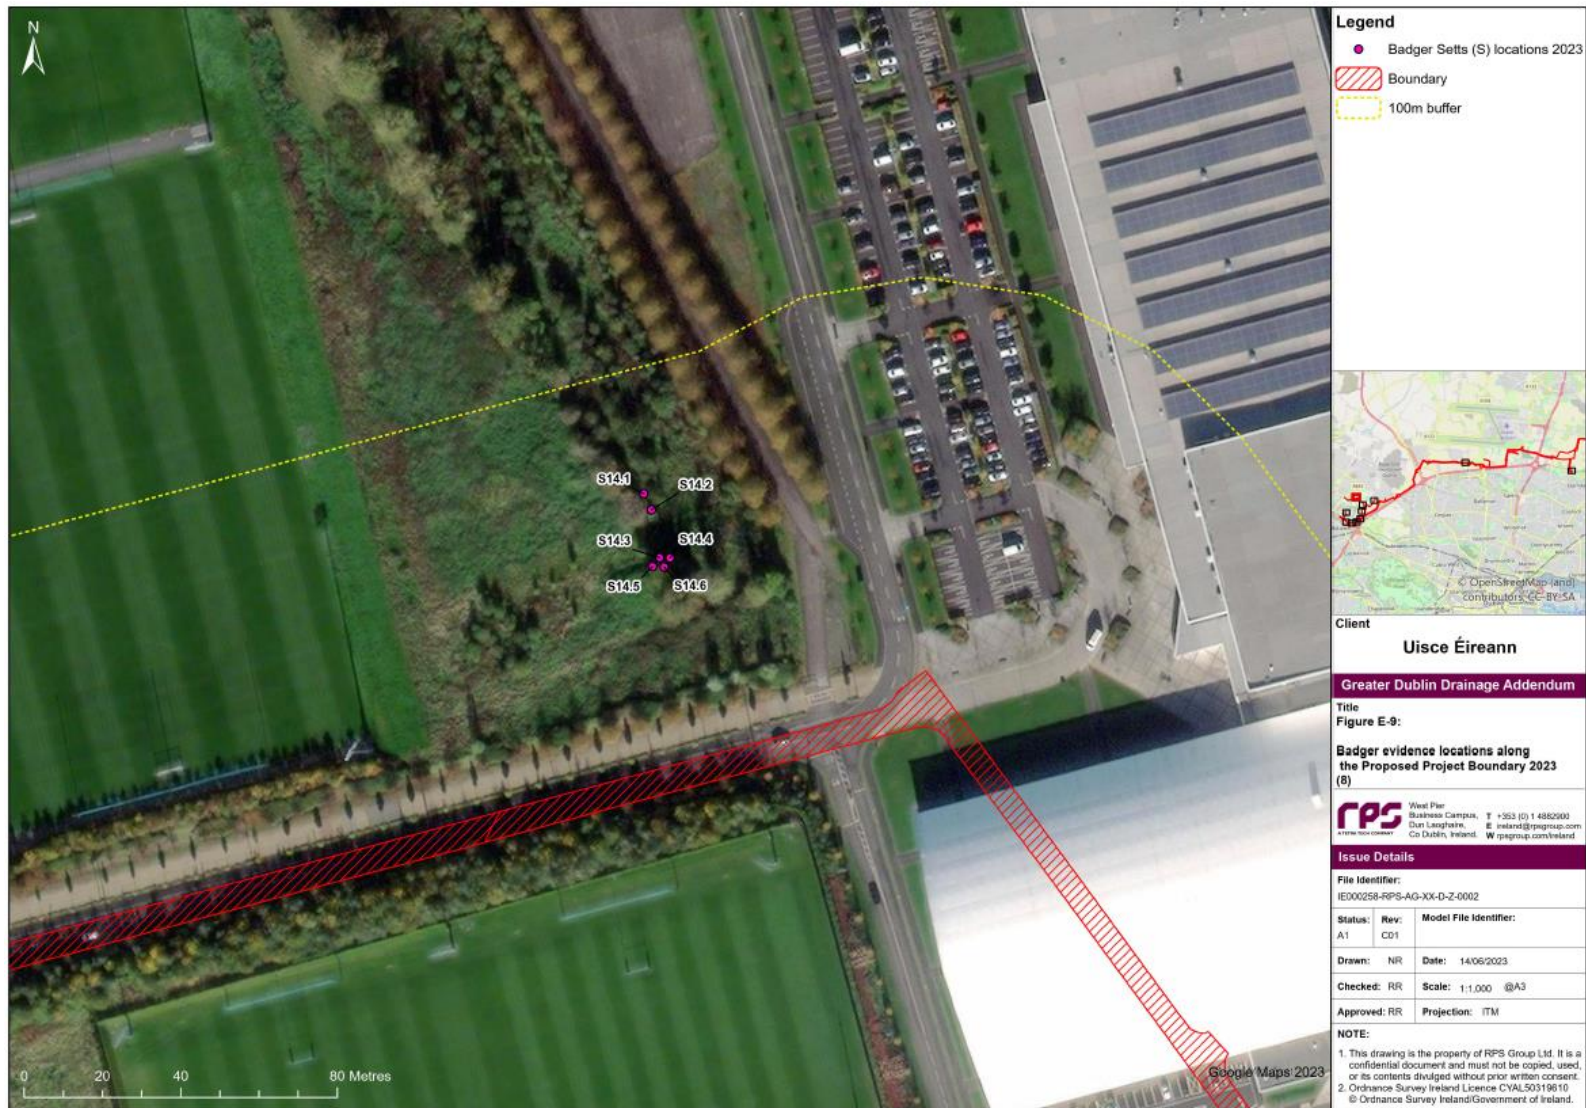
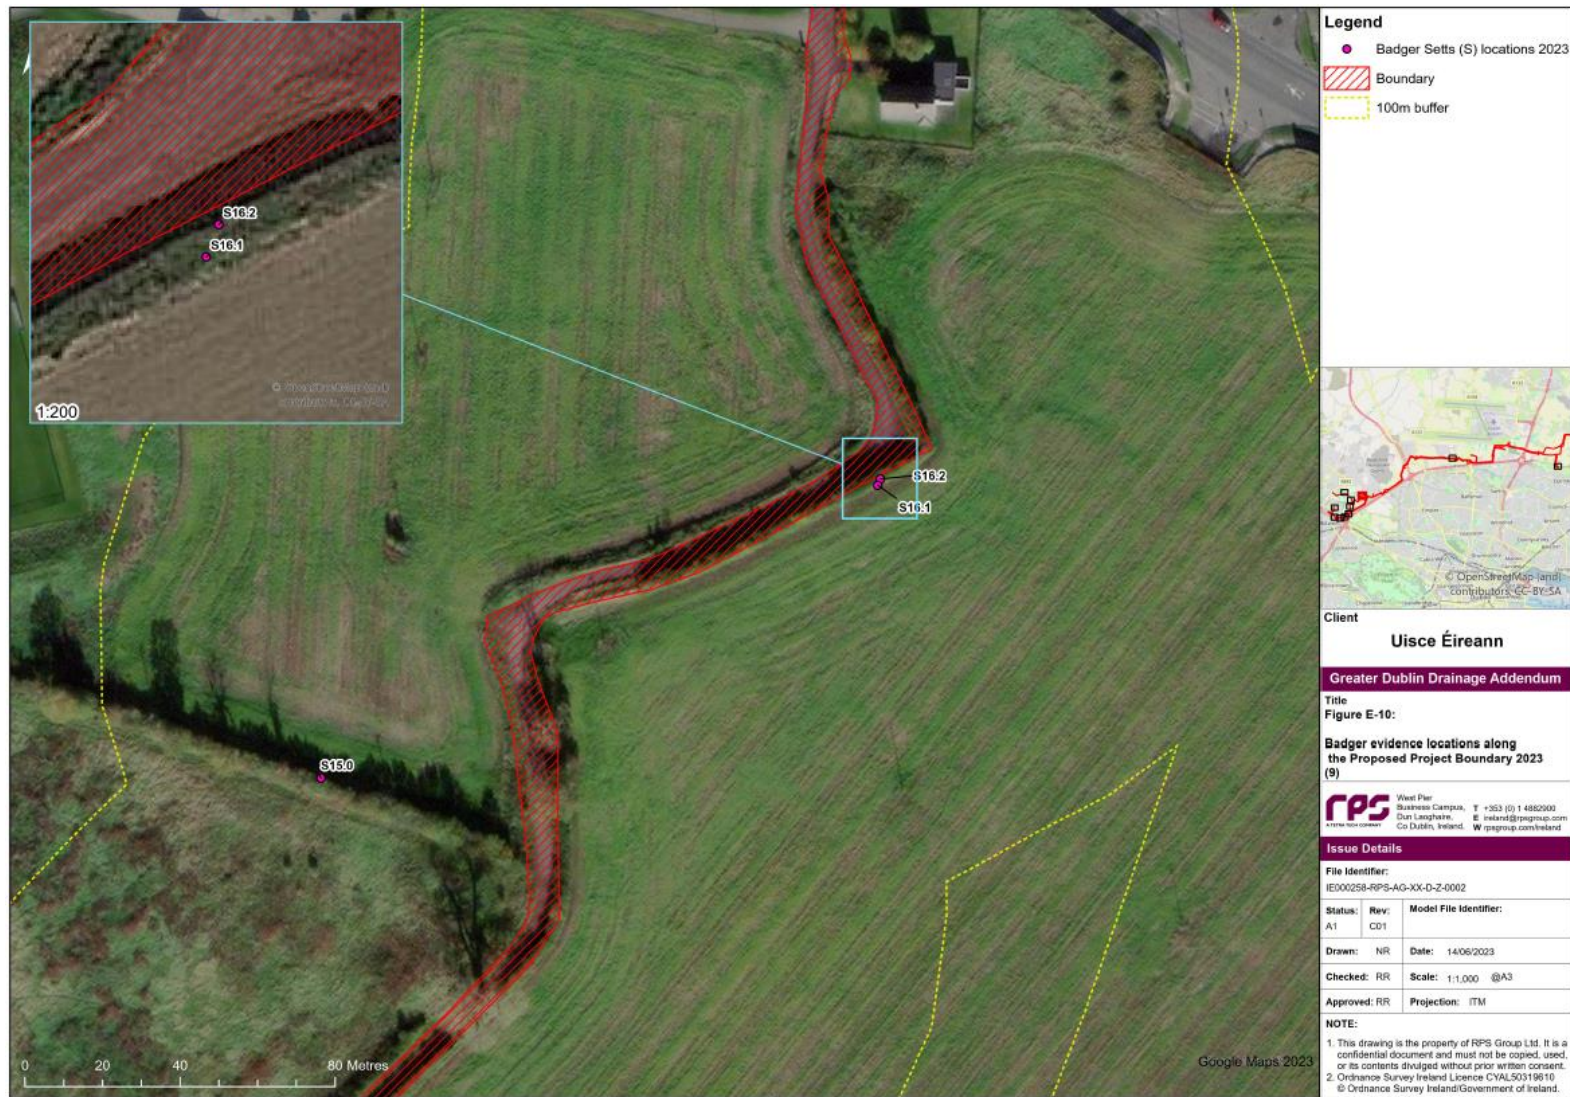
Figure G-1 Badger sett locations along the Proposed Project Boundary 2023 (Overview)

Figure G-2 Badger sett locations along the Proposed Project Boundary 2023 (1)

Figure G-3 Badger sett locations along the Proposed Project Boundary 2023 (2)

Figure G-4 Badger sett locations along the Proposed Project Boundary 2023 (3)

Figure G-5 Badger sett locations along the Proposed Project Boundary 2023 (4)

Figure G-6 Badger sett locations along the Proposed Project Boundary 2023 (5)

Figure G-7 Badger sett locations along the Proposed Project Boundary 2023 (6)

Figure G-8 Badger sett locations along the Proposed Project Boundary 2023 (7)

Figure G-9 Badger sett locations along the Proposed Project Boundary 2023 (8)

Figure G-10 Badger sett locations along the Proposed Project Boundary 2023 (9)

Figure G-11 Badger sett locations along the Proposed Project Boundary 2023 (10)

Figure G-12 Badger sett locations along the Proposed Project Boundary 2023 (11)

In 2023, 18 badger setts were identified. One sett (S17) was identified within the redline boundary of the Proposed Project. 14 badger setts (S2, S3, S4, S5, S6, S7, S8, S9, S11, S12, S13, S14, S16, S18) were identified outside of the redline boundary but within 50m of the redline boundary of the Proposed Project. Another three setts (S1, S10 and S15) were identified outside of the redline boundary but within the 50m to 100m buffer of the redline boundary of the Proposed Project. The location of these setts and further details are provided in the **Figures G-1 to G-12 of Appendix G and Table H-1 of Appendix H**.
