Appendix A16.12 Marine Archaeological Geophysical Survey Undertaken as Part of the Environmental Impact Assessment

**GREATER DUBLIN DRAINAGE SCHEME
MARINE GEOPHYSICAL SURVEY
OFF VELVET STRAND, BURROW, CO. DUBLIN
15R0092**

25th April 2016

Greater Dublin Drainage Marine Outfall Archaeo-Geo Survey Report

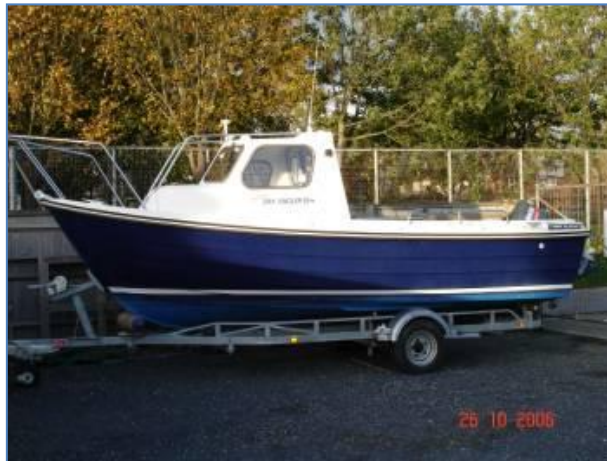
Fig. 5.1 IHD Survey Vessel 'Blue Fin'

IHD's own survey vessel 'Blue Fin' was used for the work. The vessel is a 21' launch with cabin and is fully equipped with safety equipment including in-hull echosounder transducers (Fig. 5.1). It holds a current Dept. of Transport P4 License for survey works and is ideal for shallow water work. The vessel was towed to the site and launched at a slipway in Howth harbour. The vessel operated out of Howth harbour.

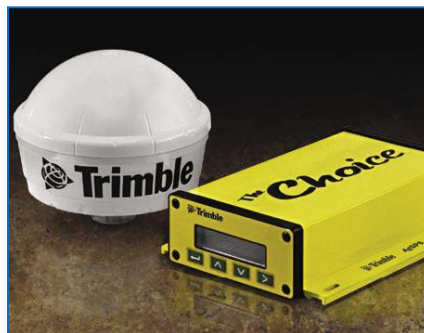
Fig. 5.2 Trimble Ag132 DGPS

Positioning of the survey vessel was achieved using Trimble Ag132 DGPS (Fig. 5.2) with OMNISTAR corrections. This provided sub-meter horizontal accuracies. Positioning was on Irish Transverse Mercator (ITM). Equipment details are provided in Appendix A.

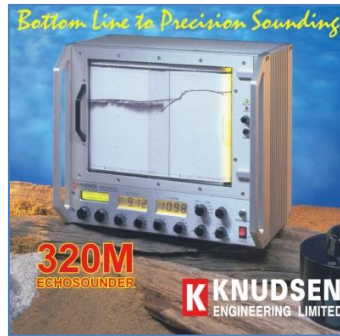
Fig. 5.3 Knudsen 320M Echosounder

A Knudsen 320M simultaneous dual frequency (33kHz, 210kHz) precision survey echosounder (Fig. 5.3) was used to acquire the depth information. Speed of sound in water was measured using an Odom Hydrographics Inc. 'Digibar'. The survey was managed using the latest version of the hydrographic survey software package 'Hypack'.

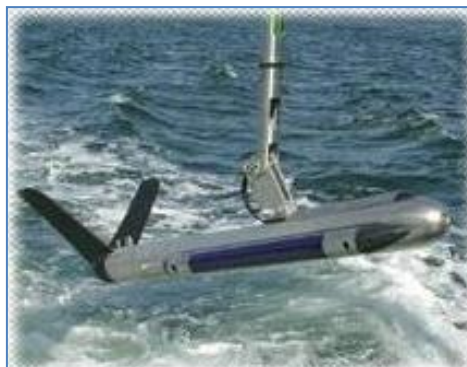
Fig. 5.4 L³-Klein System 3000 Towfish

An L³-Klein System 3000 (Fig. 5.4) simultaneous dual frequency digital sidescan sonar system was employed for the survey. The operating frequencies are 100kHz and 500kHz simultaneously, thereby providing a greater possibility of detecting objects and providing a clear image of the seabed. Data from both frequencies was logged digitally using 'SonarPro' software, for post-processing by ADCO. Data was logged in both SDF and XTF formats. The L³-Klein System 3000 is described in detail in Appendix A.

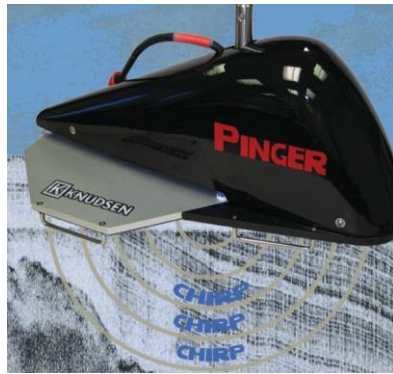
Fig. 5.6 Knudsen Pinger (Chirp) – Wet-End and Top-side units (L to R)

A Knudsen ‘chirp’ sub-bottom profiling system (Fig 5.6) was used to acquire sub-bottom data. This instrument has 15kHz and 3.5kHz bottom transmit arrays. Data was recorded in SEG-Y format for post-processing by ADCO. Equipment data sheets are provided in Appendix A.

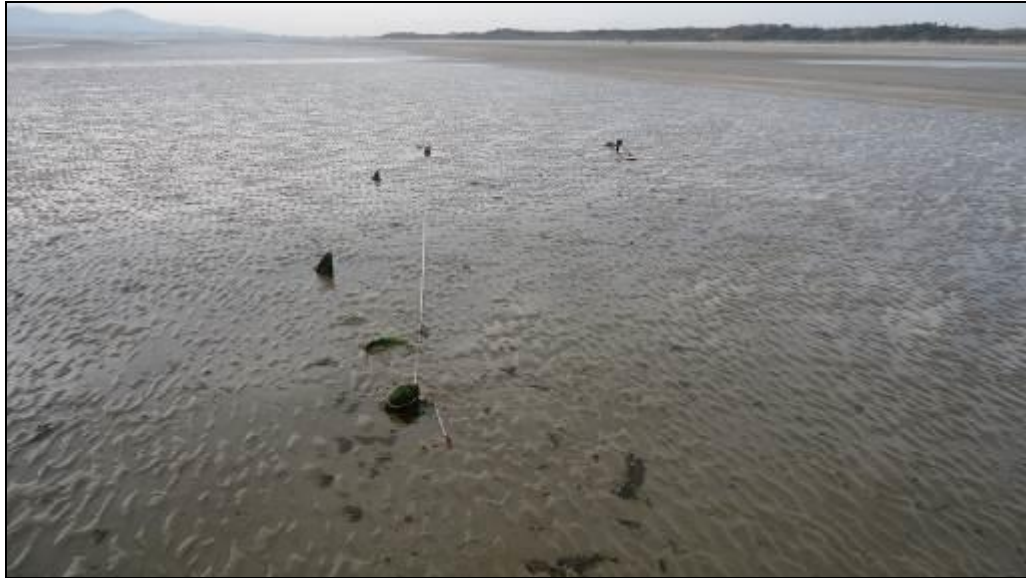
When new fieldwork was carried out on Velvet Strand in 2015 for the present project, a previously unrecorded shipwreck was identified within the development area on the north side of the proposed pipe trench route, bringing the total number of shipwreck on this section of Velvet Strand to ten (Table 2). The new discovery observed a series of six framing timbers whose eroded tips are exposed above the covering sands,

Plate 3: View taken at Low Water in April 2015, looking South across the exposed tips of the framing timbers representing the location of the new wrecksite, 80m east of Borehole 1.

AVOIDANCE. It is recommended that the site of the new wreck is avoided during site investigations and construction. To ensure avoidance, it may be necessary to erect a temporary barrier around the site, to protect it from inadvertent impacts. Such a barrier, if required by the DAHG, must be placed at least 5m distance from the exposed elements, to form a protective curtilage around the site.

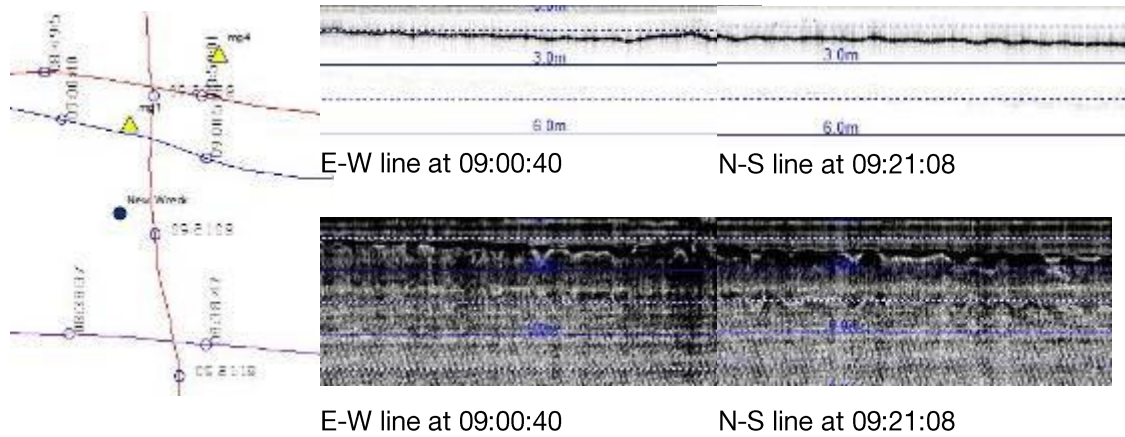
Plate 7: Detail from sub-bottom profile survey showing data traces from survey lines, 8m north and 3m east of the new wrecksite located on the intertidal foreshore. The data traces show the sub-bottom data cleaned (top) and raw (bottom).
