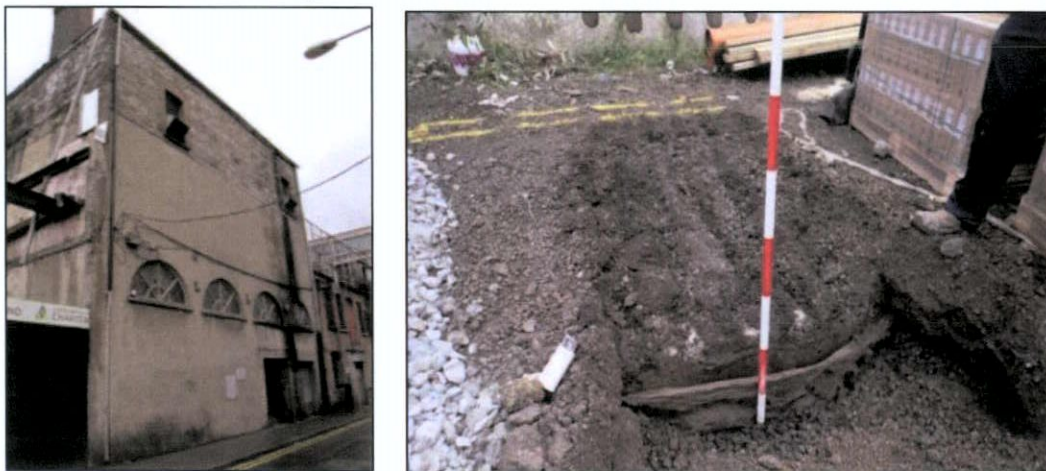
This trench was excavated in the central area of the site on the southern side, orientated north-south (Fig. 28). It exposed concrete slab almost immediately and the excavation was halted. It measured 1.80m north-south by 0.80m in width by 0.20m in depth (Fig. 35).

0.00m - 0.10m:	Stone and tarmacadam.
0.10m - 0.20m:	Black gravel.
0.20m - 0.40m:	Concrete.
0.40m - 0.60m:	Reinforced concrete.
Excavation halted.

An edge to the slab was identified on the western side of the trench, which was lined in sacking and was very modern in date, dating to 2009. There was light gravel on the western side, over slab.

Figure 34 The building on Moore Street
Figure 35 Trench 1, from the north: concrete slab

Trench 1 was located on the southern side of the site, close to the southern boundary wall and this also exposed the same slab found to extend across the site. This concrete slab is part of the floor of the original hotel, along with an additional concrete level laid in 2009.

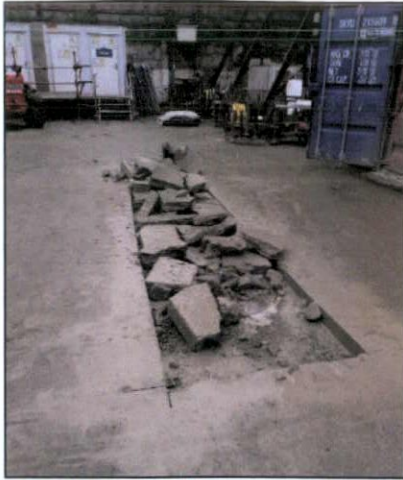
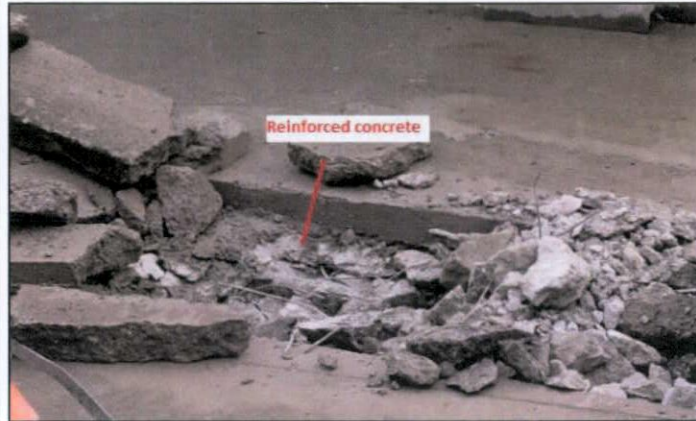
Figure 36
Figure 37

This trench was located centrally in the site, at the eastern end. It was orientated east-west and measures 6m north-south by 0.80m in width by 0.30m in depth (Figs 36-7).

0.00m - 0.15m:	Hard dark grey concrete with black and white aggregate.
0.15m - 0.35m:	Second layer of concrete.
0.35m:	Reinforced concrete.
Excavation halted.

The trench was halted immediately as the use of the rock-breaker on the reinforced concrete was causing significant vibrations, in close proximity to the Protected Structure, no. 42.

Trench 2, from the south
Trench 2 from the east

This trench revealed two layers of concrete, over a layer of reinforced concrete suggesting there was significant excavation and preparation of this site in 2009. This slab could not be removed.

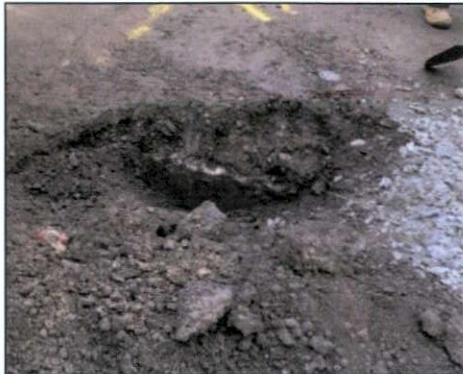
This trench was located in the central area orientated north-south but was not excavated, as preliminary investigations revealed a deep slab, as found elsewhere (Fig. 38).

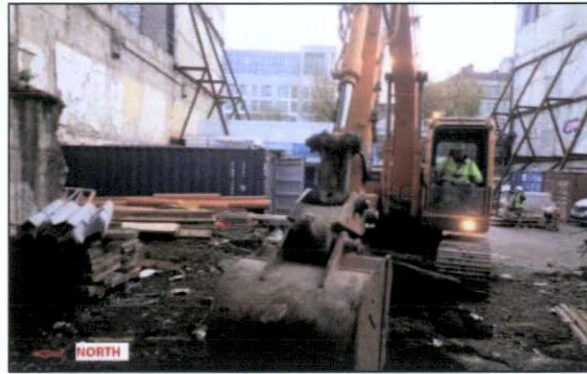
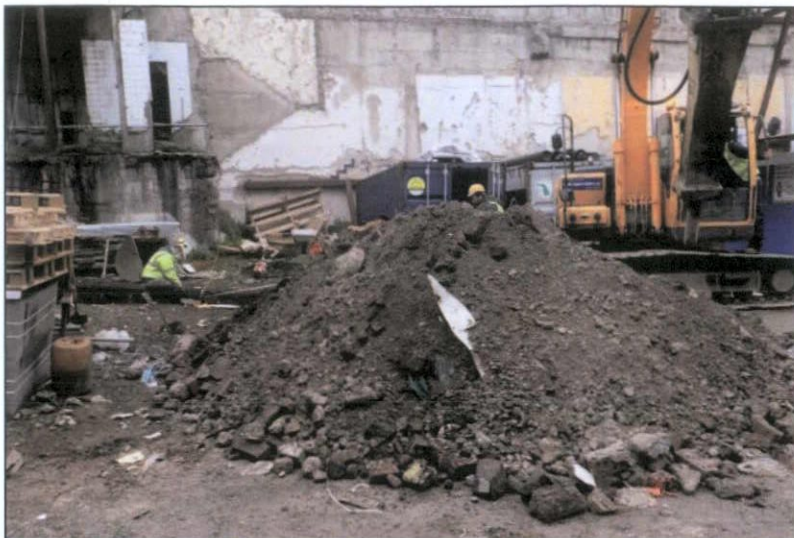
This trench was located in the north-west corner of the main part of the site and it was orientated north-east/south west, measuring 6m in length by 0.80m in width (Figs 39-42).

0.00m - 0.05m:	Tarmacadam.
0.05m - 0.90m:	Mixed organic cellar fill, brown in colour, with numerous modern brick and debris including electrical wires and concrete blocks. This deposit was deepest at the western end.
0.90m - 1.40m	Concrete slab/pad.
Excavation halted.

At the northern-western end of the site, at 0.90m below present ground level, a modern smooth slab was found beneath the brown organic infill deposit and an edge was found on the eastern side, which extended to at least 1.40m in depth: the base was not exposed. This can be identified as the temporary crane base, constructed in 2009, the exposed section measuring 3.58m east-west by 1.80m north-south. The base appears to have been inserted through the existing slab, which is likely to be part of the basement of the hotel, as a cut-line was identified on the eastern side of the pad, extending for 1.10m in width (east-west). The cut was filled with two deposits of mortar/gravel, the lower level of which was a dark grey gravel mortar. This was sealed by a loose deposit of light grey gravelly mortar mix, extending at least 1.40m in depth.

0.00m - 0.05m:	Tarmacadam.
0.05m - 0.20m:	Identical mixed brown organic cellar fill, with the remains of a small pit identified, measuring 0.15m square by 0.10m in depth. This was filled with similar brown organic clay mix.
0.20m:	Concrete slab.
Excavation halted.

Trench 3, from the south
Trench 4, from the west

Figure 40 Trench 4, from the north-east
Figure 41 The organic deposits from the south

Figure 42 The infill from Trench 4

Trench 4 revealed deposits of organic clays containing modern artefacts, and this is typical cellar fill but is clearly out of context, mixed in with modern debris. It probably originated in the site somewhere, perhaps in the ramp area.

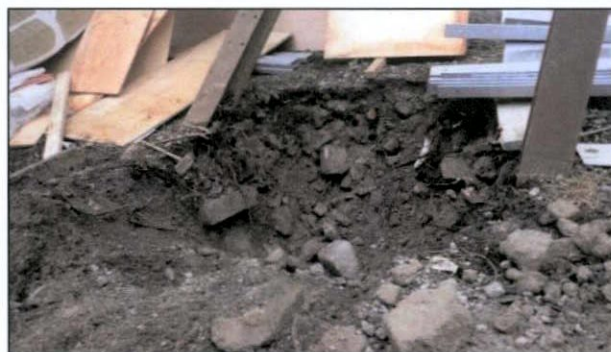
A fifth trench was attempted at the western end of the site, close to the southern wall and this measured 1.80m north-south by 2.20m east-west by 0.30m in depth (Figs 43 and 44). This exposed the concrete slab that was found elsewhere.

0.00m - 0.06m:	Tarmacadam.
0.06m - 0.30m:	Concrete blocks and light grey mortar and gravel.
0.30m +	Concrete slab with aggregate.
Excavation halted.

Figure 43 Trench 5, from the east

Figure 44 Trench 5, from the north

Trench 5 exposed the slab, as exposed elsewhere.

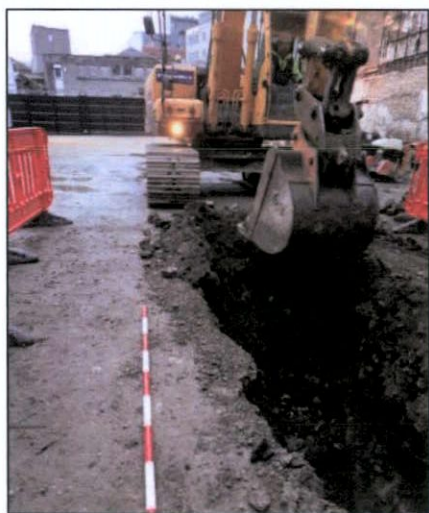
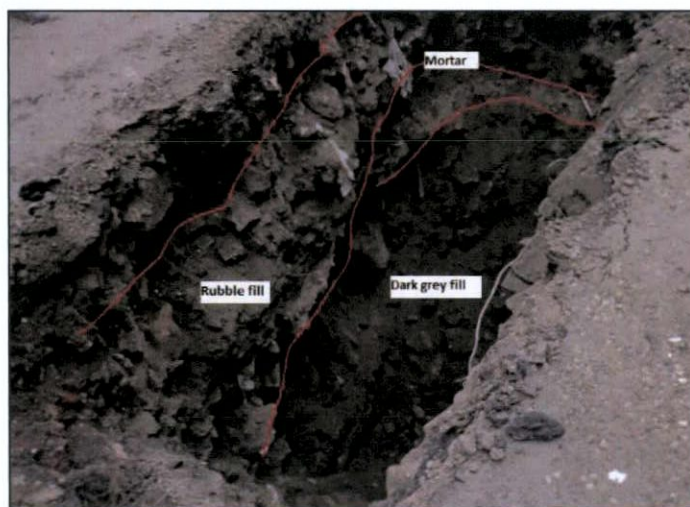
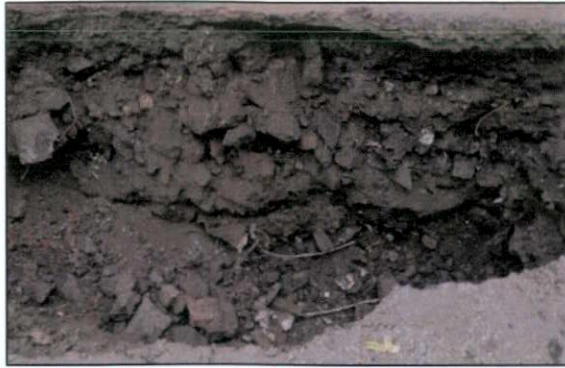
This trench was centrally located at the eastern end of the site, measuring 6m east-west by 1.40m in width by 4m in depth (Figs 43-47). This exposed modern infill down to 3.40m below present ground level. At this level there was slight evidence of burning and timbers, set into the clays, sitting over natural gravels (Figs 48-50).

Figure 45 Trench 1, from the east

Figure 46 Trench 1 from the north east

Figure 47 Trench 1, north section, from the S

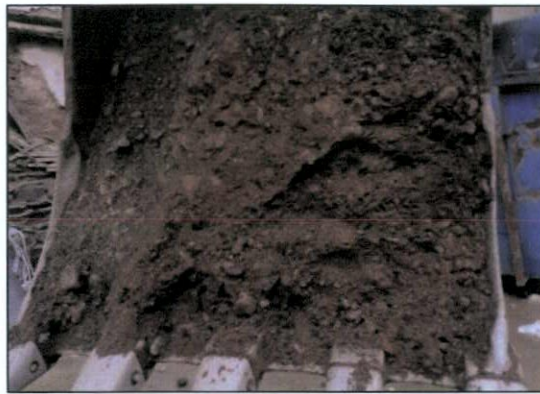
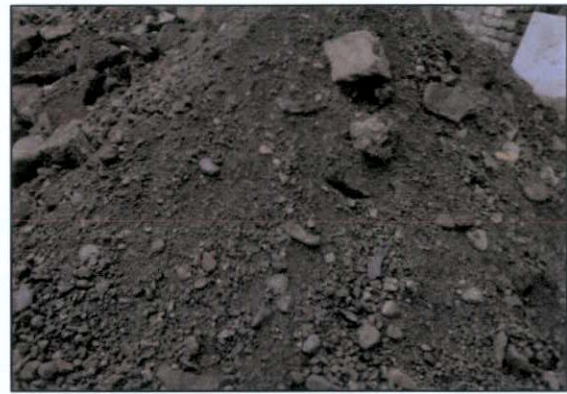
3.40m - 3.80m:	A deposit of black gravel with small chips of gravel, measuring 10mm in diameter. Three soft dark brown timber fragments were found set in the gravel, measuring 0.25m in length by 80m in width (Fig. 48). The gravel sat on mixed sticky yellow clays with faint traces of fire-reddening in the clays. The yellow clay contained charcoal and lime mortar fleck but also half brick, orange in colour with no additions. These deposits are likely to be related to the extensive brickfield in this area in the early 18 th century.

3.80m - 4.10m:	Grey rounded gravels, of assorted sizes (Fig. 50).

Figure 48 Fire-reddened clay and timbers

Figure 49 Yellow/orange clays and gravels

Figure 50 Gravels at the base of Trench 1

The trench exposed yellow clays at the base of the trench and close inspection identified areas of fire-reddening in the clay, the result of intense heat, most likely to have emanated from the brickworks, captured on Rocque's map of Dublin, dated 1756 (Figs 8 and 9). A section of the clay quarry has been found further east at nos 14-16 Moore Street (National Monument), and directly west at nos 58-66 Moore Street, where deep deposits of fire-reddened clay were found. In the site under discussion however, there are only faint traces of these clays surviving, with fragments of brick. These are sealed by deep infill of rubble, grey and brown clay.

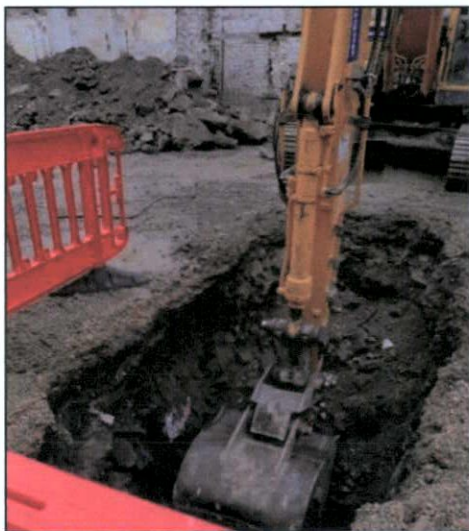
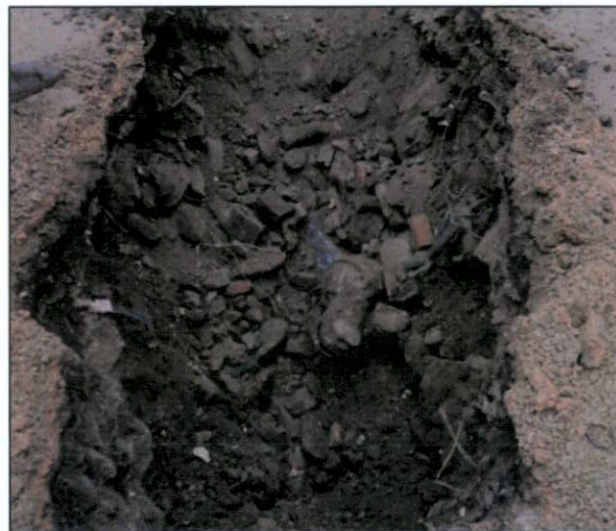
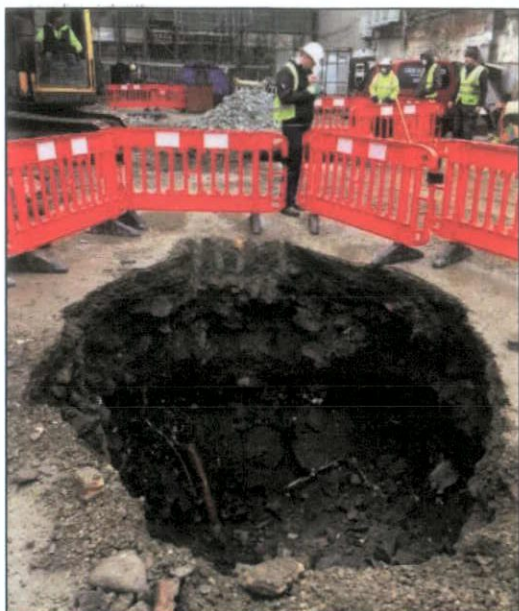
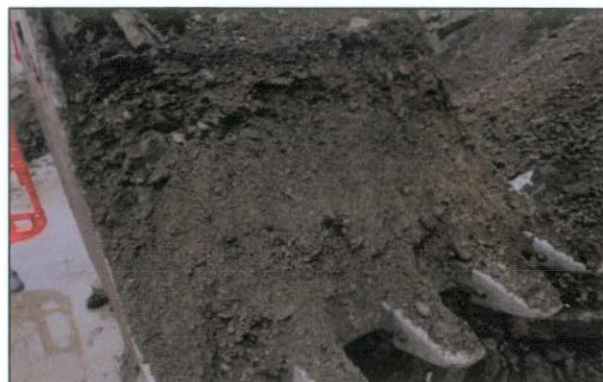
This trench was excavated after Trench 3 at the eastern end of the site. It was orientated north-south and measured 6m long by 0.80m north-south by 4m in depth (Figs 51-54). It was positioned across the projected line of the wall/structure found in Trench 3 (see below), which was orientated east-west. However, the continuation of this wall foundation was not found further east in Trench 3 (see below).

0.00m - 0.10m:	Tarmacadam.
0.10m - 0.15m:	804 stone.
0.15m - 2.80m:	Rubble infill similar to Trench 3, with bricks, grey clay, wires and blue tiles found in Trench 3. This infill included concrete blocks.
2.80m - 3.80m:	Mixed light green/grey clay with charcoal and brick fleck, and small rounded pebbles, 2mm in diameter.
3.80m - 4m:	Yellow clay with small cobbles and no inclusions.
4m:	Pure fine gravels with no inclusions.

Figure 51 Trench 2 from the south

Figure 52 Trench 2 from the south: infill deposits

Figure 53 The expanding trench

Figure 54 The gravels at 4m below present ground level

This trench was designed to establish whether or not the wall structure found in Trench 3 to the west extended eastwards. However, no trace of the wall was found. In addition to this, the trench did not expose any walls foundations, floor or structures that could be associated with the standing walls. The infill deposits were similar to those found in the other two trenches with natural deposits at approximately 4m below present ground level.

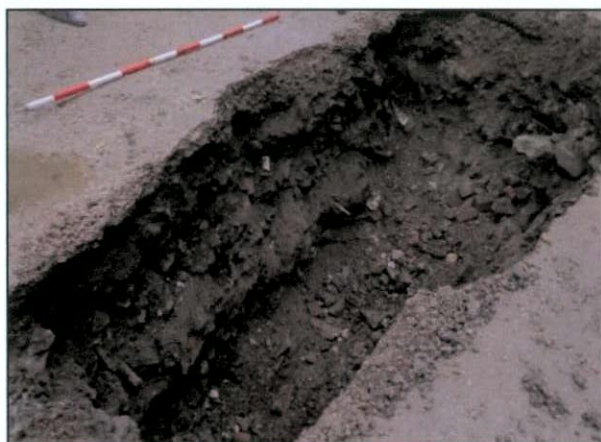
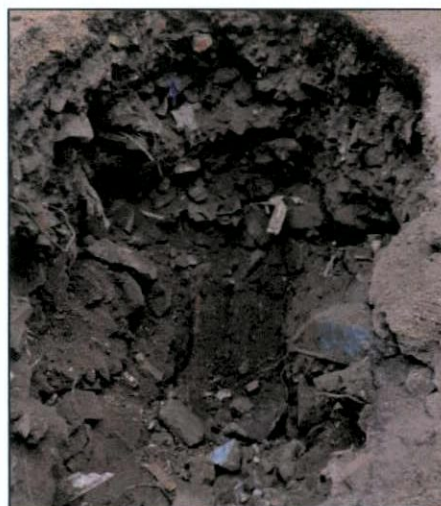
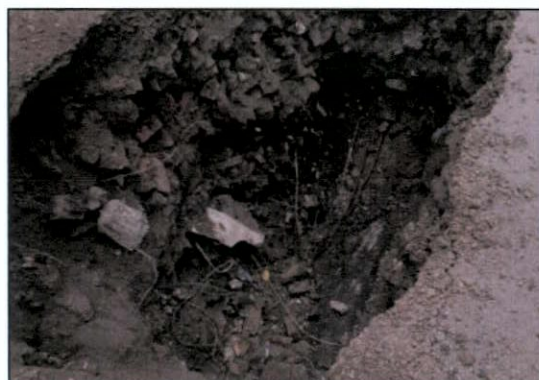
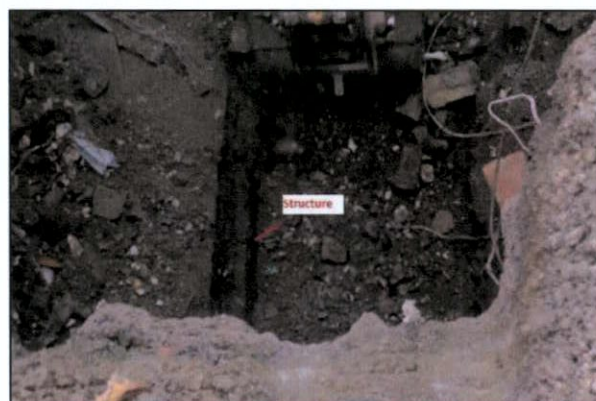
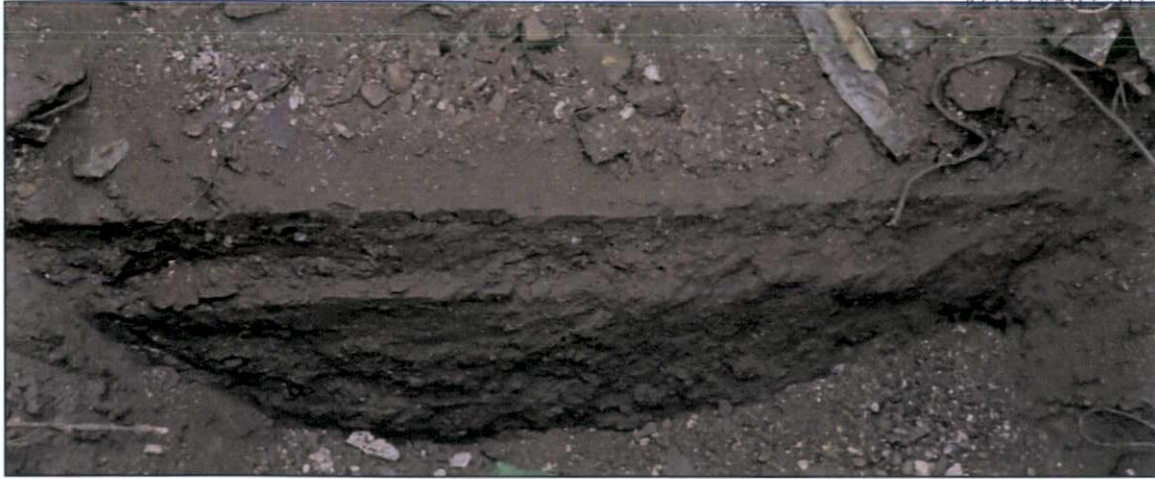
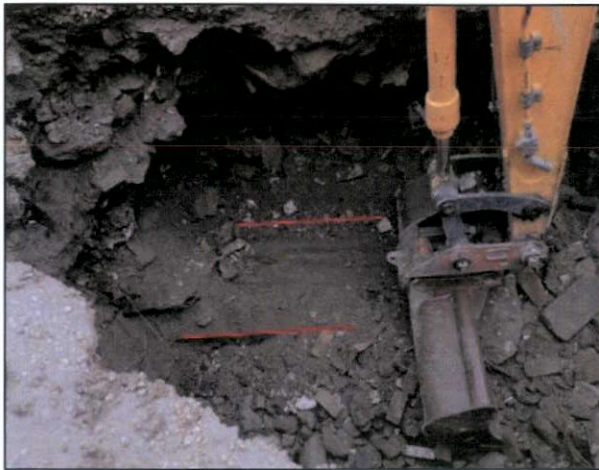
This trench measured 6m east-west by 0.80m in width by 4m in depth, located in the western side of the site, in area thought to contain a cellar (Figs 55-60). The trench located deep infill deposits, sealing a substantial limestone build, orientated north-south, which was at least 1m in width. This appears to be a wall foundation, perhaps of the basement recorded in 1893.

0.00m - 0.08m:	Tarmacadam.
0.08m - 0.10m:	804 Stone fill.
0.10m - 0.12m:	Black gravel/tarmacadam.
0.12m - 2.70m:	Infill of brick, stone, timbers (modern), brown clays, concrete, wires, modern tiles, and fragments of concrete walls.
2.70m - 2.90m:	Stone (concrete?) floor abutting the limestone build.
2.70m - 3.30m+:	Limestone build (see below), approximately 1m in width by at least 0.80m in depth, with an offset on the northern side, 80mm in width.

The limestone build was very substantial, lying 2.70m below present ground level and orientated east-west. It was constructed of small cut limestone blocks and measured approximately 1m in width by at least 0.80m in depth. It was well-faced on the exposed northern side and it had been demolished to a single continuous level. There was an offset on the northern face, set 0.14m below the top of the wall, measuring 80mm in width. A small section of what appeared to be a blackened floor was exposed on the northern side of the floor, extending for 0.35m north-south by 0.55m east-west.

Figure 55 Trench 3, from the east

Figure 56 Trench 3, infill

Figure 57 The floor abutting the wall foundation

Figure 58 Foundation from the east

Figure 59 The northern face: note modern debris

Figure 60 The structure from the north

The cartographic sources in 1893 indicates that the building at the western end of the site (Building no. 1) was two stories in height but with a basement, which was relatively unusual for a rear building. Rocque's map, dated 1756, does show a stable/coach-house, which is unlikely to have a basement but which might have been integrated into Building 1. Trench 3 was positioned at this end of the plot to try and locate the basement and the wall foundation and floor found is likely to be related to this structure. Thus, the evidence suggests that the basement was demolished but the foundations of the wall and possibly the floor are still *in situ*.

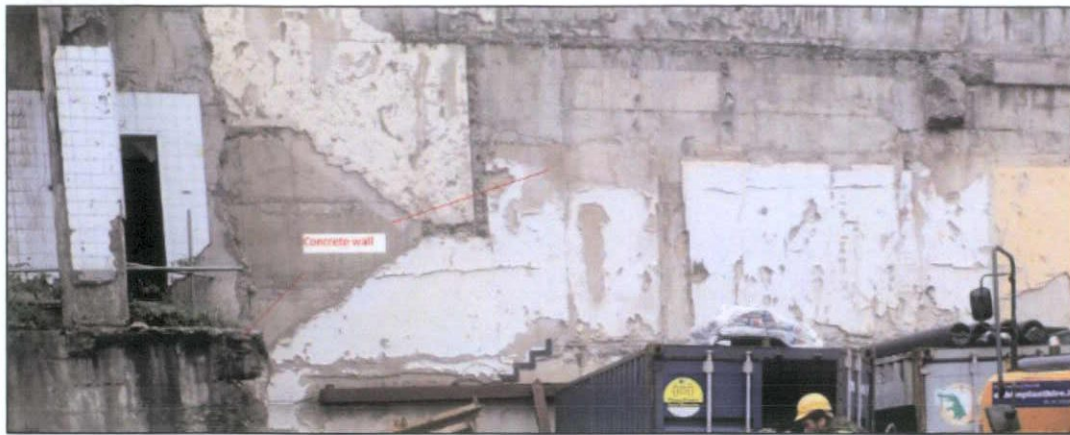
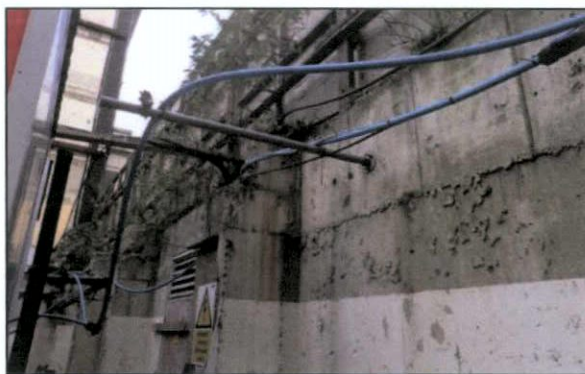
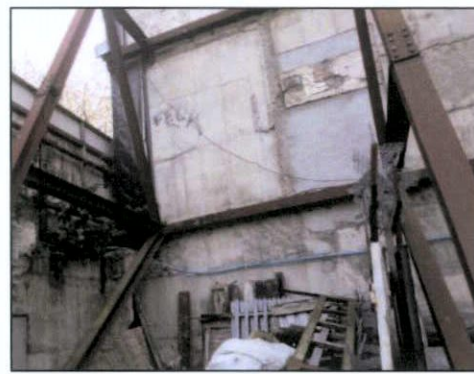
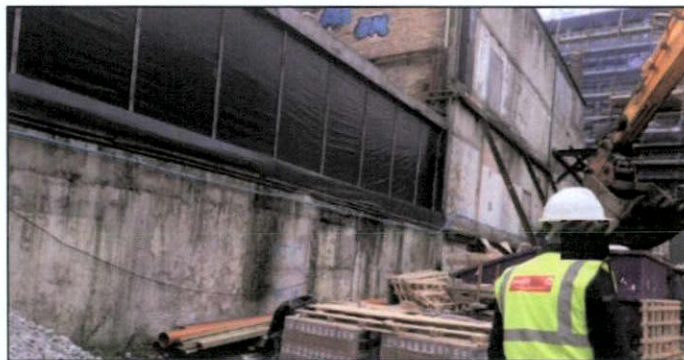
Nothing of these former buildings survive. An inspection of the site revealed that the northern wall was of concrete, as was the eastern wall, along the street frontage (Figs 62-66). The southern boundary is formed by the Protected Structure No. 42 (RPS Ref: 6022, NIAH Reg. no. 50010554) at the eastern end and the second Protected Structure at the western end (RPS Ref: 6022, Reg. no. 50010560). Most of this boundary appeared to be shuttered concrete.

Figure 62 Concrete boundaries from the south

Figure 63 The north wall

Figure 64 Eastern wall

Figure 65 The south wall, east end

Figure 66 The south wall, west end
