## APPENDIX 16.1 SUMMARY OF NATIONAL MONUMENTS LEGISLATION

### Introduction

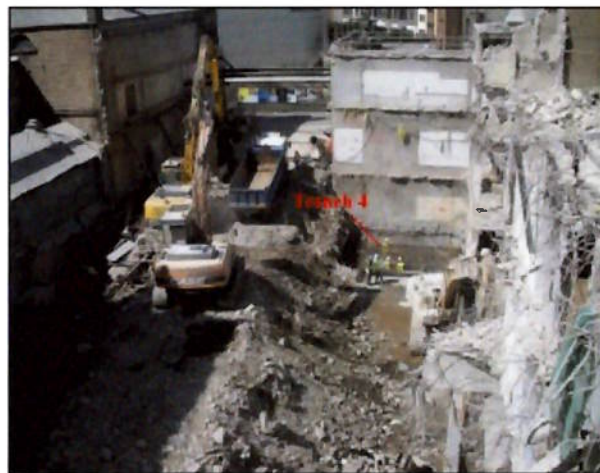
Figure 24 The site from the north, 2009

The monitoring programme established that the original concrete floor of the basement of the hotel was very substantial and still in position, made of reinforced concrete and measuring over 1m in depth (Figs 24-26). This basement was cut into deep gravel and silt deposits, presumably originally riverine deposits associated with the River Liffey, before it was reclaimed between 1678 and 1728. The gravels were carefully examined but no archaeological features or artefacts found. In April 2009, three (nos 1-3) additional engineering test-trenches were excavated in the basement area of no. 40 and this was followed in May, after the complete demolition of the hotel (nos 40-41), by the casting of a temporary crane base (no. 4) (Fig. 27). In early June, the remaining trenches (nos 5-9) were excavated, with most of the excavation works taking place in the eastern half of the site close to the O'Connell street frontage. The basement floor slab was located at approximately 3m below (2.40m O.D) below present road level of O'Connell Street (5.40m O.D.).

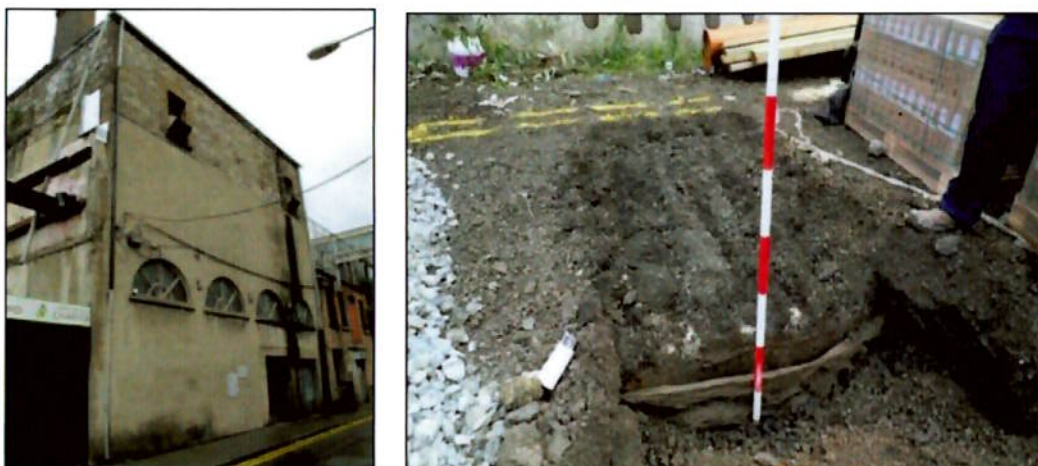
Trench 1 was located on the southern side of the site, close to the southern boundary wall and this also exposed the same slab found to extend across the site. This concrete slab is part of the floor of the original hotel, along with an additional concrete level laid in 2009.

Figure 34 The building on Moore Street  
Figure 35 Trench 1, from the north: concrete slab

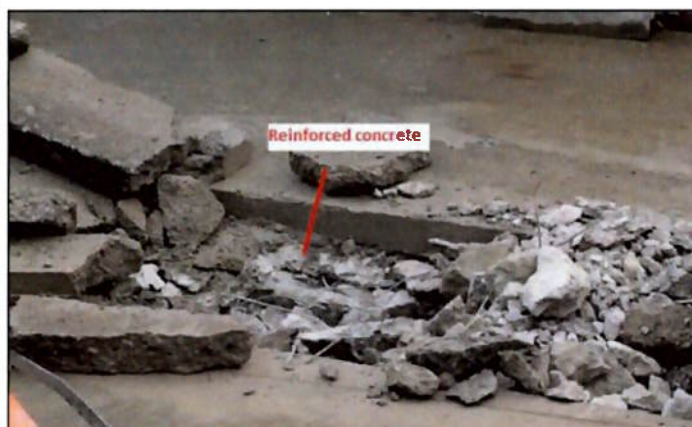
Figure 37

This trench was located in the central area orientated north-south but was not excavated, as preliminary investigations revealed a deep slab, as found elsewhere (Fig. 38).

Trench 2, from the south

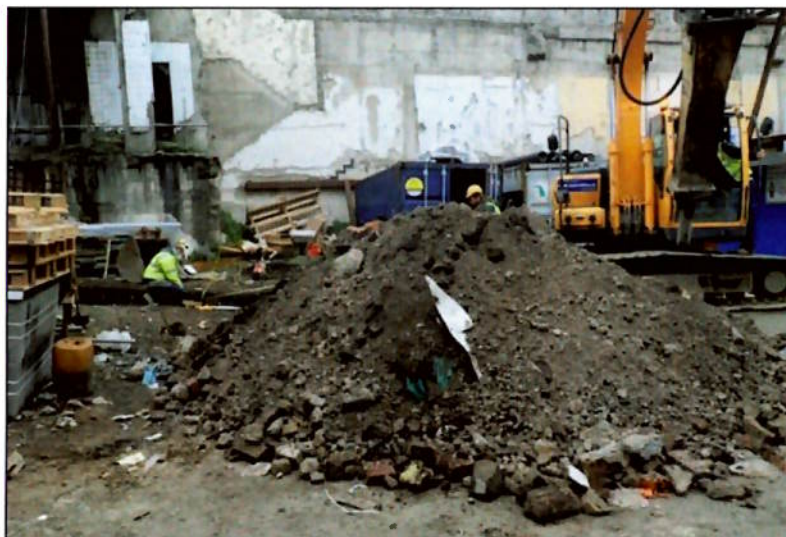
At the northern-western end of the site, at 0.90m below present ground level, a modern smooth slab was found beneath the brown organic infill deposit and an edge was found on the eastern side, which extended to at least 1.40m in depth: the base was not exposed. This can be identified as the temporary crane base, constructed in 2009, the exposed section measuring 3.58m east-west by 1.80m north-south. The base appears to have been inserted through the existing slab, which is likely to be part of the basement of the hotel, as a cut-line was identified on the eastern side of the pad, extending for 1.10m in width (east-west). The cut was filled with two deposits of mortar/gravel, the lower level of which was a dark grey gravel mortar. This was sealed by a loose deposit of light grey gravelly mortar mix, extending at least 1.40m in depth.

Figure 42 The infill from Trench 4

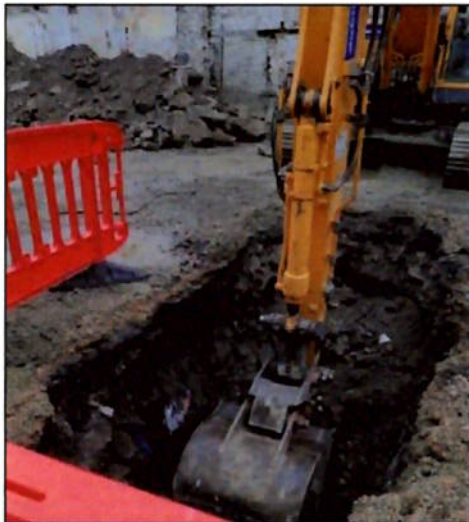
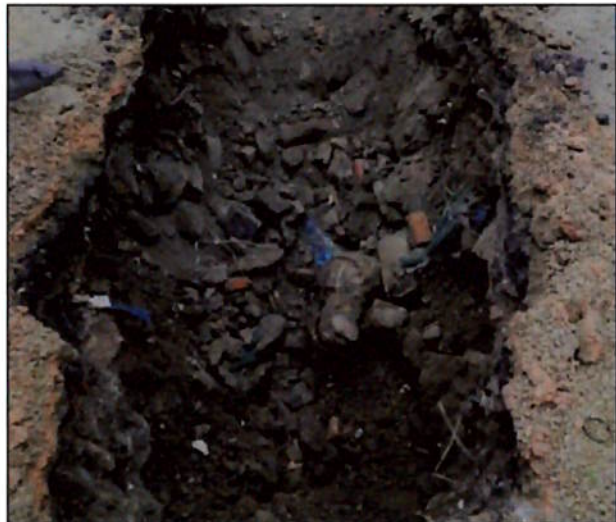
This trench was excavated after Trench 3 at the eastern end of the site. It was orientated north-south and measured 6m long by 0.80m north-south by 4m in depth (Figs 51-54). It was positioned across the projected line of the wall/structure found in Trench 3 (see below), which was orientated east-west. However, the continuation of this wall foundation was not found further east in Trench 3 (see below).

| 0.15m - 2.80m: | Rubble infill similar to Trench 3, with bricks, grey clay, wires and blue tiles found in Trench 3. This infill included concrete blocks. |

Figure 51 Trench 2 from the south

Figure 52 Trench 2 from the south: infill deposits

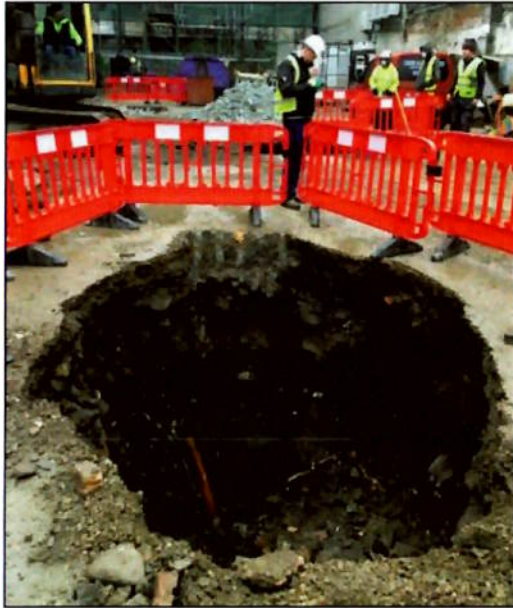
Figure 53 The expanding trench

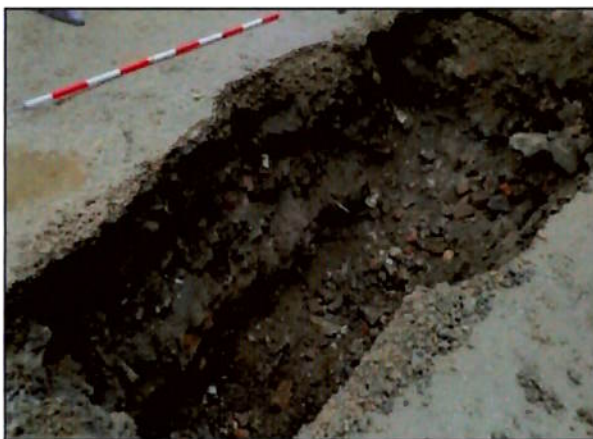
This trench measured 6m east-west by 0.80m in width by 4m in depth, located in the western side of the site, in area thought to contain a cellar (Figs 55-60). The trench located deep infill deposits, sealing a substantial limestone build, orientated north-south, which was at least 1m in width. This appears to be a wall foundation, perhaps of the basement recorded in 1893.

Figure 55 Trench 3, from the east

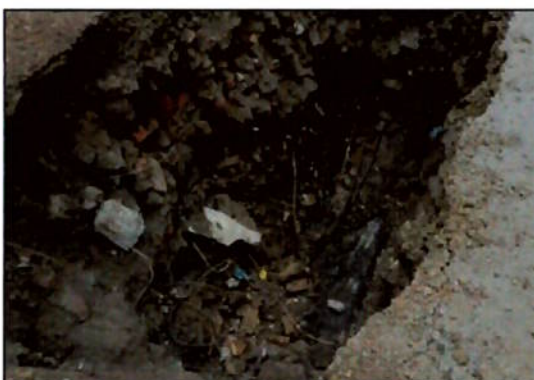
Figure 57 The floor abutting the wall foundation

The cartographic sources in 1893 indicates that the building at the western end of the site (Building no. 1) was two stories in height but with a basement, which was relatively unusual for a rear building. Rocque's map, dated 1756, does show a stable/coach-house, which is unlikely to have a basement but which might have been integrated into Building 1. Trench 3 was positioned at this end of the plot to try and locate the basement and the wall foundation and floor found is likely to be related to this structure. Thus, the evidence suggests that the basement was demolished but the foundations of the wall and possibly the floor are still *in situ*.

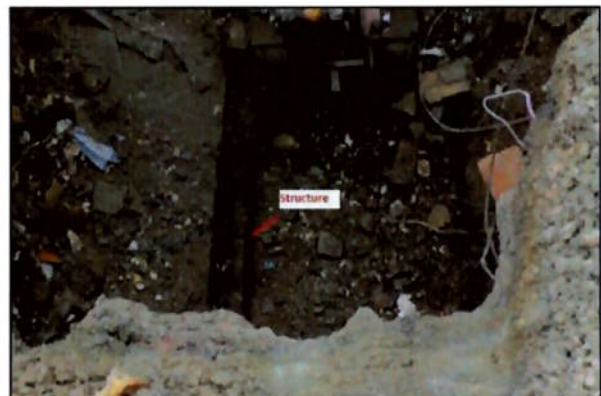
Figure 58 Foundation from the east

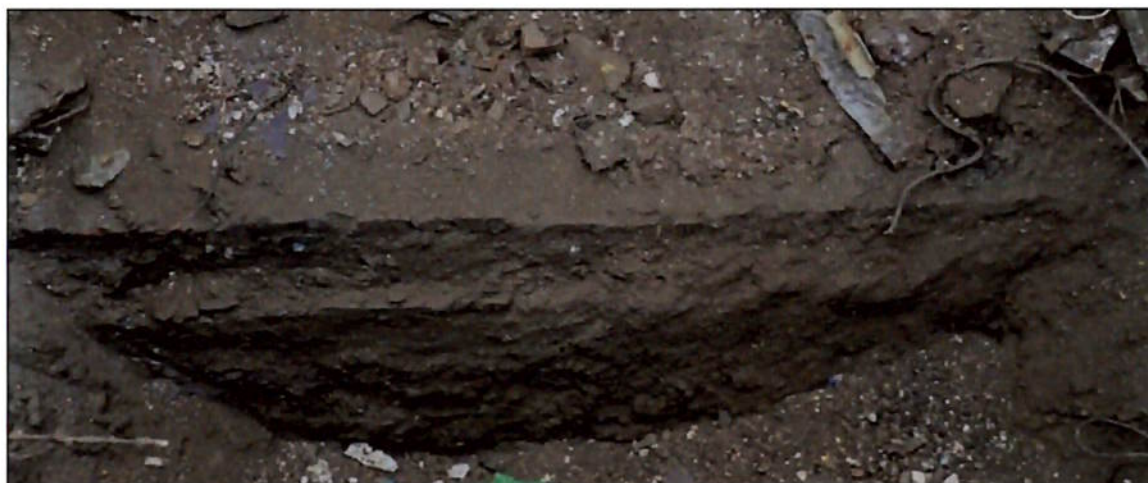
Figure 59 The northern face: note modern debris

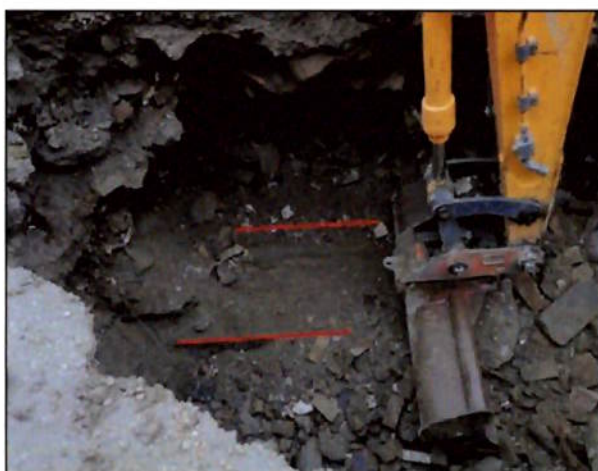
Figure 60 The structure from the north

The archaeological testing in Site B exposed deep deposits of modern debris, to approximately 3m in depth and this is likely to represent an infilled cellar associated with the building (no. 1) that is recorded on the Goad's Insurance map of 1893. The solid limestone wall, orientated east-west, was located 2.70m below present ground level in roughly the same location as the original property boundary would have been but this appears to be very wide and substantial, approximately 1m in width with a possible floor on the northern side. No other archaeological deposits or features were noted.

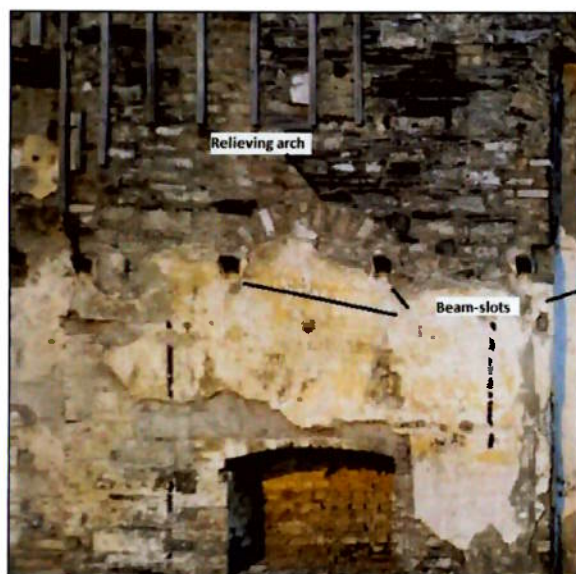
An additional floor had also been added in the grand room but this was more crudely done than Building 1, with large beam-slots inserted roughly into the chimney breast. This floor was positioned 0.55m lower than the inserted floor found in Building 1, an indication that both rooms were not linked at first floor level (Fig. 78).

Figure 78 The relieving arch and beam-slots
