ENVIRONMENTAL IMPACT ASSESSMENT REPORT (EIAR) FOR THE PROPOSED BALLINAGREE WIND FARM

CHAPTER 8 PART B - AQUATIC ECOLOGICAL ASSESSMENT

Prepared for: Ballinagree Wind DAC

Date: January 2022

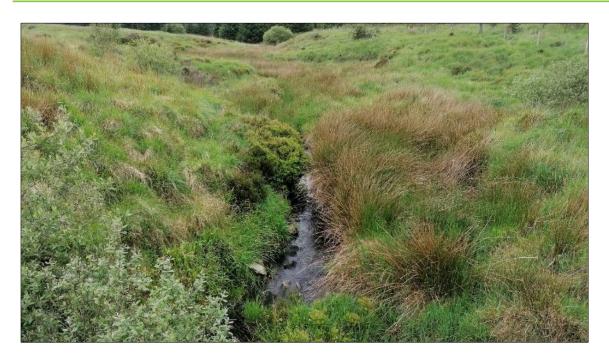
Site A1 was located on the uppermost reaches of the Nadanuller Beg Stream (EPA code: 18N05, also known locally as the Owenaluggin River). The upland eroding watercourse (FW1) was characterised by glide and riffle sequences with localised pool habitat over boulder cascades. The channel was approximately 1m wide and 0.2m deep with peat-stained water at the time of survey. The deep U-shaped channel graded into a valley with shallow slopes adjoining upland conifer plantations (WD4, 10-15 years old). The substrata were dominated by bedrock (20%), boulder (30%), large cobble (20%) and peat, with only localised coarse and medium gravels. The substrata were moderately silted and featured a very high coverage of filamentous algae at the time of survey. The adjoining lands comprised of wet grassland (GS4), blanket bog and pockets of heath, with purple moor grass (Molinia caerulea), Juncus sp. rushes and marsh bedstraw (Galium palustre) dominating. Macrophytes were absent due to the high energy of the site. However, aquatic bryophyte coverage was high locally, with Fontinalis squamosa and common earwort (Scapania undulata) present on boulder tops.

Biological water quality, based on Q-sampling, was calculated as **Q4 (good status)** (**Appendix 8B.B**). Molybdate reactive phosphorus (MRP) (0.043mg P/I) and total ammonia (0.094mg N/I) concentrations were high and, thus, the site failed meet the good status thresholds as set out under S.I. No. 77/2019 - European Union Environmental Objectives (Surface Waters) (Amendment) Regulations 2019.

Plate 8B.4-1: Representative image of site A1 on the Nadanuller Beg Stream, June 2020 (facing upstream)

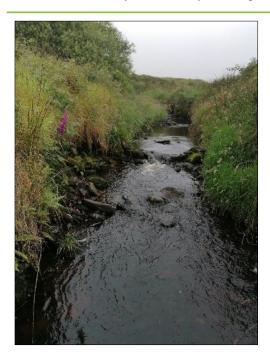
Plate 8B.4-2: Representative image of site A2 on the Nadanuller Beg Stream, July 2020

Given the excellent salmonid nursery habitat and the presence of a salmonid population and good status (Q4) water quality, the aquatic ecological evaluation of site A2 was of **local importance** (higher value).

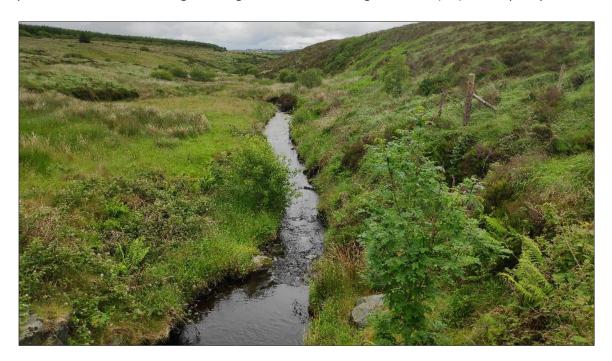
Site A5 on the upper reaches of the Glen River (EPA code: 18G04) (bridge crossing CC-L95791-005.00) was an upland eroding watercourse (FW1) characterised by glide and riffle sequences with localised pool habitat over boulder cascades. The channel averaged 2m wide and 0.3m deep with peat-stained water at the time of survey. The shallow U-shaped channel was cut into a shallow sloping valley. The site drained an upland area which featured frequent coniferous afforestation (WD4). The adjoining lands comprised heath (south bank)) and wet grassland with pockets of heath to the north. The riparian zone featured open banks with low lying cover of soft rush (Juncus effusus), ferns, common sorrel (Rumex acetosa), bramble (Rubus fruticosus agg.), foxglove (Digitalis purpurea), heather (Calluna vulgaris), purple moor grass, rank grasses and occasional willow and rowan (Sorbus aucuparia). The substrata were dominated by boulder (30%), large cobble (40%) with coarse and medium gravels (20%). The remaining proportions comprised silt and small pockets of finer gravel in interstitial spaces, with a concrete apron near the bridge. The substrata were heavily covered with floc and filamentous algae. Macrophytes were not present upstream but downstream slower glide supported small beds of water crowfoot vegetation (Ranunculus sp.). The site had a high coverage of Fontinalis squamosa and Chiloscyphus polyanthos, with common earwort and yellow fringe moss also present. The presence of more than three indicator macrophyte/bryophyte species means the site's aquatic vegetative community was representative of the Annex I habitat 'Water courses of plain to montane levels with the Ranunculion fluitantis and Callitricho-Batrachion vegetation and aquatic mosses [3260]'.

Site A5 was located within the Boggeragh Mountains NHA (0002447), a site designated for peatlands. This site was therefore considered of **national importance**. The site also supported good-quality salmonid habitat, the presence of Annex I 'floating river vegetation' habitat and good status (Q4) water quality.

Plate 8B.4-5: Representative image of site A5 on the Glen River (facing downstream from bridge)

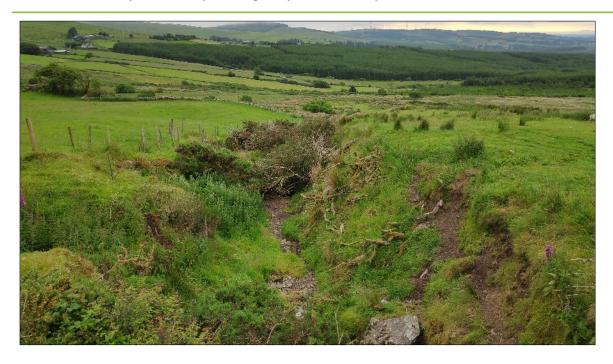
Plate 8B.4-7: Representative image of site B2 on the upper reaches of an unnamed stream at Knocknagappul (site 100% dry during the survey period)

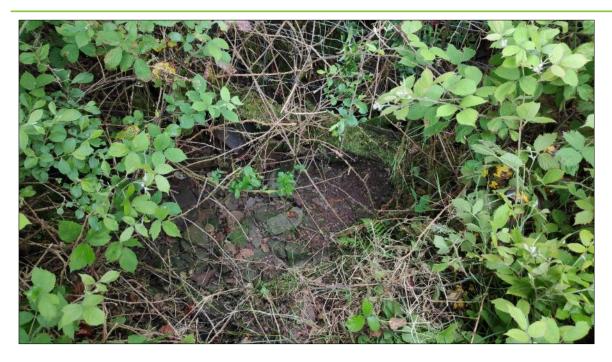
Plate 8B.4-8: Representative image of site B3 on the West Ballynagree Stream (100% dry during the survey period)

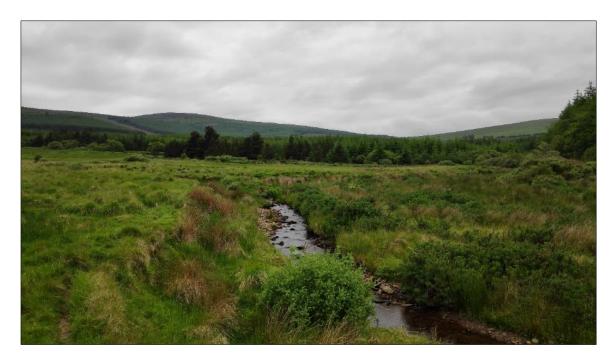
Site B4 was located on the lower reaches of the Knocknagappul Stream (EPA code: 19K04, approx. 50m upstream of the confluence with the River Laney. The natural upland eroding watercourse (FW1) averaged 1-1.5m wide and 0.1-0.2m deep in a deeply cut (near vertical-sided) U-shaped channel. Shallow glide and riffle dominated the site (40% each) with only localised plunge pools, some to 1m in depth but mostly shallower. Bankfull heights were 1.5-2m and the channel evidently conveyed significantly more water during spate conditions. Natural bank scouring was frequent, particularly on the many meanders at the site. The substrata were dominated by small cobble (40%) with occasional small boulder (5%). Fine to medium gravels were frequent (30% overall), with sand also present (10%). Some exposed peat was present locally. Although some silt plumes were present underfoot, overall siltation levels were low in this high-energy channel. The stream meandered through a valley floor with mosaics of lowland blanket bog (PB4) and degraded raised bog (PB1). Common plant species included purple moor grass, soft rush, heath milkwort (Polygala serpyllifolia), marsh lousewort (Pedicularis palustris), tormentil (Potentilla erecta) bog myrtle (Myrica gale) and localised bog cotton (Eriophorum angustifolium). The area was exposed to low intensity sheep grazing and the bank of the stream were open, with low-height scrub and rank grasses. There was no instream macrophyte growth given the typically high energy of the site (spate channel). The bryophyte community was also poorly represented with only very limited drab brook moss (Hygrohypnum luridum) on instream boulders.

Given the presence of a salmonid population, the aquatic ecological evaluation of site B4 was of **local importance** (higher value).

Plate 8B.4-9: Representative image of site B4 on the Knocknagappul Stream (facing upstream from near River Laney confluence).

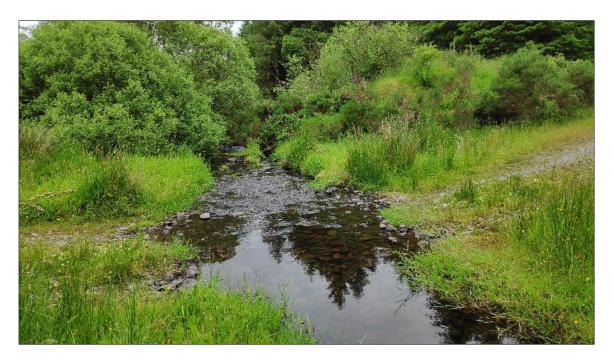
Plate 8B.4-12: Representative image of site B7 on an unnamed stream at Ballynagree East (at forestry track ford crossing and watercourse crossing WF-HF9)

Biological water quality, based on Q-sampling (June 2021), was calculated as **Q4-5** (high status) (Appendix 8B.B).

Given the presence of a salmonid population and high status (Q4-5) water quality, the aquatic ecological evaluation of site B7 was of **local importance** (higher value).

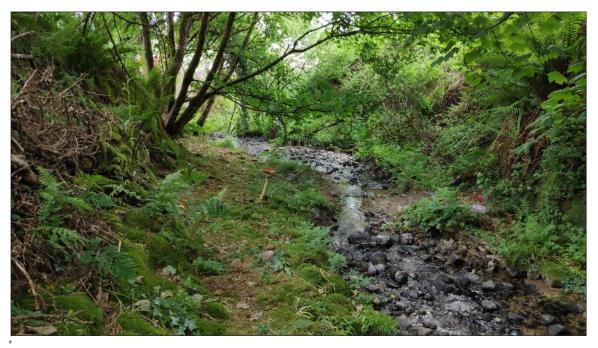
Plate 8B.4-15: Representative image of site B10 on the Ballynagree East Stream

Biological water quality, based on Q-sampling, was calculated as **Q4 (good status)** (**Appendix 8B.B**). The site failed to meet the EPA nitrate threshold for good status water quality (i.e. very high TON of 2.299mg N/I) (**Table 8B.4.1**).

Given the presence of a salmonid population and good status water quality, the aquatic ecological evaluation of site B10 was of local importance (higher value).

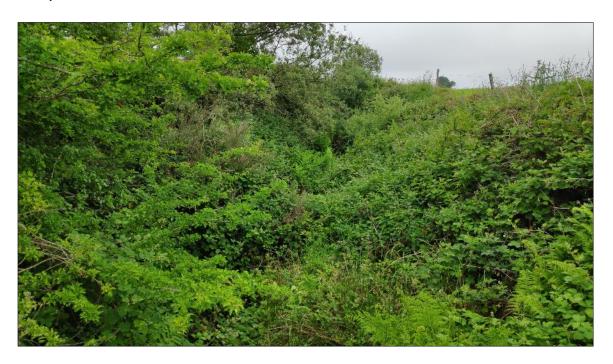
Plate 8B.4-20: Representative image of site C4 on the Rahalisk Stream, Knocknagappul (heavily bound in scrub)

Given the poor fisheries value, the aquatic ecological evaluation of site C4 was of **local importance (lower value).**

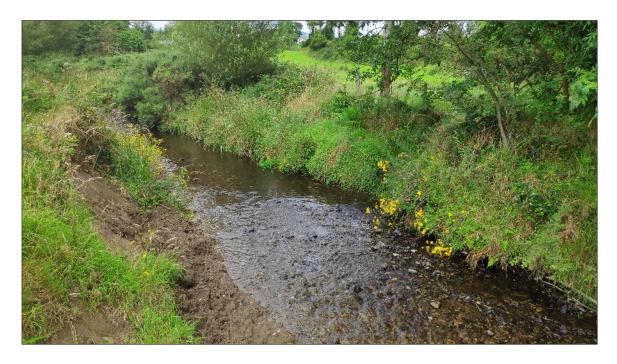
Plate 8B.4-21: Representative image of site C5 on the Carrigthomas Stream downstream of Coppeleenbawn Bridge

Biological water quality, based on Q-sampling, was calculated as Q3-4 (moderate status) (Appendix 8B.B).

Given the presence of a salmonid population and *Lampetra* sp. ammocoetes, the aquatic ecological evaluation of site C5 was of **local importance (higher value).**

Sites C5 (Carrigthomas Stream, Q3-4 moderate status) and C17 (Coolaniddane River, Q3 poor status) failed to meet the good status (≥Q4) requirements of the European Union Environmental Objectives (Surface Waters) (Amendment) Regulations 2019 and the Water Framework Directive (2000/60/EC).

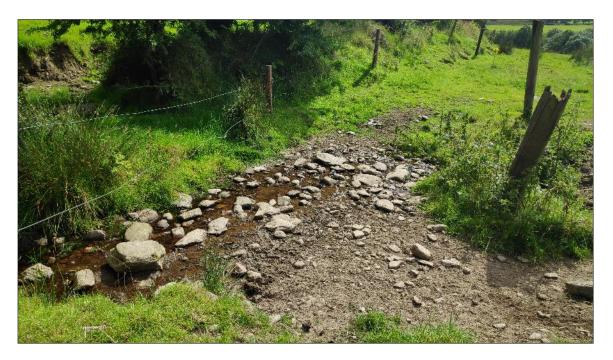
Plate 8B.4-30: Representative image of site C14 the Clonavrick Stream (downstream of road culvert)

Given the lack of fisheries value, semi-dry nature and evident water quality issues, the aquatic ecological evaluation of site C14 was of **local importance (lower value)**.

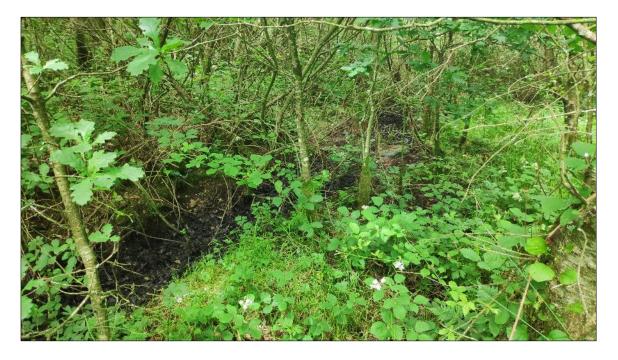
Plate 8B.4-32: Representative image of site C16 on the Kilberrihert Stream (downstream of road culvert)

It was not possible to assess biological water quality at this site given a lack of water and flow.

Given the lack of fisheries value and evident non-perennial nature (dry channel), the aquatic ecological evaluation of site C16 was of **local importance (lower value)**.

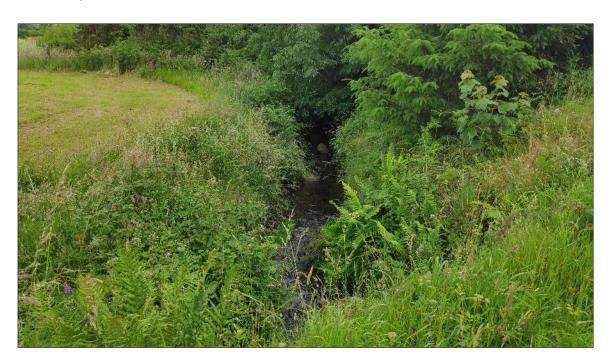
Plate 8B.4-33: Representative image of site C17 the Coolaniddane River (upstream of road culvert)

Biological water quality, based on Q-sampling, was calculated as **Q3** (poor status) (Appendix 8B.B). The site failed to meet the EPA nitrate threshold for good status water quality (i.e. very high TON of 2.489mg N/I) (**Table 8B.4.1**).

Given the poor fisheries value and poor status water quality, the aquatic ecological evaluation of site C17 was of **local importance (lower value).**

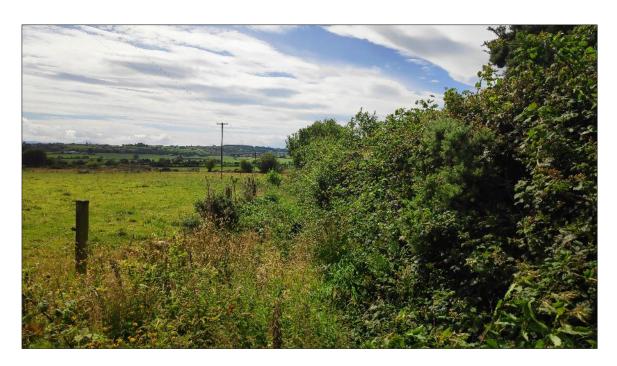
Plate 8B.4-34: Representative image of site C18 the Caherbaroul Stream (downstream of road culvert, heavily bound in scrub)

Given the lack of fisheries value, non-perennial nature and evident water quality issues, the aquatic ecological evaluation of site C18 was of **local importance (lower value)**.

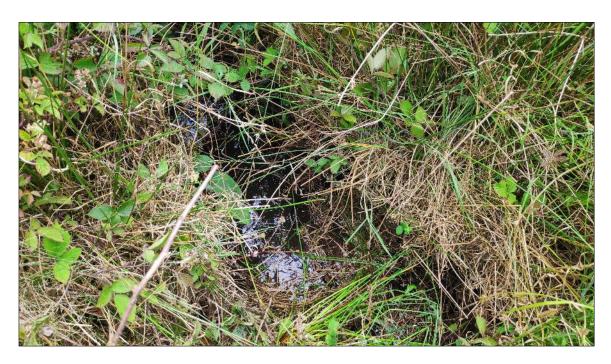
Plate 8B.4-35: Representative image of site C19 the Bealick Stream (semi-dry channel, localised ponding only)

Given the lack of fisheries value and non-perennial nature, the aquatic ecological evaluation of site C19 was of local importance (lower value).

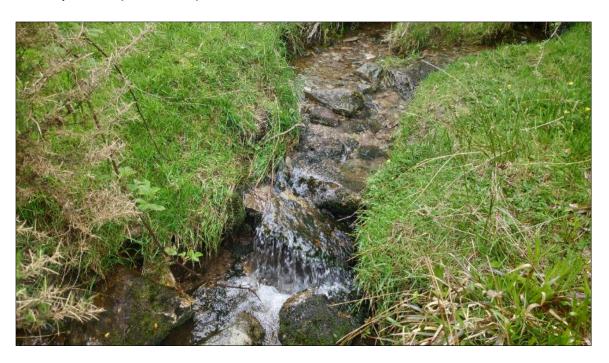
Plate 8B.4-36: Representative image of site N1 on the West Ballynagree Stream at proposed watercourse crossing WF-HF5

Whilst a Q-sample was taken in June 2021, the paucity of macro-invertebrates recorded (very low numbers of Tubificidae larvae and *Lumbriculus* sp.) was not sufficient to reliably calculate water quality status (**Appendix 8B.B**). This was presumably an artefact of the non-perennial nature of the stream.

Given the poor fisheries value and non-perennial nature, the aquatic ecological evaluation of site N1 was of local importance (lower value).
