Land, Soils & Geology

- Appendix 7-1 - Cloghroe Ground Investigation Report – Interpretive’ - Ocbgeo

Cloghroe Housing Development – Site Investigation Interpretative Report

Report No.: OCB20-087

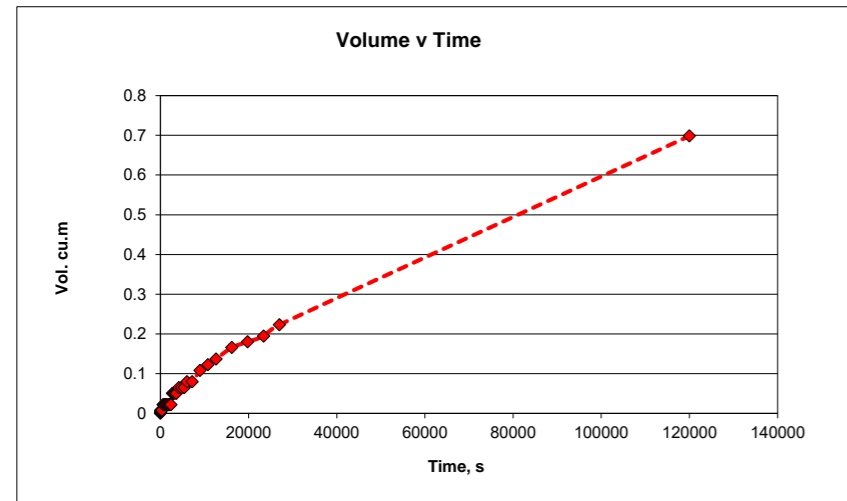
Area 1.44 m²
 50% Area_eff, a_{p50} 3.375 m²
 $V_{p75-25 \text{ theory}}$ volume 0.6966 m³
 V_{p75-25} volume 1.2384
 t_{p75-25} time 114000 s
Infiltration Coefficient f 3.2E-06 ms⁻¹

NOTES:
 Last datapoint extrapolated from available data to facilitate an estimated Infiltration Coefficient calculation

Appendix F presents the results and analysis of the infiltration test. The absence of outflow from the pits precluded calculation of infiltration coefficients in two of the tests. An estimated Infiltration Coefficient of 3.2×10^{-6} was calculated for the TP05 test.

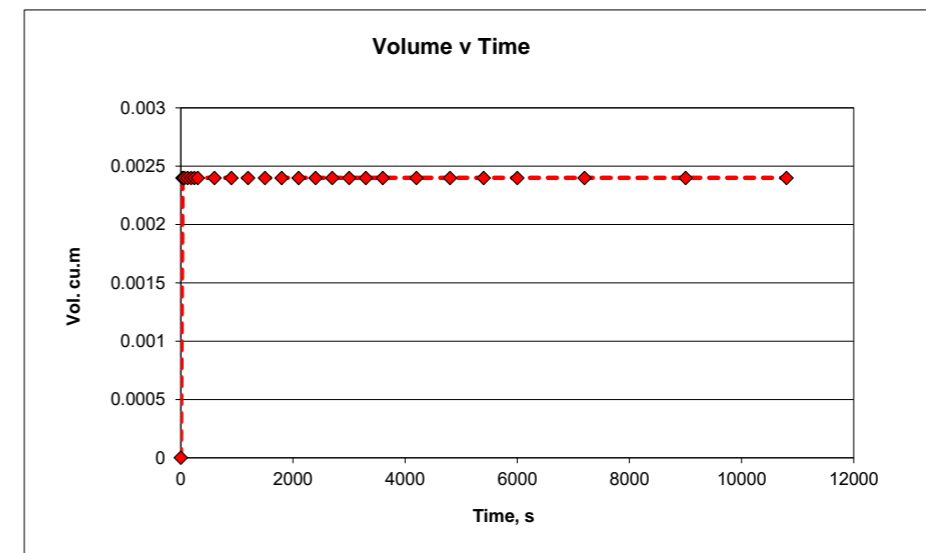
Area 2.4 m²
 50% Area_eff, a_{p50} 4.745 m²
 $V_{p75-25 \text{ theory}}$ volume 0.903 m³
 V_{p75-25} volume
 t_{p75-25} time s
Infiltration Coefficient f ms⁻¹

NOTES:
 Water level did not fall sufficiently to calculate an Infiltration Coefficient
