15.6.2 Mitigation measures for the development of Site 3

A site wide cumulative Masterplan has been prepared by Dublin Central GP Limited (the 'Applicant') to set out the overall development vision for the Dublin Central project. This is called the Dublin Central Masterplan. The Dublin Central Masterplan area is divided into six identifiable sites for the purpose of making individual planning applications; Sites 1 and 2 (2AB and 2C) lie east of Moore Lane and Sites 3, 4 and 5 lie to the west. Site 3 is in its own block and bound to the north and east by Henry Place (See Figure 16.1 below).

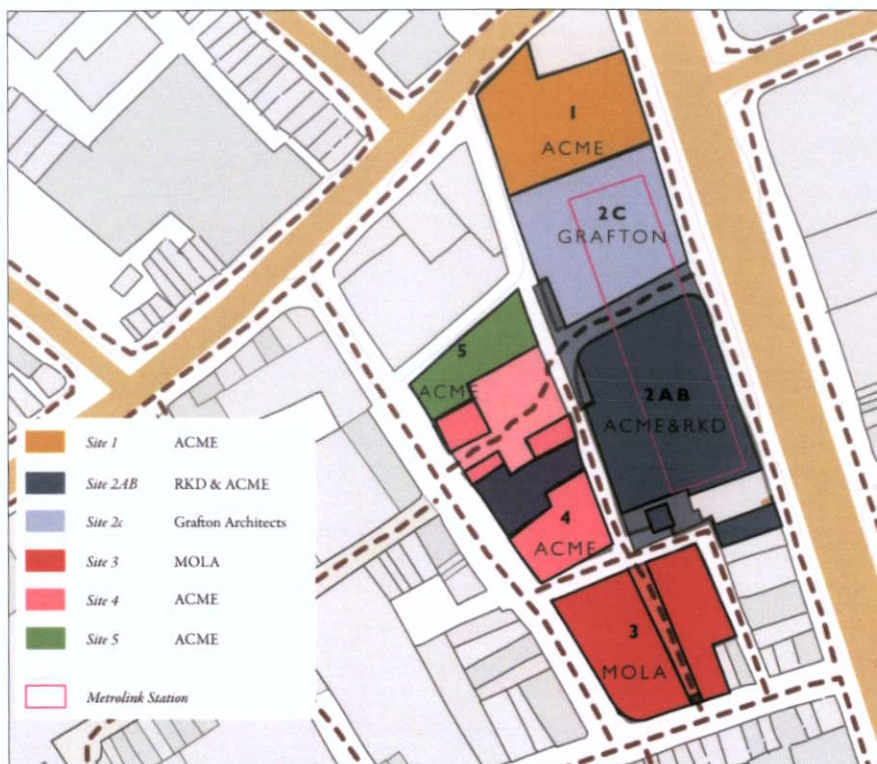
Figure 16.1: Dublin Central Masterplan area and development sites.

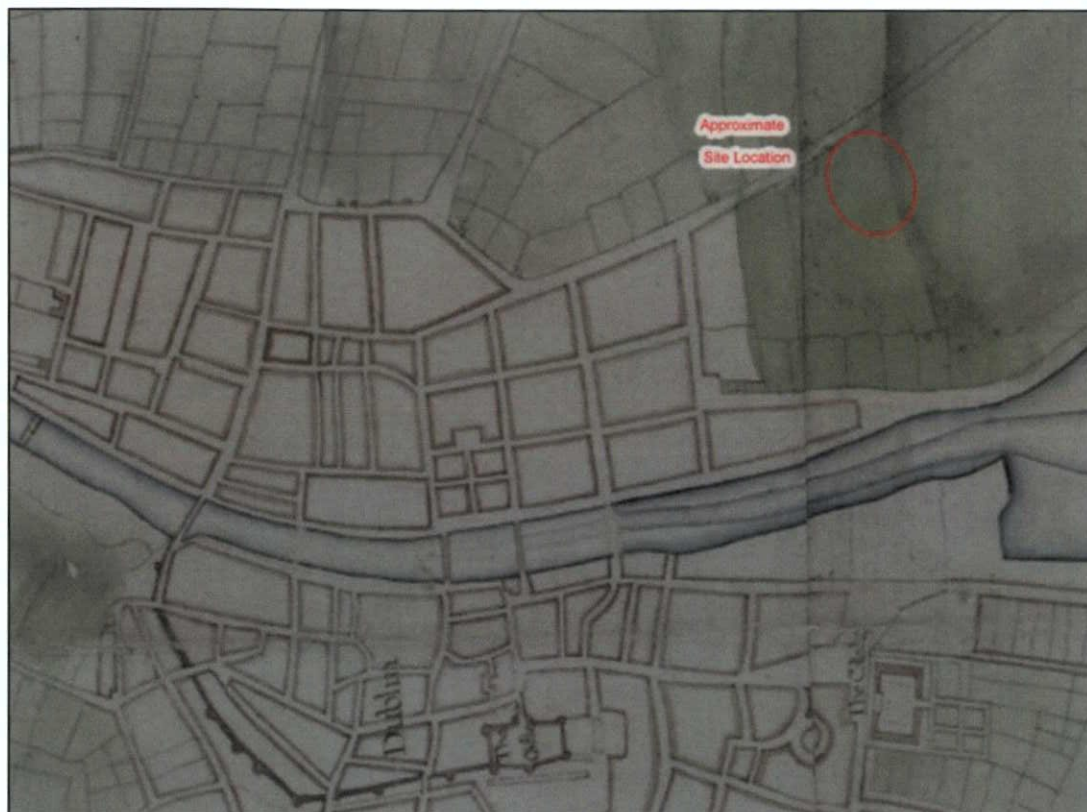
Figure 16.7: Phillips' map, dated 1685.

Thomas Phillip's map of 1685 (Figure 16.7) shows the northern foreshore of the Liffey reclaimed and the modern alignment of quays running east to the end of Bachelor's Walk and several new bridge crossings connecting both sides of the rapidly expanding city. Abbey Street runs east to intersect with the east end of the new quays, Marys Street runs north and parallel to this but only continues to easterly as far as the present-day Liffey Street, Liffey Street extends south from Great Britain Street (modern Parnell Street) to intersect with the west end of the new quay at Bachelor's Walk. It appears that the Moore Street area has yet to be developed and continues to part of an open tract of undeveloped land.

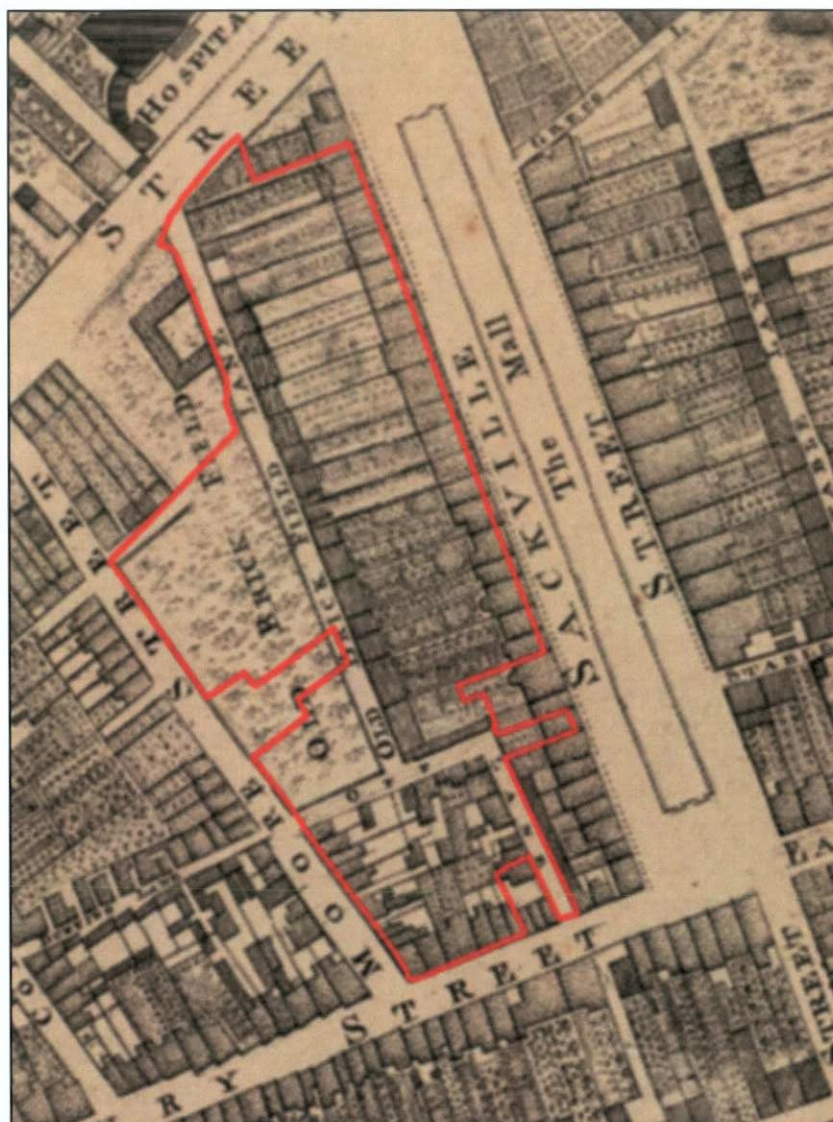
Figure 16.9: John Rocque, 'An exact survey of the city and suburbs of Dublin', dated 1756 and approximate Dublin Central Masterplan area location.

By the mid-18th century, the Moore Street/ O'Connell Street area was developed for housing and this is captured on Rocque's map of the city, dated 1756 (Figure 16.8). This is the first map to show the individual plots of land and structures associated with them, it shows a greatly expanded city. The present streetscape has been developed. In addition to Moore Street, Off Lane (now Henry Lane) and Old Brick Field Lane (now Moore Lane) is laid out. Only the western section of Sackville Lane (now O'Rahilly Parade) has been formed and is unnamed. In terms of the plot development, the information shown on Rocque's map does not correlate to Brooking's map. According to Rocque only the northern and southern ends of Moore Street are fully developed, comprising houses of varying sizes with rear plots and some gardens.

An area bounded by Moore Street / Off Lane / Old Brick Field Lane, consists of a large open area called *Old Brick Field*, which stretches from Parnell Street to Off Lane within Sites 5 and 4 of the Dublin Central Masterplan area). It appears to have been partially enclosed by a wall, including a 'u' shaped structure at the northern end of the field (recent excavations on O'Connell Street show that the brickfield may have been much more extensive, see Section 16.4.2).

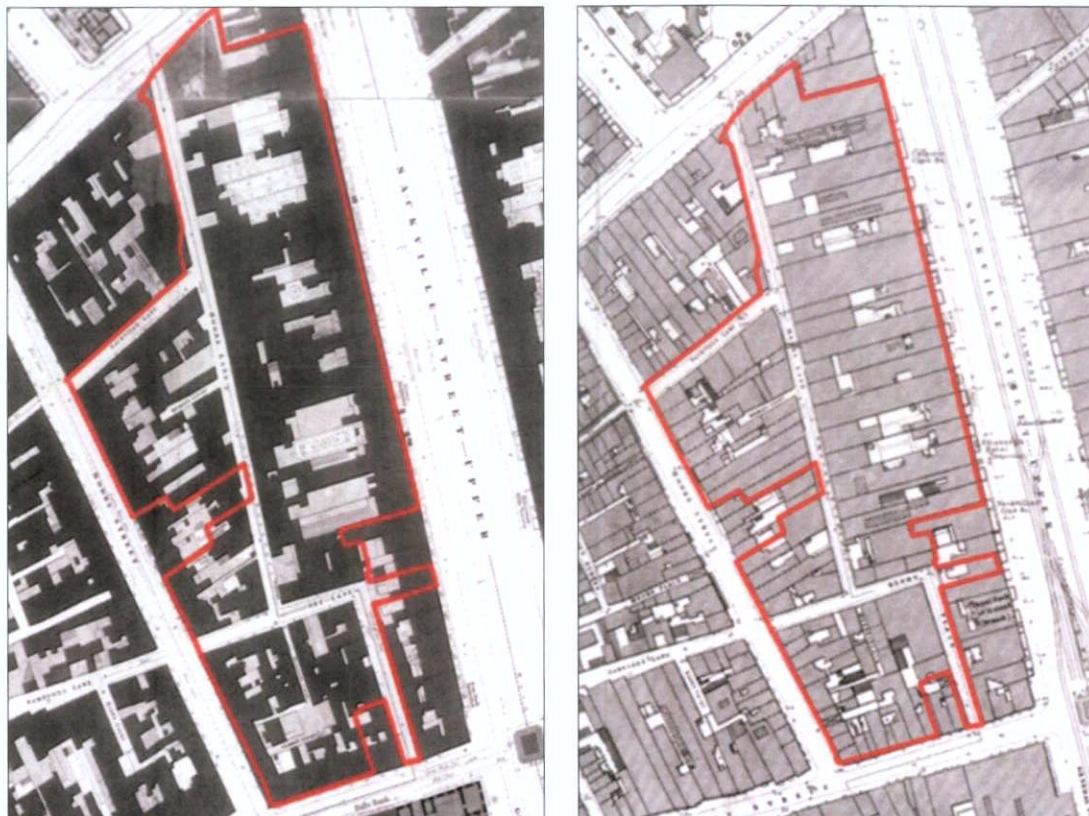
Figure 16.13: First Edition of the Ordnance Survey, dating to between 1838 and 47.

By the first Edition of the Ordnance Survey map, dating to between 1838 and 1847, the modern streetscape is recognisable. Substantial development has taken place at the site and the brickfield has been completed developed. 'Old Brick Field Lane', now renamed Moore Lane and 'Sackville Lane', now O'Rahilly Parade, is also shown (Figure 16.13). But there are still gardens intact on both sides of the development site where presumably there was minimal ground disturbance.

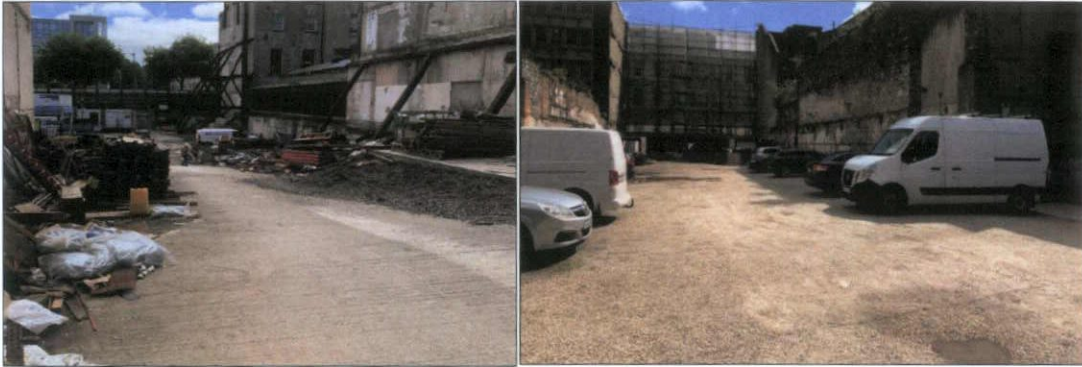
Figure 16.16: Nos. 40 – 41 O'Connell Street (left) and Nos. 50 – 51 O'Connell Street (right).

Archaeological testing was undertaken on behalf of the Applicant in two vacant plots within the Dublin Central Masterplan area, at Nos. 40 – 41 O’Connell Street and Nos. 50 – 51 O’Connell Street (Licence Number 20E0649, (Figure 16.16). The testing was carried out on Saturday the 28th of and the 30th of November 2020 under licence no. 20E0649 (Simpson 2020). Both sites are open car-parks, stretching between O’Connell Street on the east and Moore Lane on the west. The full testing report is provided in Appendix 16.4.

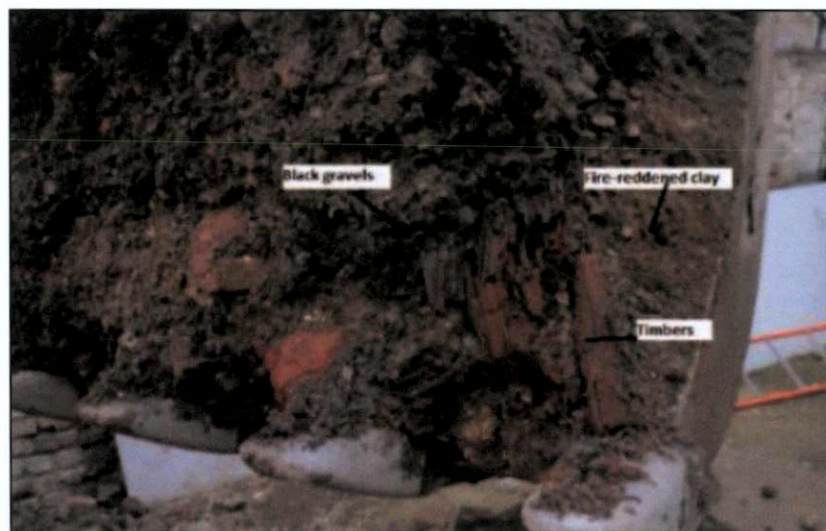
Trench 1 exposed modern fill up to 3.40m. It exposed yellow clays at the base of the trench and close inspection identified areas of fire-reddening in the clay, the result of intense heat, most likely to have emanated from the brickworks, captured on Rocque's map of Dublin, dated 1756.

Figure 16.17: Fire reddened clay and timbers found at the base of Trench 1.

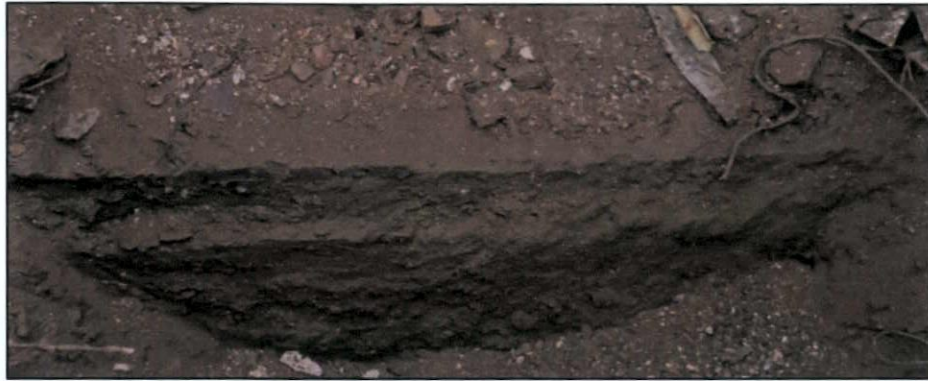
In trench 3, a substantial limestone footing lying 2.70m below present ground level and orientated east-west was identified. It was constructed of small cut limestone blocks and measured approximately 1m in width by at least 0.80m in depth. It was well-faced on the exposed northern side and it had been demolished to a single continuous level. There was an offset on the northern face, set 0.14m below the top of the wall, measuring 80mm in width. A small section of what appeared to be a blackened floor was exposed on the northern side of the trench, extending for 0.35m north-south by 0.55m east-west perhaps suggesting that there was a cellar in this location originally.

Figure 16.18: The northern face: note modern debris.

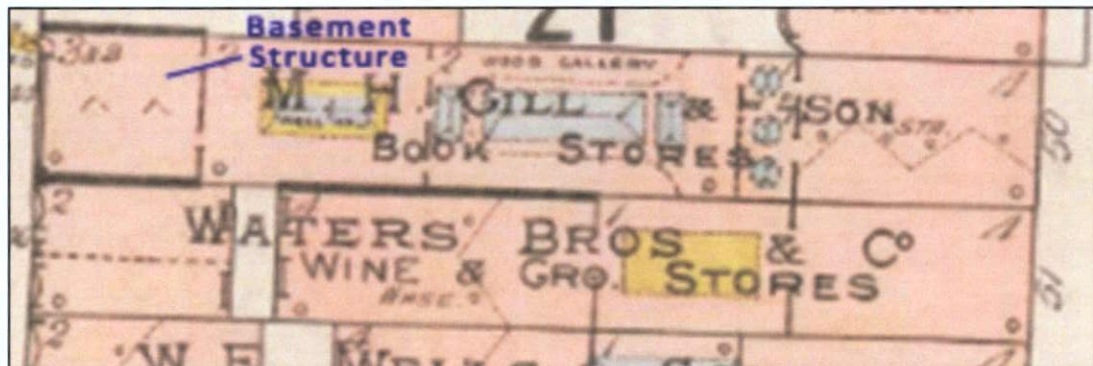
The Goad's Insurance map of 1893 indicates that the building at the western end of the site was two stories in height but with a basement, which was relatively unusual for a rear building. Rocque's map, dated 1756, does show a stable/coach-house, which is unlikely to have a basement, but which might have been integrated into the building on Goads Map. The wall foundation and floor found in Trench 3 is likely to be related to this structure. The evidence suggests that the basement was demolished but the foundations of the wall and possibly the floor are still *in situ*.

Figure 16.19: Goad's Insurance map of 1893 showing Nos 50 and 51 O'Connell Street.

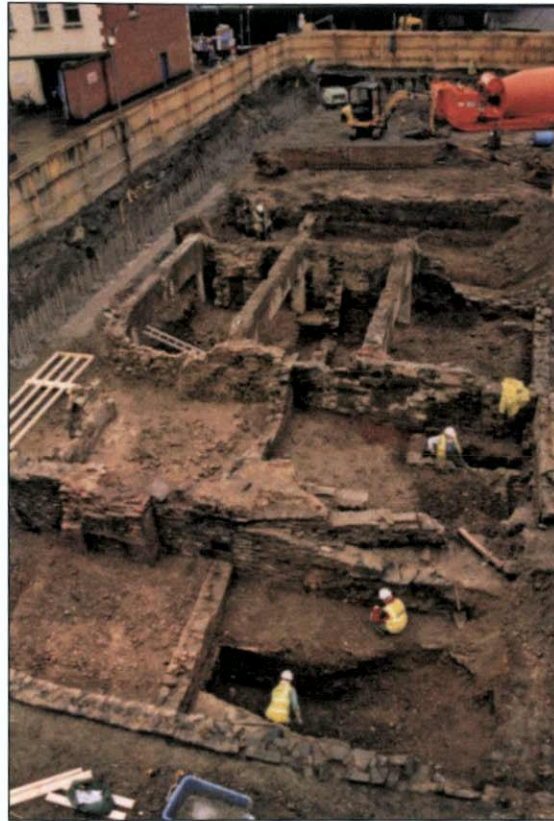
In general, the surviving remains consisted of stone and brick structures, cellars, buildings, cobbles, drains, a lime-kiln, paths and vaults and extended to 3m in depth on average (Figure 16.21). The cellars were deepest along O’Rahilly Parade at 3.10m but each plot had additional buildings, some with some basements, in the rear plots. Where there were no basements there were garden soils to a depth of between 0.20m and 0.50m in depth, the lowest levels of which were medieval in date, the upper post-medieval. However, there were also large refuse pits some as deep as 3.50m cut into the boulder clay (O’Donovan, 2004).

Figure 16.21: Excavations at Parnell Street: Note red clay deposits associated with brick-making (after O’Donovan, 2004).
