APPENDIX 6.4 POTENTIAL ROOST FEATURE (PRF) PHOTOS FROM BUILDING INSPECTIONS

ENVIRONMENTAL ASSESSMENT (SITE INVESTIGATION)

ENVIRONMENTAL ASSESSMENT

January 2009

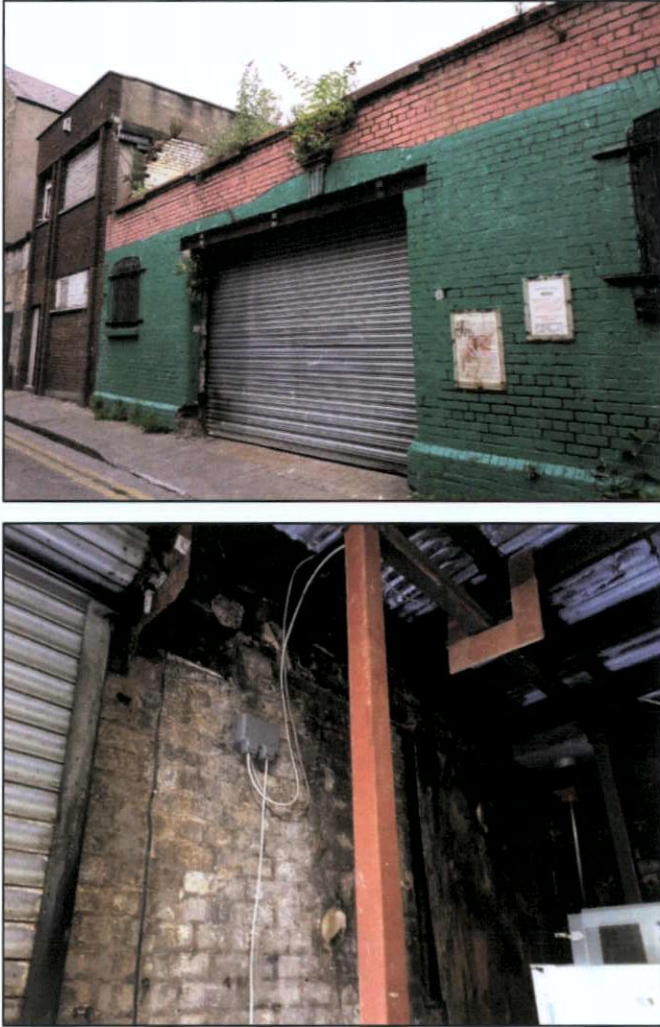
Building	PRFs	PRF Suitability	Photograph
<p>Building 4 (10-11 Moore Lane)</p>	<p>Flat roofed building, with gaps on external wall between brick work and roof, and access into building above sliding door at entrance.</p>	<p>Low</p>

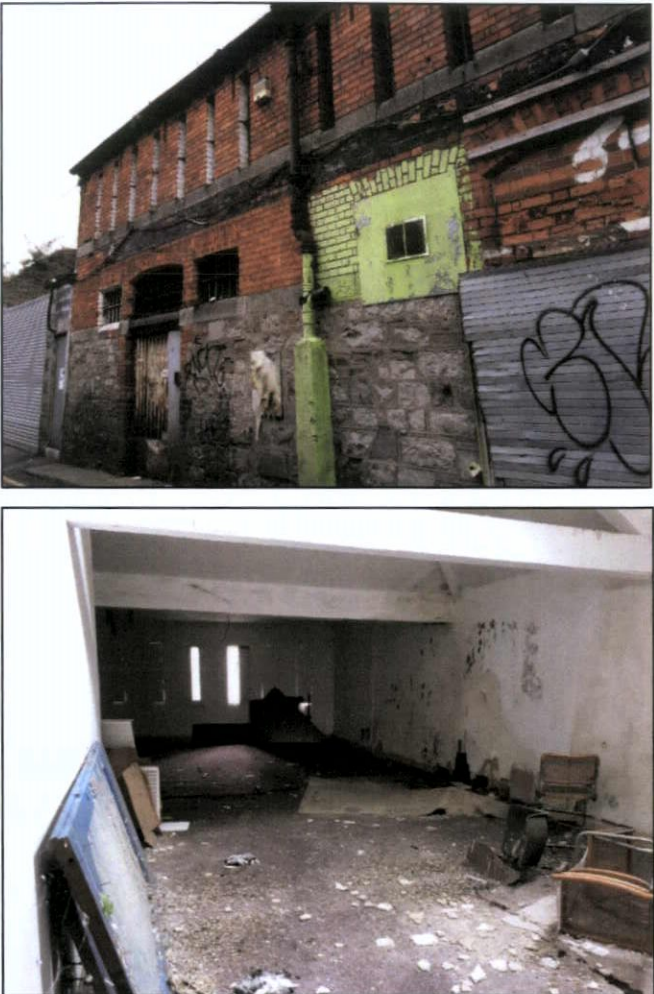
Building	PRFs	PRF Suitability	Photograph
<p>Building 5 (6-8 Moore Lane)</p>	<p>Pitched roof building with open grated buildings allowing access within, also gaps between brickwork on external walls.</p>	<p>Low</p>

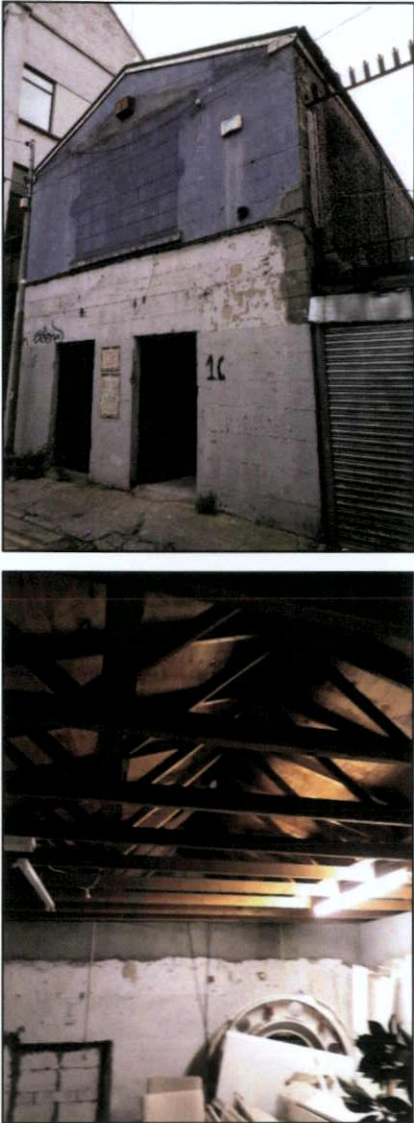
Building	PRFs	PRF Suitability	Photograph
<p>Building 6 (10 Henry Place)</p>	<p>Pitched roof building with attic space, PRFs on external walls between brickwork and soffits where they join the external walls.</p>	<p>Low</p>

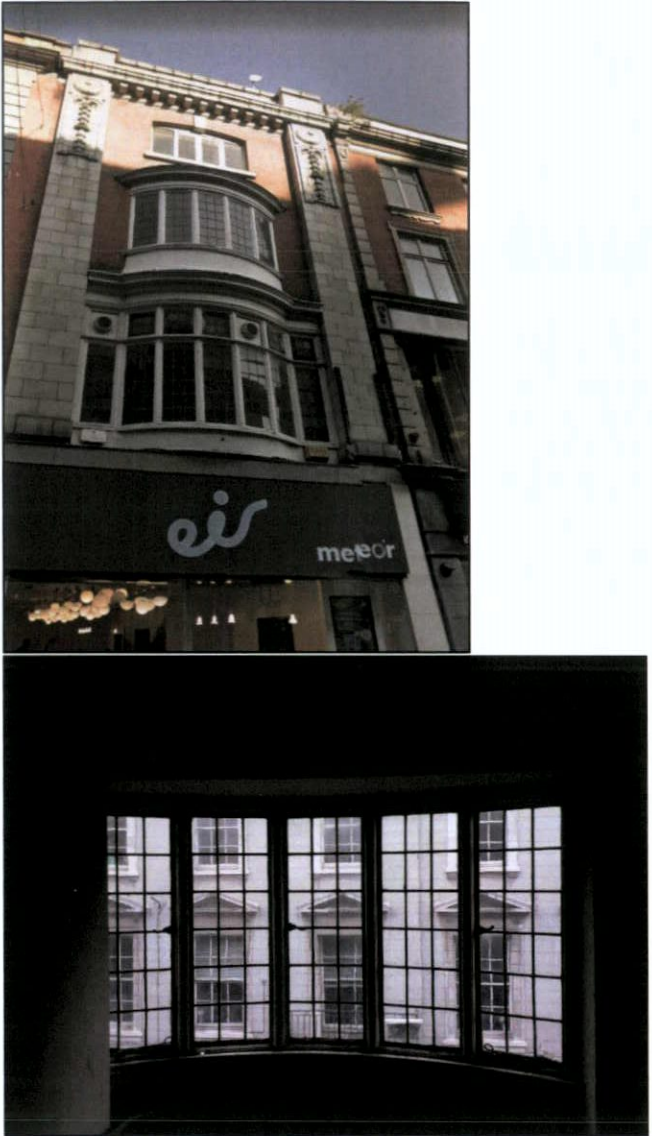
Building	PRFs	PRF Suitability	Photograph
<p>Building 7 (37 Henry Street)</p>	<p>No attic space within this building (flat roof), but PRFs on external walls and above window lintels .</p>	<p>Low</p>

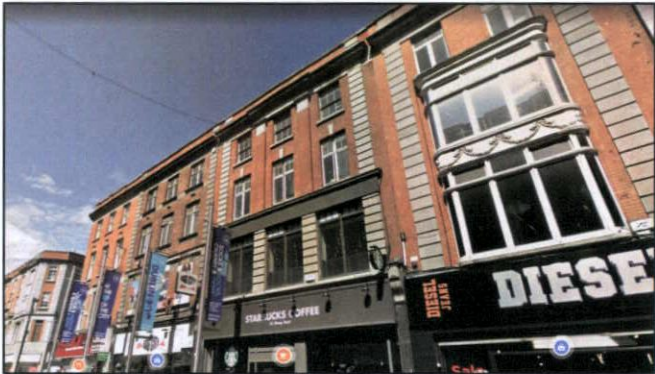
Building	PRFs	PRF Suitability	Photograph
<p>Henry Street</p>	<p>Flat roofed, well-sealed retail units, no surrounding vegetation suitable for commuting/foraging.</p>	<p>Negligible</p>

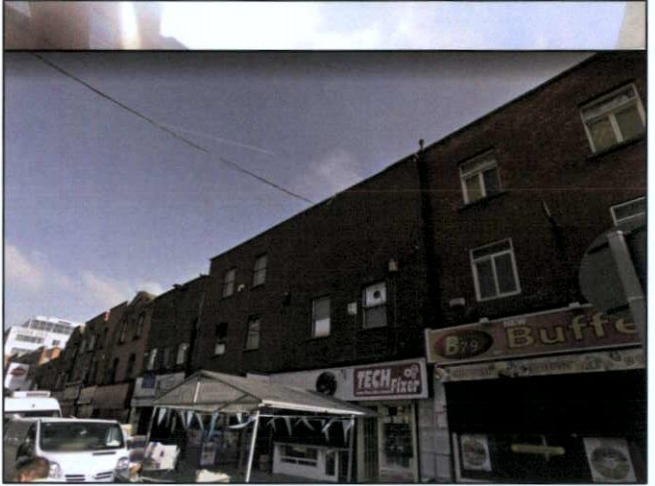
<p>Moore Street</p>	<p>Red brick flat-roofed buildings with very little gaps or crevices suitable for roosting bats. No surrounding vegetation for commuting/foraging bats.</p>	<p>Negligible</p>

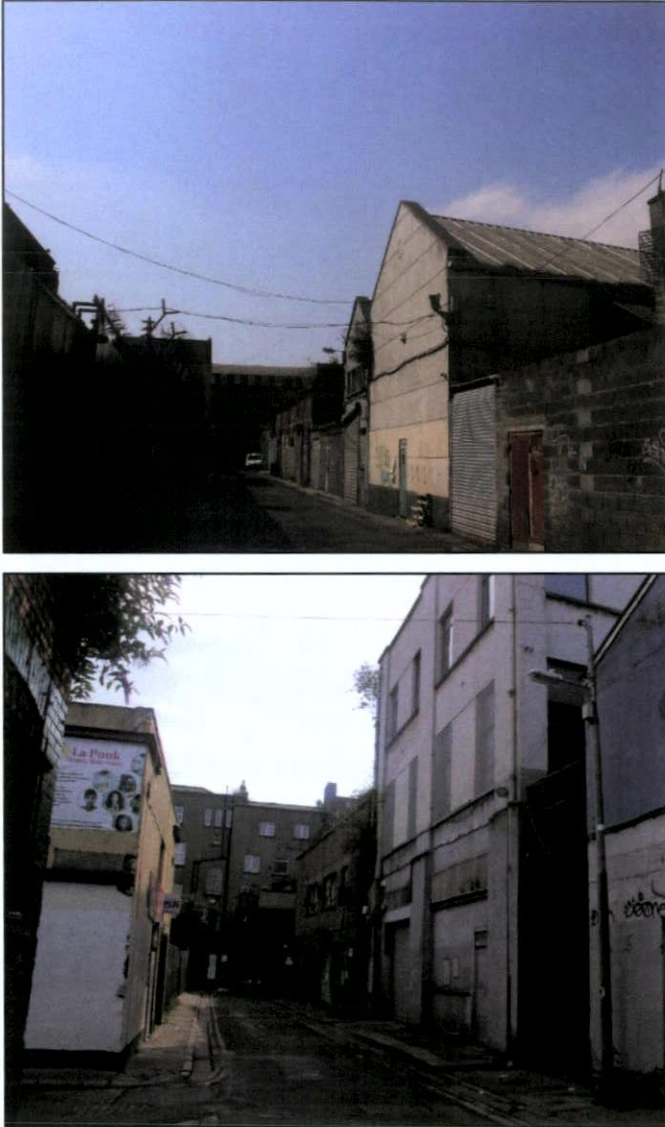
Building	PRFs	PRF Suitability	Photograph
<p>Moore Lane</p>	<p>Mostly dilapidated, run-down buildings, some with low potential as described above. Largely unsuitable for bats with no PRFs, or too exposed to be suitable for roosting bats. No surrounding vegetation for commuting/foraging.</p>	<p>Negligible</p>

<p>The top photograph shows a narrow, dark alleyway between old, weathered buildings under a clear blue sky. The bottom photograph shows a similar view from a different angle, highlighting the narrowness of the lane and the state of the surrounding structures.</p>

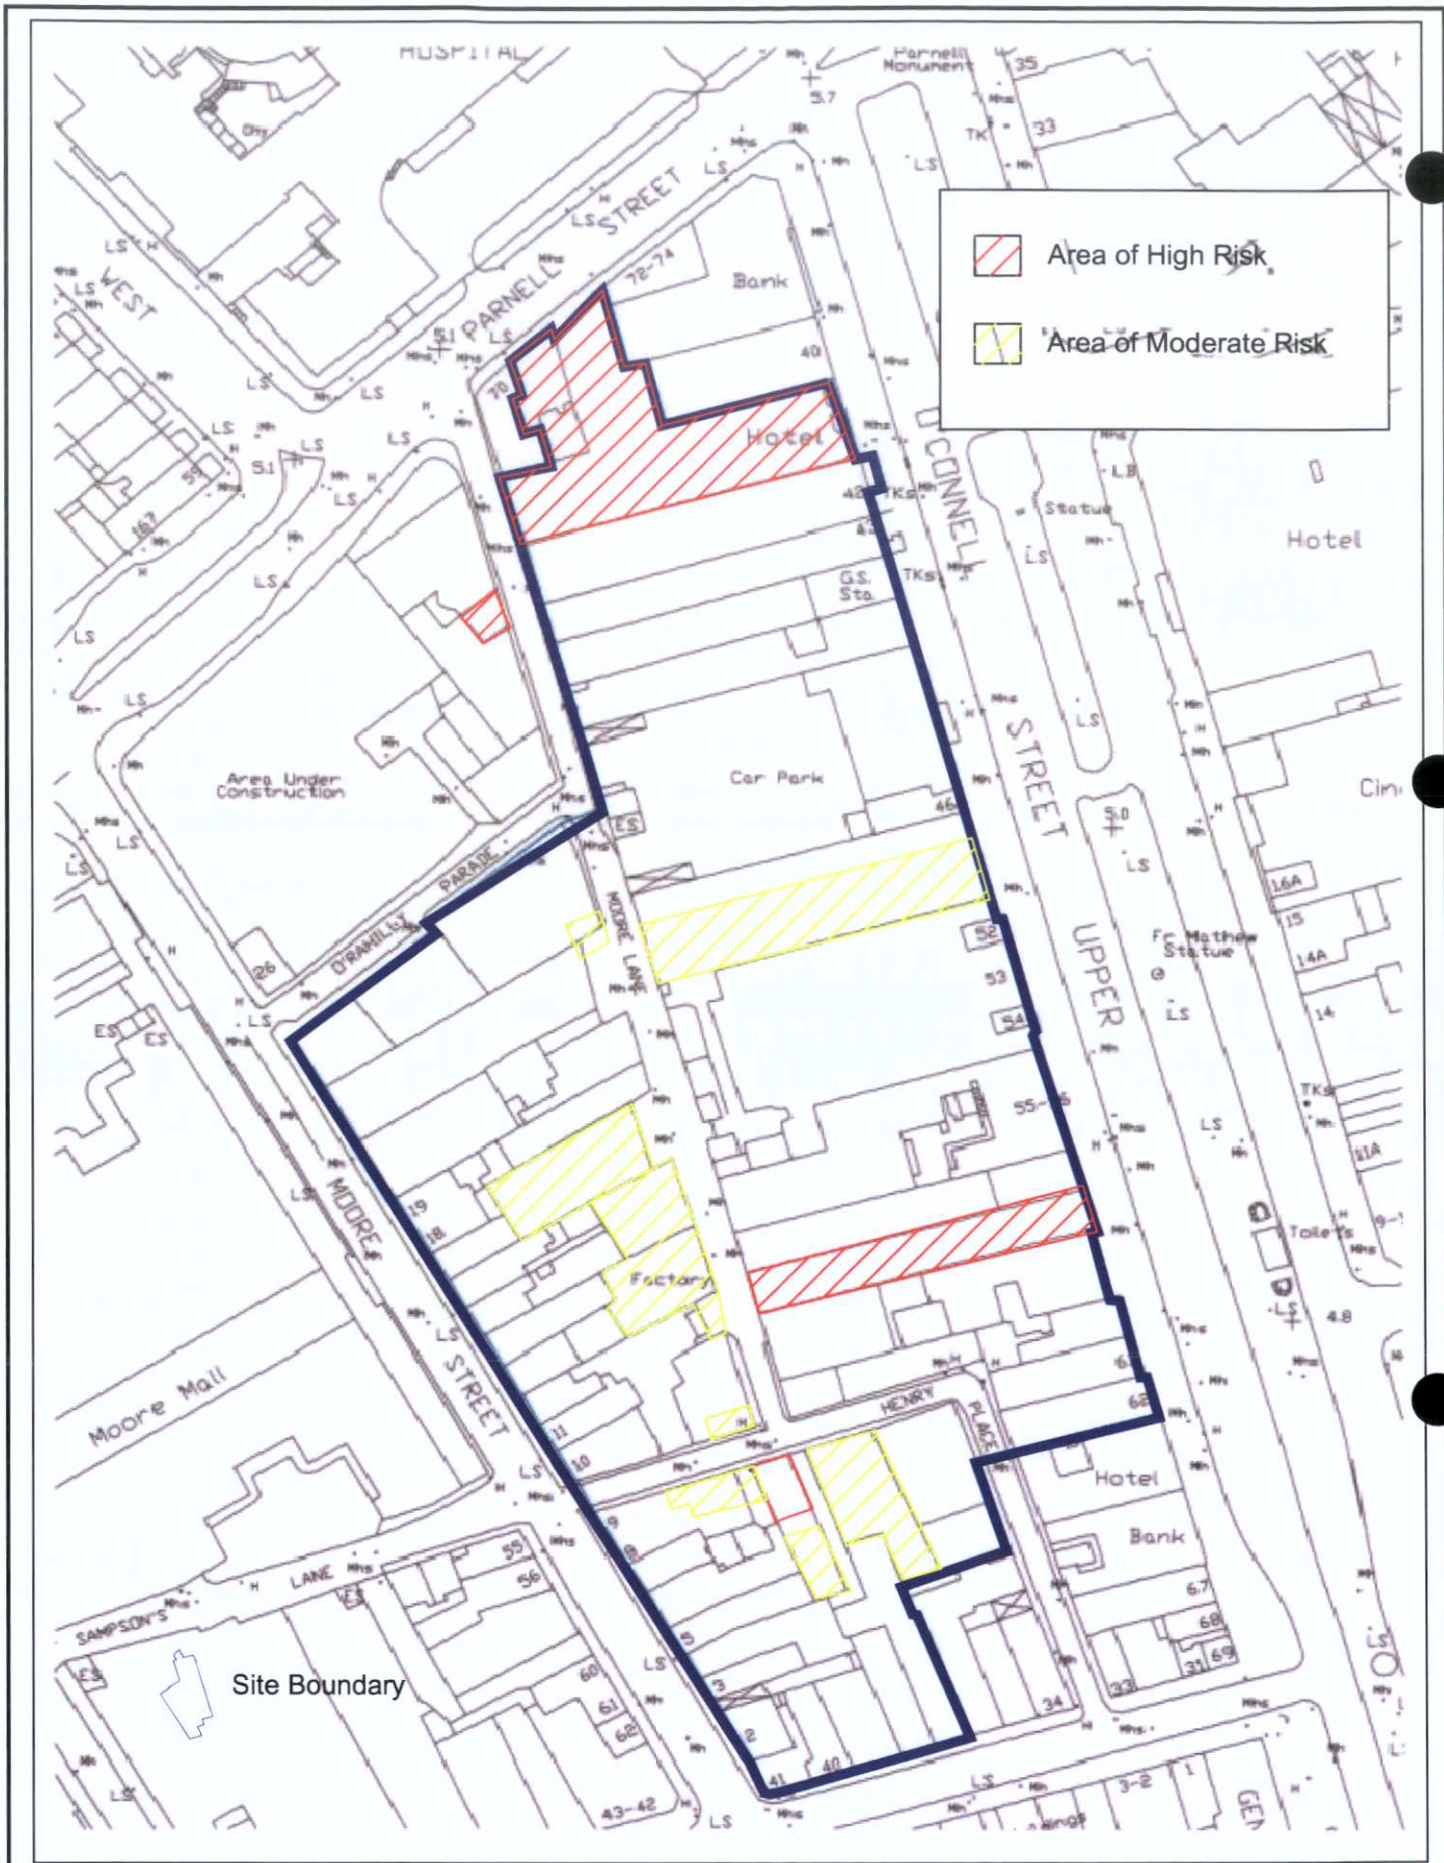
The assessment involved a desk study of available information on historic land use and a site inspection, based on which OCM prepared a Map outlining areas of potential high, moderate and low risk of contamination (Ref.: Figure 1).

<p>O' Callaghan Moran & Associates. Granary House, Rutland Street, Cork, Ireland. Tel. (021) 321521 Fax. (021) 321522 email : info@ocallaghanmoran.com</p>	<p>CLIENT Chartered Land Ltd.</p>	<p>DETAILS</p>	<p>Figure No. 1</p>
	<p>TITLE Areas of Risk from 2006</p>	<p>SCALE</p>	<p>REVISIONS</p>
