4. THE DEVELOPMENT SITES, A AND B

6. THE TESTING PROGRAMME

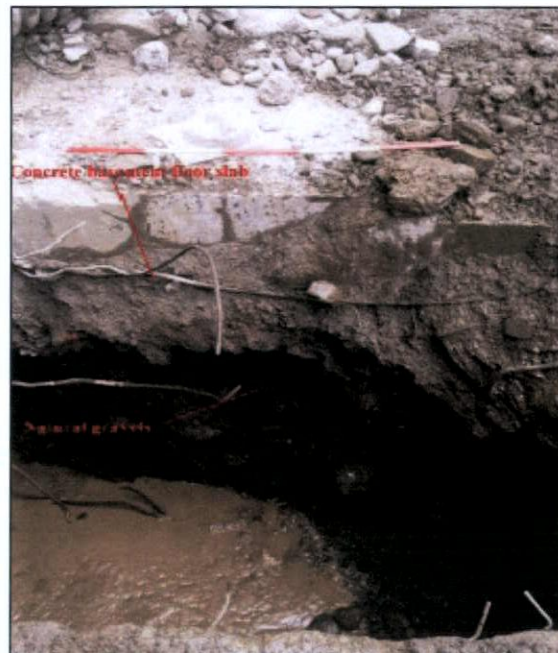
The monitoring programme established that the original concrete floor of the basement of the hotel was very substantial and still in position, made of reinforced concrete and measuring over 1m in depth (Figs 24-26). This basement was cut into deep gravel and silt deposits, presumably originally riverine deposits associated with the River Liffey, before it was reclaimed between 1678 and 1728. The gravels were carefully examined but no archaeological features or artefacts found. In April 2009, three (nos 1-3) additional engineering test-trenches were excavated in the basement area of no. 40 and this was followed in May, after the complete demolition of the hotel (nos 40-41), by the casting of a temporary crane base (no. 4) (Fig. 27). In early June, the remaining trenches (nos 5-9) were excavated, with most of the excavation works taking place in the eastern half of the site close to the O'Connell street frontage. The basement floor slab was located at approximately 3m below (2.40m O.D) below present road level of O'Connell Street (5.40m O.D.).

Figure 25 Trench B, concrete and natural gravels

Figure 26 The section through Trench B

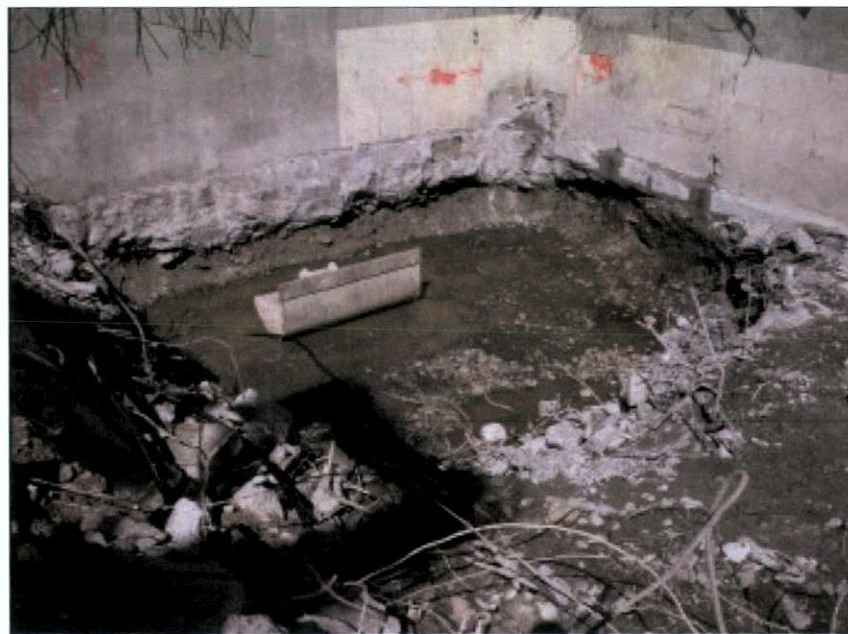
Figure 28 Site A: Trench location

This trench was excavated in the central area of the site on the southern side, orientated north-south (Fig. 28). It exposed concrete slab almost immediately and the excavation was halted. It measured 1.80m north-south by 0.80m in width by 0.20m in depth (Fig. 35).

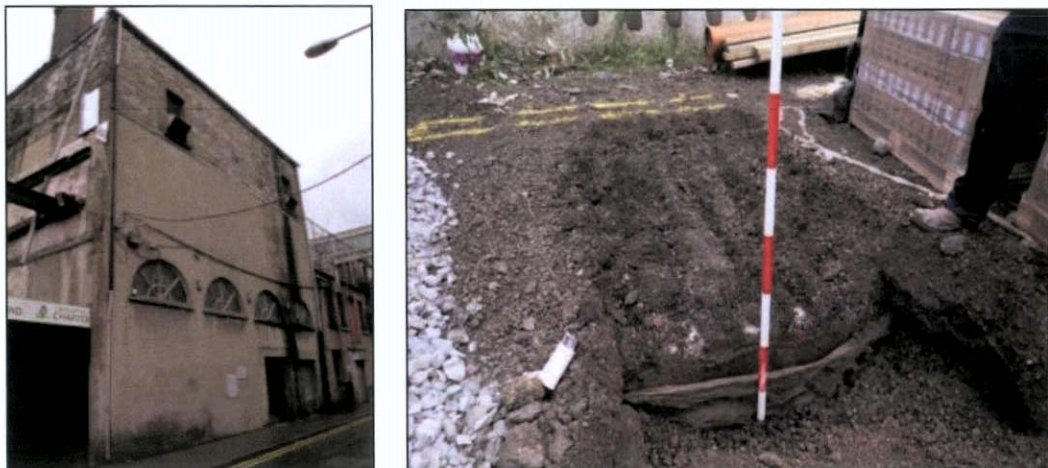
0.00m - 0.10m:	Stone and tarmacadam.
0.10m - 0.20m:	Black gravel.
0.20m - 0.40m:	Concrete.
0.40m - 0.60m:	Reinforced concrete.
Excavation halted.

An edge to the slab was identified on the western side of the trench, which was lined in sacking and was very modern in date, dating to 2009. There was light gravel on the western side, over slab.

Figure 34 The building on Moore Street
Figure 35 Trench 1, from the north: concrete slab

Trench 1 was located on the southern side of the site, close to the southern boundary wall and this also exposed the same slab found to extend across the site. This concrete slab is part of the floor of the original hotel, along with an additional concrete level laid in 2009.

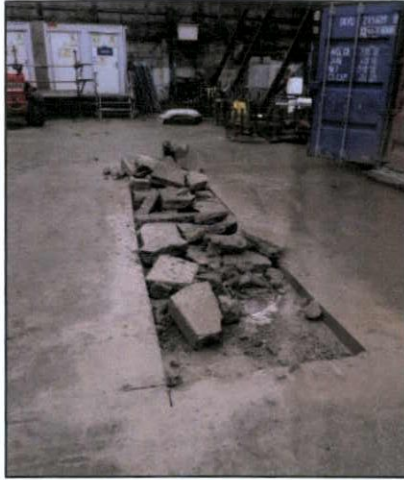
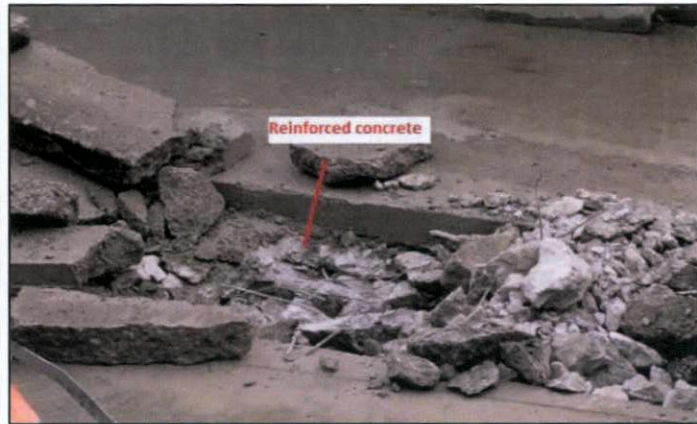
Figure 36 Trench 2, from the south
Figure 37 Trench 2 from the east

This trench was located centrally in the site, at the eastern end. It was orientated east-west and measures 6m north-south by 0.80m in width by 0.30m in depth (Figs 36-7).

0.00m - 0.15m:	Hard dark grey concrete with black and white aggregate.
0.15m - 0.35m:	Second layer of concrete.
0.35m:	Reinforced concrete.
Excavation halted..

The trench was halted immediately as the use of the rock-breaker on the reinforced concrete was causing significant vibrations, in close proximity to the Protected Structure, no. 42.

This trench revealed two layers of concrete, over a layer of reinforced concrete suggesting there was significant excavation and preparation of this site in 2009. This slab could not be removed.

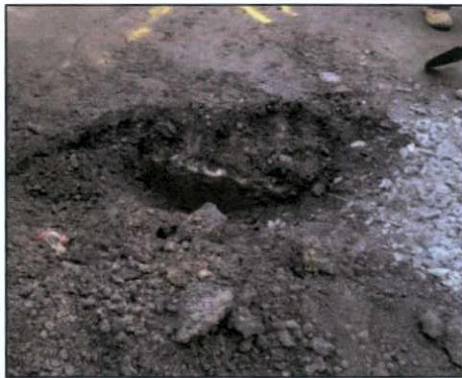
This trench was located in the central area orientated north-south but was not excavated, as preliminary investigations revealed a deep slab, as found elsewhere (Fig. 38).

Figure 38 Trench 3, from the south
Figure 39 Trench 4, from the west

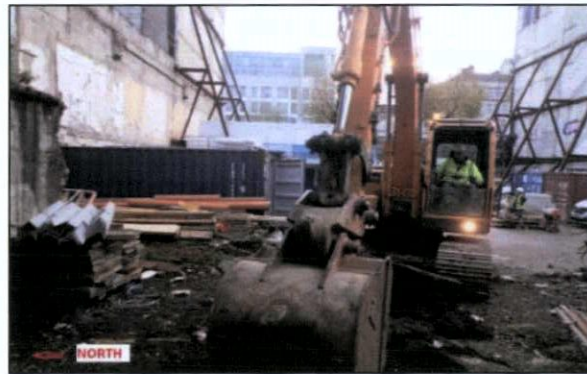
This trench was located in the north-west corner of the main part of the site and it was orientated north-east/south west, measuring 6m in length by 0.80m in width (Figs 39-42).

0.00m - 0.05m:	Tarmacadam.
0.05m - 0.90m:	Mixed organic cellar fill, brown in colour, with numerous modern brick and debris including electrical wires and concrete blocks. This deposit was deepest at the western end.
0.90m - 1.40m	Concrete slab/pad.
Excavation halted.

At the northern-western end of the site, at 0.90m below present ground level, a modern smooth slab was found beneath the brown organic infill deposit and an edge was found on the eastern side, which extended to at least 1.40m in depth: the base was not exposed. This can be identified as the temporary crane base, constructed in 2009, the exposed section measuring 3.58m east-west by 1.80m north-south. The base appears to have been inserted through the existing slab, which is likely to be part of the basement of the hotel, as a cut-line was identified on the eastern side of the pad, extending for 1.10m in width (east-west). The cut was filled with two deposits of mortar/gravel, the lower level of which was a dark grey gravel mortar. This was sealed by a loose deposit of light grey gravelly mortar mix, extending at least 1.40m in depth.

Figure 40 Trench 4, from the north-east
Figure 41 The organic deposits from the south

Trench 4 revealed deposits of organic clays containing modern artefacts, and this is typical cellar fill but is clearly out of context, mixed in with modern debris. It probably originated in the site somewhere, perhaps in the ramp area.

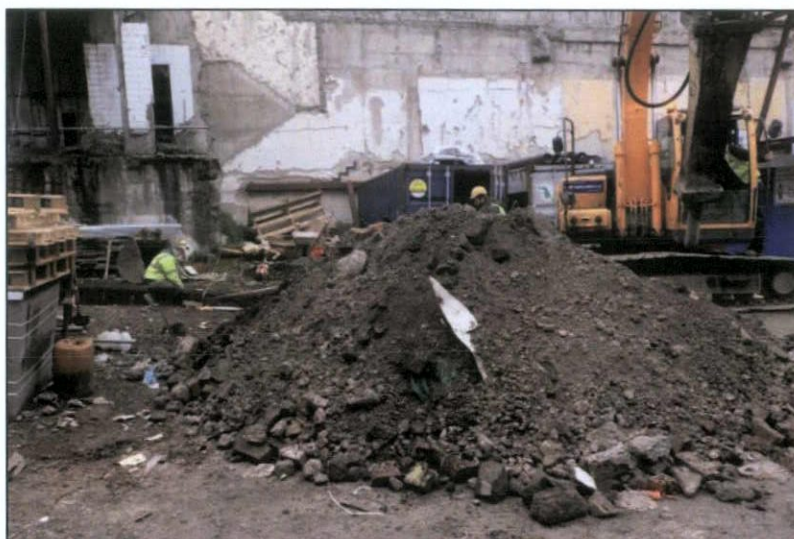
Figure 42 The infill from Trench 4

0.00m - 0.05m:	Tarmacadam.
0.05m - 0.20m:	Identical mixed brown organic cellar fill, with the remains of a small pit identified, measuring 0.15m square by 0.10m in depth. This was filled with similar brown organic clay mix.
0.20m:	Concrete slab.
Excavation halted.

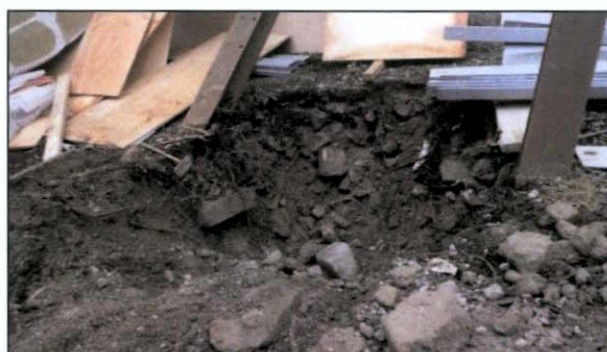
A fifth trench was attempted at the western end of the site, close to the southern wall and this measured 1.80m north-south by 2.20m east-west by 0.30m in depth (Figs 43 and 44). This exposed the concrete slab that was found elsewhere.

0.00m - 0.06m:	Tarmacadam.
0.06m - 0.30m:	Concrete blocks and light grey mortar and gravel.
0.30m +	Concrete slab with aggregate.
Excavation halted.

Figure 43 Trench 5, from the east

Figure 44 Trench 5, from the north

Trench 5 exposed the slab, as exposed elsewhere.

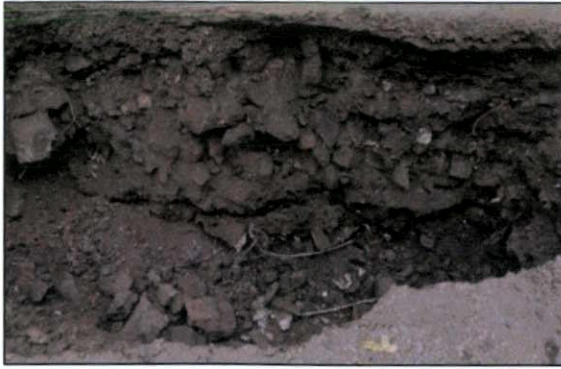
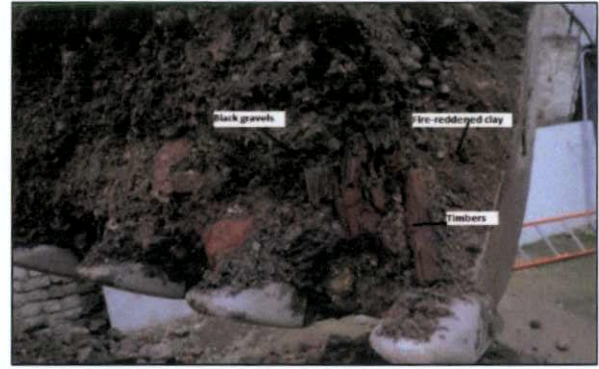
3.40m - 3.80m:	A deposit of black gravel with small chips of gravel, measuring 10mm in diameter. Three soft dark brown timber fragments were found set in the gravel, measuring 0.25m in length by 80m in width (Fig. 48). The gravel sat on mixed sticky yellow clays with faint traces of fire-reddening in the clays. The yellow clay contained charcoal and lime mortar fleck but also half brick, orange in colour with no additions. These deposits are likely to be related to the extensive brickfield in this area in the early 18 th century.

The trench exposed yellow clays at the base of the trench and close inspection identified areas of fire-reddening in the clay, the result of intense heat, most likely to have emanated from the brickworks, captured on Rocque's map of Dublin, dated 1756 (Figs 8 and 9). A section of the clay quarry has been found further east at nos 14-16 Moore Street (National Monument), and directly west at nos 58-66 Moore Street, where deep deposits of fire-reddened clay were found. In the site under discussion however, there are only faint traces of these clays surviving, with fragments of brick. These are sealed by deep infill of rubble, grey and brown clay.

Figure 47 Trench 1, north section, from the S

Figure 48 Fire-reddened clay and timbers

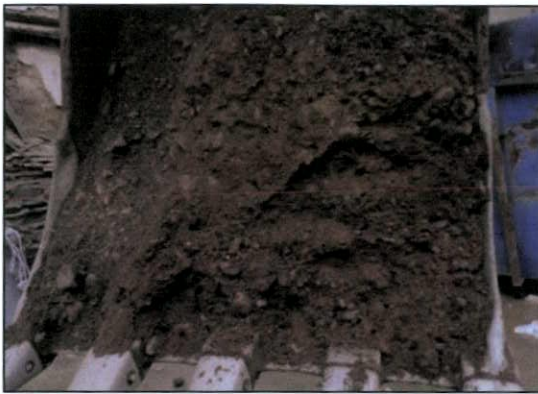
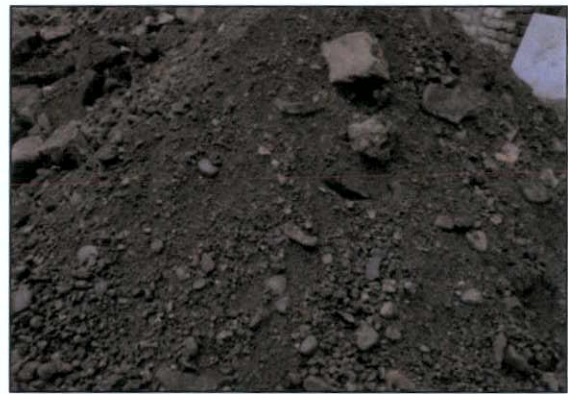
This trench was centrally located at the eastern end of the site, measuring 6m east-west by 1.40m in width by 4m in depth (Figs 43-47). This exposed modern infill down to 3.40m below present ground level. At this level there was slight evidence of burning and timbers, set into the clays, sitting over natural gravels (Figs 48-50).

Figure 49 Yellow/orange clays and gravels

Figure 50 Gravels at the base of Trench 1

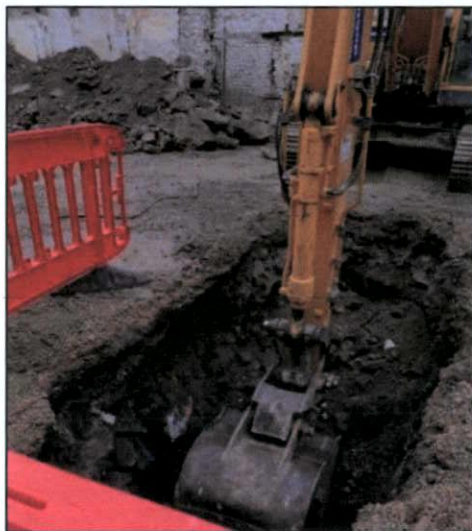
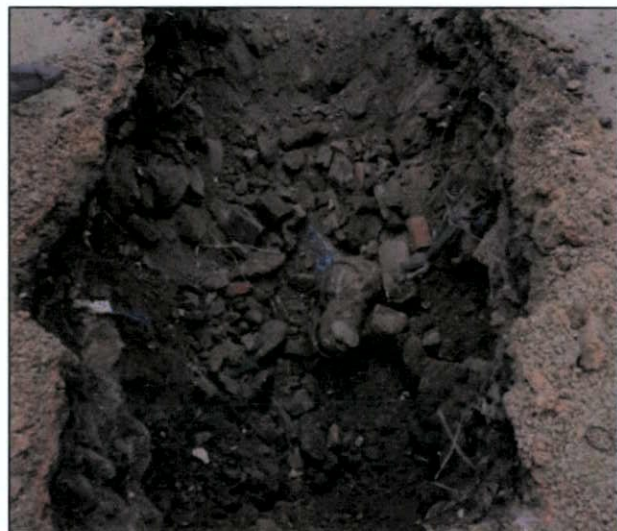
This trench was excavated after Trench 3 at the eastern end of the site. It was orientated north-south and measured 6m long by 0.80m north-south by 4m in depth (Figs 51-54). It was positioned across the projected line of the wall/structure found in Trench 3 (see below), which was orientated east-west. However, the continuation of this wall foundation was not found further east in Trench 3 (see below).

0.00m - 0.10m:	Tarmacadam.
0.10m - 0.15m:	804 stone.
0.15m - 2.80m:	Rubble infill similar to Trench 3, with bricks, grey clay, wires and blue tiles found in Trench 3. This infill included concrete blocks.
2.80m - 3.80m:	Mixed light green/grey clay with charcoal and brick fleck, and small rounded pebbles, 2mm in diameter.
3.80m - 4m:	Yellow clay with small cobbles and no inclusions.
4m:	Pure fine gravels with no inclusions.

Figure 51 Trench 2 from the south

Figure 52 Trench 2 from the south: infill deposits

This trench was designed to establish whether or not the wall structure found in Trench 3 to the west extended eastwards. However, no trace of the wall was found. In addition to this, the trench did not expose any walls foundations, floor or structures that could be associated with the standing walls. The infill deposits were similar to those found in the other two trenches with natural deposits at approximately 4m below present ground level.
