## APPENDIX 16.1

## SUMMARY OF NATIONAL MONUMENTS LEGISLATION

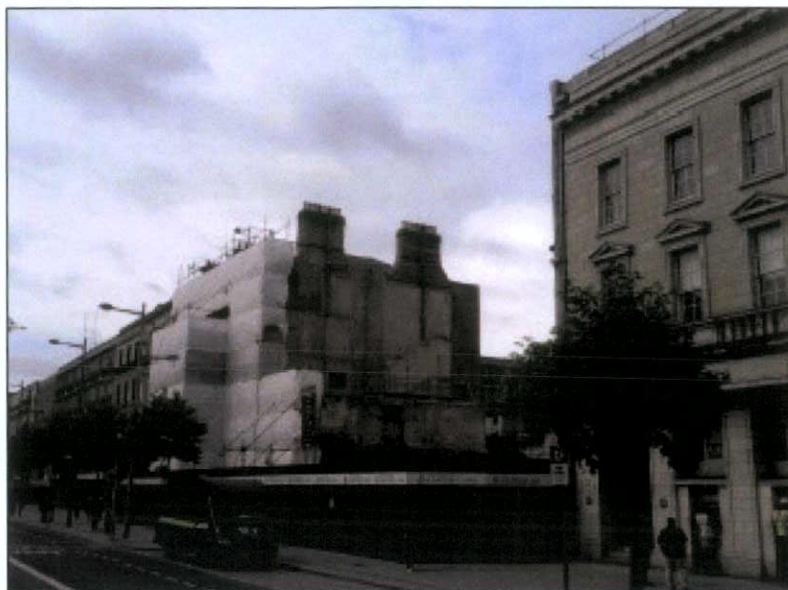
Figure 20 The Royal Dublin Hotel from the north pre demolition

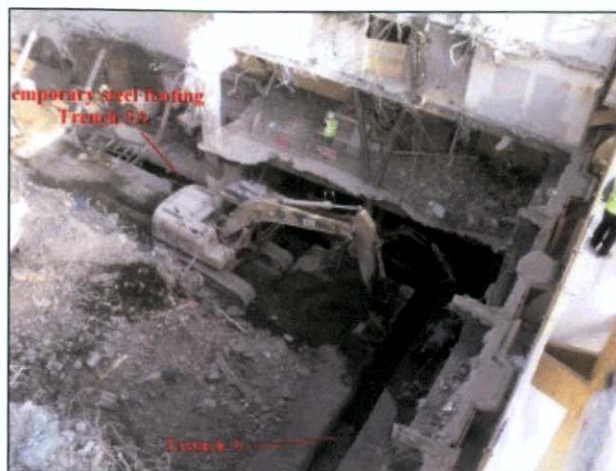
Figure 22 Trenches in 2009

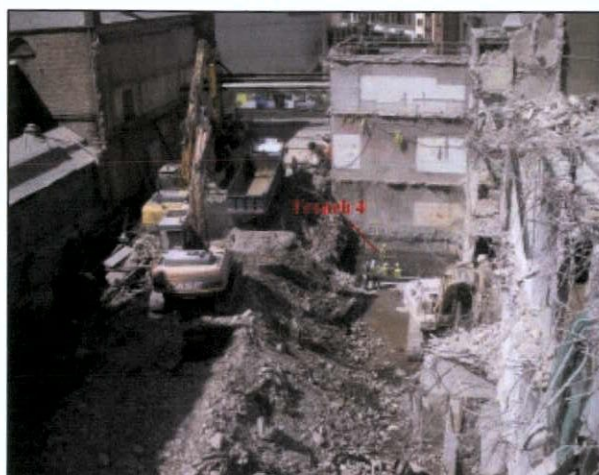
The monitoring programme established that the original concrete floor of the basement of the hotel was very substantial and still in position, made of reinforced concrete and measuring over 1m in depth (Figs 24-26). This basement was cut into deep gravel and silt deposits, presumably originally riverine deposits associated with the River Liffey, before it was reclaimed between 1678 and 1728. The gravels were carefully examined but no archaeological features or artefacts found. In April 2009, three (nos 1-3) additional engineering test-trenches were excavated in the basement area of no. 40 and this was followed in May, after the complete demolition of the hotel (nos 40-41), by the casting of a temporary crane base (no. 4) (Fig. 27). In early June, the remaining trenches (nos 5-9) were excavated, with most of the excavation works taking place in the eastern half of the site close to the O'Connell street frontage. The basement floor slab was located at approximately 3m below (2.40m O.D) below present road level of O'Connell Street (5.40m O.D.).

Figure 23 Overview of steel footing trench

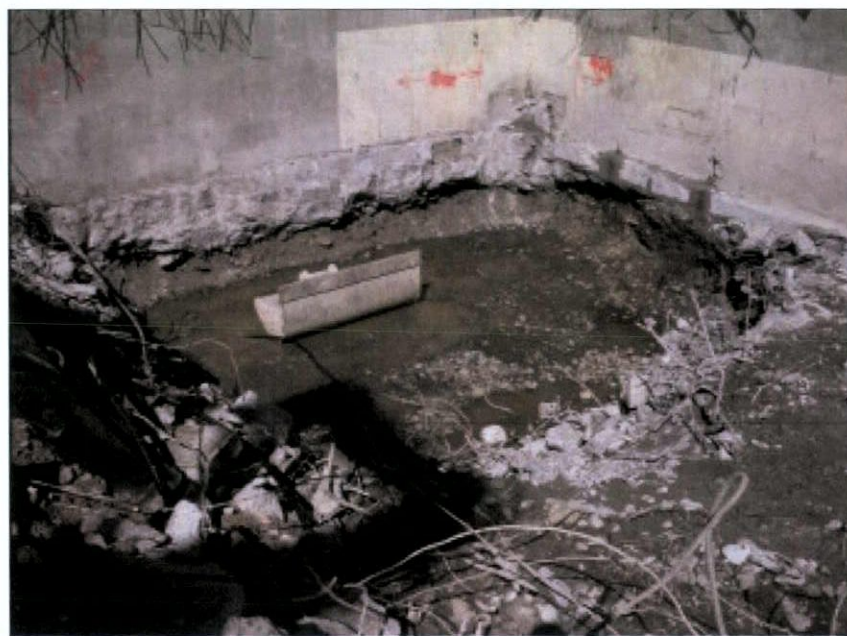
Figure 26 The section through Trench B

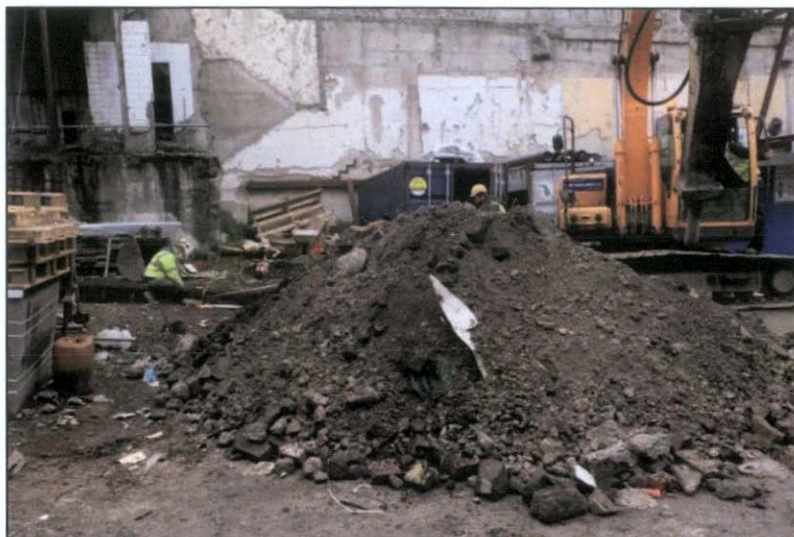
Figure 42 The infill from Trench 4

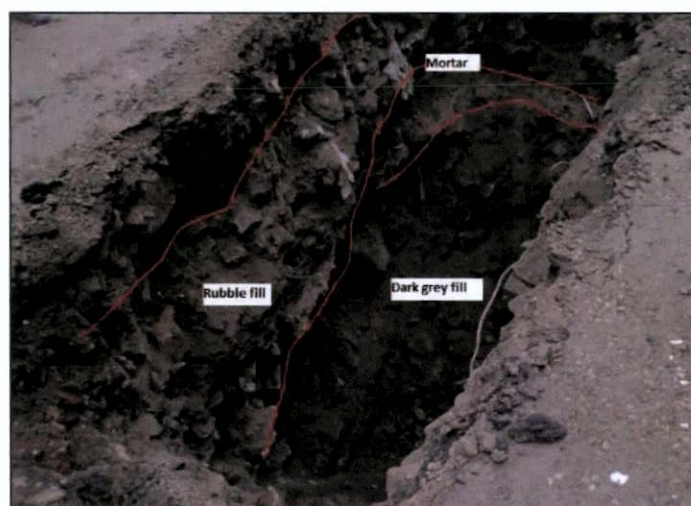
This trench was centrally located at the eastern end of the site, measuring 6m east-west by 1.40m in width by 4m in depth (Figs 43-47). This exposed modern infill down to 3.40m below present ground level. At this level there was slight evidence of burning and timbers, set into the clays, sitting over natural gravels (Figs 48-50).

Figure 46 Trench 1 from the north east

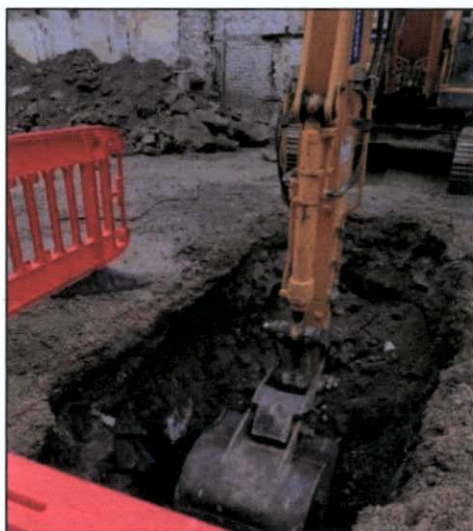
This trench was excavated after Trench 3 at the eastern end of the site. It was orientated north-south and measured 6m long by 0.80m north-south by 4m in depth (Figs 51-54). It was positioned across the projected line of the wall/structure found in Trench 3 (see below), which was orientated east-west. However, the continuation of this wall foundation was not found further east in Trench 3 (see below).

Figure 51 Trench 2 from the south

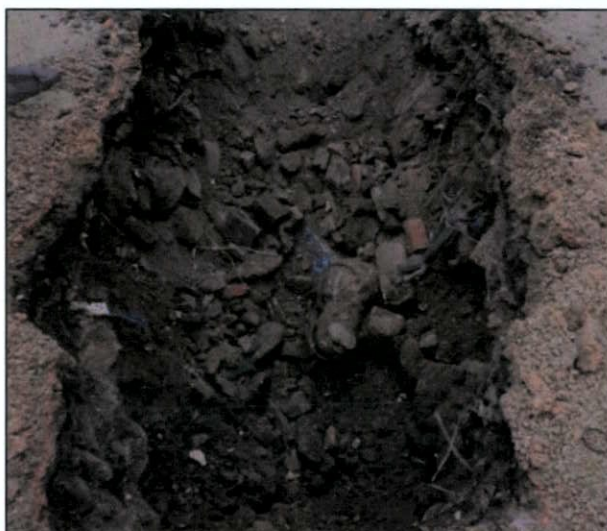
| 0.15m - 2.80m: | Rubble infill similar to Trench 3, with bricks, grey clay, wires and blue tiles found in Trench 3. This infill included concrete blocks. |

Figure 52 Trench 2 from the south: infill deposits

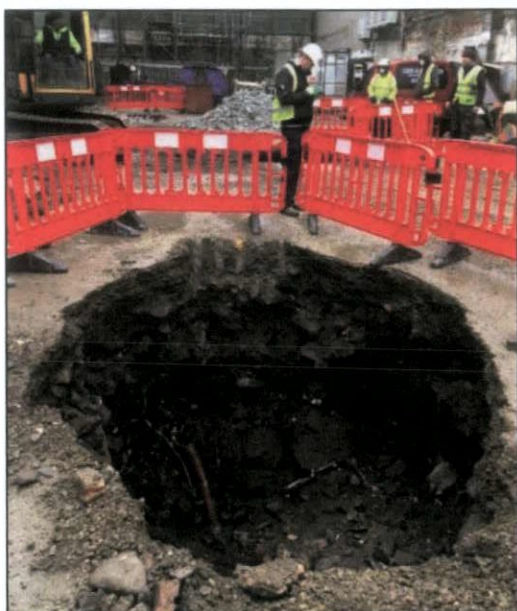
Figure 53 The expanding trench

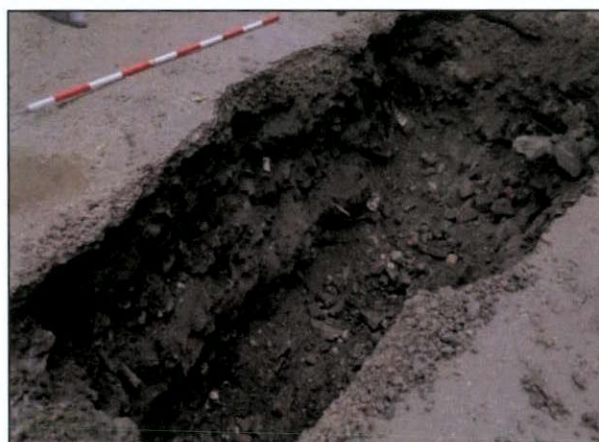
This trench measured 6m east-west by 0.80m in width by 4m in depth, located in the western side of the site, in area thought to contain a cellar (Figs 55-60). The trench located deep infill deposits, sealing a substantial limestone build, orientated north-south, which was at least 1m in width. This appears to be a wall foundation, perhaps of the basement recorded in 1893.

Figure 55 Trench 3, from the east

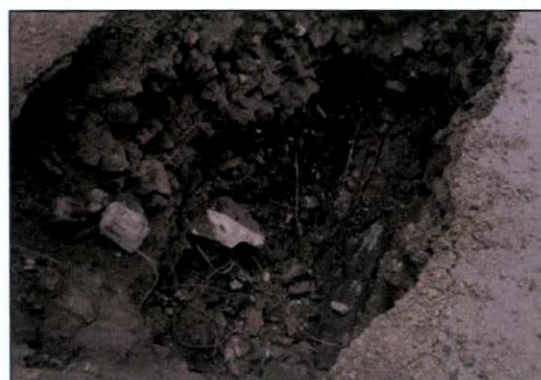
Figure 57 The floor abutting the wall foundation

- 8.7. A cellar is recorded at the western end of the plot on the Goad's Insurance map of 1893 and a possible foundation was identified, which may have been associated with this structure. This wall was found in the central area of the site and orientated north-south, was comprehensively demolished, the top of the wall lying at 2.70m below present ground. The remains of a blackened (concrete?) floor abutting the wall was possibly that of the cellar although this was not certain. The trenches were carefully positioned to try and trace any walls that could be associated with the historic standing walls. However, no other features were found.

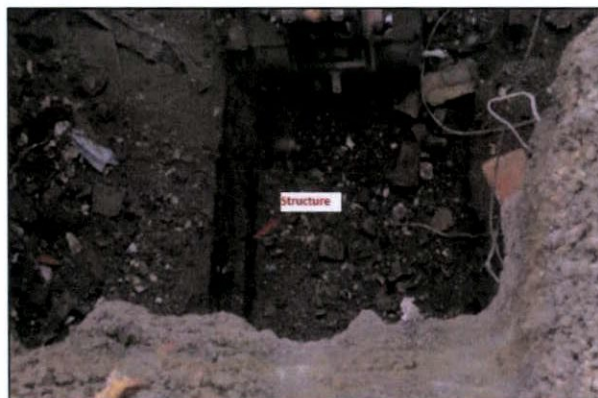
Figure 58 Foundation from the east

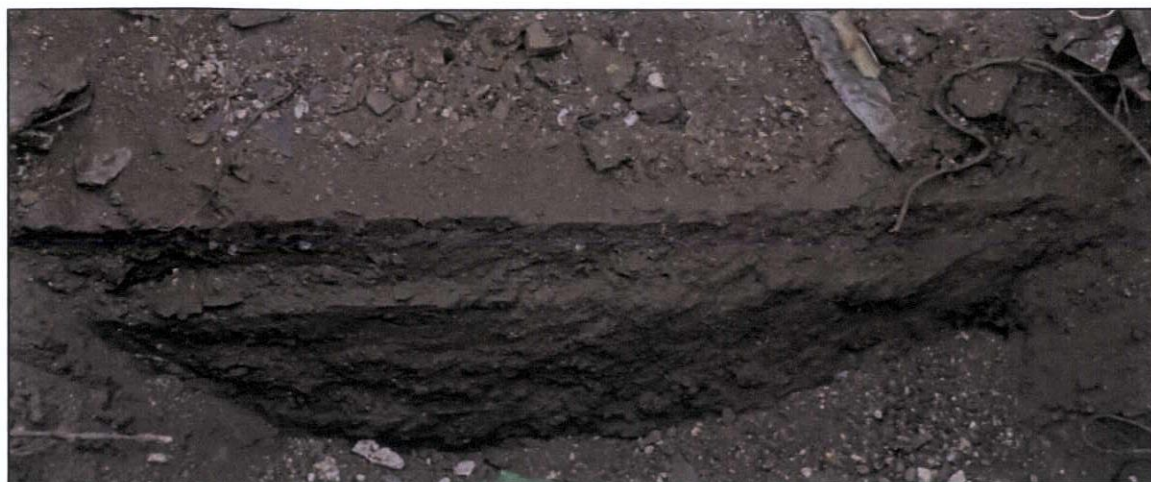
Figure 59 The northern face: note modern debris

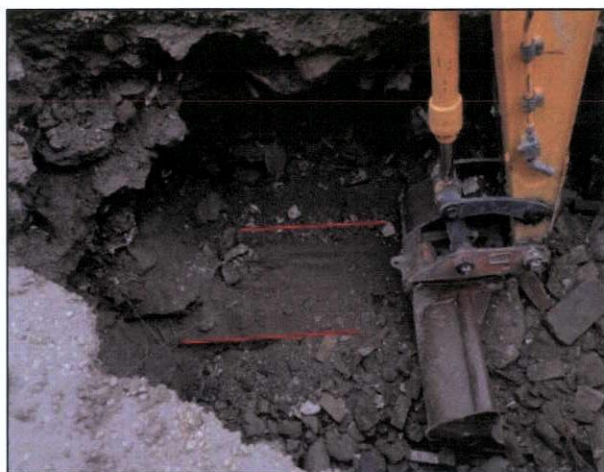
Figure 60 The structure from the north

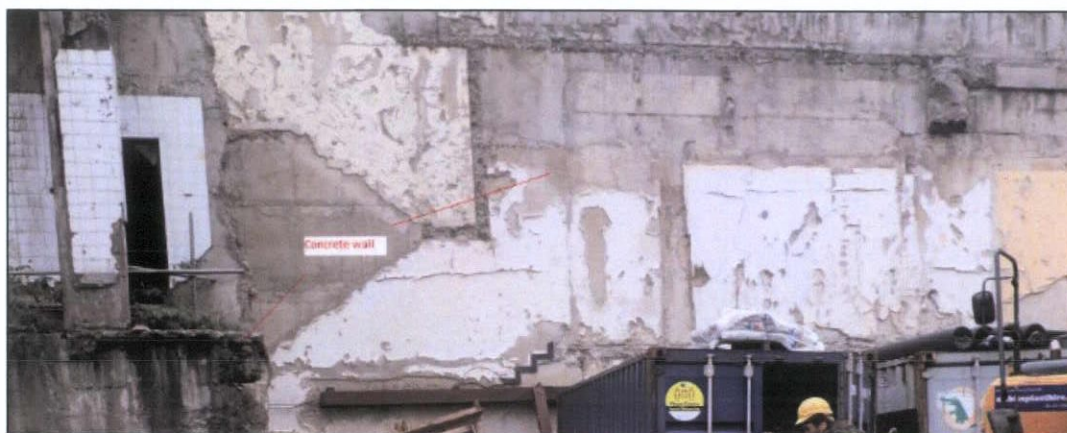
Figure 63 The north wall

- 9.7. Site B, as mentioned above, preserves the remains of the historic northern and southern boundary walls and full recording of both the north and south walls is likely to be a requirement. This requirement is likely to include scaled survey and description, as per best practice. It is highly likely other significant buildings and boundary walls survive on other parts of the site and the recording process of the above-ground historic remains and the buried foundations of these buildings be an integrated approach. Conservation architects Molloy Associates are carrying out a detailed record and architectural assessment as part of an assessment and conservation plan of all the structures within the proposed development.

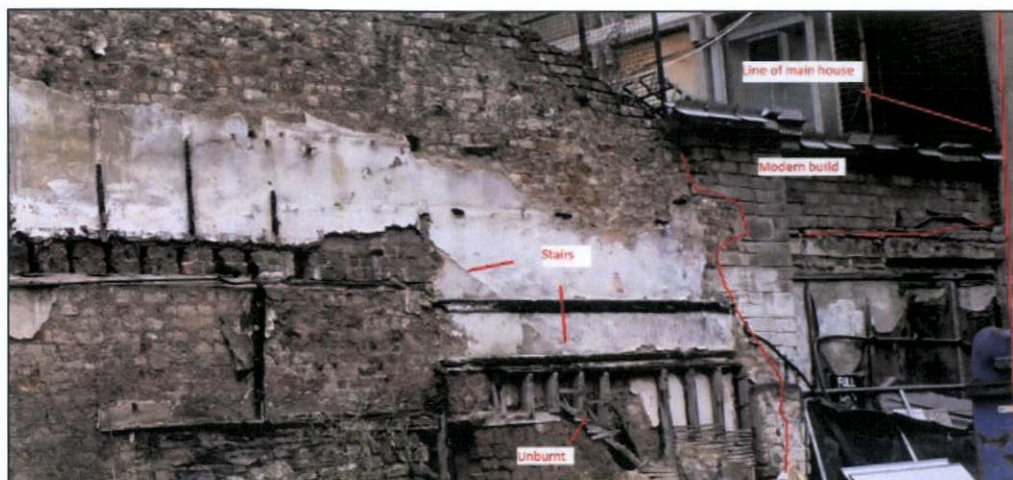
The brick and plaster preserve what is likely to be a stairway, preserved as a diagonal scar in the plaster (Figs 87 - 89). This stair runs from east to west and provides access to a first floor on the eastern side, which runs the length of the building (see below). The diagonal line of the stairs is marked by timber laths, which do not appear to have been burnt with a diagonal plaster line above this. The stair was constructed against an existing boundary wall, as mentioned above, which was composed of limestone and brick. This is confirmed by the fact Ope 5 had already been infilled in brick before the stairwell was constructed, as the vertical timber, which obscured the ope, was part of the stairwell structure.

Figure 88 The stairs at the eastern end
