Intended for  
**Vantage Data Centers DUB11 Limited**

Project Number  
**1620012232-003**

# **KILCARBERY SUBSTATION AND TRANSMISSION LINES**

## **VOLUME 3: TECHNICAL APPENDICIES**

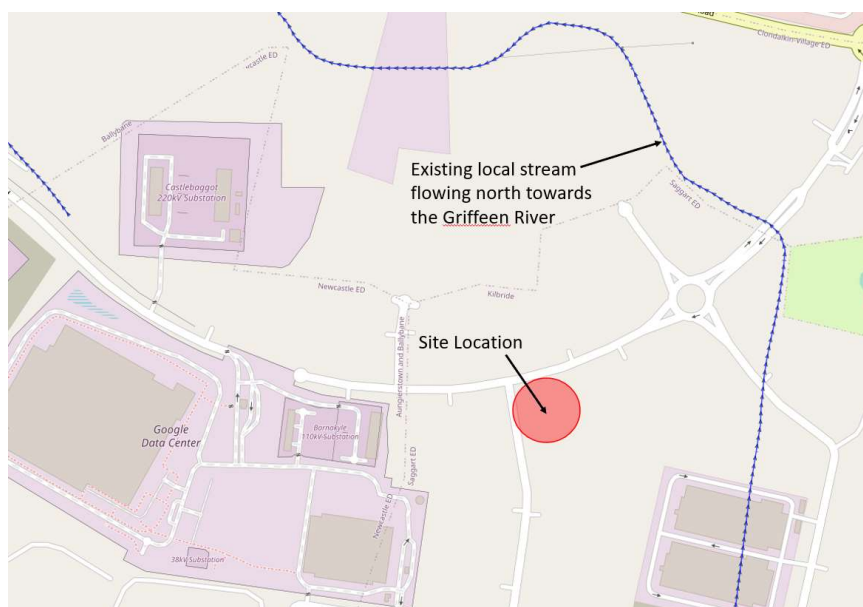
**Figure 6: Extract from GeoHive Mapping indicating location of stream adjacent to site**

Information Source	Remarks
1	Information on watercourse and streams in the study area such as those available from OS Maps, EPA and GeoHive	An extract from EPA map viewer <a href="https://gis.epa.ie/EPAMaps/">https://gis.epa.ie/EPAMaps/</a> ; with active <i>stream</i> and <i>flow direction</i> layers in Figure 6 shows the presence of a stream to the east of the site, running north toward the Griffeen River.
2	Predictive fluvial, coastal, pluvial and groundwater flood maps available on CFRAMS mapping obtained for the site from <a href="https://www.floodinfo.ie/map/floodmaps/">https://www.floodinfo.ie/map/floodmaps/</a>	The site lies in Flood Zone C with 3% of the site having a 0.1% probability of flooding.
	SI ground water levels – See Appendix A.	Trial pits were free of water, with the only seepage occurring at 2.30m.
