Appendix 8.1

Additional Hydrogeological Figures

206955-22/12/2020-EIAR Volume 3 Appendices Part 6
(Appendices 8.1 to 11.1 and 14.1 to 14.6)

EIAR - Gouldings Development

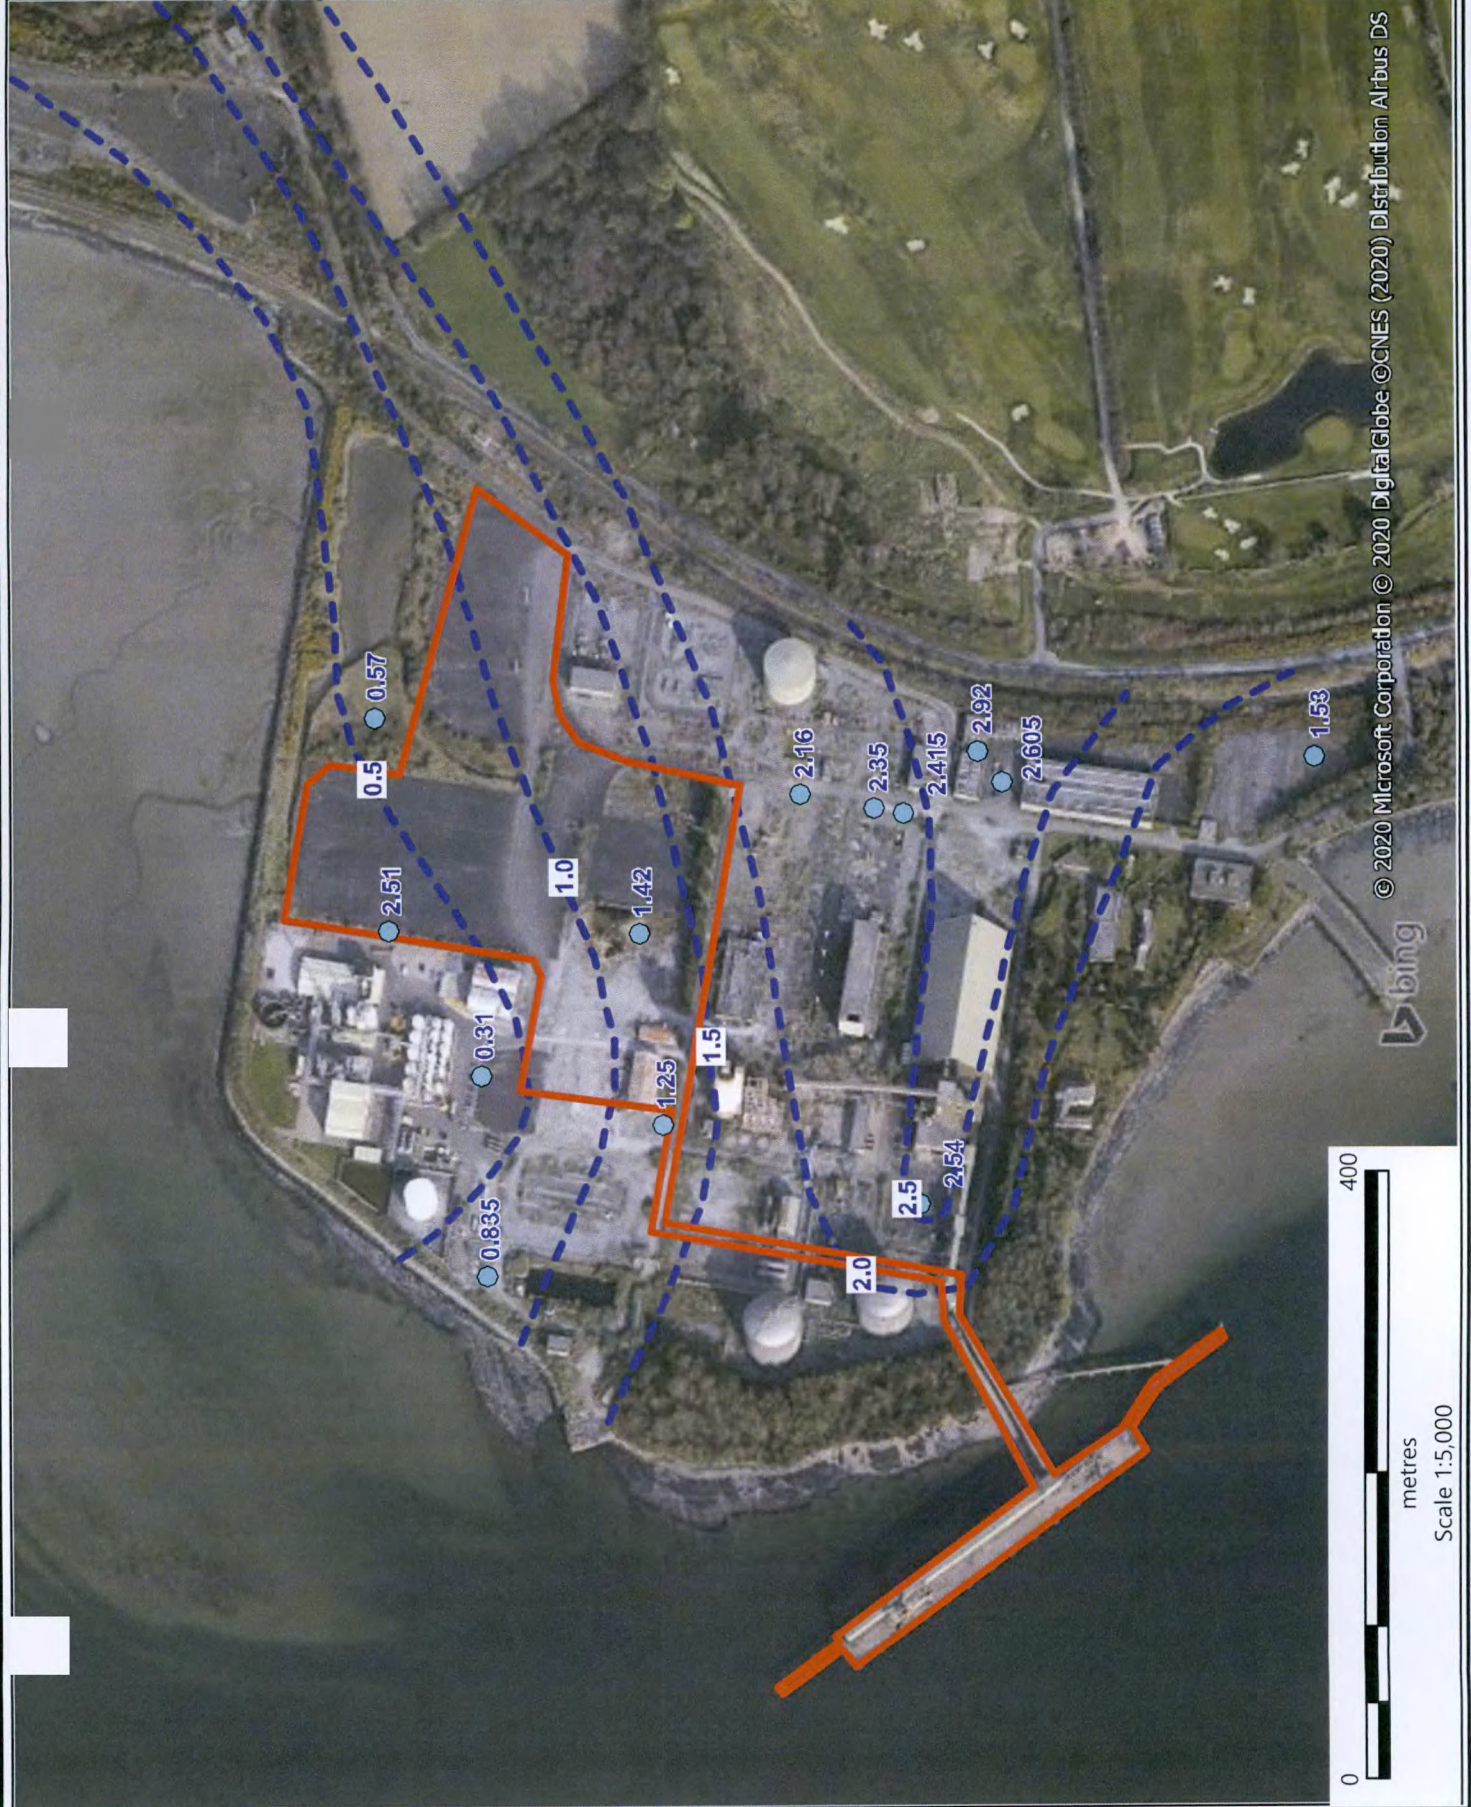
Figure A.8.1

Groundwater Flow
3 July 2019 (Low Tide)

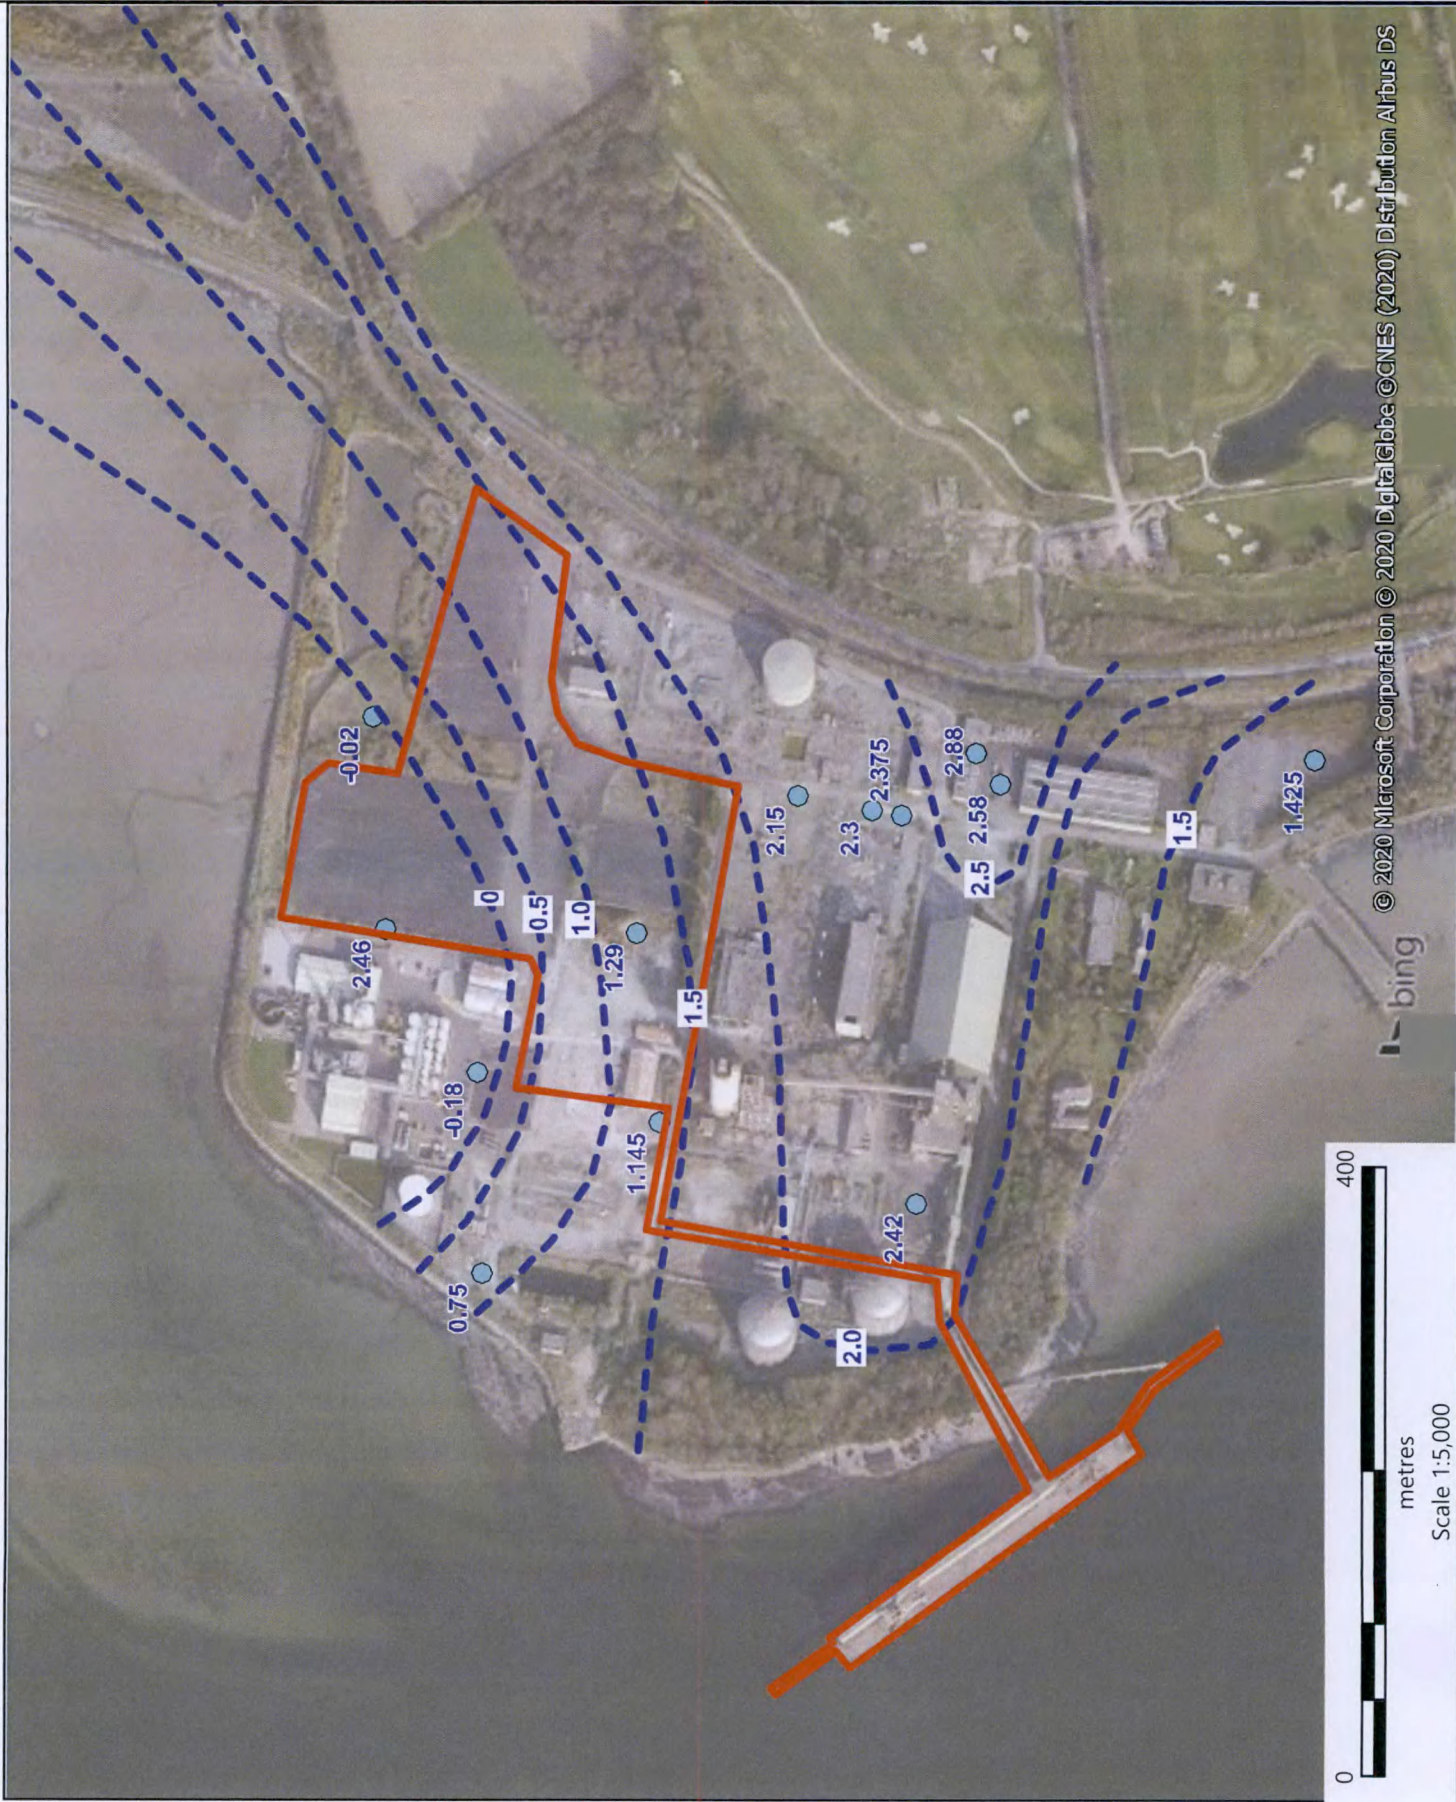
Figure A 8.2

Groundwater Flow
28 May 2019 (Mid Tide)

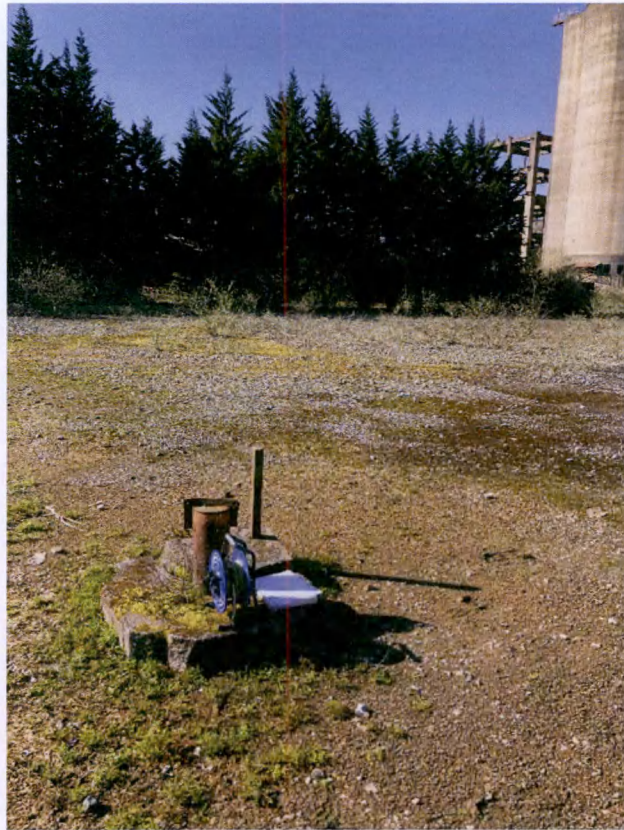
Monitoring Well 95-6

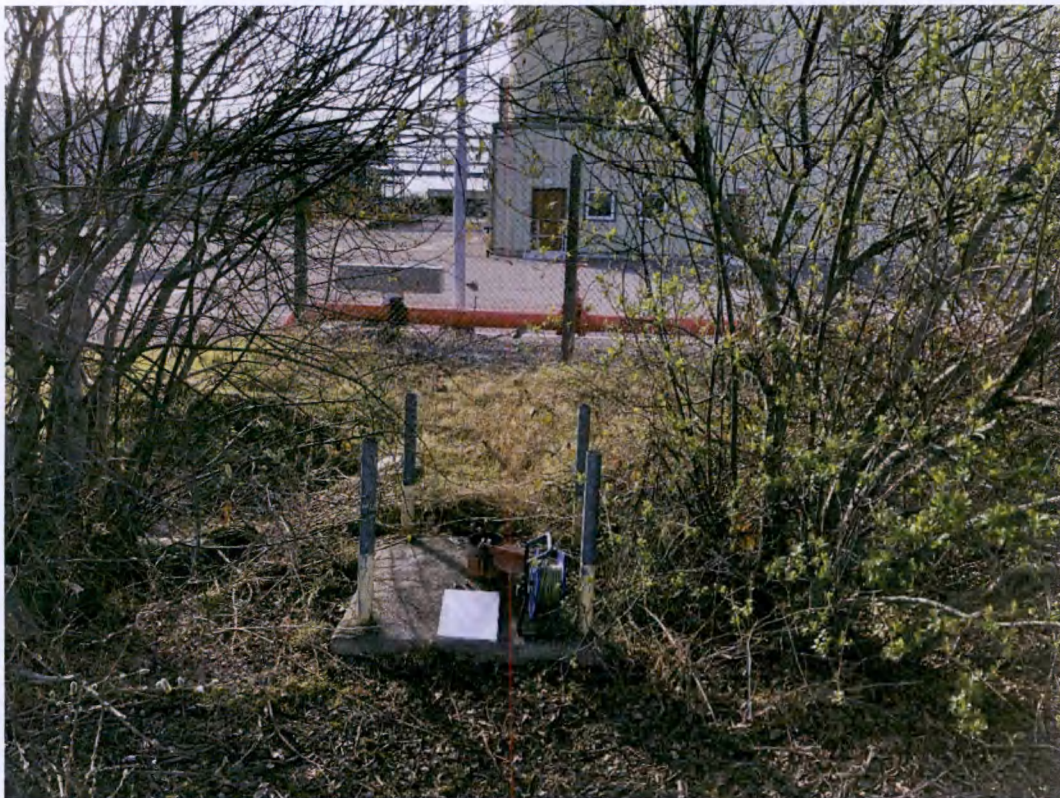
Monitoring Well 95-9

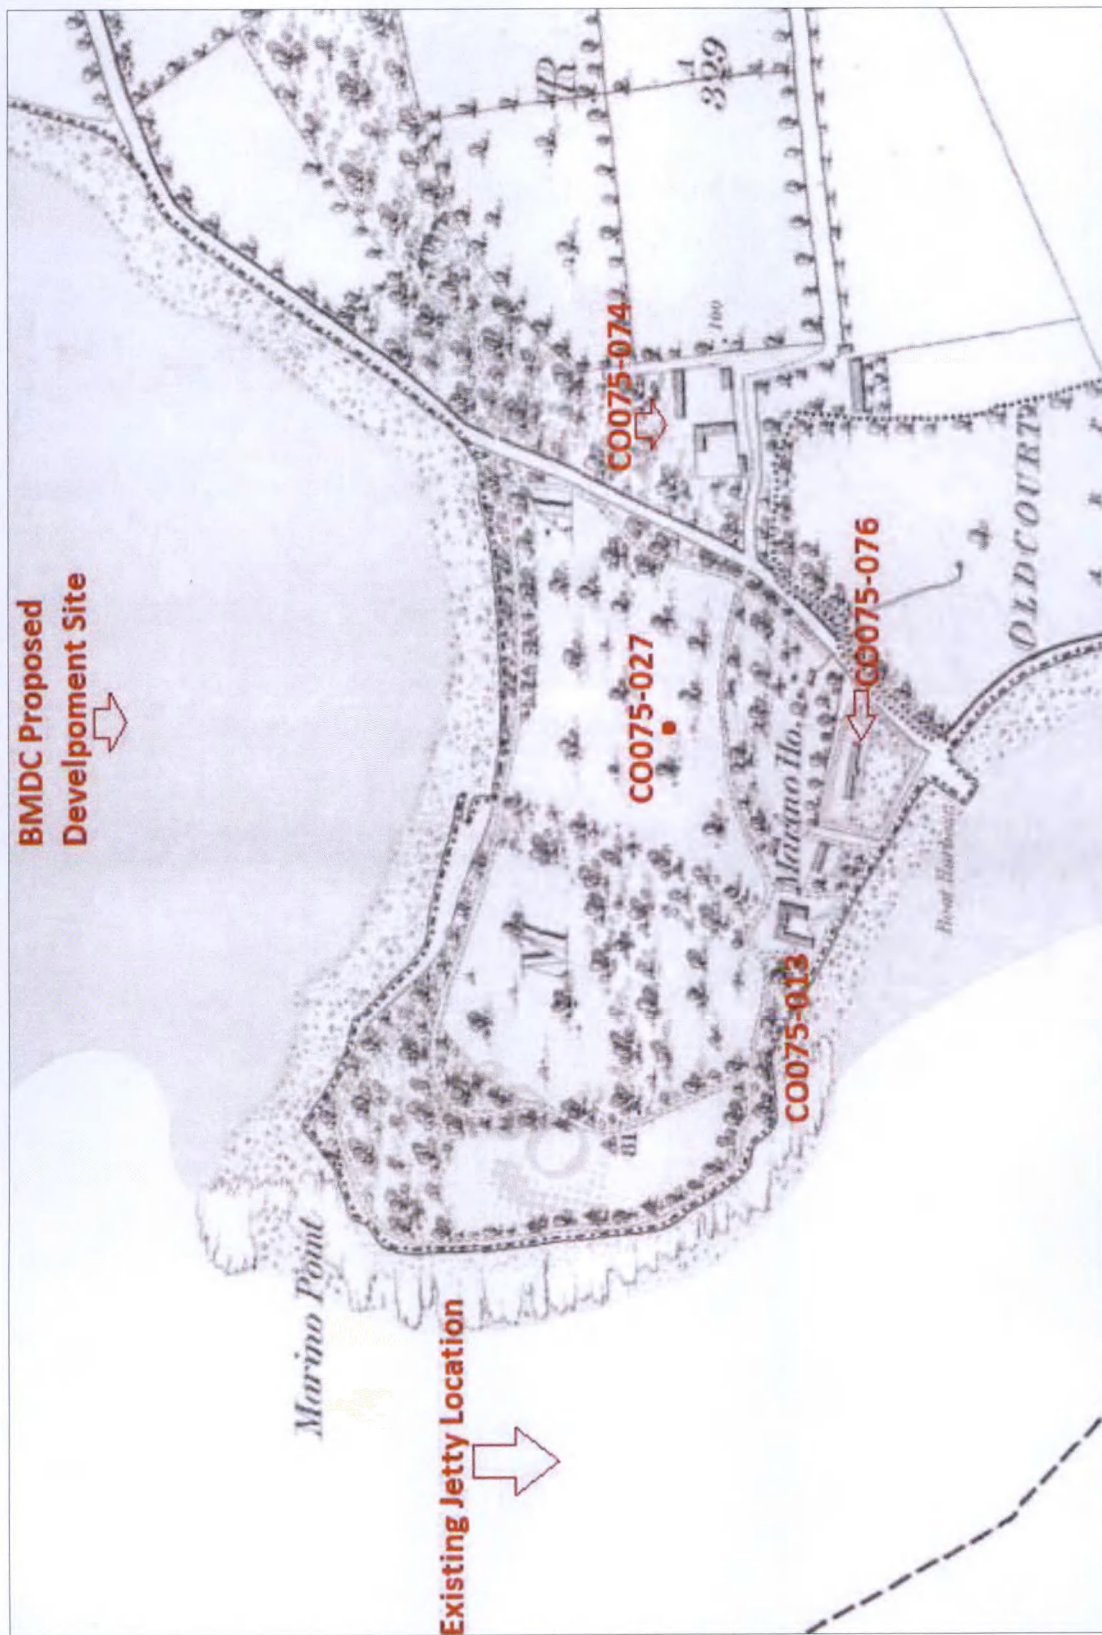
Figure 10.4: OS 6-inch map (1841-42) with location of proposed development site arrowed prior to reclamation to the north of demesne lands associated with Marino House shaded in grey www.geohivemapviewer.ie

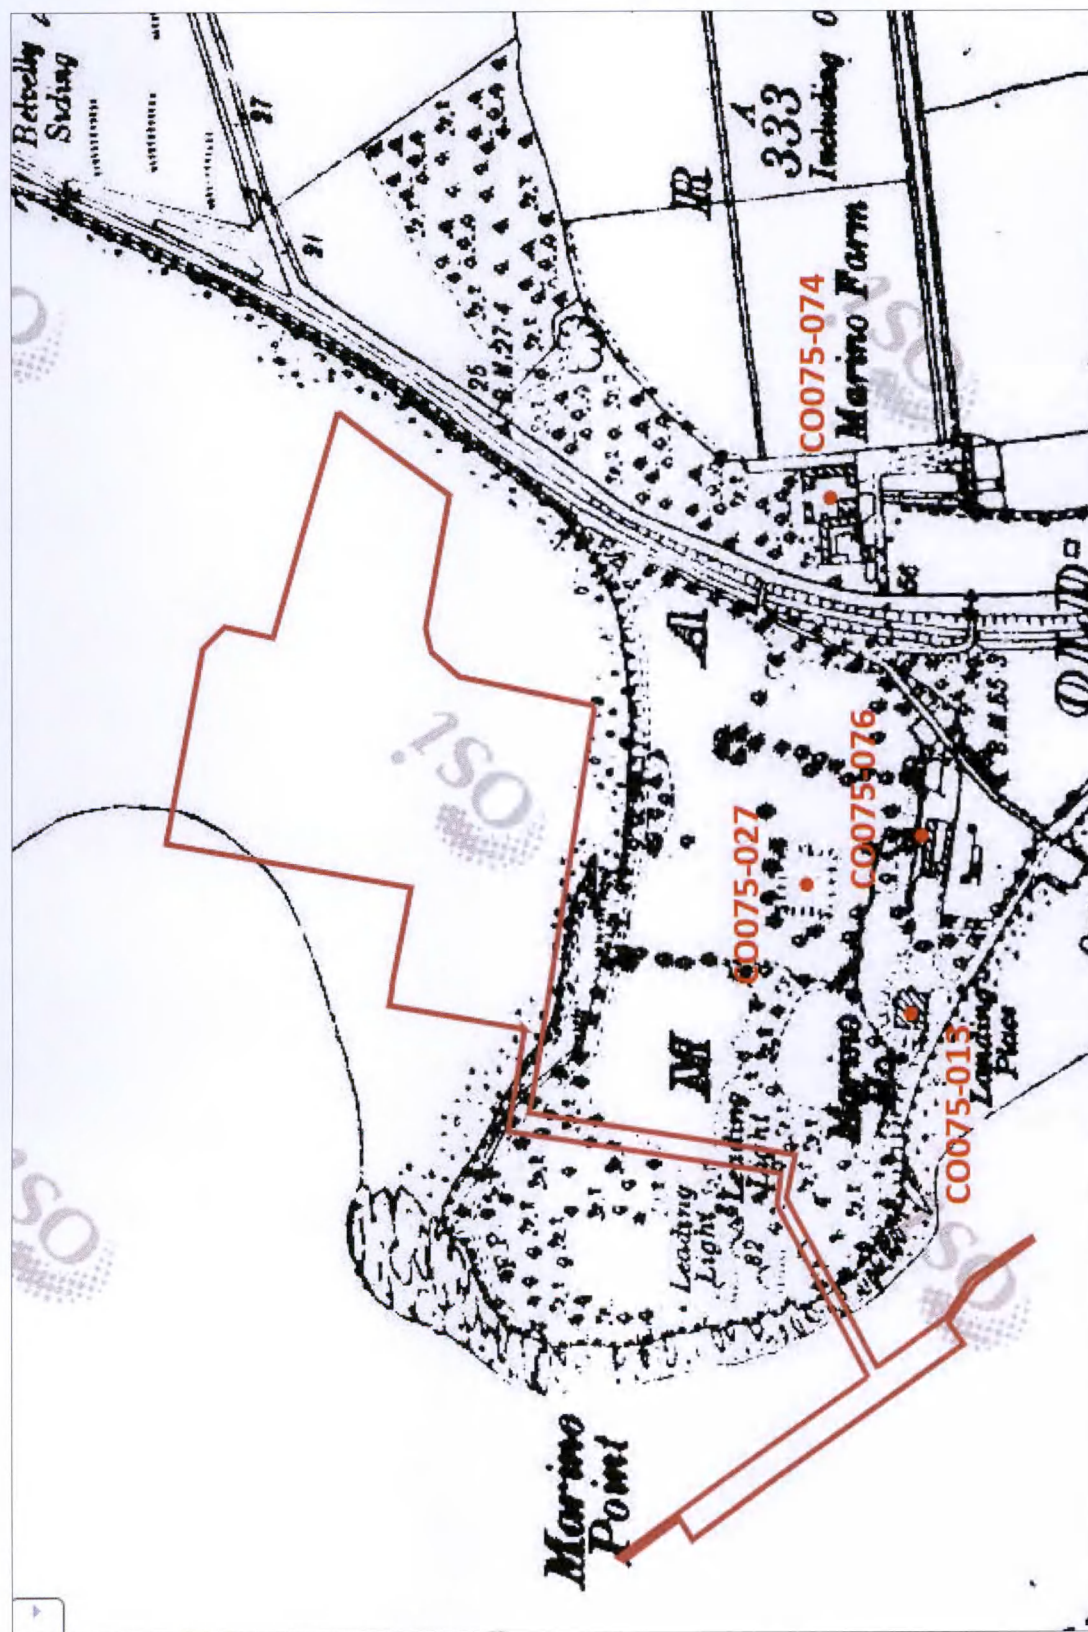
Figure 10.6: OS 6-inch map (1935) depicting the proposed development site outlined in red prior to reclamation, to the north of Marino Peninsula and demesne lands associated with Marino House (CO075-013) www.archaeology.ie
