Title: **STAGE 1 ROAD SAFETY AUDIT**

**Proposed Residential Development, Greenhills Road,  
Walkinstown, Dublin 12.**

Report reference: **1353R01**

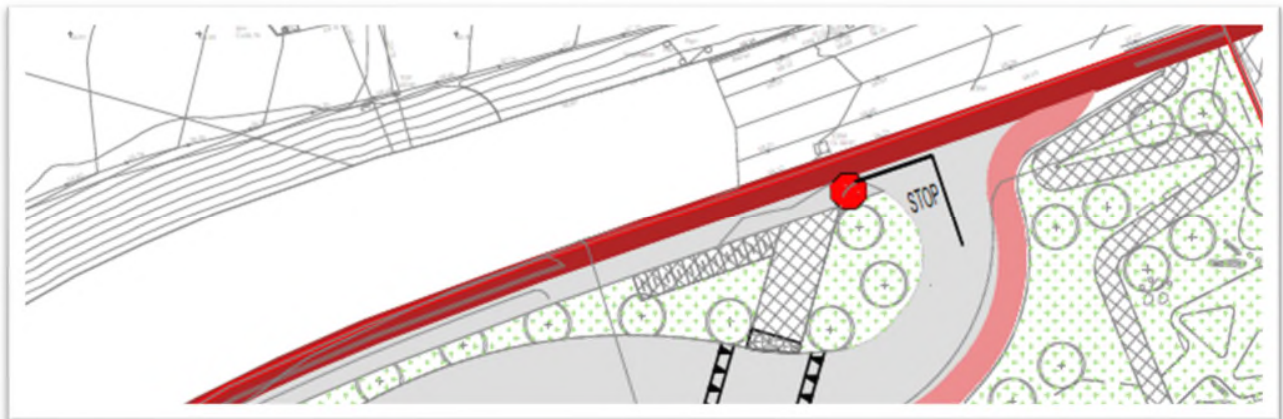
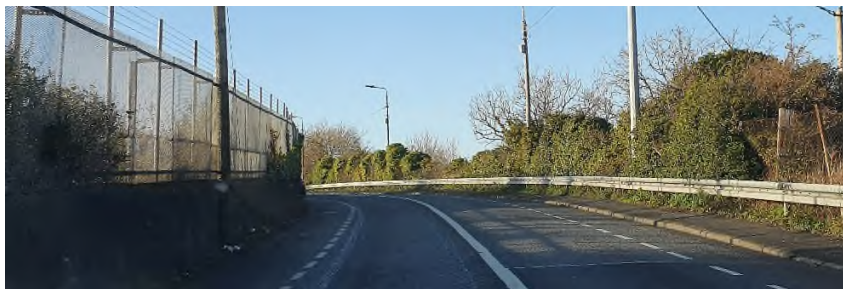
Drawing 20189-LDE-07-00-DR-SC-1C03 Rev P, Vehicular access onto Greenhills Road.

There is a vertical crest curve on Greenhills Road to the west of the proposed access. There is a risk that this may obscure visibility of drivers exiting the development to oncoming eastbound vehicles on Greenhills Road resulting in side-impact or rear-end collisions.

It is recommended that the visibility be checked in the vertical plane to ensure sufficient visibility is available.

3.1	Yes	Yes - We have checked (in accordance with the requirements outlined in DMURS) and provided visibility splays drawing for the entrance/exit junction into the development. It was determined that drivers have sufficient visibility when exiting the development. Furthermore, the existing high fence along the northern frontage of the development obscuring the view of upcoming traffic travelling southbound will be demolished and replaced with a lower, more user friendly from a visibility point of view vehicle restraint system.		Yes

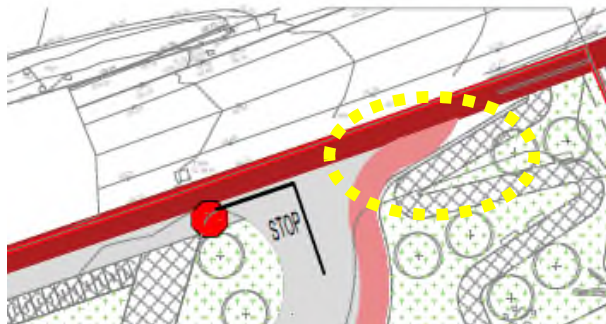
Drawing 20189-LDE-07-00-DR-SC-1C03 Rev P, Cycle Lane at Greenhills Road.

Cyclists exiting the development and wishing to travel towards the Walkinstown Roundabout may have difficulty crossing Greenhills Road to access the advisory cycle lane given the high traffic volumes. This may result in cyclists travelling on the footpath or contra-flow on the outbound cycle lane where there would be an increased risk of collisions with pedestrians or other cyclists.

It is recommended that crossing facilities for cyclists (and pedestrians) be provided on Greenhills Road.

3.3	Yes.	Yes. – A vehicle dwell area of 2.4m in length has been provided with a fall of 1/25 (i.e. 2.29 degrees).		Yes
3.4	Yes.	Yes. – An uncontrolled 4.0m wide pedestrian/cyclist crossing		Yes

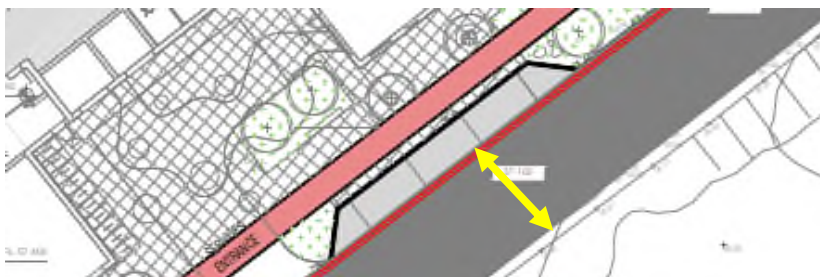
Drawing 20189-LDE-07-00-DR-SC-1C03 Rev P, Road to the south of the site.

The industrial road at the south of the site is relatively narrow and has a high usage by heavy goods vehicles. There is a risk that vehicles will not be able to pass especially when cars are parked in the parallel parking spaces. This could lead to side-swipe collisions.

It is recommended that a swept path analysis be carried out to ensure that heavy goods vehicles can pass each other and turn at industrial accesses along the back lane.

has been introduced west off the main entrance/exit access point to the development.		
3.5	No.	No.	Existing southern access road will have an average width of 6.5m across the full extent of our site upon completion of the development. In accordance to DMURS a 6.5m road width is suitable and has sufficient space for heavy goods vehicles to simultaneously use the road. It's important to note that the existing footpath (on side facing our site in question) of the existing southern access road will be omitted and instead used as road space upon completion of the development.	Yes

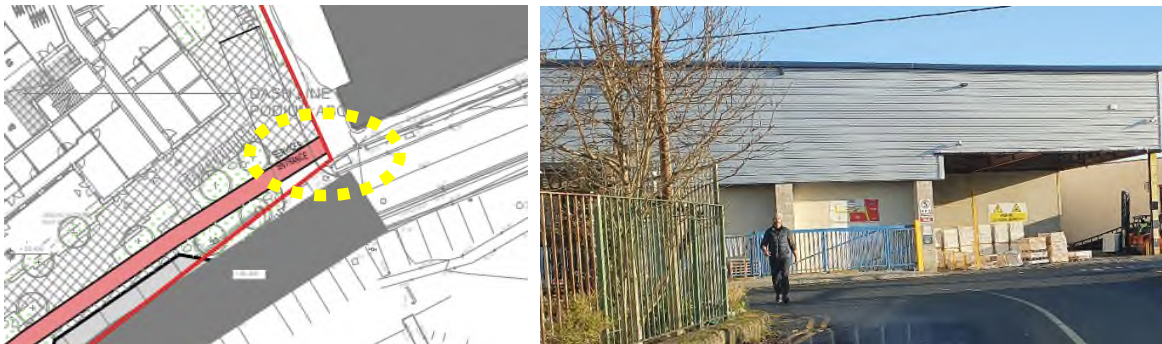
Drawing 20189-LDE-07-00-DR-SC-1C03 Rev P, Road to the south of the site.

It is proposed to provide a cycle track parallel to the back lane. This cycle route terminates at the site boundary without connectivity to the internal cycle network. There is a sharp 90 degree bend on the back lane that has limited visibility to/from cyclists. There is a risk that the proposed parallel cycle track may lead to greater cyclist numbers at this severe bend and therefore greater risk of collisions with commercial/industrial turning traffic.

It is recommended that the cycle track be omitted or connected to the internal cycle network.

3.6	No.	No.	It has been specifically requested by SDCC that we have both a footpath and a cycle lane along the northern & southern frontages of the development. Cyclists traveling on the southern cycle track can exit the development via the internal cycle track traversing the site and out the primary exit/entrance point located north-east of the development.	Yes
