Appendix A

Appendix B

JV TIERNEY & CO

MECHANICAL ELECTRICAL & SUSTAINABLE ENGINEERS

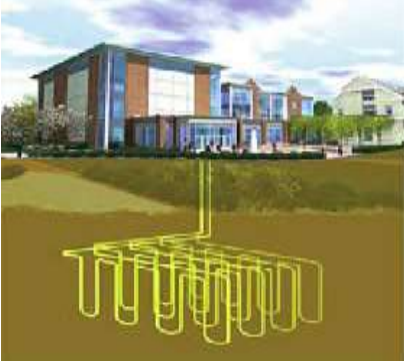
Table 3: GSHP Feasibility

√			GSHP technology uses seasonal differences between ground and air temperatures to provide heating in winter and cooling in summer. GSHP provide low temperature heating and high temperature cooling suitable for underfloor heating or chilled beams. Site restrictions would be a consideration with vertical boreholes been most practical but also more capital intensive. Impact on the Primary Energy factor can be significant with Heat Pumps but additional capital and area required is a constraint.

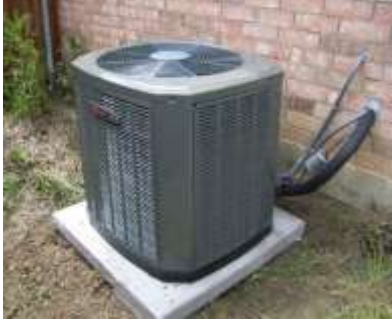
Table 4: ASHP Feasibility

√			ASHP technology uses seasonal differences between external air temperatures and refrigerant temperatures to provide heating in winter and cooling in summer. As most of the energy is taken from the air they produce less greenhouse gas than a conventional heating system over the heating season. Most efficient when used as a pre-heat mechanism as the COP remains high and therefore has a major impact on the RER % and NZEB criteria.

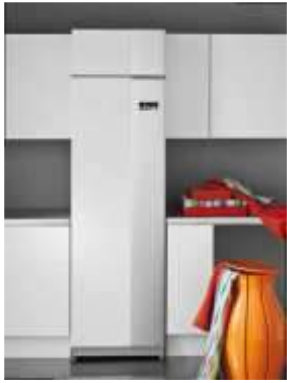
Table 5: EAHP Feasibility

√			Hot water for space and hot water heating is generated via. an exhaust air heat pump. Part L compliance is met through generating space heating and hot water from heat recovered from hot air within the apartment. Ventilation is provided by exhaust air working on differential pressure. Very efficient when the COP of the unit is high and therefore has a major impact on the RER % and NZEB criteria. Can be used to heat hot water only.

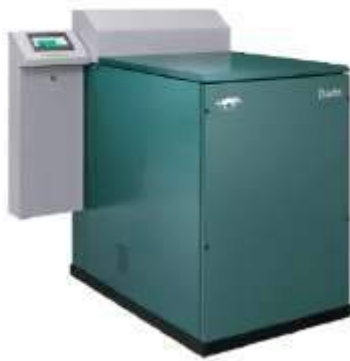
√			Combined heat and power (CHP) refers to the local simultaneous generation of electricity and heat. CHP works best in areas that have a constant “round the clock” demands for heat. CHP systems typically run on oil or gas with biomass also used. Key to a CHP installation is to ensure that the demand load for heating and electricity usage are utilized, i.e. to size the unit correctly on a base load basis. Can assist in meeting the RER requirement under NZEB but energy load dependent.

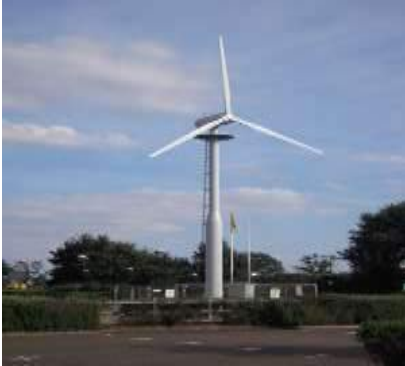
Table 6: CHP & Wind Power Feasibility

√	Micro wind turbines can be fitted to roofs but do not supply much energy. Full scale turbines need open space and are capital intensive but deliver large energy savings. Good impact from a Primary Energy perspective but the site would not be suitable for a large scale turbine given proximity of existing infrastructure.

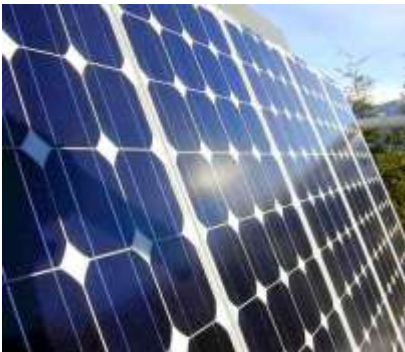
Table 7: Solar PV Feasibility

√			Solar PV collectors absorb the sun’s energy and converts it into electricity. PV Panels can be discrete roof-mounted units or embedded in conventional facades, etc. The ideal location for locating the PV system is facing a southerly direction. Good impact from a Primary Energy perspective and RER% under NZEB.

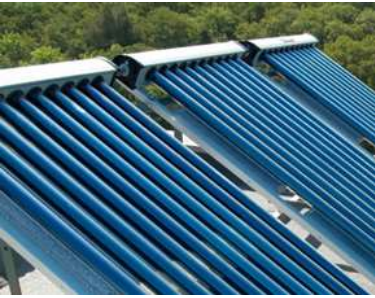
√		Solar collectors absorb the sun’s energy and provide energy for space heating and hot water generation. The ideal location for locating the solar system is southerly direction. Solar systems are usually designed to meet only a portion of the heating load. Available roof area is better utilised with PV Panels as these have a higher Primary Energy impact and hence if roof space available PV Solar Panels would be the preferred option.
	Feasibility			
Technology	H	M	L	Comments
Biomass Heating

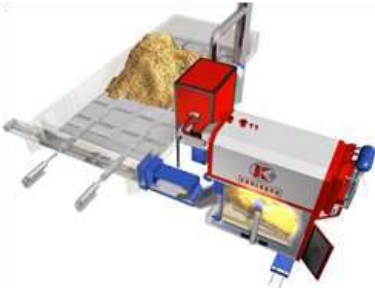
Table 8: Solar Thermal & Biomass Heating Feasibility

√	Biomass boilers combust wood chips or pellets and is considered carbon neutral. The technology requires significant plant space and ongoing maintenance.

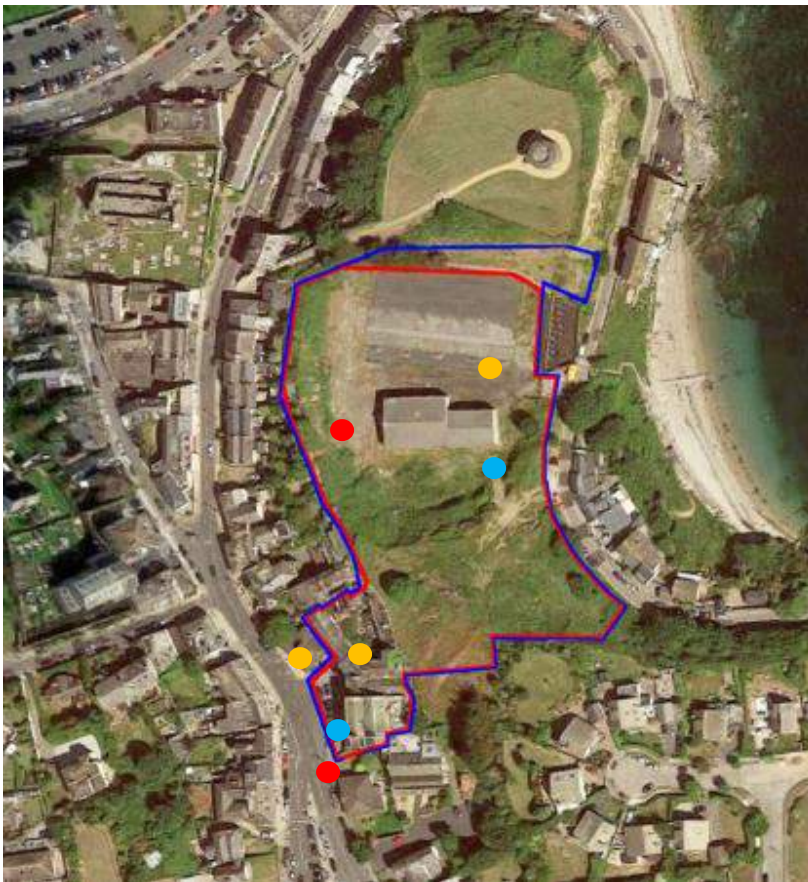
Figure 4: Aerial photograph (Source: Enviroguide Consulting).

The surveyors, over the course of the three surveys were located as indicated on the aerial photograph below: Dusk Survey (12/8/2021 – Orange Circles); Dusk Survey (24/8/2021 – Blue Circles) and Dawn Survey (25/8/2021 – Red Circles). While the buildings were the primary focus of the surveys in order to record roosting sites, surveyors documented any bat activity presented within the survey area (i.e. commuting and foraging activity).

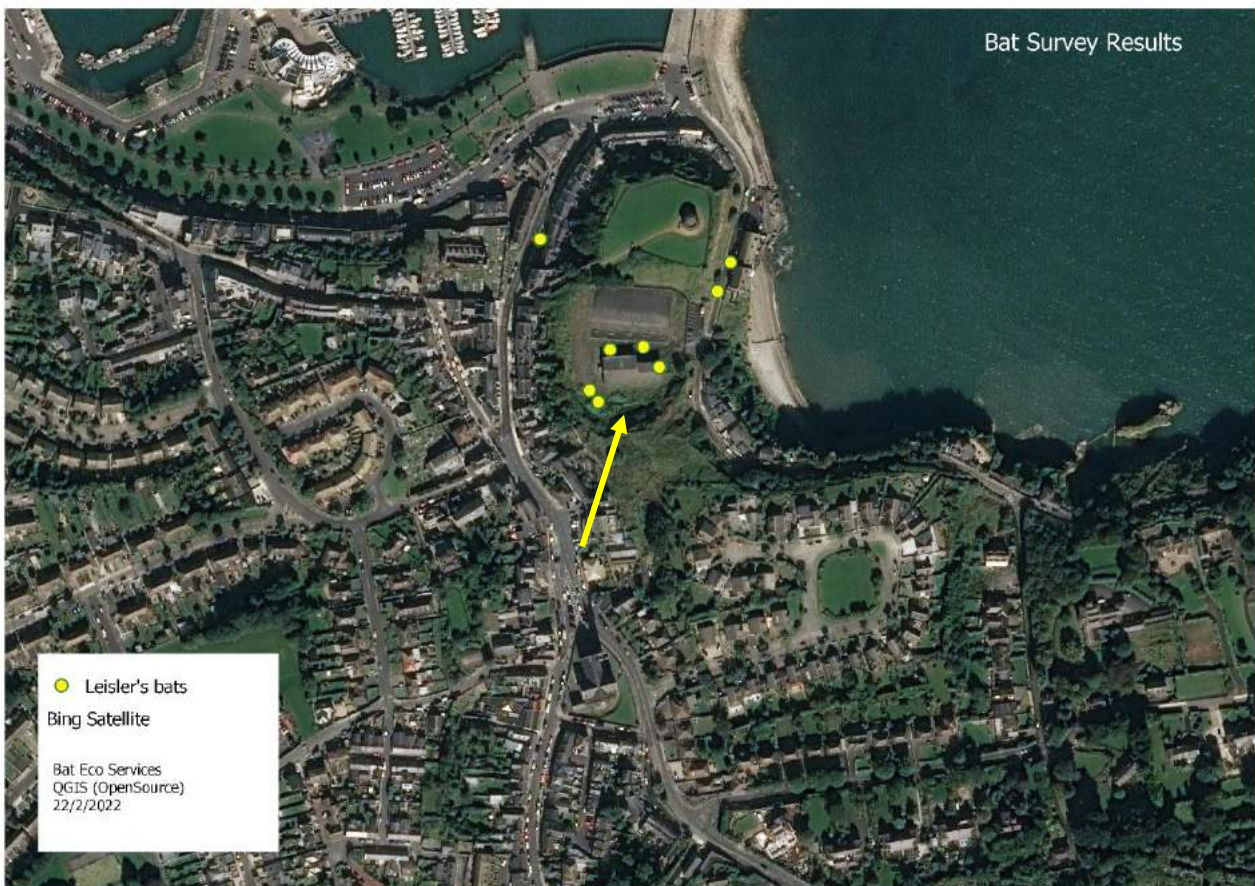
Figure 5a: Leisler's bat encounters during bat surveys. Yellow Arrow – direction of commuting bats.

The following maps are a combination of the three survey dates (dusk and dawn surveys and walking transects) to indicate the location of bat encounters (the three survey dates were combined due to the low level of bat encounters recorded overall).

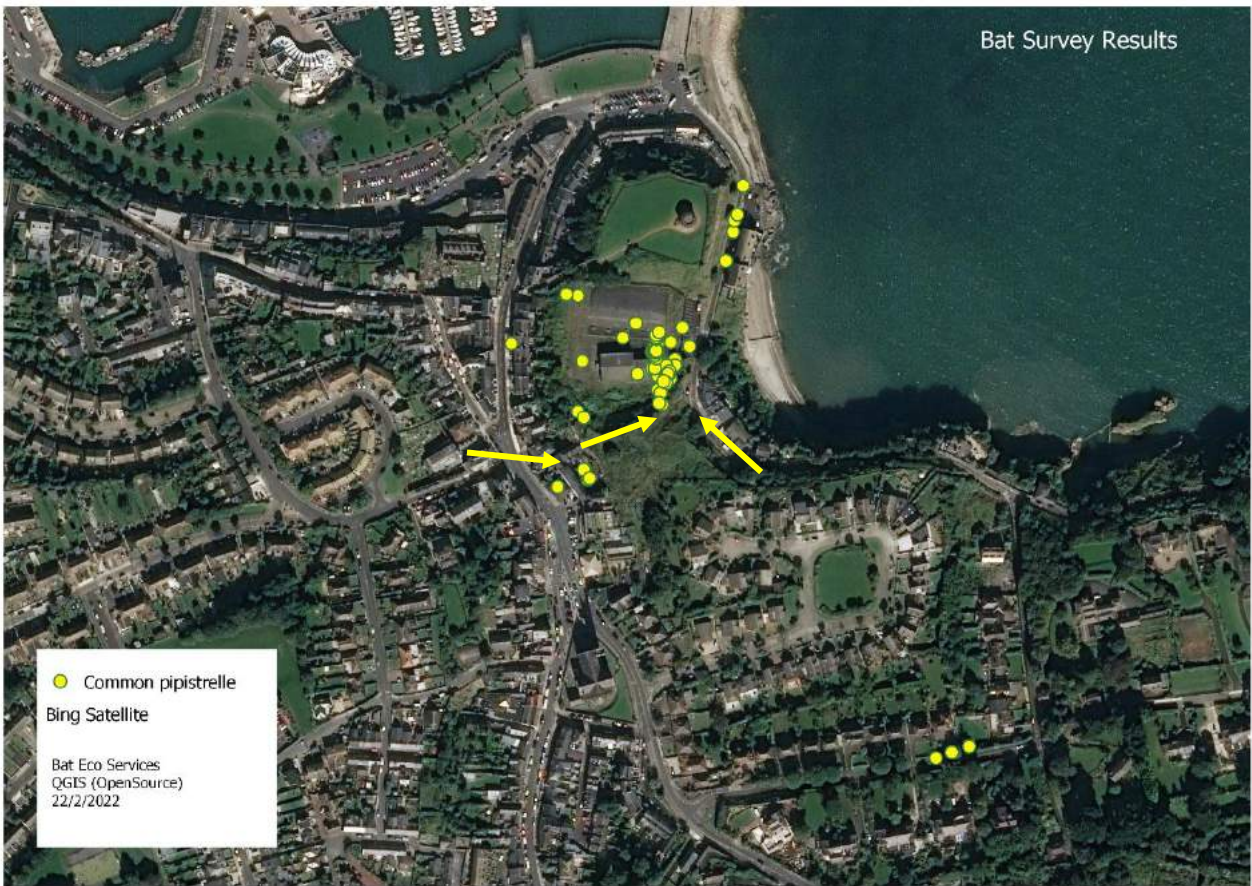
Figure 5b: Common pipistrelle bat encounters during bat surveys. Yellow Arrows: direction of commuting bats.

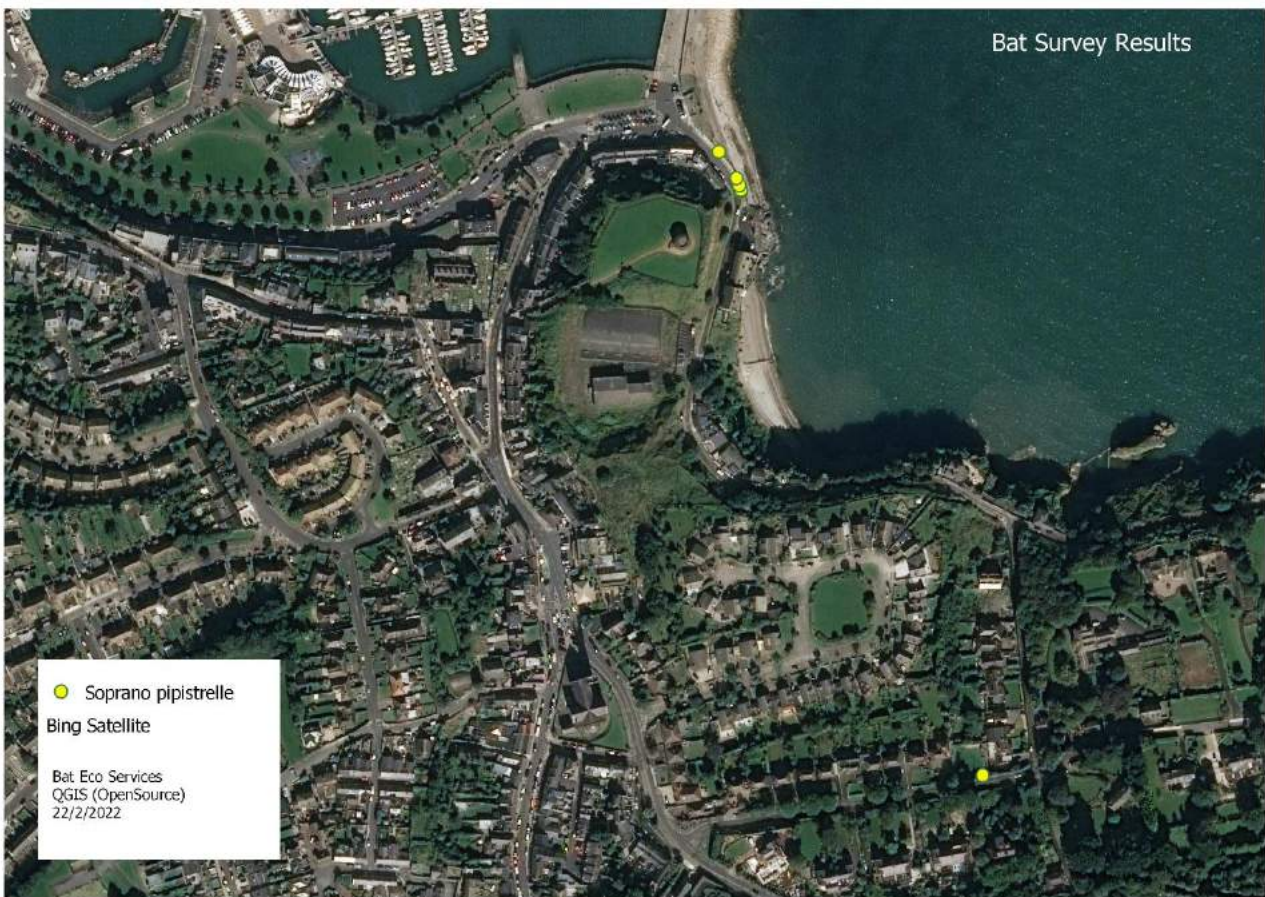
Figure 5c: Soprano pipistrelle bat encounters during bat surveys.

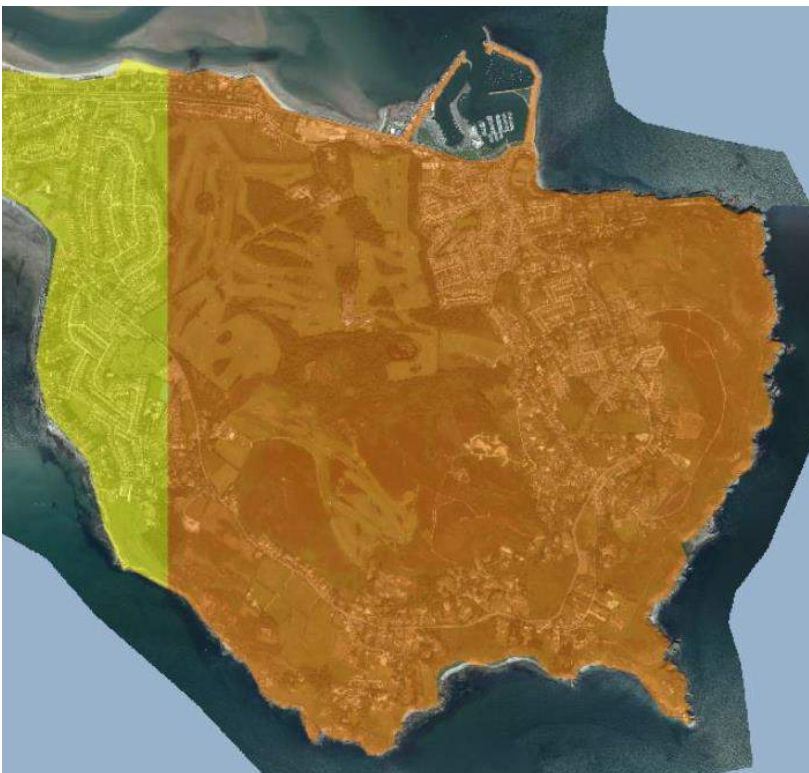
Figure 7: Bat Landscape Favourability Model (All Bats) (Source: NBDC).

Figure 7 depicts the BCIreland Bat Landscape Favourability Model (Lundy *et al.*, 2011) for all bat species (individual species values are presented in Section 10.10). The country is divided into 5km squares and the darker the shading of the square, the higher favourability of the 5km square for bats. This GIS layer is hosted on the NBDC website www.biodiversityireland.ie. The proposed development site is approximately location in the Blue Box.

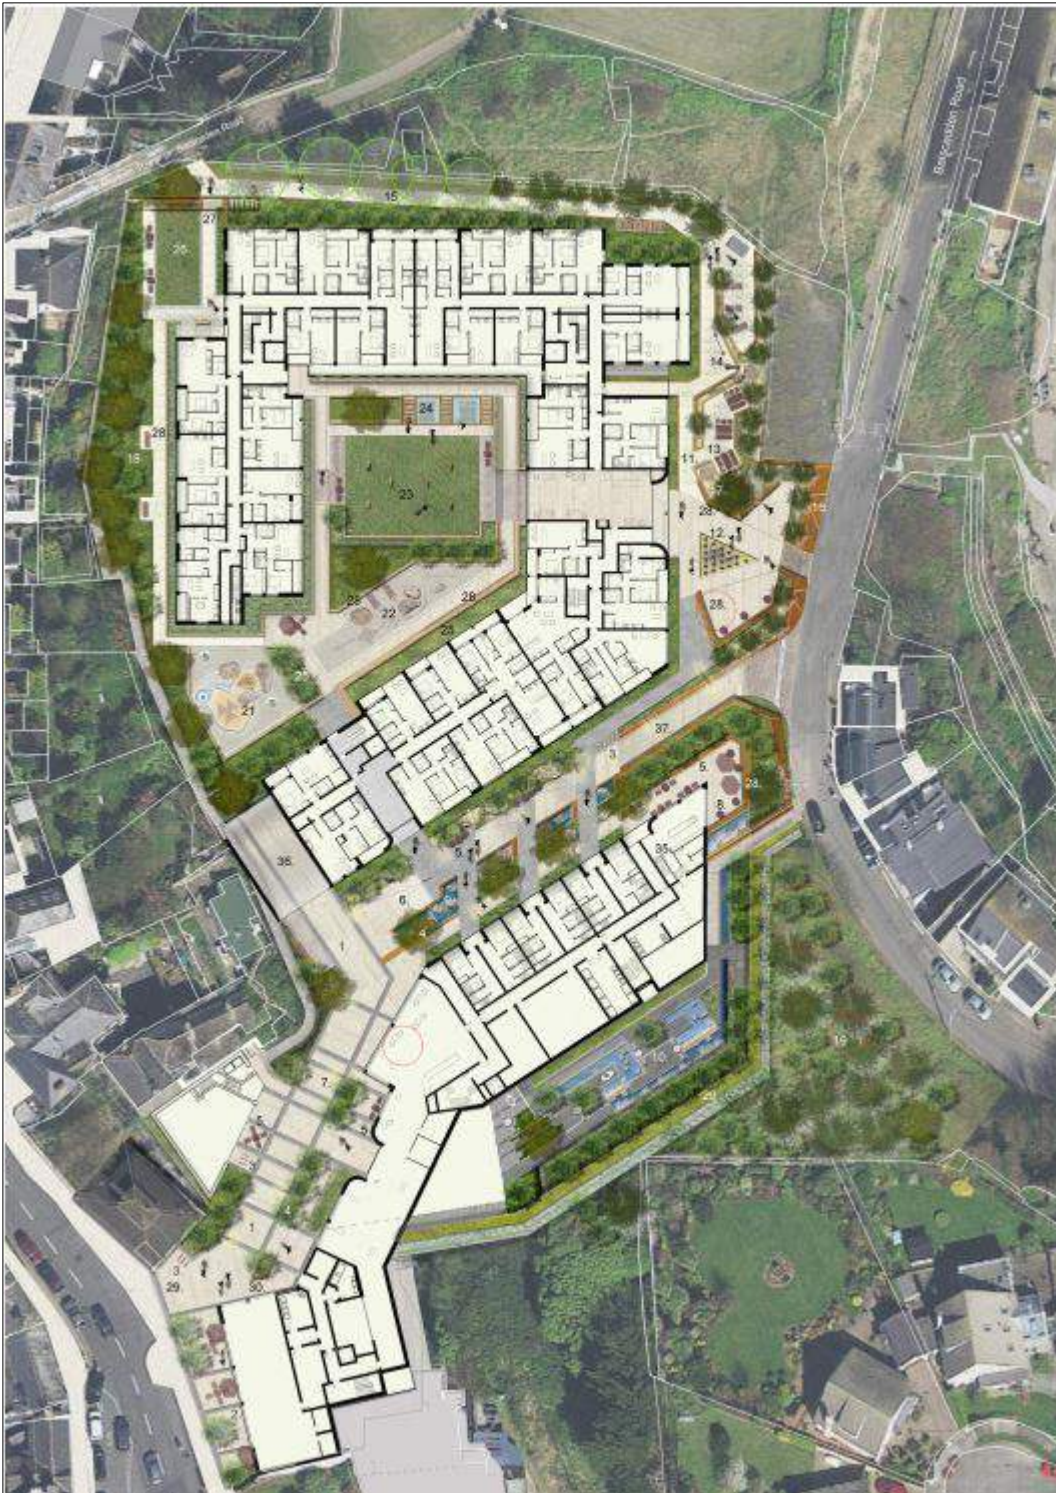
Figure 8: Landscape Plan for proposed development site.

The southern boundary of the proposed development site will consist of a native hedgerow planting along with planting of a semi-natural tree covered embankment. The western boundary will also have a new native treeline planted. These will have a positive impact on local bat populations by providing native tree planting and a potential area to erect bat mitigation measures.

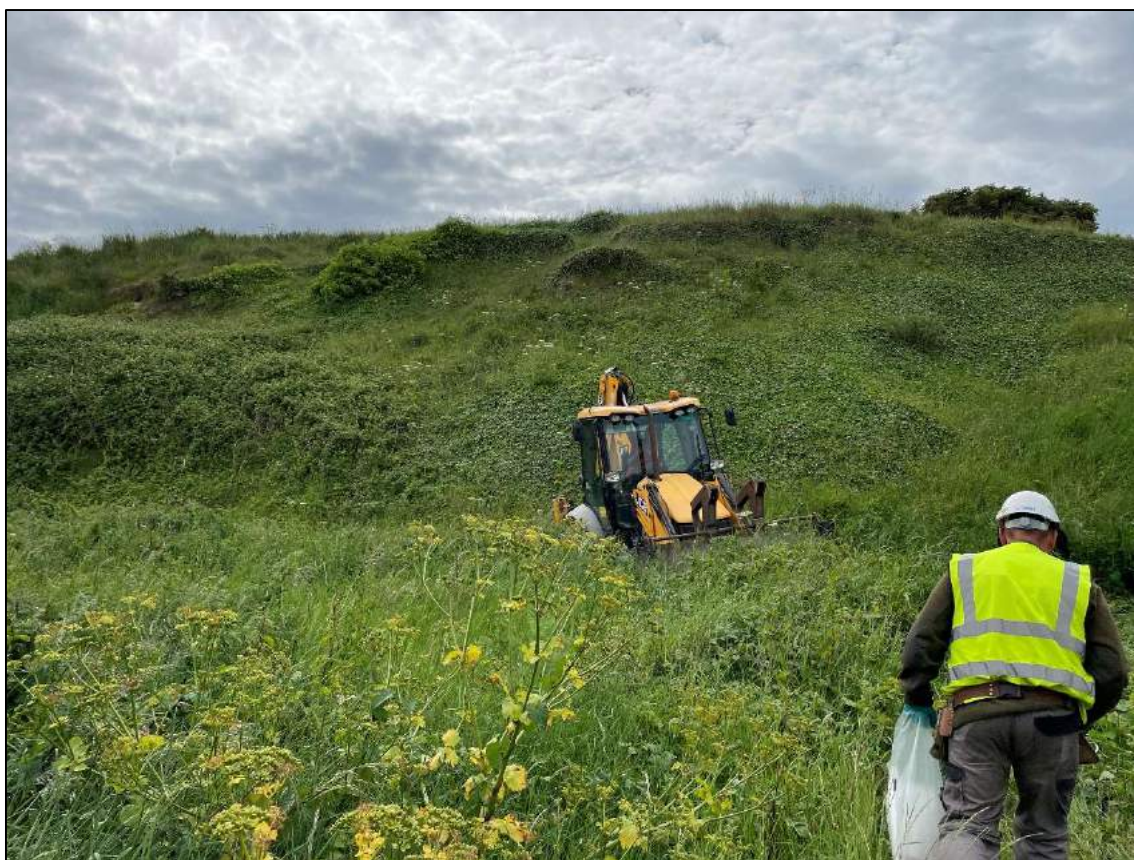
Figure 2.2: Topographical Changes Across the site

There are significant topographical changes across the site, with the site sloping steeply from an elevation of approximately +20m OD across the site to approximately +35m OD to the rear of the sports hall. These topographical changes will require significant earthworks and retaining walls, the design of which are outlined in this report.

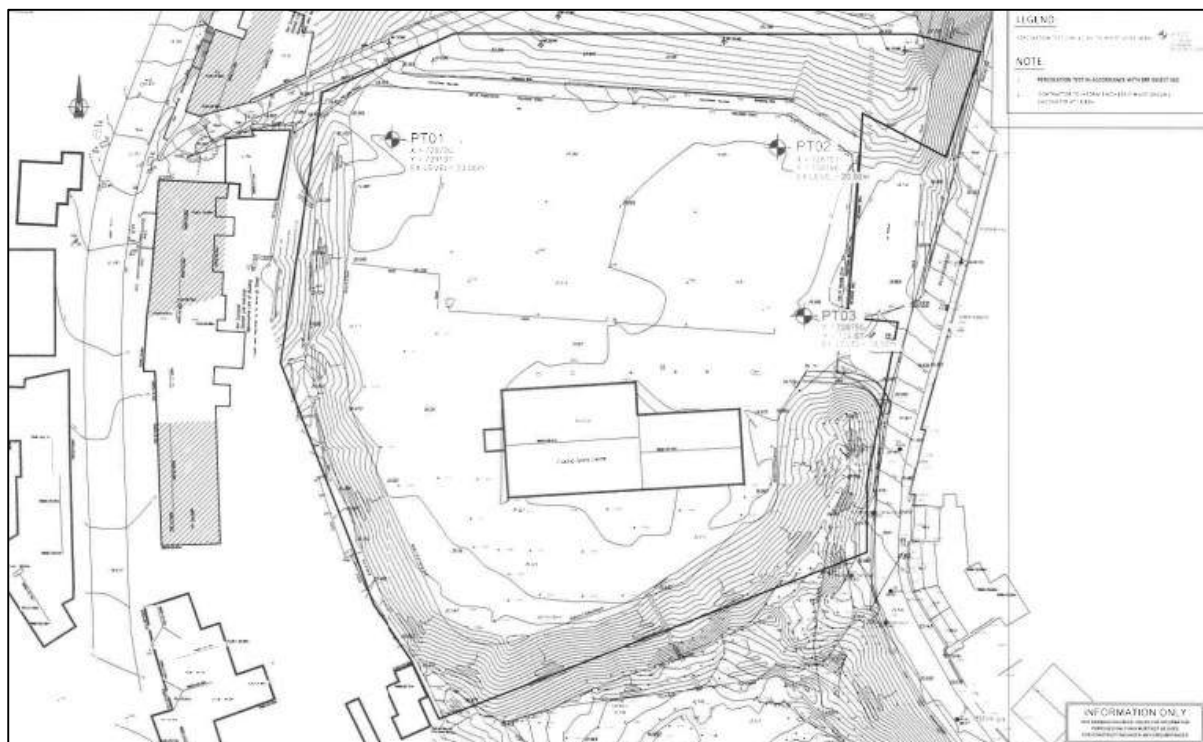
Figure 4.6: Ground Investigations Ireland 2017 Exploratory Hole Plan

The exploratory hole plan is shown as Figure 4.6.

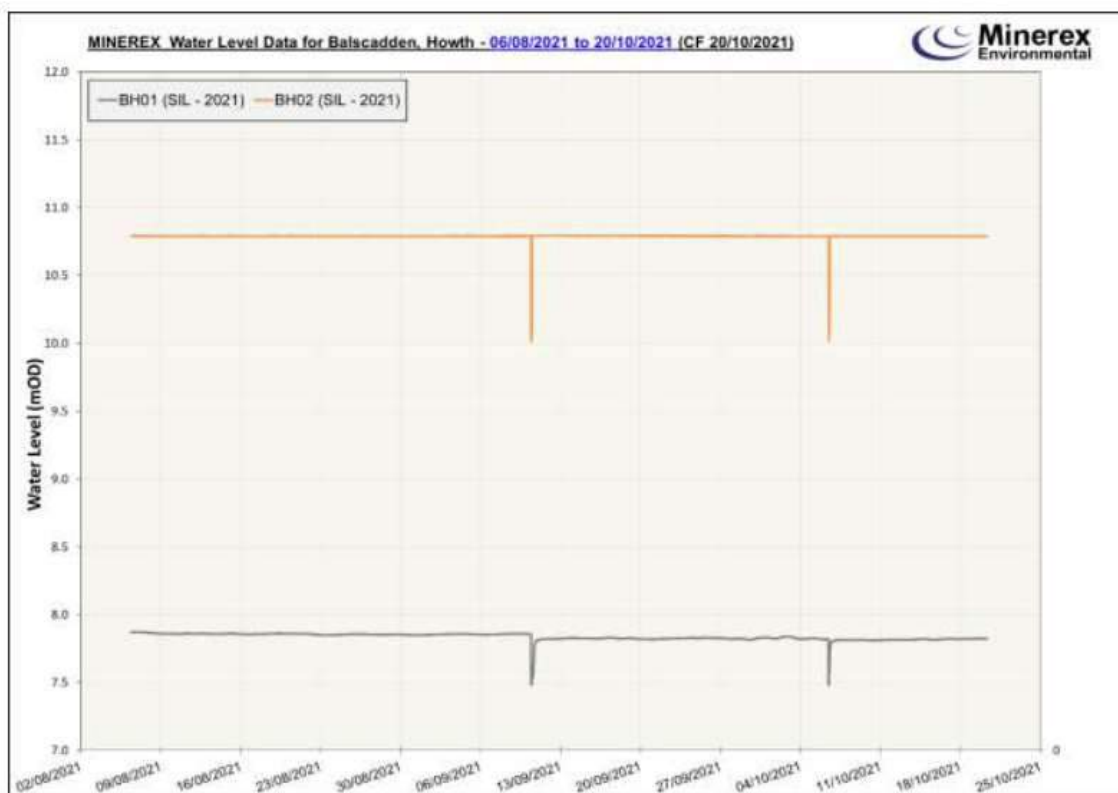
Figure 4.8: Groundwater Monitoring

included as Appendix B, Borehole BH-GDG-01 was dry throughout the monitoring period. The recorded groundwater levels in BH01 and BH02 are shown as Figure 4.8.

Based on the above groundwater monitoring, a conservative groundwater level of 12m OD has been proposed as a design groundwater level.

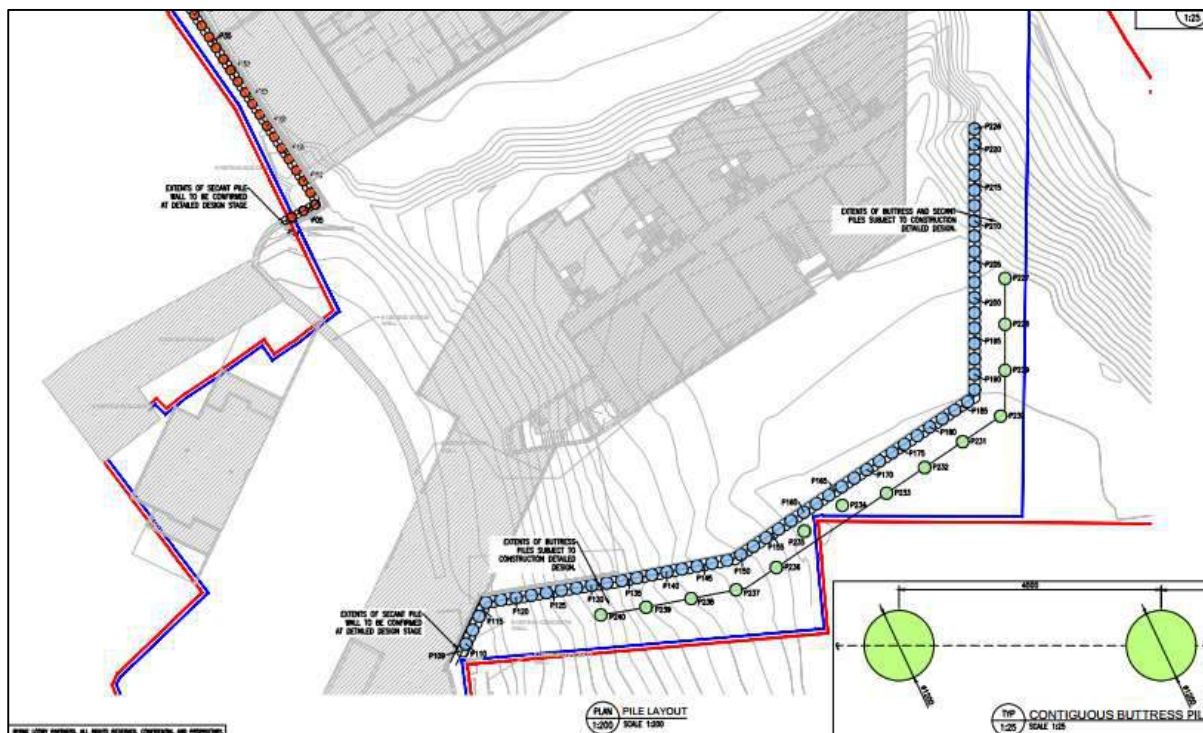
Figure 5.2: Proposed Secant Pile Wall Layout

Based on significant elevation changes across the site, a retaining wall will be required along the southern elevation. An indicative section is shown as Figure 5.1 and proposed layout shown as Figure 5.2. The proposed retaining wall solution is a secant pile wall with additional buttress piles installed to the rear of the secant pile wall to limit pile wall deflections.

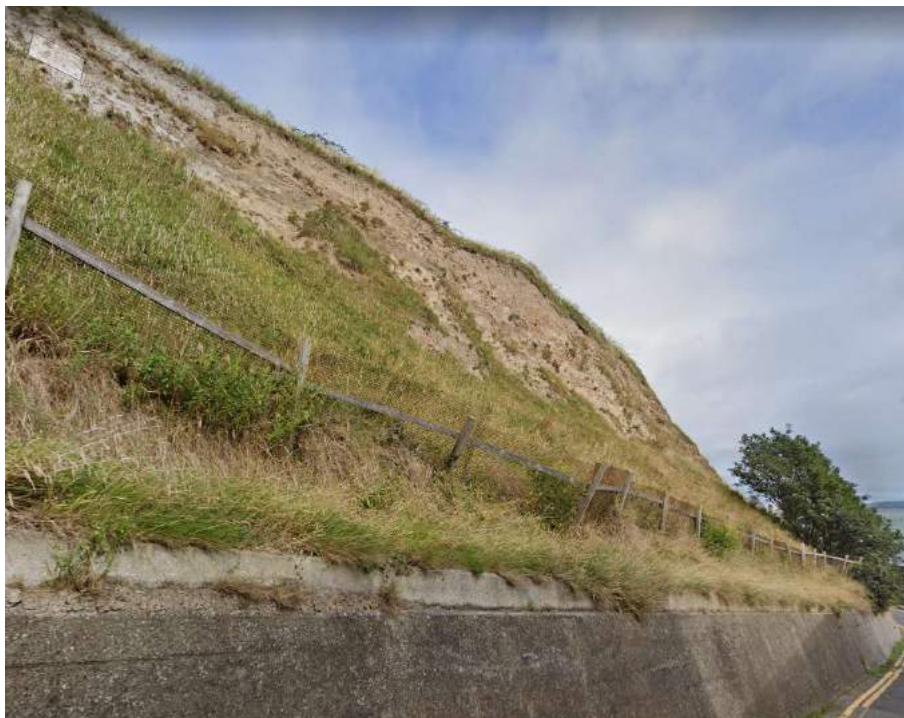
Figure 9.1: Balscadden Road adjacent to Martello Tower (ref. Google Maps) South East of the Site

Evidence of local slippages such as scarp and displaced fenceposts are observed to the south-east of the site, adjacent to Martello Tower, as shown in Figure 9.1. This is outside the site boundary and a vibration monitoring regime will be established along this boundary to ensure the proposed works do not cause slippages. All ground works will involve low-vibration methods of construction.

The recommended remedial works involve the use of soil nailing and a flexible mesh. Soil nailing is a technique which reinforces the slope by the insertion of tendons. The nails address the global slope stability, which are connected in turn to a facing system which provides surficial stability. A suitable mesh would be selected in the construction which would encourage the growth of vegetation following its construction. It is recommended that the remedial works be completed in advance of the main piling and excavation works in the site.

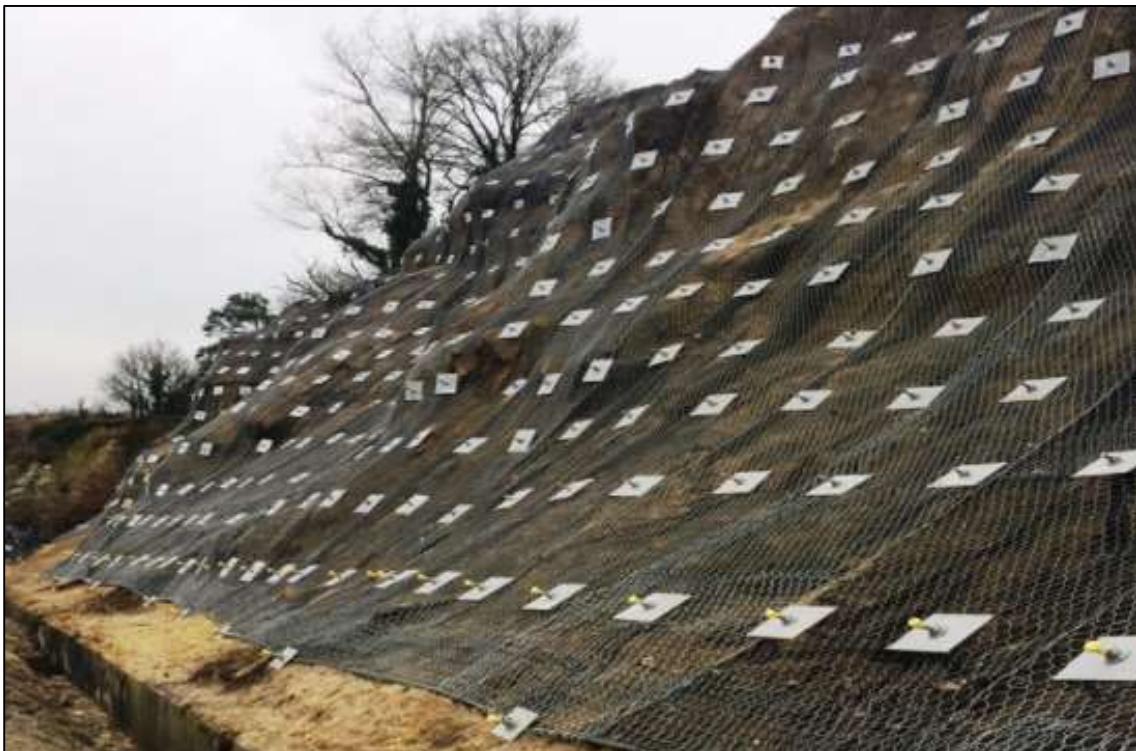
Figure 9.3 Soil Nailing Example, prior to vegetation re-growth

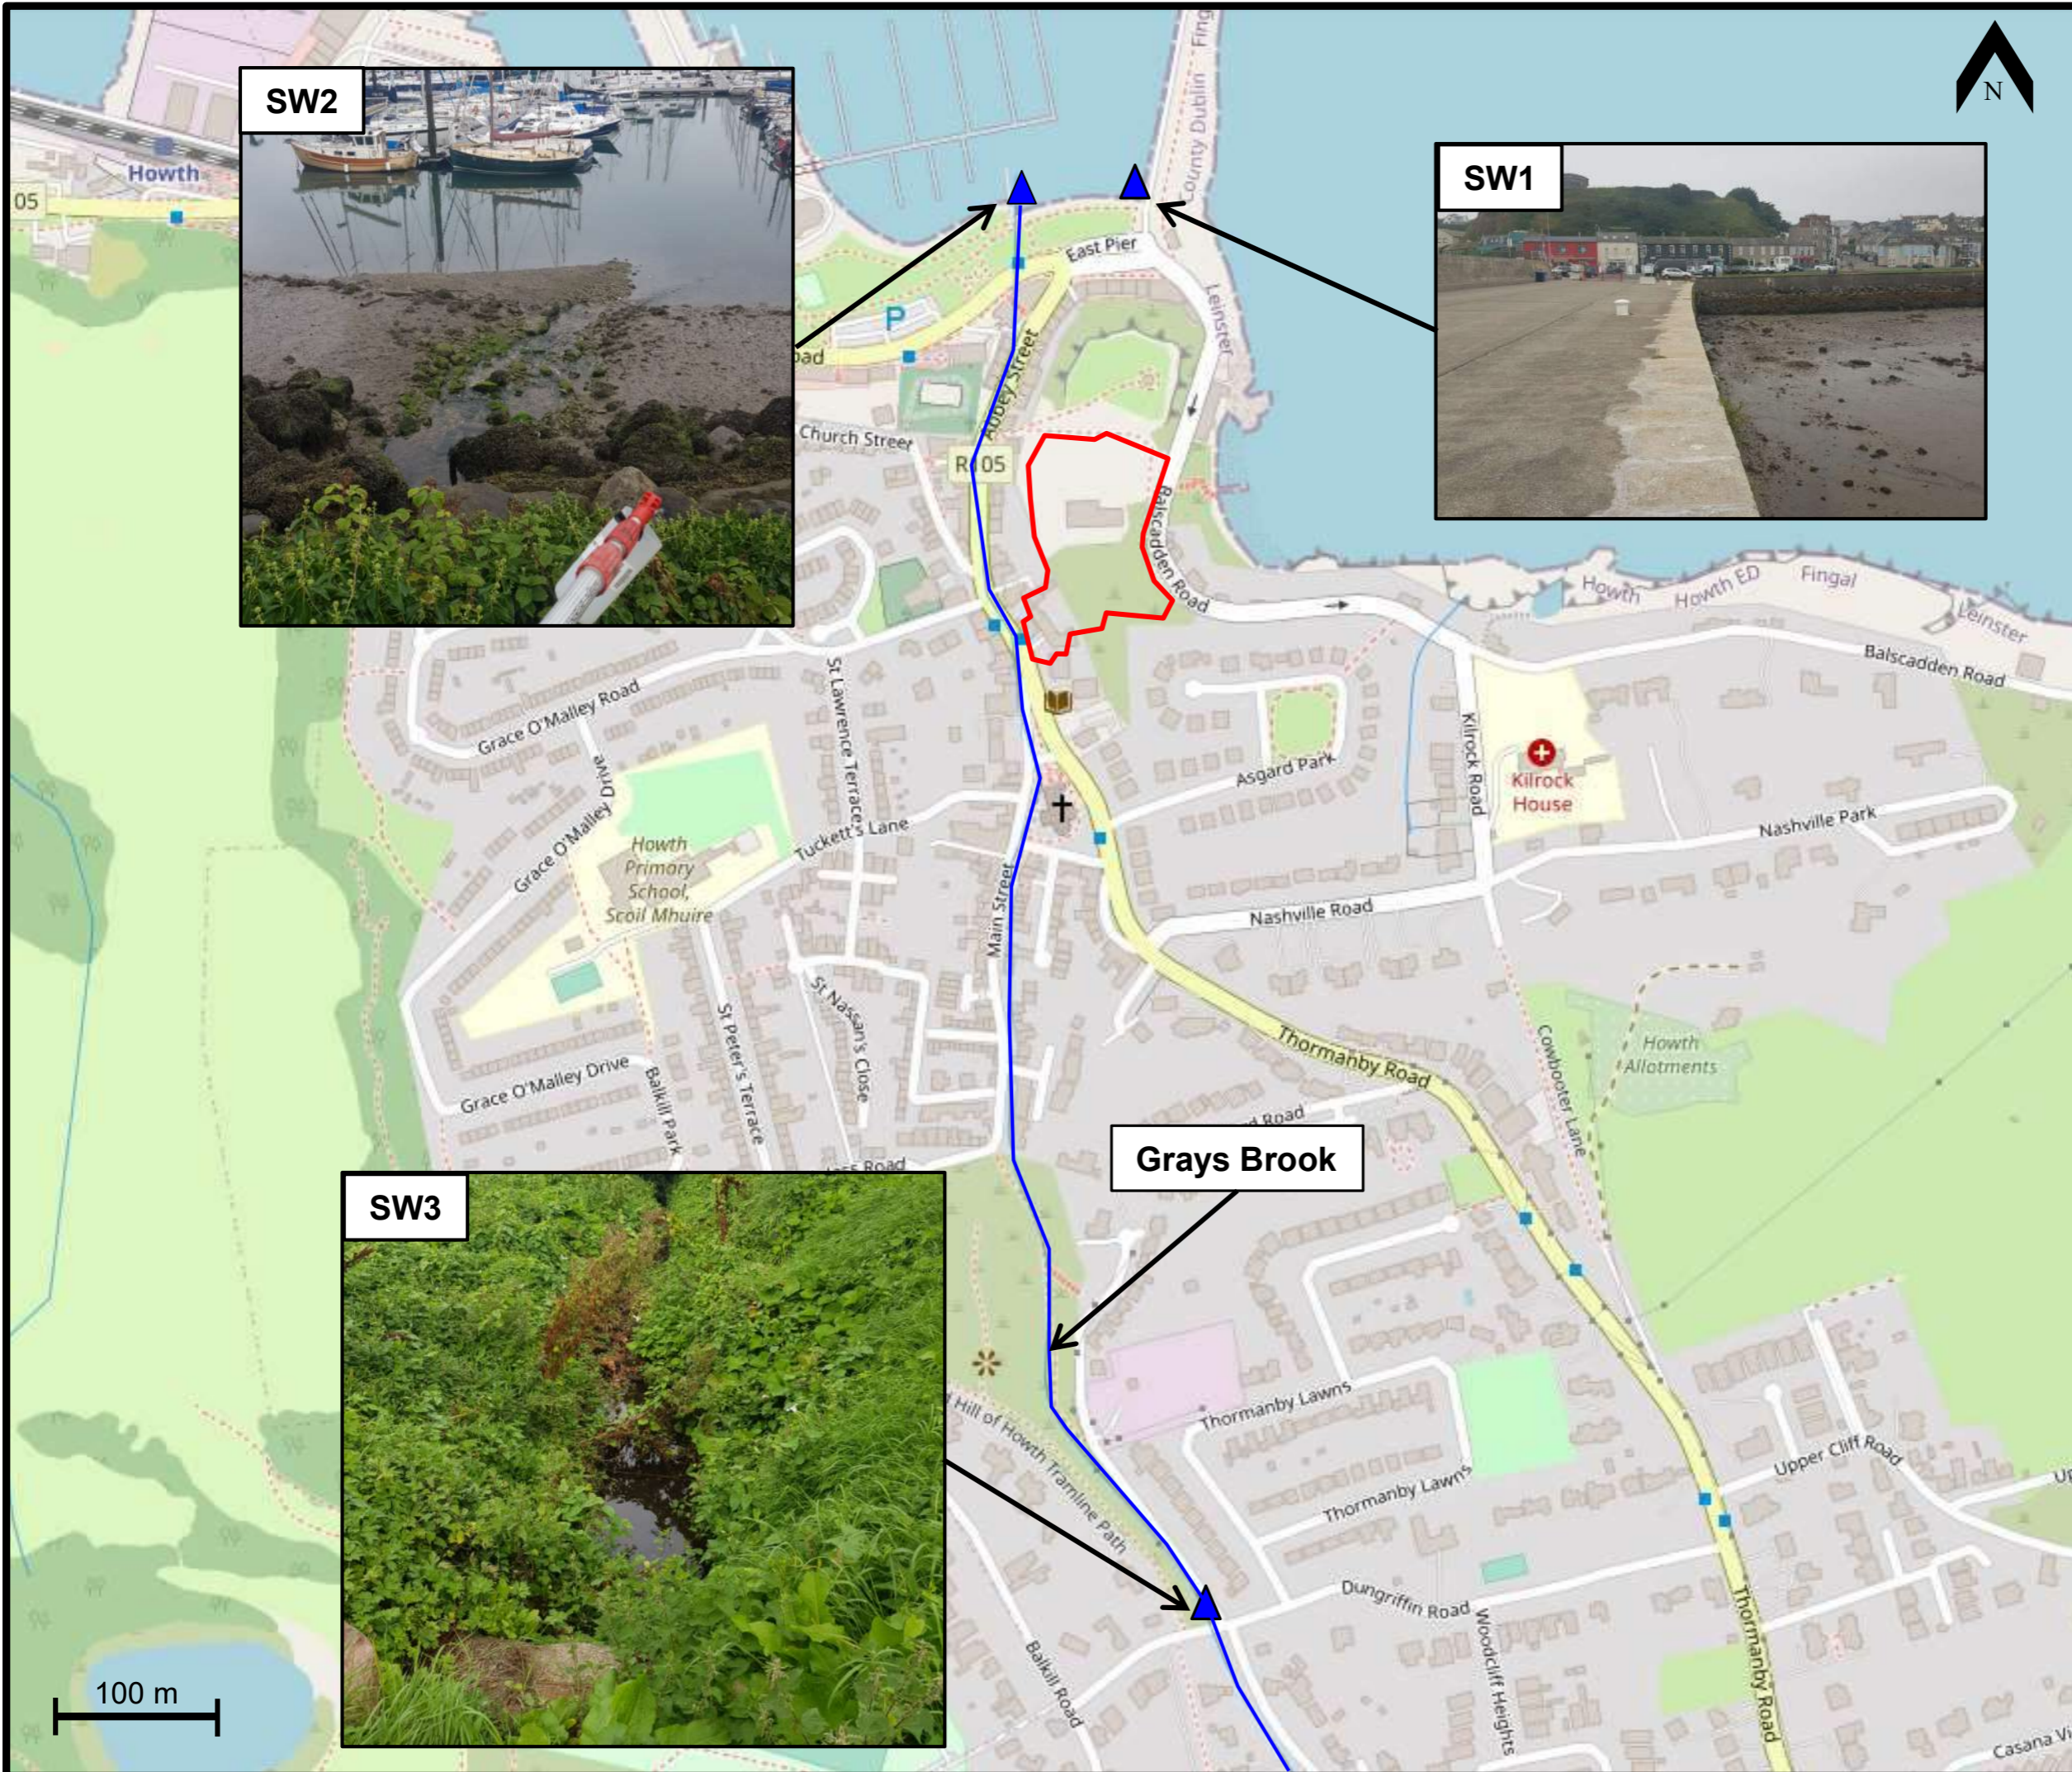
Figure 3.3
Sampling Locations

Three springs were sampled where sufficient water volume could be obtained. The locations and photos of each sampling point is presented in Figure 3.3. Sample SP1 was obtained from a concrete trough on Balscadden Road. The trough is fed from a drainage pipe cast into the retaining wall below the Martello Tower. Sample SP2 was obtained from a spring seepage apparent underneath the buildings at the northern end of Balscadden Bay. Sample SP3 was obtained from a spring flow through the concrete wall and pathway at the top of Balscadden Beach. This spring was located below the pedestrian steps to the beach. Several springs are also visible in the breccia exposed on the southern end of Balscadden Bay (Figure 2.4) however, flows were not sufficient to obtain a sample.

The Howth Tunnel was constructed between 1955 and 1956 as the last section of a Main Trunk Sewer. It consists of a high and low level tunnel, which together are one-mile long (Ref. 5). The internal diameter of the sewer is 6.0 feet (1.83m) throughout the tunnel. The first 300m (1,000 feet) of the tunnel (from the Harbour Road Shaft), had to be supported with the primary lining RC segment rings. In that area material was not self – supporting or sound, and it predominantly consisted of boulder clay, limestone rock, dense clays of various colours, and loose brecciated quartzite rock. The tunnel passes under the site as shown in Figure 3.3.

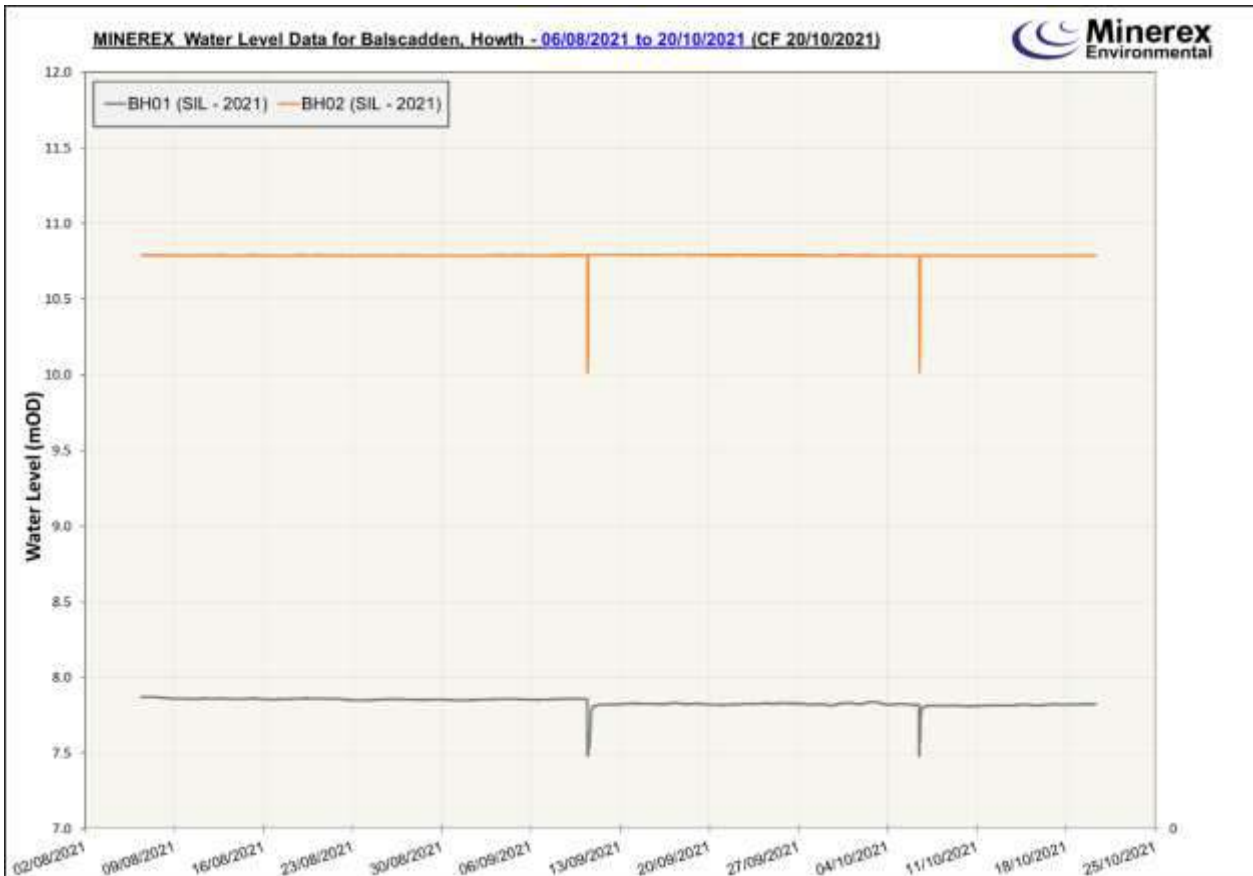
Figure 4.2 Continuous water level data from BH01 and BH02.

Continuous water level data and antecedent rainfall taken from Met Eireann (Dublin Airport) is presented in Figures 4.2 – 4.4. The water level was consistently deeper (approx. 3m) in BH01 compared to BH02. Borehole BH-GDG-01 was dry during initial monitoring in 2017. It was dry throughout the course of this investigation in 2021.

Continuous water level data and antecedent rainfall taken from Met Eireann (Dublin Airport) is presented in Figures 4.2 – 4.4. The water level was consistently deeper (approx. 3m) in BH01 compared to BH02. Borehole BH-GDG-01 was dry during initial monitoring in 2017. It was dry throughout the course of this investigation in 2021.

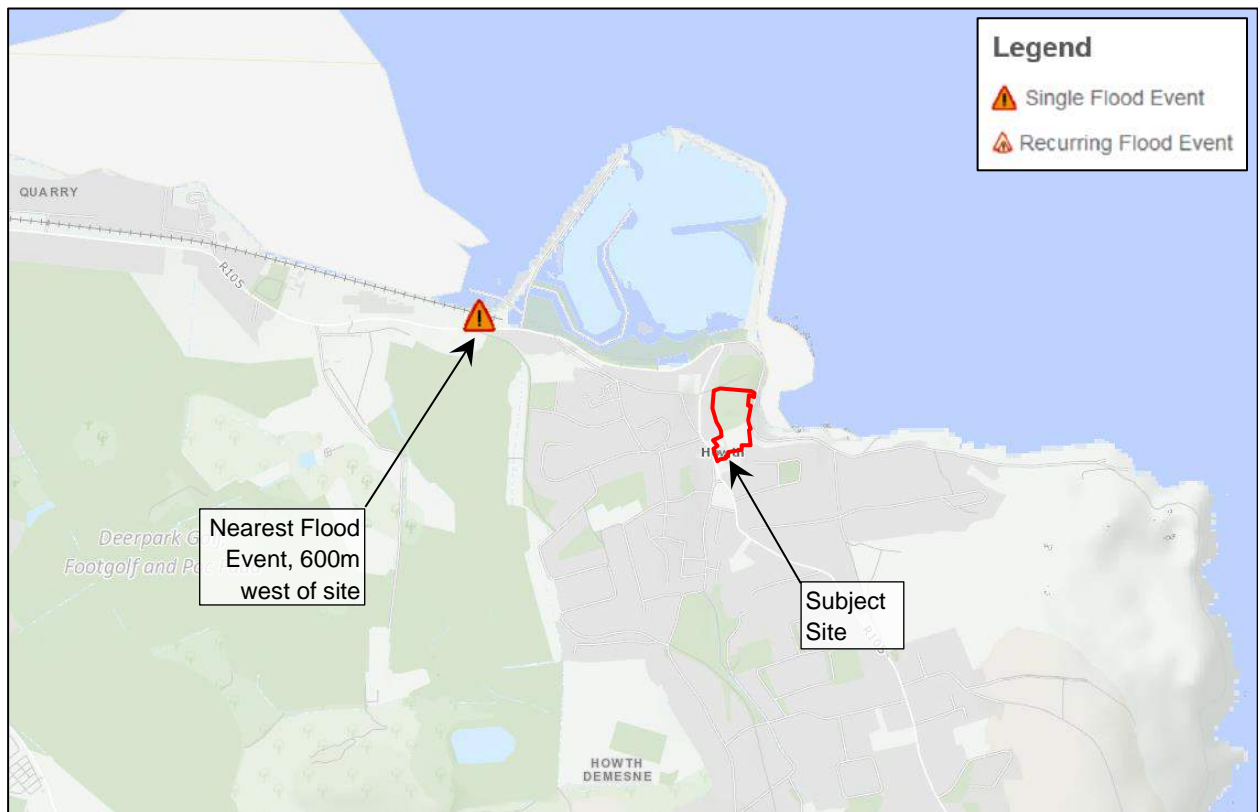
Figure 4 | Extract from the OPW's Past Flood Events Map

The OPW's National Flood Hazard Maps, extracted below, have been consulted to identify recorded instances of flooding in the vicinity of the site. The nearest recorded flood event occurred approximately 600m west of the site at the Howth Dart Station, due to coastal/estuarine waters flooding the banks of the Bloody Stream.

With no history of flooding in the area due to surcharging, the likelihood of such flooding occurring is considered low.

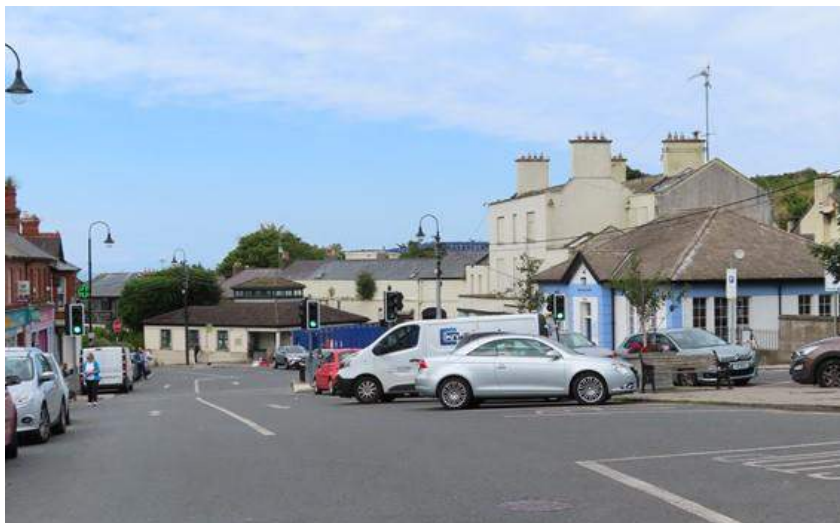
Plate 5: View northwards towards site and hotel

The hotel is set back from the carriageway by an area of parking. To the rear the ground rises steeply to the higher, southern, portion of the application site.

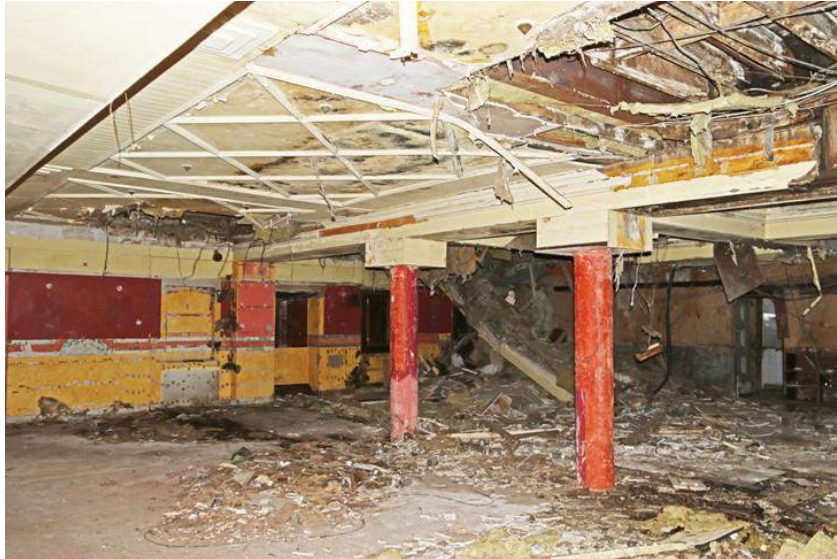
Plate 6: Interior of Baily Court Hotel, 2021

The interior of the hotel was examined in 2012 and it was found that a great deal of the interior fit-out dated from the mid- to late-twentieth century. Original cornicing remained in limited areas on the first floor, along with shutters and architraves, though throughout the rest of the building the features were of later date. Extensive water penetration had occurred at that time and there were extensive signs of resulting damage, including staining indicative of significant quantities of water in the walls, while fruiting bodies of fungal attack were also evident, including in original cornicing. On a return visit in 2021 the building was found to be very extensively damaged and was largely too dangerous to allow examination beyond a limited area.

The present writer inspected the interior of the hotel in 2012 and observed that there was little left of the original internal features within the hotel. At that time there were many places where water was penetrating into the building, with consequent warping of flooring, collapsing of some ceilings, fungal attack, water staining and mould growth.

The building is generally in poor condition, with water penetrating down through the building to ground floor level, causing severe buckling in the floor coverings and extensive water staining in places on the walls and ceilings, much of it accompanied by brown staining that suggests that fungal attack is concealed behind the surface. The substantial level of water penetration has severely damaged the building and there has been further damage through vandalism.
