Appendix A

Appendix B

JV TIERNEY & CO

MECHANICAL ELECTRICAL & SUSTAINABLE ENGINEERS

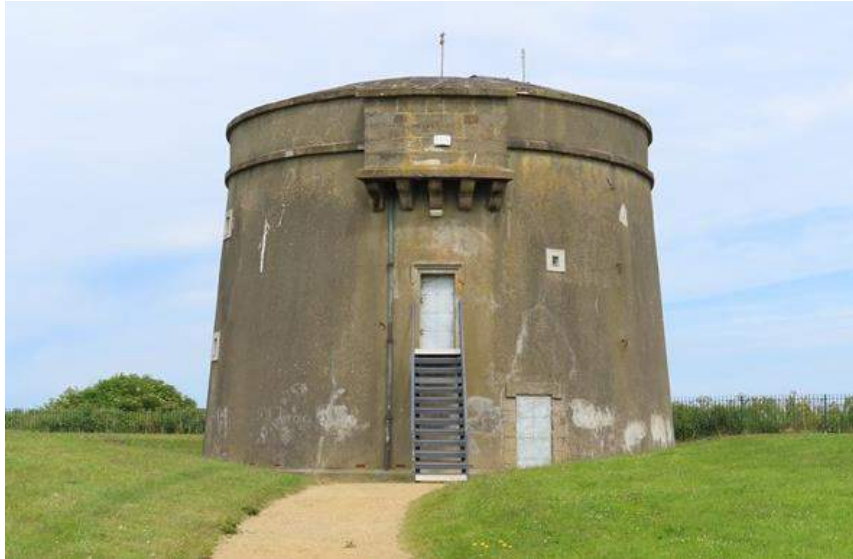
Plate 9: Howth Martello tower

The tower itself is a circular building with its main door at first floor, approached via a flight of steel stairs. There is one window, facing north away from the application site. The tower is rendered and has a machicolation over the door. The machicolation – seen projecting above the doorway, was an overhanging feature that provided the opportunity for those defending the tower to shoot pistols or muskets down at anyone who was attempting to force their way through the door. In this view of the tower there would be no impact on the character or setting of the tower, as the application site is off to the right in this view.

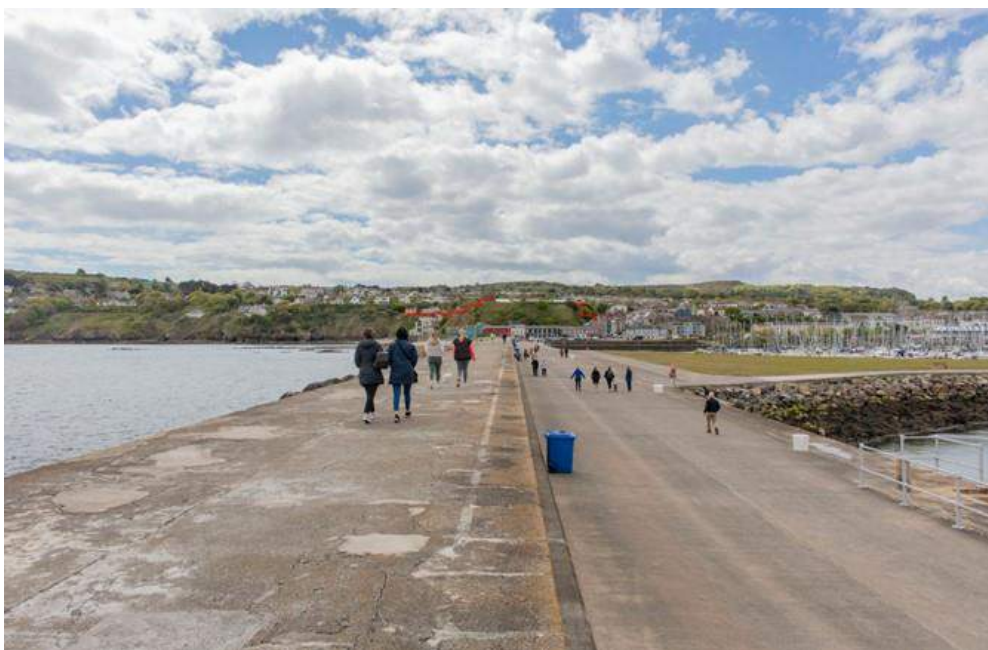
Plate 15: Photomontage View 17, showing proposed development from the East Pier

The photograph above was taken from near the first turn in the East Pier, on its lower walkway, at a distance of approximately 450 metres from the tower, using a telephoto lens. From this viewpoint the tower is seen with the rising ground beyond as a backdrop and to a significant extent it blends into the background. The top of the tower of the Church of the Assumption in Main Street is seen to the right of the Martello tower. This church is located significantly higher up the street than the Baily Court Hotel and it gives an indication of the extent to which the high ground on which the Martello tower stands masks the land beyond. The proposed buildings would begin to be visible from this point, as seen in montage View 17 reproduced below, from the Verified Photomontages document produced by Digital Dimensions and submitted with this application. The proposed buildings would not stand out in this view due to the backdrop of the Hill of Howth behind it. As View 17 shows, there would be no appreciable impact.

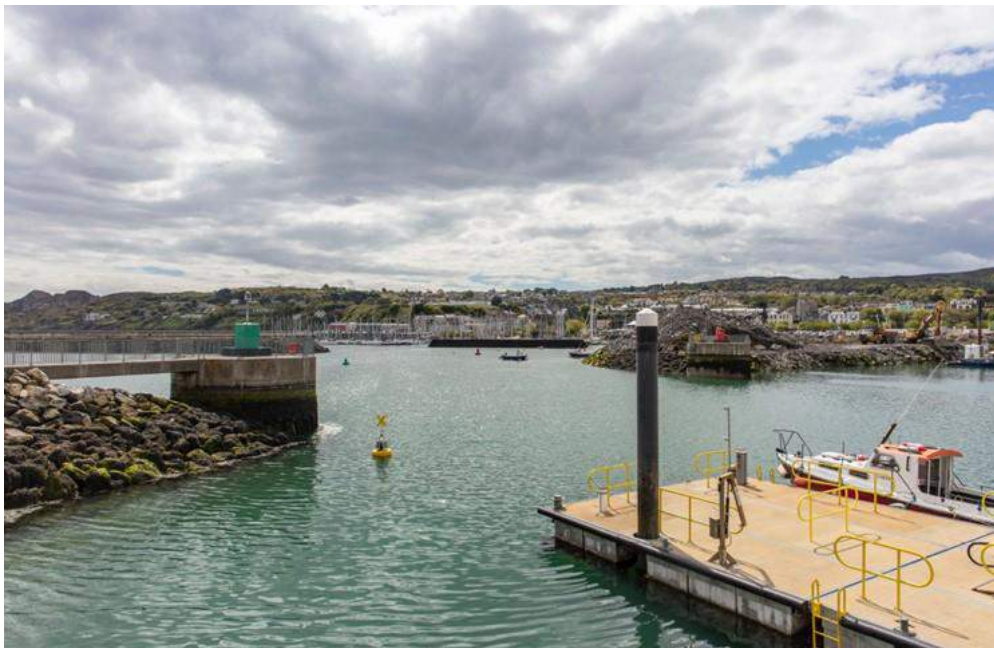
Plate 17: Photomontage View 18, showing proposed development from the West Pier

Montage View 18 reproduced below, from the Verified Photomontages document produced by Digital Dimensions and submitted with this application, shows the view from the West Pier. The proposed buildings would be barely discernible in this view due to the backdrop of the Hill of Howth behind them. As View 18 shows, there would be no appreciable impact.

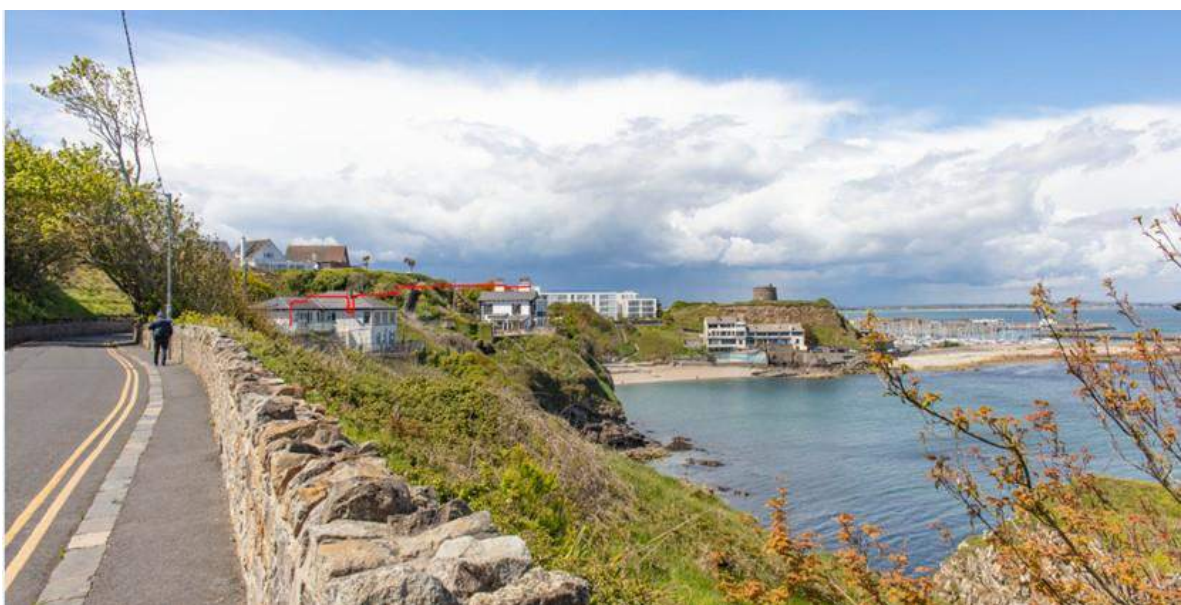
Plate 21: Photomontage View 16, showing proposed development from Balscadden Road

From some locations along Balscadden Road to the east of the application site there are views of the Martello tower on its high ground. The application site is located to the left of the Martello tower in this view. The proposed buildings that would be closest to the tower would be 3-4-storey in height above ground level at this point, with a basement car park below. The base of the tower would be close to the floor level of the top-floor apartments in the building closest to the tower, as seen in site sections submitted with the application. The closest distance between the nearest proposed building and the tower would be approximately 47 metres and at this distance the small height to which the building would rise above the base of the tower would ensure that the proposed building would have little or no impact on the setting of the tower as seen from this angle. The proposal is shown in View 16 reproduced below taken from the Verified Photomontages document produced by Digital Dimensions and submitted with this application.

Balscadden Road. However, there is a significant angular distance between the proposed buildings and the tower when seen from this viewpoint and this is illustrated in View V16 submitted with the application. The tower stands high and proud in this view, while the proposed buildings would be significantly lower and would be set into the hollow ground, thereby being less visible than the tower and having little or no impact on its setting. It should be noted that there is no public access to the roof of the Martello tower, which is used for the location of antennae in connection with the Hurdy Gurdy Museum of Radio and hence the view from the roof, or gun emplacement, is not a significant factor in the impact on the Martello tower.

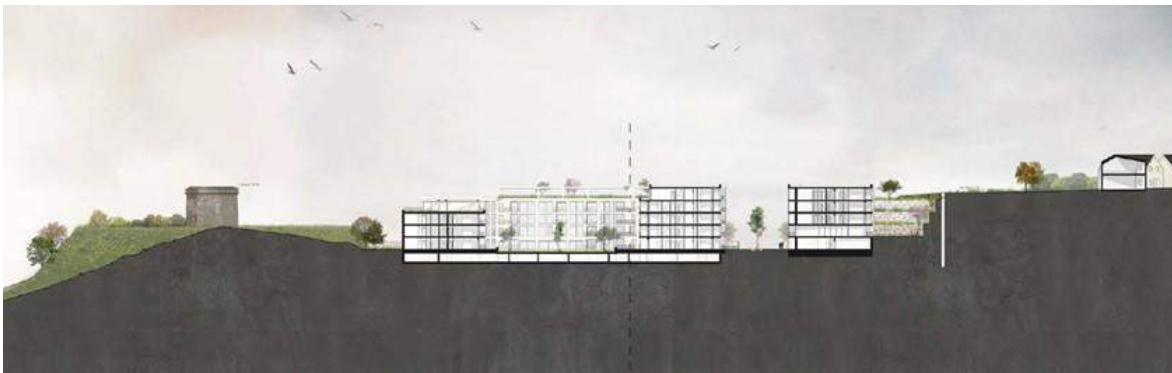
Figure 9: Section through site from north to south

The image above shows a section through the application site, looking to the east, with the proposed development seen in the centre. The Martello tower is seen toward the left. It may be seen from this that the proposed buildings at the northern end of the site are lower than the tower and are separated by a significant distance. The view also illustrates how the high elevation of the ground on which the Martello tower sits ensures that any viewer from the harbour to the north is looking up at the tower, while the proposed development is concealed by the rising ground when looking from the north.

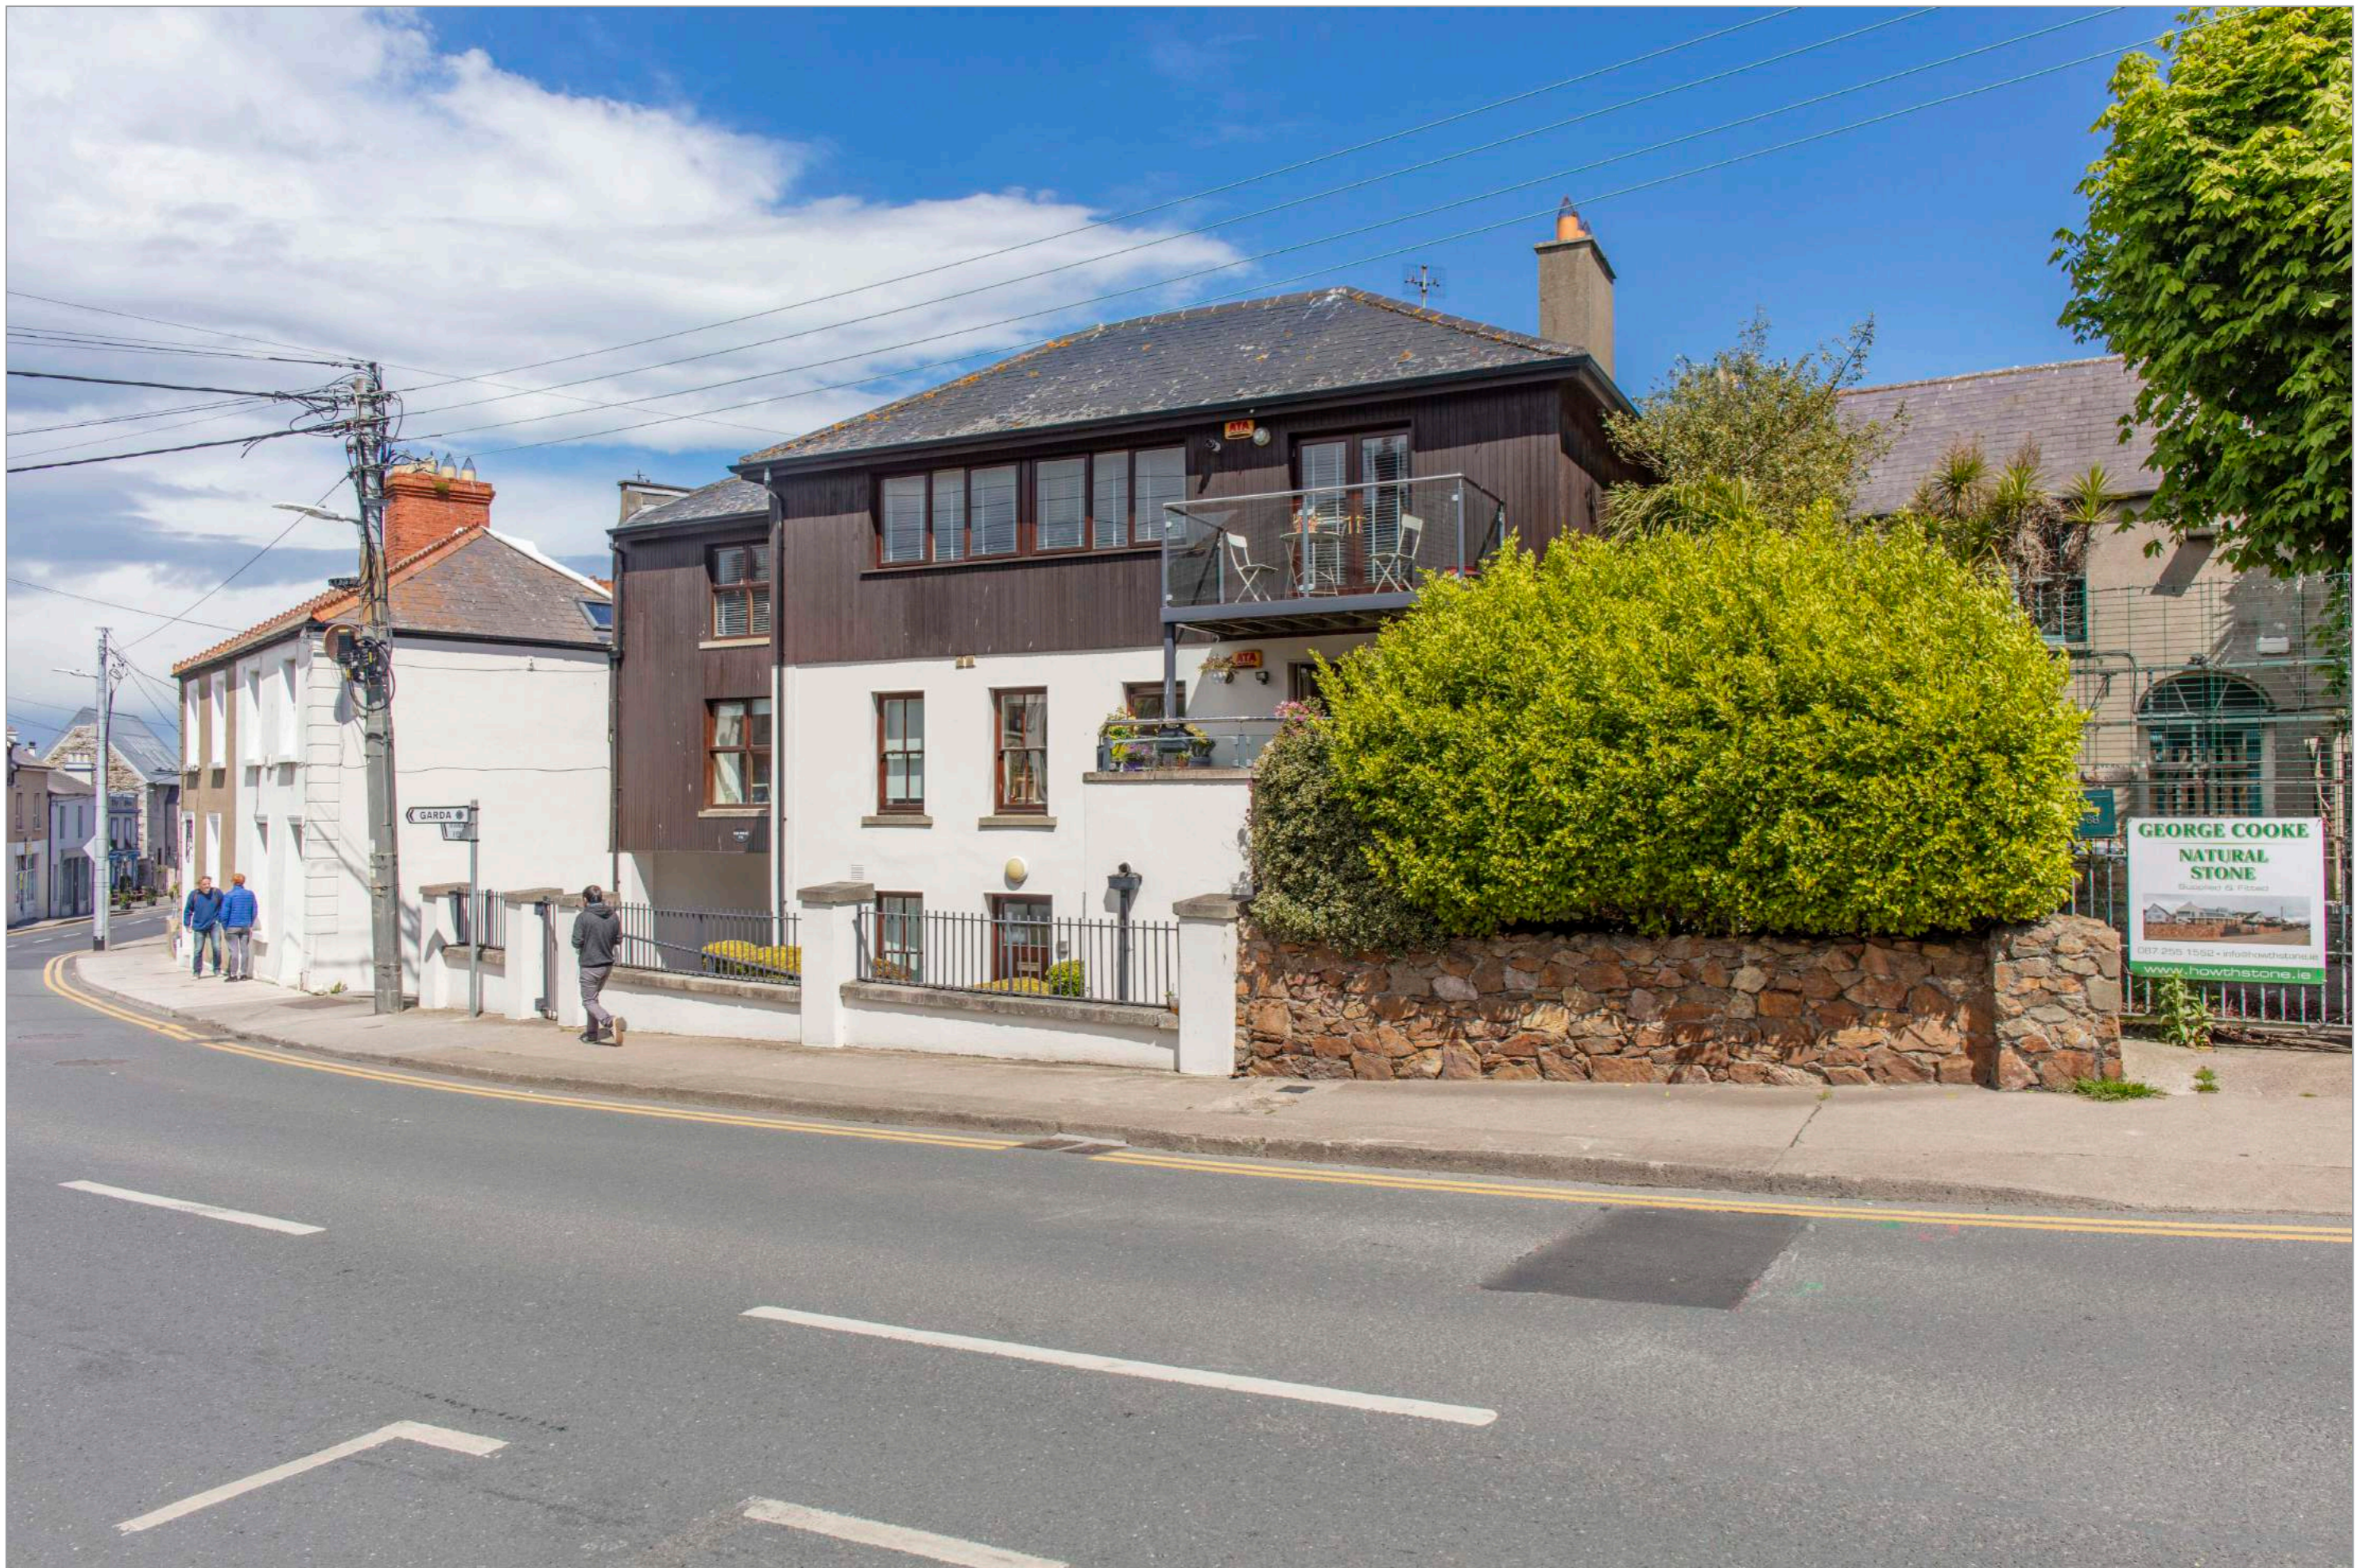
Location	Description	Photography Date	Field of view	35mm equivalent	Distance to site boundary	Camera model
View 1 Existing	Main Street Howth from Bus Stop No 575 looking North	18/05/21	74°	24mm	25.5m	Canon EOS 5DS

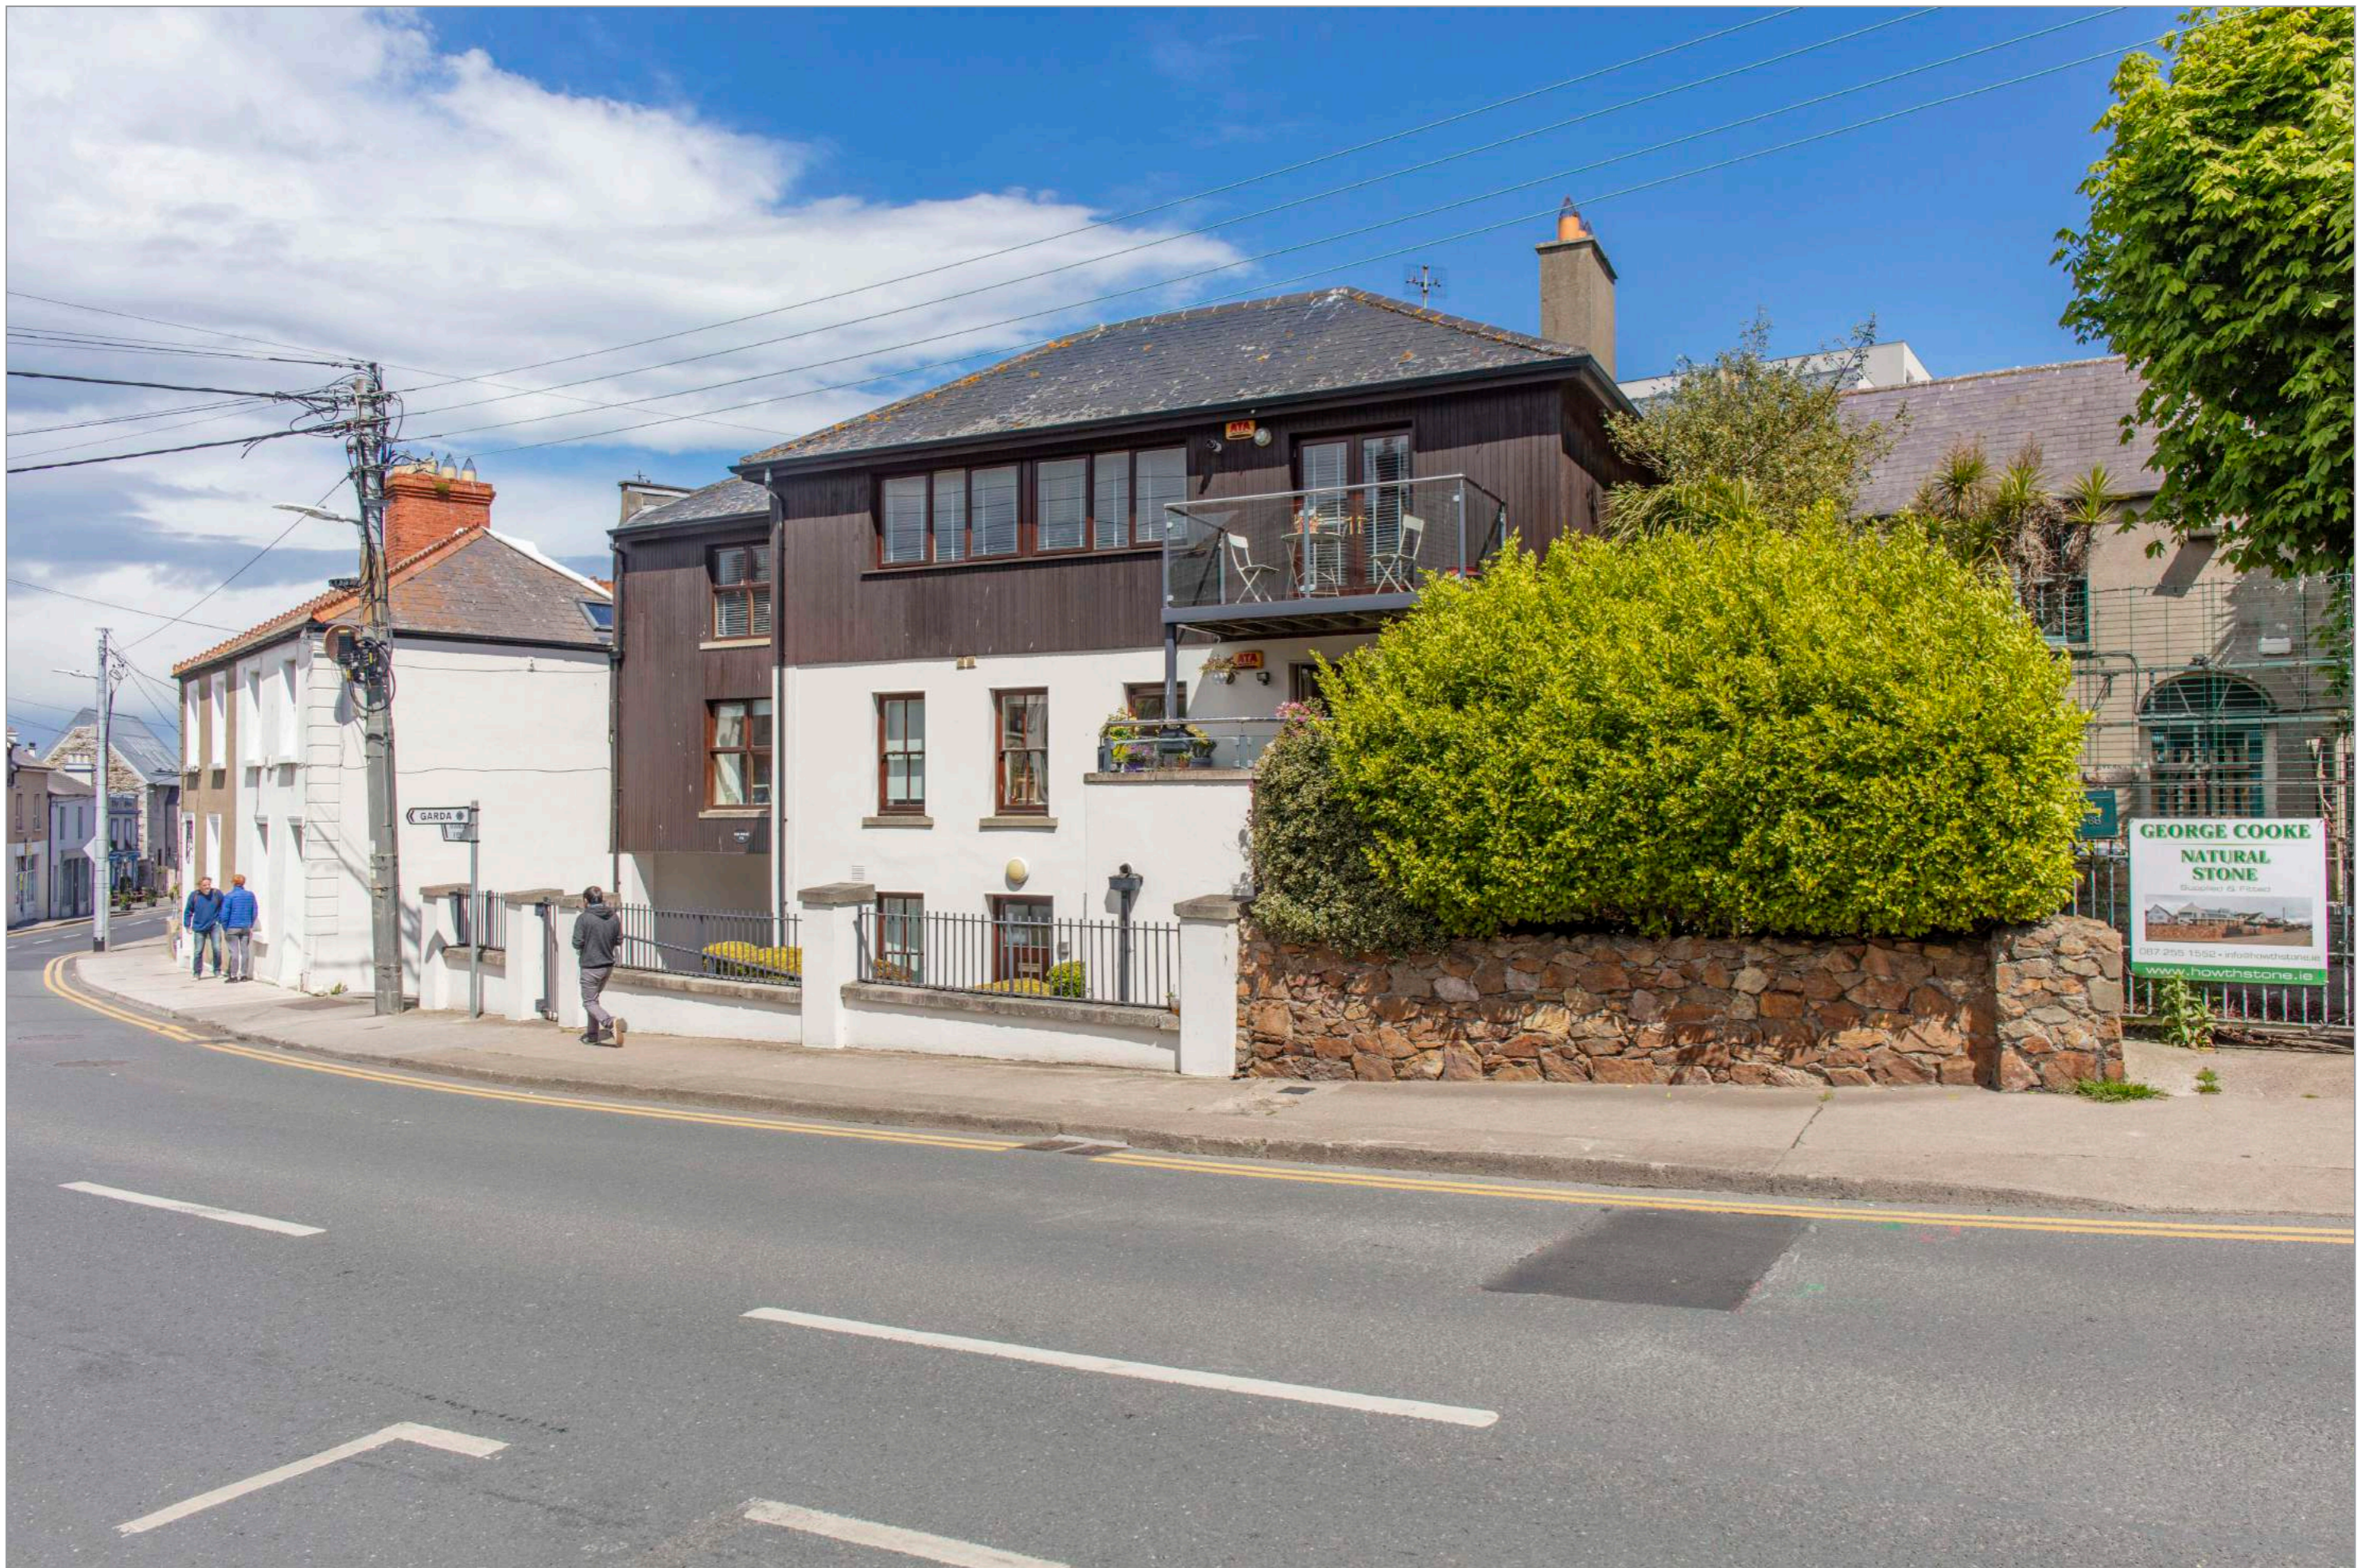
Location	Description	Photography Date	Field of view	35mm equivalent	Distance to site boundary	Camera model
View 1 Proposed	Main Street Howth from Bus Stop No 575 looking North	18/05/21	74°	24mm	25.5m	Canon EOS 5DS

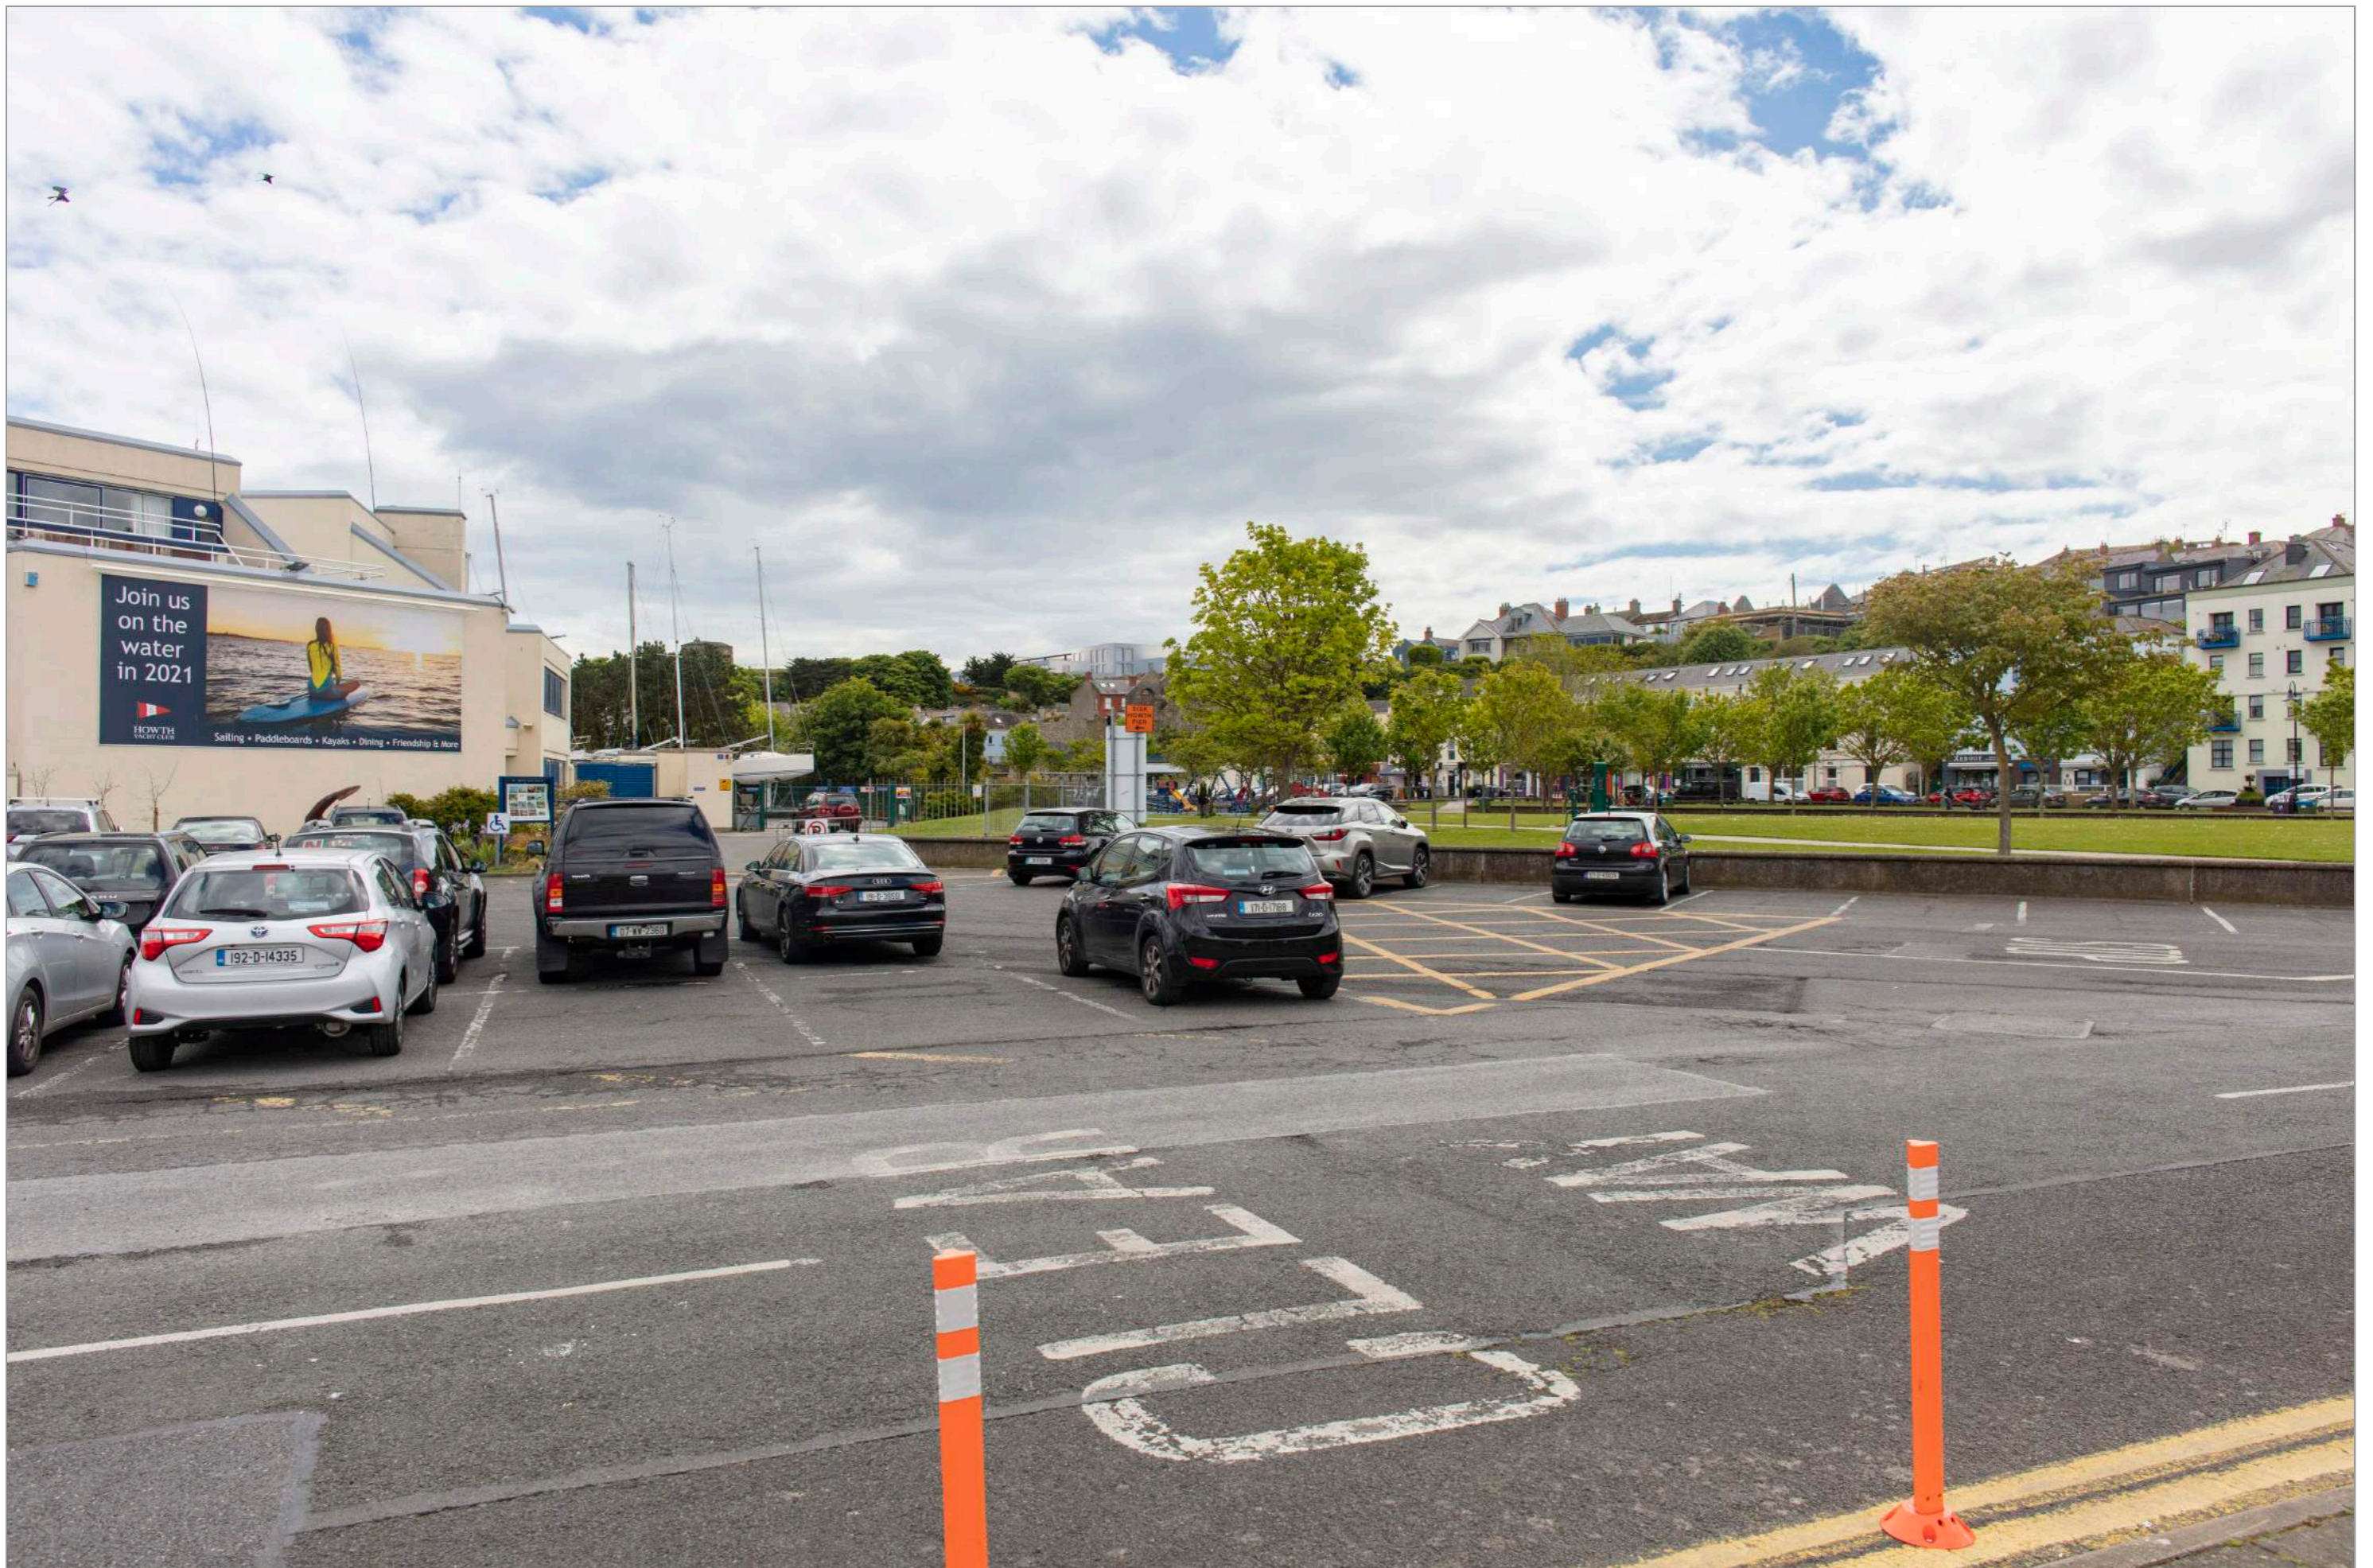
Location	Description	Photography Date	Field of view	35mm equivalent	Distance to site boundary	Camera model
View 19 Existing	From Car Park at Howth Yacht Club looking East	18/05/21	74°	24mm	289m	Canon EOS 5DS

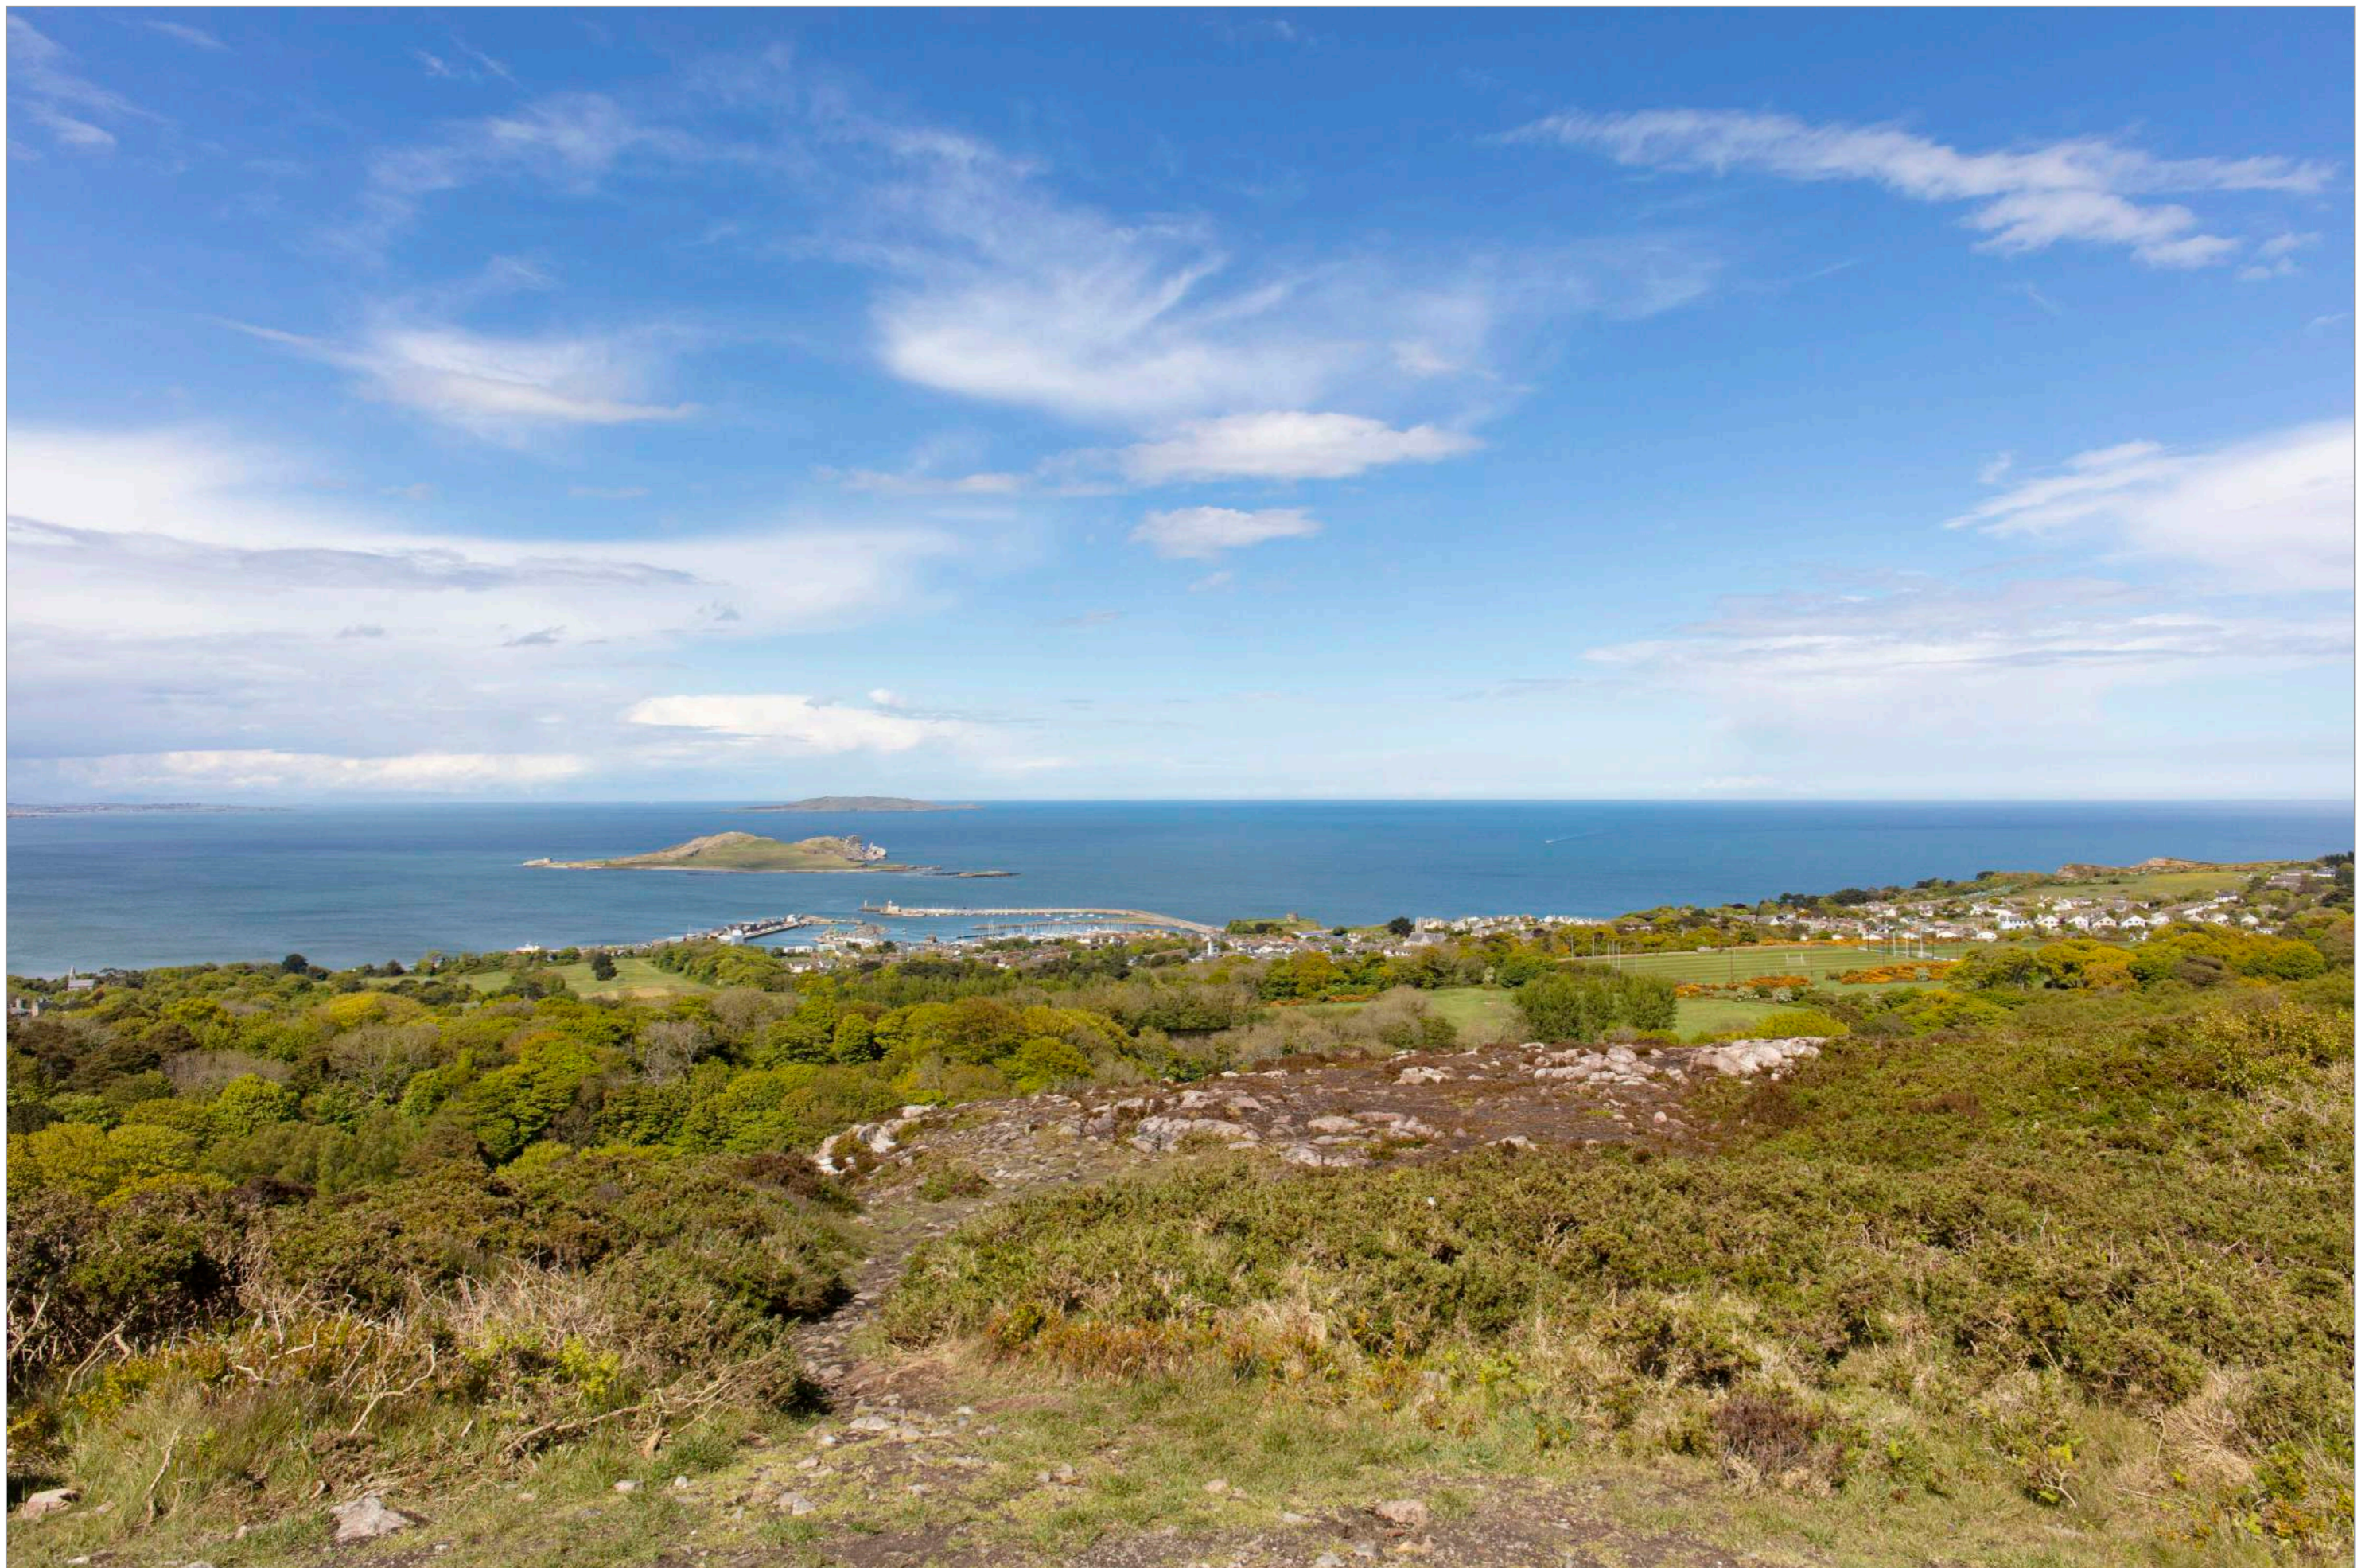
Location	Description	Photography Date	Field of view	35mm equivalent	Distance to site boundary	Camera model
View 19 Proposed	From Car Park at Howth Yacht Club looking East	18/05/21	74°	24mm	289m	Canon EOS 5DS

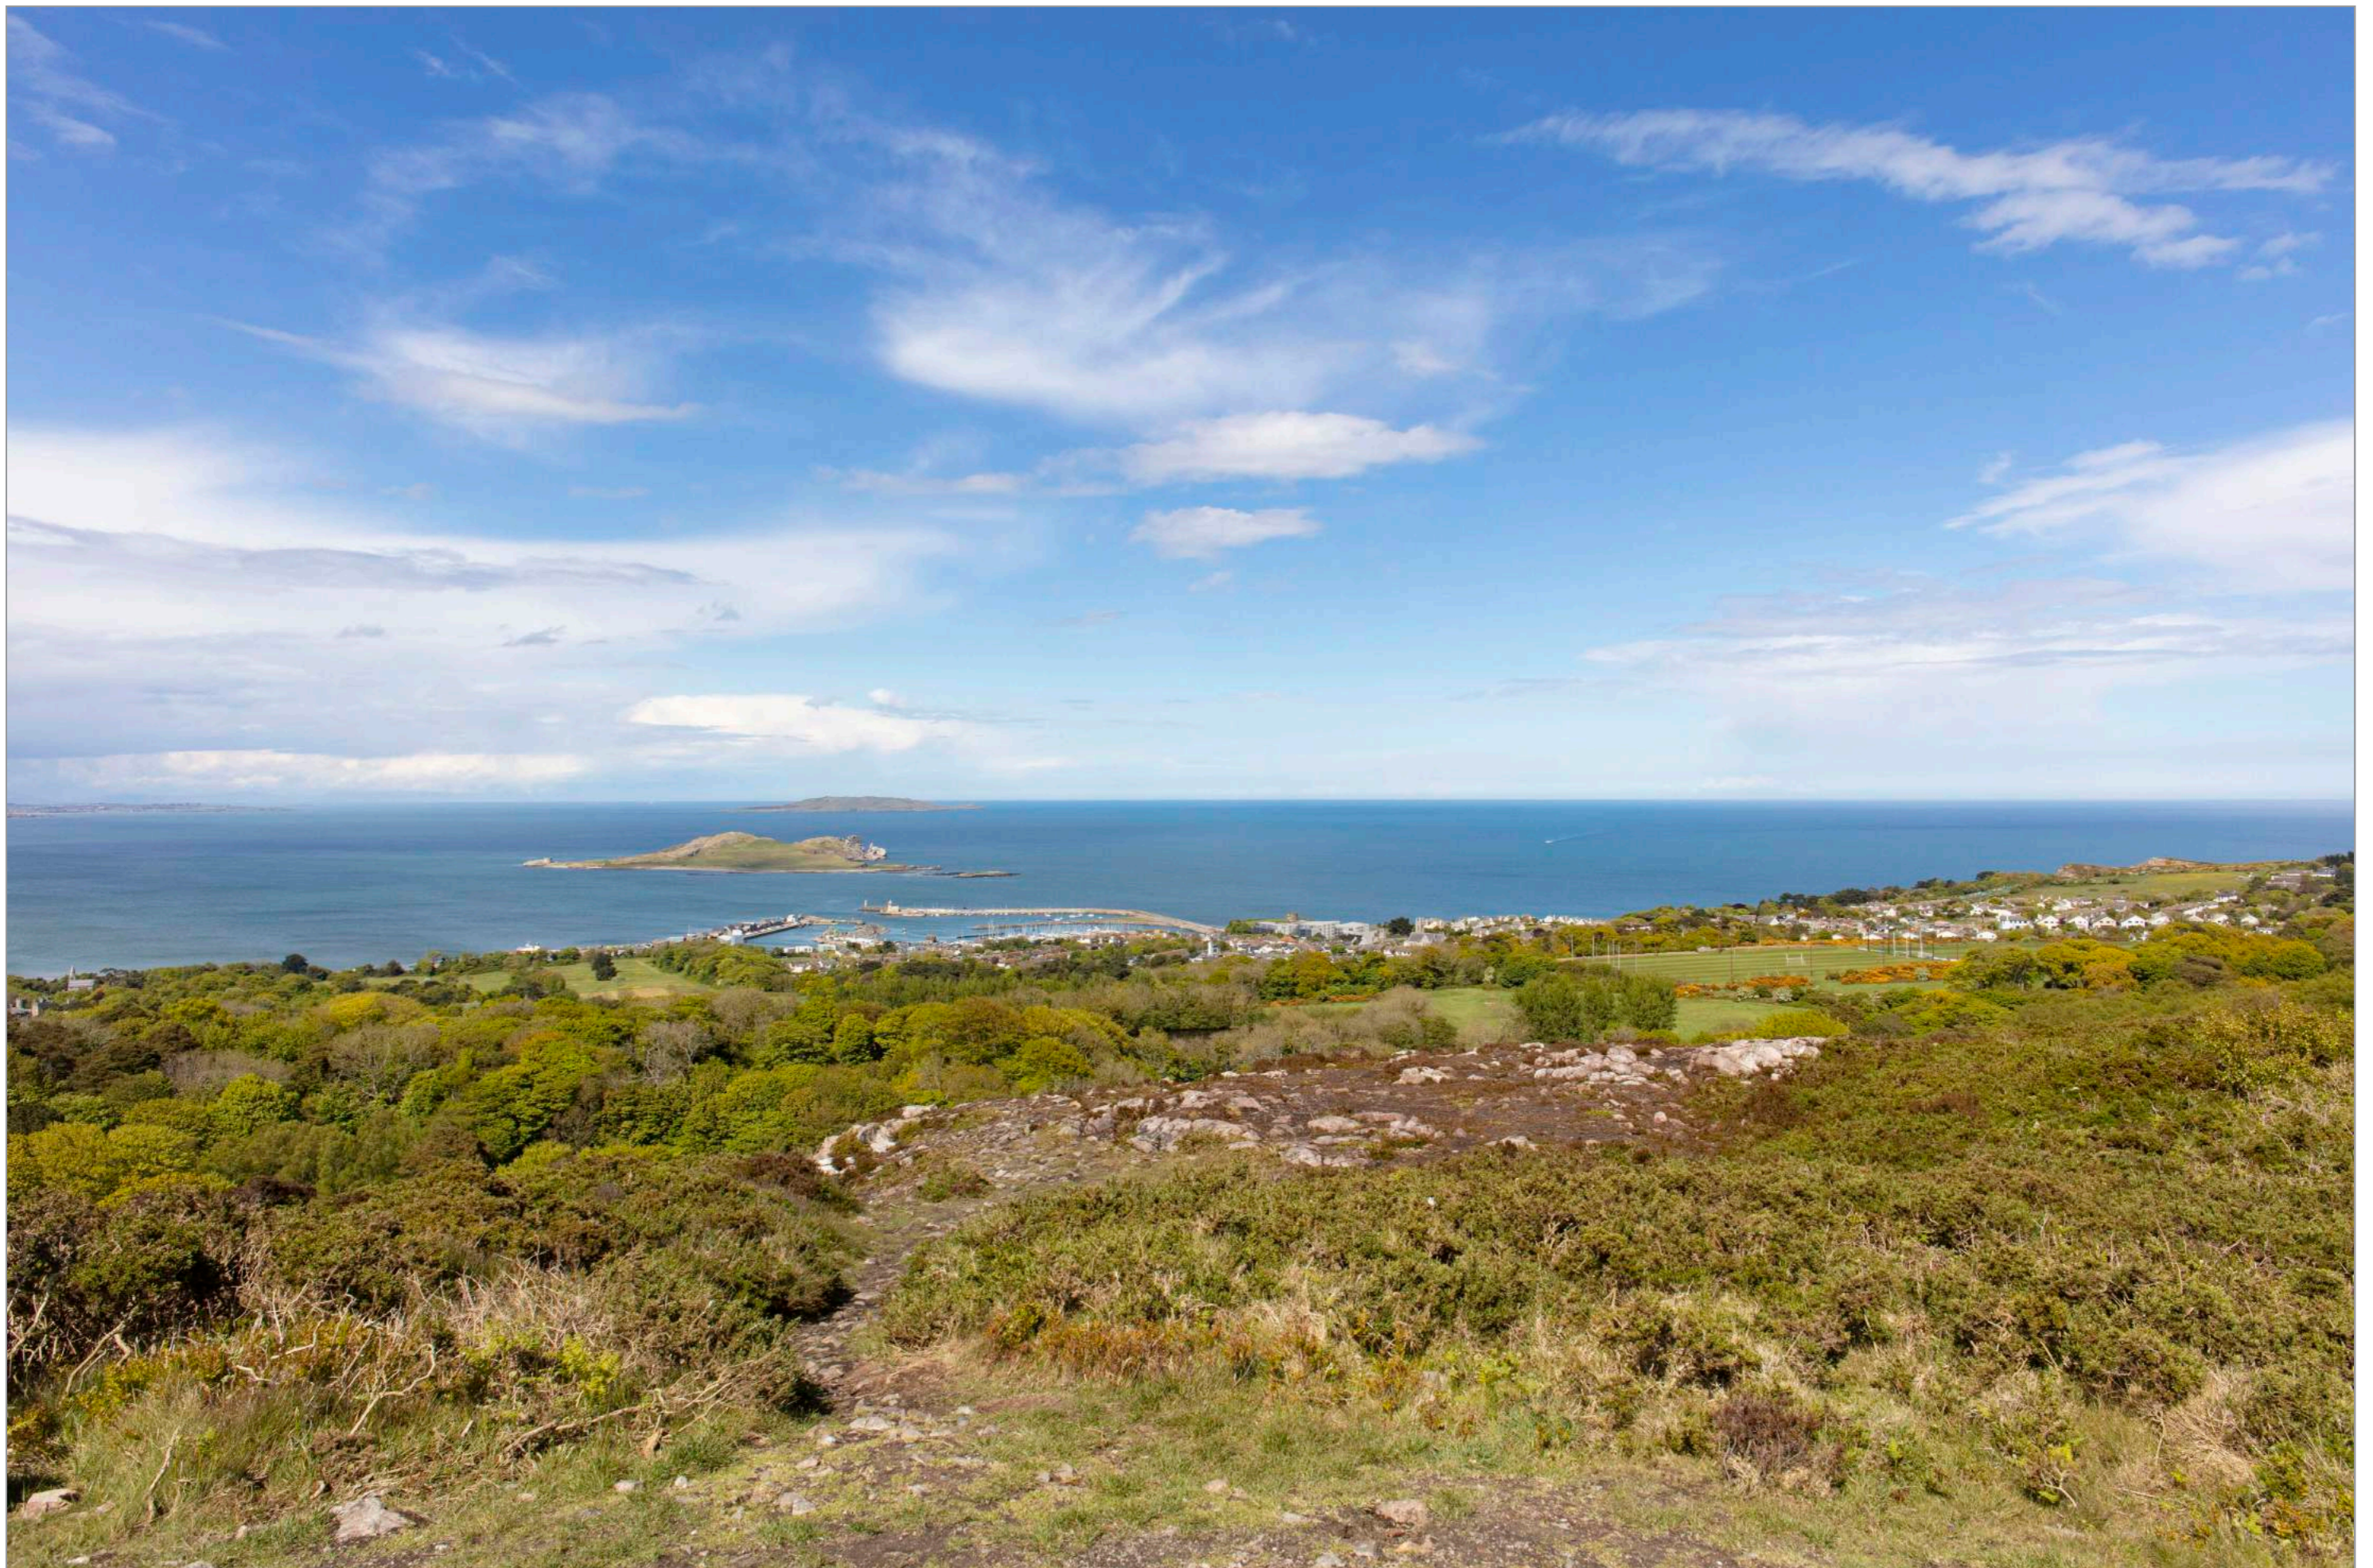
Location	Description	Photography Date	Field of view	35mm equivalent	Distance to site boundary	Camera model
View 20 Existing	From Top of Howth Hill looking North	18/05/21	74°	24mm	1374m	Canon EOS 5DS
