Appendix A

Appendix B

JV TIERNEY & CO

MECHANICAL ELECTRICAL & SUSTAINABLE ENGINEERS

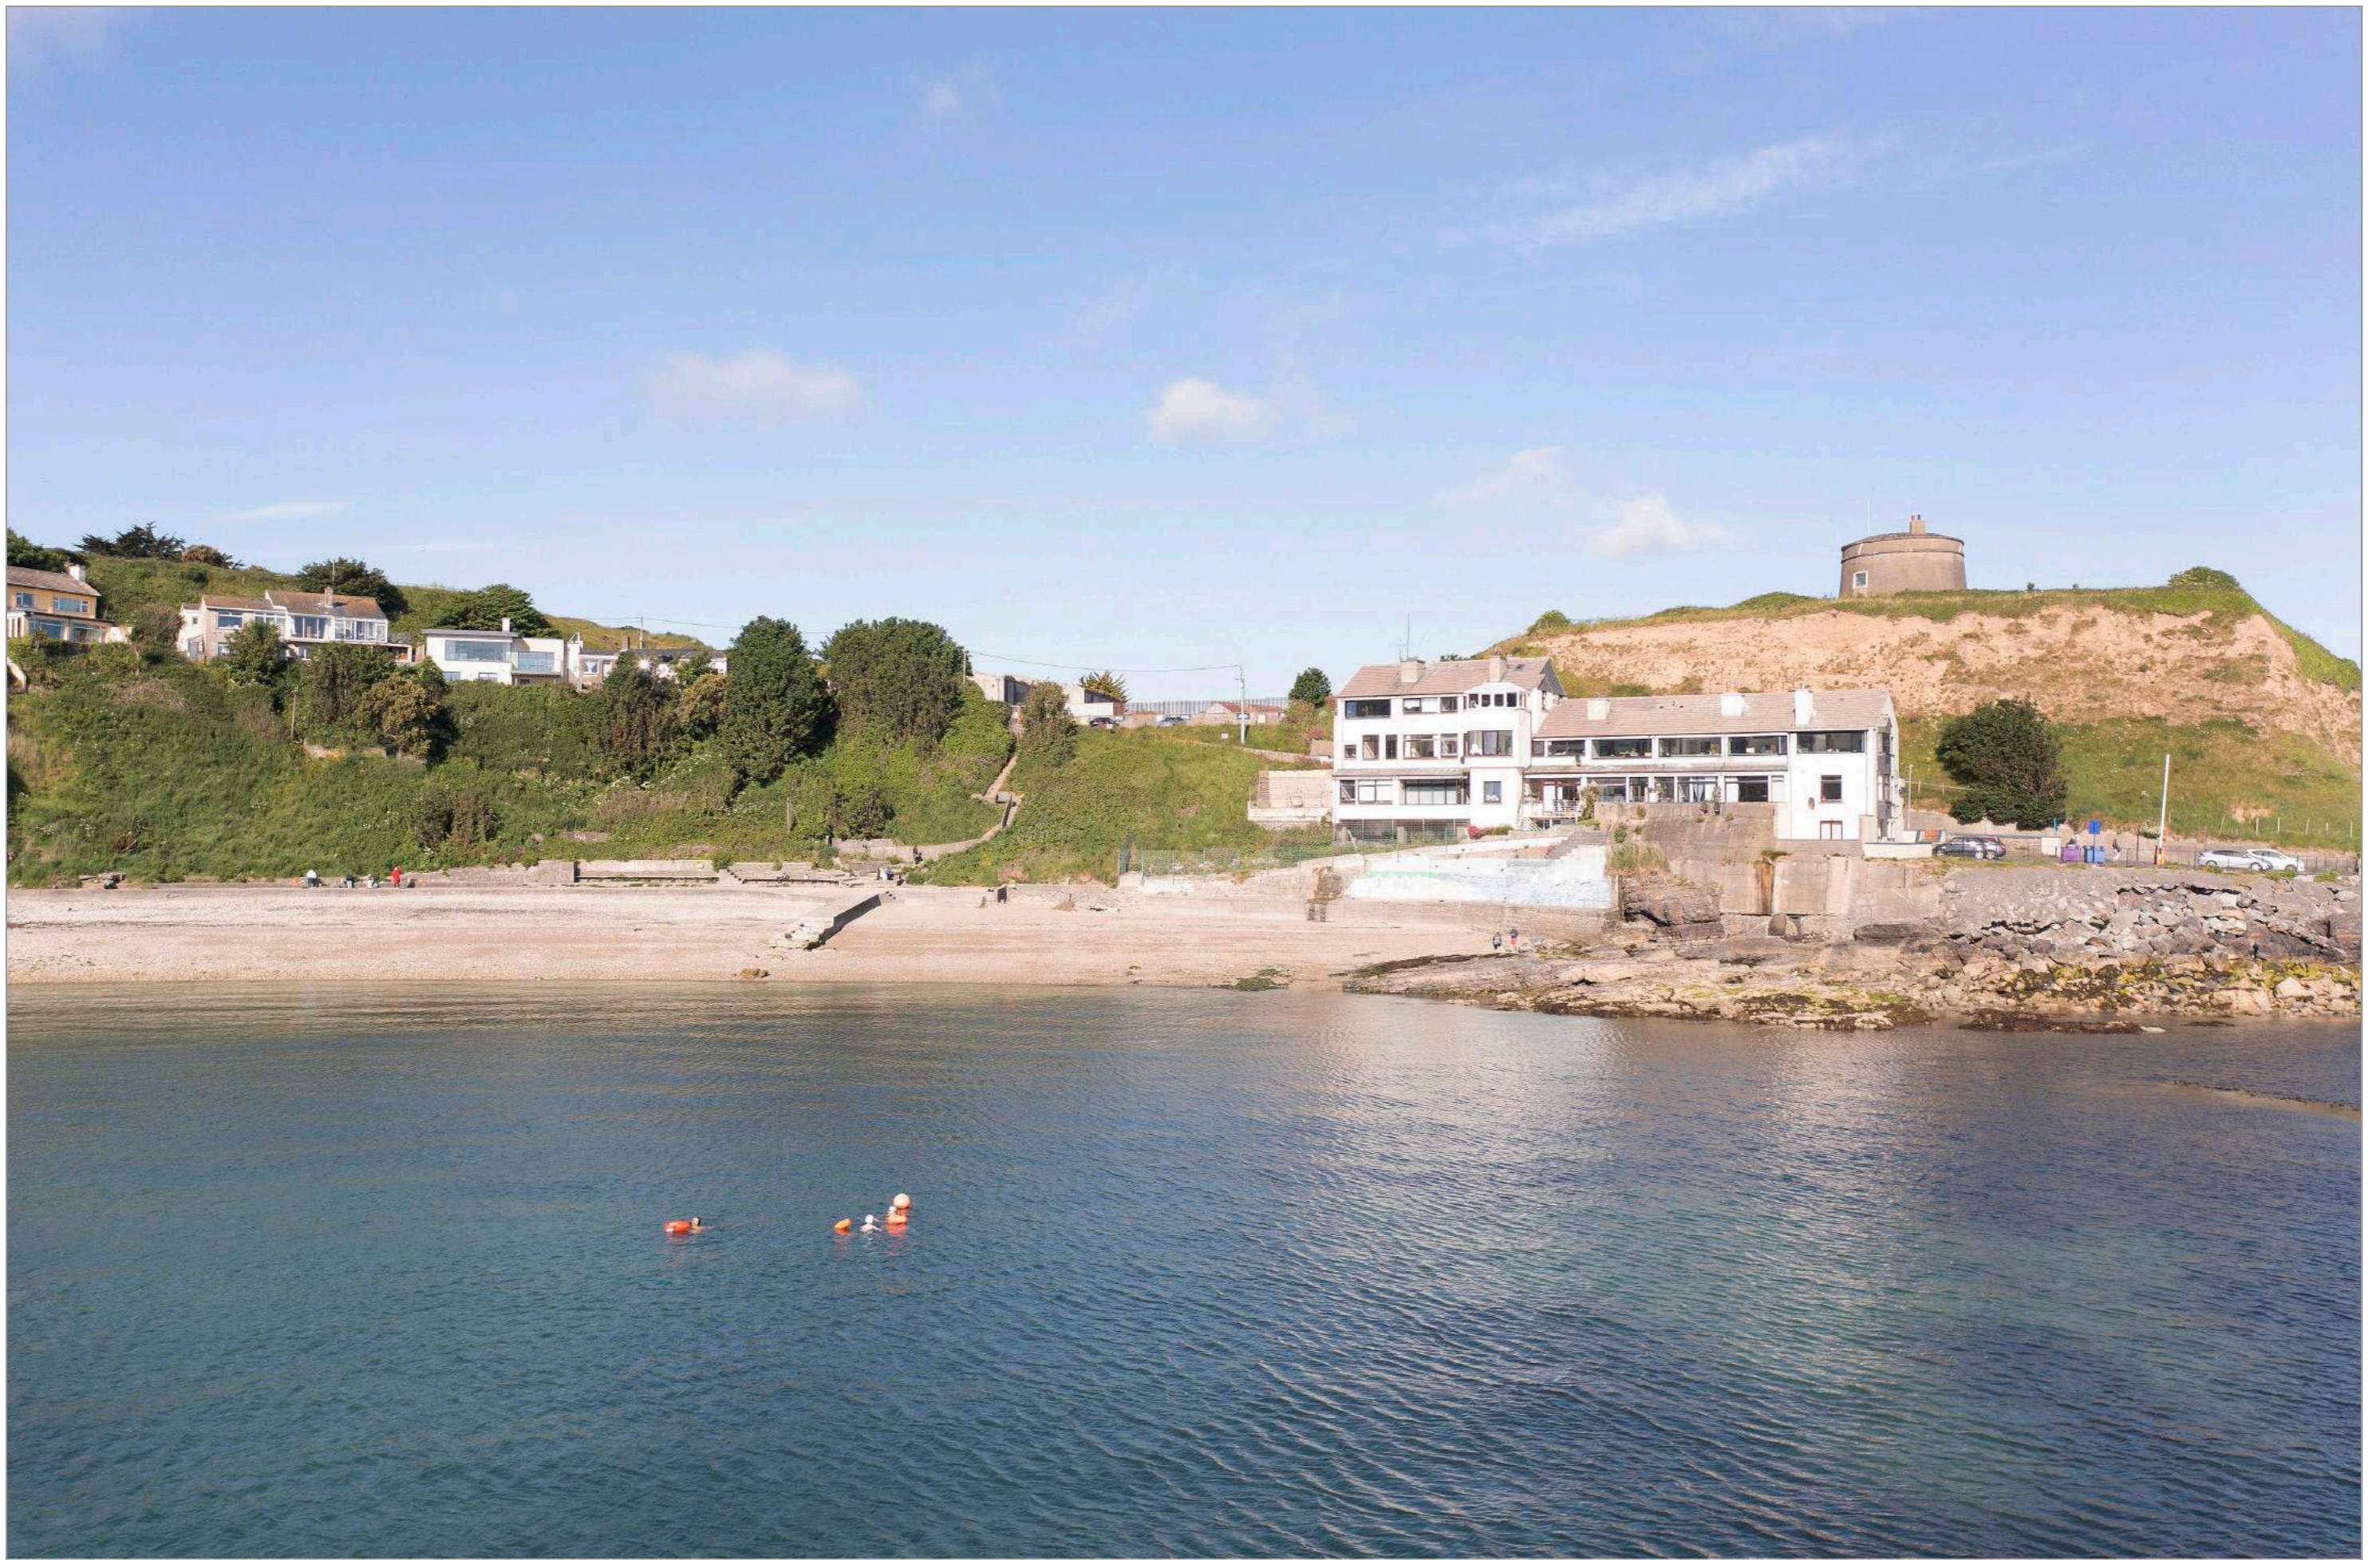
Location	Description	Photography Date	Field of view	35mm equivalent	Distance to site boundary	Camera model
View 20 Proposed	From Top of Howth Hill looking North	18/05/21	74°	24mm	1374m	Canon EOS 5DS

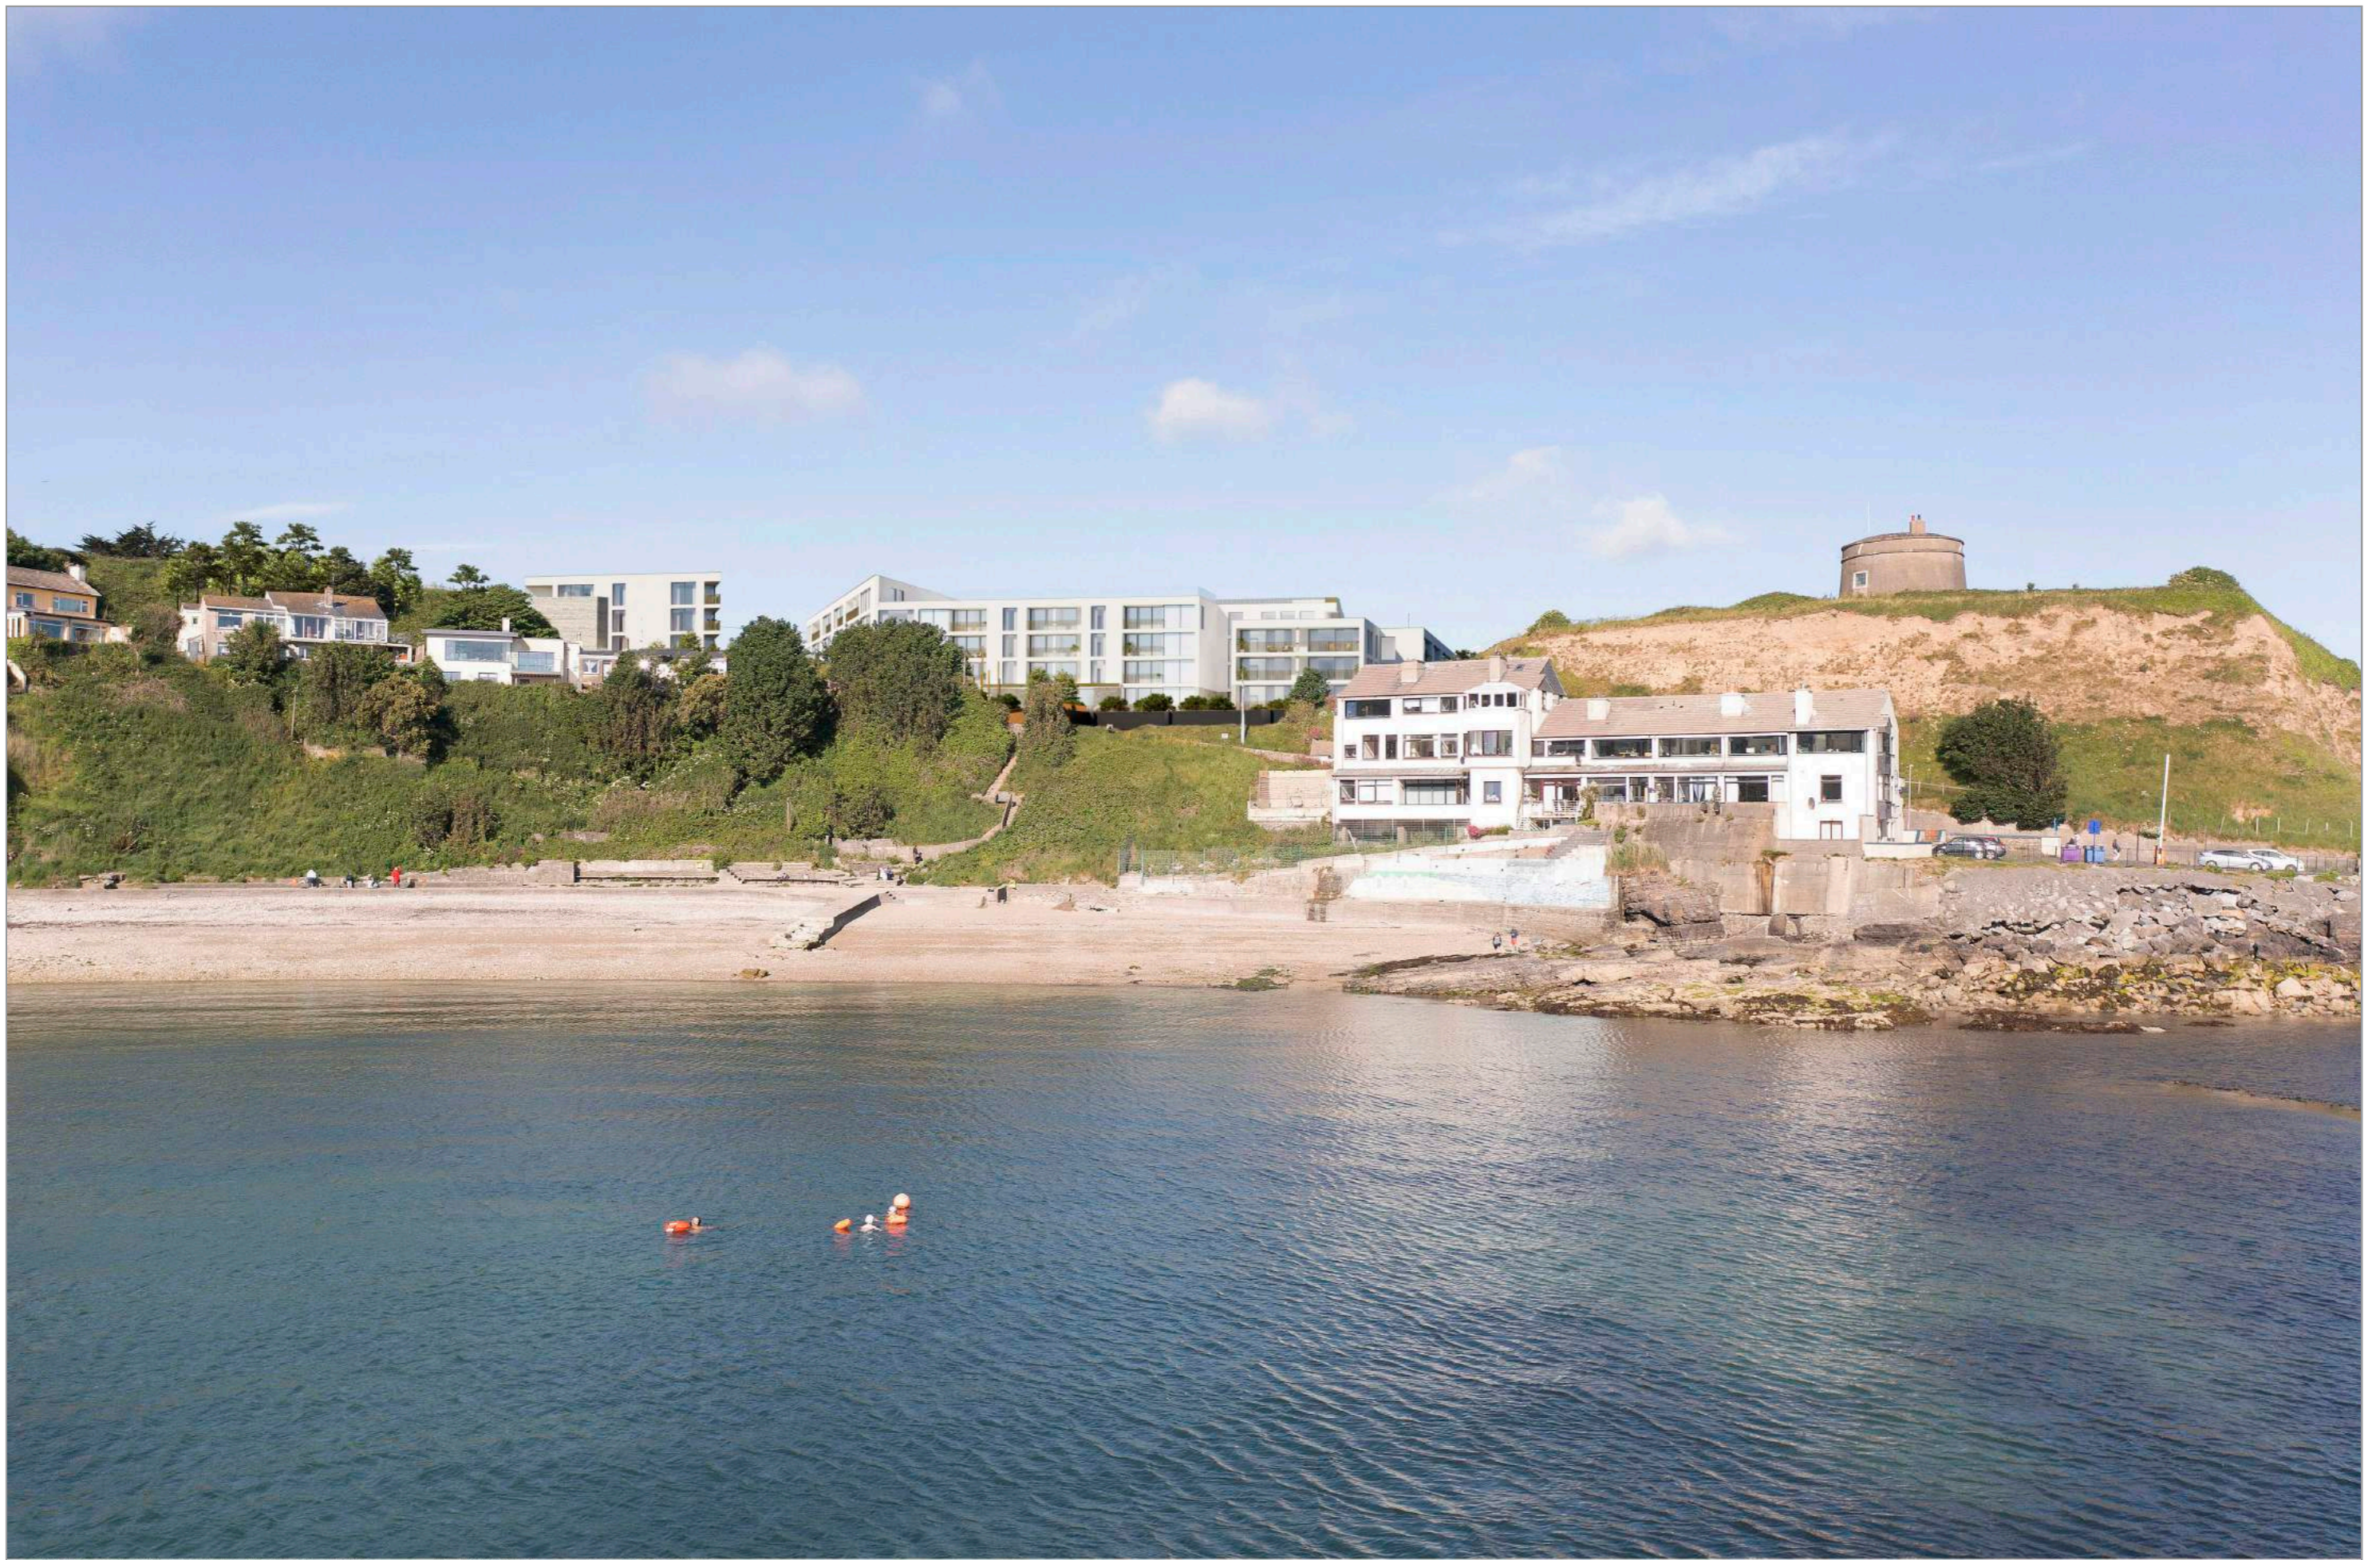
Location	Description	Photography Date	Field of view	35mm equivalent	Distance to site boundary	Camera model
View 21 Existing	Drone View from Balscadden Bay looking West	17/06/21	65.4°	28mm	unknown	Canon EOS 5DS

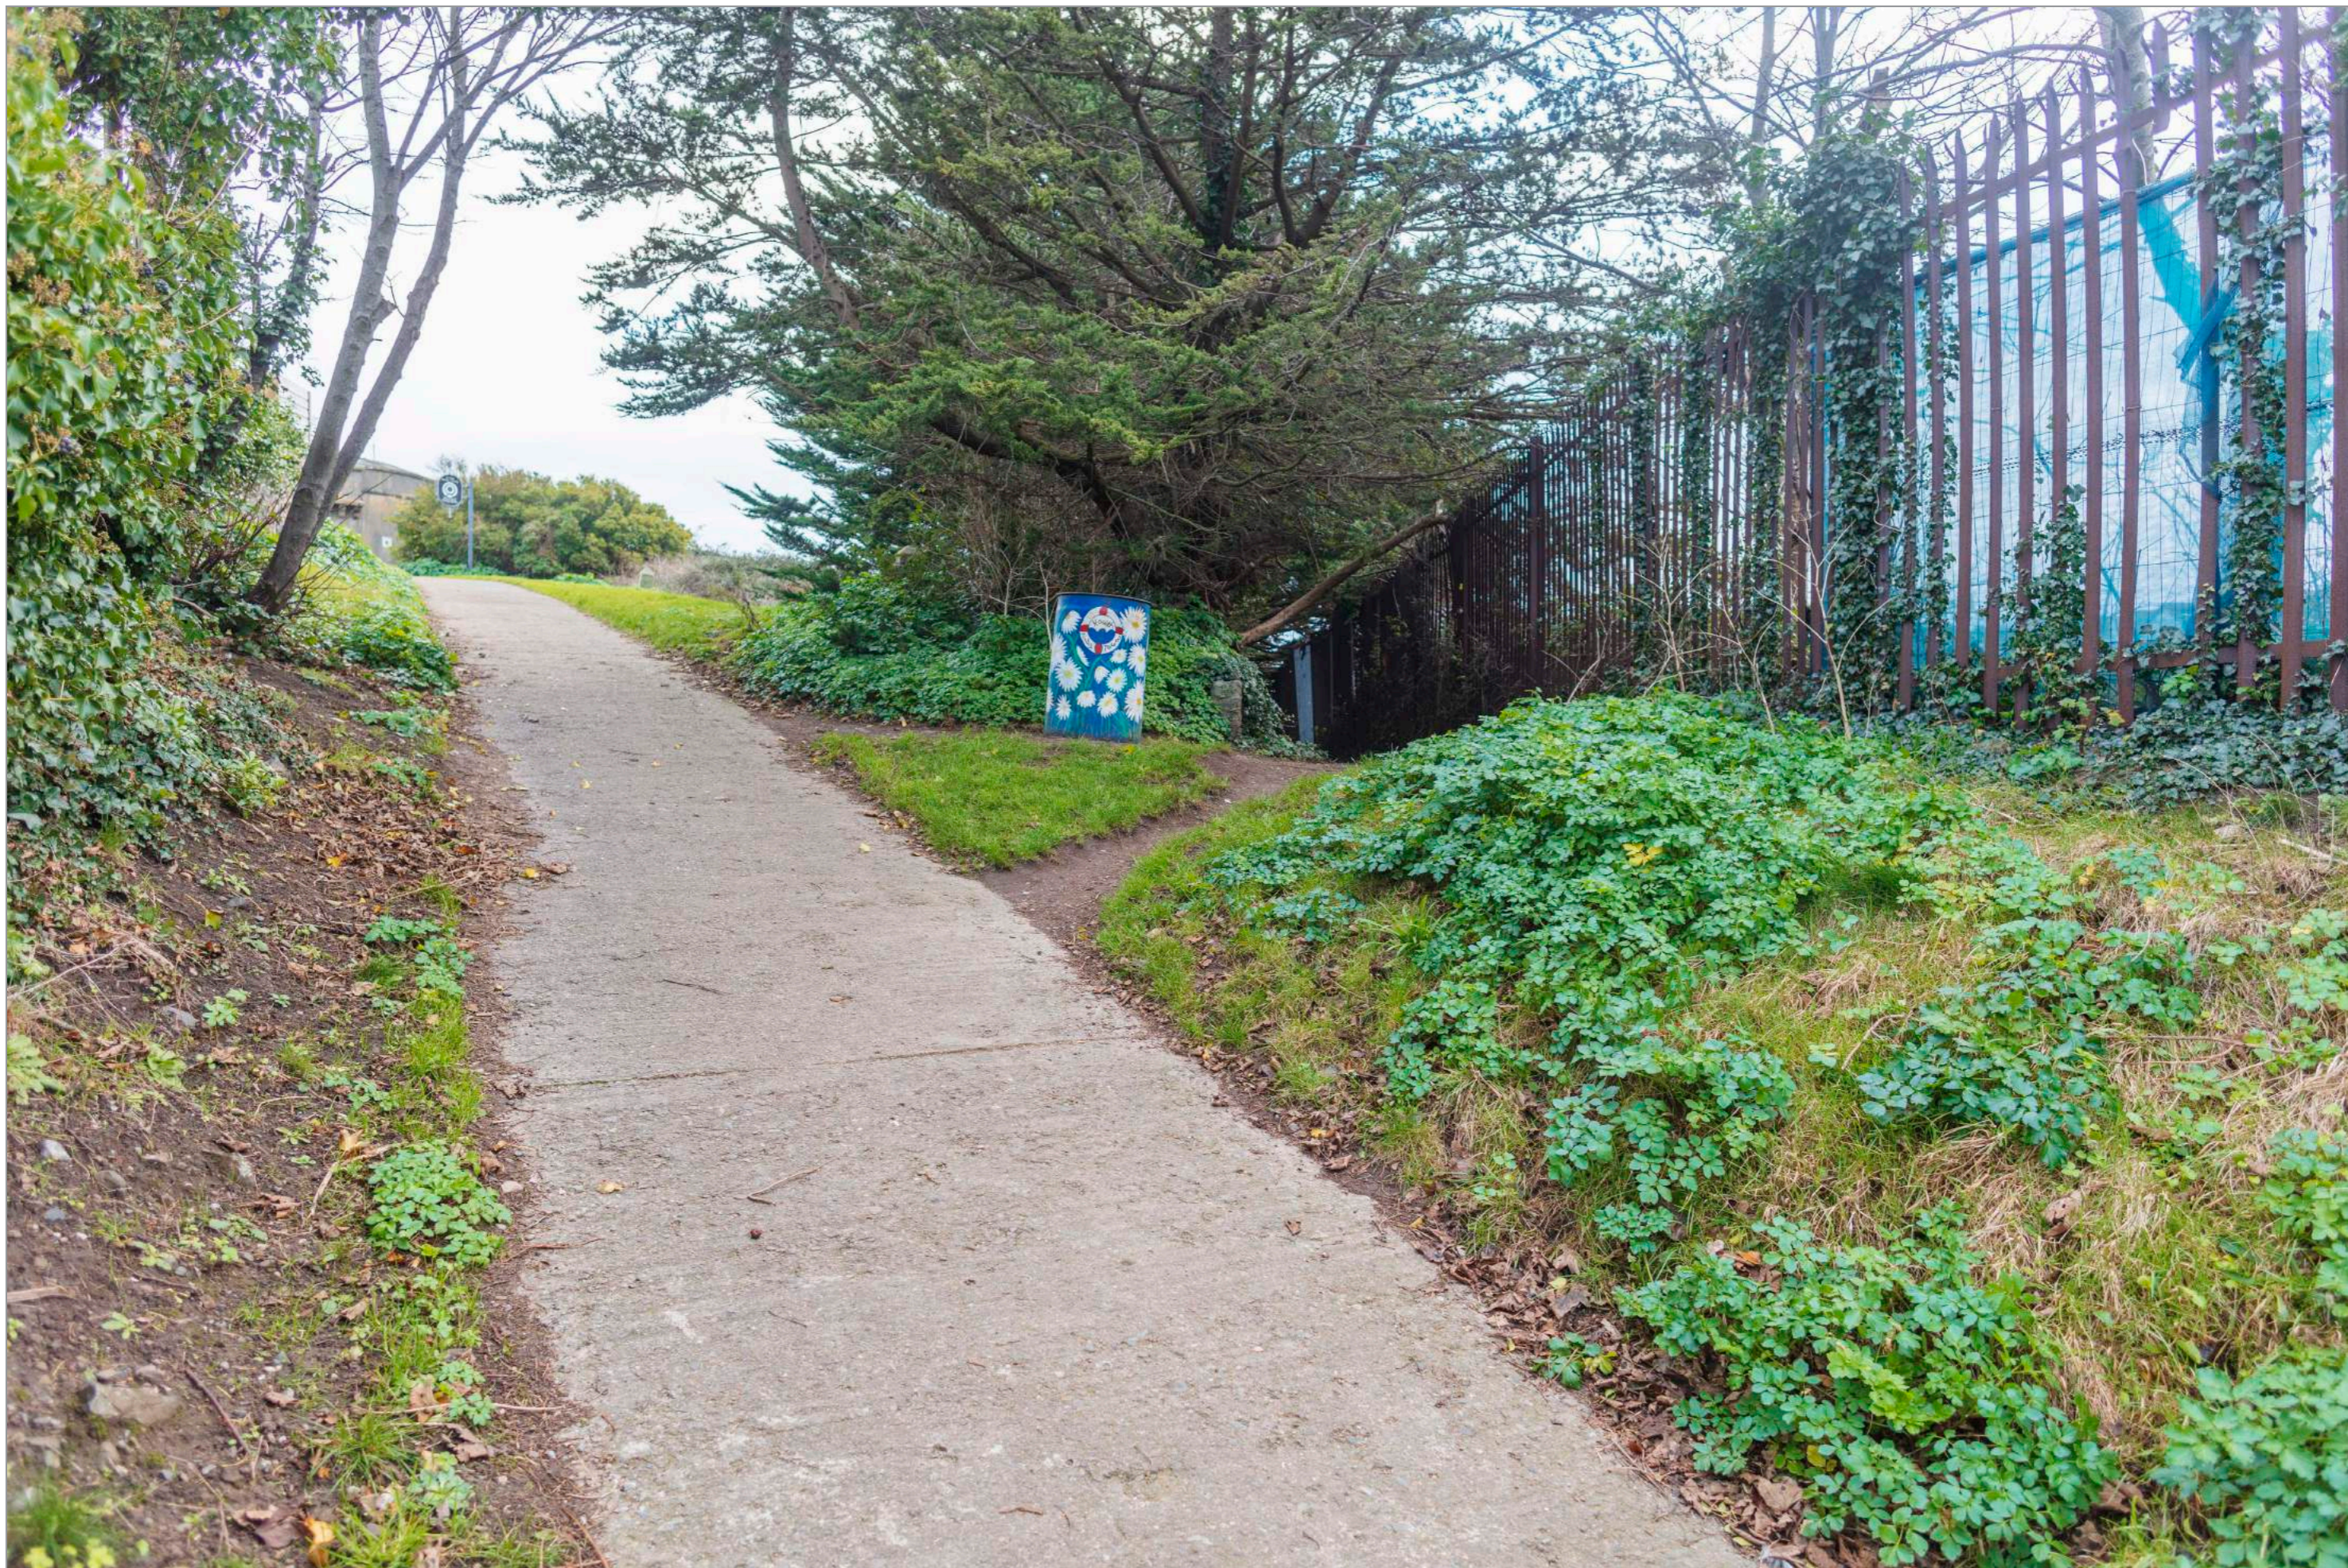
Location	Description	Photography Date	Field of view	35mm equivalent	Distance to site boundary	Camera model
View 21 Proposed	Drone View from Balscadden Bay looking West	18/05/21	65.4°	24mm	unknown	Canon EOS 5DS
