Balscadden Development, Howth, Co. Dublin

Geotechnical Report

Report No. B1800-GEO-R001

21 March 2022

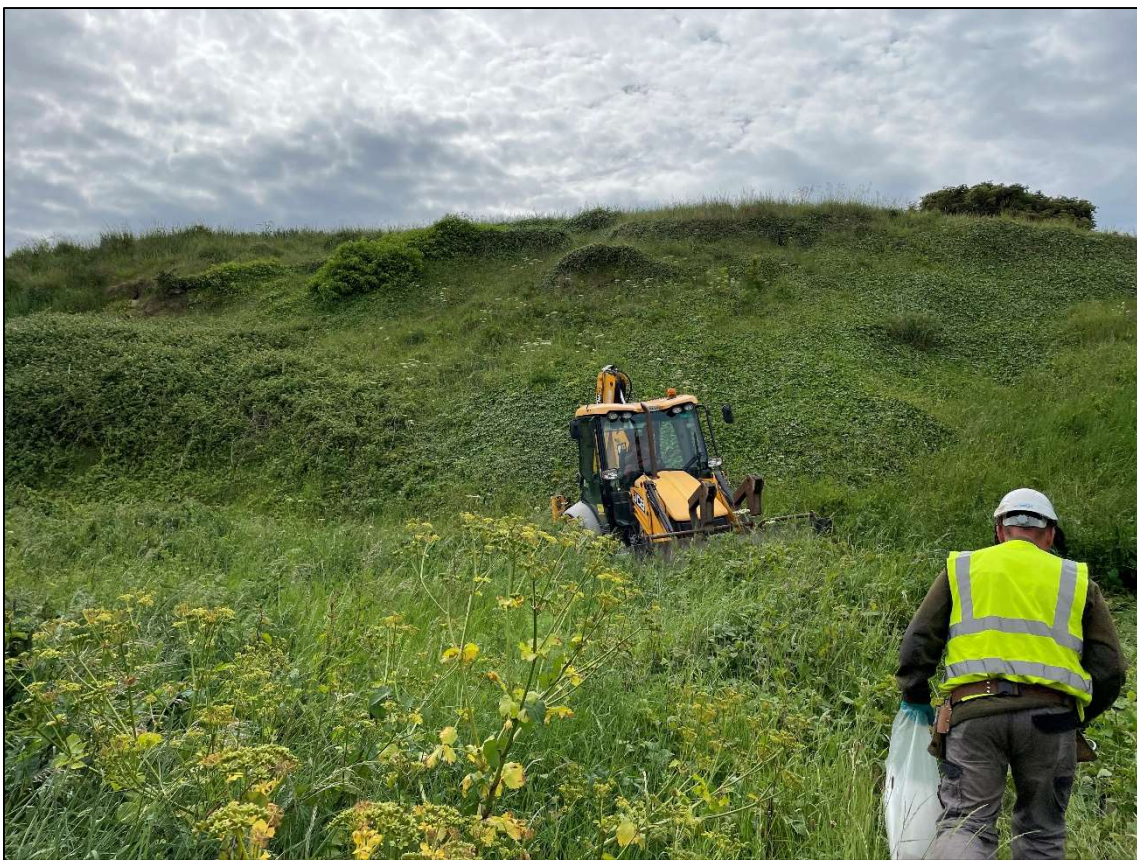
Figure 2.2: Topographical Changes Across the site

Additionally, the historical Howth Sewer Tunnel passes under the site.

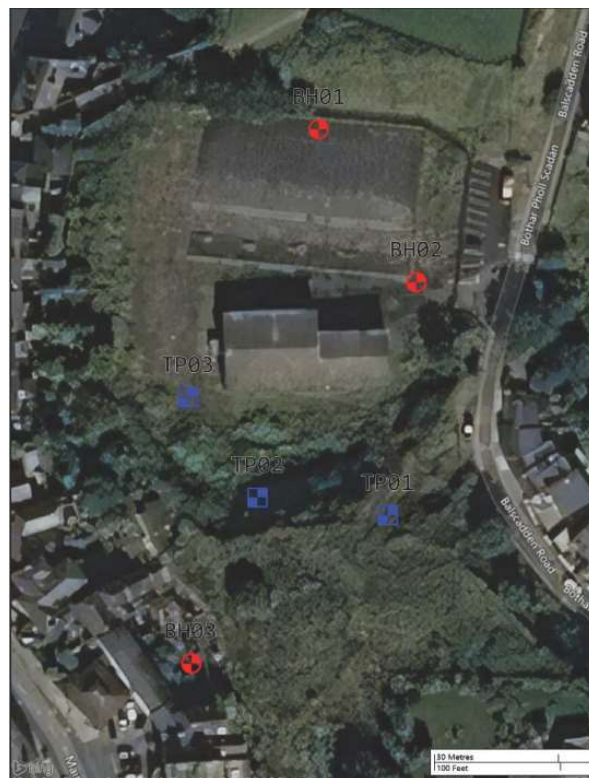
Figure 4.4: Site Investigation 2021 Exploratory Hole Plan

The exploratory hole plan is shown as Figure 4.4.

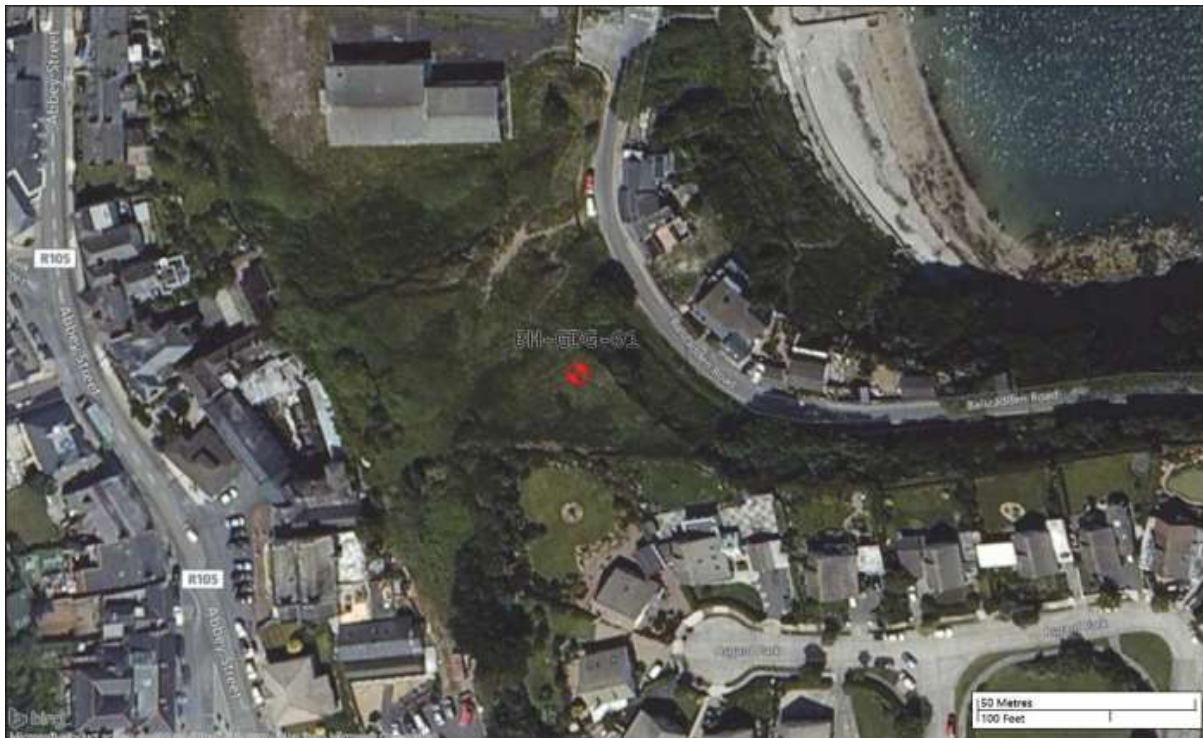
Figure 4.5: Site Investigation 2017 Exploratory Hole Plan

The exploratory hole plan is shown as Figure 4.5.

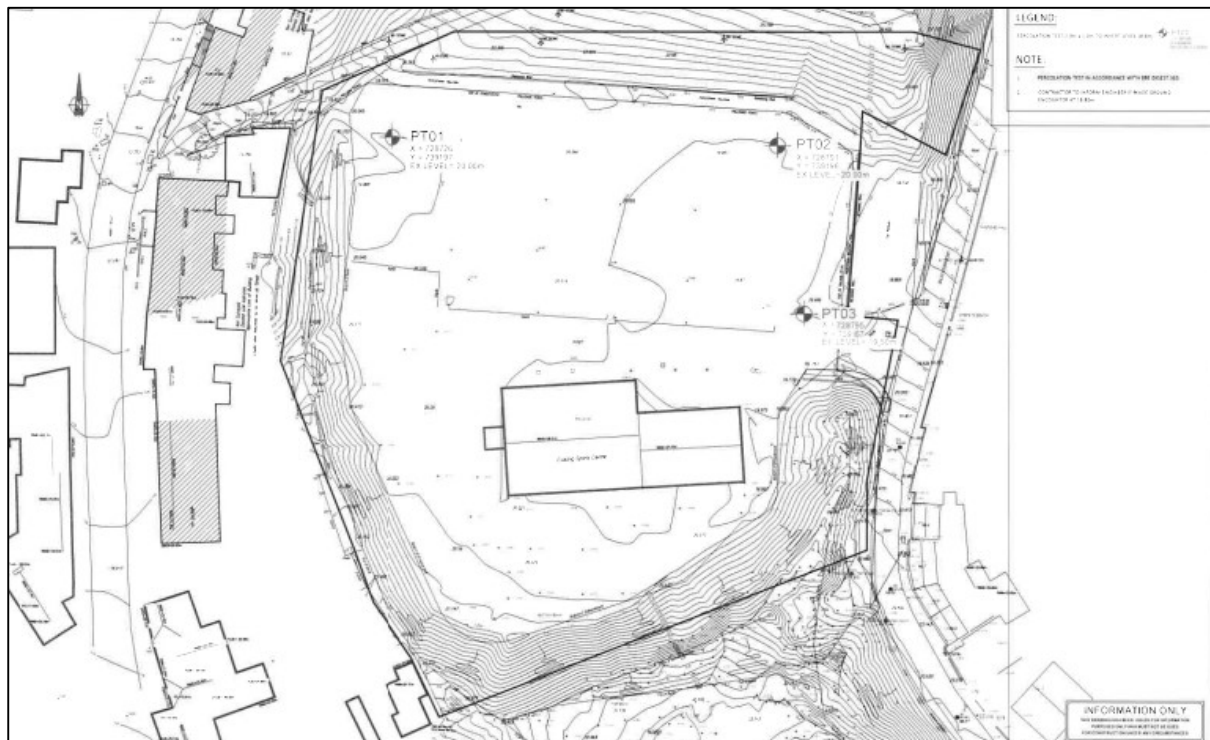
Figure 4.6: Ground Investigations Ireland 2017 Exploratory Hole Plan

The exploratory hole plan is shown as Figure 4.6.

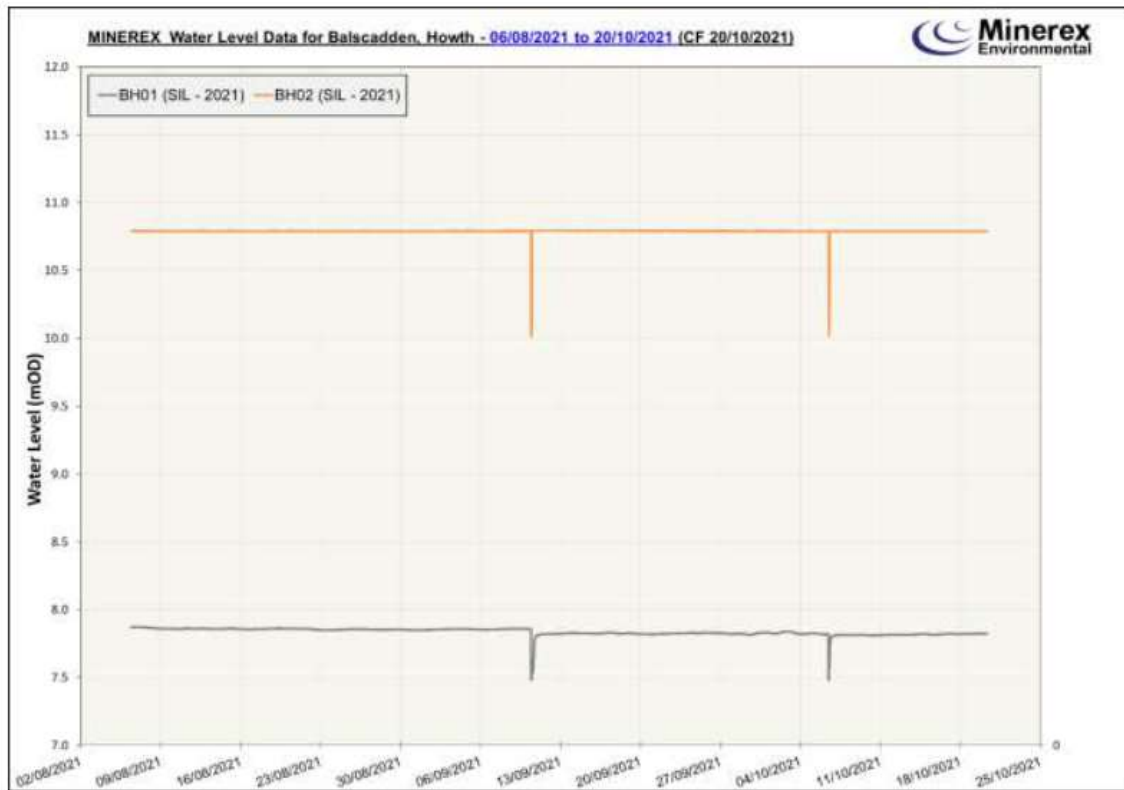
Figure 4.8: Groundwater Monitoring

included as Appendix B, Borehole BH-GDG-01 was dry throughout the monitoring period. The recorded groundwater levels in BH01 and BH02 are shown as Figure 4.8.

Based on the above groundwater monitoring, a conservative groundwater level of 12m OD has been proposed as a design groundwater level.

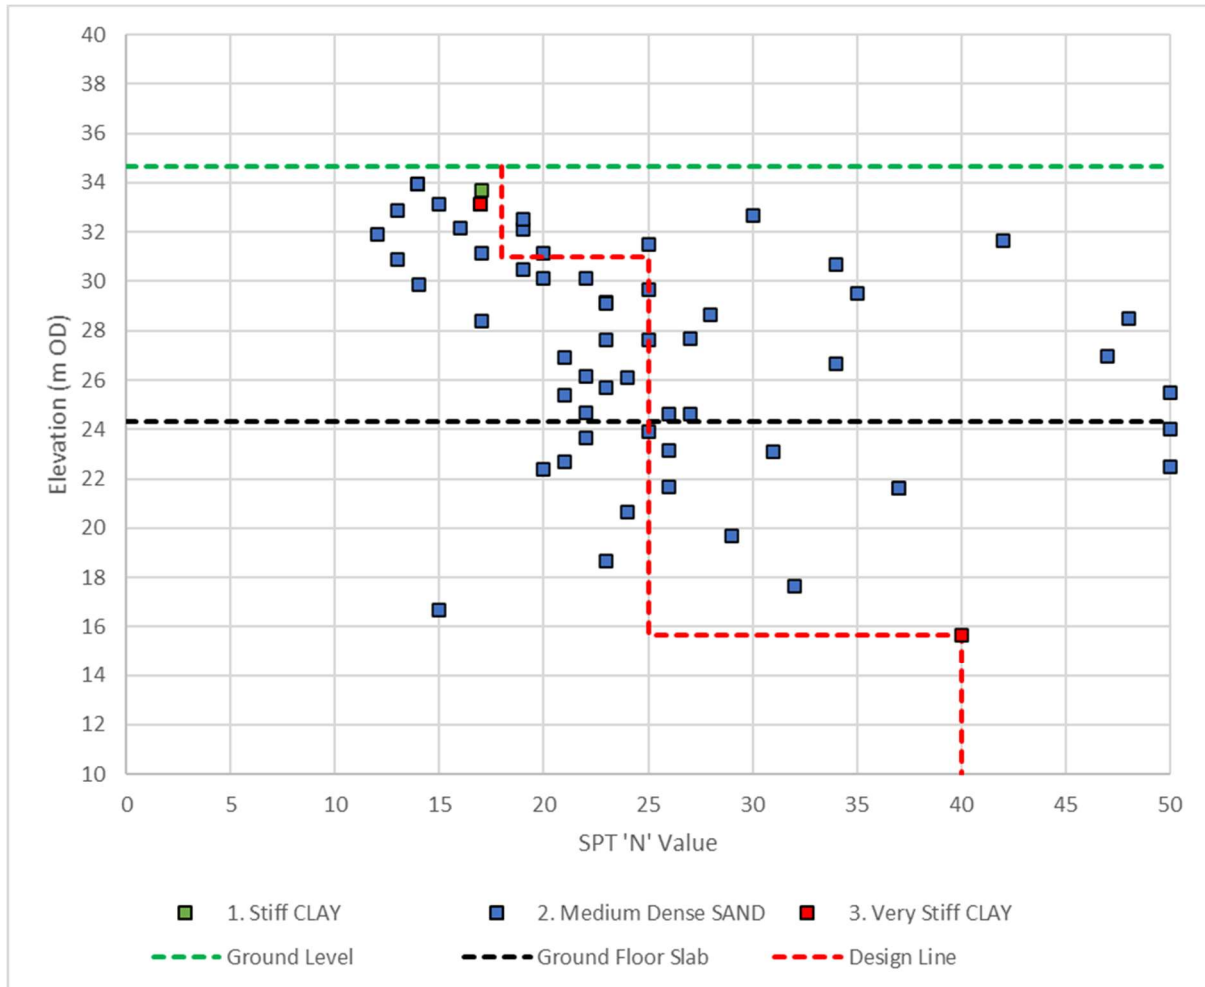
Figure 4.9: SPT Data – Southern Elevation

The SPT ‘N’ values have been plotted against elevation. These have been split out into two separate plots based on the topographical changes across the site and are shown in Figure 4. and Figure 4.. The characteristic soil parameters can be estimated by correlating the SPT ‘N’ values recorded in the boreholes with various soil parameters, based on published relationships.

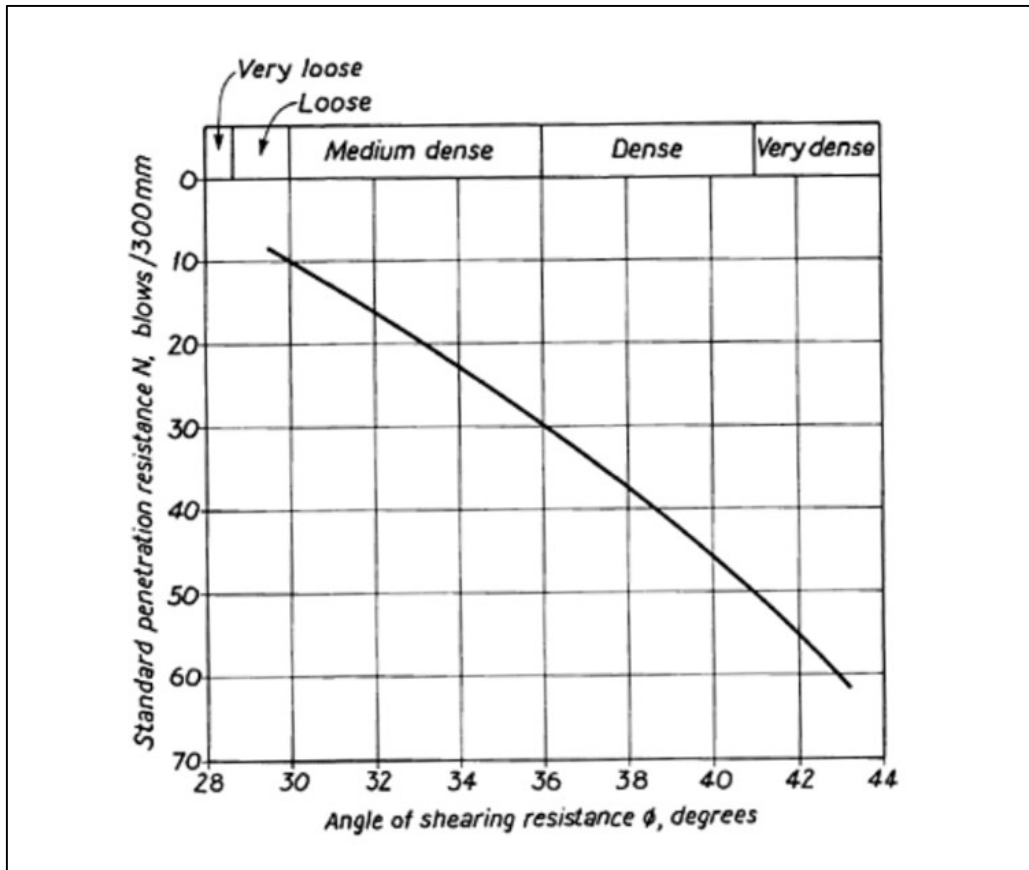
Figure 4.11: Peck's Relationship between SPT 'N' and angle of Shearing Resistance

- The internal angle of friction of the granular materials can be calculated after the relationship published by Peck, with Figure 4. below detailing Peck’s relationship between SPT ‘N’ values and the angle of shearing resistance.
- The undrained shear strength of the cohesive material can be calculated based on the Stroud correlation, $C_u = f_1 N$, shown in Figure 4.. The parameter f_1 is related to the plasticity index of the material. In the absence of Atterberg limit tests, f_1 is to be taken as 5.
- The stiffness of cohesive soils can also be approximated using relationships as set out in CIRIA C760. The soil stiffness modulus is based on $600 \times C_u$ for the undrained case and 66% of this value for the drained case. For granular soils, the stiffness has been taken as $2000 \times 'N'$.

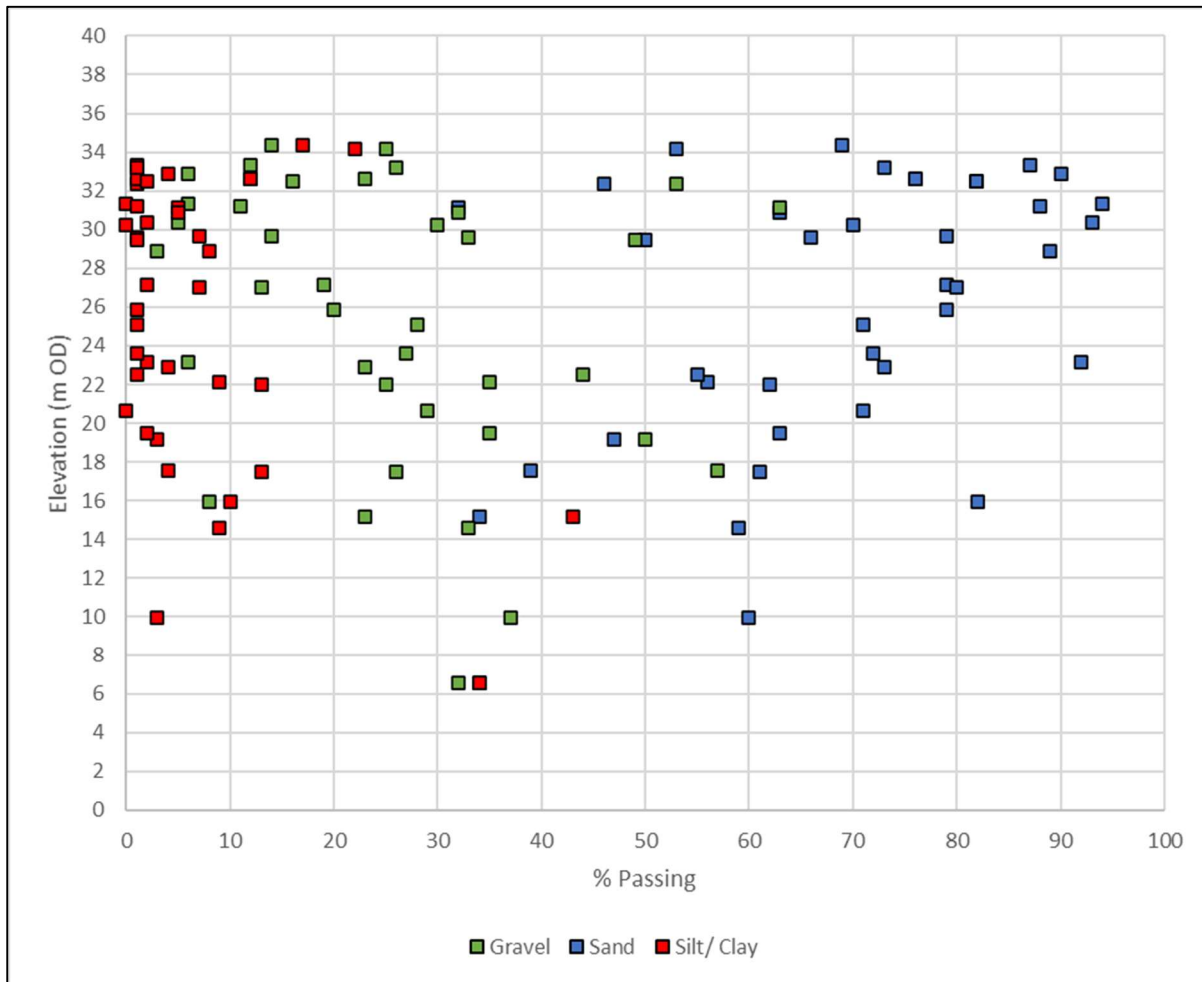
Figure 4.9: Particle Size Distribution Test Results

A series of particle size distribution tests were completed as part of the various phases of investigation. The results of the tests are summarised in Figure 4.9.

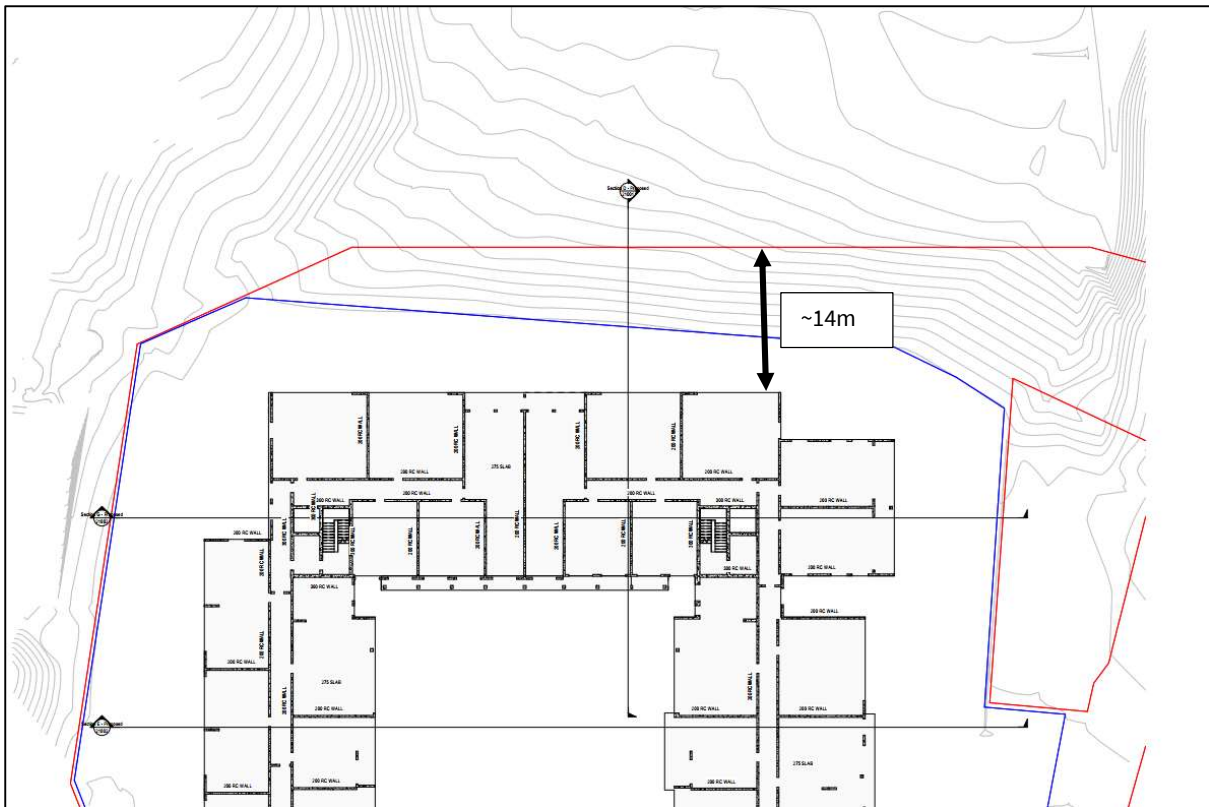
Figure 7.1: Block B Basement Layout

The revised proposal for Block B is offset from the site boundary. Based on the offset, it is proposed to construct the basement using open cut excavation techniques. The proximity of the Block B basement to the northern site boundary is shown in Figure 7.1 and Figure 7.2, with the red line representing the site boundary and the blue line representing the development boundary.

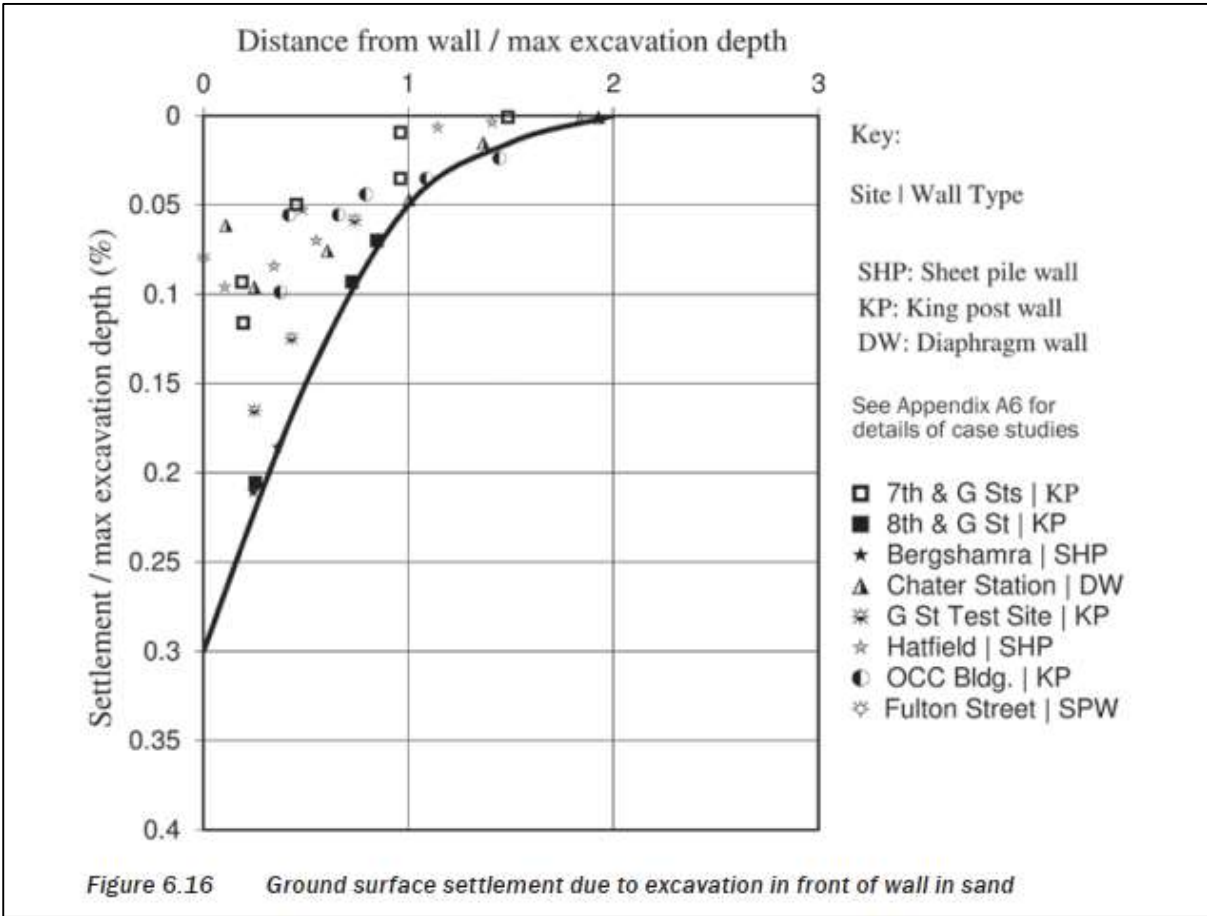
Figure 7.3: Ground Surface Settlement due to excavation in front of wall in sand (CIRIA C760 Fig. 6.16)

Based on concerns regarding the basement’s construction, ground movements associated with the excavation works and their impact on the adjacent Martello Tower, ByrneLooby have undertaken a building damage assessment. The assessment has been undertaken using ground movement curves caused by the lateral deflection of an embedded retaining wall, which are based on default values within CIRIA C760, which are derived from a number of historic cases. This is considered conservative, as the ground movements generated from open cut excavations will be significantly less and the assessment is considered worst-case. The ground movement curve used in the assessment is the ‘Ground Surface Settlement due to excavation in front of a wall in Sand’ as shown in Figure 7.3.

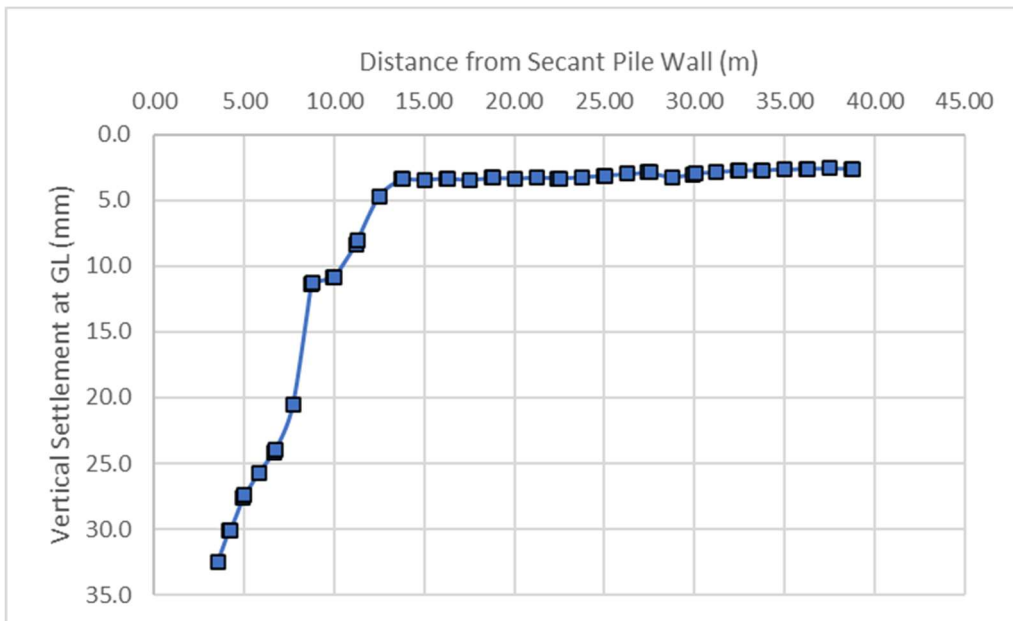
Figure 8.1: Southern Boundary Vertical Settlement

The predicted ground movements along the southern elevation, adjacent to the secant pile wall have been outlined in Section 5. For the basis of the ground movement analysis only the long-term analysis (worst-case analysis) has been considered. These ground movements have been presented as Figure 8.1 and Figure 8.2. Although, vertical settlements of 2.5mm are recorded at a distance from the wall, these are caused by the application of the 10kPa UDL rather than any impact of the basement excavation.

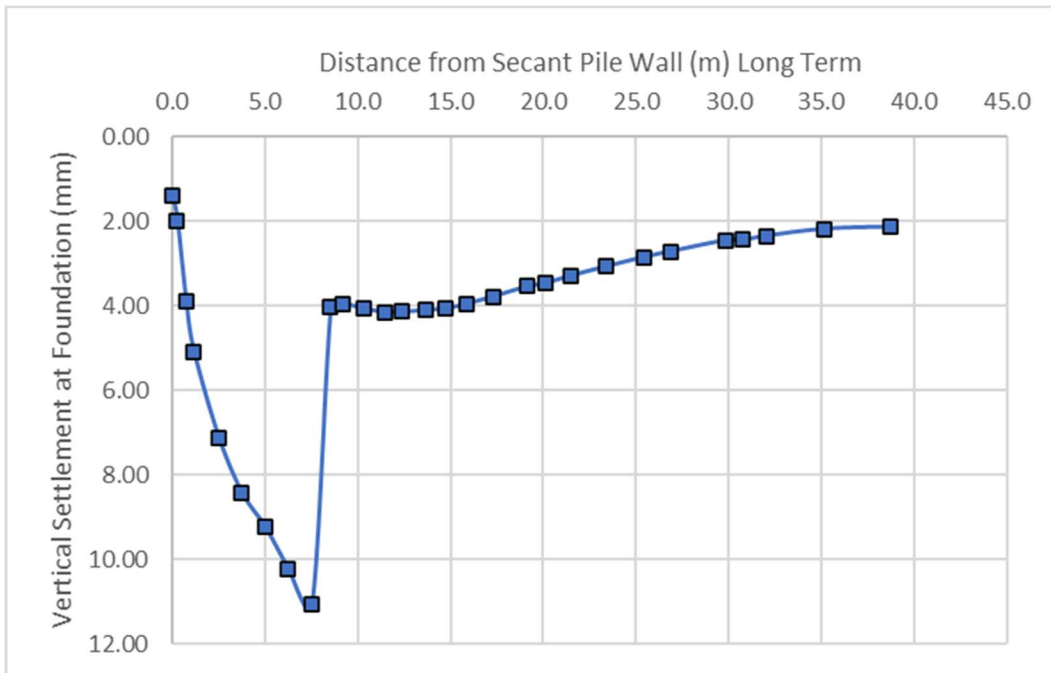
Figure 8.3: Western Boundary Vertical Settlement

The predicted ground movements along the western elevation, adjacent to the secant pile wall have been outlined in Section 6. For the basis of the ground movement analysis only the long-term analysis (worst-case analysis) has been considered. These ground movements have been presented as Figure 8.3 and Figure 8.4 and are the calculated movements at the adjacent Building’s foundation level, which is assumed as 1m bgl (+24.5m OD).

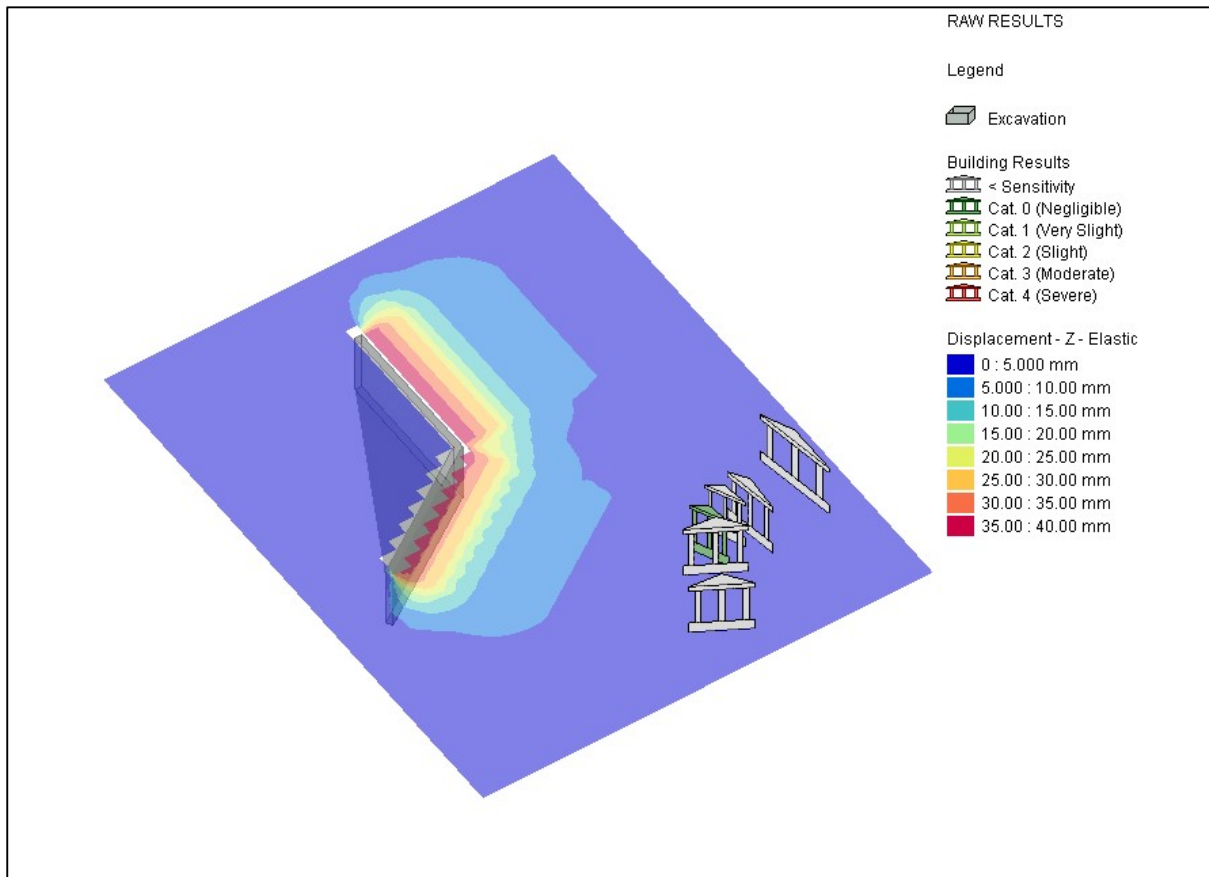
Figure 8.5: Building Damage Assessment – Southern Elevation Secant Pile Wall

Based on the predicted ground movements, a **Category 0 (Negligible category)** has been determined for the garage of 22 Asgard Park, while 21 and 22 Asgard Park lie outside the zone of sensitivity, as shown in Figure 8.5.

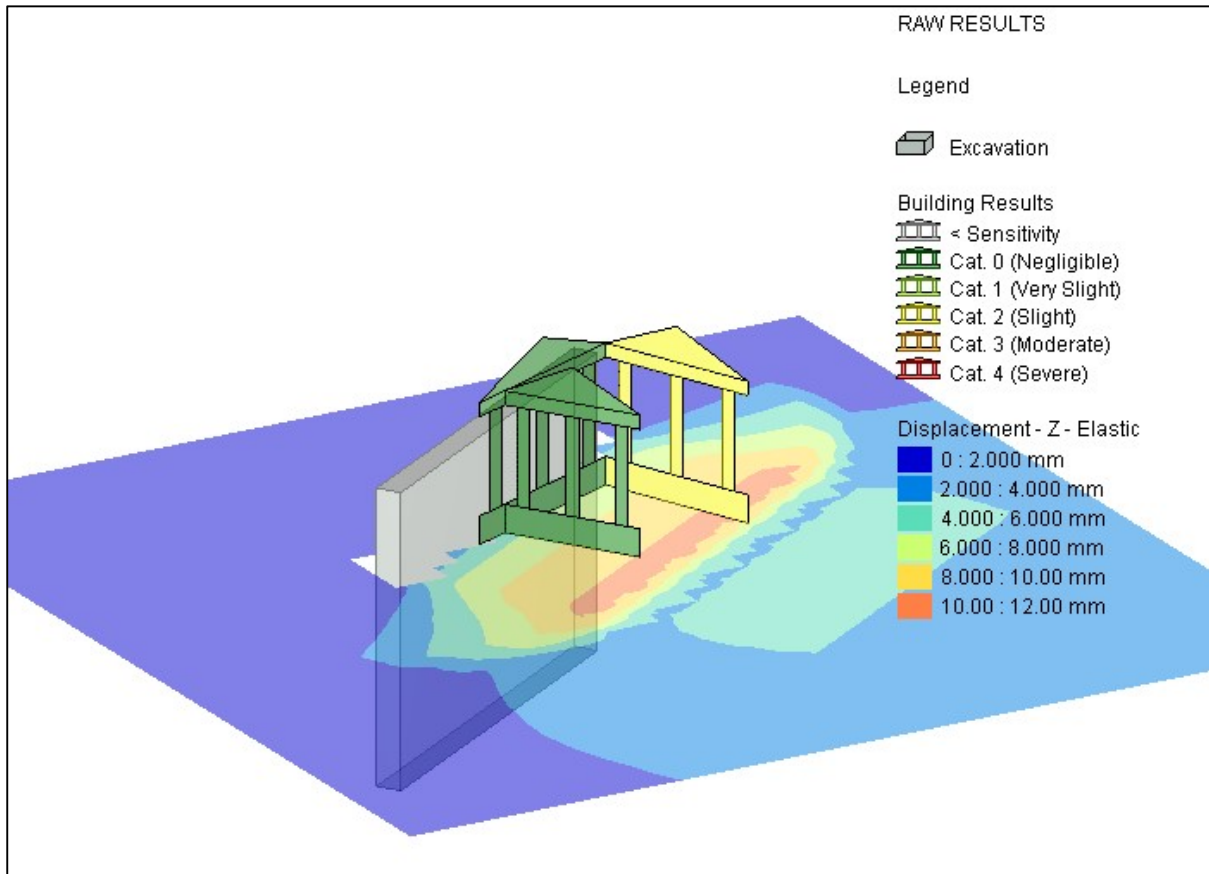
Figure 8.6: Building Damage Assessment – Southern Elevation Secant Pile Wall

Based on the predicted movements and proximity of the adjacent building, a **Category 2 (Slight category)** has been determined for the single storey property to the rear of 25 Abbey Street, as shown in Figure 8.6. Category 2 is considered an aesthetic damage category as outlined in Table 8.1.

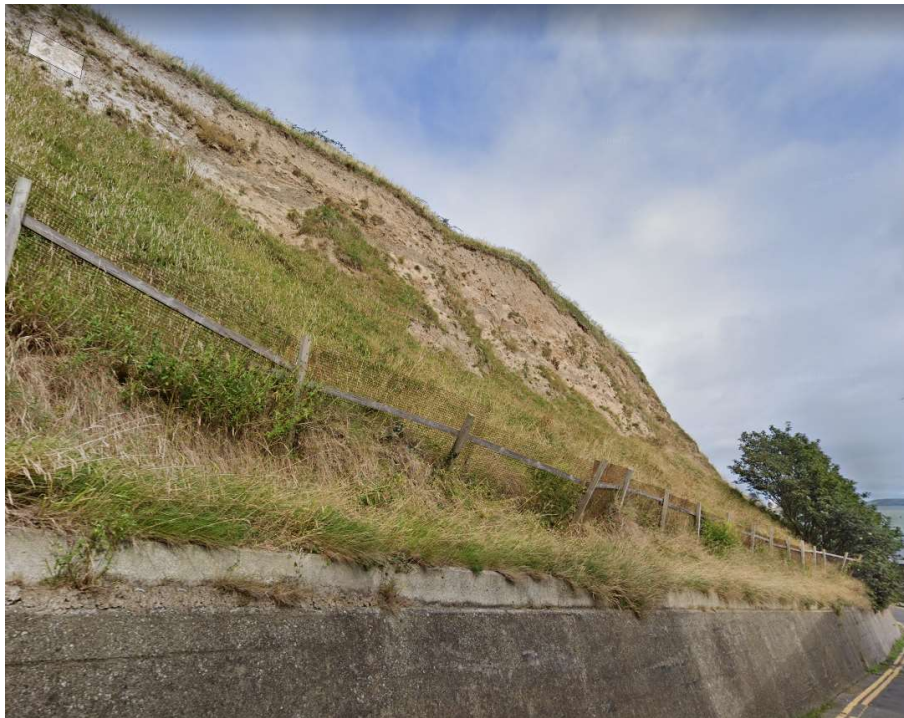
Figure 9.1: Balscadden Road adjacent to Martello Tower (ref. Google Maps) South East of the Site

Evidence of local slippages such as scarp and displaced fenceposts are observed to the south-east of the site, adjacent to Martello Tower, as shown in Figure 9.1. This is outside the site boundary and a vibration monitoring regime will be established along this boundary to ensure the proposed works do not cause slippages. All ground works will involve low-vibration methods of construction.

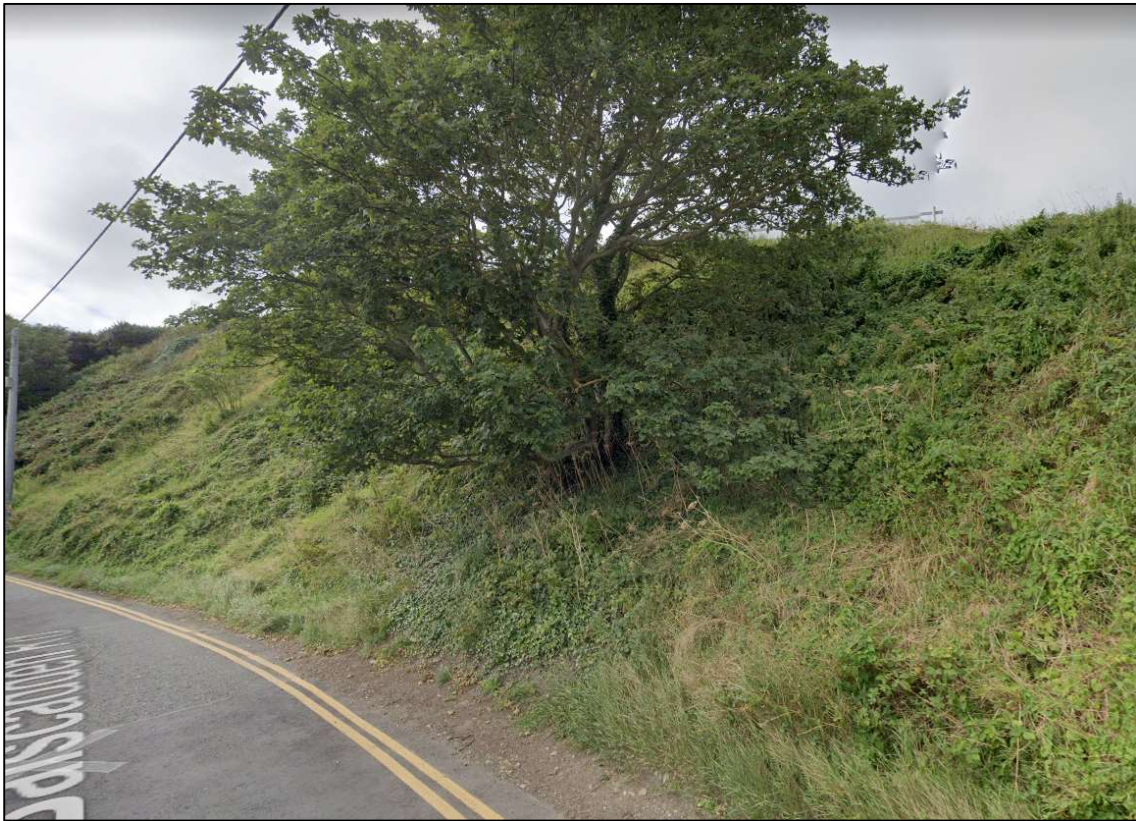
Figure 9.2: Balscadden Road adjacent to the site

It is recommended that remedial works are carried out on the eastern elevation adjacent to the site, to prevent any potential future slips occurring. The eastern elevation is shown as Figure 9.2.

The recommended remedial works involve the use of soil nailing and a flexible mesh. Soil nailing is a technique which reinforces the slope by the insertion of tendons. The nails address the global slope stability, which are connected in turn to a facing system which provides surficial stability. A suitable mesh would be selected in the construction which would encourage the growth of vegetation following its construction. It is recommended that the remedial works be completed in advance of the main piling and excavation works in the site.

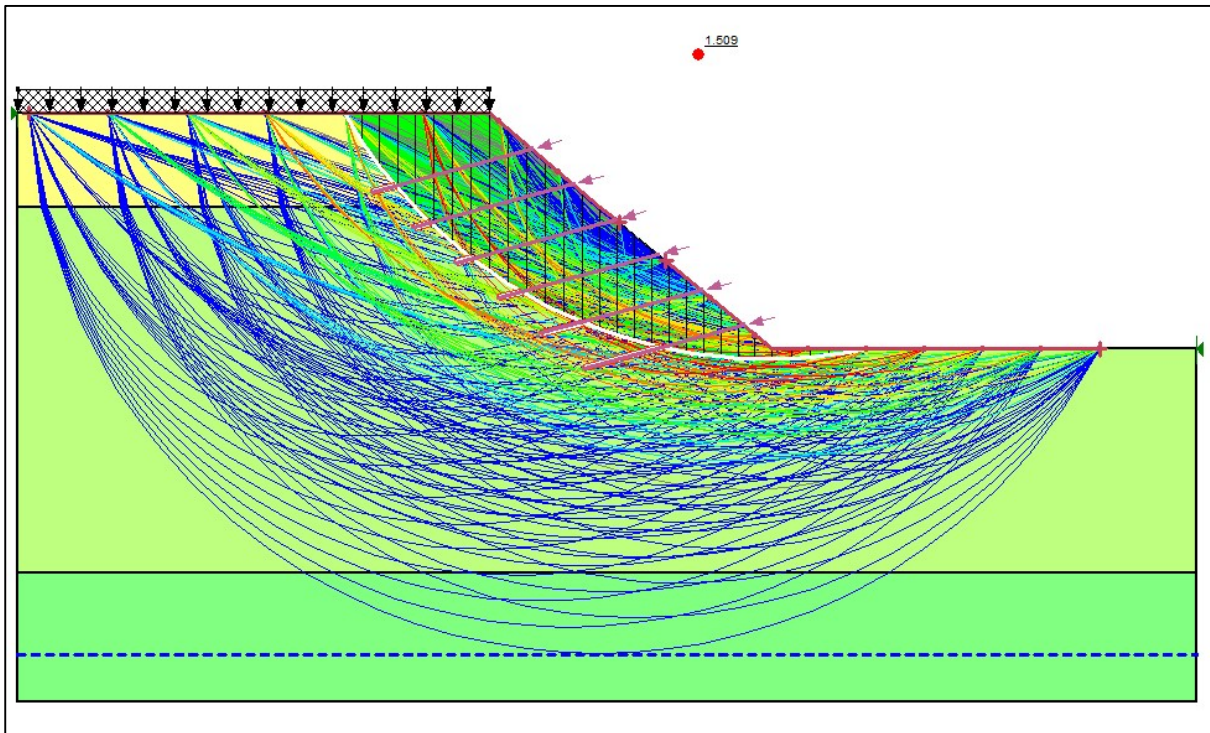
Figure 9.4: Slope/W SLS Analysis Results

Section	Vertical Spacing (m)	Horiz. Spacing (m)	Total No. of Rows	FoS / ODF		
				SLS	ULS Set 1	ULS Set 2
1	1.5	1.5	6	1.509	1.410	1.130

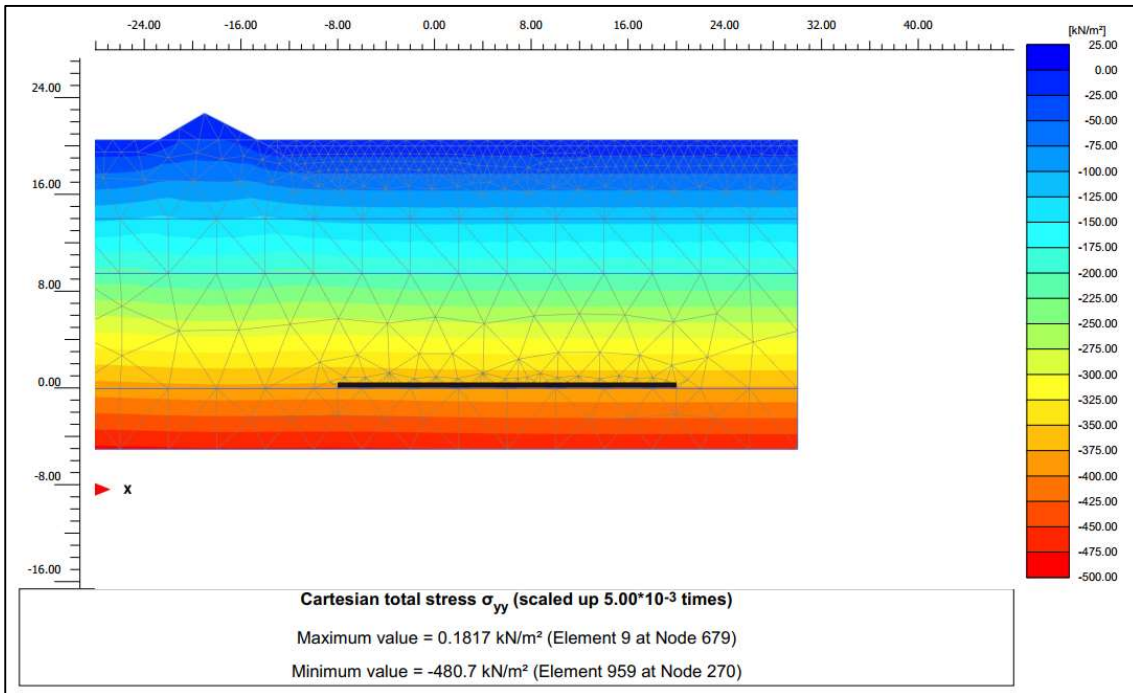
Figure 10.3: Sewer Assessment - Short Term

Based on the above information, the stress on the tunnel prior to any construction works has been calculated as 373kN/m². Following bulk excavation works, construction of the basement raft slab and the building, the stress on the tunnel has been calculated as 387kN/m², resulting in an increase in stress of 14kN/m² (4% increase in stress), with the results shown in Figure 10.3 and Figure 10.4. It is noted that the tunnel sewer has been presented as a line indicating the assumed level of the tunnel invert. Based on the limited stress increase on the tunnel, and that the initial tunnel stresses being greater north of this section (where the overburden over the tunnel is significantly greater) than the net stresses under Block B, the above increase in stress is considered acceptable.

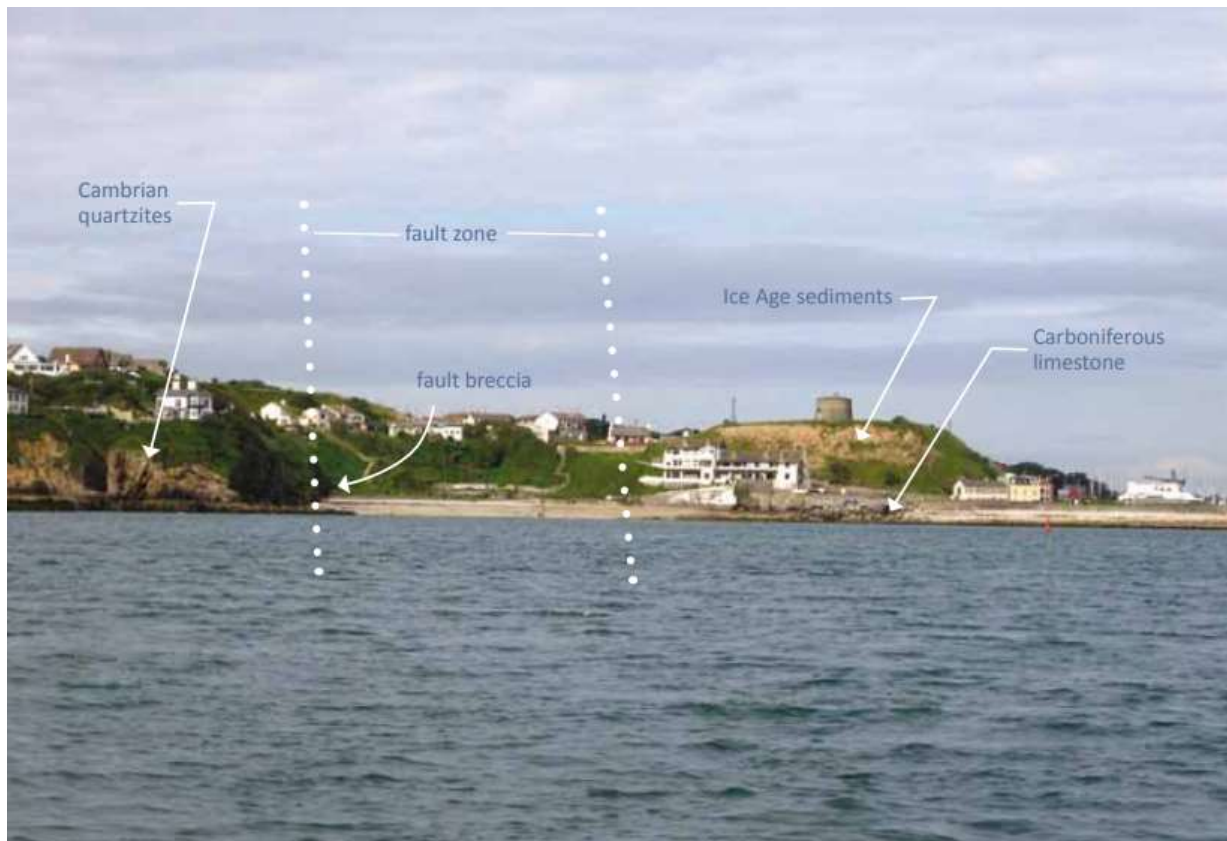
Figure 2.1 Eastward view of Balscadden Bay showing bedrock lithology and fault (Ref.1)

A description of the local geology of Balscadden Bay including the fault located at the southern end of the site is included in Ref. 1 (see Figures 2.1 and 2.2). The southern side of Balscadden Bay is comprised of Cambrian aged 500-million-year-old bedrock that is more typical of the rest of the Howth peninsula. A wide fault zone spans the entire back of Balscadden Bay with fault Breccias evident on the southern end of the beach (Figures 2.3 and 2.4). Further north, The Martello Tower is underlain by glacial sediments which are in turn underlain by the aforementioned Carboniferous Limestone that is visible gently dipping along the beach (Figure 2.5).
