Balscadden Development, Howth, Co. Dublin

Geotechnical Report

Report No. B1800-GEO-R001

21 March 2022

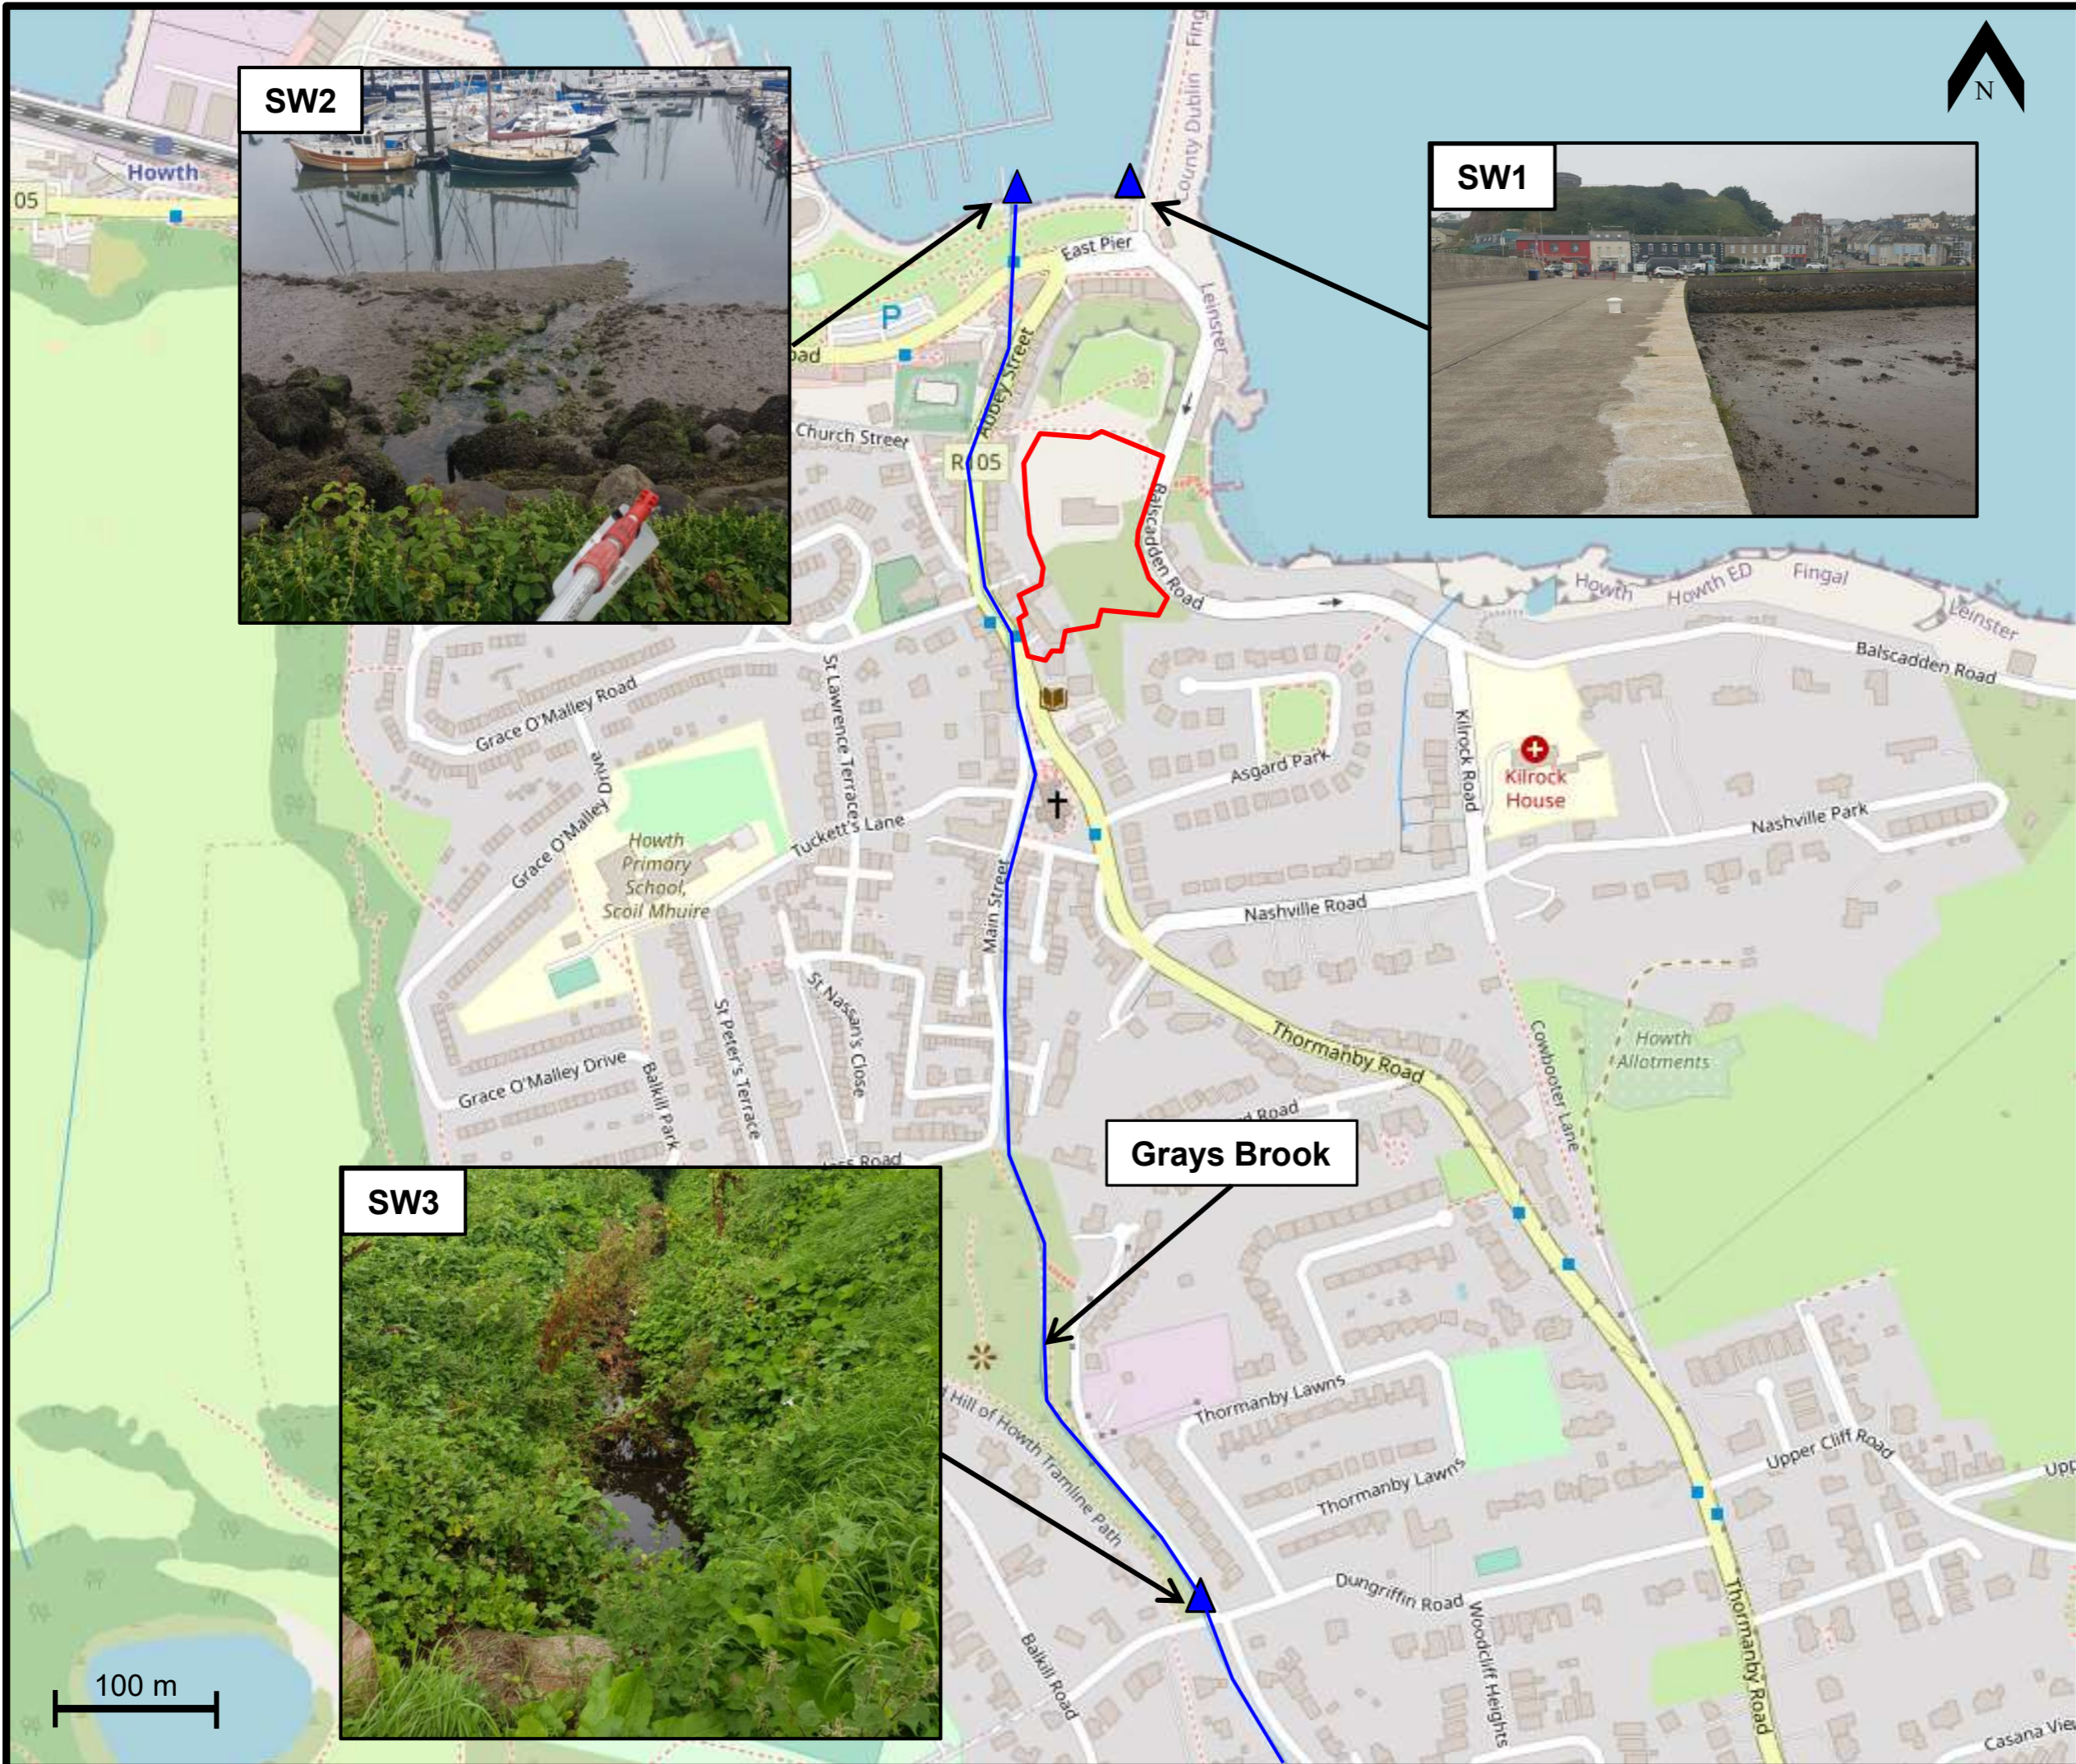
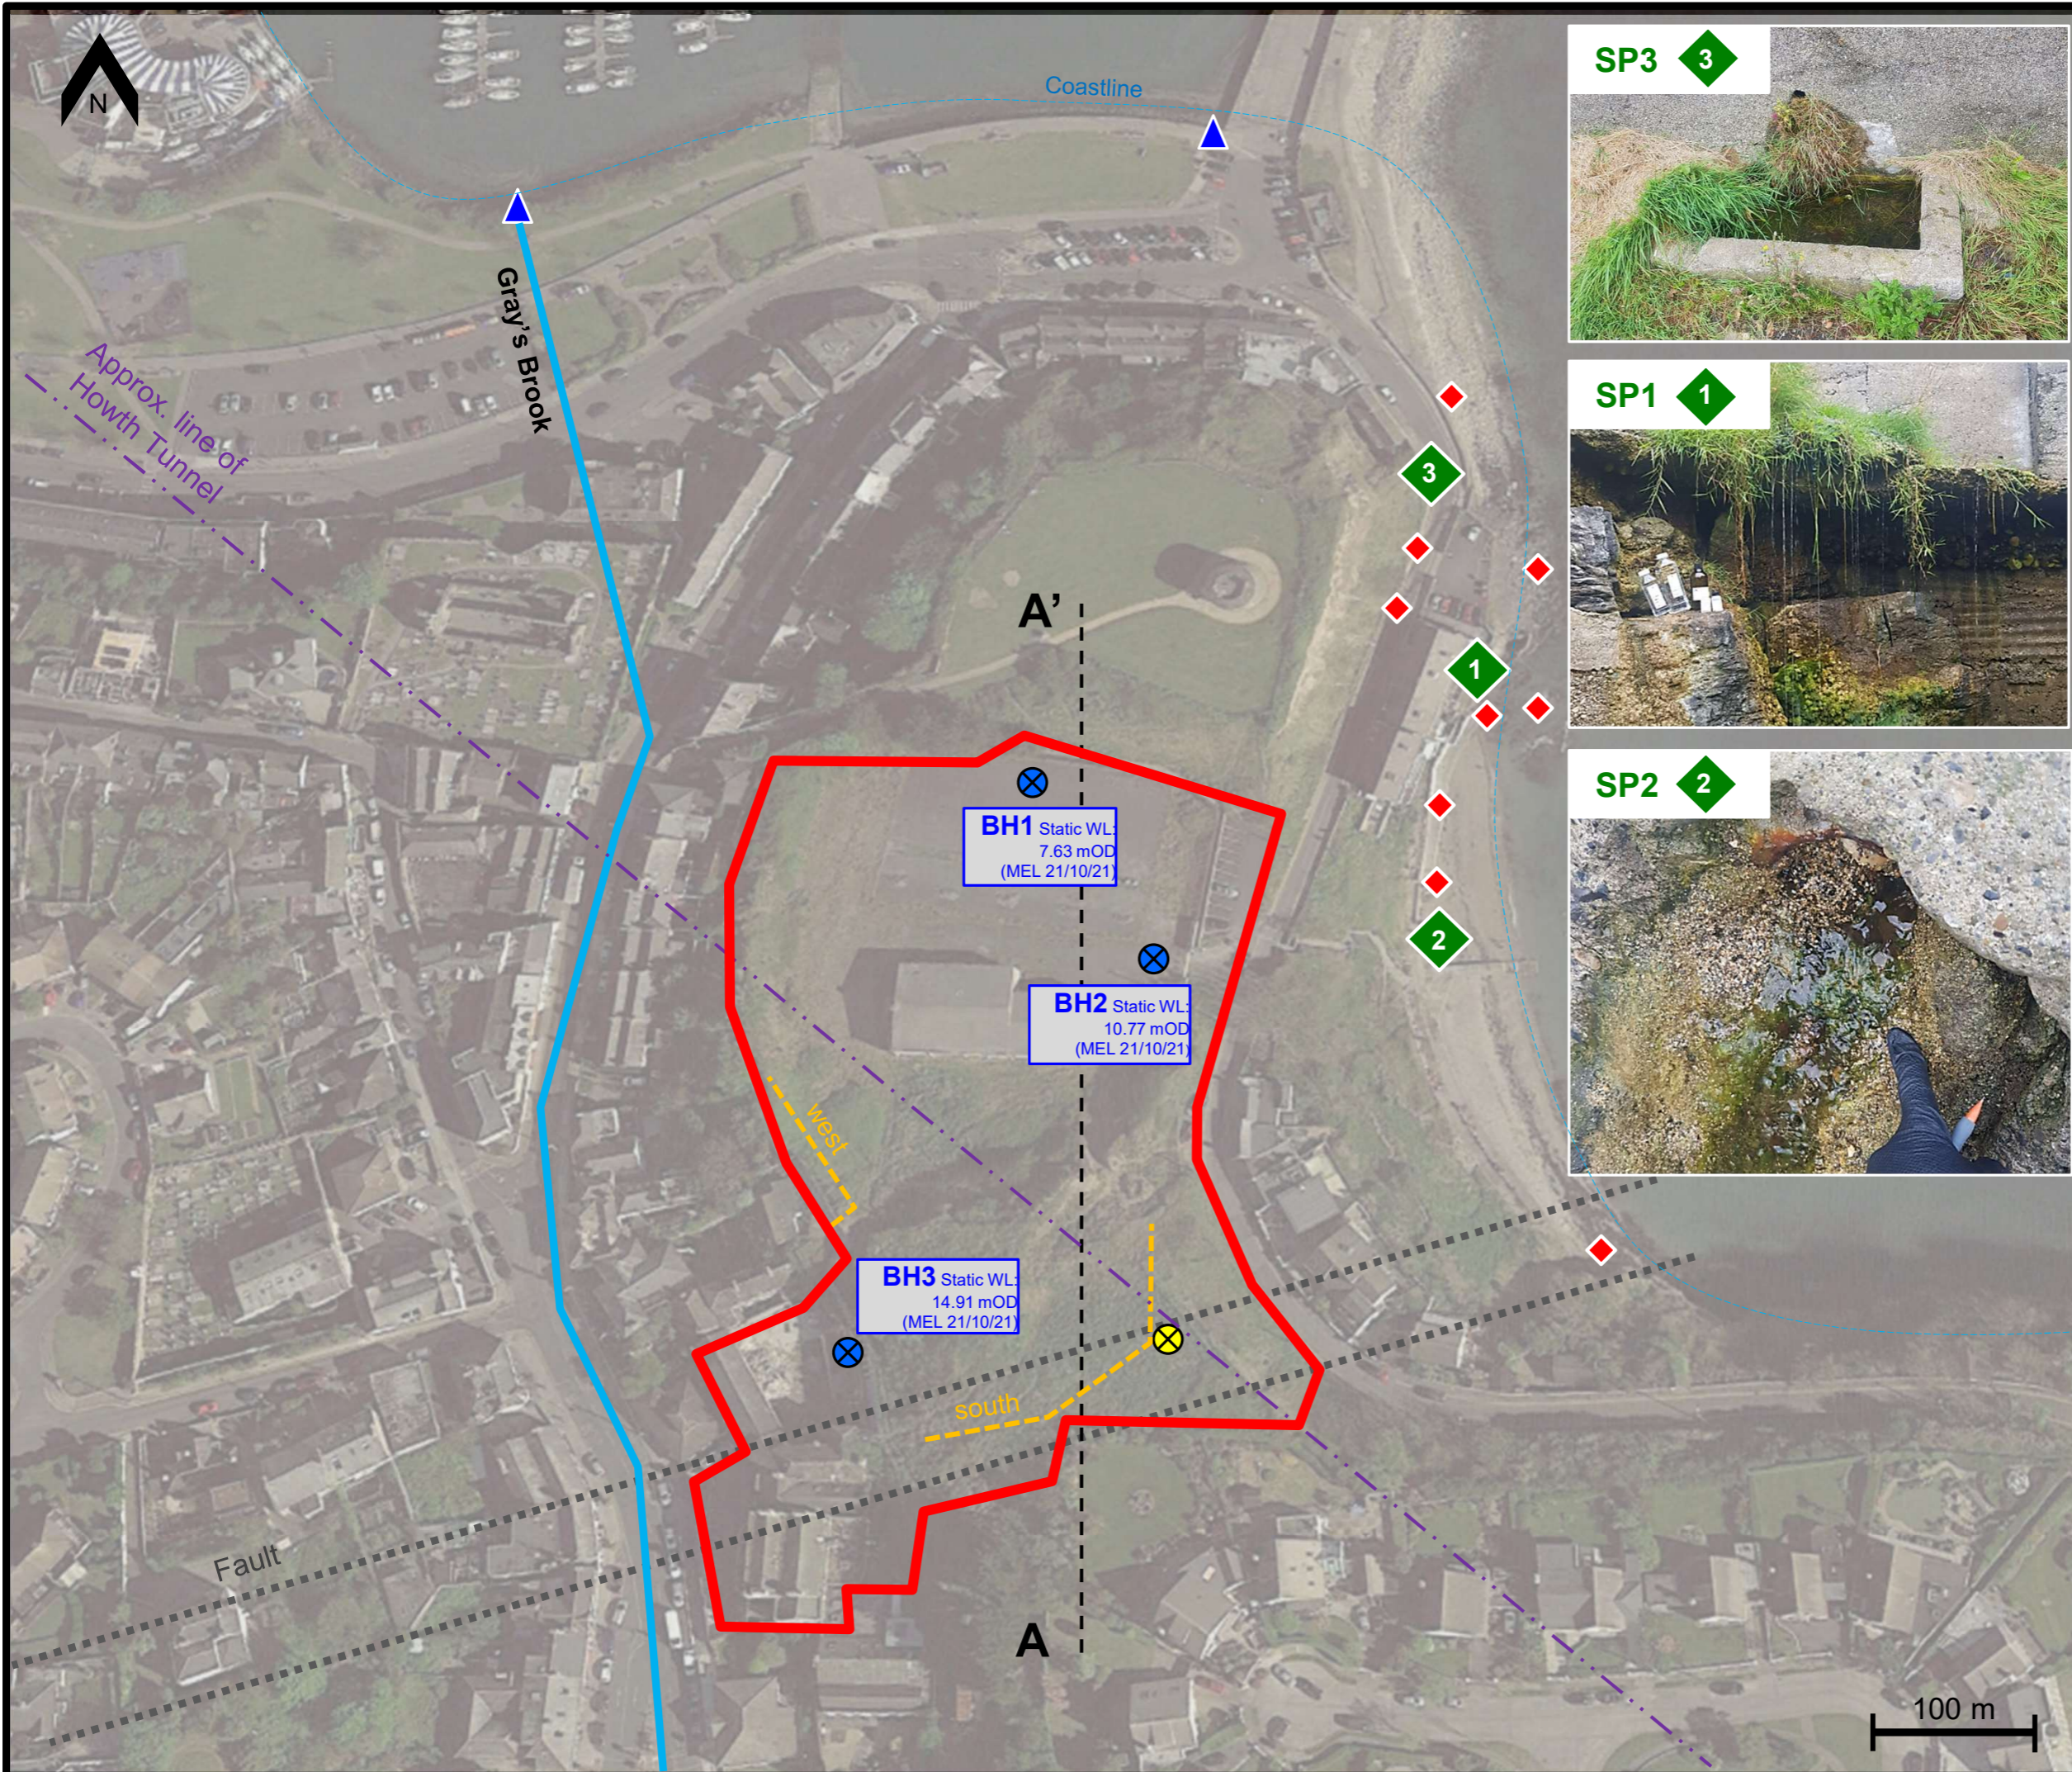
Figure 3.3
Sampling Locations

Three springs were sampled where sufficient water volume could be obtained. The locations and photos of each sampling point is presented in Figure 3.3. Sample SP1 was obtained from a concrete trough on Balscadden Road. The trough is fed from a drainage pipe cast into the retaining wall below the Martello Tower. Sample SP2 was obtained from a spring seepage apparent underneath the buildings at the northern end of Balscadden Bay. Sample SP3 was obtained from a spring flow through the concrete wall and pathway at the top of Balscadden Beach. This spring was located below the pedestrian steps to the beach. Several springs are also visible in the breccia exposed on the southern end of Balscadden Bay (Figure 2.4) however, flows were not sufficient to obtain a sample.

The Howth Tunnel was constructed between 1955 and 1956 as the last section of a Main Trunk Sewer. It consists of a high and low level tunnel, which together are one-mile long (Ref. 5). The internal diameter of the sewer is 6.0 feet (1.83m) throughout the tunnel. The first 300m (1,000 feet) of the tunnel (from the Harbour Road Shaft), had to be supported with the primary lining RC segment rings. In that area material was not self – supporting or sound, and it predominantly consisted of boulder clay, limestone rock, dense clays of various colours, and loose brecciated quartzite rock. The tunnel passes under the site as shown in Figure 3.3.

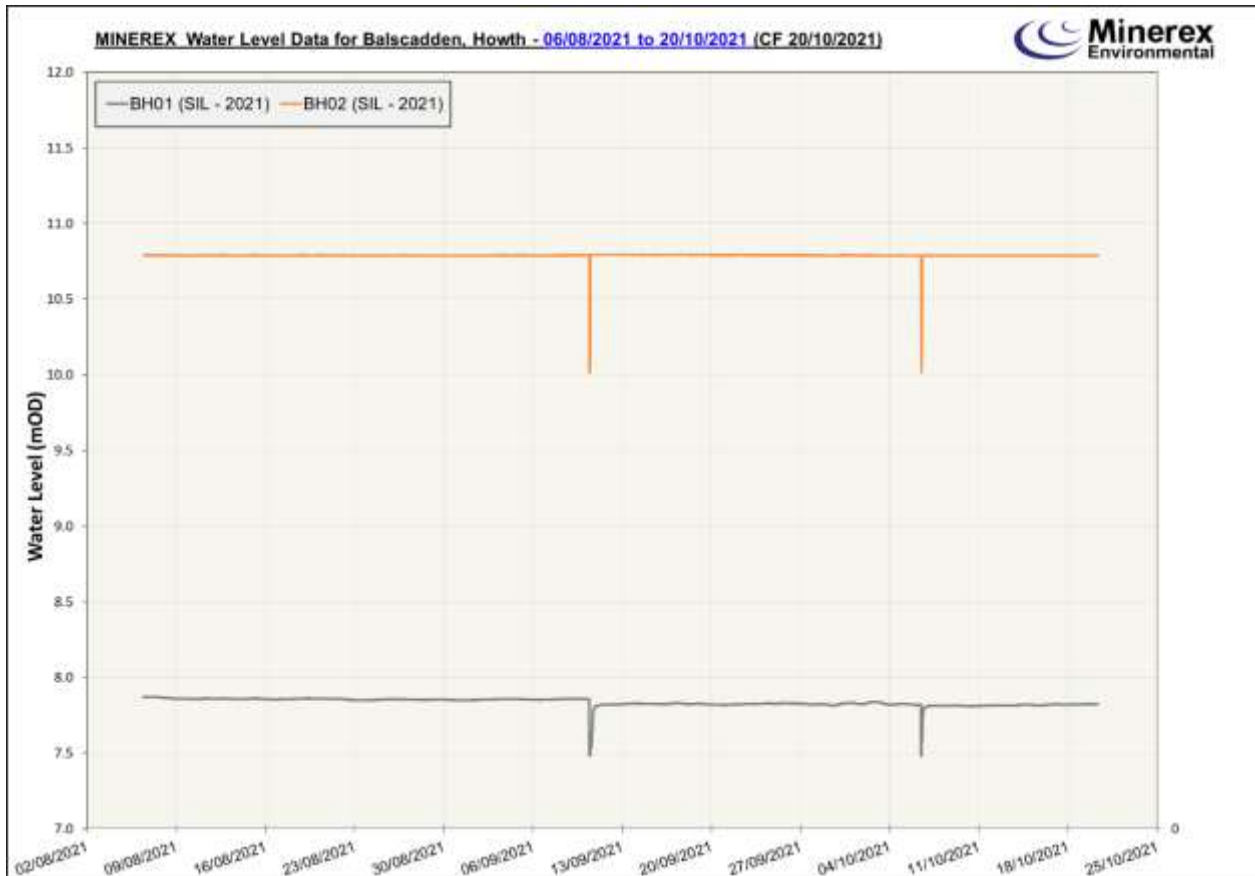
Figure 4.2 Continuous water level data from BH01 and BH02.

Continuous water level data and antecedent rainfall taken from Met Eireann (Dublin Airport) is presented in Figures 4.2 – 4.4. The water level was consistently deeper (approx. 3m) in BH01 compared to BH02. Borehole BH-GDG-01 was dry during initial monitoring in 2017. It was dry throughout the course of this investigation in 2021.

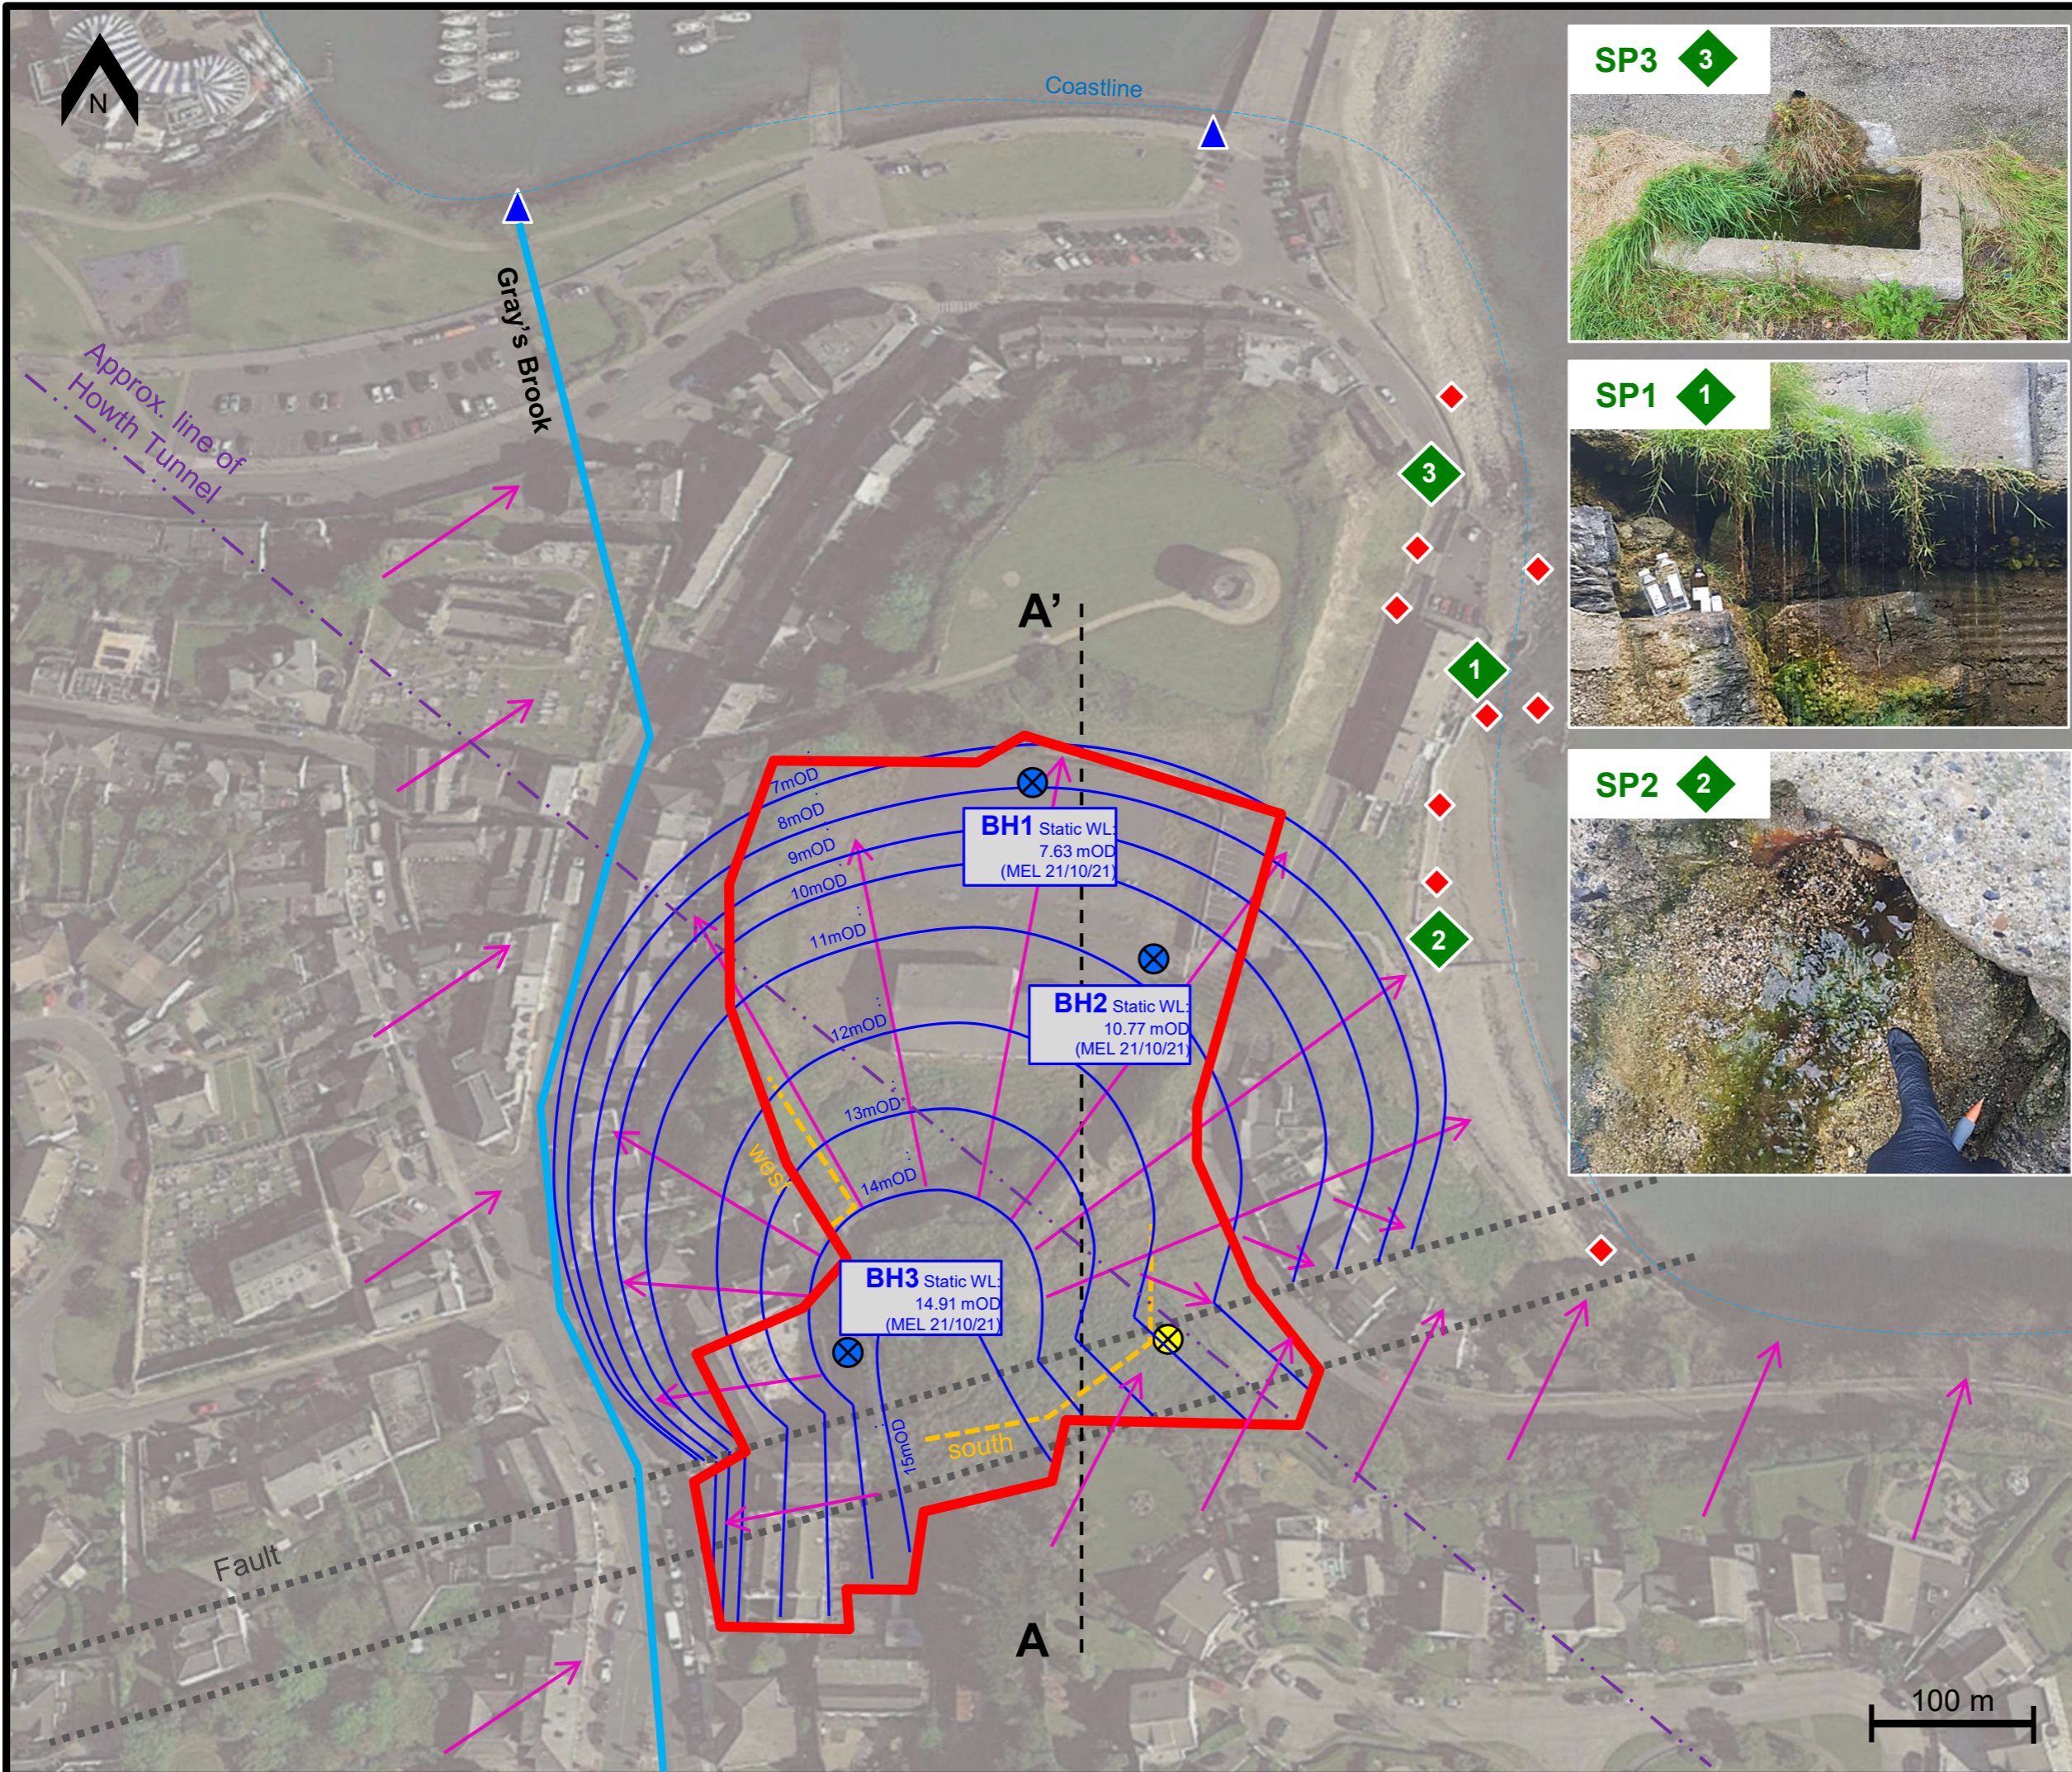
Figure 5.2
Hydrogeological Cross-Section

Conceptual GW flow direction

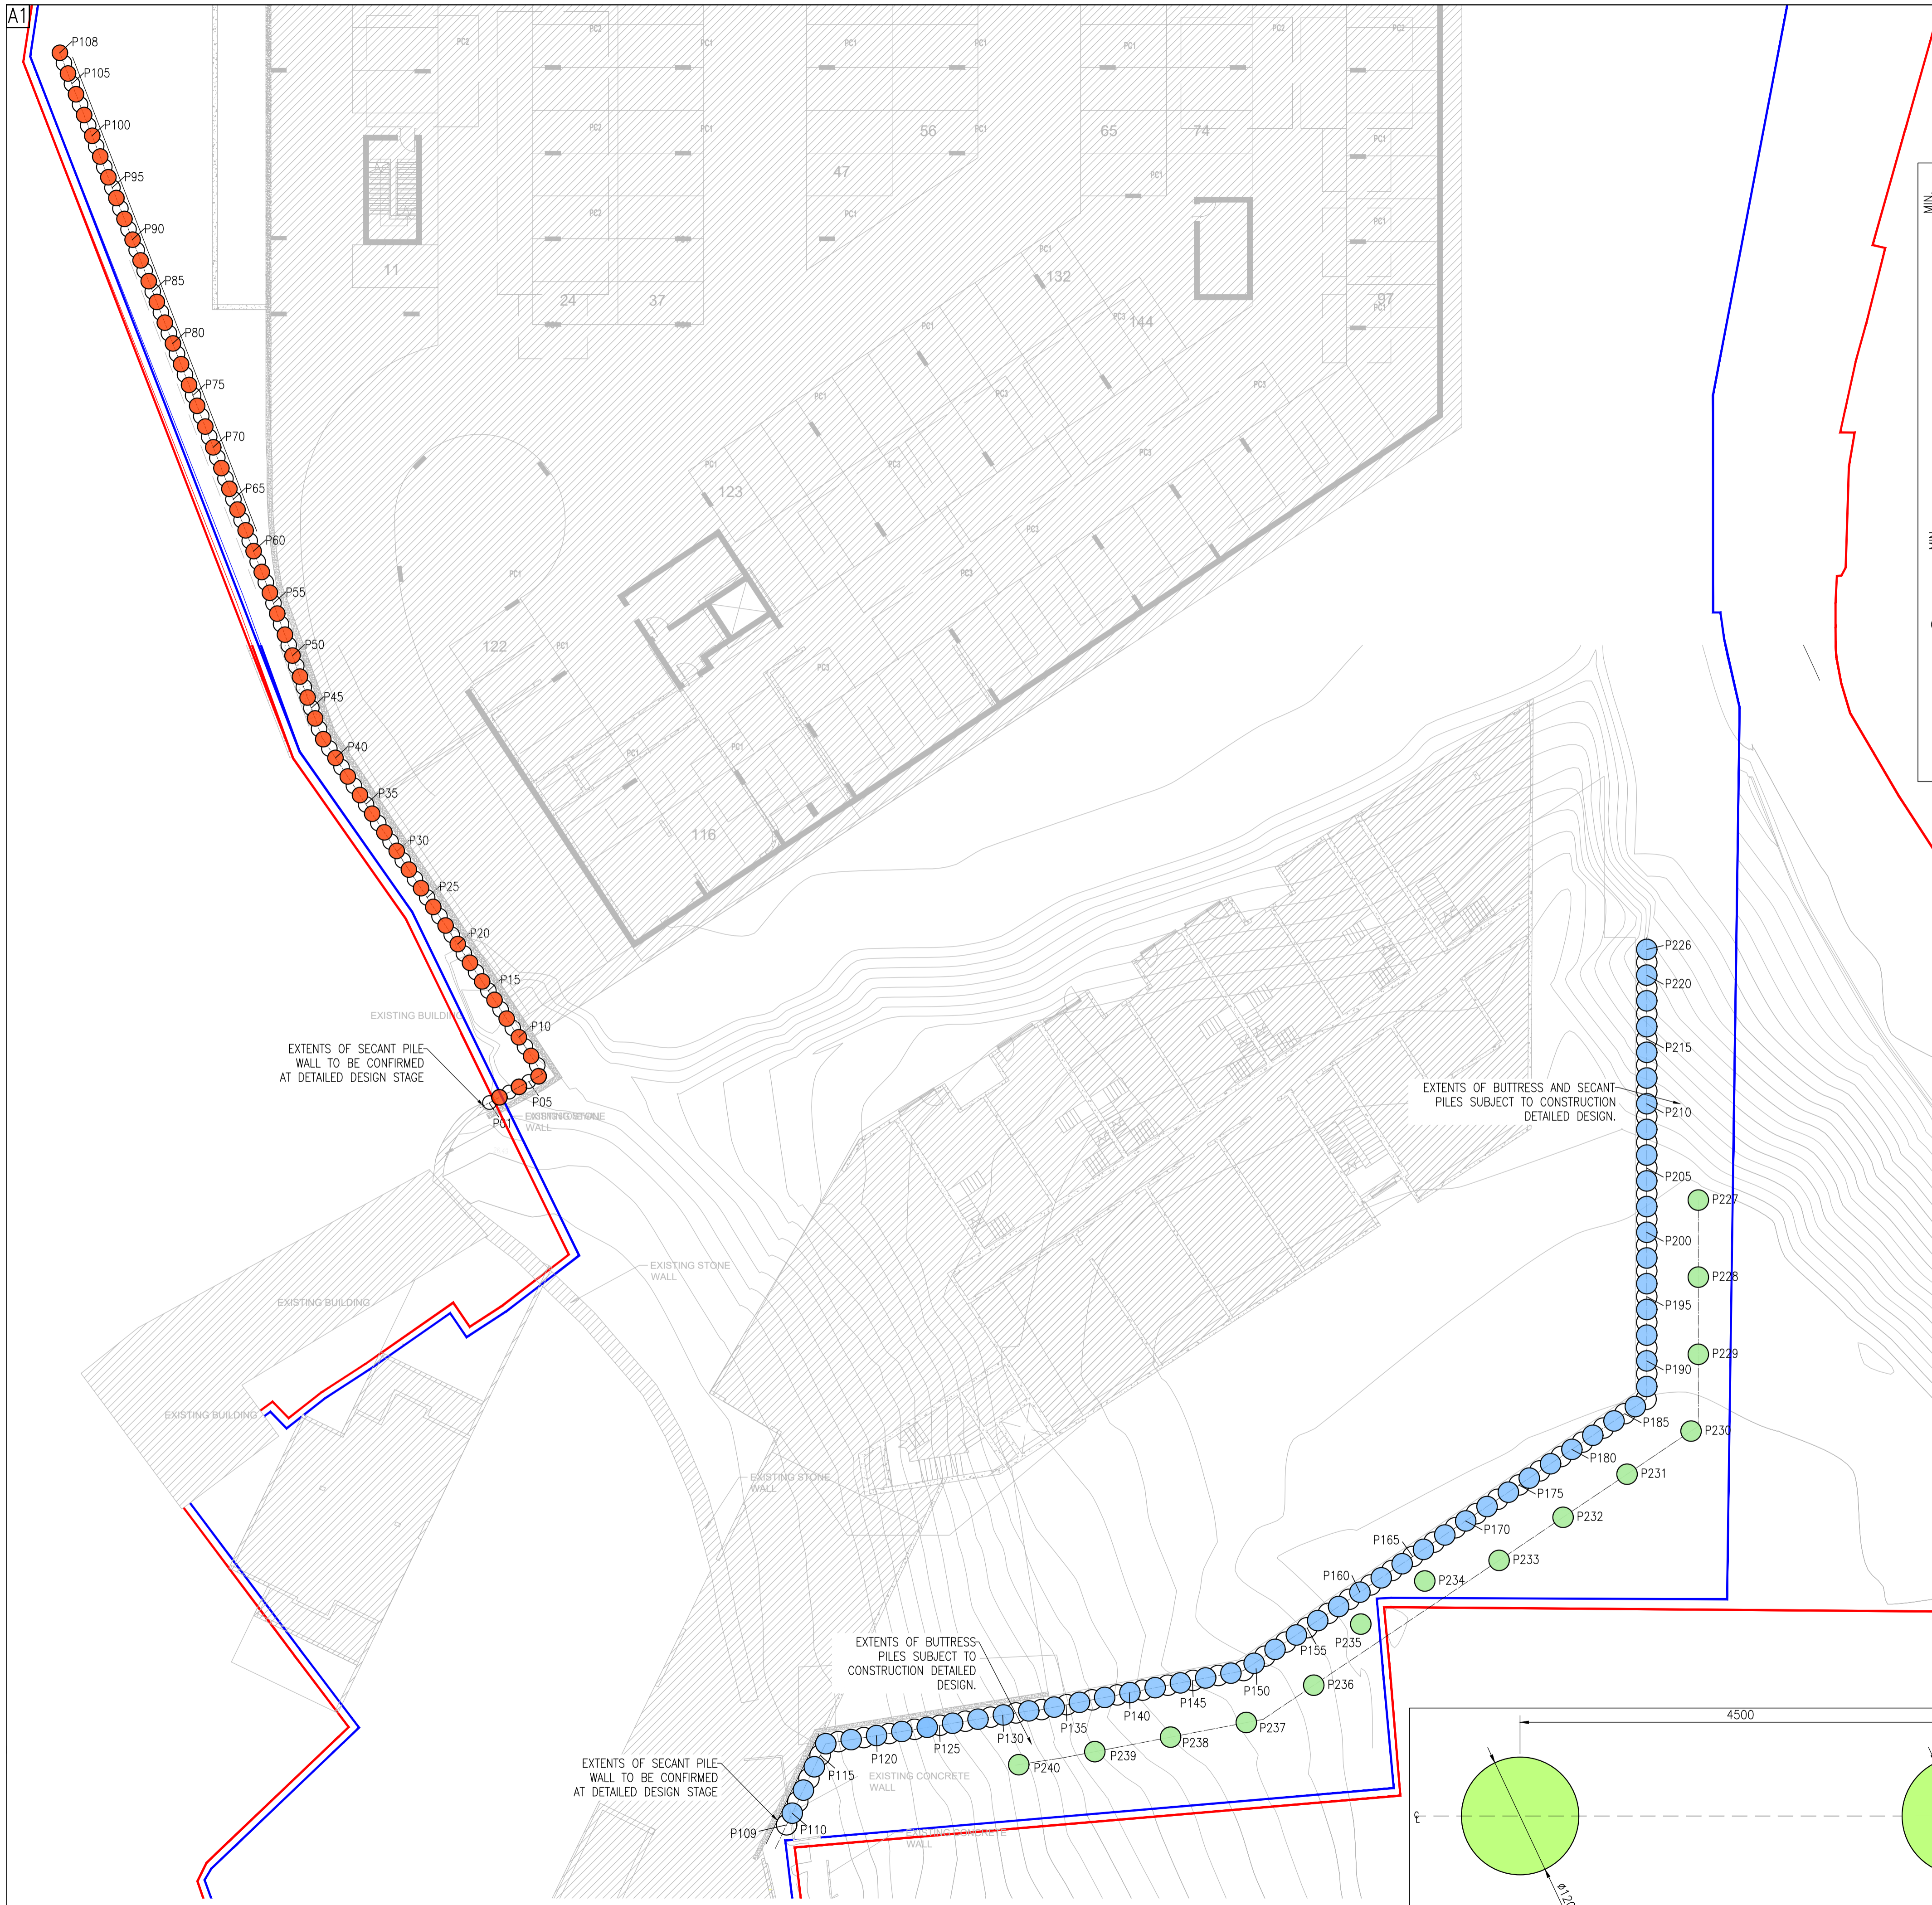
Date: 26/11/21	Scale: 1:300	Drawn: MON	Chk: NP	App: MR
Project No: B1800	Drwg. No: B1800-1000	Rev:		01

TYP SECANT PILE WALL TYPICAL SETOUT
SCALE 1:25

Based on significant elevation changes across the site, a retaining wall will be required along the southern elevation. An indicative section is shown as Figure 5.1 and proposed layout shown as Figure 5.2. The proposed retaining wall solution is a secant pile wall with additional buttress piles installed to the rear of the secant pile wall to limit pile wall deflections.

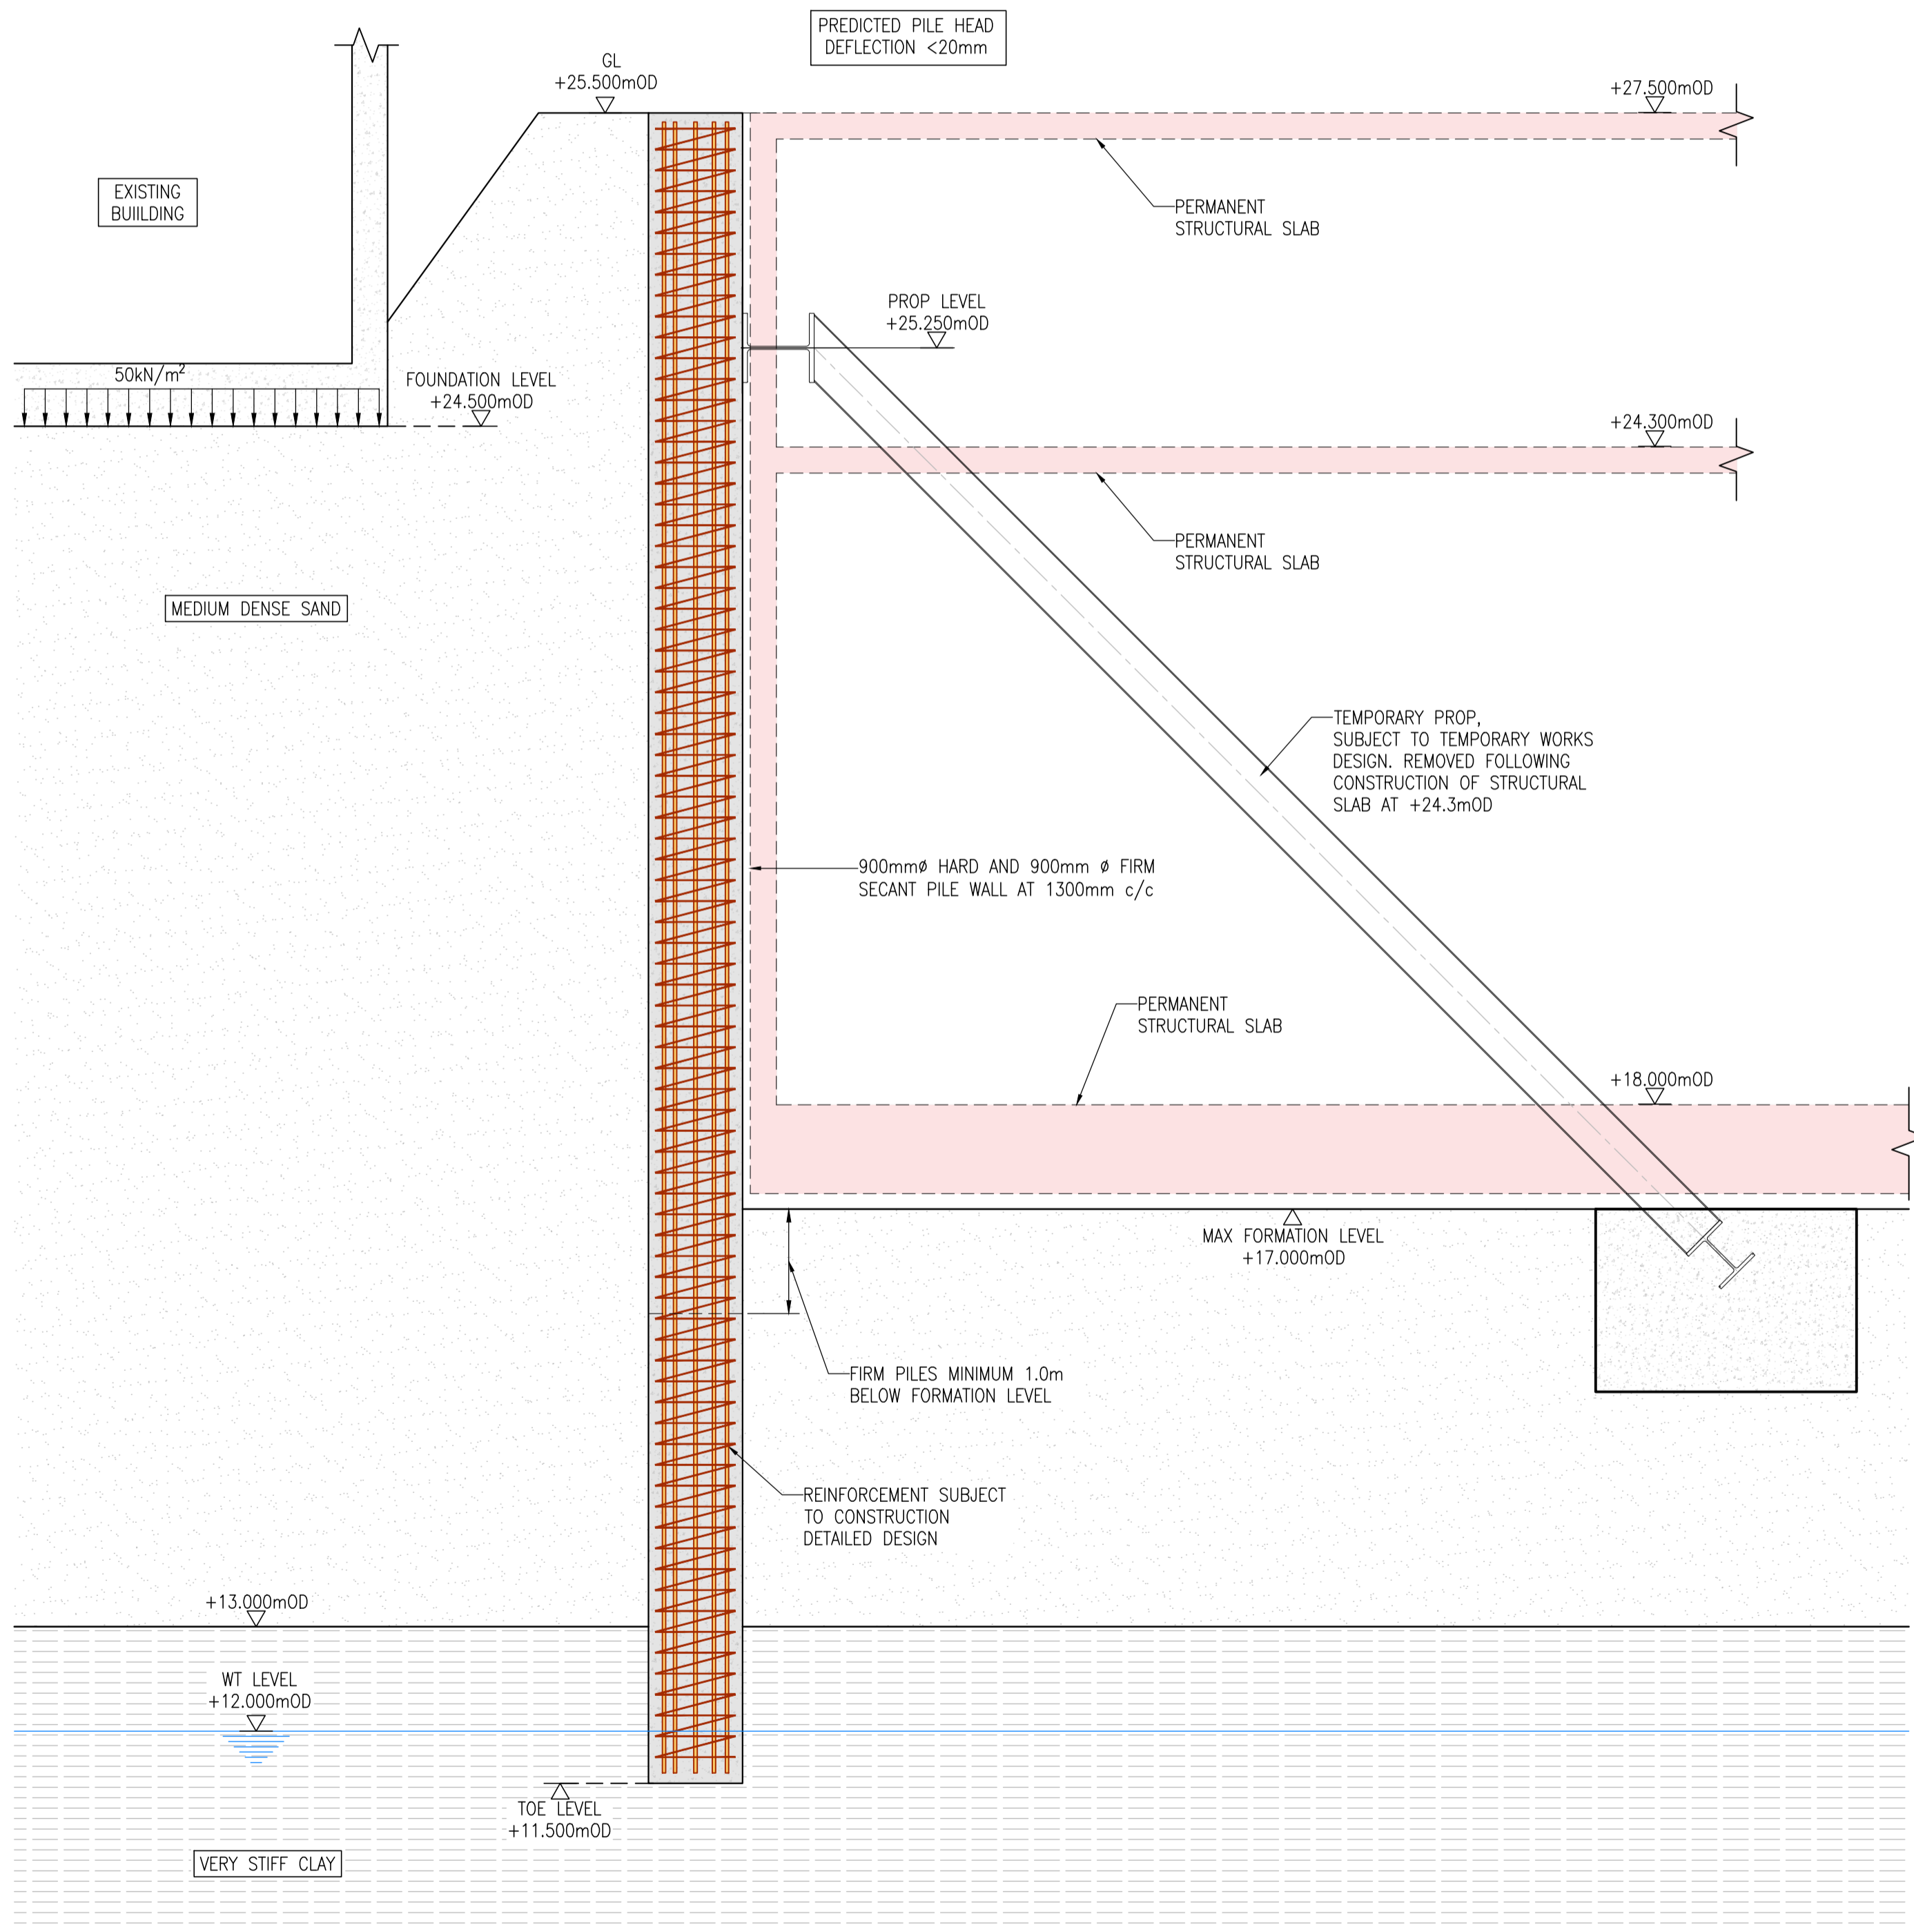
WT02 SECANT PILE WALL TYPE 02
SCALE 1:50

- SECANT PILE WALL TYPE 02**
1. CONSTRUCT PILING PLATFORM AND FORM SUITABLE ACCESS FOR PILING RIG;
 2. INSTALL FEMALE UNREINFORCED SECANT PILES TO DESIGN TOE LENGTHS;
 3. INSTALL MALE REINFORCED SECANT PILES TO DESIGN TOE LENGTHS;
 4. COMPLETE INITIAL EXCAVATION;
 5. EXCAVATE TO UNDERSIDE OF TEMPORARY PROP;
 6. INSTALL TEMPORARY RAKING PROP AND CONSTRUCT THRUST BLOCKS;
 7. EXCAVATE TO FORMATION;
 8. CONSTRUCT BASEMENT FLOOR SLAB, GROUND FLOOR SLAB AND FIRST FLOOR SLAB;
 9. REMOVE TEMPORARY RAKING PROP;
 10. CONSTRUCT CRIB WALL OR ARCHITECTURAL FEATURE IN FRONT OF SECANT PILE WALL.
