Lismore Homes Limited

Residential Development Baldoyle GA2

Stage 1 Road Safety Audit

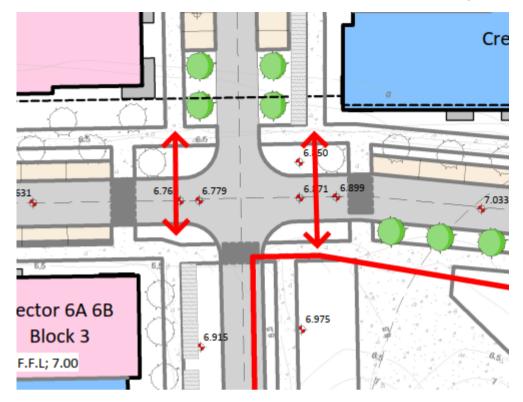
Figure 2: Example of pedestrian crossings not lined up with desire lines

2.4 Problem: Pedestrian Crossings Offset From Desire Lines

Some pedestrian crossings are offset from the pedestrian desire-line. Pedestrians are more likely therefore to cross at a location where they may trip on kerbs. This may also lead to confusion as drivers might not expect pedestrians away from designated crossings, resulting in vehicle/pedestrian collisions.

Recommendation

Crossings should be provided on pedestrian desire-lines.

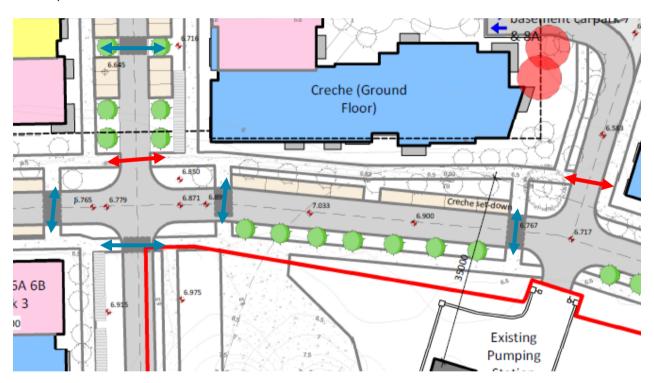
Figure 3: Mixed types of pedestrian crossings throughout the scheme (blue-zebra, red-uncontrolled).

2.8 Problem: Mixed Use of Zebra and Uncontrolled Pedestrian Crossings

There appears to be a mix of zebra and uncontrolled, courtesy pedestrian crossing points proposed throughout the development. This inconsistency could confuse road users as to priority on crossings and lead to pedestrian/vehicle collisions.

Recommendation

Ideally only one type of crossings should be provided through the scheme. However, if there are reasons to differentiate, a more coherent approach should be applied to ensure the road environment is self-explanatory and consistent.
