# APPENDIX 8 MICRO CLIMATE STUDY

# **Coolagad Wind Microclimate**

Wind Microclimate Study

Report For: Cairn Homes Properties Ltd Project No: 16036

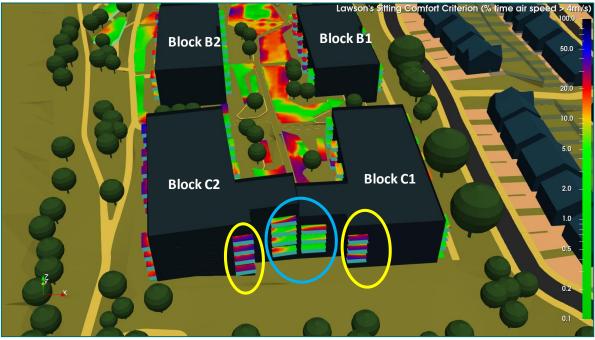
Figure 6: Sitting Comfort Criterion: View of the balconies on the south façade

<u>Figure 5</u> to <u>Figure 8</u> show the balconies on the west and south façade of block C1 and block C2. These balconies show the limited compliance with the requirements of the Lawson's Sitting Comfort criterion. These balconies are circled in yellow in <u>Figure 5</u> and <u>Figure 6</u>. The local air speed is likely to exceed 4m/s for more than 20% of the year at these locations. These balconies also show limited compliance with the requirements of the Lawson's Standing Comfort criterion. The local air speed also exceeds 6m/s for up to 20% of the year at these locations, see <u>Figure 7</u> and <u>Figure 8</u>. These balconies are directly impacted due to a strong wind breeze flowing from the prevailing southwest and west direction.

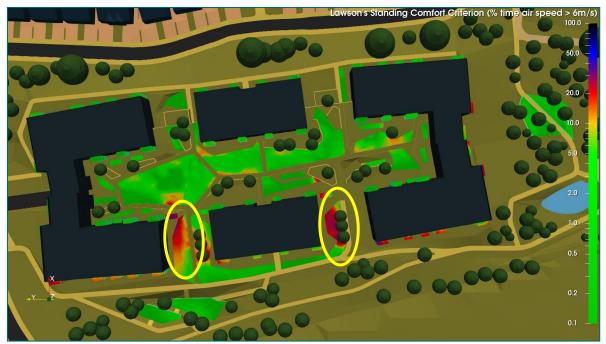
Figure 10: Standing Comfort Criterion: Ground Amenities: Courtyard

However, on comparing the results for these locations to Lawson's Standing Comfort Criterion results, they show excellent compliance, i.e. the local air speed does not exceed 6m/s for more than 5% of the year. See Figure 10. Of the 20% of year when the local air speed exceeds 4m/s, three quarters of that collective time (i.e. 15% of the year) it does not exceed 6m/s. The local air speed on these spaces will be less than 4m/s for 80% of the year. Any exceedance noted can be considered very marginal and it will not lead to an environment which is unpleasant to use. The local air speed is only going to be greater than a gentle breeze but most frequently less than a moderate breeze. Such conditions are unlikely to have any impact on usability of space for recreation.

A portion of these ground spaces demonstrate the local air speed exceeding 6m/s for more than 5% of the year, see Figure 10. These spaces are impacted due to prevailing southwesterly wind and are subject to acceleration that can occur due to flow through narrow passage between blocks. But these locations are more likely to be used as an access path to the central courtyard. Sitting/Standing type activities are unlikely in these locations. So no further mitigation measures will be required.

<u>Figure 9</u> and <u>Figure 10</u> show the results of sitting and standing comfort on the ground amenity spaces surrounded by the residential blocks.

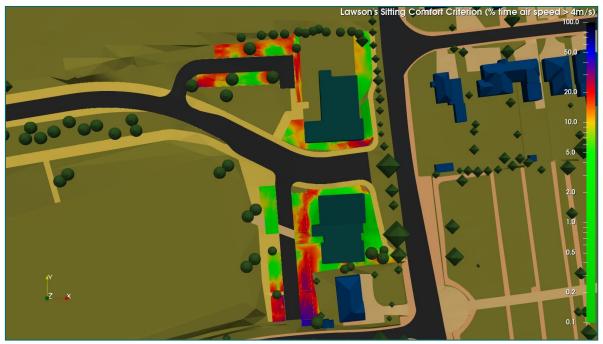
Figure 11: Sitting Comfort Criterion: Ground Amenities: Creche and Community buildings

However, on comparing the results for these locations to Lawson's Standing Comfort Criterion results, they show excellent compliance, i.e. the local air speed does not exceed 6m/s for more than 5% of the year, see Figure 12. Of the 20% of year when the local air speed exceeds 4m/s, three quarters of that collective time (i.e. 15% of the year) it does not exceed 6m/s. The local air speed on these spaces will be less than 4m/s for 80% of the year. Any exceedance noted can be considered very marginal and it will not lead to an environment which is unpleasant to use. The local air speed is only going to be greater than a gentle breeze but most frequently less than a moderate breeze. Such conditions are unlikely to have any impact on usability of this space.

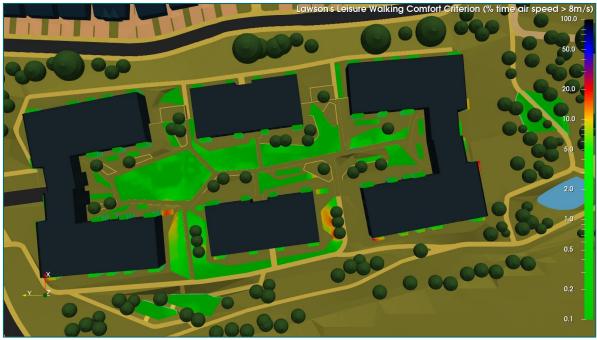
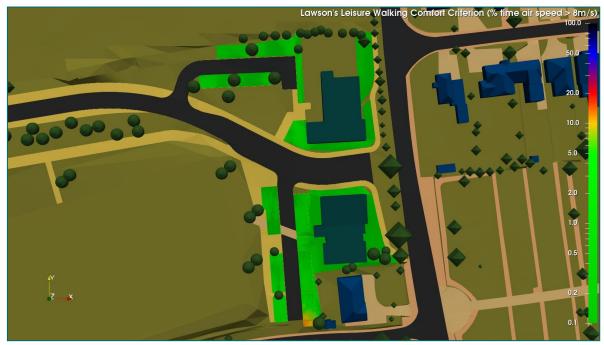
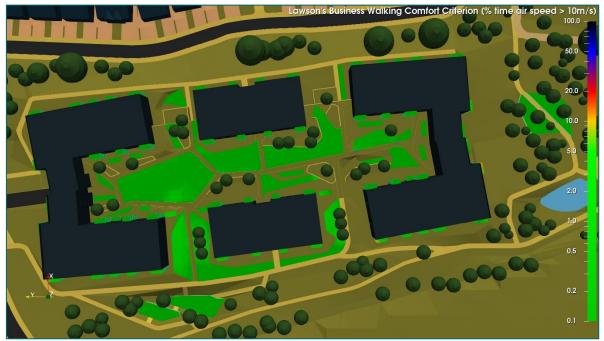
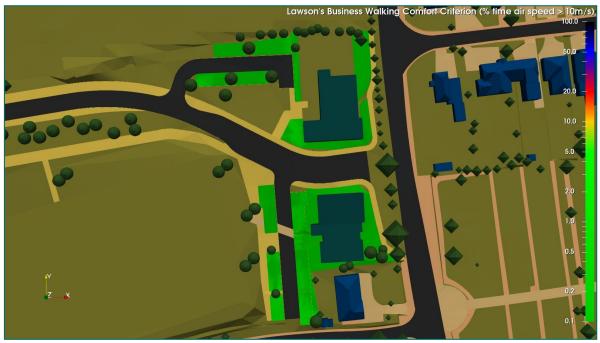
Figure 13: Leisure Walking Comfort Criterion: View of the residential blocks

Figure 14: Leisure Walking Comfort Criterion: View of the Creche and Community buildings

Figure 15: Business Walking Comfort Criterion: View of the residential blocks

Figure 16: Business Walking Comfort Criterion: View of the Creche and Community buildings

These show excellent compliance with the requirements of the Lawson's Leisure walking, and Business walking Comfort Criteria. The local air speed does not exceed 8m/s, and 10 m/s for more than 5% of the year, respectively.

The Lawson's Leisure Walking comfort criteria states that the local air speed at designated locations should not exceed 8m/s for more than 5% of the duration analysed, on the various paths around the development. The Lawson's Business Walking comfort criteria states that the local air speed at designated locations should not exceed 10m/s for more than 5% of the duration analysed, on the various paths around the development.

Figure 13 to Figure 16 show the results of walking comfort criteria.

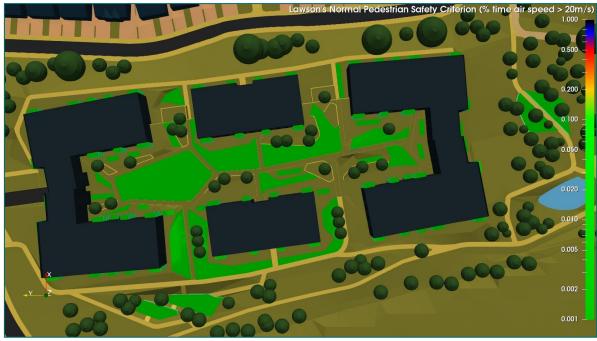
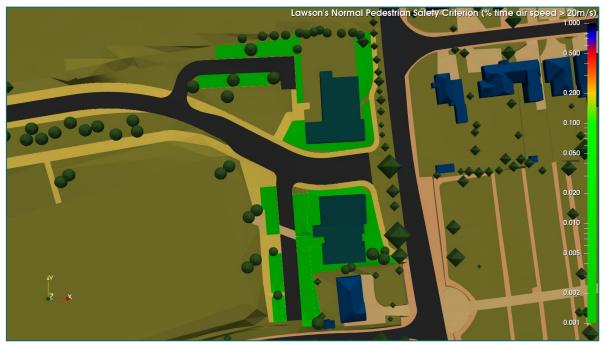
Figure 17: Normal Pedestrian Safety Criterion: View of the residential blocks

Figure 18: Normal Pedestrian Safety Criterion: View of the Creche and Community buildings

These criteria are also intended for various paths, and grounds around the development, as access is required at all times irrespective of weather conditions to enter or exit the various buildings. Figure 17 to Figure 20 show the results of safety criteria assessment. The criterion for the normal and sensitive pedestrian is achieved throughout the site. None of the paths around the development show even 0.01% prevalence of local air speeds exceeding 20m/s i.e. Normal Safety Criterion threshold.

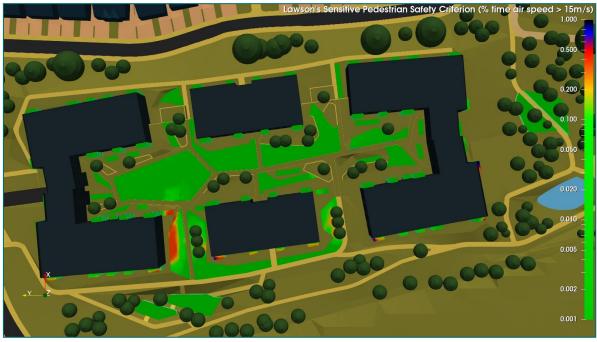
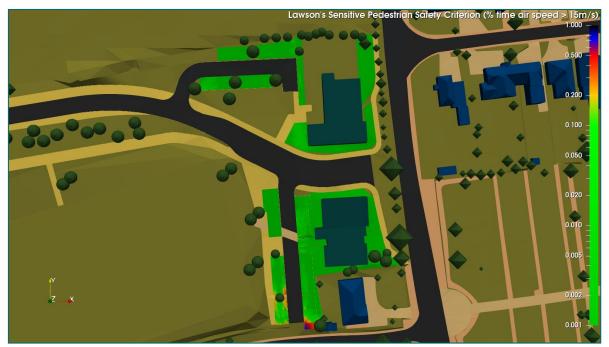
Few spots around the development exceeds the 0.01% prevalence of local air speeds exceeding 15m/s as required by the Sensitive Pedestrian Safety Criterion threshold. These are visible in red, contour color. The green areas in <u>Figure 19</u> and <u>Figure 20</u> are fully compliant with the requirements of the Sensitive Pedestrian Safety Criterion.

Figure 19: Sensitive Pedestrian Safety Criterion: View of the residential blocks

Figure 20: Sensitive Pedestrian Safety Criterion: View of the Creche and Community buildings

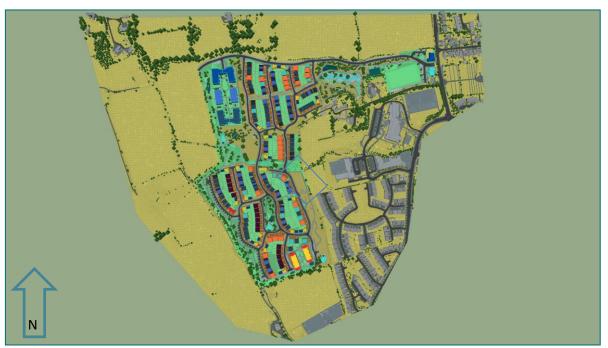
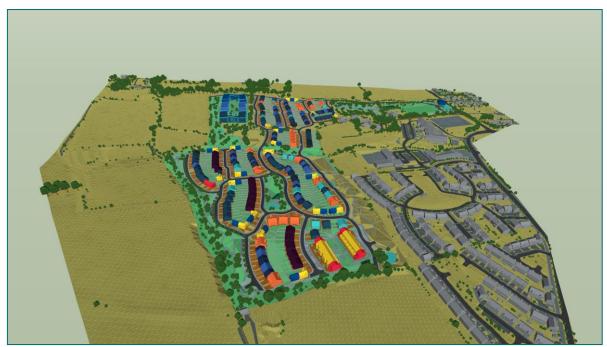
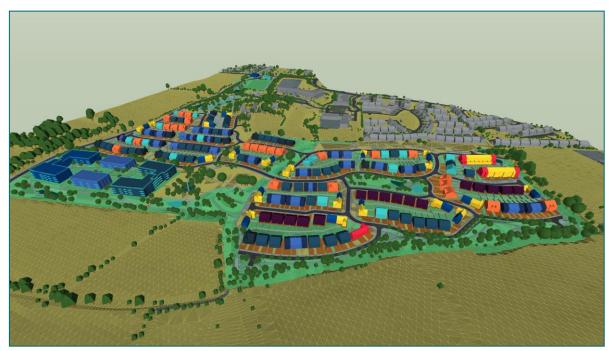
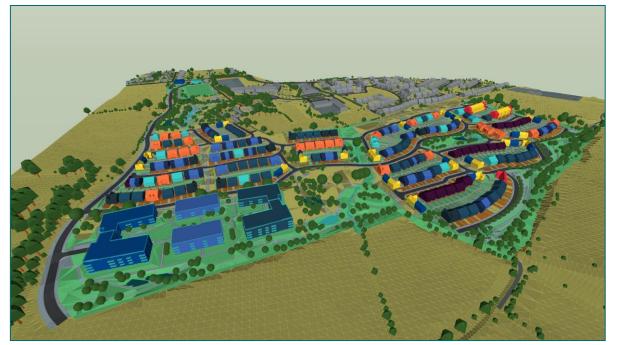
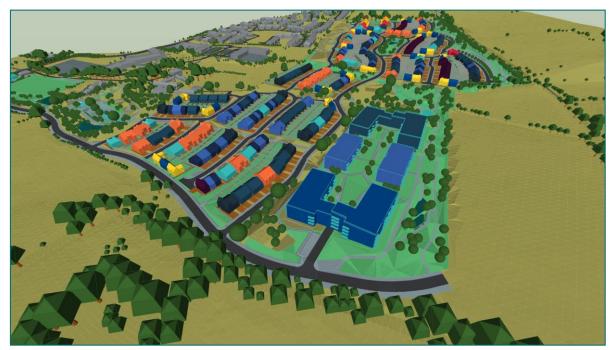
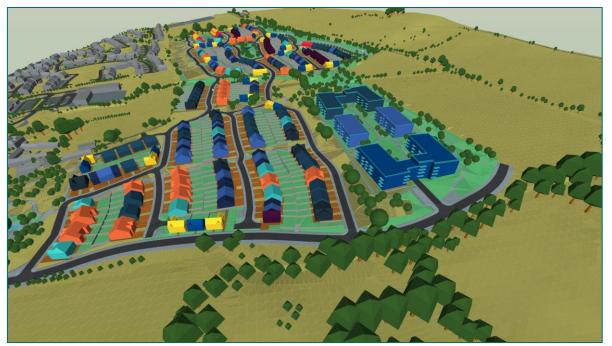
Figure 25: Plan view of the site

Figure 26: View of the site from the south

Figure 28: View of the site from the west

Figure 29: View of the site from the northwest

Figure 30: View of the site from the north

Figure 31: View of the site from the northeast

Figure 25 to Figure 48 show the geometry as modelled.

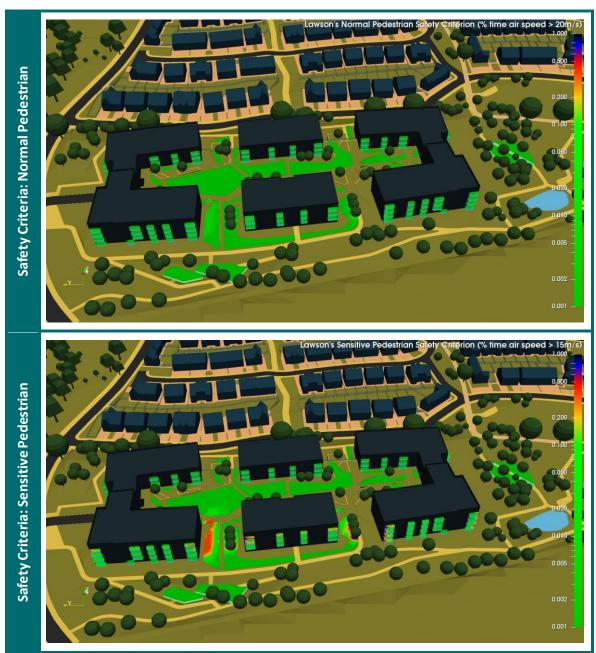
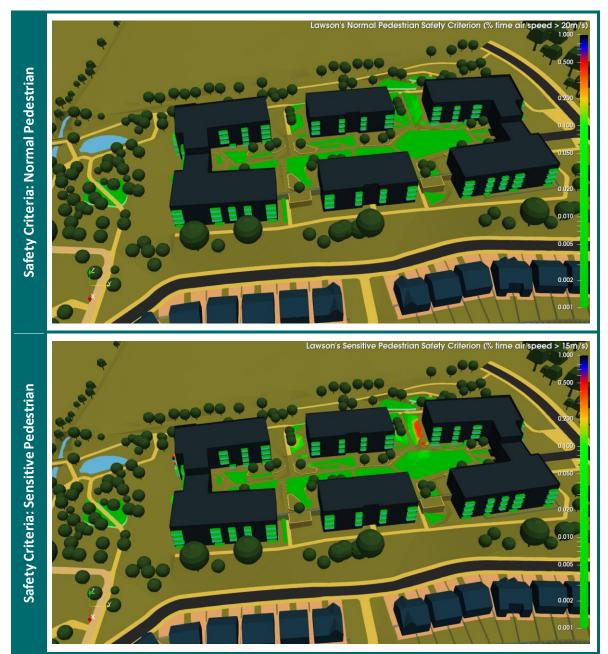
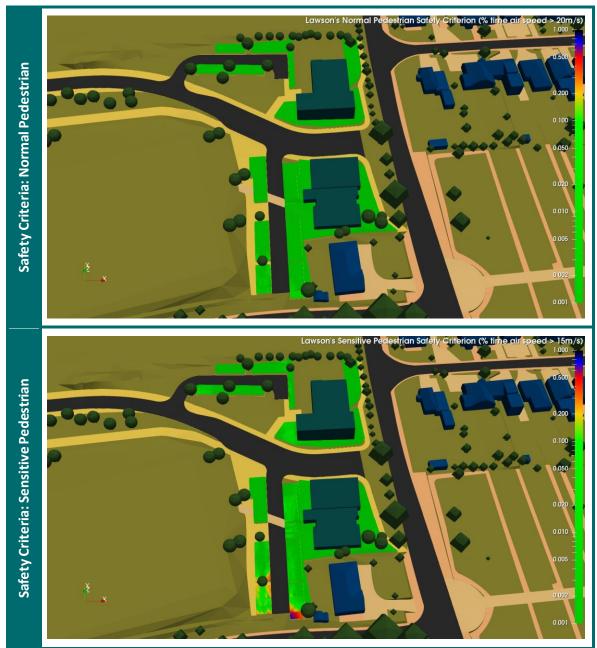
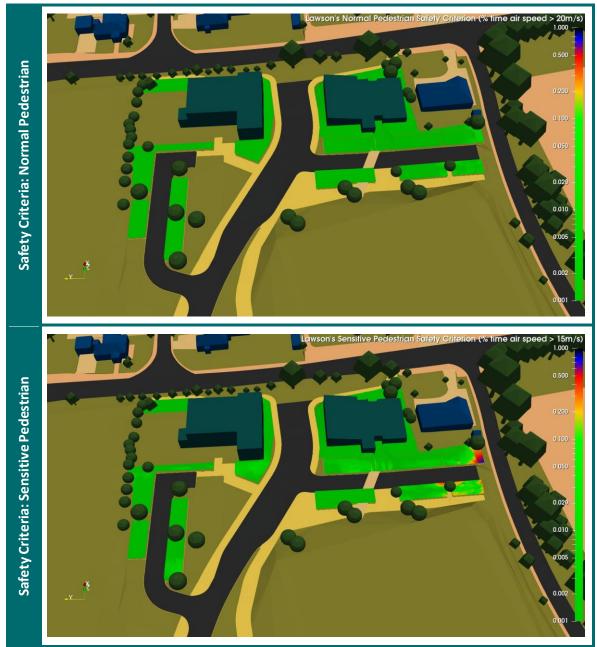
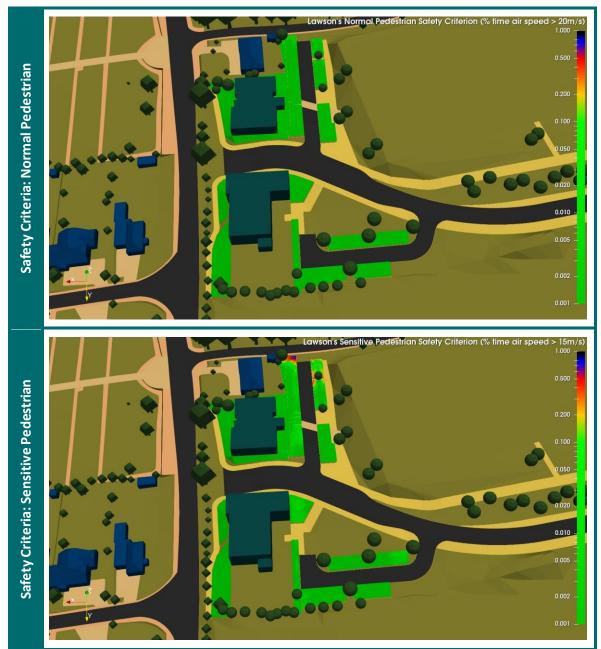
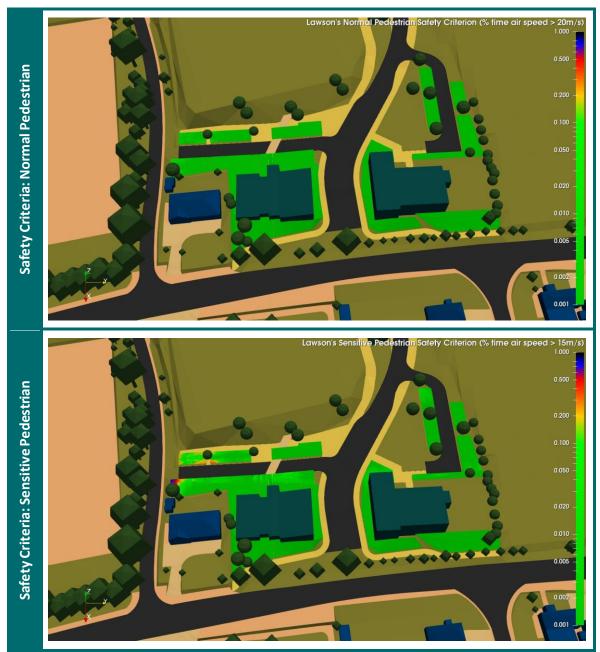
Figure 61: Safety Criteria: All Season: View of the residential blocks from the west

Figure 63: Safety Criteria: All Season: View of the residential blocks from the east

Figure 65: Safety Criteria: All Season: View of the Creche and Community buildings from the south

Figure 66: Safety Criteria: All Season: View of the Creche and Community buildings from the west

Figure 67: Safety Criteria: All Season: View of the Creche and Community buildings from the north

Figure 68: Safety Criteria: All Season: View of the Creche and Community buildings from the east

Figure 59 to Figure 68 show the percentage of the year the hourly wind speed exceeds the threshold value for the safety criteria for all seasons. The threshold values are 20m/s for normal pedestrian and 15m/s for sensitive pedestrian.

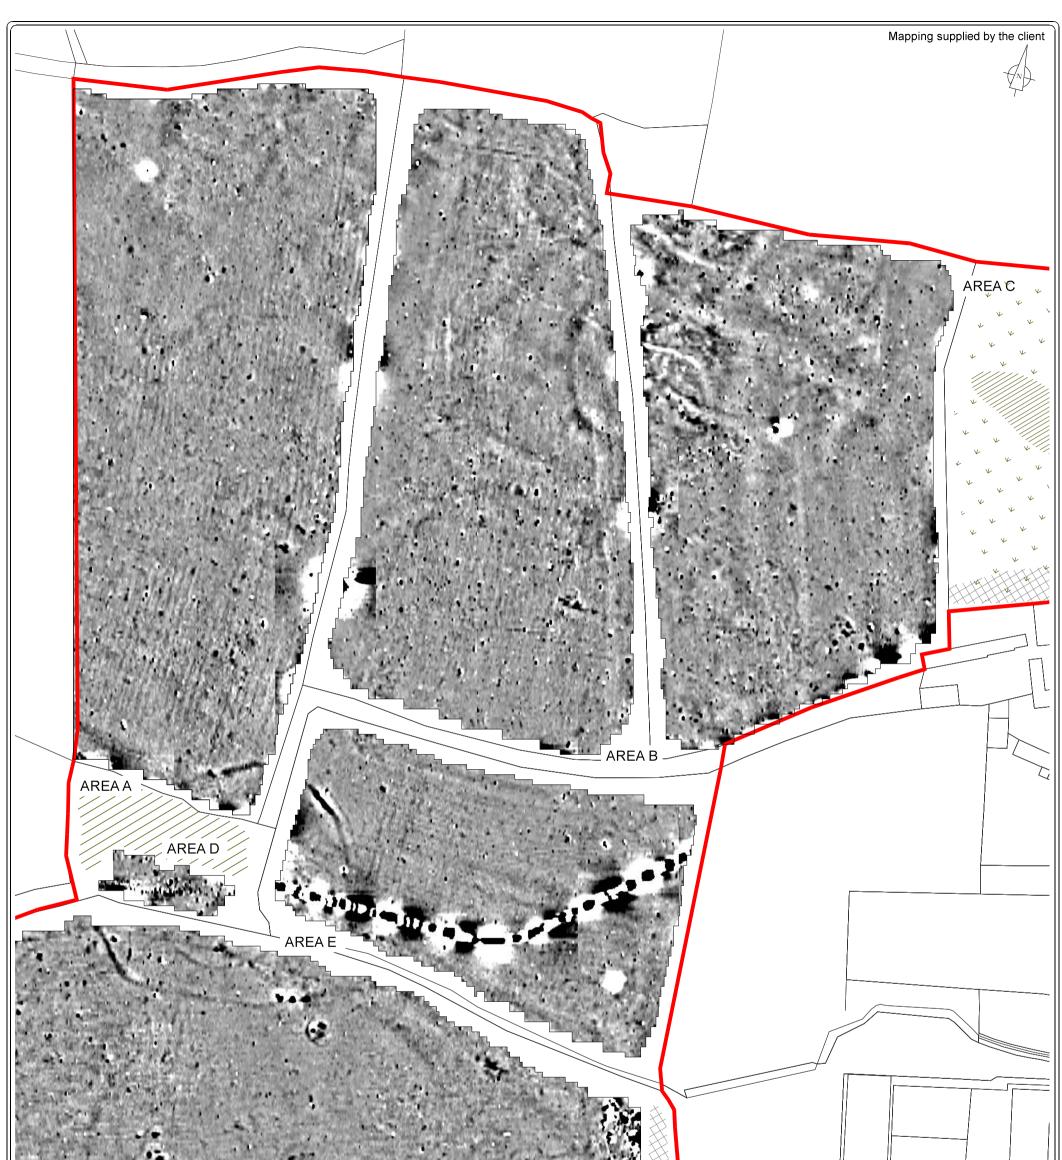
-1.5 nT 2.5	Not suitable for survey - Not sui Overgrown Vegetation Dense	table for survey - Modern m vegetation / Hedgerow Interference		0 metres 60
Client: IAC Ltd.	Project: Geophysical Survey Coolagad, Greystones County Wicklow	Title: Gradiometer Survey Greyscale Image: Areas A, B,C, D and E	M. Leigh Surveys Ltd. www.jmlsurveys.com	Scale @ A3:         1:1,500           Figure:         4           Licence No.:         20R0212           Issue Date:         04.12.2020

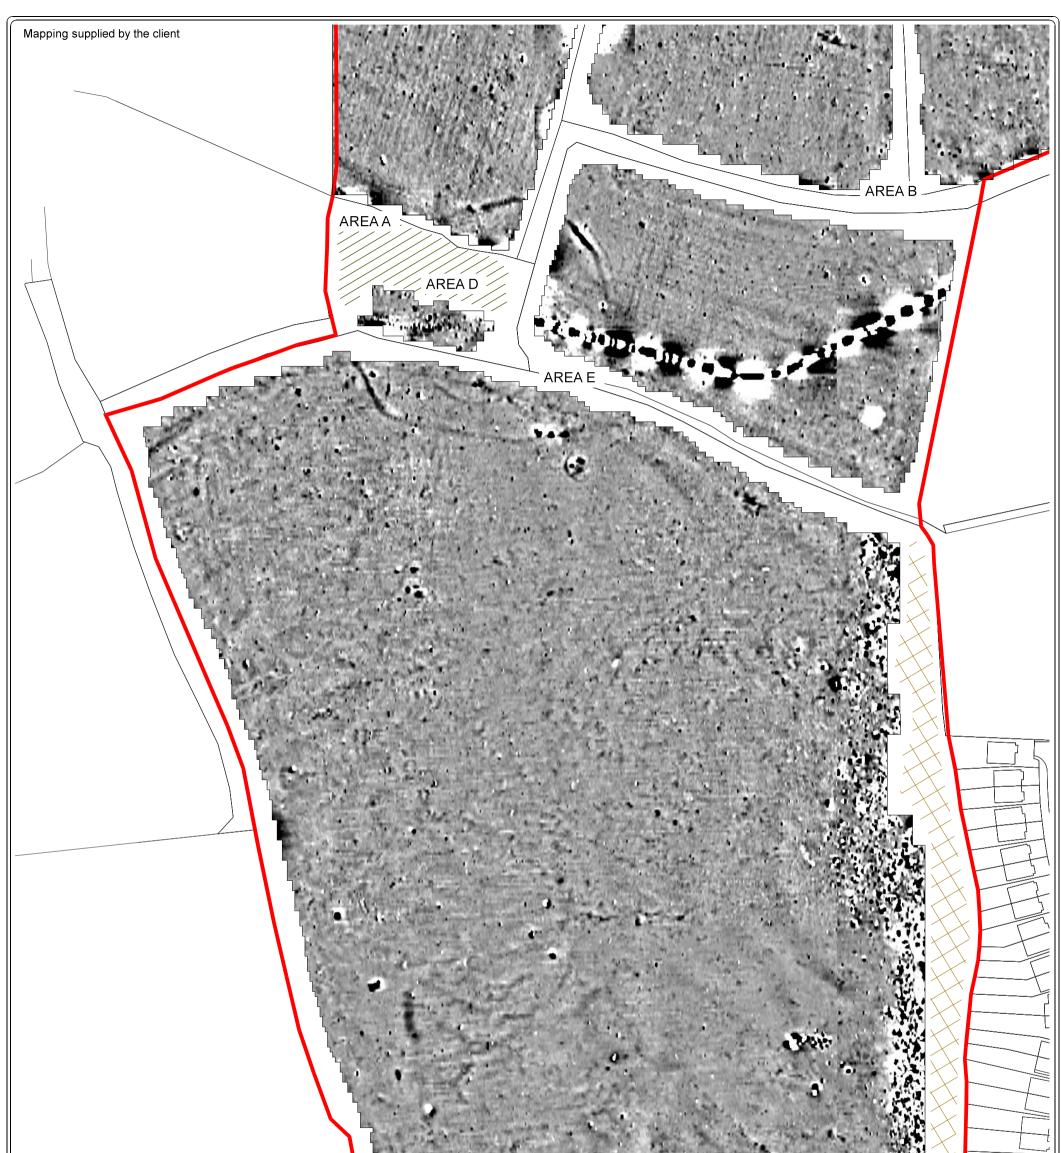
Client:	Project: Geophysical Survey Coolagad, Greystones County Wicklow	Title: Gradiometer Survey Greyscale Image: Area F	M. Leigh Surveys Ltd.	Scale @ A3:         1:1,500           Figure:         6           Licence No.:         20R0212           Issue Date:         04.12.2020
-1.5 nT 2.5			AREA F

- 5.13 Similar sized faint curvilinear trends (12) are recorded in Area F. Interpretation of these is less clear as the trends are poorly defined. Although they may represent plough damaged features, they may equally represent natural variations in the subsoil.

- 5.15 Two responses (14) in the south of Area F are curious. Although they appear to be isolated, they both have a magnetic signature indicative of a burnt feature such as a hearth or kiln. It is possible that the responses represent the remains of plough damaged archaeology and they are considered to be of archaeological potential.
- 5.16 A small area of increased response (15) is located in the south of Area F. Although it is possible that this represents modern ground disturbance, it is equally possible that a spread of burnt archaeological material is represented here. It is noted that incoherent trends and the isolated responses (14) are located in the south of Area F and it is possible that these all represent the remains of plough damaged archaeology. This is speculative but must be considered.

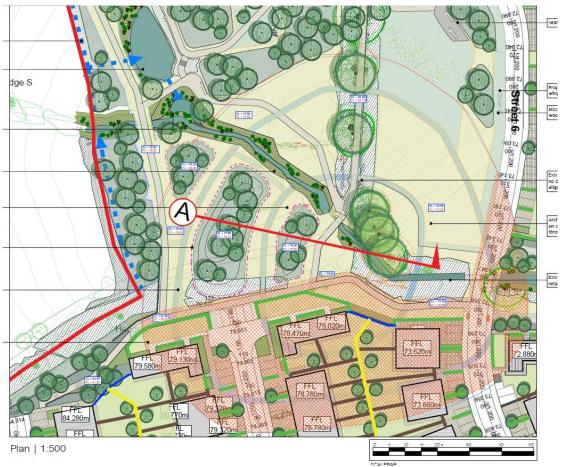
FIGURE 3 AA1 showing proposed excavation area hatched purple

It is proposed to preserve the southern portion of the enclosure by record (archaeological excavation) in advance of development (Figure 3). This will involve full archaeological excavation under licence to the National Monuments Service of the Department of Housing, Local Government and Heritage should a grant of planning be obtained and should the proposed archaeological mitigation strategies outlined in this document be deemed appropriate.

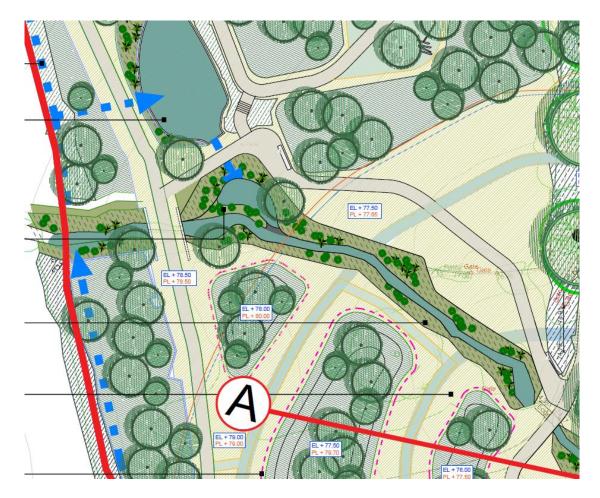
# **FIGURE 5** AA1 showing stream treatment and planting detail (Source: KFLA
