- 11.1 This Chapter of the Environmental Impact Assessment Report (EIAR) relates to the potential effects of the continued use of the existing permitted quarry at Barryscourt & Rossmore Tds., Carrigtohill, Co. Cork on material assets.

- 11.2 The planning application is for continuance of use of the existing quarry to the permitted extraction level of -40mOD. The application made in accordance with the requirements of the Planning and Development Regulations 2001-2018 (as amended).

KILSARAN CONCRETE
ENVIRONMENTAL IMPACT ASSESSMENT REPORT
ROSSMORE QUARRY
ROSSMORE, CARRIGTOHILL, CO.CORK

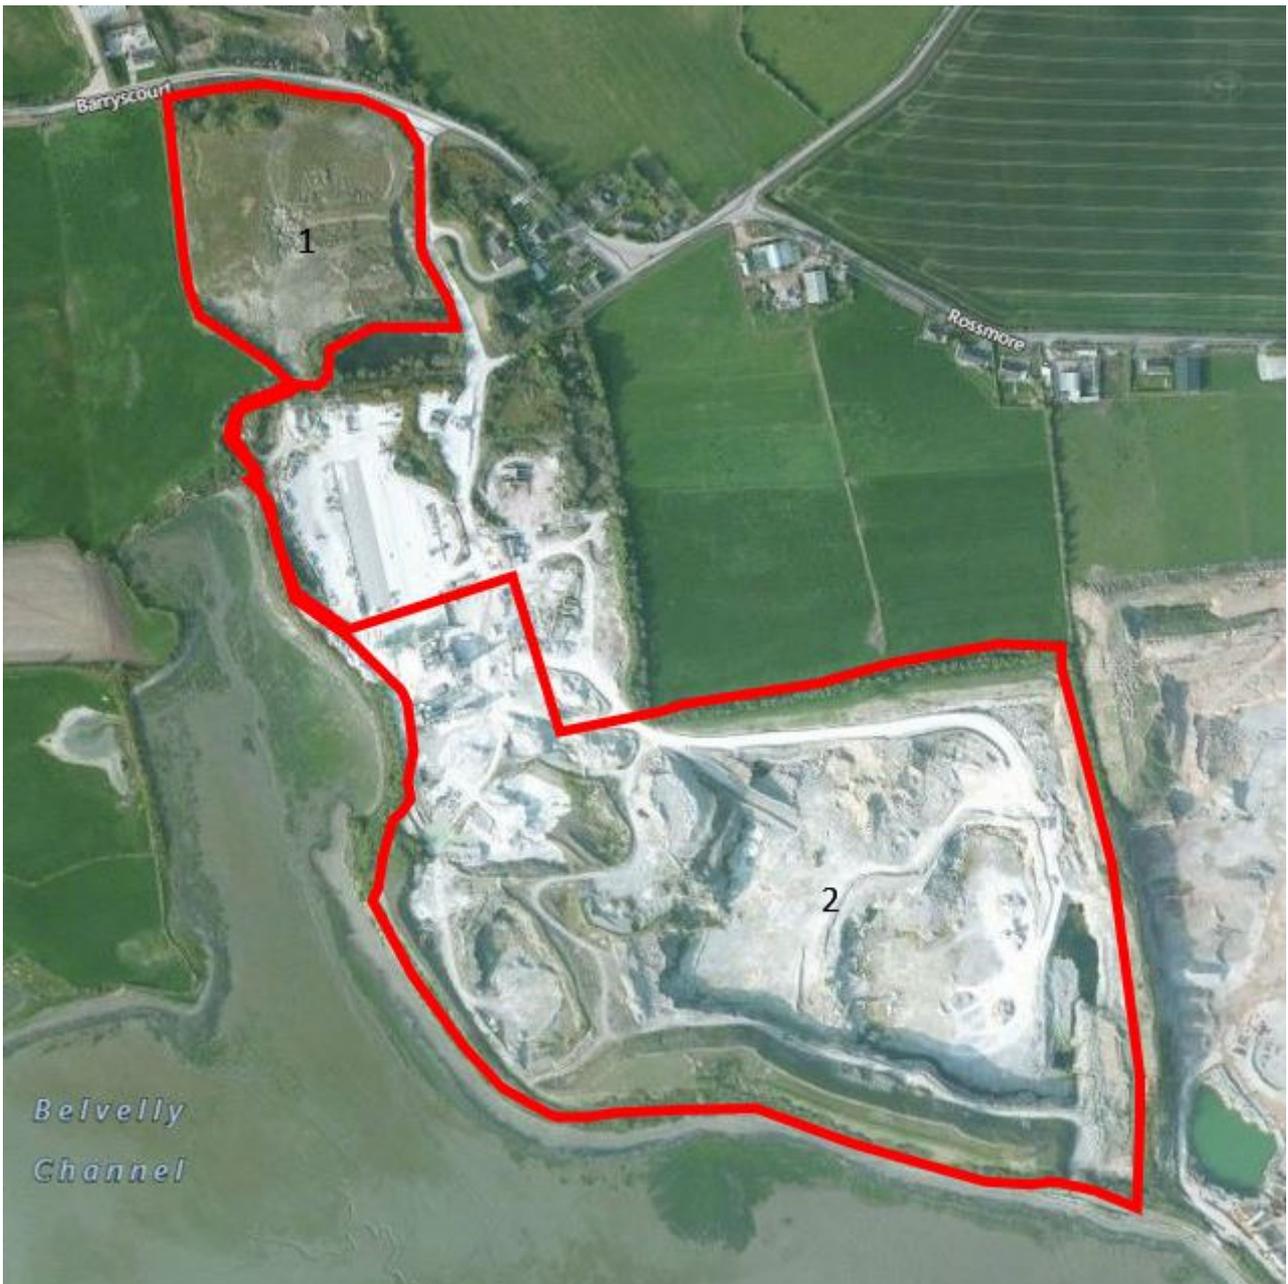
Plate 12-2

Aerial image of the application area from Bing Maps showing the numbered fieldwork areas.

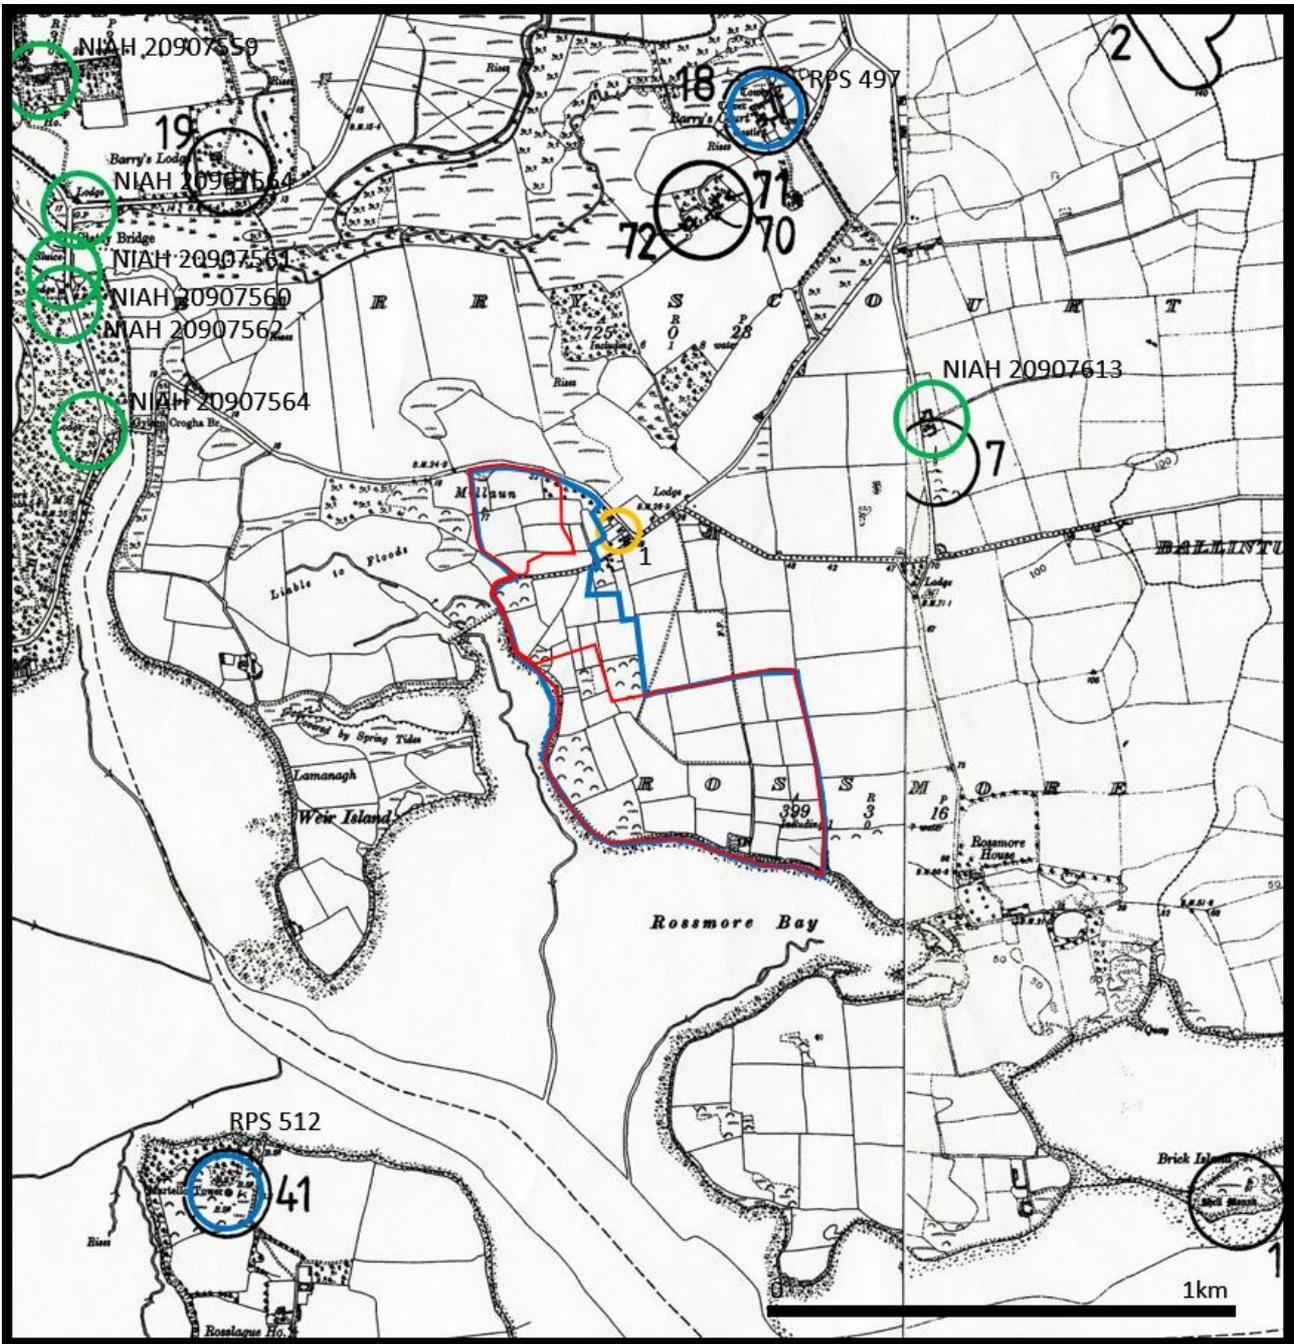
Figure 12-1

The study area. The red line is the application area and the blue line is the land holding. RMP sites are indicated with black circles. Structures in the Record of Protected Structures with blue circles, in the NIAH with green circles and upstanding structures on the 1935 OS mapping within 300m of the extraction area with gold circles.

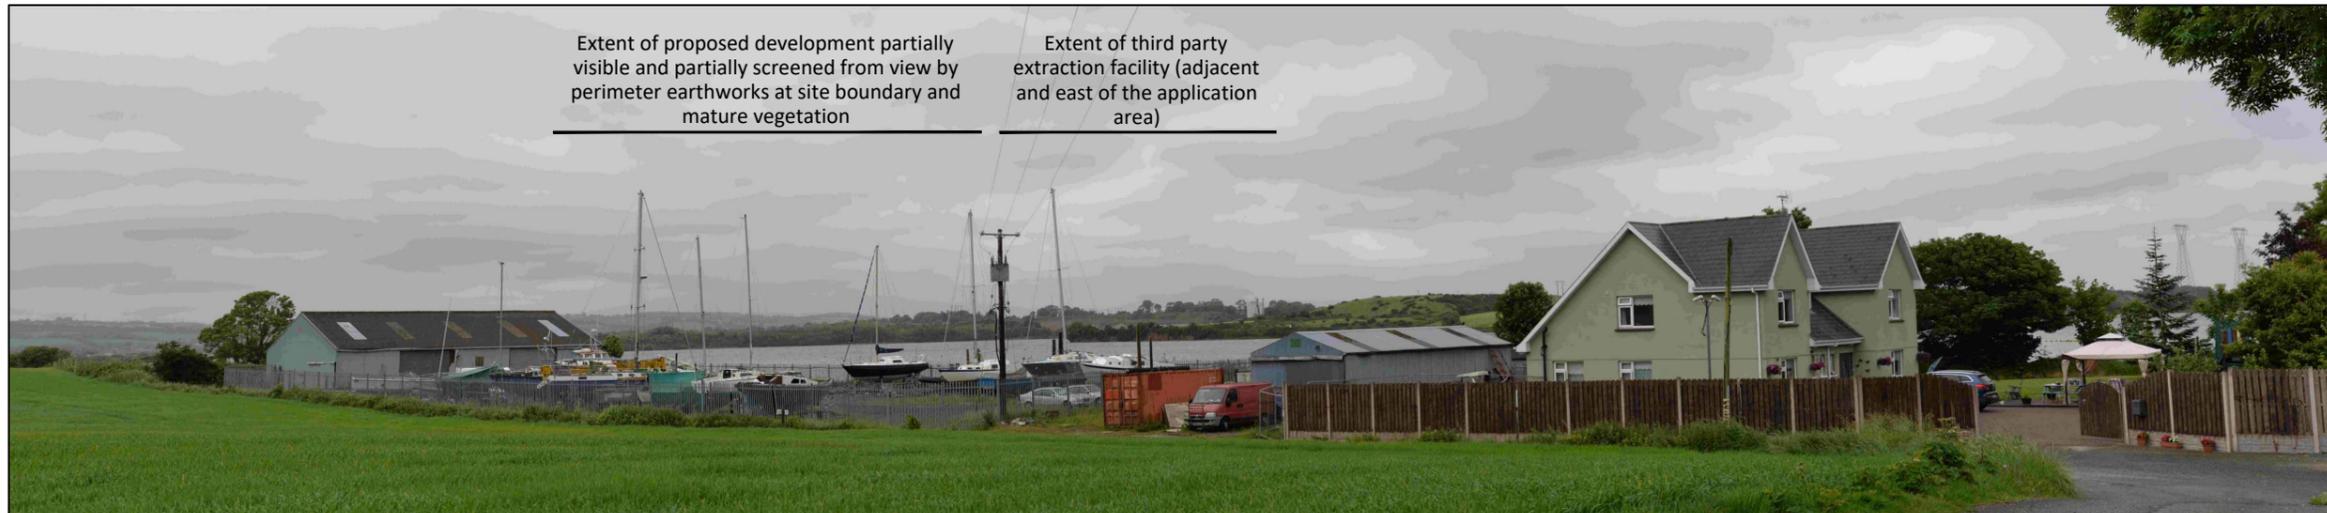
Extent of proposed development partially visible and partially screened from view by perimeter earthworks at site boundary and mature vegetation

Extent of third party extraction facility (adjacent and east of the application area)

Description: Views are available towards Rossmore Bay and the hill farmland further north. The perimeter earthworks associated with the application area is partially visible, above the line of existing vegetation at the shoreline. Structures associated with the third party extraction facility, adjacent and east of the application area are clearly visible, including mineral faces and silo. The foreground features sailing boats, isolated buildings and a low voltage overhead powerline.

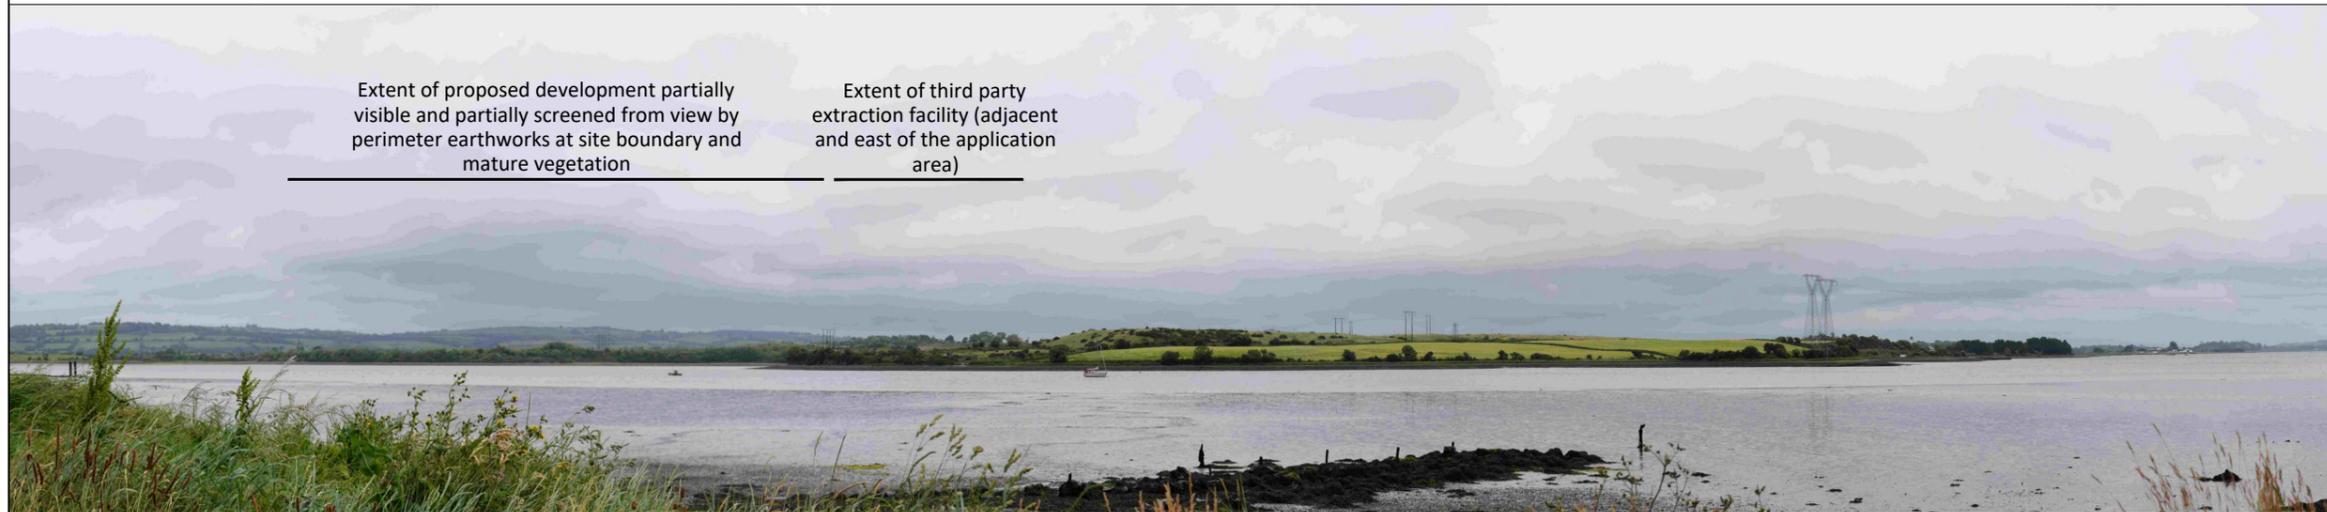
Extent of proposed development partially visible and partially screened from view by perimeter earthworks at site boundary and mature vegetation

Extent of third party extraction facility (adjacent and east of the application area)

Description: Panoramic views are available of Great Island Channel and undulating farmland to the north including the promontories at Brick Island and Weir Island. Overhead power lines and pylons are clearly visible. Part of the application area, specifically the earthworks, is visible as a small element above the line of existing vegetation at the shoreline in this panoramic view. Part of the third party extraction facility, adjacent and east of the application area is clearly visible as a small element.

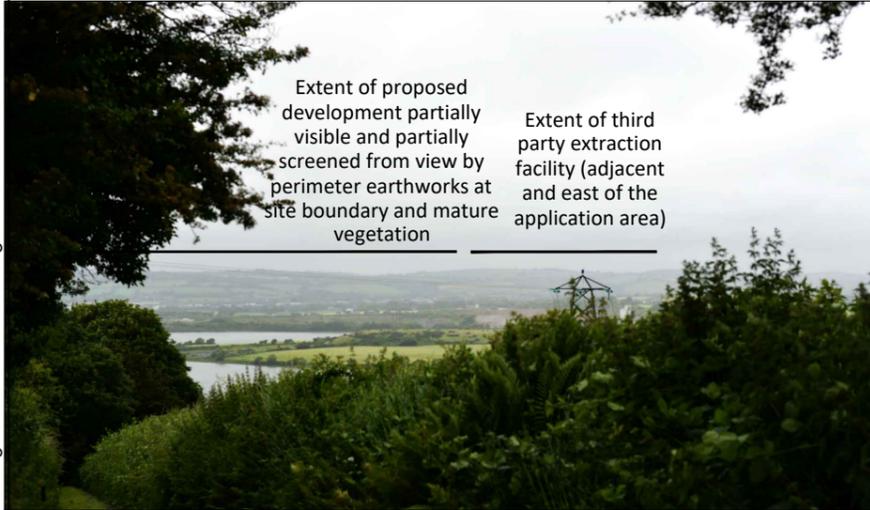
Extent of proposed development partially visible and partially screened from view by perimeter earthworks at site boundary and mature vegetation

Extent of third party extraction facility (adjacent and east of the application area)

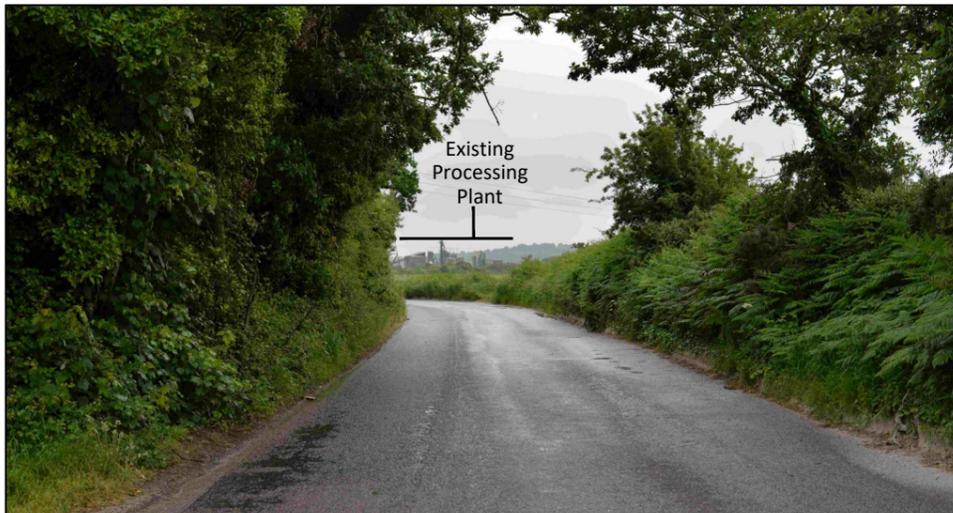
VIEWPOINT E: Minor Road west of the application area
 Approximate Grid Coordinates: **581017, 571865** Approximate Elevation: **2m AOD**
 Distance from planning application boundary: **0.7km** Direction of View: **South East**
Description: Views are available of the existing facilities, specifically the processing plant within the application area through a break in the roadside vegetation.

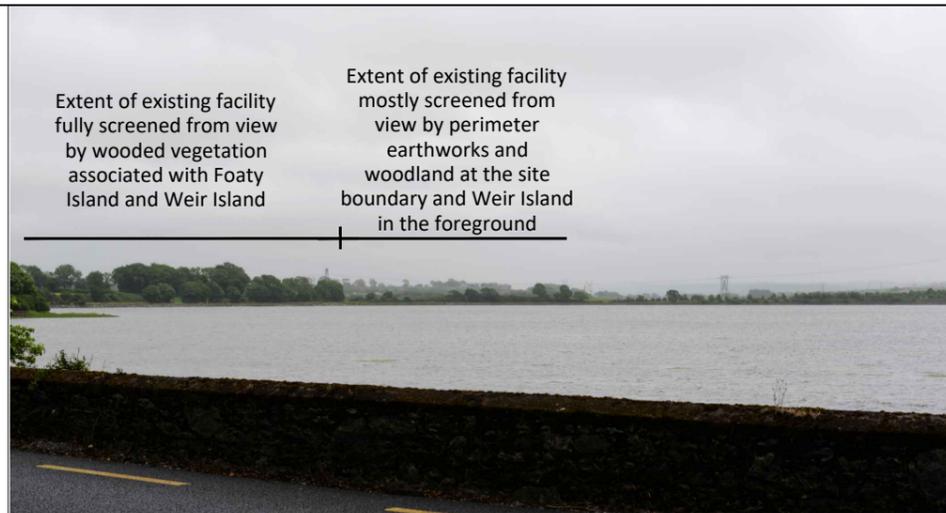
VIEWPOINT H: R624 Regional Road on Foaty Island
 Approximate Grid Coordinates: **580201, 571267** Approximate Elevation: **7m AOD**
 Distance from planning application boundary: **1.5km** Direction of View: **East**
Description: Panoramic views are available of Great Island Channel. Part of the wooded edge of Foaty Island is visible in the foreground to the left of the viewer. Overhead powerlines and pylons are visible in the distance. A very small part of the eastern end of the existing facility is visible above the line of existing vegetation and earthworks at the site boundary with Weir Island in the foreground.

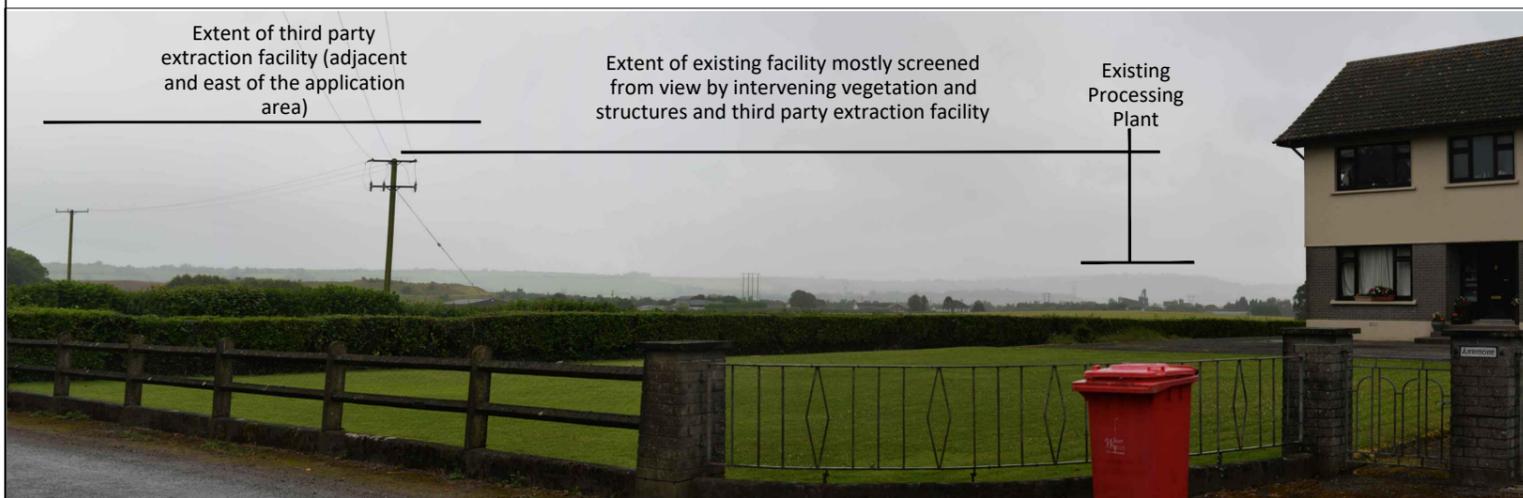
VIEWPOINT F: Edge of settlement of Barryscourt.
 Approximate Grid Coordinates: **582453, 572031** Approximate Elevation: **18m AOD** Distance from planning application boundary: **0.9km** Direction of View: **South**
Description: Views are available of the processing plant associated with the existing facility with farmland in the foreground and against the backdrop of the hill farmed landscape of Great Island. Earthworks associated with the third party extractive facility located east of the application area are clearly visible together with overhead power lines and pylons.

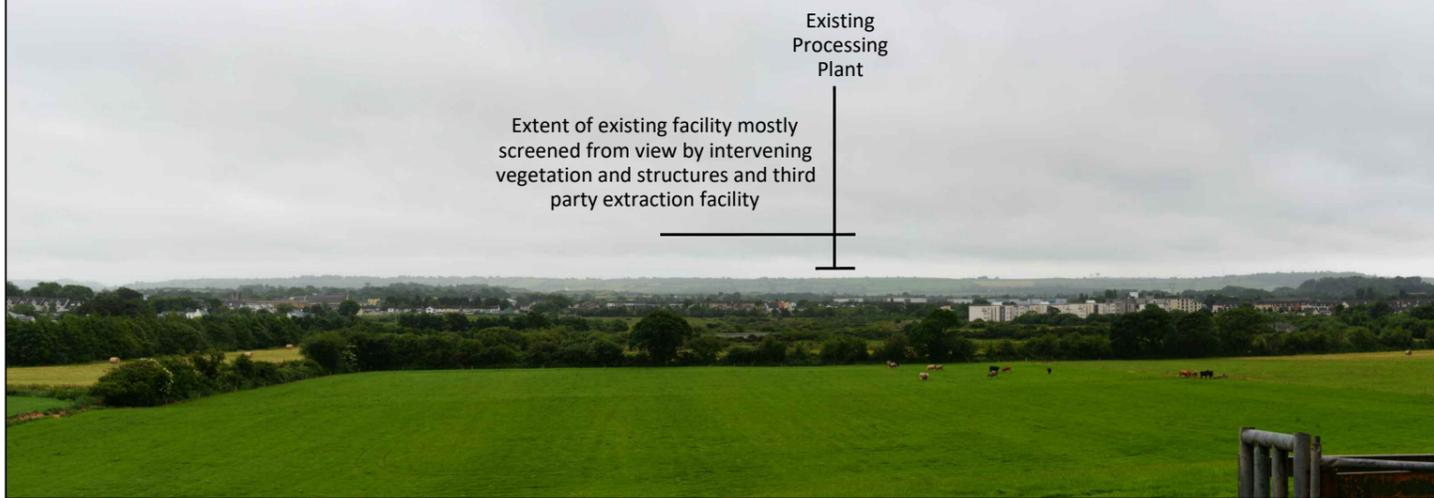
VIEWPOINT G: Minor Road at Ballynoe.
 Approximate Grid Coordinates: **581613, 574186** Approximate Elevation: **28m AOD** Distance from planning application boundary: **2.7km** Direction of View: **South**
Description: Panoramic views are available of farmland and the settlement of Carrigtohill including larger scale industrial buildings and multi unit developments in the foreground against the backdrop of the hill farmland of Great Island further afield. The existing processing plant within the application area is barely visible as a small element in the distance. Structures associated with the third party extraction facility, adjacent and east of the application area, including earthworks silo are clearly visible albeit as small elements in the distance.

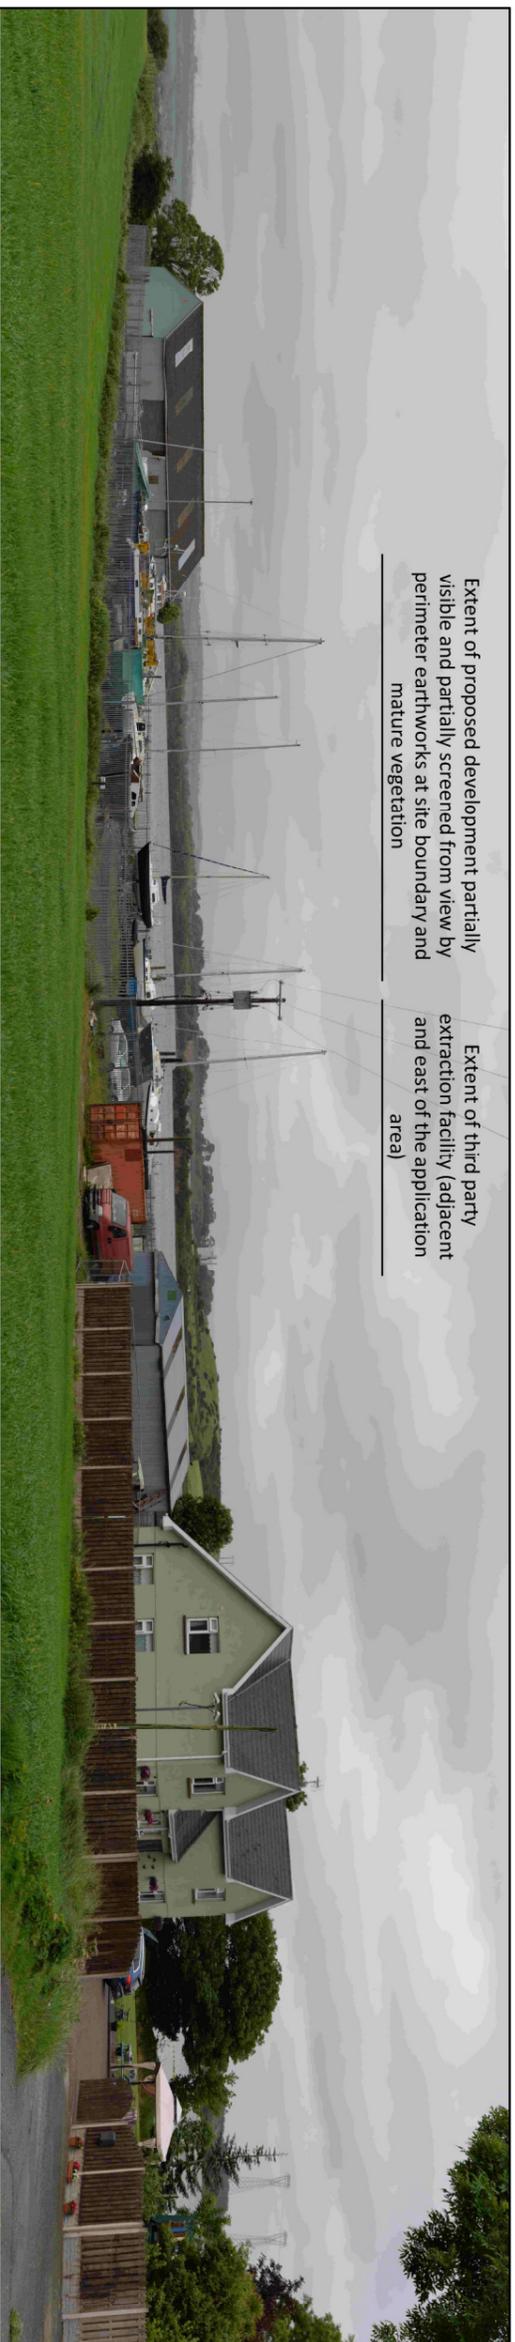
Extent of proposed development partially visible and partially screened from view by perimeter earthworks at site boundary and mature vegetation

Extent of third party extraction facility (adjacent and east of the application area)

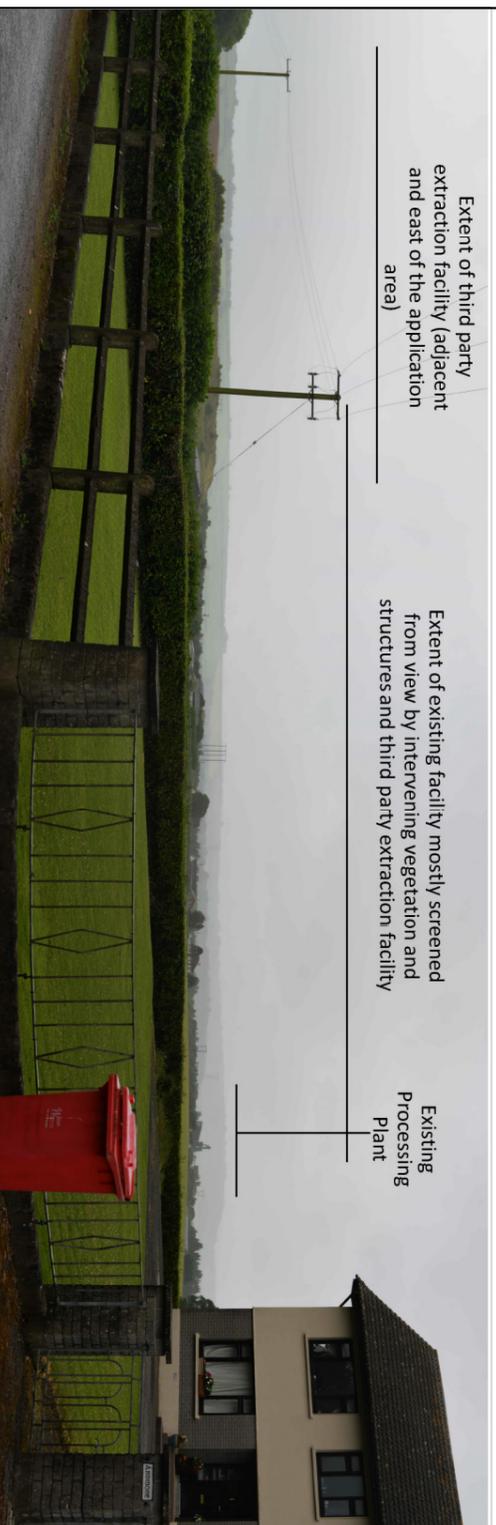
VIEWPOINT F: Edge of settlement of Barryscourt.
 Approximate Grid Coordinates: **582453, 572031** Approximate Elevation: **18m AOD** Distance from planning application boundary: **0.9km** Direction of View: **South**
 Description: Views are available of the processing plant associated with the existing facility within farmland in the foreground and against the backdrop of the hill farmed landscape of Great Island. Earthworks associated with the third party extraction facility located east of the application area are clearly visible together with overhead power lines and pylons.

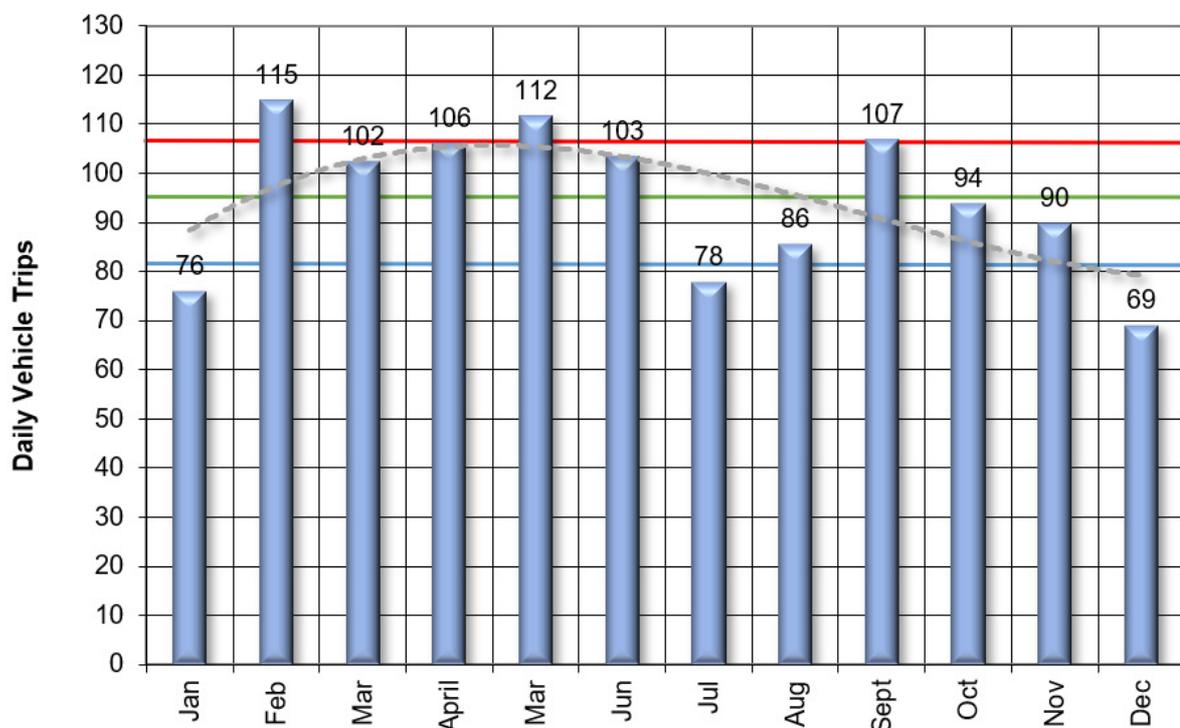
Figure 14 - 1
Total Daily HGV Generation at Existing Site 2019

- 14.47 The data includes for all HGV traffic movements including those transporting aggregates, ready mix concrete, concrete blocks from the site and HGV delivering sand and cement for use in the onsite manufacture of value-added products. The figures are based upon the average daily traffic flow recorded each month. The dotted grey line shows the polynomial average monthly HGV traffic generation over the course of the year. The 'red' line indicates the 85th percentile traffic generation rate often used as the upper value figure in the assessment of road network capacity and junction analyses. The 'green' line shows the average traffic generation of the site whilst the 'blue' line shows the traffic generation recorded on the day of the survey. The 85th percentile or upper value is 108 trips per day, the average daily traffic generation is 95 trips per day.

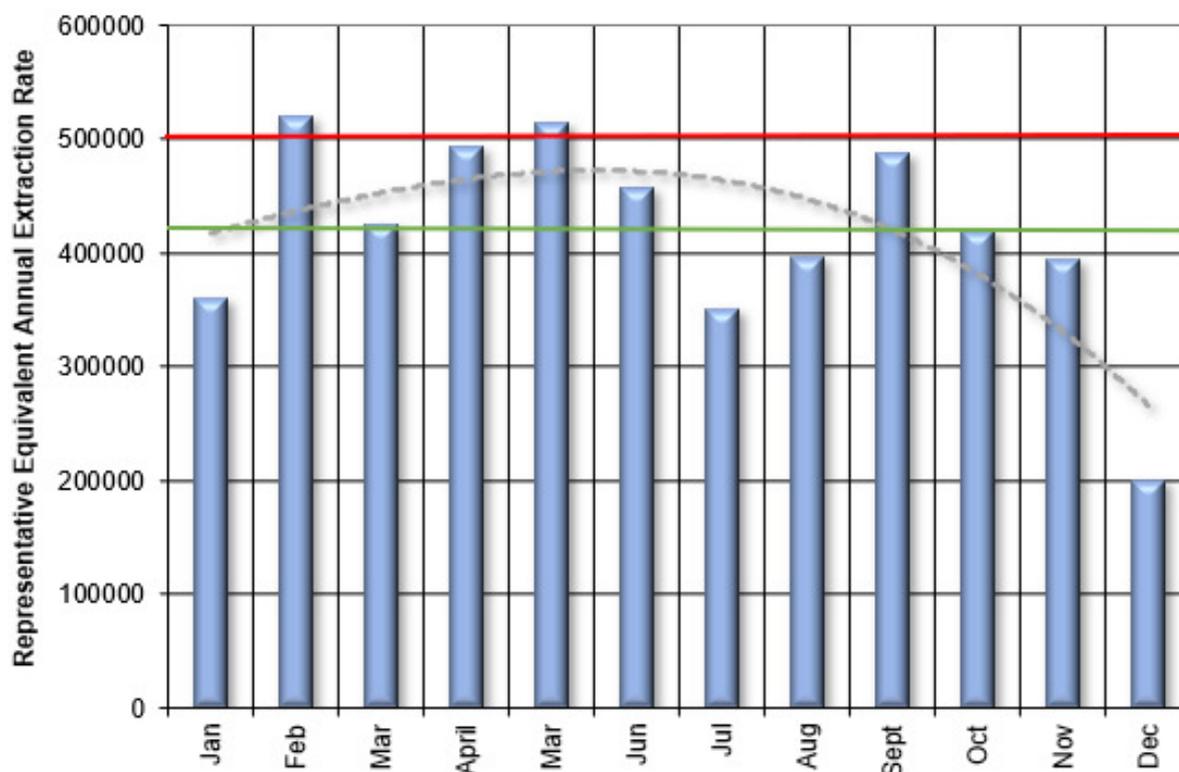
Figure 14 - 2
Total Monthly Volume of Aggregate Extracted at Existing Site 2019

- 14.79 The green line in **Figure 14-2** is representative of the average annual extraction rate of 419,245t whilst the red line is representative of the 85th percentile or upper value for traffic assessment which equates to 502,124t per annum. The maximum value recorded in 2019 was in February when the rate of extraction was equivalent to an annual extraction rate of 521,393t.

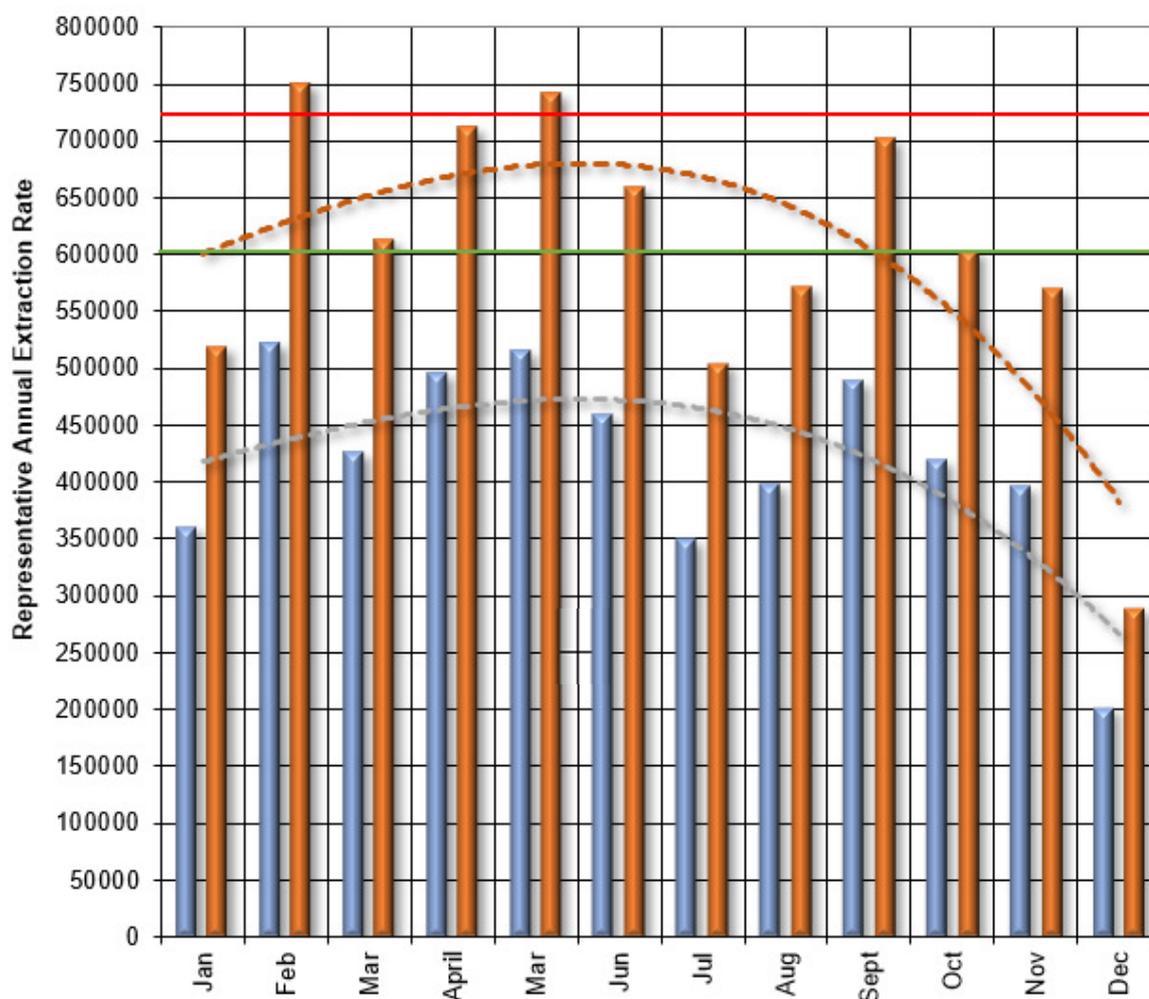
Figure 14 - 3
Total Monthly Volume of Aggregate Extracted in 2019 v. Total Permitted

Monthly Extraction Rate Extrapolated to 12 Months Representative Rate 2019
Current Permitted Extraction Rate 750,000t per Annum

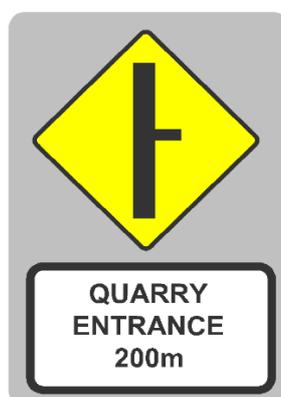
Image 14 - 1
Proposed Advance Signage

details of legend size etc. will be designed in accordance with the Traffic Signs Manual and the precise location agreed with the planning authority. The following **Image 14-1** provides a suggested layout.
