Title: STAGE 1 ROAD SAFETY AUDIT

Proposed Residential Development at Hacketstown, Skerries.

Client: DBFL/Land Development Agency

Report reference: 1389R01

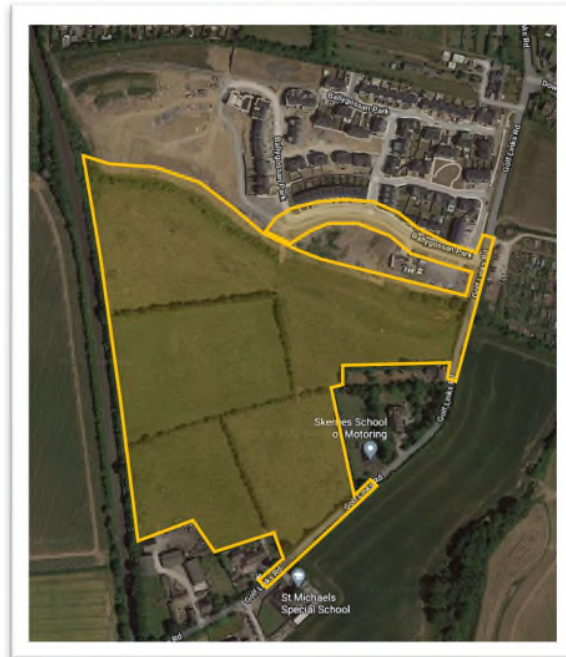
The scope of the Audit includes the existing Ballygossan Park access from Golf Links Road as well as the proposed development and the direct access onto Golf Links Road. The scope is outlined in yellow on the image below.

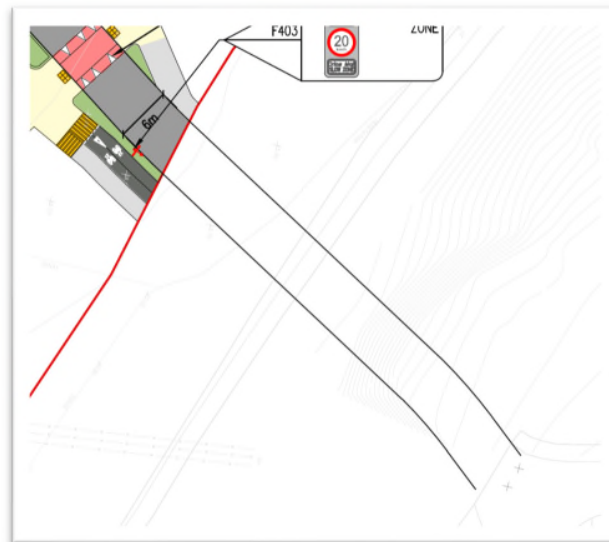
3.1 Problem

Drawing 190170-DBFL-RD-SP-DR-C-1002 Rev P02.01, Road Marking & Signage Layout Plan, Link to Ballygossan Park.

Details have not been provided of the section of road to be provided linking the proposed development to the main access road in Ballygossan Park. A varying cross section may lead to risks for pedestrians and cyclists and a steep vertical alignment could lead to lack of traction for vehicles and possibly affect stopping sight distance.

It is recommended that a constant cross section be provided along the link and that the vertical alignment takes into account the required stopping sight distance.

| Paragraph No. in Safety Audit Report | Problem accepted (yes/no) | Recommended measure accepted (yes/no) | Alternative measures (describe) | Alternative measures accepted by Auditors (Yes/No) |
|---|---|---|--|--|
| 3.1 | Yes | Yes | The road link across the Regional Drainage Facility and associated open space is subject to a separate planning application (by the same applicant) for which planning permission by FCC has been granted. We confirm that the design of this link provides a constant cross section, the required visibility splays safeguard, and appropriate tie-in provided with Ballygossan Rd Phase 1 infrastructure; as per auditors recommendations. | Yes |

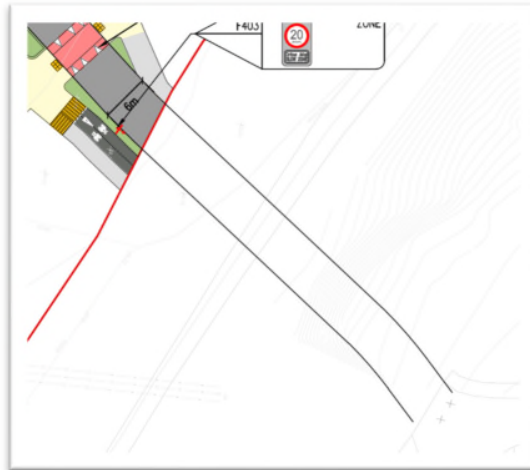
3.2 Problem

Drawing 190170-DBFL-RD-SP-DR-C-1002 Rev P02.01, Road Marking & Signage Layout Plan, Link to Ballygossan Park.

Details have not been provided of the section of road to be provided linking the proposed development to the main access road in Ballygossan Park. Given the topography of the site a bridge structure will likely be

required. There is a risk that errant vehicles could descent the height hazard and also a risk that vulnerable road users could fall from a height.

It is recommended suitable parapet railings/walls/restraint systems be provided which extend over the length of need.

| Paragraph No. in Safety Audit Report | Problem accepted (yes/no) | Recommended measure accepted (yes/no) | Alternative measures (describe) | Alternative measures accepted by Auditors (Yes/No) |
|---|---|---|--|--|
| 3.2 | Yes | No | The subject road link is to be constructed using an embankment with gently sloping sides (and rounded transitions) opposed to the alternative bridge structure option considered by the auditors. The gradient of the embankments side slopes varies (typically 1:7) however at its steepest position it will still be relatively shallow with a max fall of 1:5 with an overall the height difference of criteria 4.15m. The provision of this level of gradient with appropriate transitions and a height difference of less than 6m negates the need to provide the requested restraint system. | Yes |

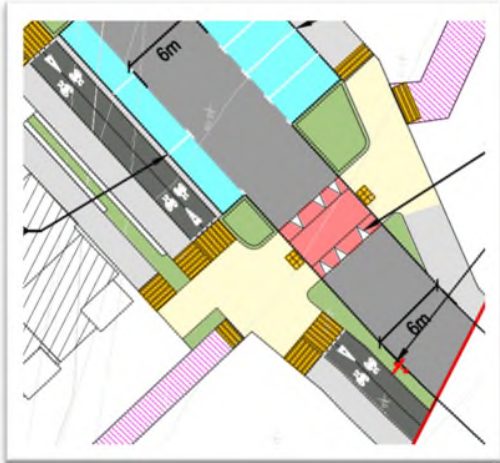
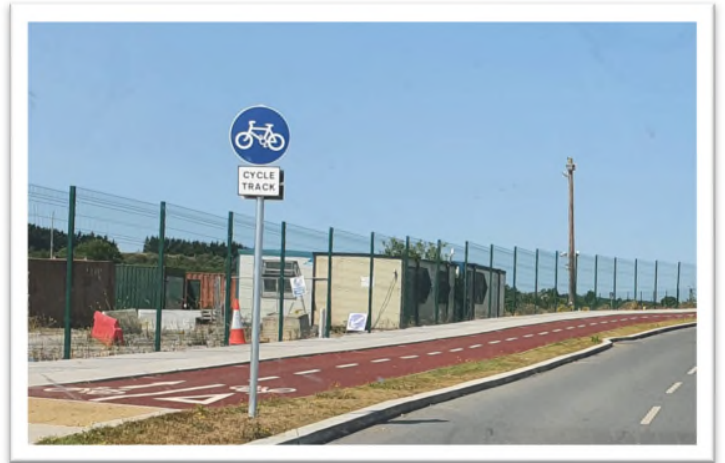
3.3 Problem

Drawing 190170-DBFL-RD-SP-DR-C-1002 Rev P02.01, Road Marking & Signage Layout Plan, Cycle track.

It was observed during the site visit that the existing two-way cycle track in Ballygossan Park has red surfacing. It is unclear if the proposed two-way cycle track is to have a similar colour. A lack of consistency in colour of the cycle tracks may lead to confusion for users and lead to cyclists mixing with pedestrians.

It is recommended that a consistent approach be provided as already exists in Ballygossan Park.

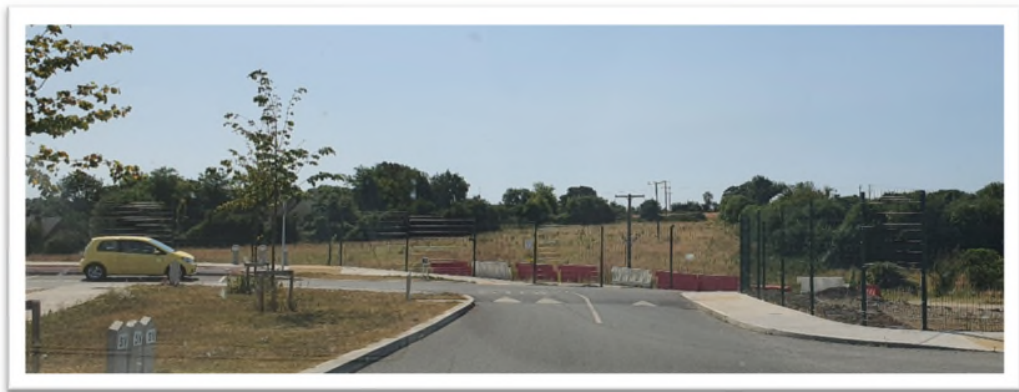
3.4 Problem

Drawing 190170-DBFL-RD-SP-DR-C-1002 Rev P02.01, Road Marking & Signage Layout Plan, Site Observation.

When the link from Ballygossan Park is completed those that turn right into and left out of units 72-103 will have to give way to through traffic. The road markings show that they currently have to stop however this is not reinforced with a stop sign or other warning sign and there is currently no conflicting traffic so drivers are not used to stopping.

It is recommended that a stop sign be added at the sideroad and that warning signage (temporary only should be suffice) to warn drivers of a revised layout at the junction.

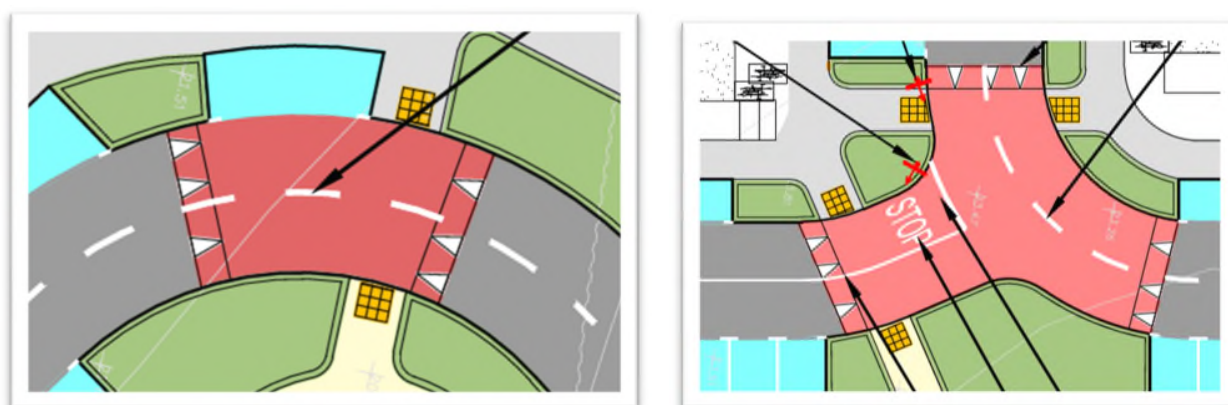
3.5 Problem

Drawing 190170-DBFL-RD-SP-DR-C-1002 Rev P02.01, Road Marking & Signage Layout Plan, Raised Tables throughout the development.

It is proposed to provide raised tables throughout the development including at sharp changes in direction. There is a risk that drivers will cut the corners and mount the adjacent verge/footpath if the raised tables are at the same height. This could be a risk for pedestrians.

It is recommended that suitable vertical segregation between the top of the raised table and the top of the kerbs be provided.

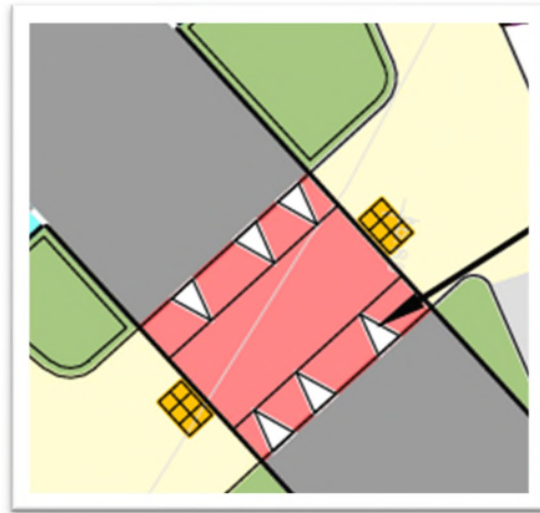
3.6 Problem

Drawing 190170-DBFL-RD-SP-DR-C-1002 Rev P02.01, Road Marking & Signage Layout Plan, Raised Tables throughout the development.

The raised tables throughout the development generally have associated uncontrolled pedestrian crossings. It is unclear if the crossings are dished at the tactile paving only or across the entire footpath width. If there are areas where the footpath is flush with the raised table and without tactile paving a blind or partially

sighted pedestrian may inadvertently enter the carriageway. This could lead to collisions with passing vehicles. In addition, some pedestrian crossing locations appear to be narrow (three tiles i.e. 1200mm) which may not cater for the volume of users.

It is recommended that tactile paving be provided over the entire width of dropped kerbs/flush kerbs with the raised tables and that the area of dropped kerb be of sufficient width to match the demand.

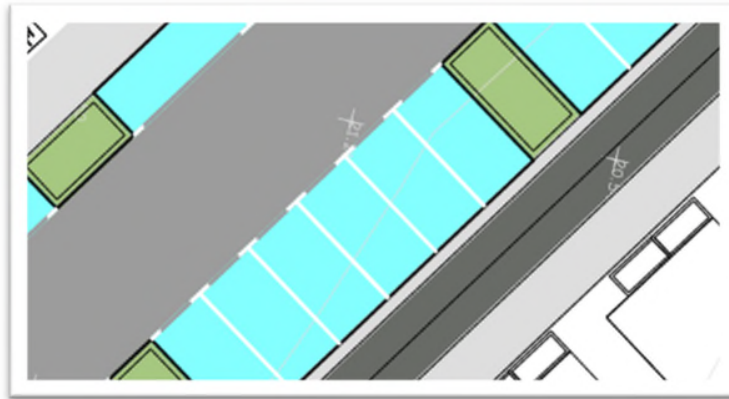
3.7 Problem

Drawing 190170-DBFL-RD-SP-DR-C-1002 Rev P02.01, Road Marking & Signage Layout Plan, Perpendicular Parking outside Block A2.

It is unclear how vehicle occupants who park in the perpendicular parking spaces outside Block A2 can access the residential units if they are pushing buggies or are somewhat mobility impaired. The gaps in the parking will be landscaped and it is assumed that there will be a high kerb at the buffer zone between the parking spaces and the two-way cycle track.

It is recommended that convenient access routes be provided without steps or trip hazards to cater for the mobility impaired. A similar situation exists at other Blocks within the development.

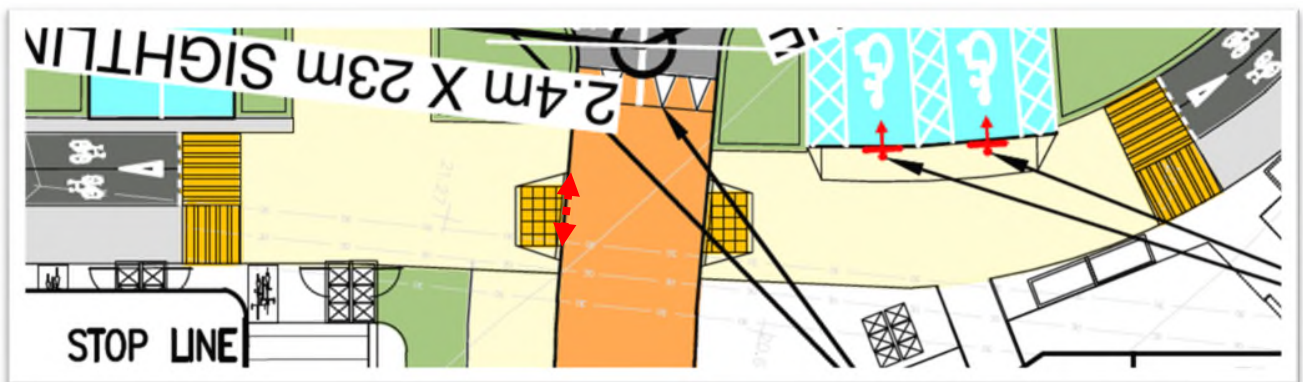
3.8 Problem

Drawing 190170-DBFL-RD-SP-DR-C-1002 Rev P02.01, Road Marking & Signage Layout Plan, Shared use Street between Block B1 and Block A2

There is a proposed to provide a 2m wide uncontrolled crossing of the shared street. This may lead to collisions between two-way cyclists and pedestrians as they try and share the same space.

It is recommended that a wider crossing area be provided.

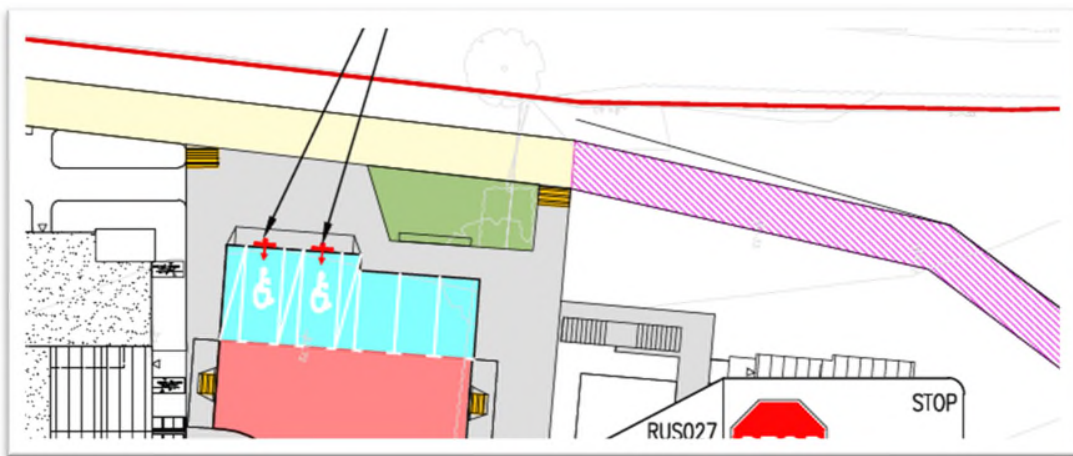
3.9 Problem

Drawing 190170-DBFL-RD-SP-DR-C-1002 Rev P02.01, Road Marking & Signage Layout Plan, Landscape Path.

It is unclear if the landscape path is designed for cyclists. The landscape path joins the shared use pedestrian cycle route at the northern side of the site. If the path is unsuitable for cyclists it is unclear where they should travel once they reach the interface point. A lack of provision could lead to cyclists sharing with pedestrians and thereby increasing the risk of a collision.

It is recommended that cyclists be given a clear route to get to the link to Ballygossan Park.

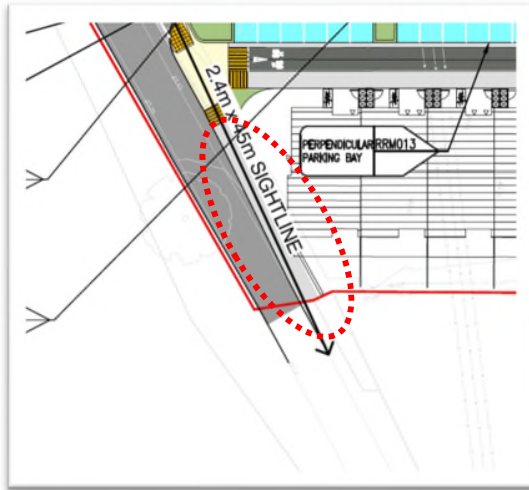
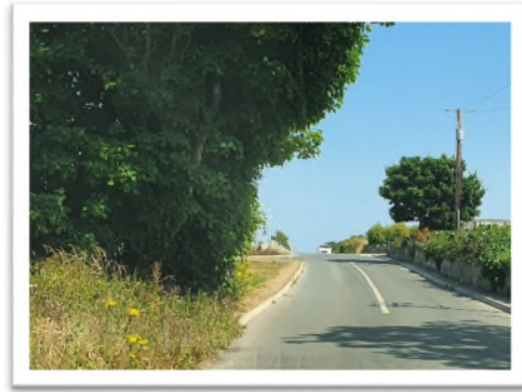
3.10 Problem

Drawing 190170-DBFL-RD-SP-DR-C-1002 Rev P02.01, Road Marking & Signage Layout Plan, Access onto Golf Links Road.

There will be a discontinuity in the footpath provision on Golf Links Road between the direct access and the Ballygossan Park access. Pedestrians will step into the carriageway where they will be at greater risk of being struck by a passing vehicle.

It is recommended that the footpath be made continuous along Golf Links Road.

If this is not feasible due to land ownership issues then the footpath should continue no further than the link to the internal network of footpaths and cycle tracks.

| Paragraph No. in Safety Audit Report | Problem accepted (yes/no) | Recommended measure accepted (yes/no) | Alternative measures (describe) | Alternative measures accepted by Auditors (Yes/No) |
|---|---|---|--|--|
| 3.10 | Yes | No | The footpath has been retained as it leads to/from a private side entrance to the rear | |

| | | | garden of the adjoining residential dwelling. The scheme proposals will deliver a number of alternative safe segregated high quality pedestrian routes through the proposed residential development which will accommodate the subject travel desire line for pedestrians seeking to gain access to destinations to the north. | Yes |

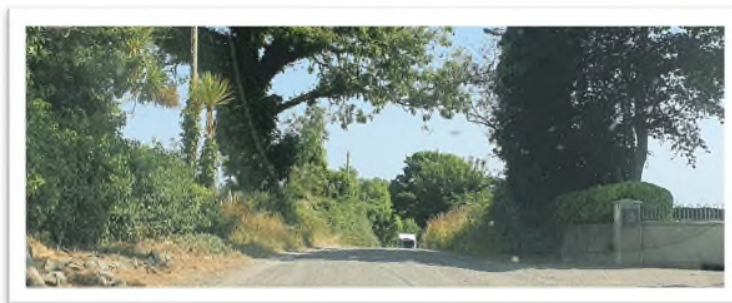
3.11 Problem

Drawing 190170-DBFL-RD-SP-DR-C-1002 Rev P02.01, Road Marking & Signage Layout Plan, Access onto Golf Links Road.

Golf Links Road has a steep vertical alignment at the St. Michael's special school side. There is a risk that visibility in the vertical plane might not be sufficient for vehicles exiting from the proposed accesses. This could lead to side-impact or rear-end collisions.

It is recommended that visibility in the vertical plane be checked for compliance with the relevant standards.
