Client: Cairn Homes PLC
Engineer: Waterman Moylan
Contractor: Site Investigations Ltd

Brennanstown Road Additional Investigation,
Cabinteely, Dublin 18
Site Investigation Report

Issue Date:	12/05/2021
Status	Final
Revision	1

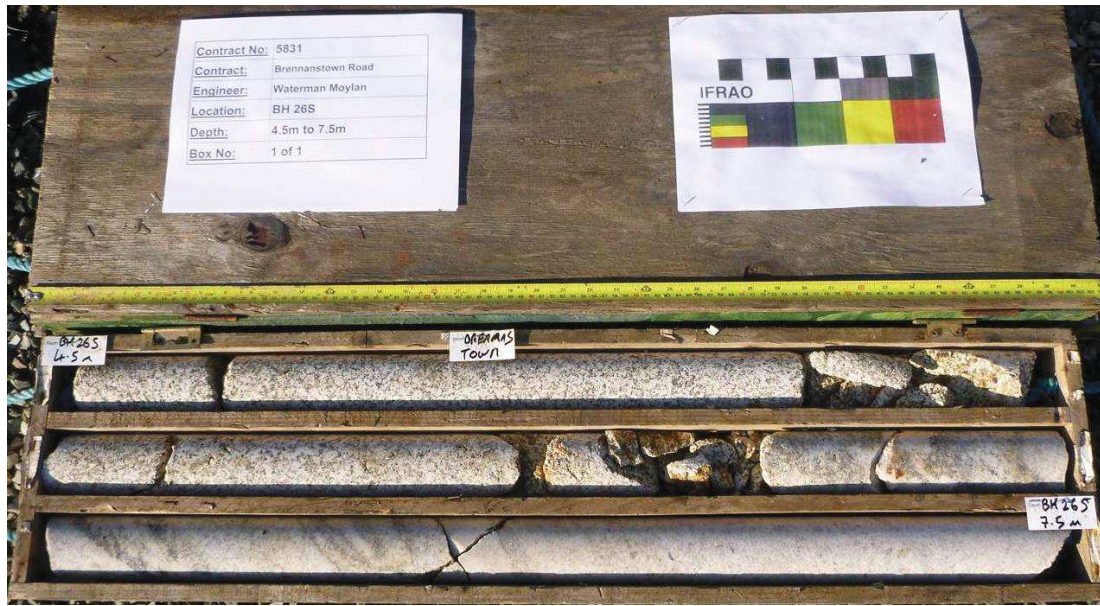
BH26S Box 1 of 1

0.5											
1.0											
1.5											
2.0											
2.5											
3.0											
3.5											
4.0											
4.5	4.50	Very strong light grey coarse grained GRANITE. Fresh to slightly weathered. <i>Discontinuities - rough, planar, tight to open, sub-horizontal dip, clean surfaces.</i>	+

5.0			+								
5.5		<i>Discontinuities - rough, planar to slightly undulating, tight to open, sub-horizontal to sub-vertical dip, clean with occasional brown staining.</i>	+

6.0			+								
6.20	6.20	Very strong to extremely strong light grey coarse grained GRANITE with occasional inclusions of pegmatite. Fresh to slightly weathered. <i>Discontinuities - smooth to rough, planar to slightly undulating, tight to open, 30° to 50° dip, clean surfaces.</i>	+

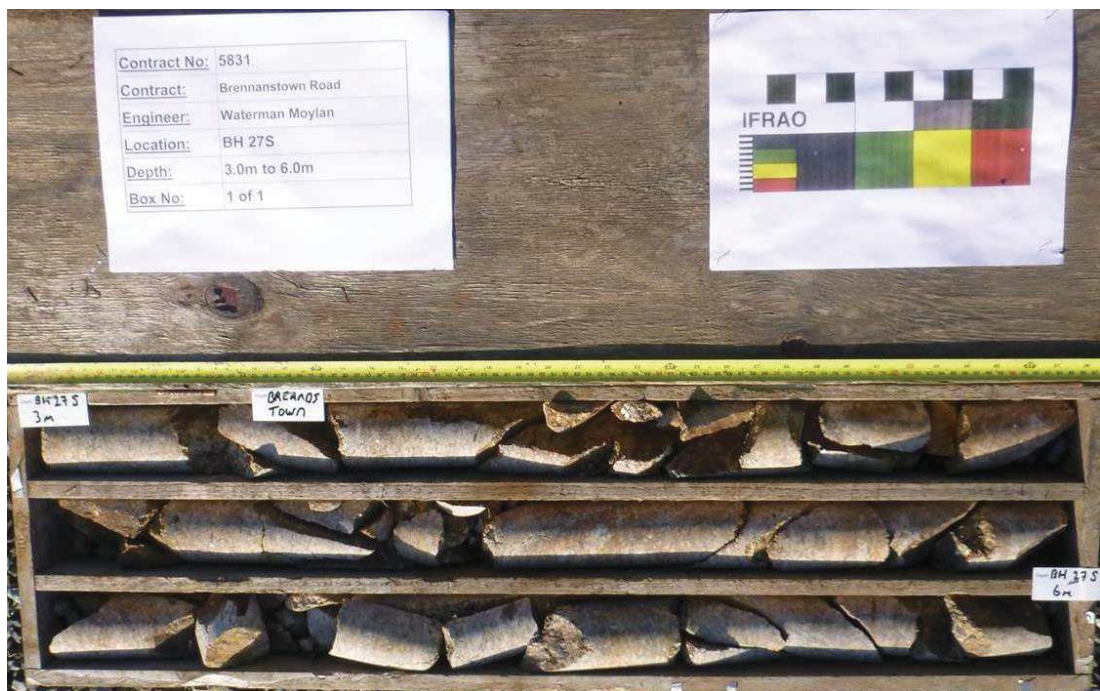
BH27S Box 1 of 1

0.5				74.0							
1.0				73.5							
1.5				73.0							
2.0				72.5							
2.5				72.0							
3.0	3.00	Strong to very strong light grey coarse grained GRANITE. Fresh to slightly weathered. <i>Discontinuities - rough, planar, tight to open, 45° to 60°, occasionally sub-horizontal and sub-vertical dip, surfaces stained brown.</i>	+	71.5	71.56	N=29 (6,7,7,7,8,7)

3.5			+	71.0		3.00 - 4.00	95	70	35		10
4.0			+	70.5							
4.5		<i>Discontinuities - rough, planar to slightly undulating and stepped, tight to open, 60° to 70°, occasionally sub-horizontal and sub-vertical dip, surfaces stained brown.</i>	+	70.0		4.00 - 5.00	94	82	45

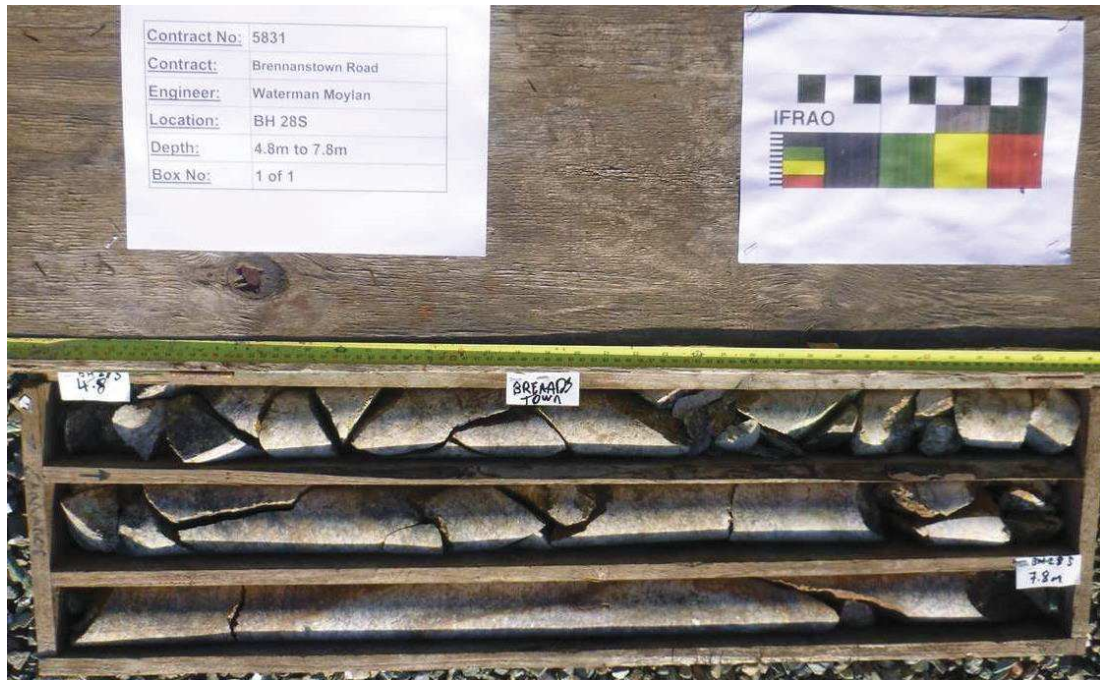
BH28S Box 1 of 1

5.0		Very strong to extremely strong light grey coarse grained GRANITE with occasional inclusions of pegmatite. Fresh to slightly weathered. <i>Discontinuities - rough, planar to undulating, tight to open, sub-horizontal to sub-vertical dip, clean with occasional brown staining.</i>		67.5		4.80 - 5.80	95	79	25	15

5.5				67.0							
6.0		<i>Discontinuities - rough, occasionally smooth, planar, occasionally stepped, tight to open, 45° to 60°, occasionally sub-horizontal and sub-vertical dip, clean with occasional brown staining.</i>		66.5		5.80 - 6.80	94	82	53	7

6.5				66.0							
7.0		<i>Discontinuities - smooth to rough, planar, tight to open, 60° to 75°, surfaces stained brown.</i>	65.5		6.80 - 7.80	94	94	94	3

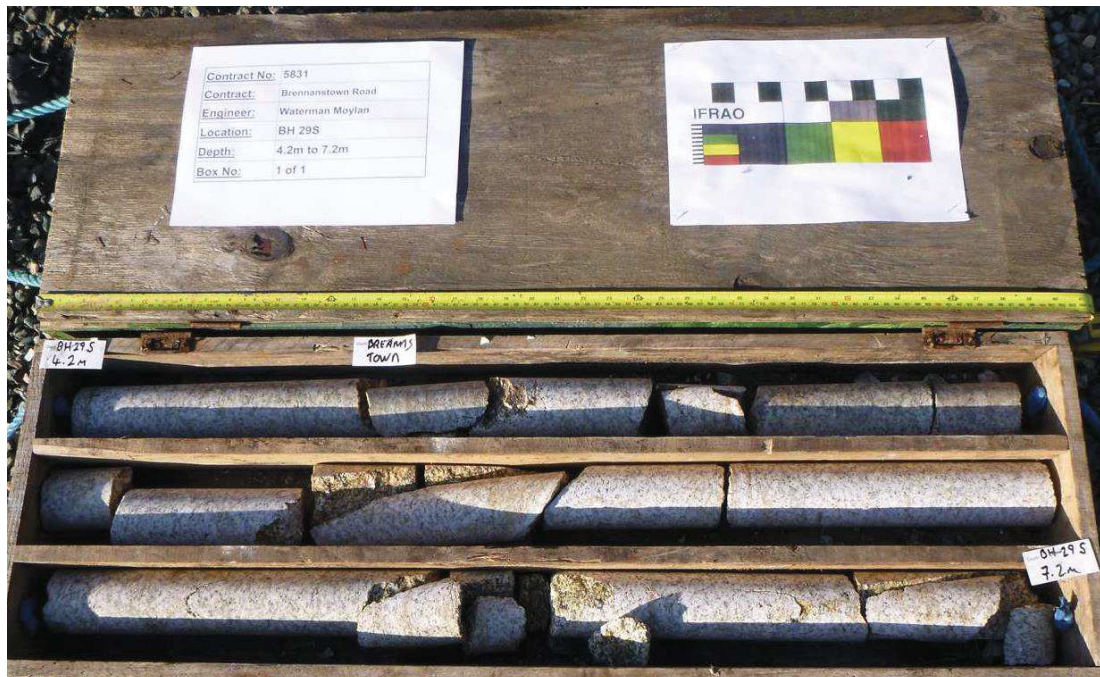
BH29S Box 1 of 1

1.0				67.5											
1.5				67.0											
2.0				66.5											
2.5		Very strong to extremely strong light grey coarse grained GRANITE with occasional inclusions of pegmatite. Fresh to slightly weathered. <i>Discontinuities - smooth to rough, planar to slightly undulating, tight to open, sub-horizontal to sub-vertical dip, clean with occasional brown staining.</i>		66.0		4.20 - 5.20	96	96	76	7

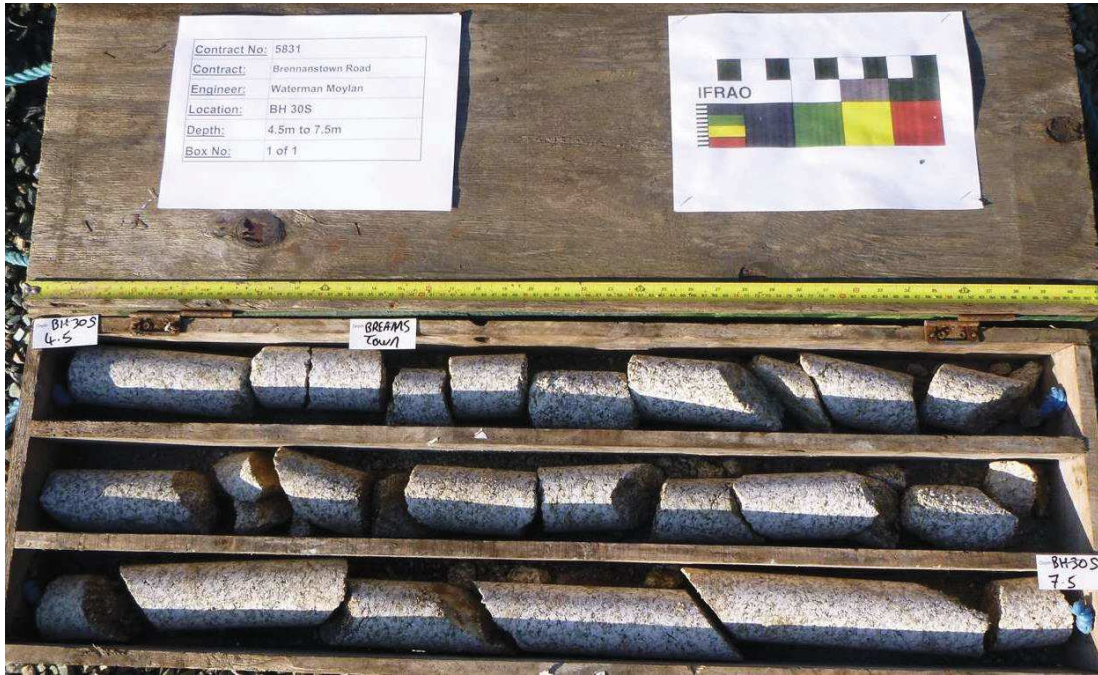
BH30S Box 1 of 1

0.5											
1.0											
1.5											
2.0											
2.5											
3.0											
3.5											
4.0											
4.5	4.50	Strong to very strong light grey coarse grained GRANITE. Fresh to slightly weathered. <i>Discontinuities - smooth to rough, planar, tight to open, sub-horizontal to 60° dip, clean with occasional brown staining.</i>	+++

5.0			+++								
5.5			+++								
6.0			+++								
6.5		<i>Discontinuities - smooth to rough, planar, tight to open, 40° to 50° dip, clean with occasional brown staining.</i>	+++

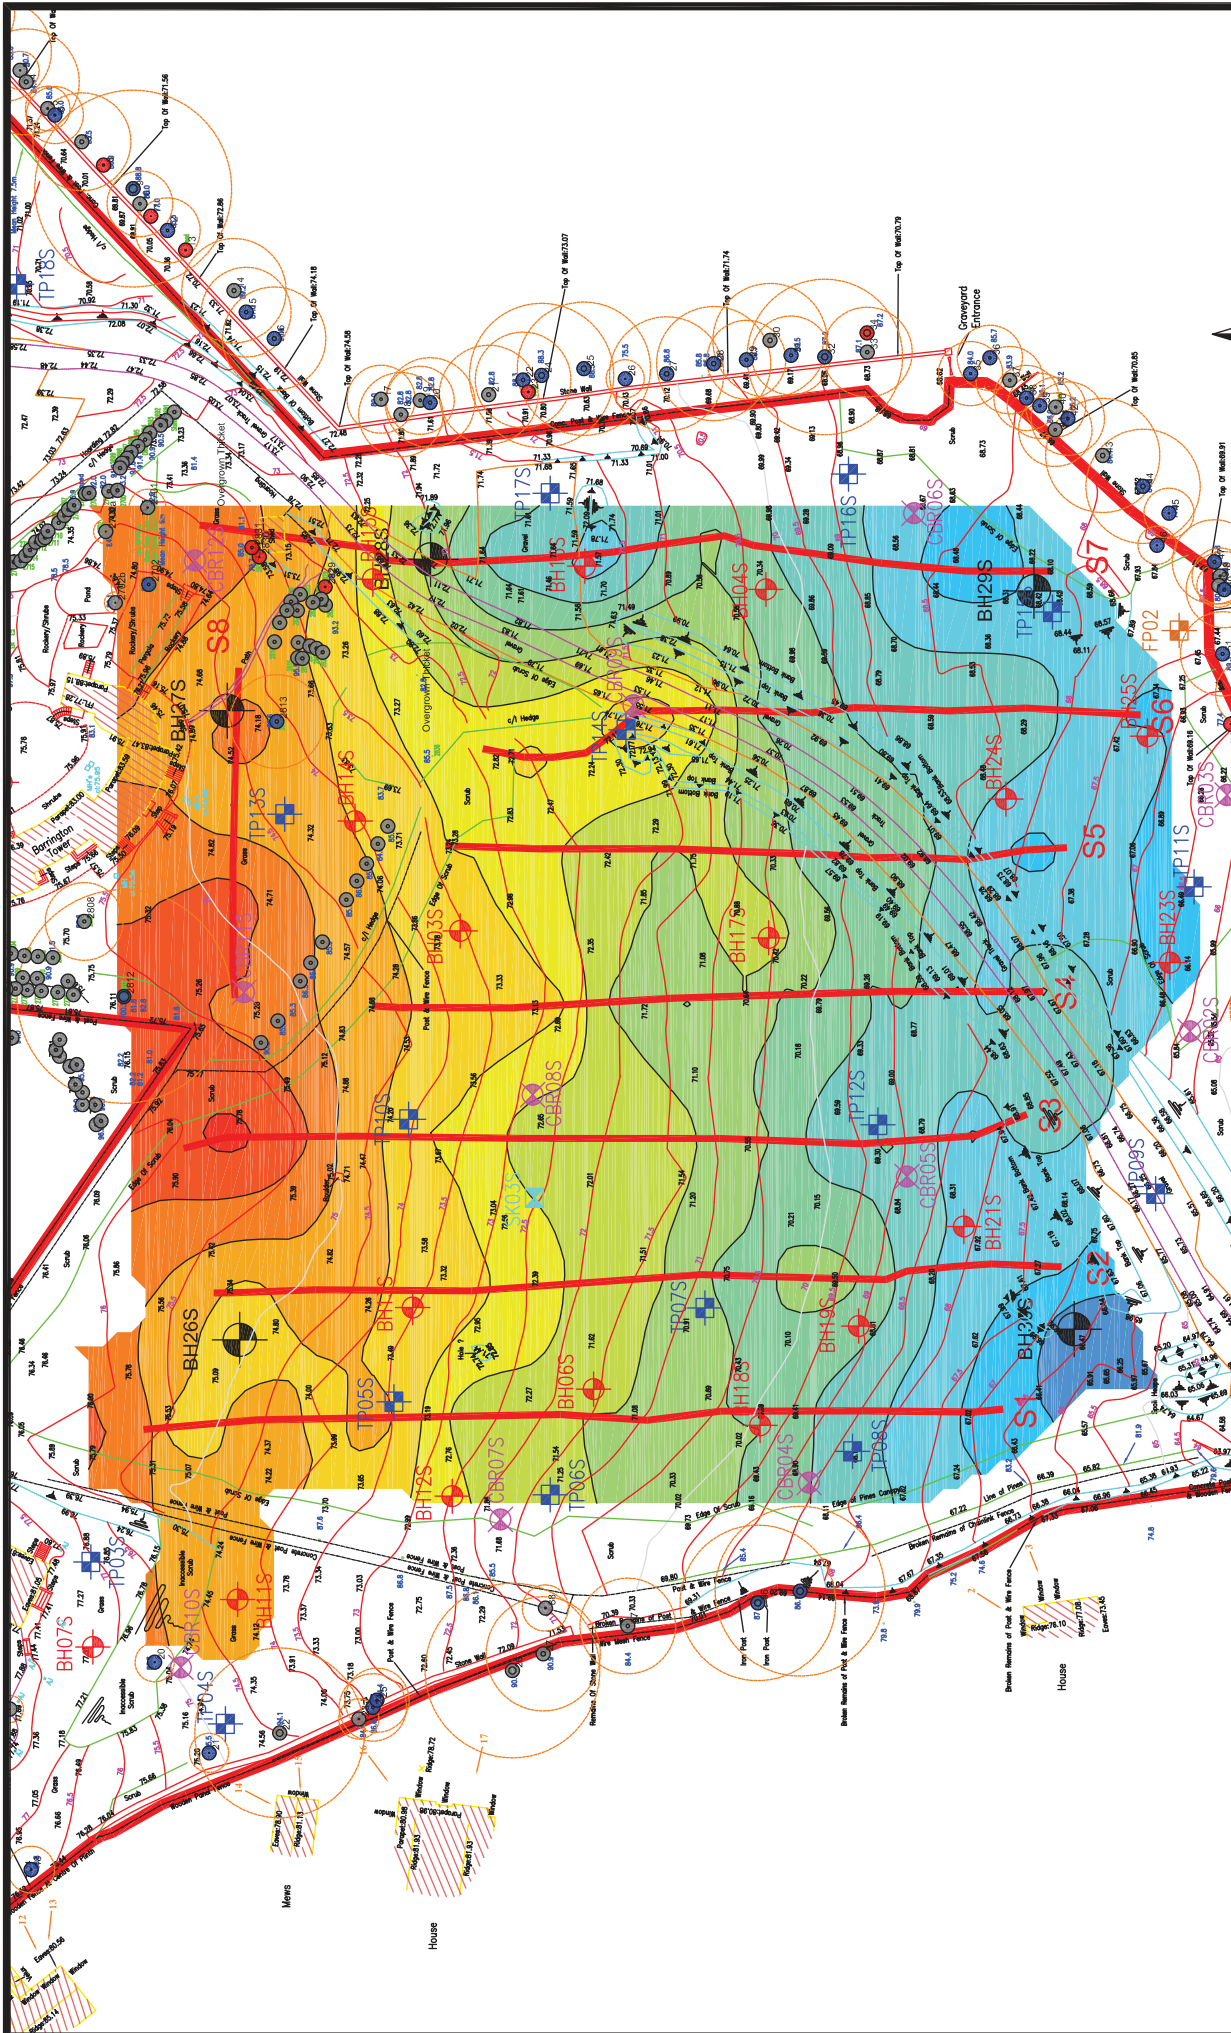
8. The top of the elevation of the weathered and good granite are shown on contour maps (Maps 2 and 3). These surfaces show a general dip from North to South with some modulations of the elevations.

LEGEND: Elevations (mOD) of the Interpreted Weathered Granite:

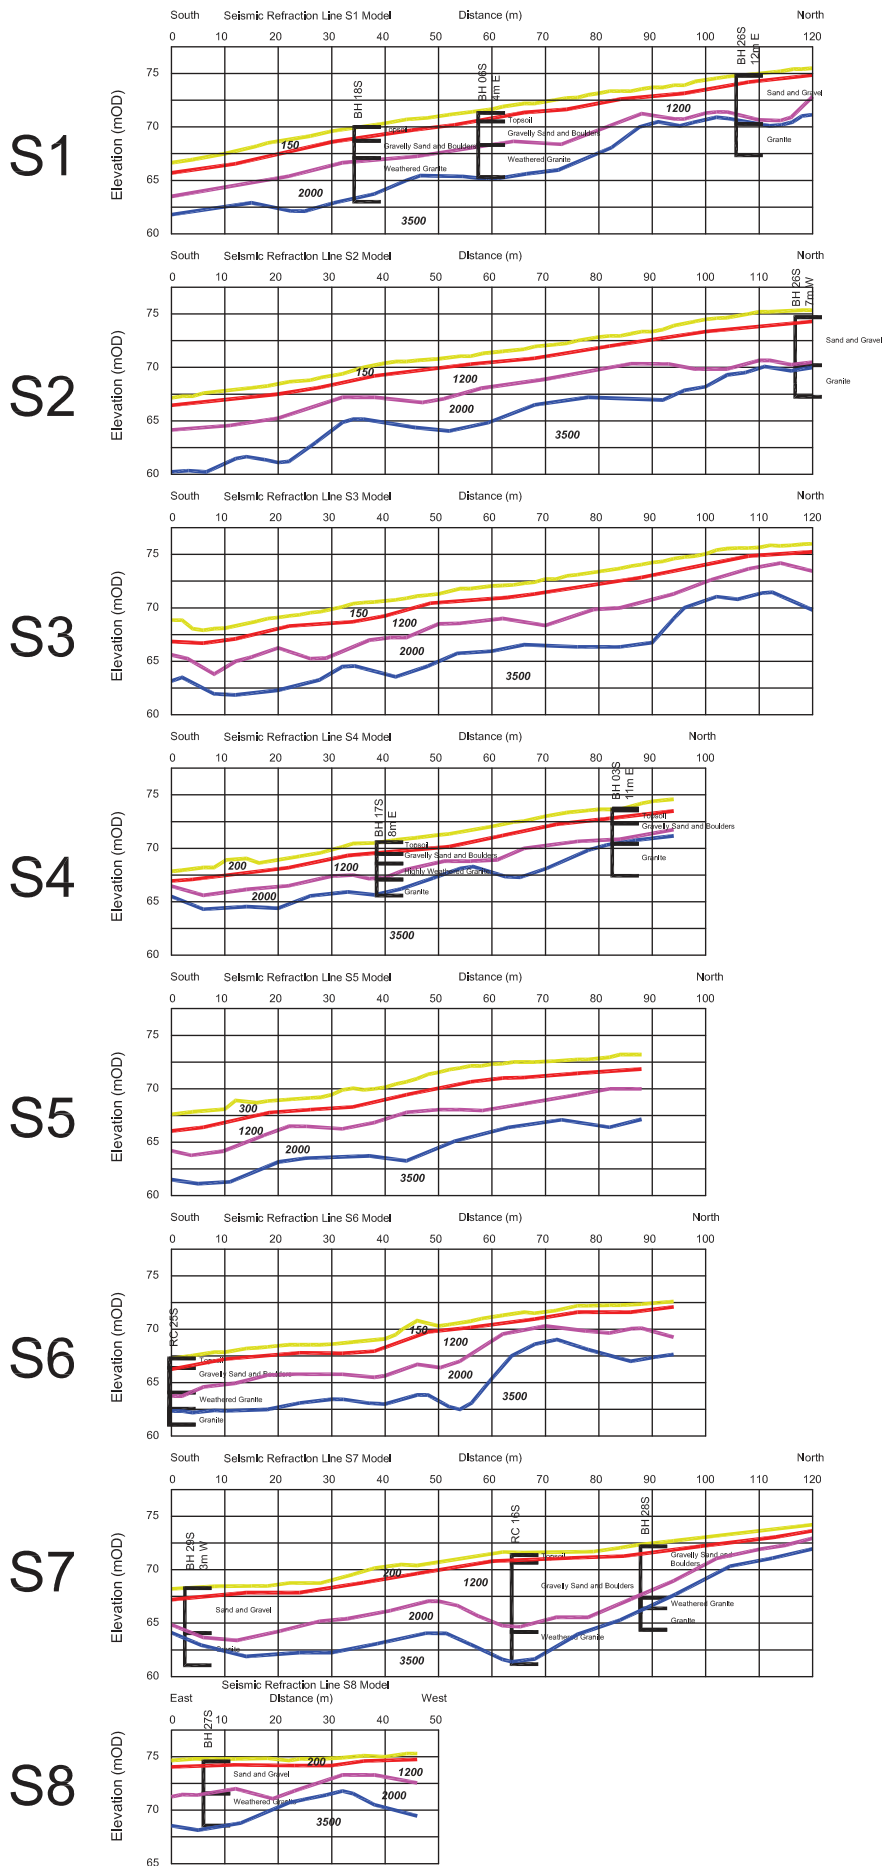
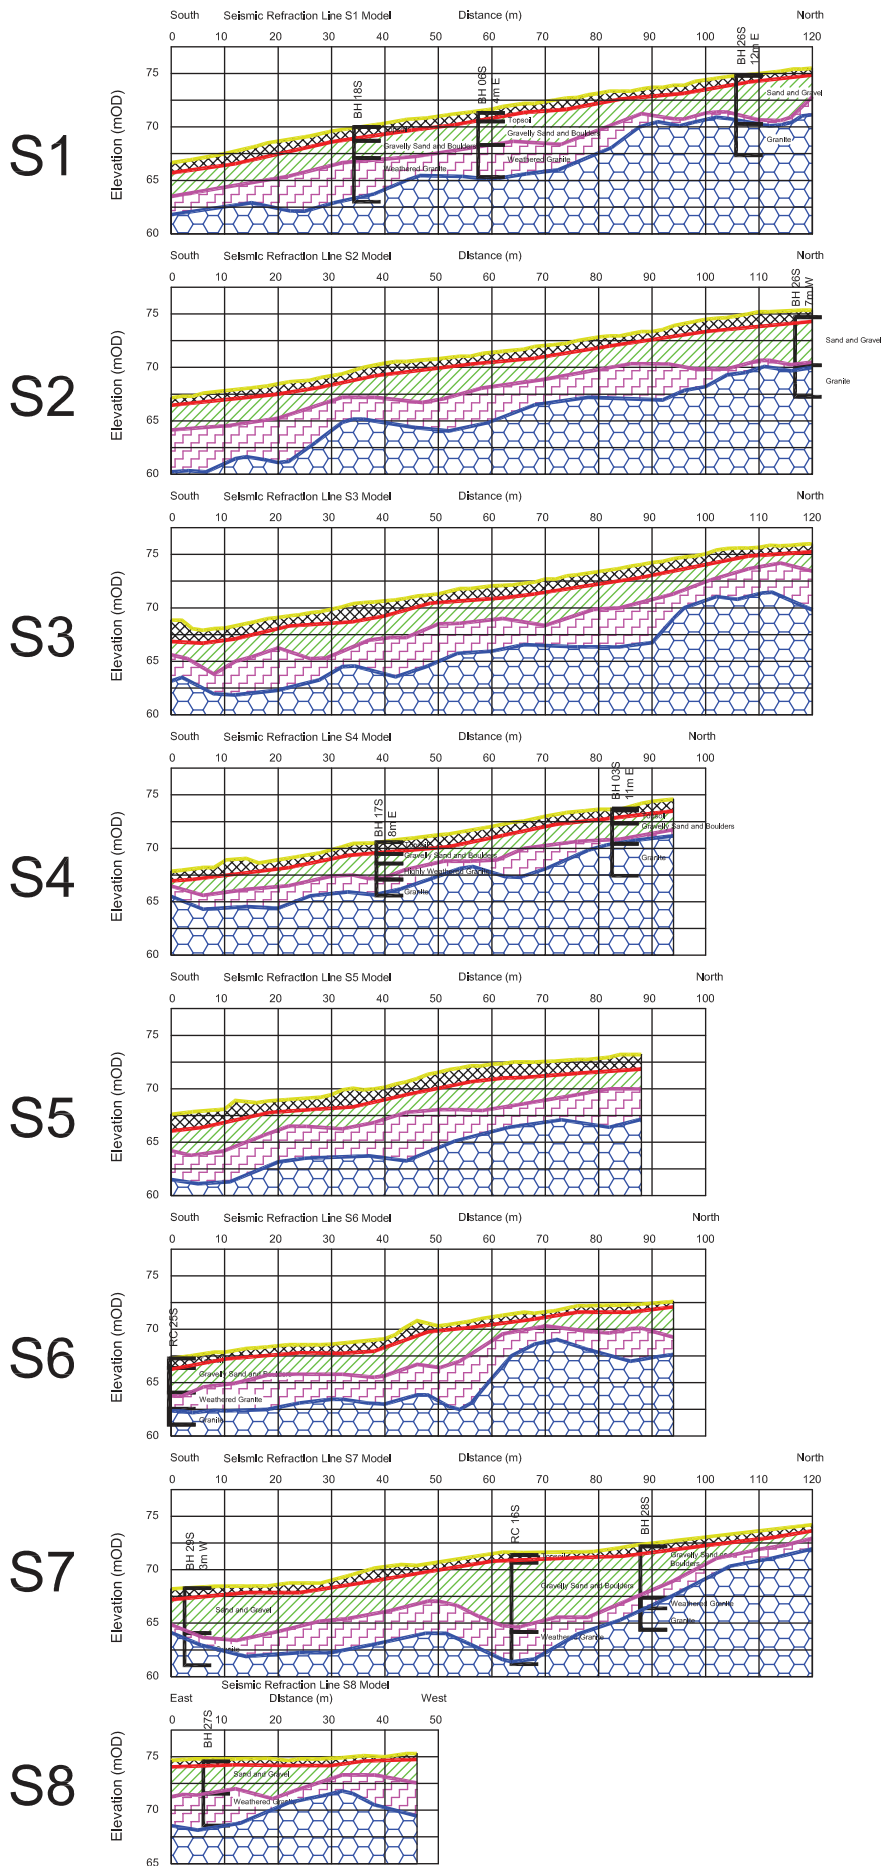
Layer	General Seismic Velocity Range (km/sec)	Compaction or Strength or Rock Quality	Interpretation	Estimated Excavation Method
1	150 - 200	Soft or loose	Topsoil	Diggable
2	1200	Firm or dense	Overburden	Diggable
3	2000	Poor to fair Rock	Weathered Granite	Diggable to marginal rippable or some breaking of Boulders
4	3500	Good Rock	Granite	Breaking & Blasting

LEGEND:	Interpretation of Seismic Refraction
	1 Soft or loose Topsoil
	2 Firm or dense Overburden
	3 Poor to fair weathered Granite
	4 Good Granite

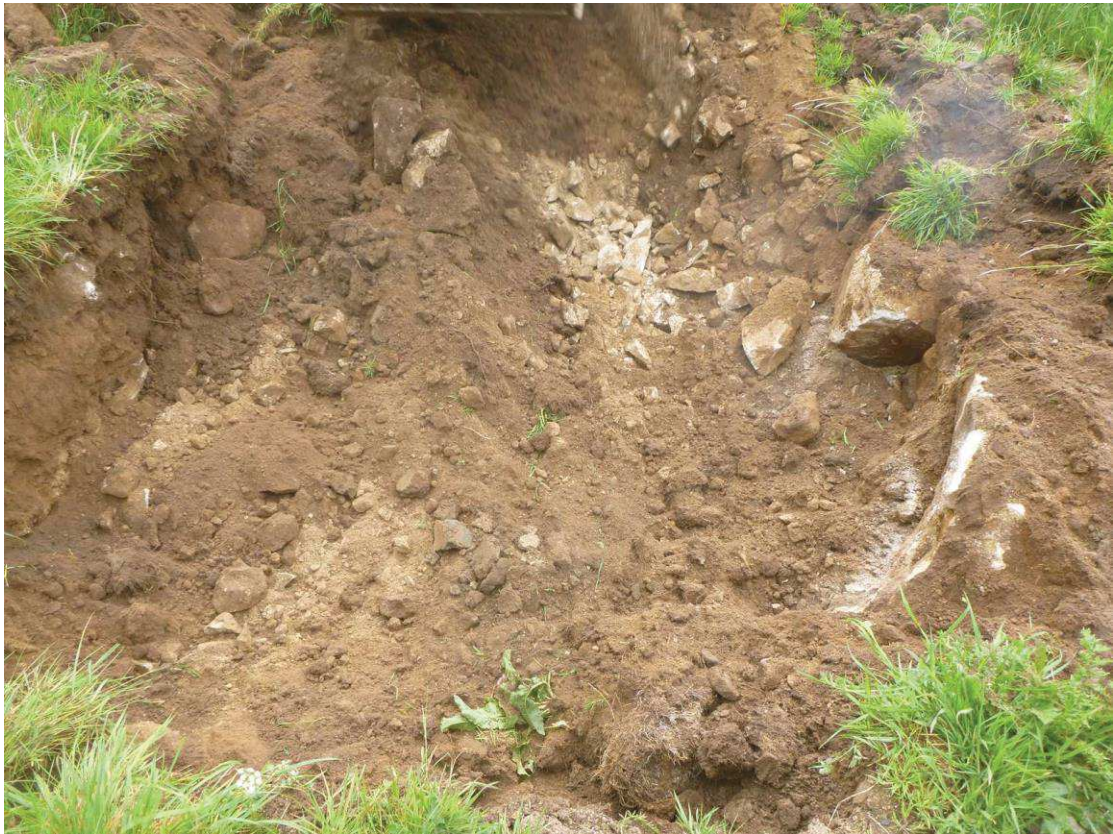
Top of Weathered Bedrock

Ground Conditions		
From	To	
0.00	0.30	TOPSOIL.
0.30	0.90	Brown very clayey sandy GRAVEL with high cobble and low boulder content.
0.90	2.30	Firm grey sandy slightly gravelly silty CLAY.
2.30	3.20	Extremely strong light grey with orange staining, coarse crystalline GRANITE.

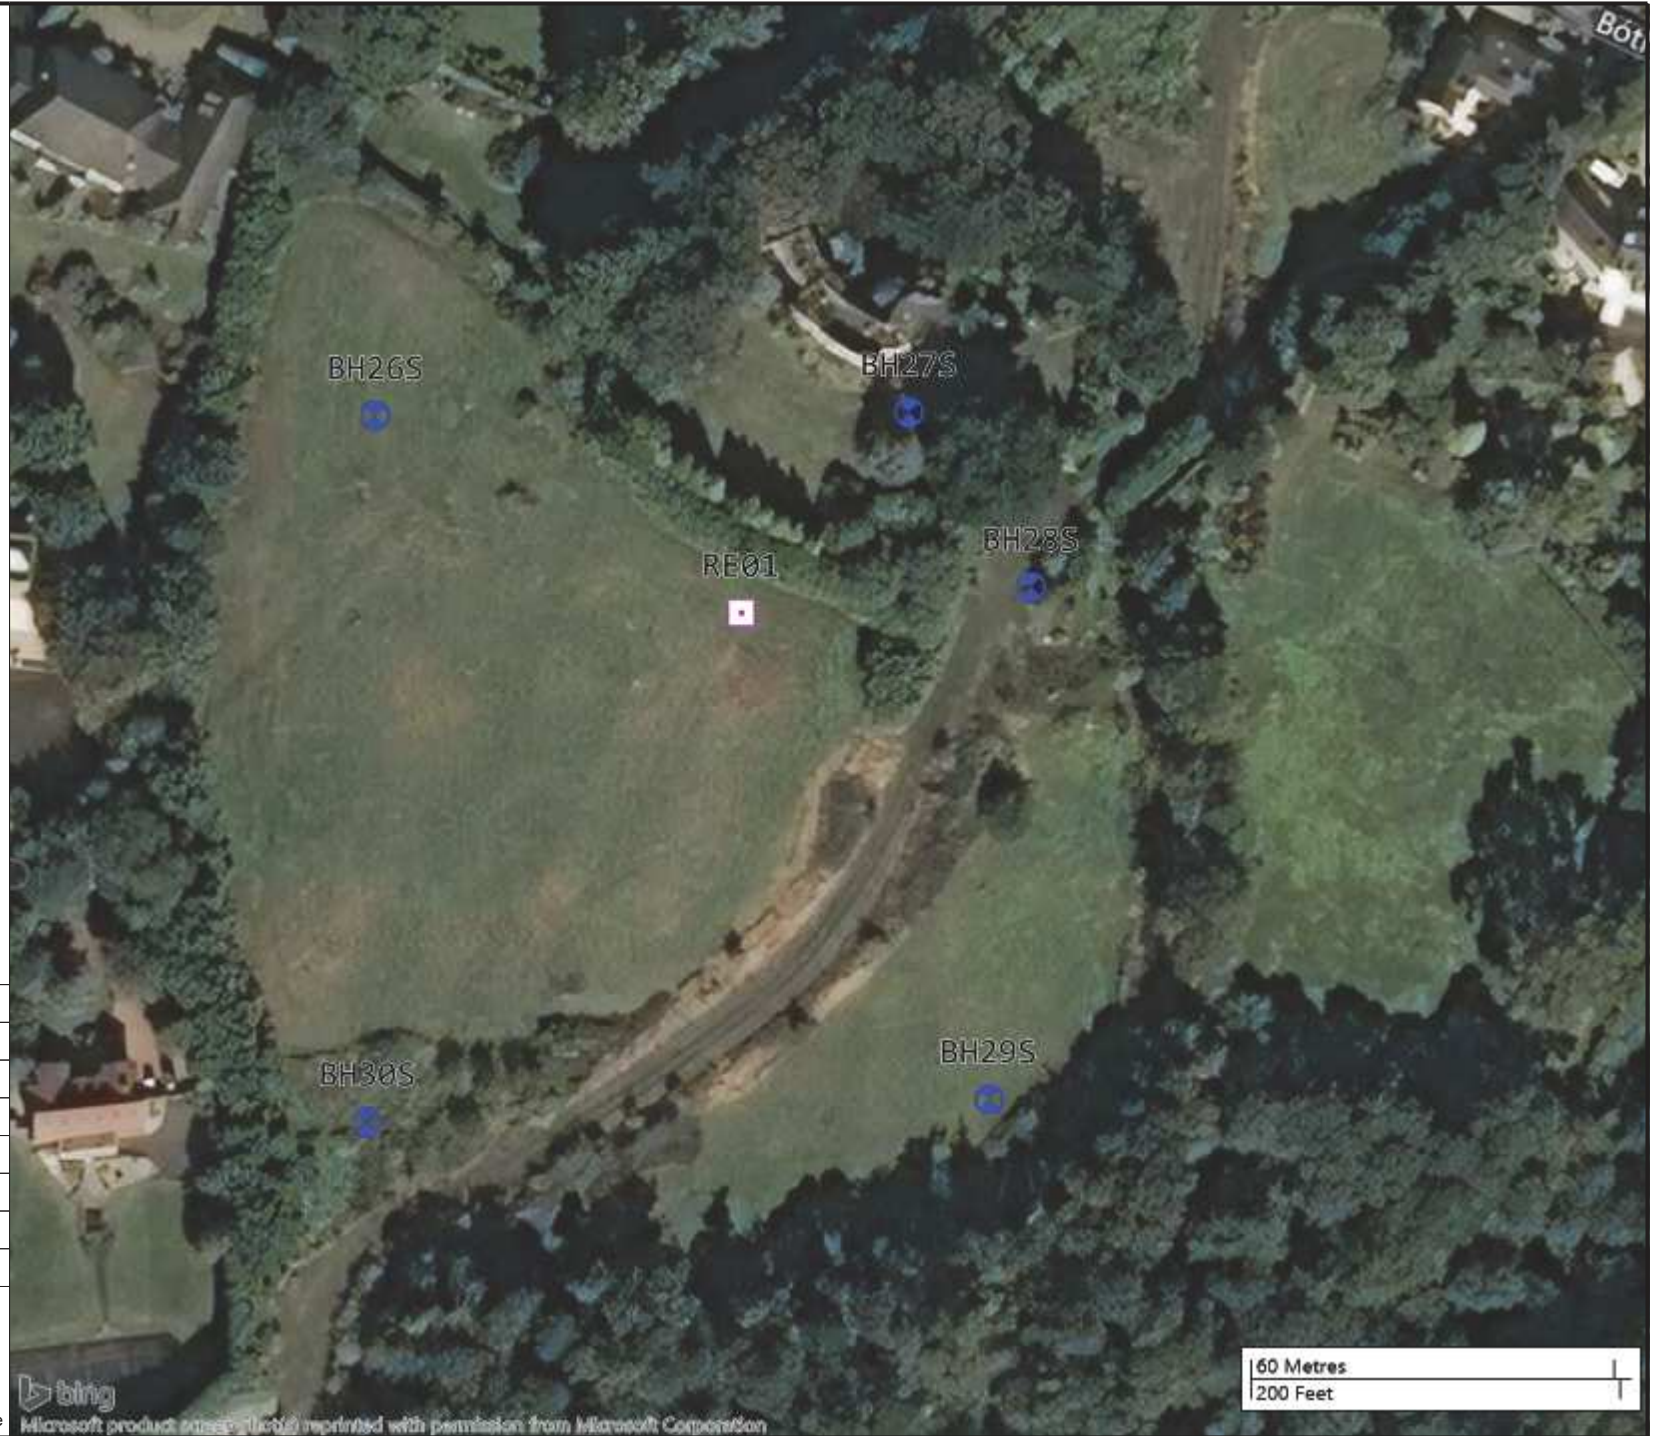
Contract No:	5831
Contract Name:	Brennanstown Road
Location:	Cabinteely, Dublin 18
Client:	Cairn Homes PLC
Engineer:	Waterman Moylan
Title:	Site Plan
Scale:	1:1250
Drawn By:	SL

- ▣ Locations By Type - IP
- ⊕ Locations By Type - RC
