ENVIRONMENTAL IMPACT ASSESSMENT REPORT – VOLUME II (APPENDICES)

STRATEGIC HOUSING DEVELOPMENT & VILLAGE CENTRE

PRIORSLAND, CHERRYWOOD, DUBLIN 18.

Bat Fauna Survey for a proposed Strategic Housing Development (SHD) at Priorsland, Cherrywood, Dublin 18.

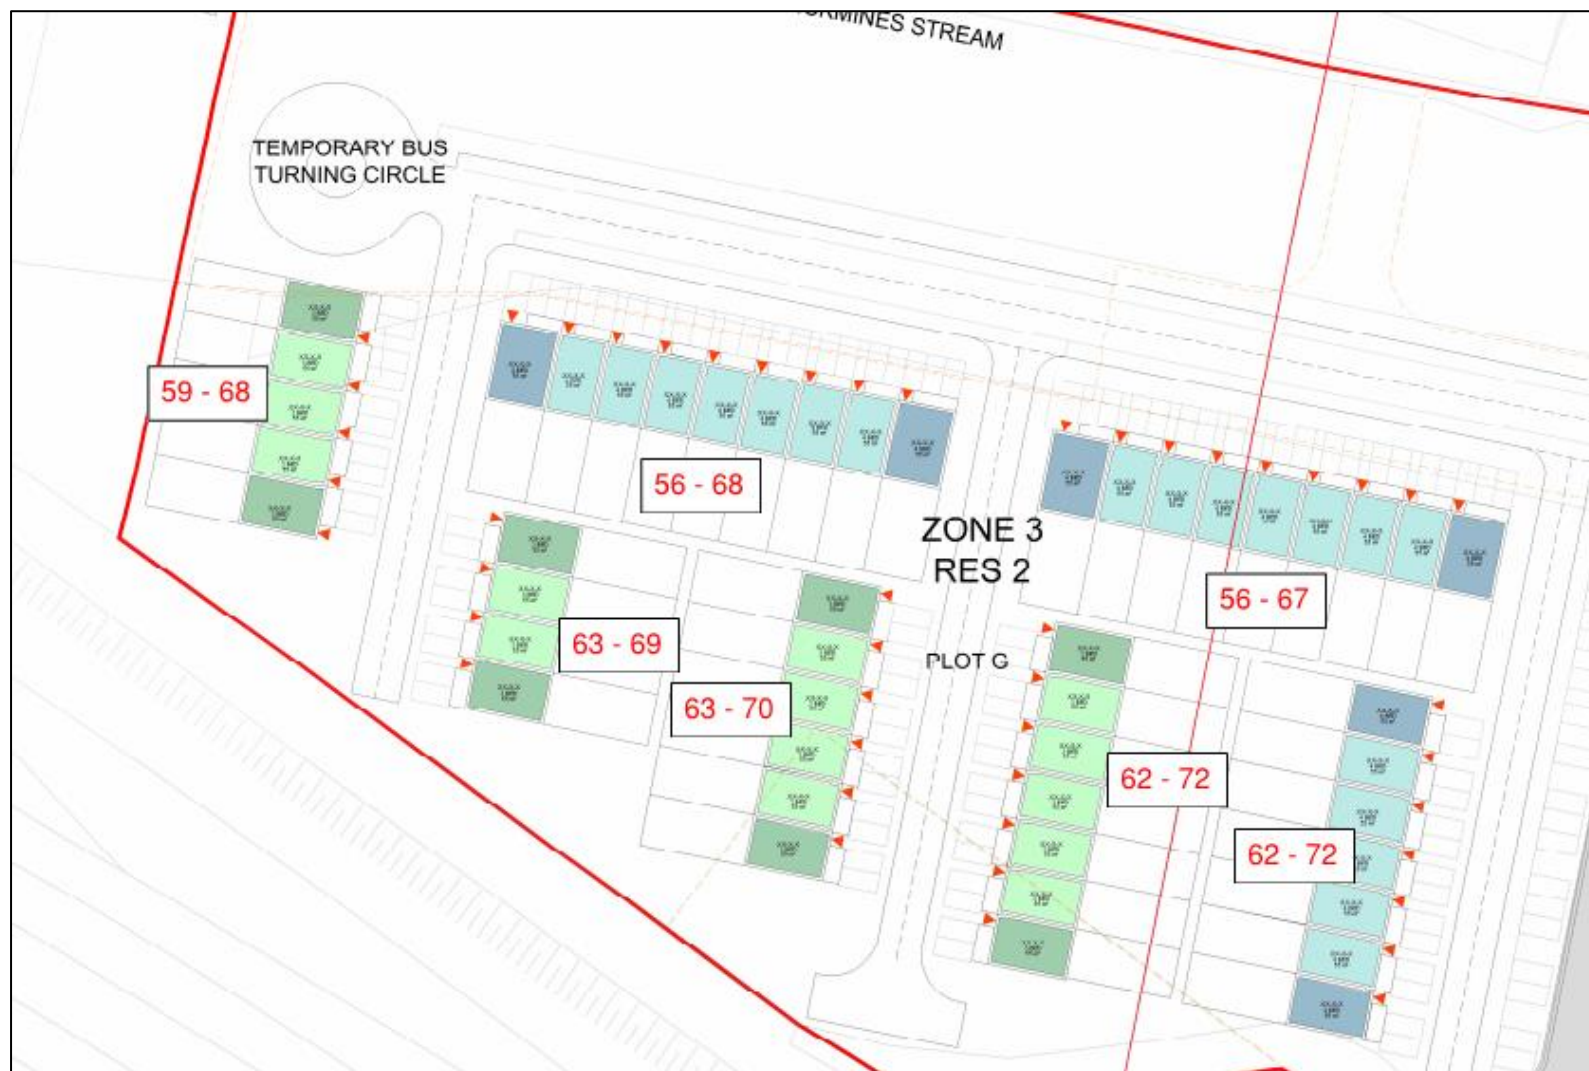
Figure A2 Predicted Ambient Noise Levels For Dwellings (No Attenuation Measures Provided)

As can be seen in Figure A2, all of the predicted ambient noise levels exceed the optimum external design criteria. As expected, this indicates that additional mitigation measures are required.

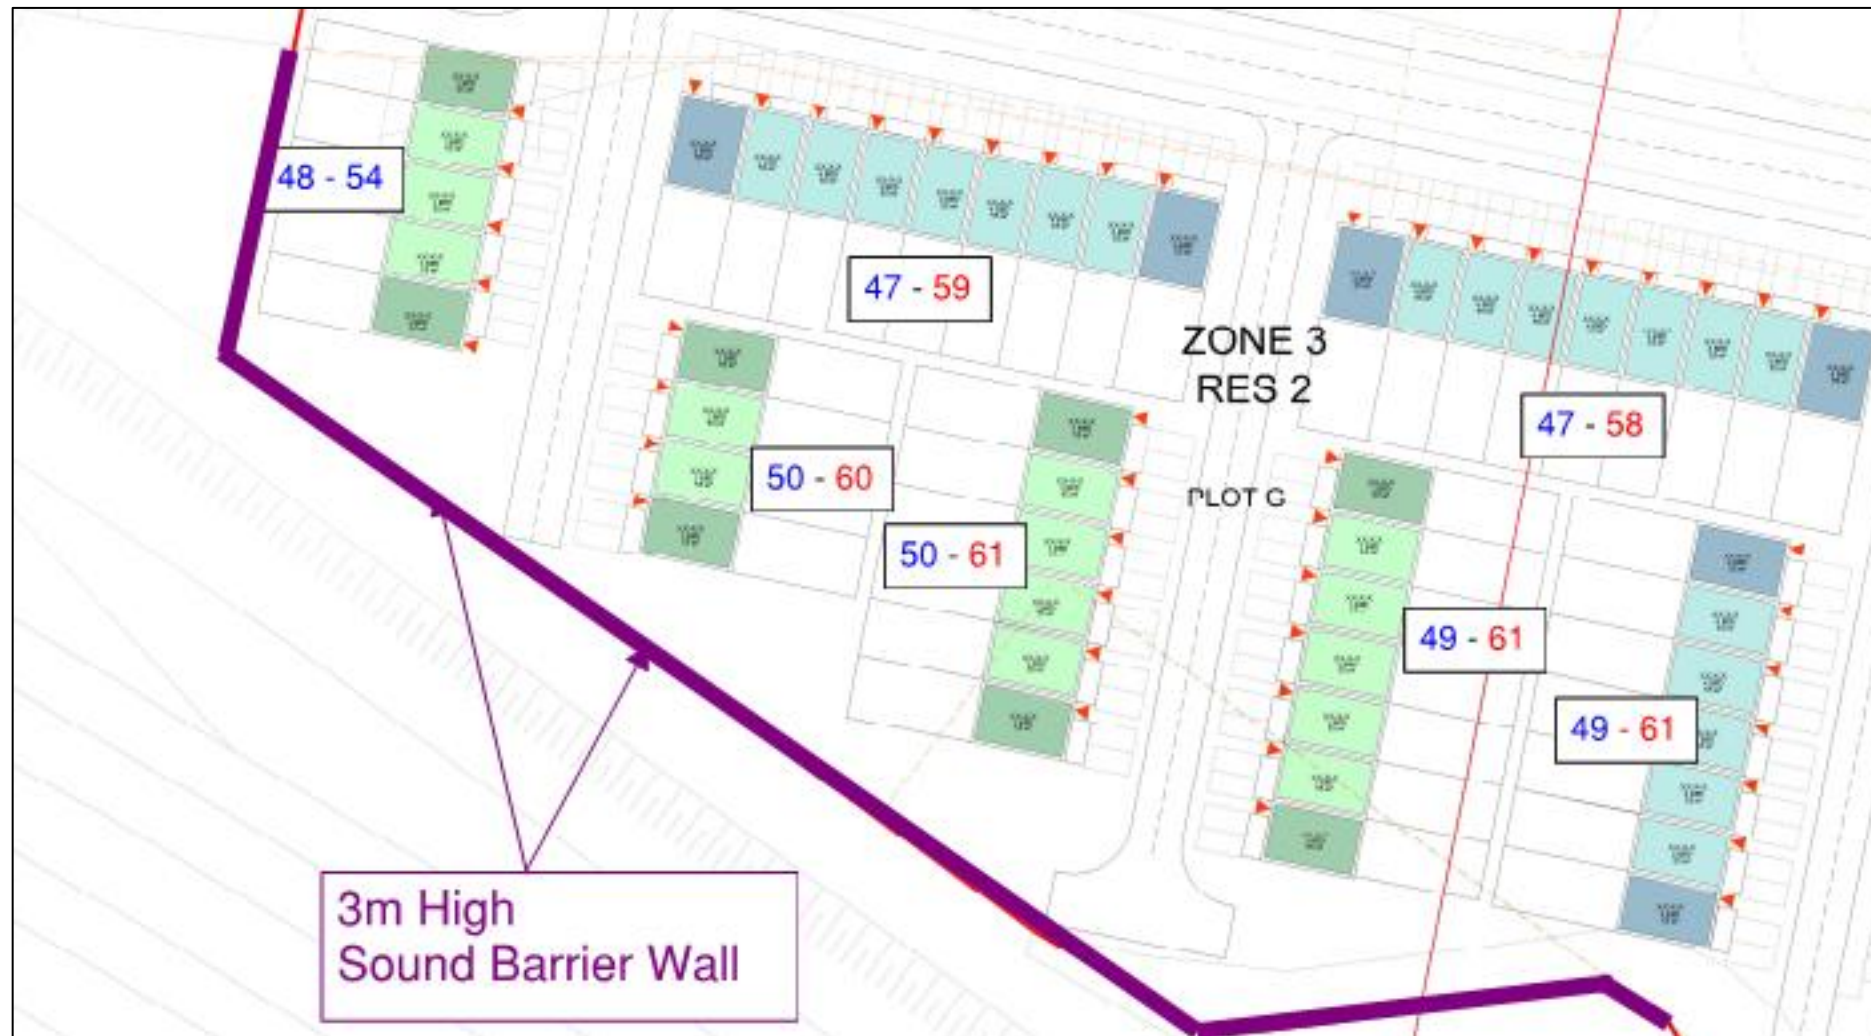
Figure A3 Predicted Ambient Noise Levels With 3m High Barrier Wall Provided Along Property Boundary

As can be seen in Figure A3, ambient noise levels across the development due to M50 noise emissions are significantly reduced with provision of the perimeter sound barrier wall. Although the upper levels in the predicted ranges would still exceed the upper criteria level of 55dB L_{Aeq} in the majority of rear gardens during portions of the daytime period, the exceedances would likely only occur during rush hour periods and would be considered to be both minimal and minimised as far as practicable (note: increases in height of the sound barrier walls would be impractical due to both difficulty and unsightliness as well as the limited additional decrease in noise reduction).

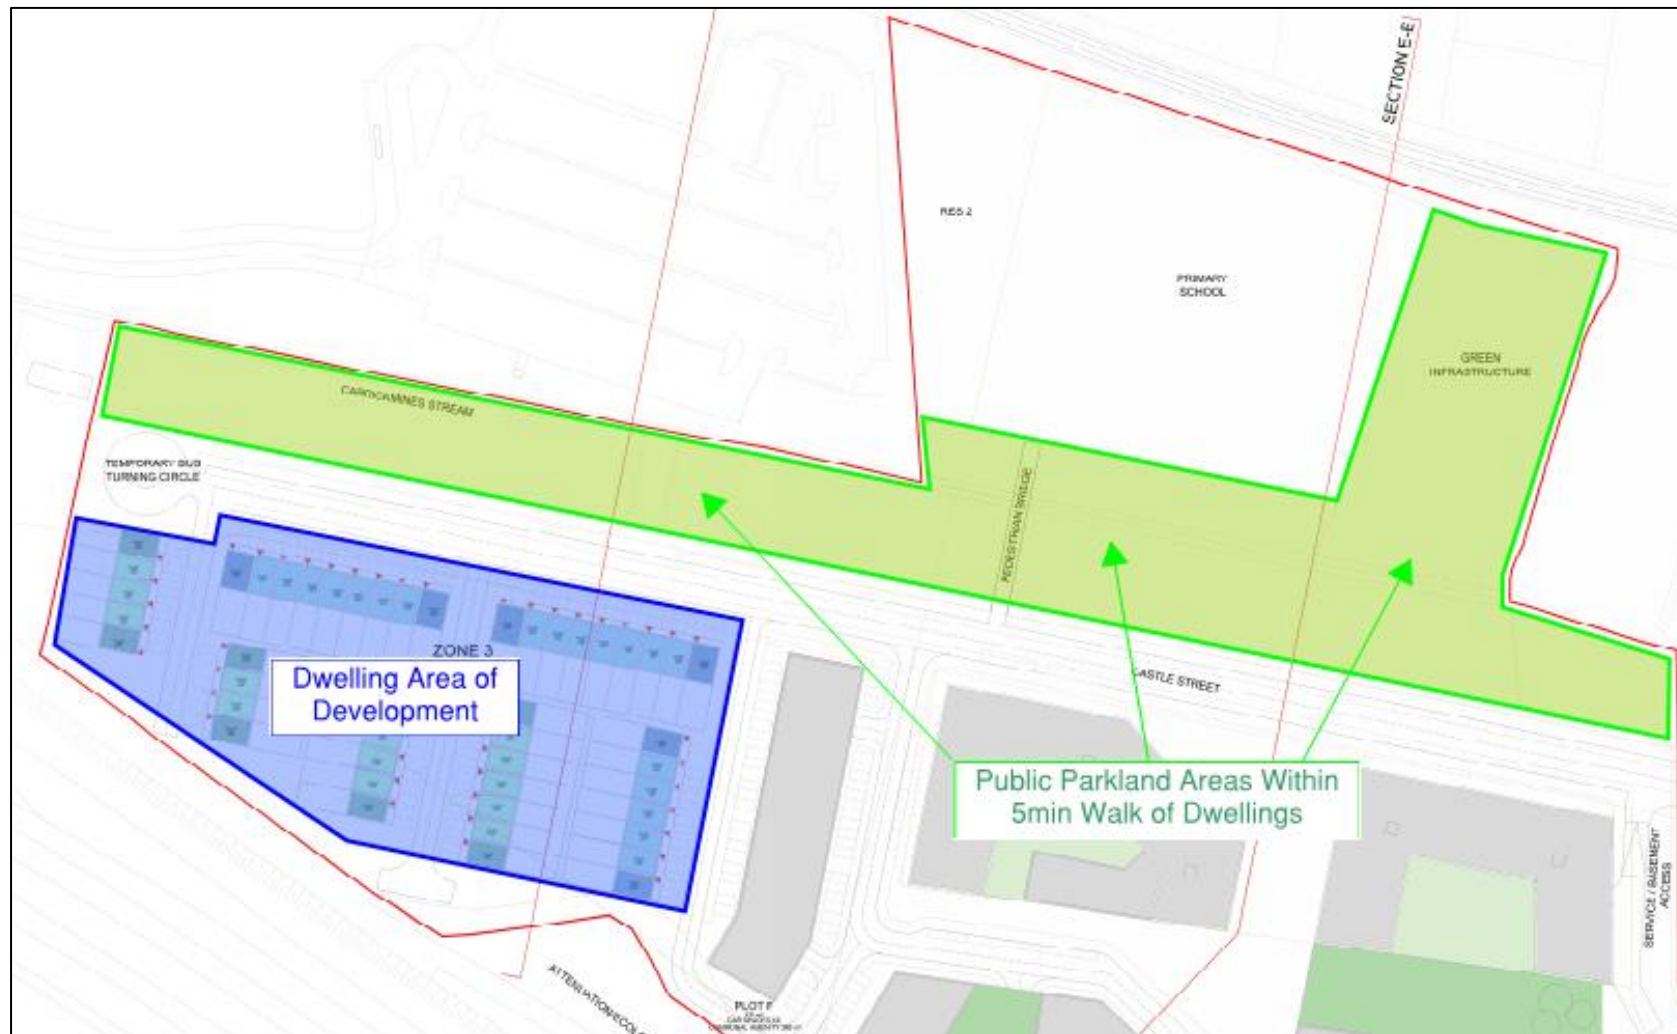
Figure A4 Public Parkland Areas Within A 5min Walk of Development Dwelling Area

The parkland areas near the dwelling zone will be located in areas of development lands that are farthest away from the M50 and which will also be well shielded from the motorway by the dwellings and other development buildings themselves. They should serve to provide a relatively quiet amenity area in very close proximity to the dwellings and would therefore adequately fulfil this adopted guidance goal as well.

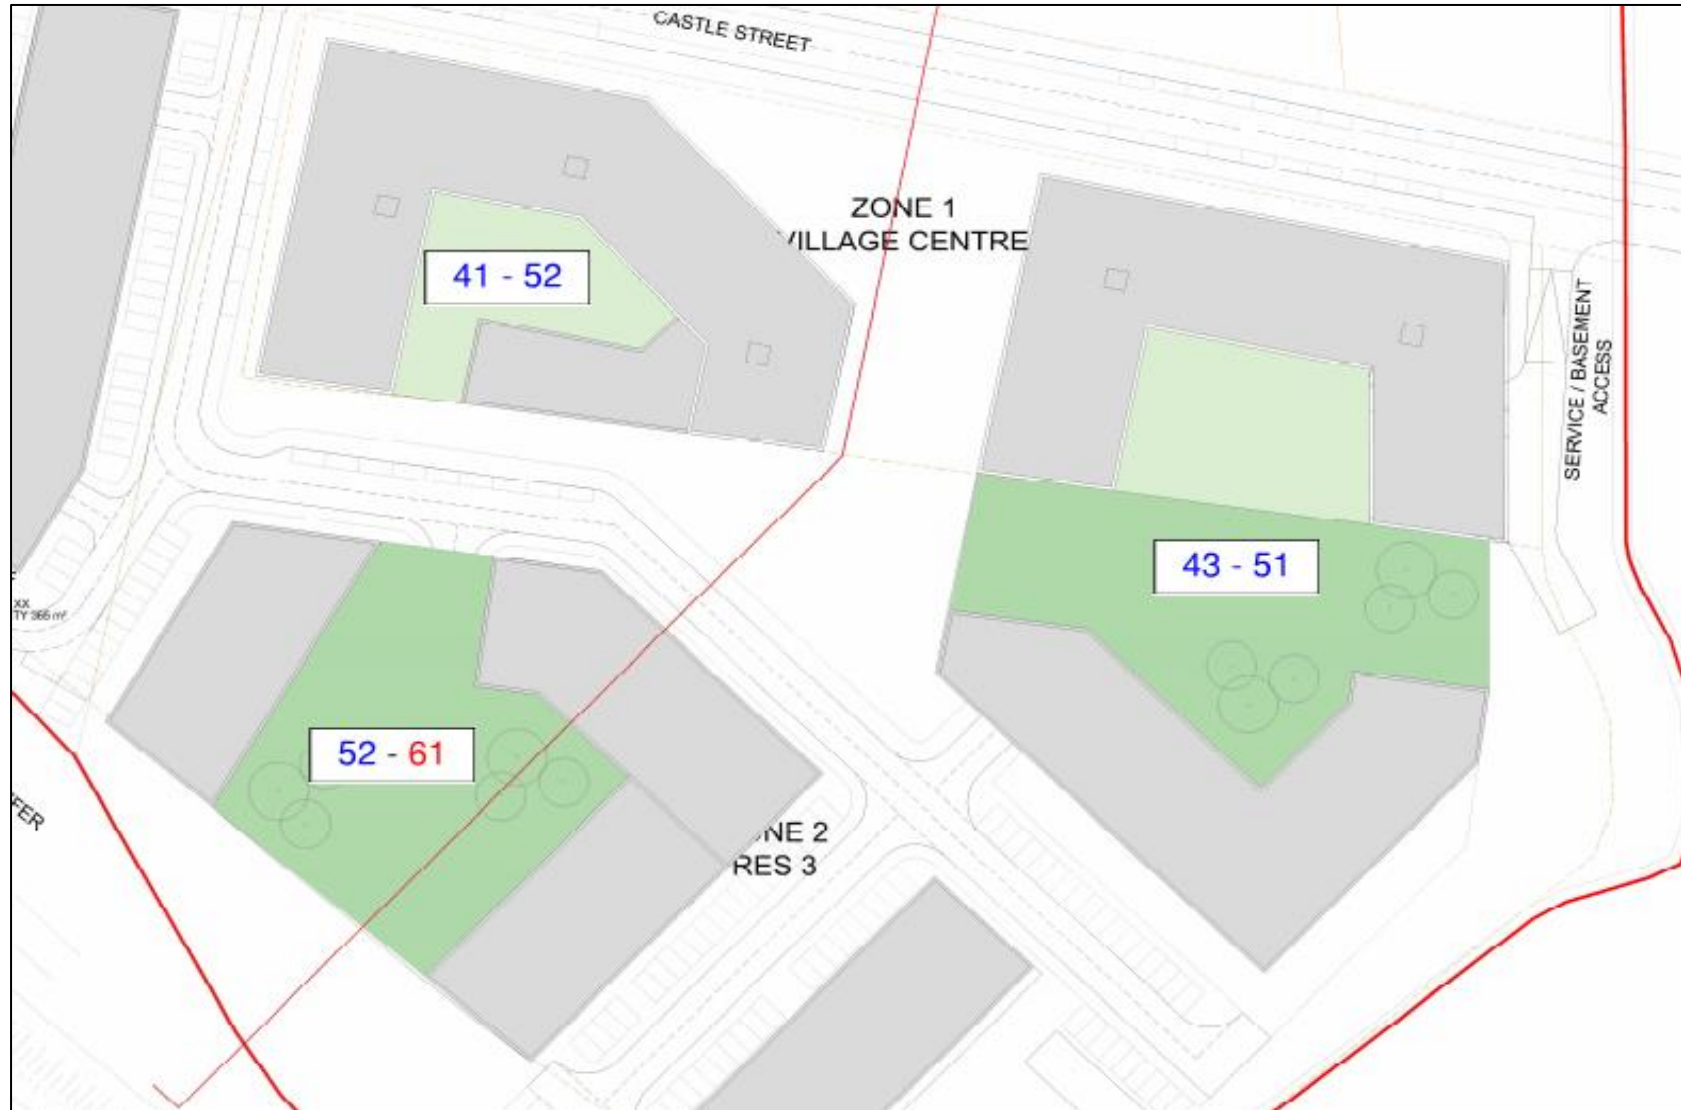
Figure A6 Predicted Ambient Noise Levels For Apartment Block Amenity Areas (No Mitigation Measures Provided)

As can be seen in Figure A6, most of the predicted ambient noise levels in the central amenity areas will comply with the optimum 50 - 55dB L_{Aeq} external design criteria during daytime periods. The only exceedance would be in the Block E1 / E2 central amenity area during busier traffic periods of the day. However, these noise levels could be reduced slightly by increasing the 1.1m high sound barrier wall at the perimeter edge of the podium level to 1.5m. This configuration is modelled and the predicted results are shown in Figure A7 on the following page.

A computer model analysis was conducted similar to the one conducted for the dwellings with the apartment blocks modelled as currently designed. The results are shown in Figure A6 below.

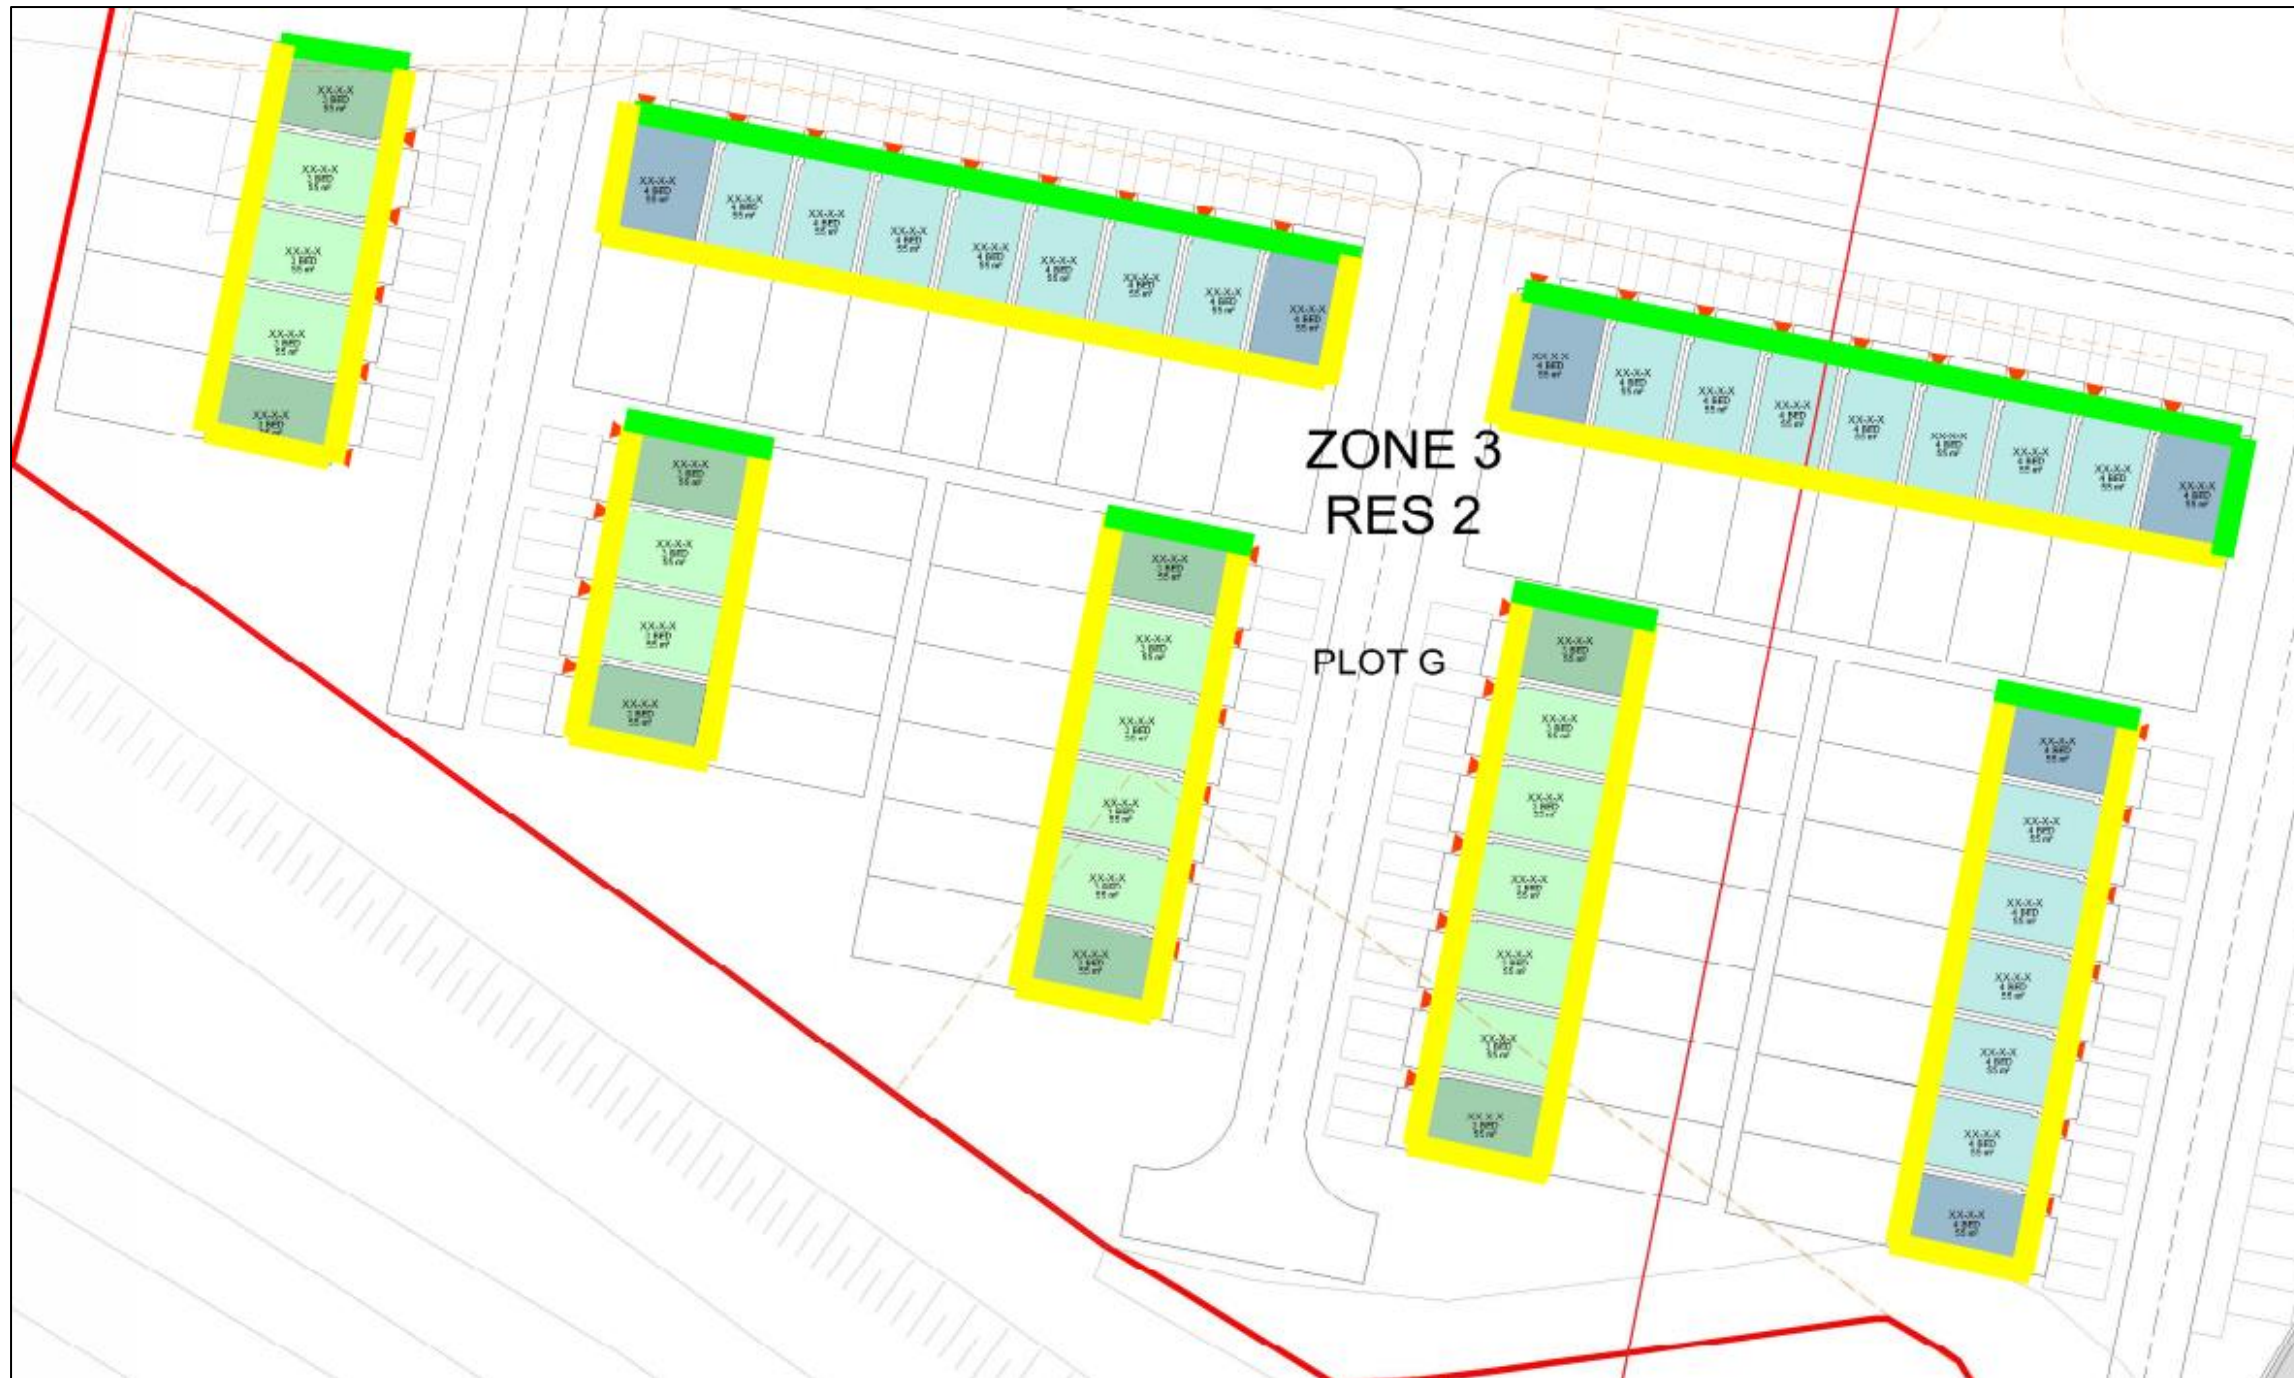
Figure A10 Dwelling Ground Floor Glazing Sound Insulation Minimum Performance Requirements (SRI)

- Glazing Specification A
- Glazing Specification B
- Glazing Specification C

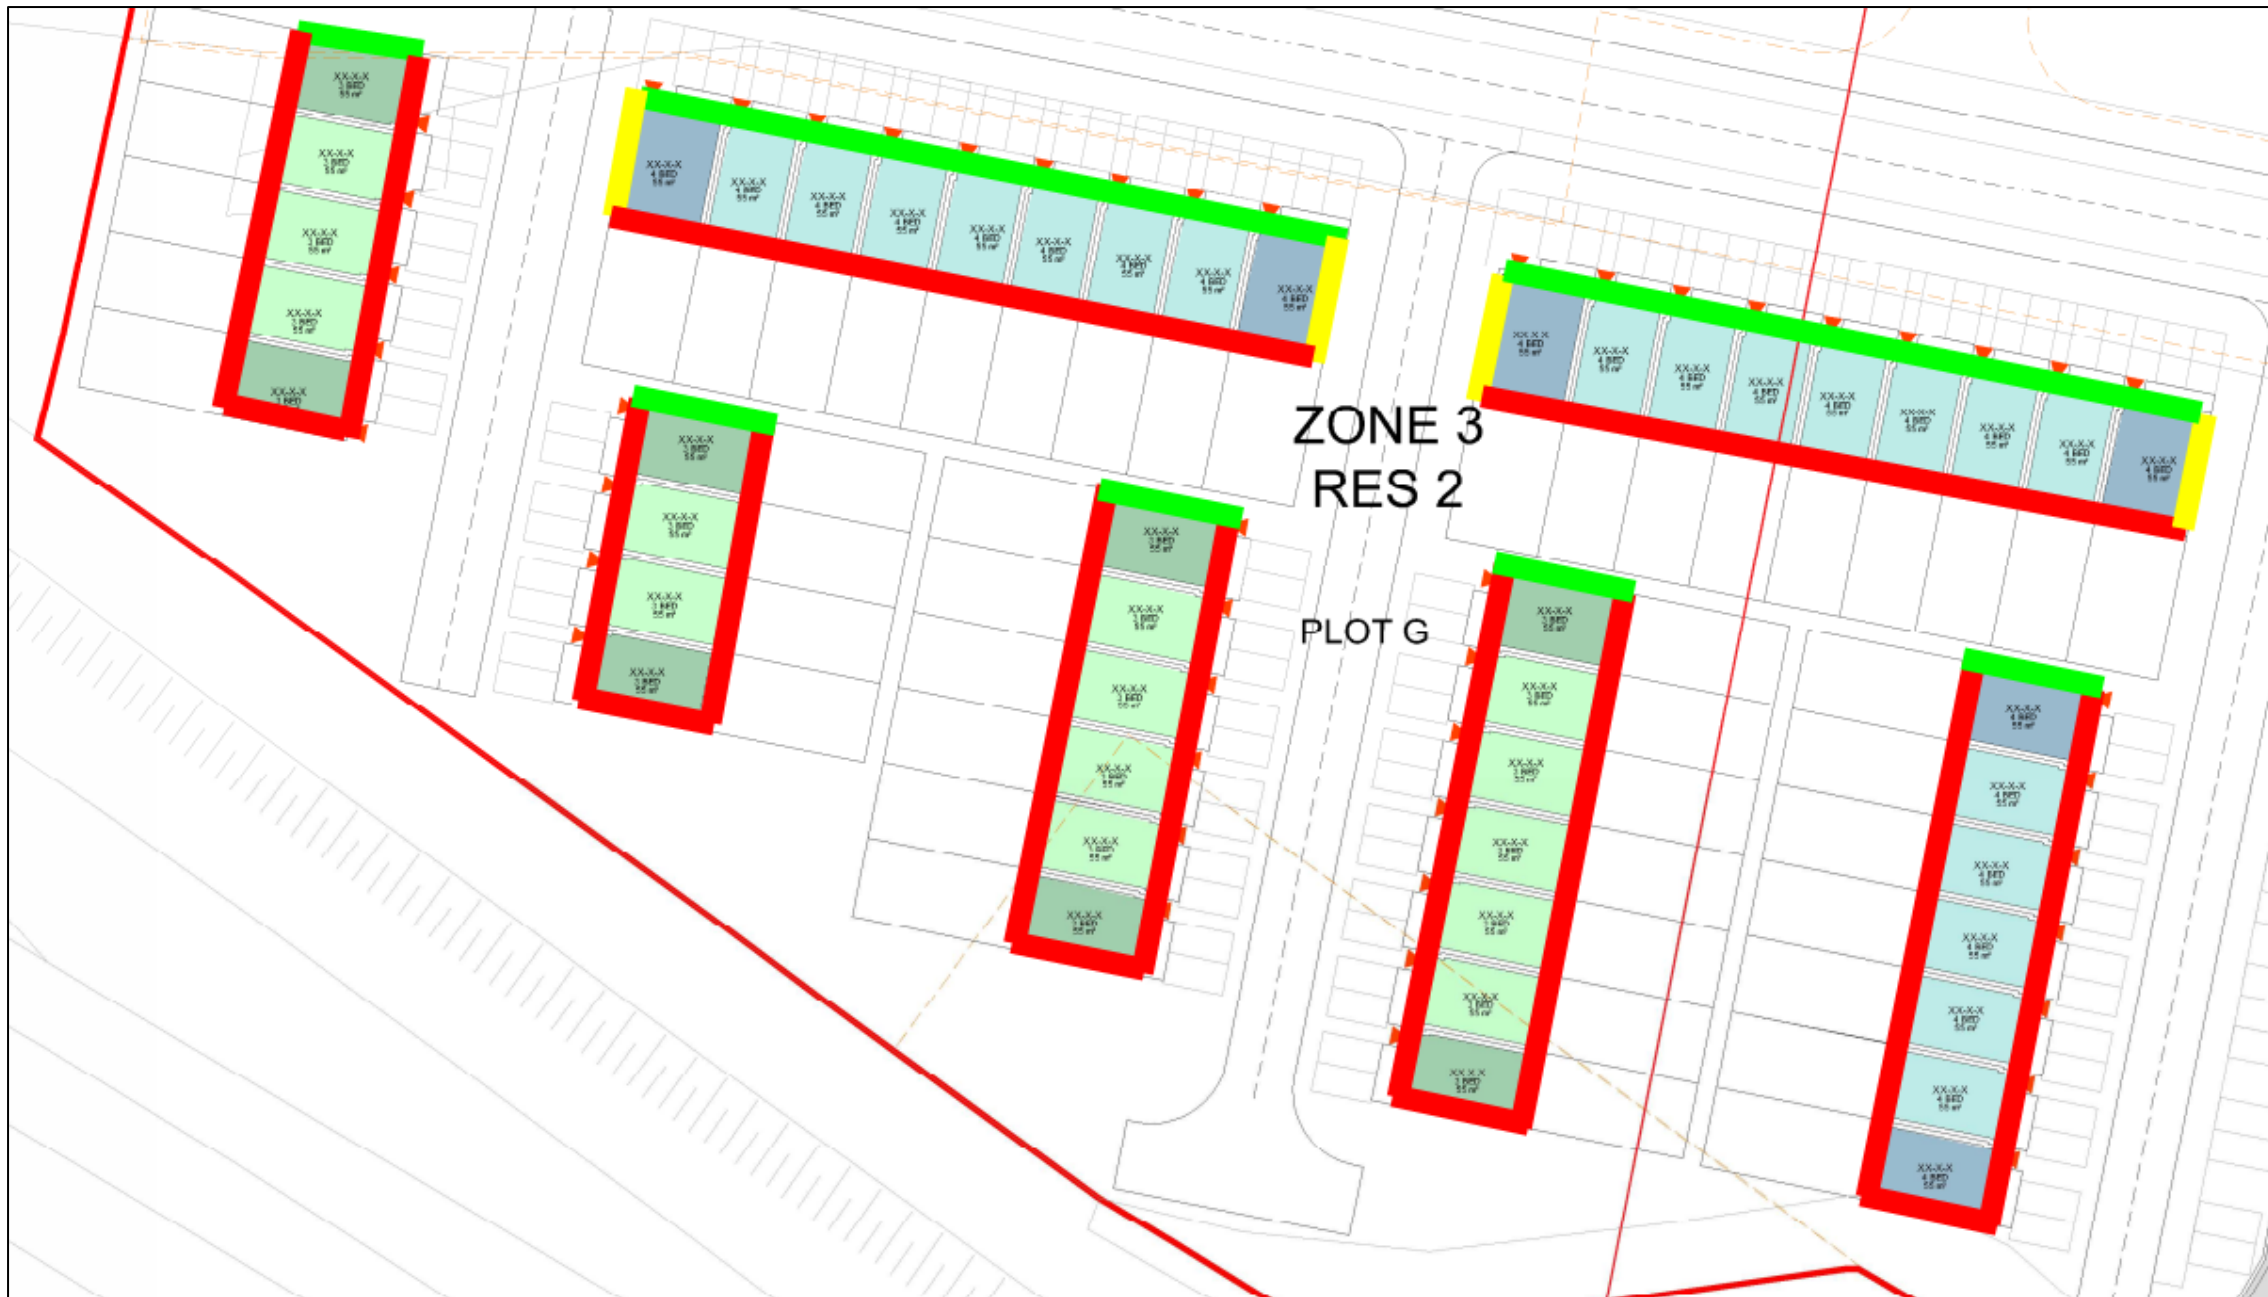
Figure A11 Dwelling First & Second Floor Glazing Sound Insulation Minimum Performance Requirements (SRI)

- Glazing Specification A
- Glazing Specification B
- Glazing Specification C

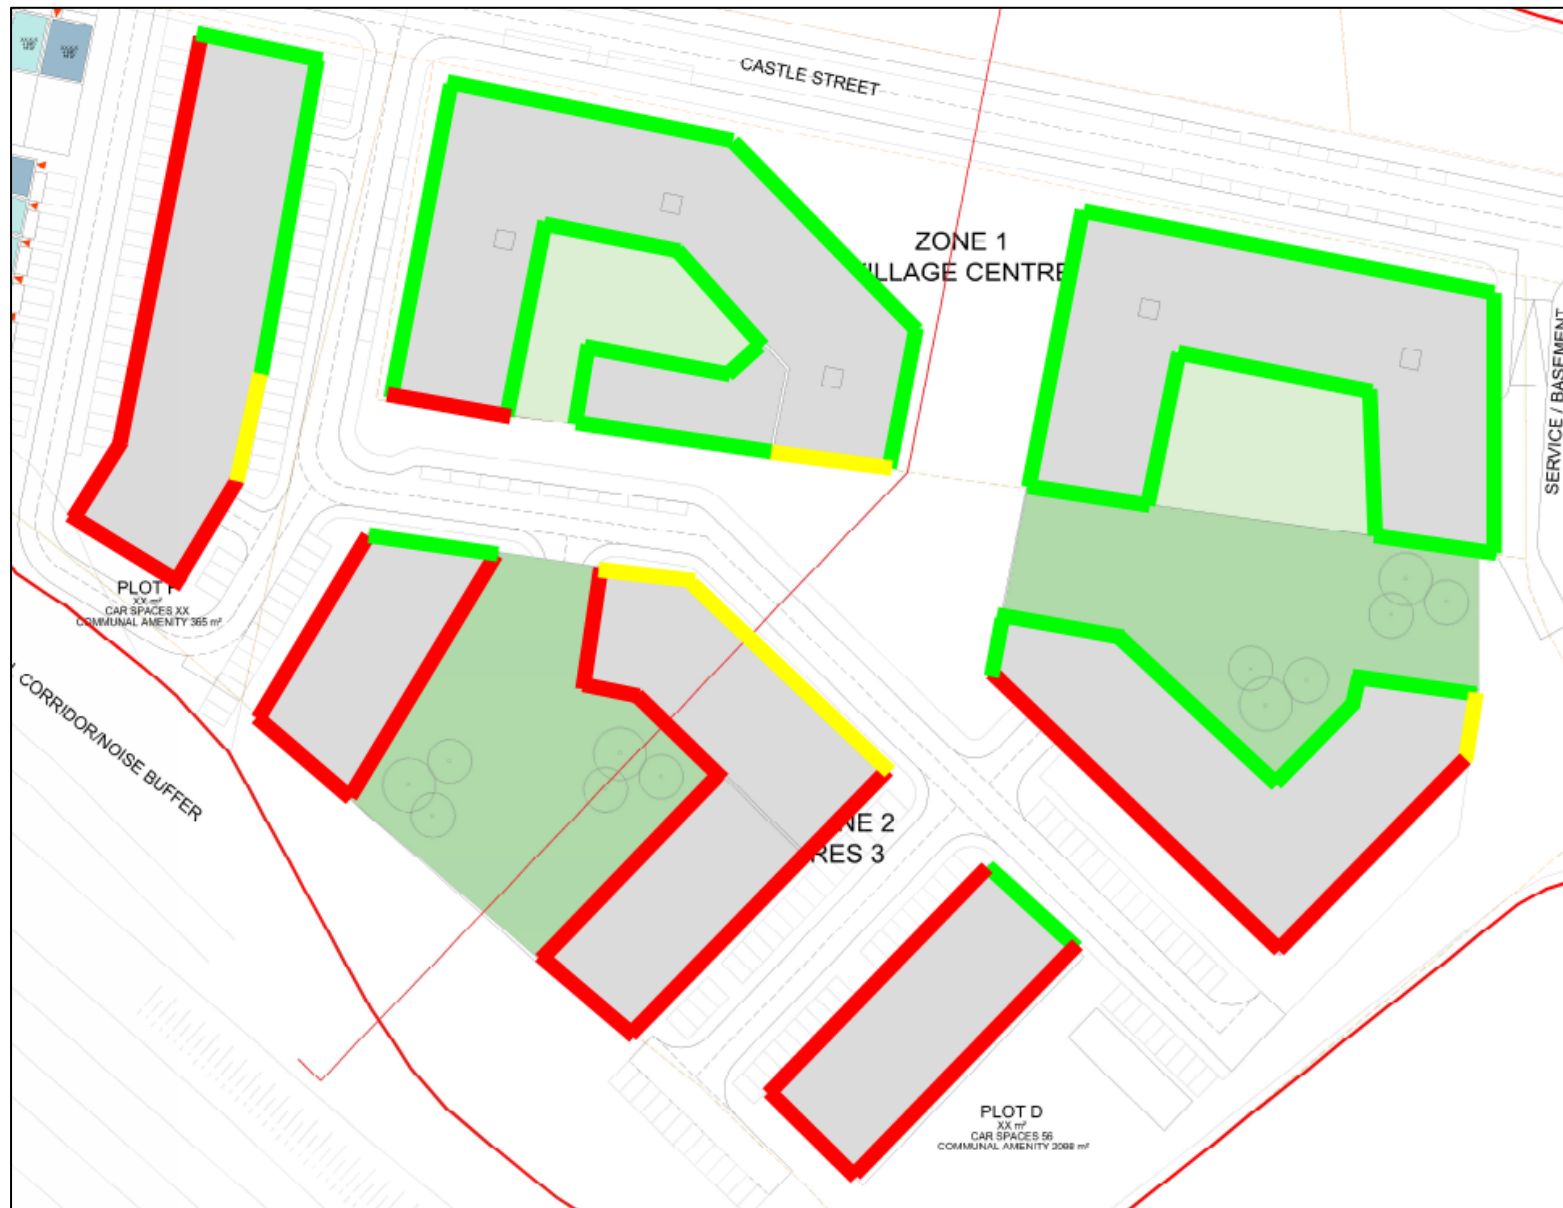
Figure A12 Apartment Block Glazing Sound Insulation Minimum Performance Requirements (SRI)

- █ : Glazing Specification A
- █ : Glazing Specification B
- █ : Glazing Specification C
