**Appendix A14.1**  
Scheme Walkover  
Summary

## Appendix A14.1: Scheme Walkover Summary

The following is a summary of the observations by the Land, Soils, Geology and Hydrogeology Environmental Impact Assessment Team following a physical walkover of the Proposed Scheme. The walkover occurred on 20 February 2020 and 31 January 2022.

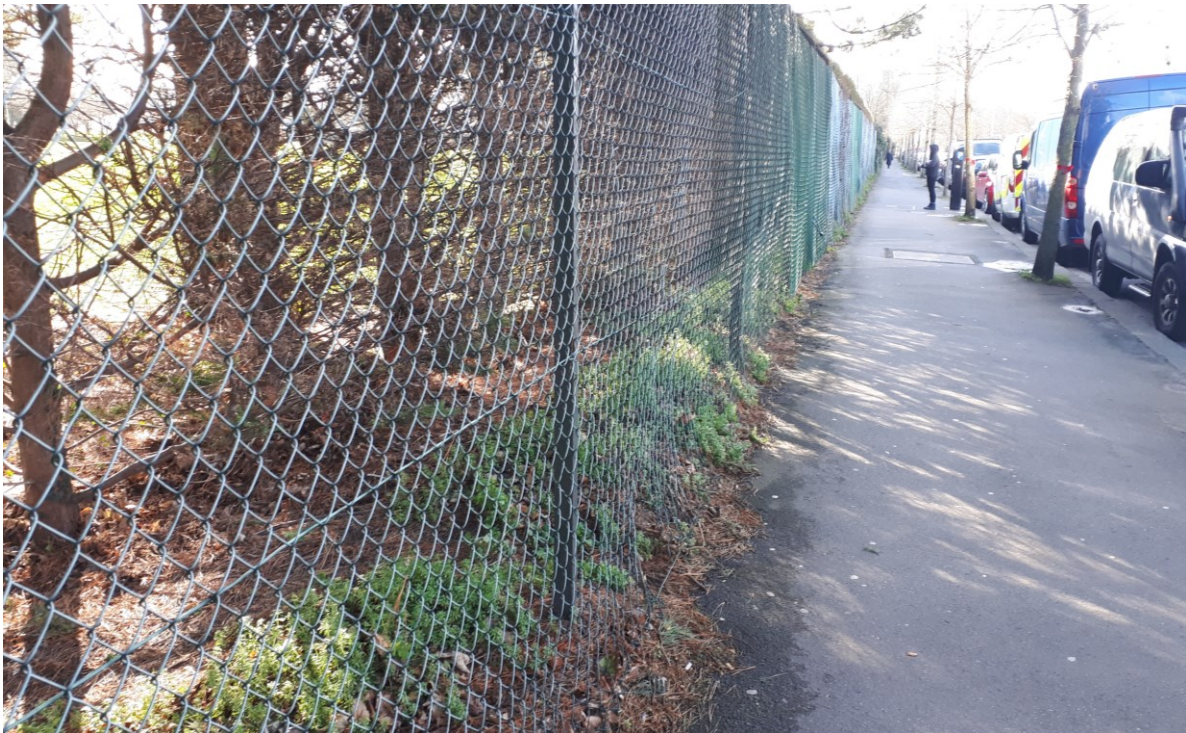
| Photo ID | Caption | Date Taken | Coordinates |
|---|--|---|---|
| Belfield Black_Image_01 | Nutley Lane proposed road widening along the Elm Park Golf & Sports Club boundary near St. Vincent's University Hospital | 20/02/2020 | 718762,731067 (ITM) |

| Observation | General Arrangement (GA) Drawing Sheet Number (refer to Volume 3 of the EIAR for GA drawings) | Description | Possible Impact | Photo Number |
|---|---|---|---|---|
| Nutley Lane proposed road widening | Sheets 22 to 23 | Proposed widening of the road along Nutley Lane along the boundary of Elm Park Golf & Sports Club near St. Vincent's University Hospital. | This may pose an issue for the earthworks balance and waste assessment. | Belfield Black_Image_01 |

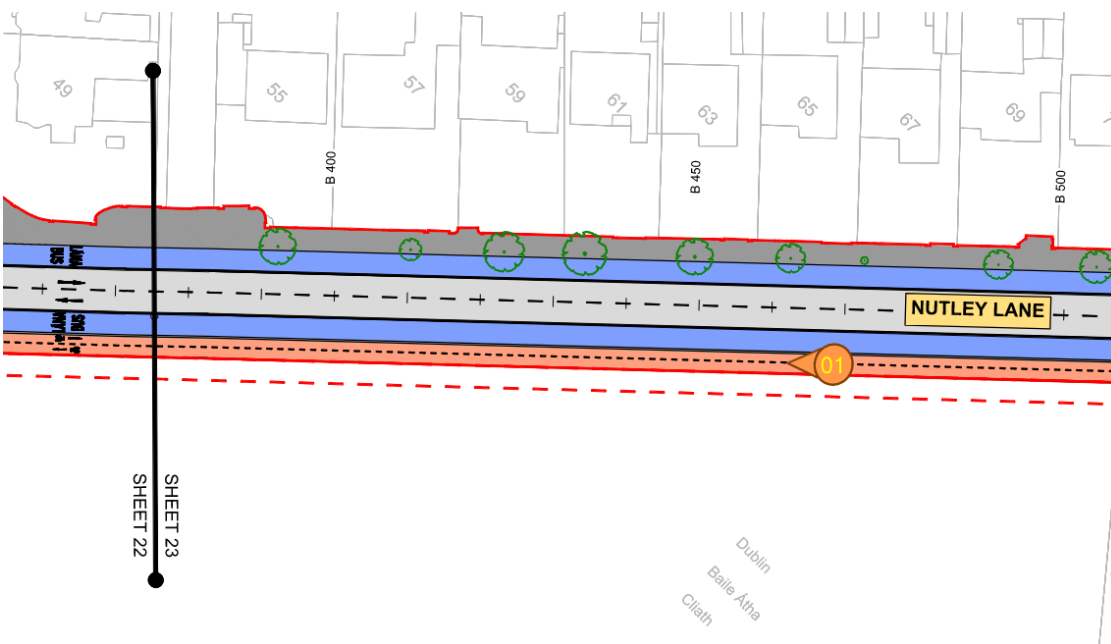
| Photo ID | Caption | Date Taken | Coordinates |
|---|---|---|---|
| Belfield Black_Image_02 | Proposed widening of the road along Nutley Lane between the entrance of Elm Park Golf & Sports Club and RTE studios | 20/02/2020 | 718605,730912 (ITM) |

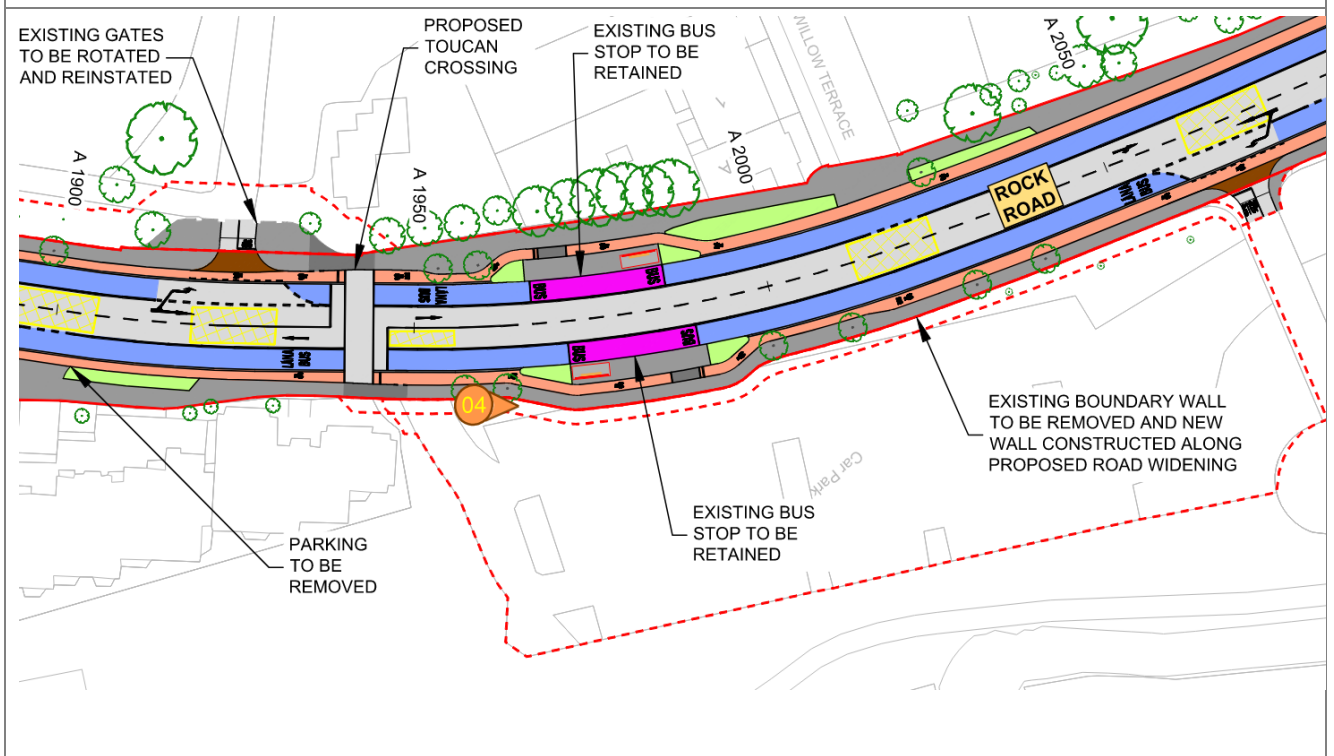
| Observation | General Arrangement (GA) Drawing Sheet Number (refer to Volume 3 of the EIAR for GA drawings) | Description | Possible Impact | Photo Number |
|---|---|---|---|---|
| Rock Road | Sheets 4 to 5 | Proposed widening of the scheme along the Rock Road near the Blackrock Clinic where minor level changes were noted | This may pose an issue for the earthworks balance and waste assessment. | Belfield Black_Image_05 |

| Photo ID | Caption | Date Taken | Coordinates |
|---|--|---|---|
| Belfield Black_Image_05 | Proposed widening of the scheme along the Rock Road near the Blackrock Clinic where minor level changes were noted | 20/02/2020 | 720770,729826 (ITM) |
