# Environmental Impact Assessment Report (Addendum)

## Development of Two Data Halls and Ancillary Structures

## Volume 4 – EIA Appendix II

**COMAH LAND USE  
PLANNING ASSESSMENT  
FOR PROPOSED  
SUBSTATION AND  
UNDERGROUND CABLE  
ROUTES, CO. DUBLIN**

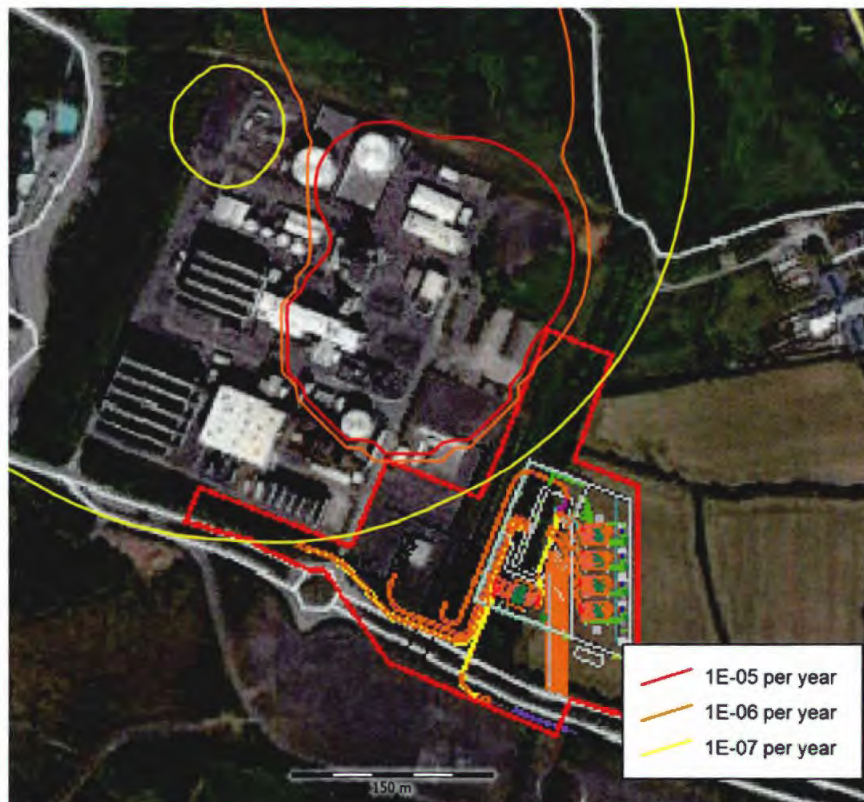
The cumulative individual risk contours for Huntstown Power Station corresponding to the boundary of the inner, middle and outer land use planning zones are illustrated as follows.

It is concluded that the LUP Outer zone and Middle zone of Huntstown Power Station extends to the proposed development. The individual risk contours corresponding to the Inner LUP zone does not extend to the proposed development; therefore, the level of individual risk at the proposed development is acceptable.

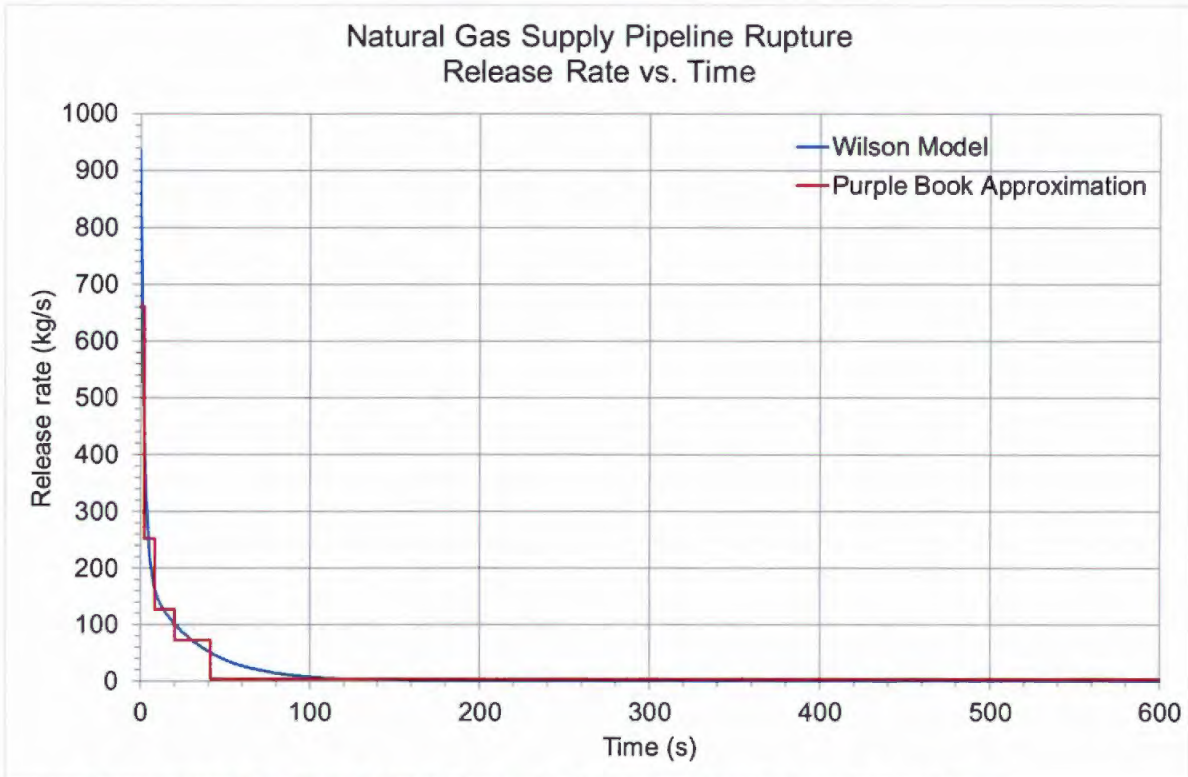
Figure 10 High Pressure Natural Gas Supply Pipeline Rupture: Release Rate vs. Time

The long pipeline model calculates the drop off in release rate with time, and also the "Purple Book" representative release rate over time in 5 steps, as illustrated on Figure 10.

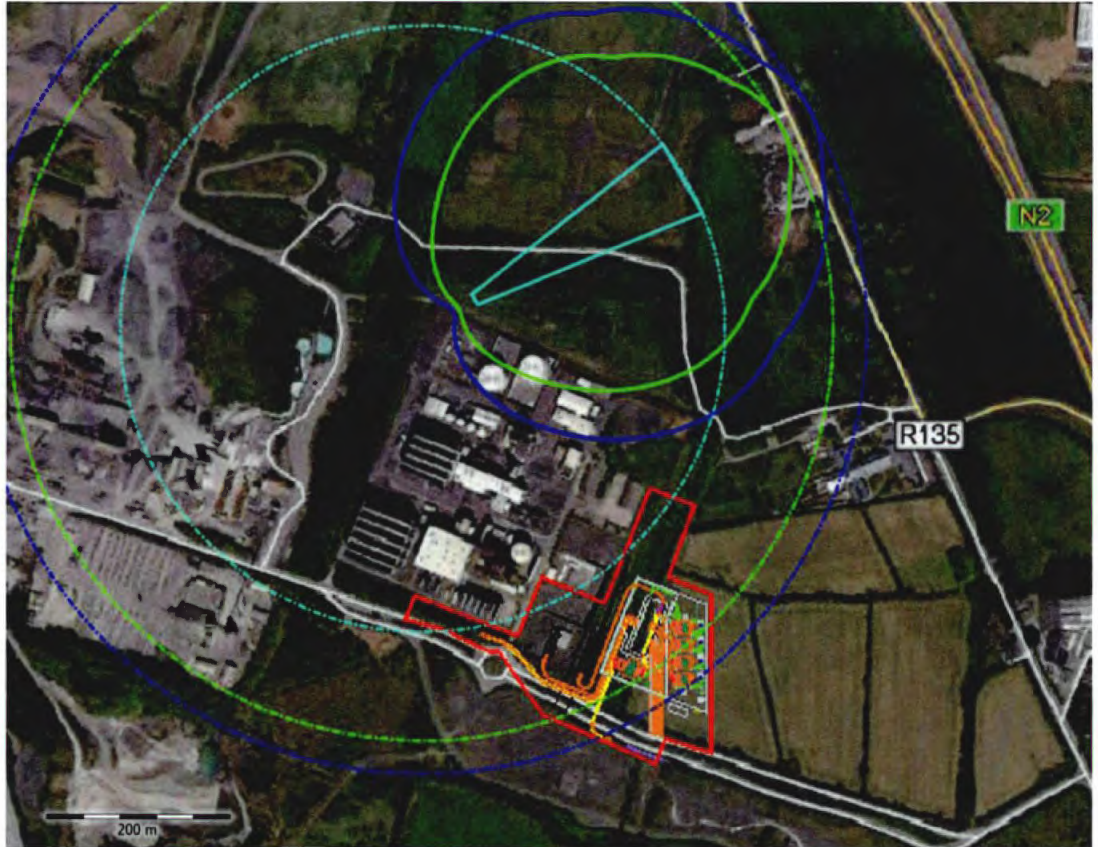
Figure 16 Natural Gas Jet Fire at GNI AGI: Outdoor Mortality Contours

Thermal radiation contours and effect areas are presented on the following figures (for the worst case wind speed scenario):

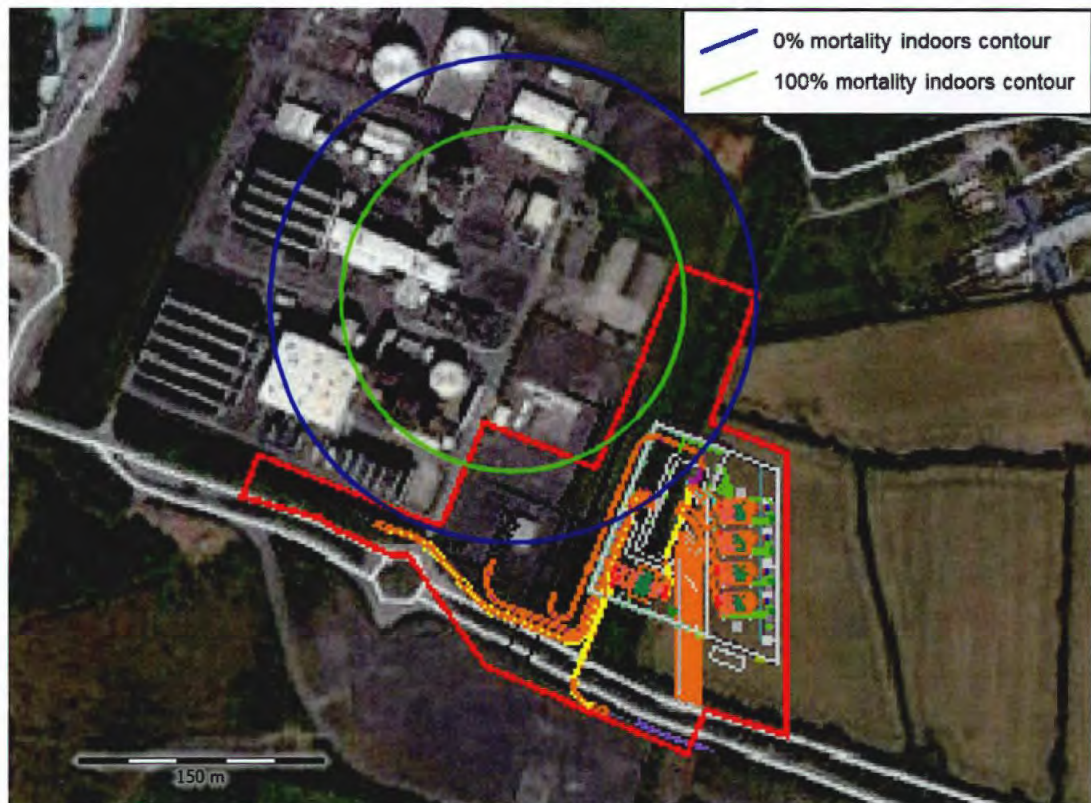
**Figure 29** LPG Fireball: Indoor Mortality

The thermal radiation levels corresponding to indoor mortality is illustrated on Figure 29.

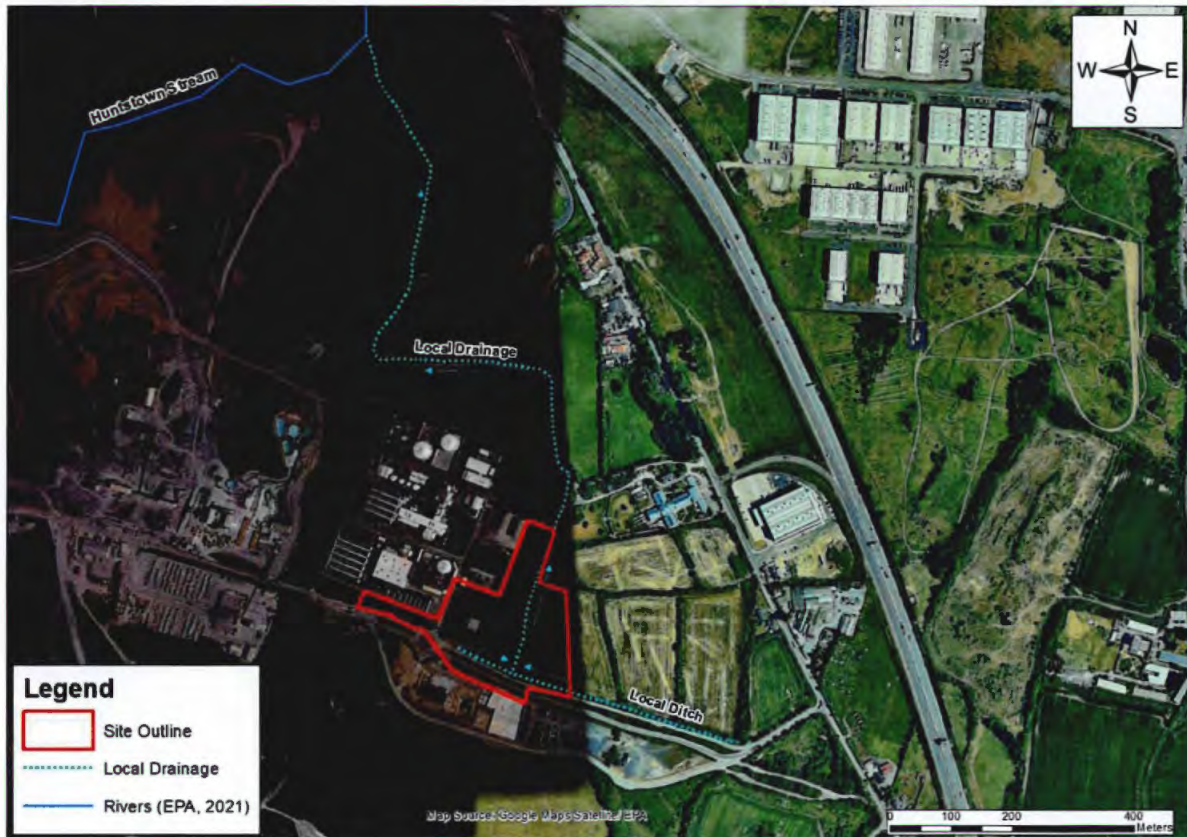
The local drainage network comprises a series of shallow ditches running along the field boundaries which consist of a series of local manmade drainage, with intermittent or ephemeral characteristics and likely fed from surface runoff. The local drainage ultimately flows in a northerly direction towards the Huntstown Stream (located c. 850 m to the north of the site, refer to Figure 2.1 below).

Figure 2.1 Local area with hydrological environment

An existing ditch crosses the site (refer to Figure 2.1 above), and this will be diverted as part of the proposed development application. The diversion has been designed in accordance with OPW Guidelines in order to ensure there will be not impact on the site in terms of flood risk. Details of the design of the ditch diversion, and associated engineering calculations, are provided in its associated CSEA Engineering Planning Report (Document No. 20\_099-CSE-00-XX-RP-C-005), included along with the Infrastructure Report (AECOM, 2021) with the planning application documentation.

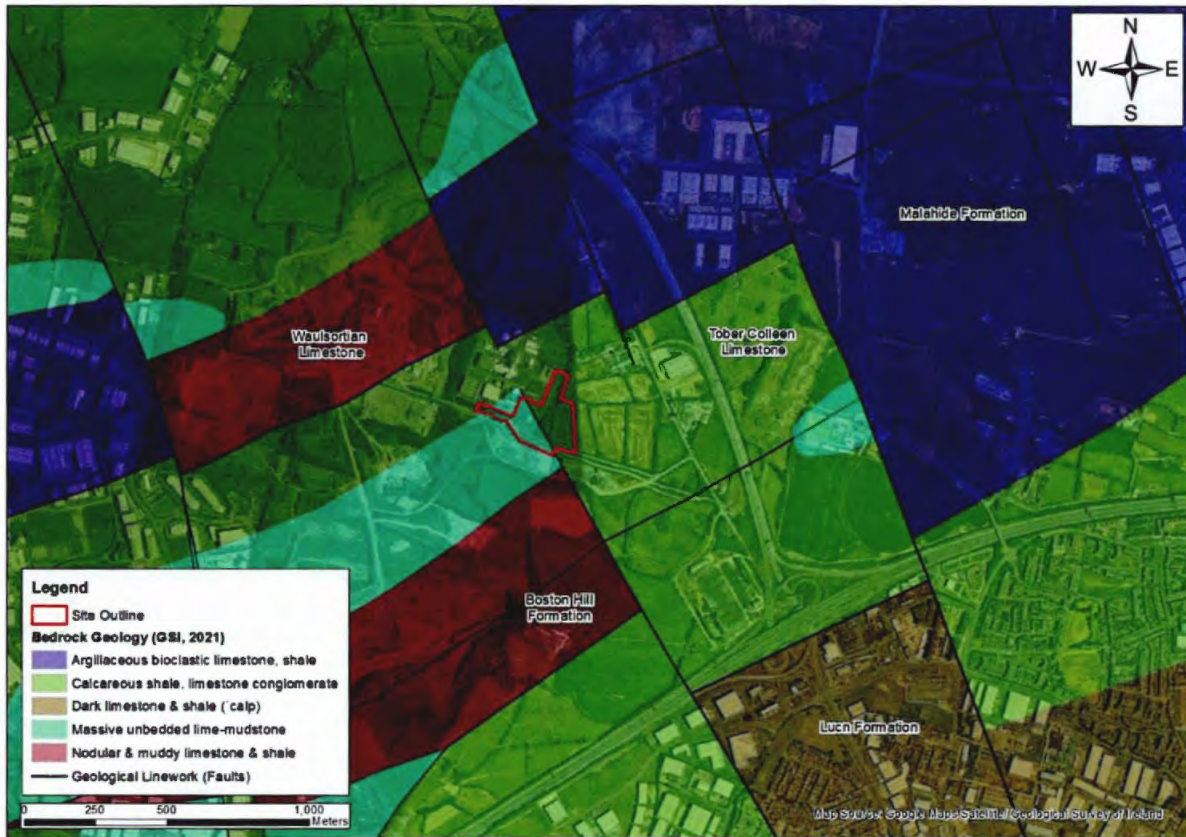
Inspection of the available GSI (2021) records (Data Sheet 16 and on-line mapping database) shows that the bedrock geology of the site and the surrounding area is dominated by rocks from the Chadian and Tournaisian age. The site is located over dark-grey, calcareous, commonly bioturbated mudstones and subordinate thin micritic limestones referred to as the Tober Colleen Formation (Rock Unit code: CDTOBE) and over pale-grey, crudely bedded or massive limestone associated to the Waulsortian Limestones Formation (CDWAUL) to the west. (refer to Figure 2.2 below).

The regional area is highly geologically variable. GSI maps do show the site as overlying the Tober Colleen formation which is bordered to the south west by Waulsortian Limestones (which have been noted to underly the Tober Colleen), further to the south by the Boston Hill Formation, to the south east by the Lucan Formation and to the north by the Malahide Formation. Due to this variability the GSI (2020) bedrock geology map (100K structural database) indicates a number of faults in the study area with one bounding the sites to the south west.

Figure 2.2 Bedrock Geology Map (GSI, 2021)

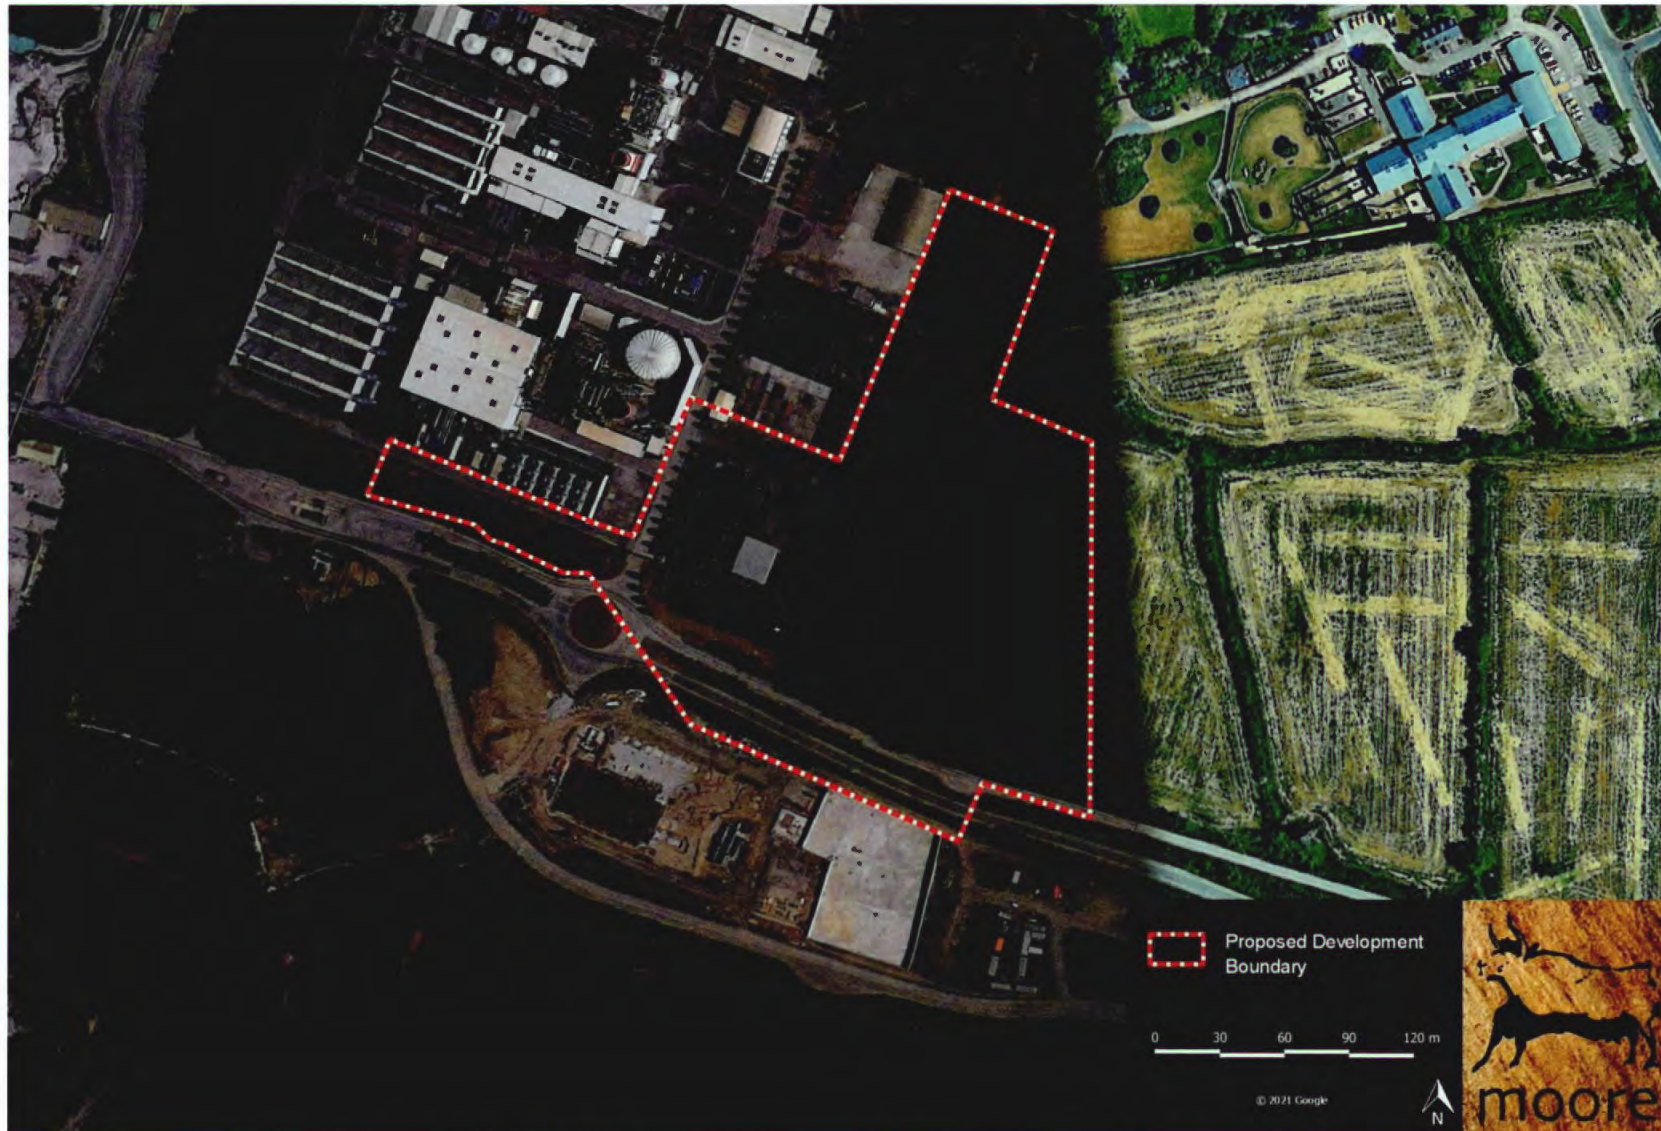
Figure 2. Showing the Proposed Development boundary on recent aerial photography.

Figure 1 shows the Proposed Development location and Figure 2 shows a detailed view of the Proposed Development boundary on recent aerial photography. Figure 3 shows the layout of the Proposed Development.

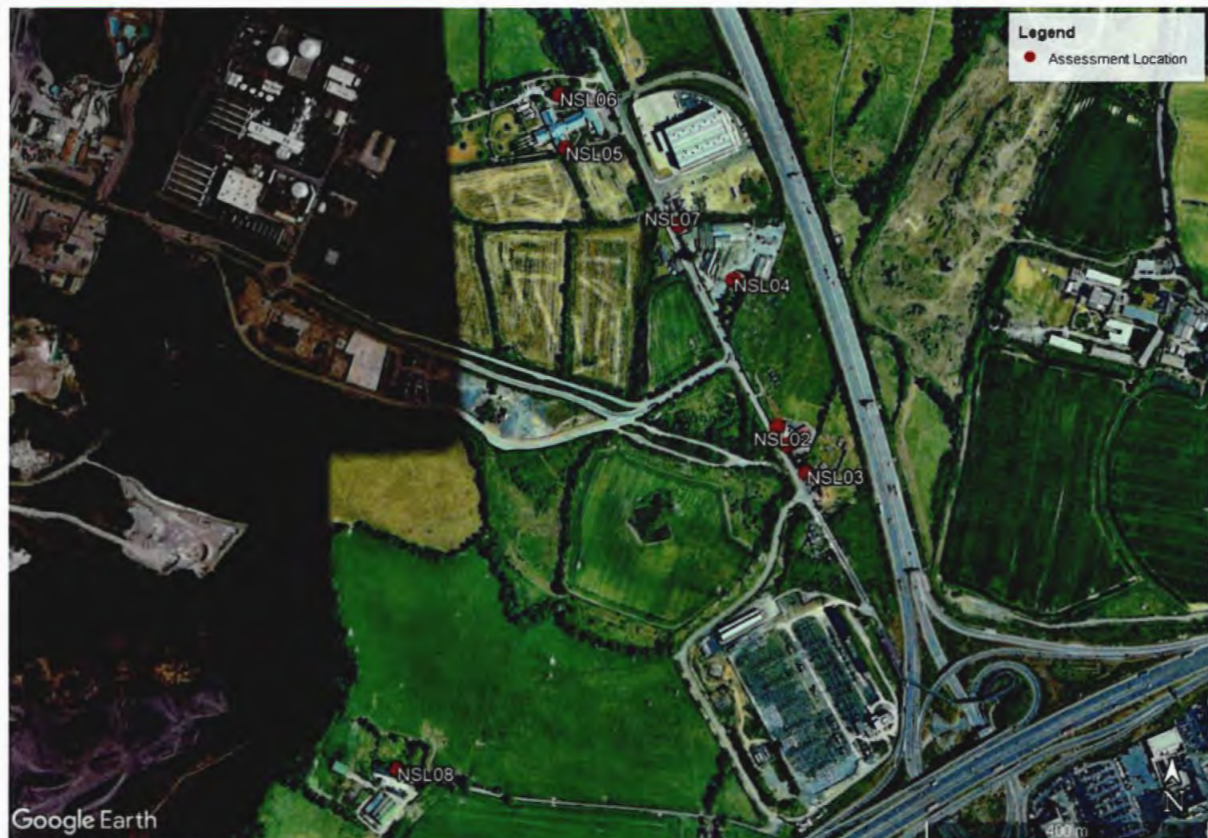
Nearby sensitive properties in the vicinity of the Proposed Development are summarised in Figure 10.4.1 below:

Figure 10.4.1 Sensitive Receptors

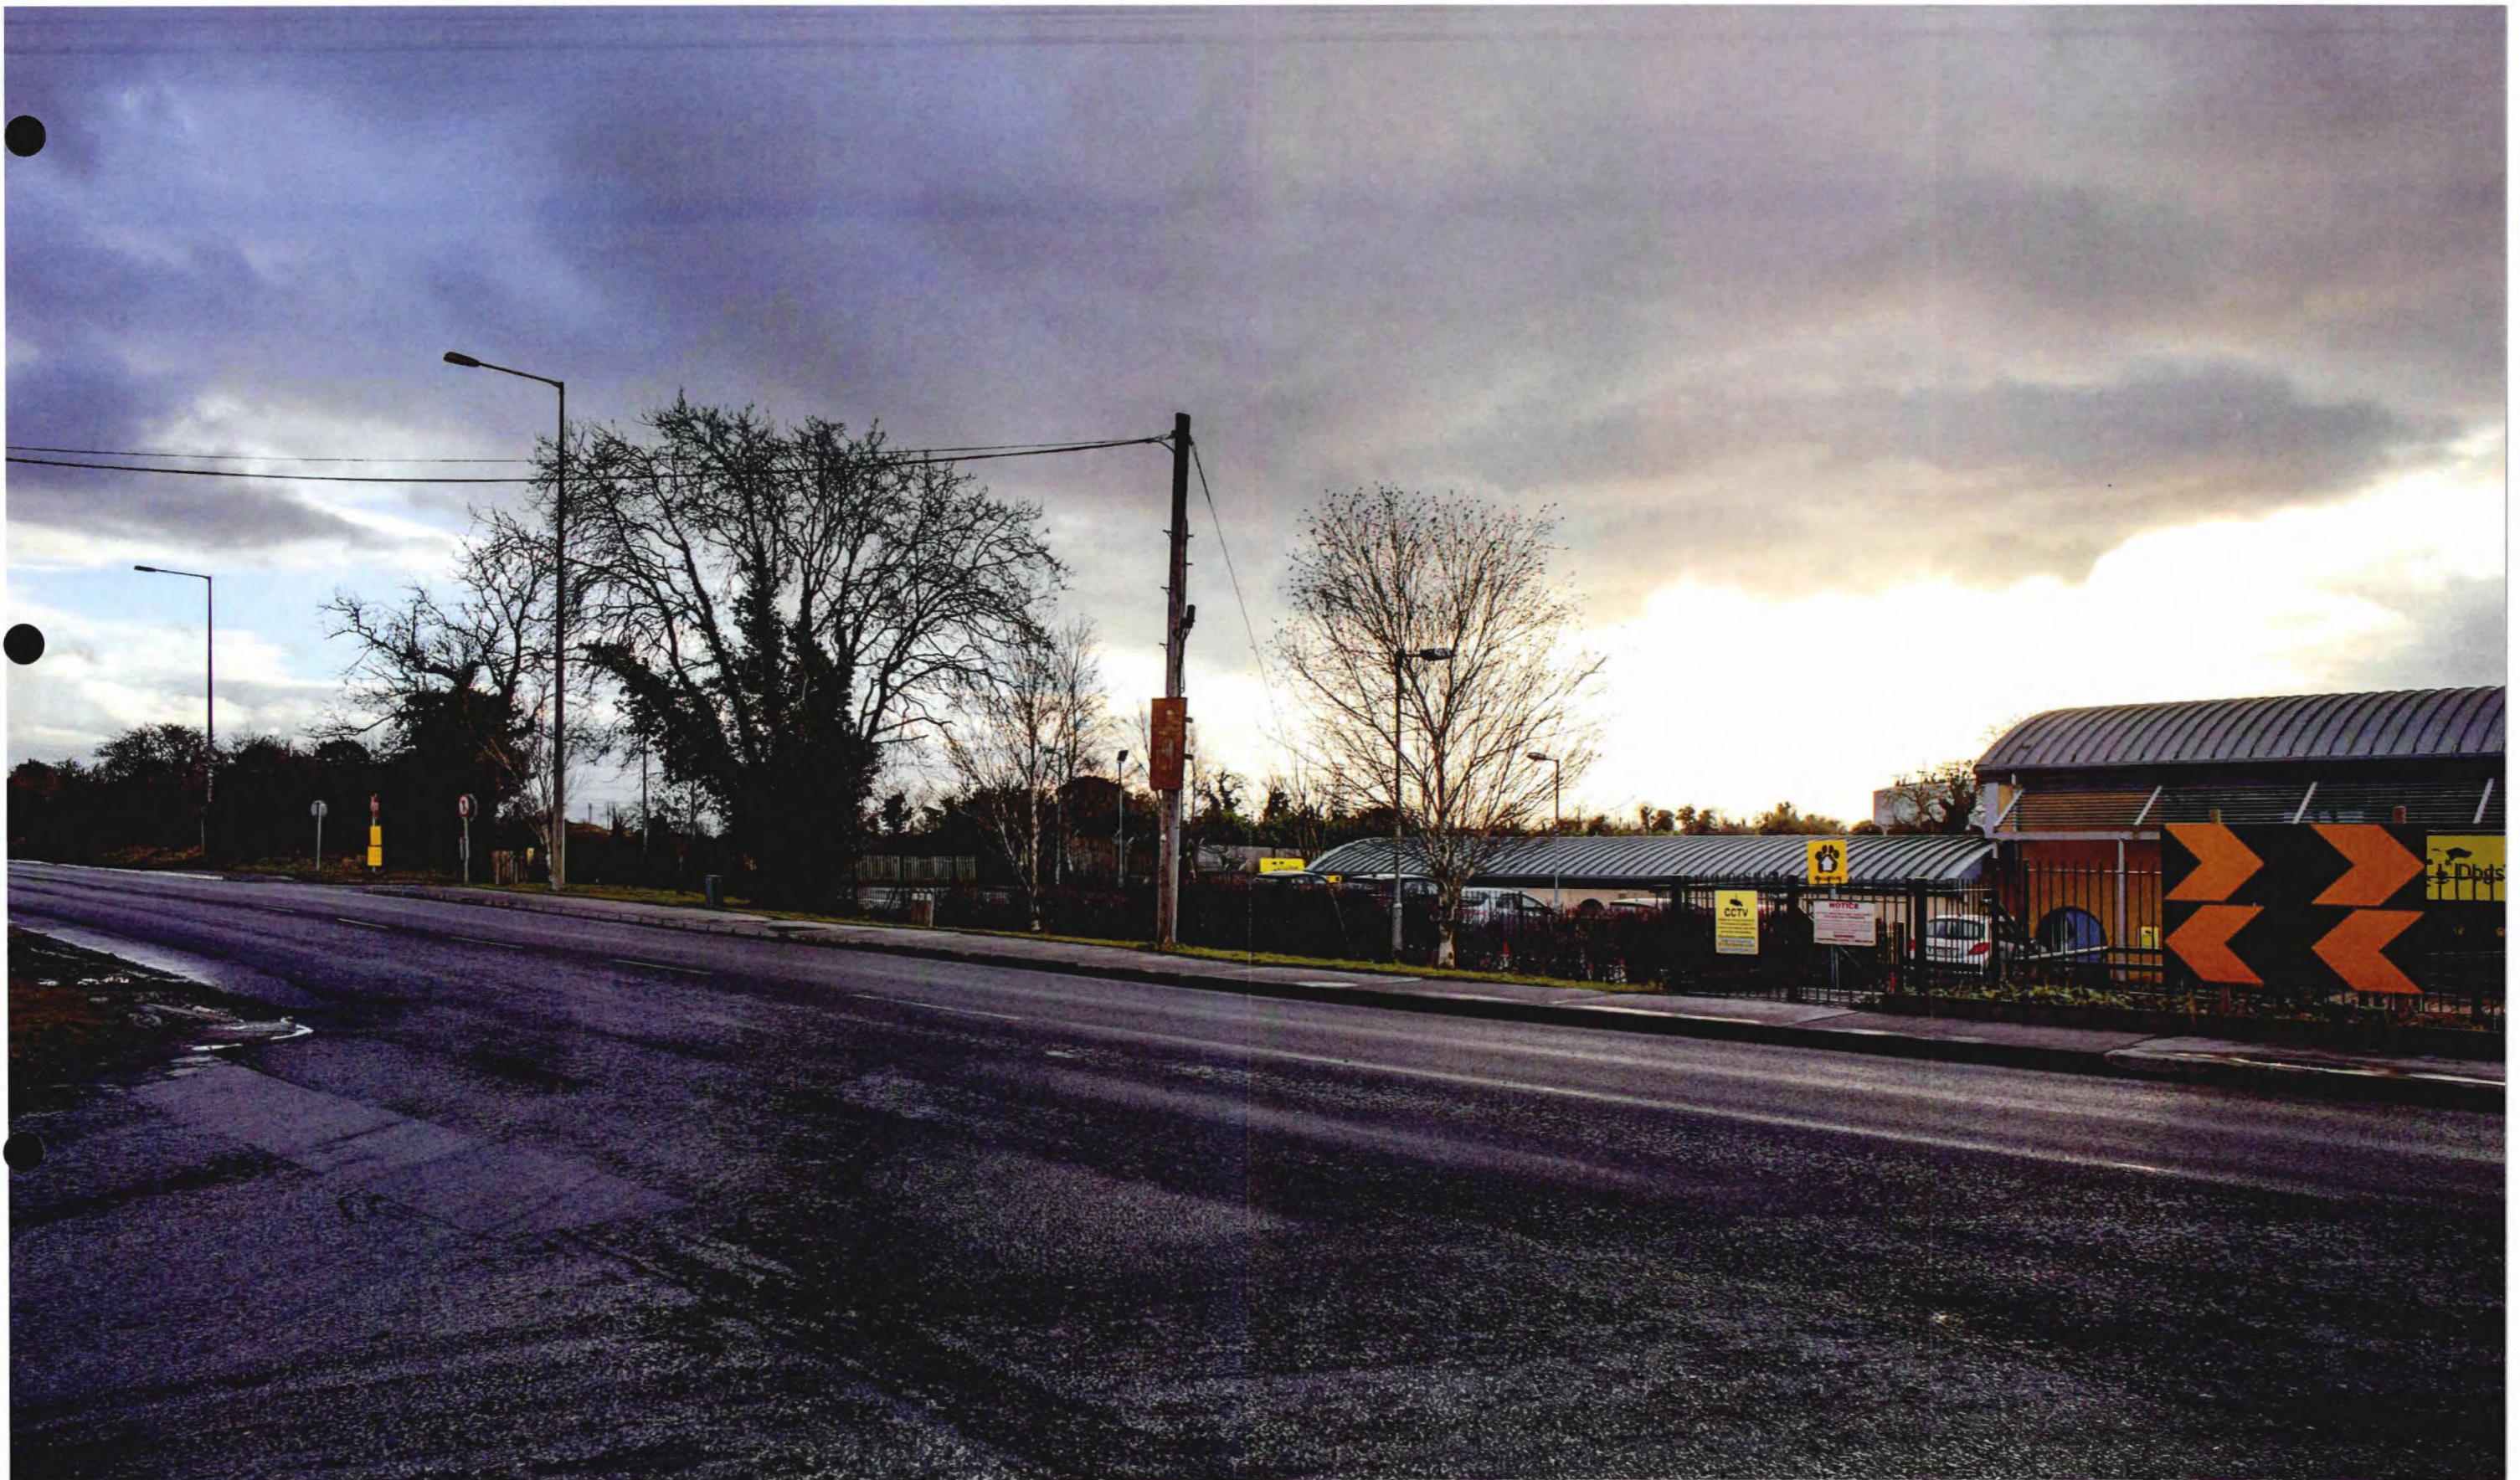
Location	Date	Field of view	35mm equivalent	Distance to site	Camera model
View 1 Existing	04-02-2021	74°	24mm	72m	Canon EOS 5DS

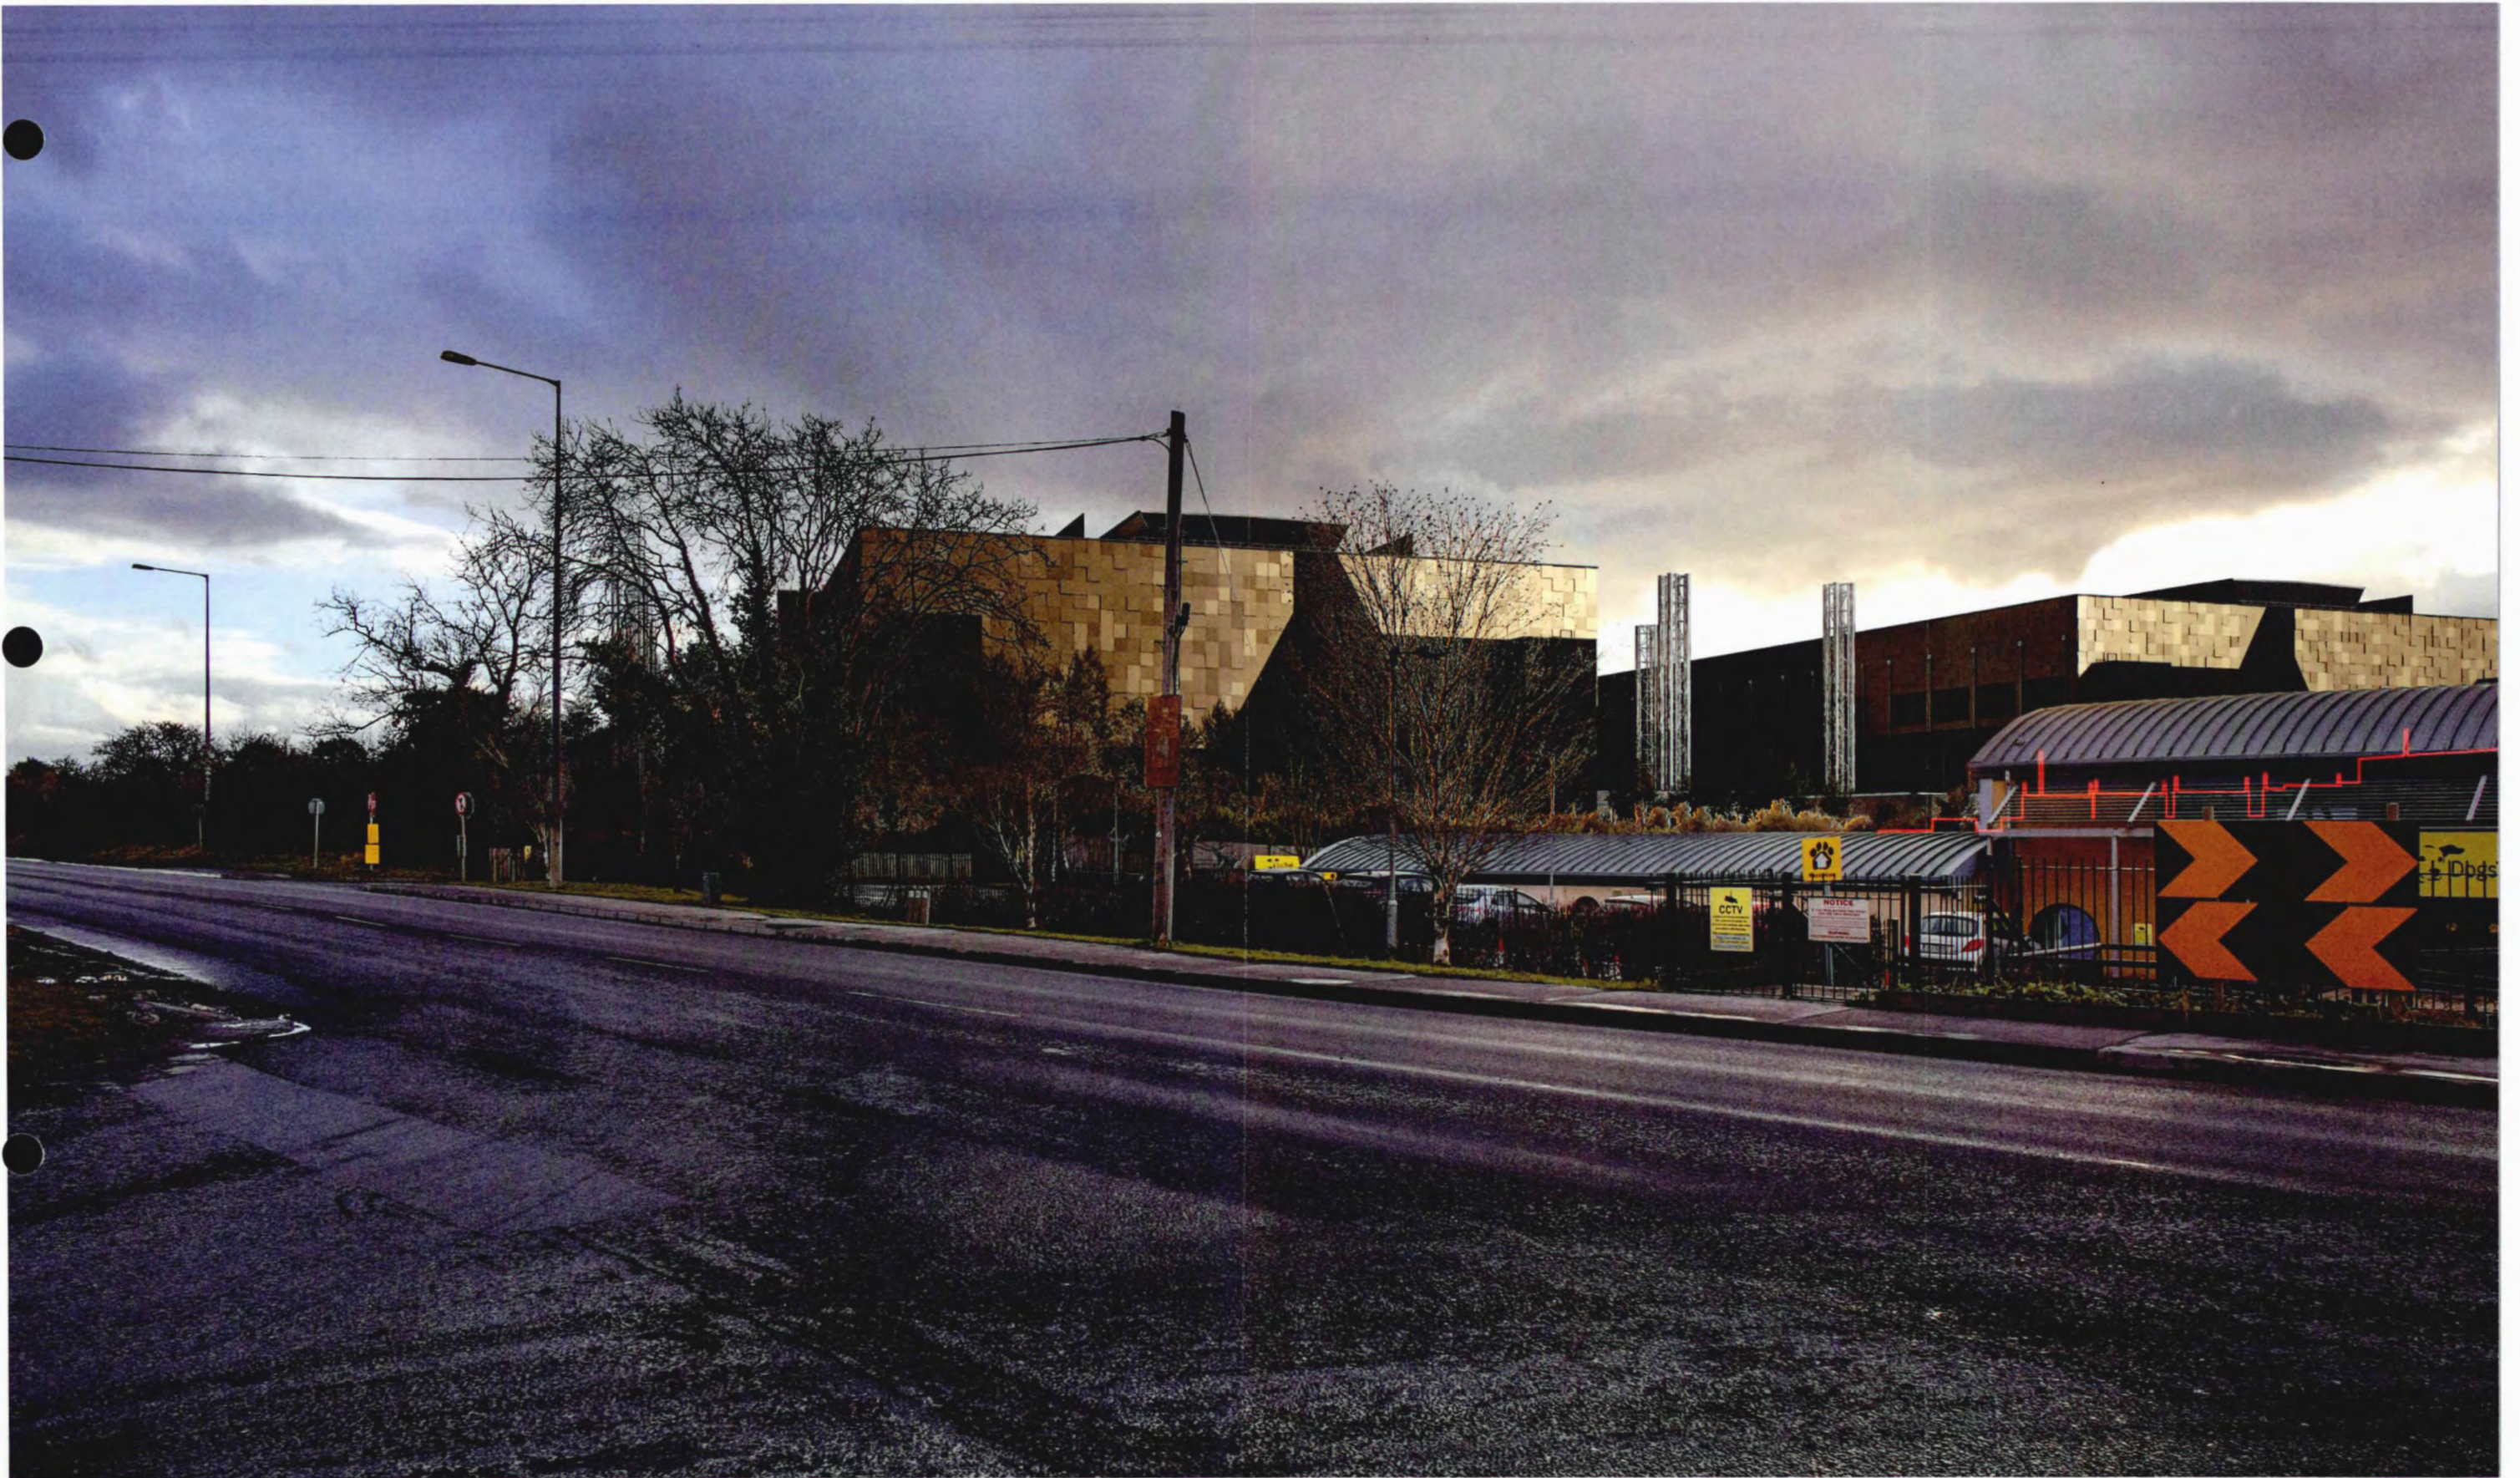
Location	Date	Field of view	35mm equivalent	Distance to site	Camera model
View 1 Proposed	04-02-2021	74°	24mm	72m	Canon EOS 5DS

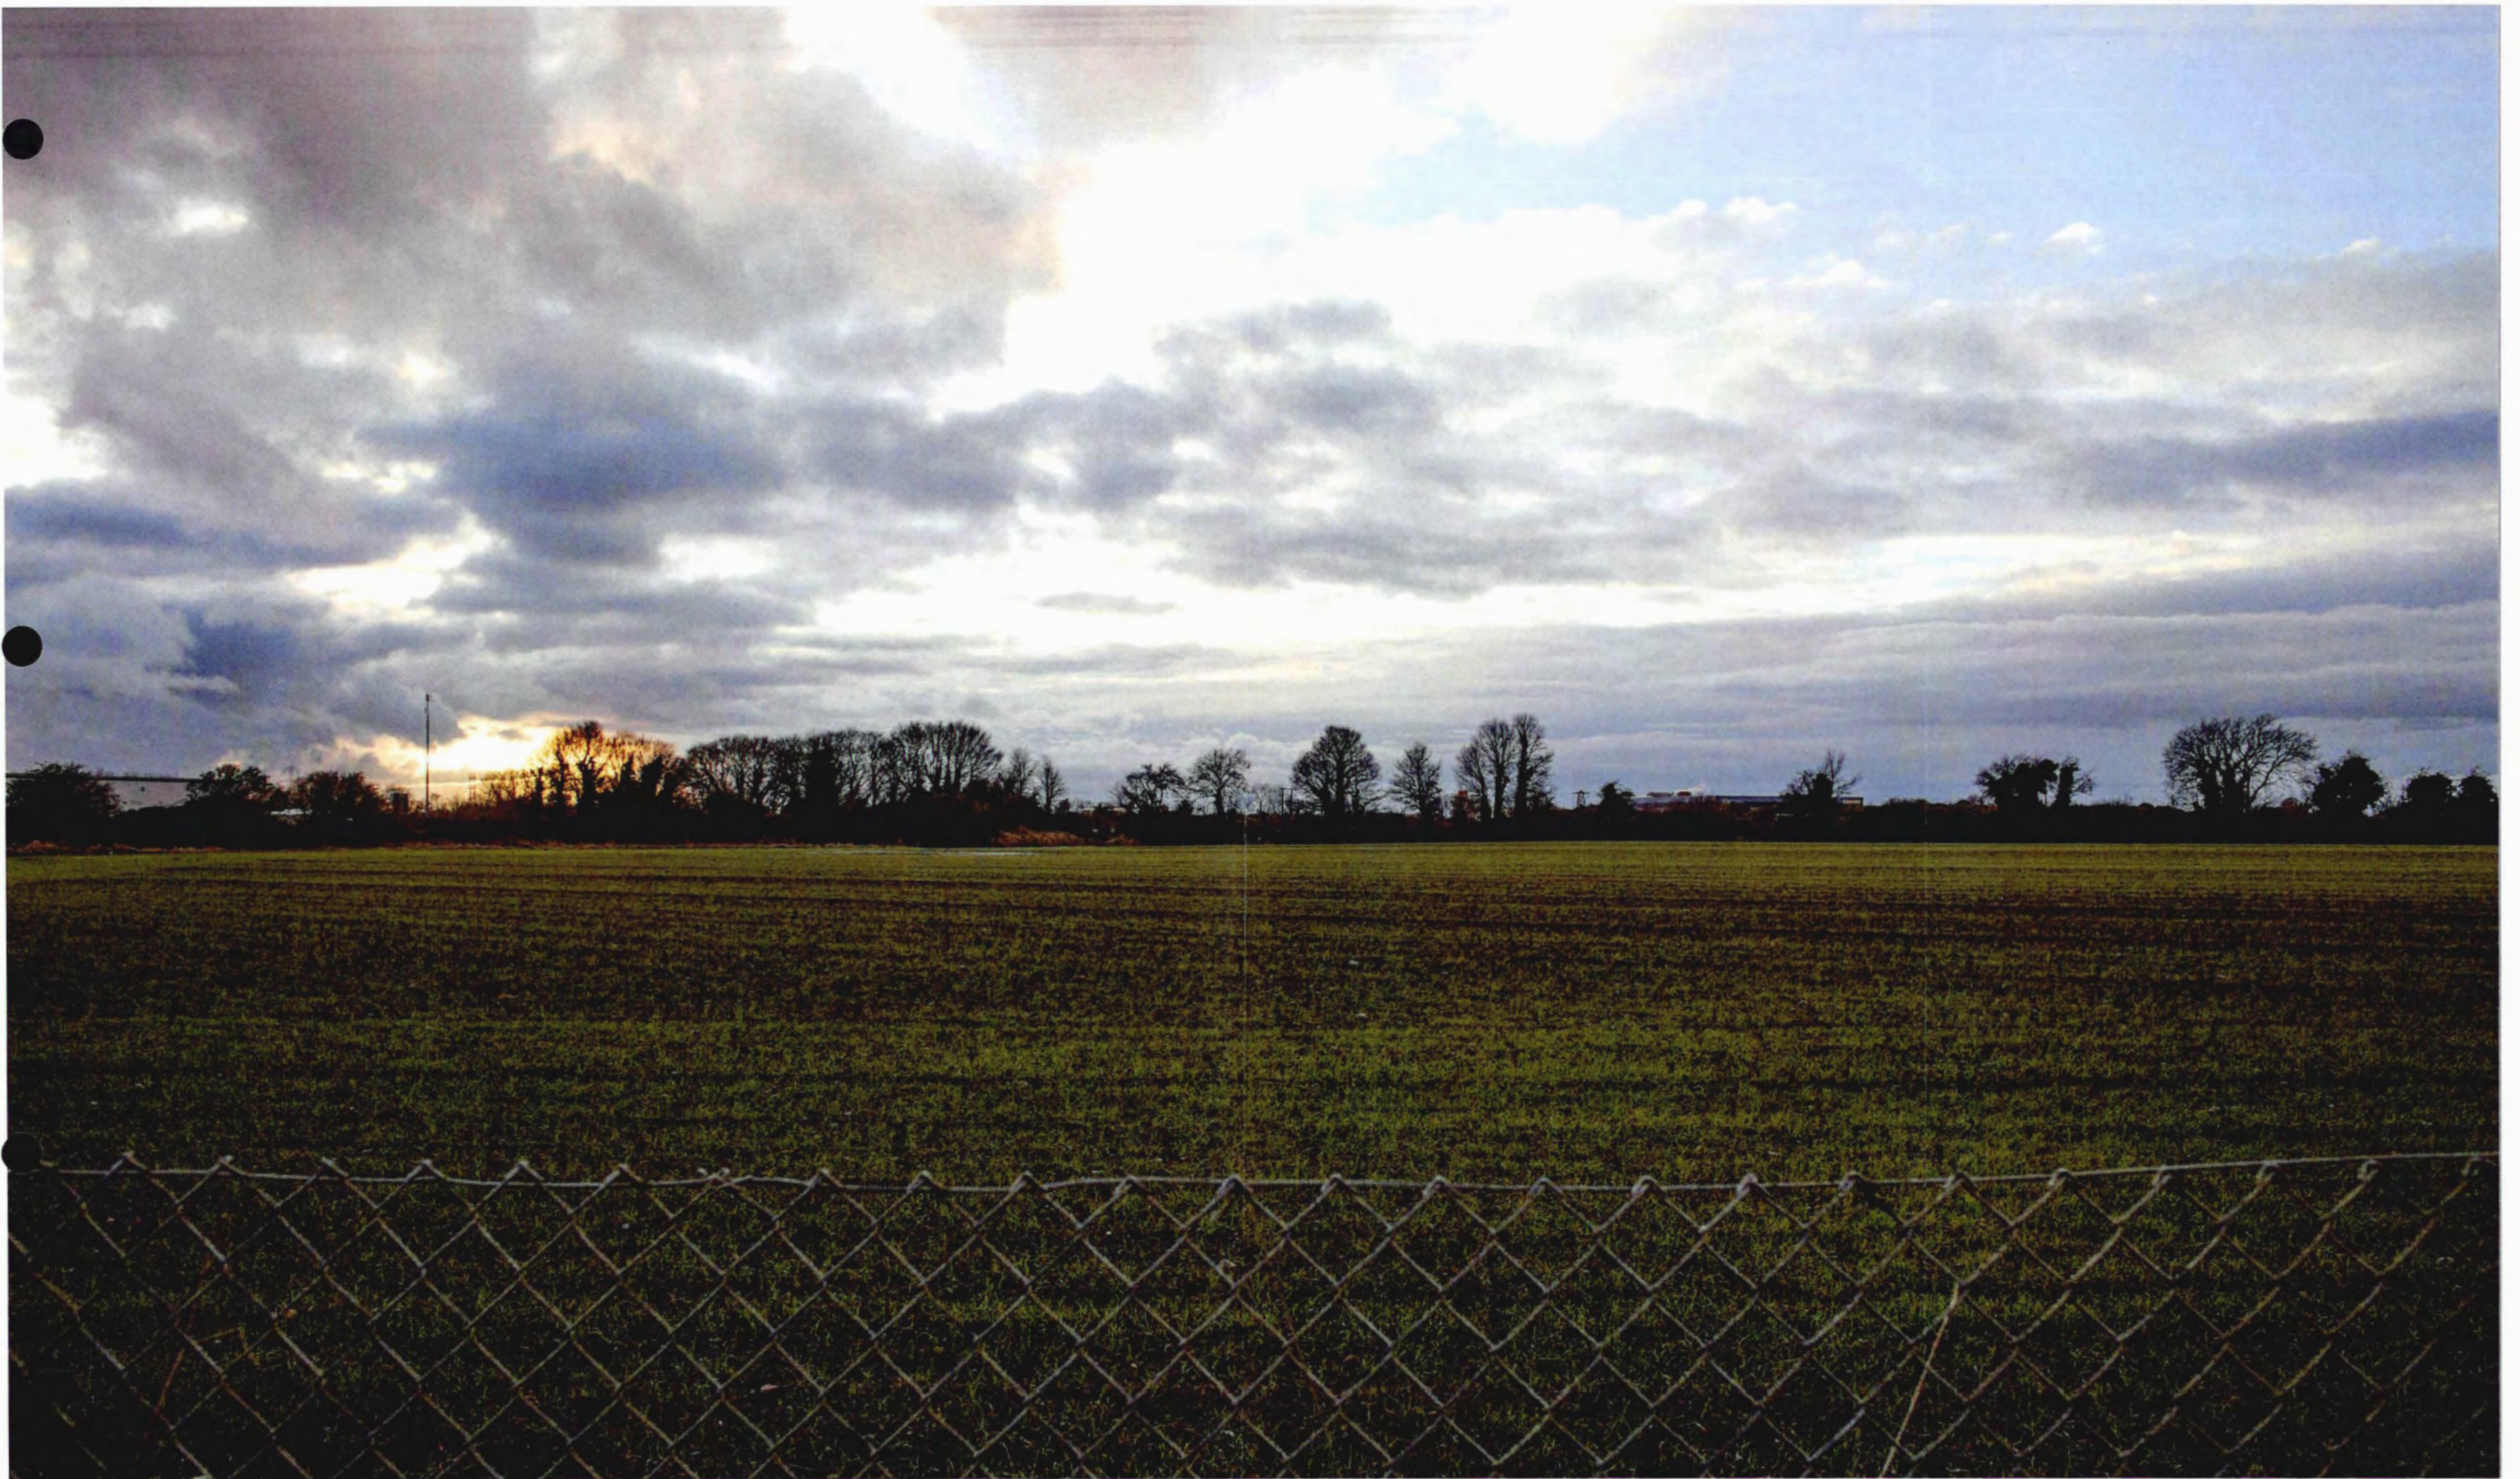
Location	Date	Field of view	35mm equivalent	Distance to site	Camera model
View 2 Existing	04-02-2021	74°	24mm	711m	Canon EOS 5DS
