# Environmental Impact Assessment Report (Addendum)

## Development of Two Data Halls and Ancillary Structures

## Volume 4 – EIA Appendix II

**COMAH LAND USE  
PLANNING ASSESSMENT  
FOR PROPOSED  
SUBSTATION AND  
UNDERGROUND CABLE  
ROUTES, CO. DUBLIN**

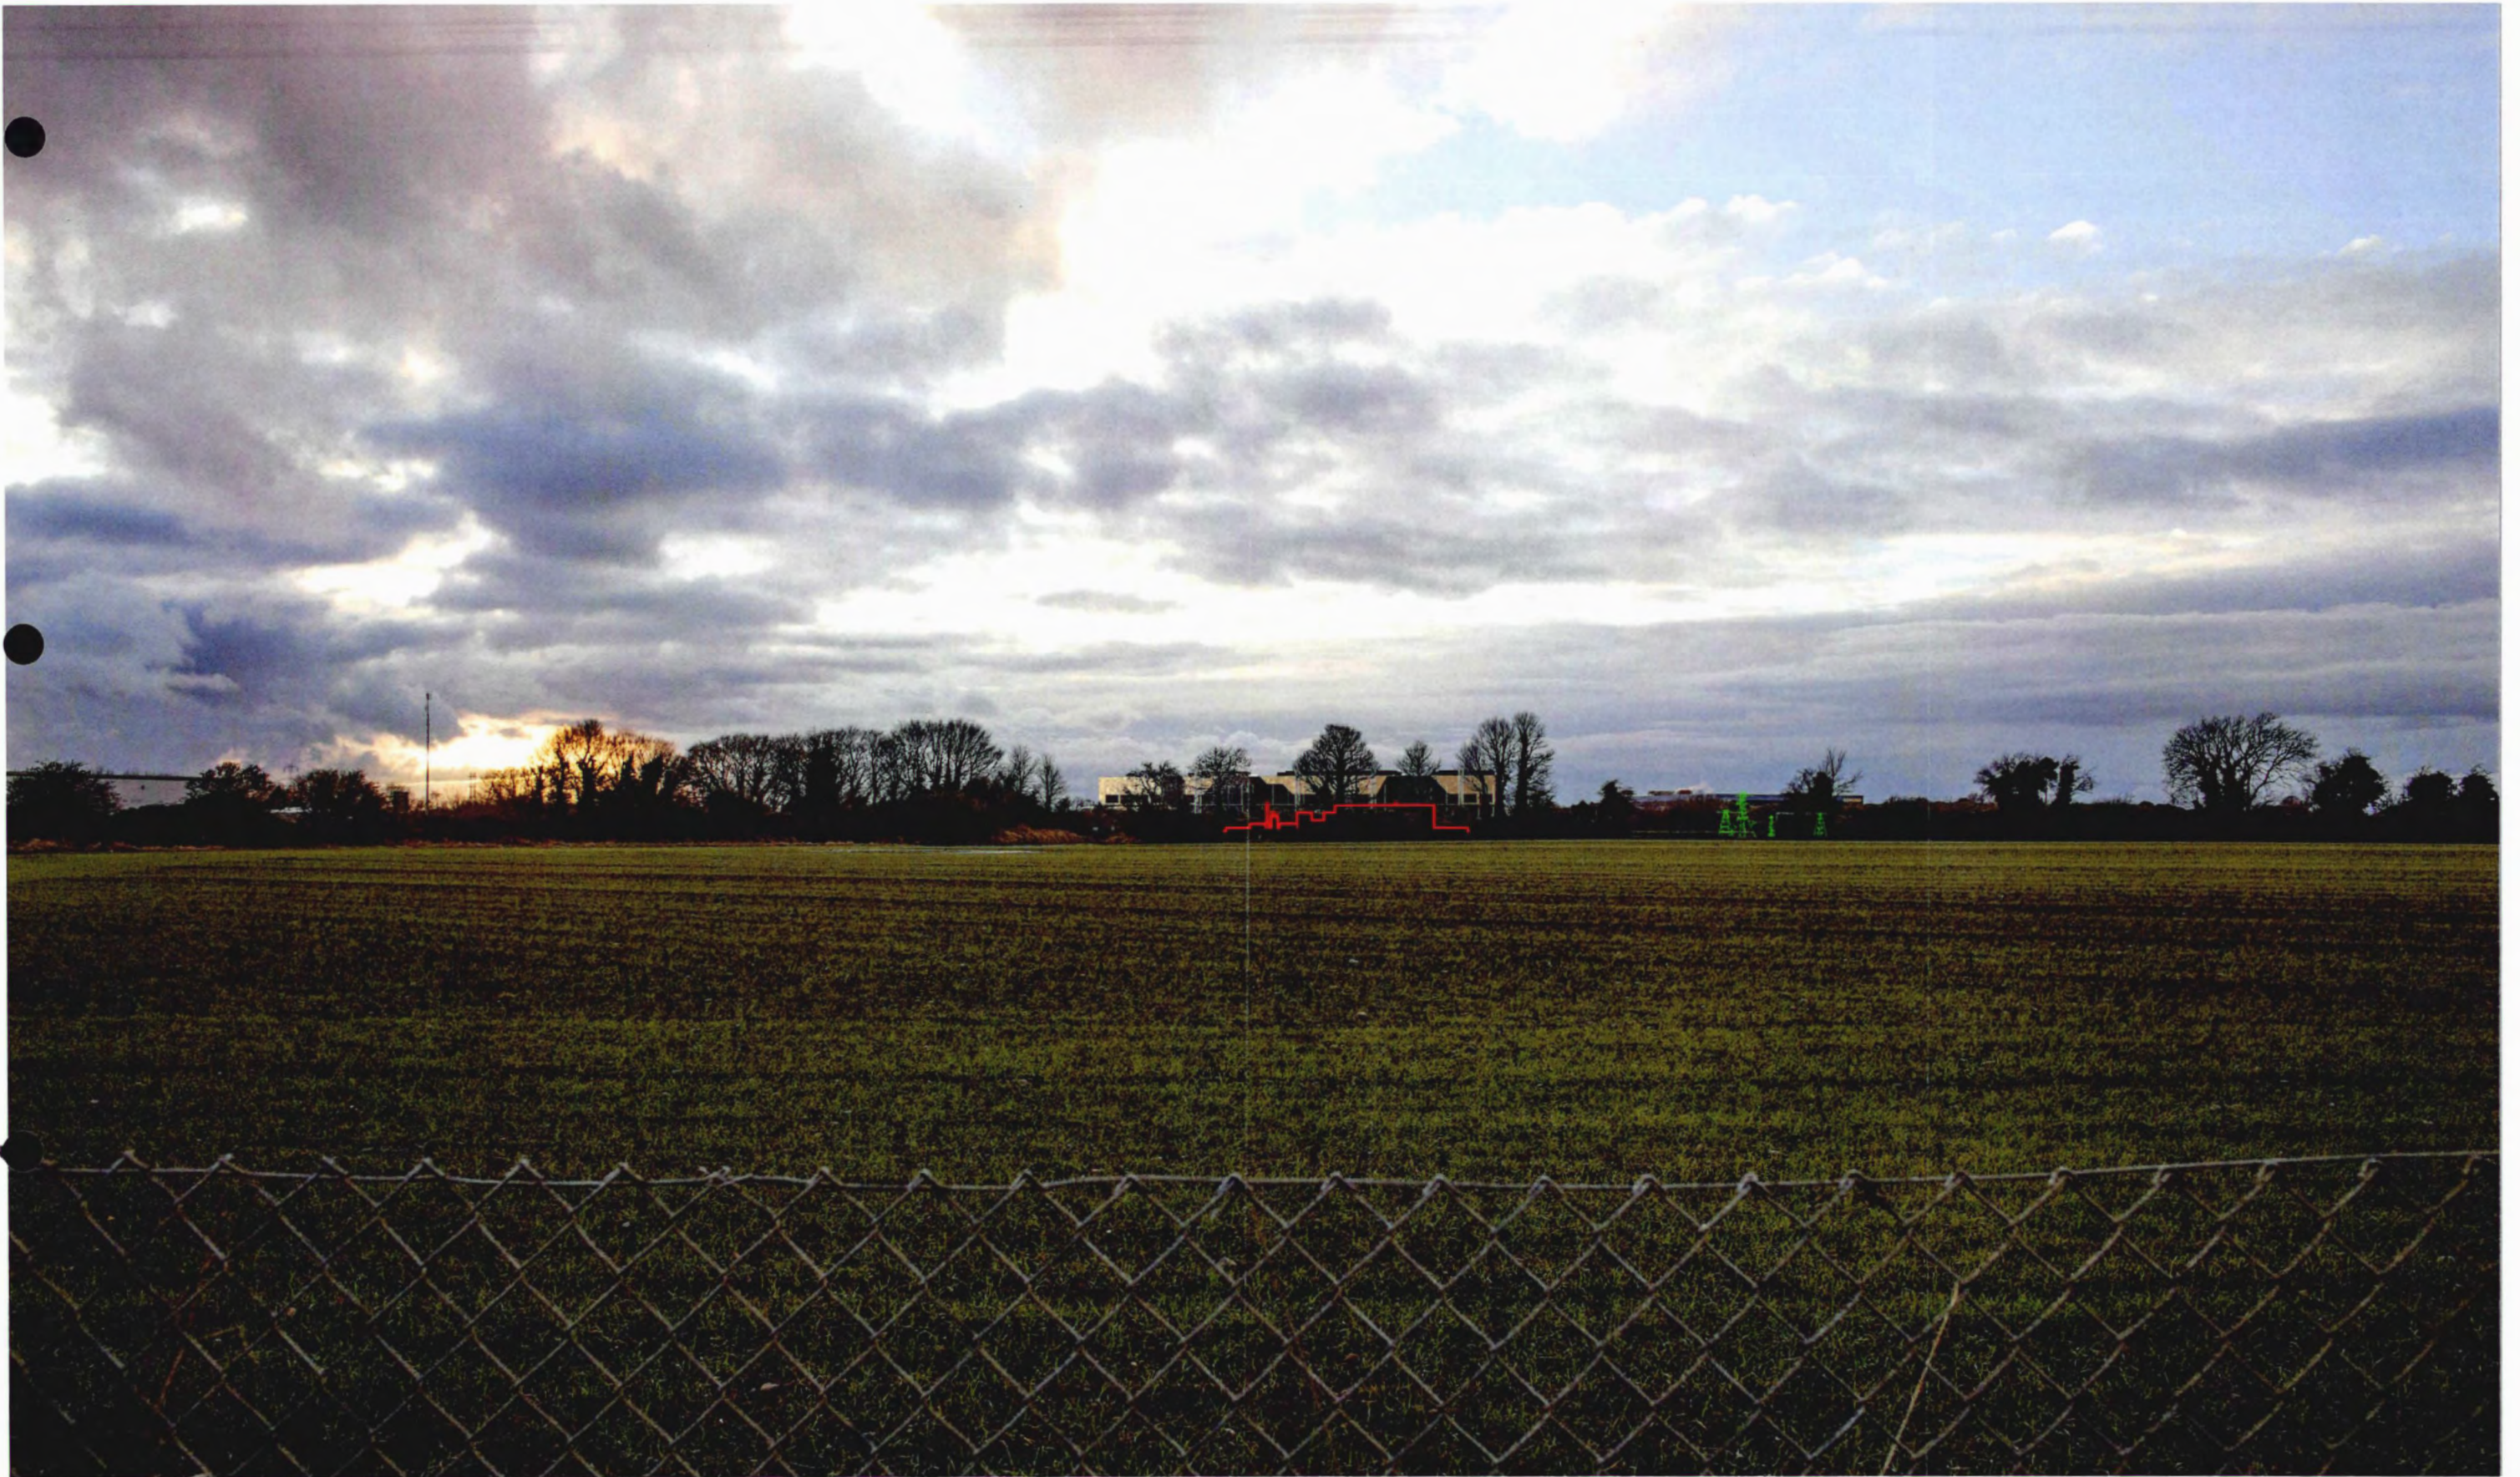
Location	Date	Field of view	35mm equivalent	Distance to site	Camera model
View 2 Proposed	04-02-2021	74°	24mm	711m	Canon EOS 5DS

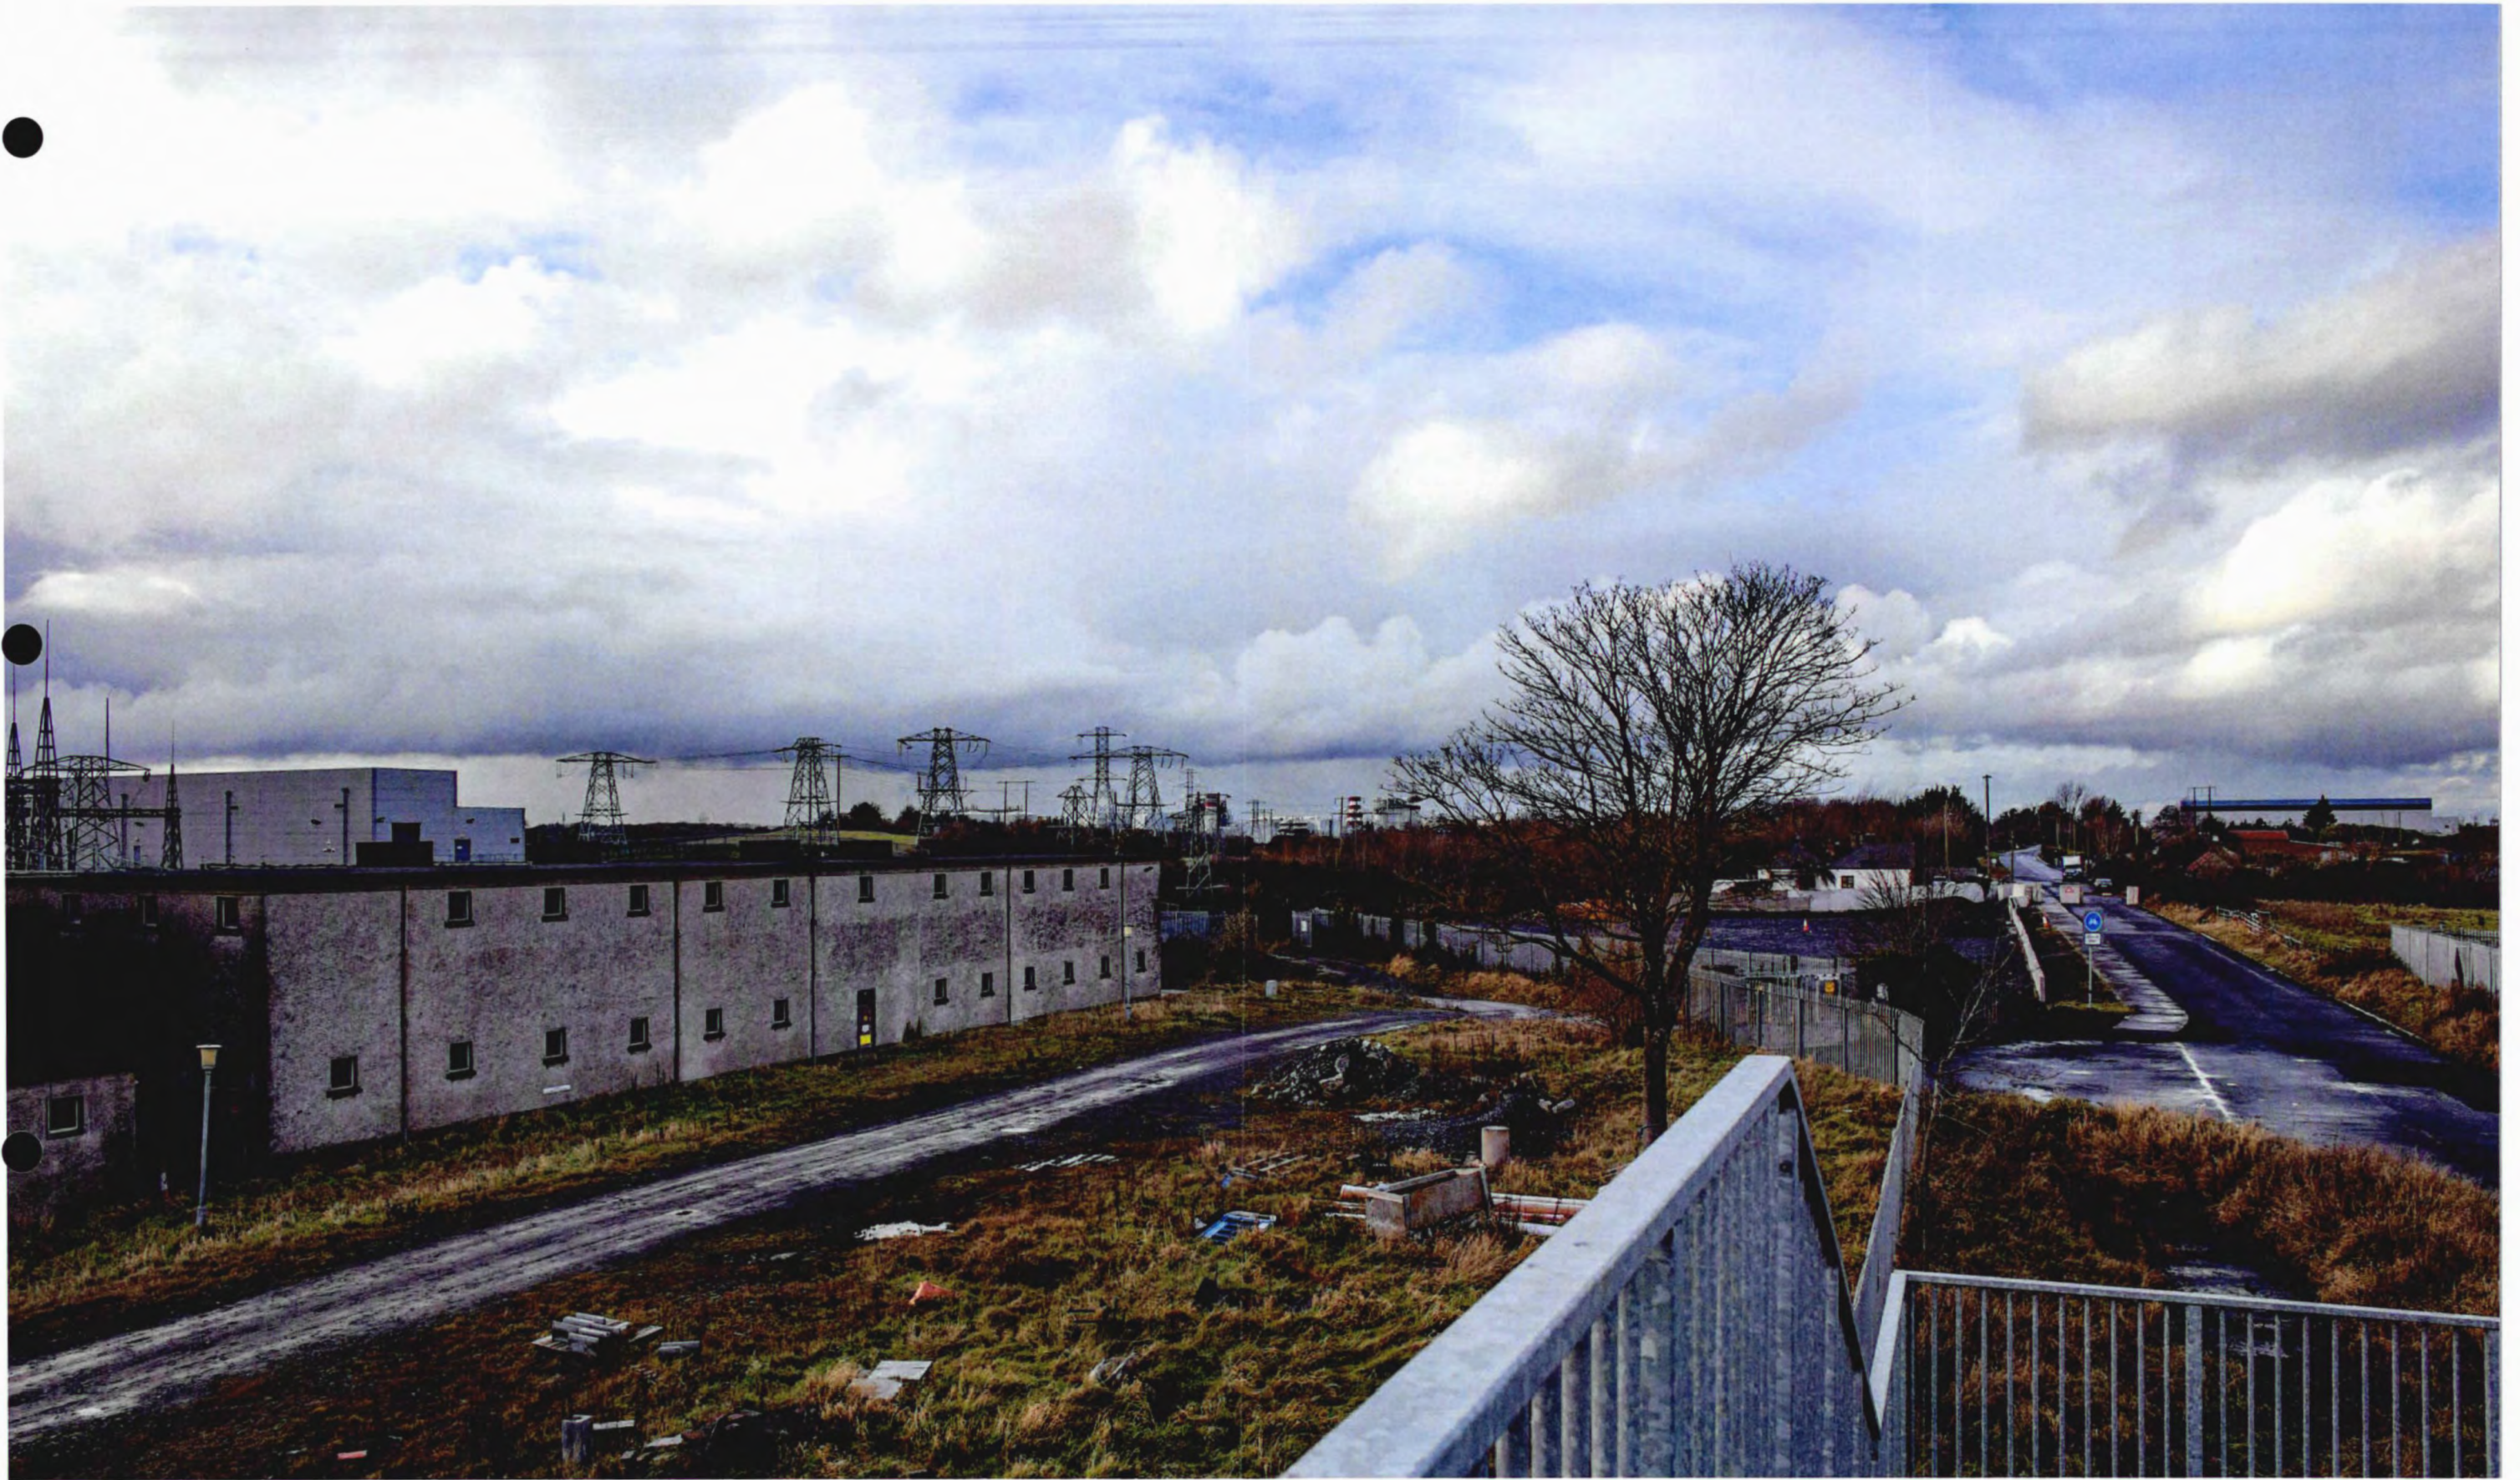
Location	Date	Field of view	35mm equivalent	Distance to site	Camera model
View 3 Existing	04-02-2021	74°	24mm	468m	Canon EOS 5DS

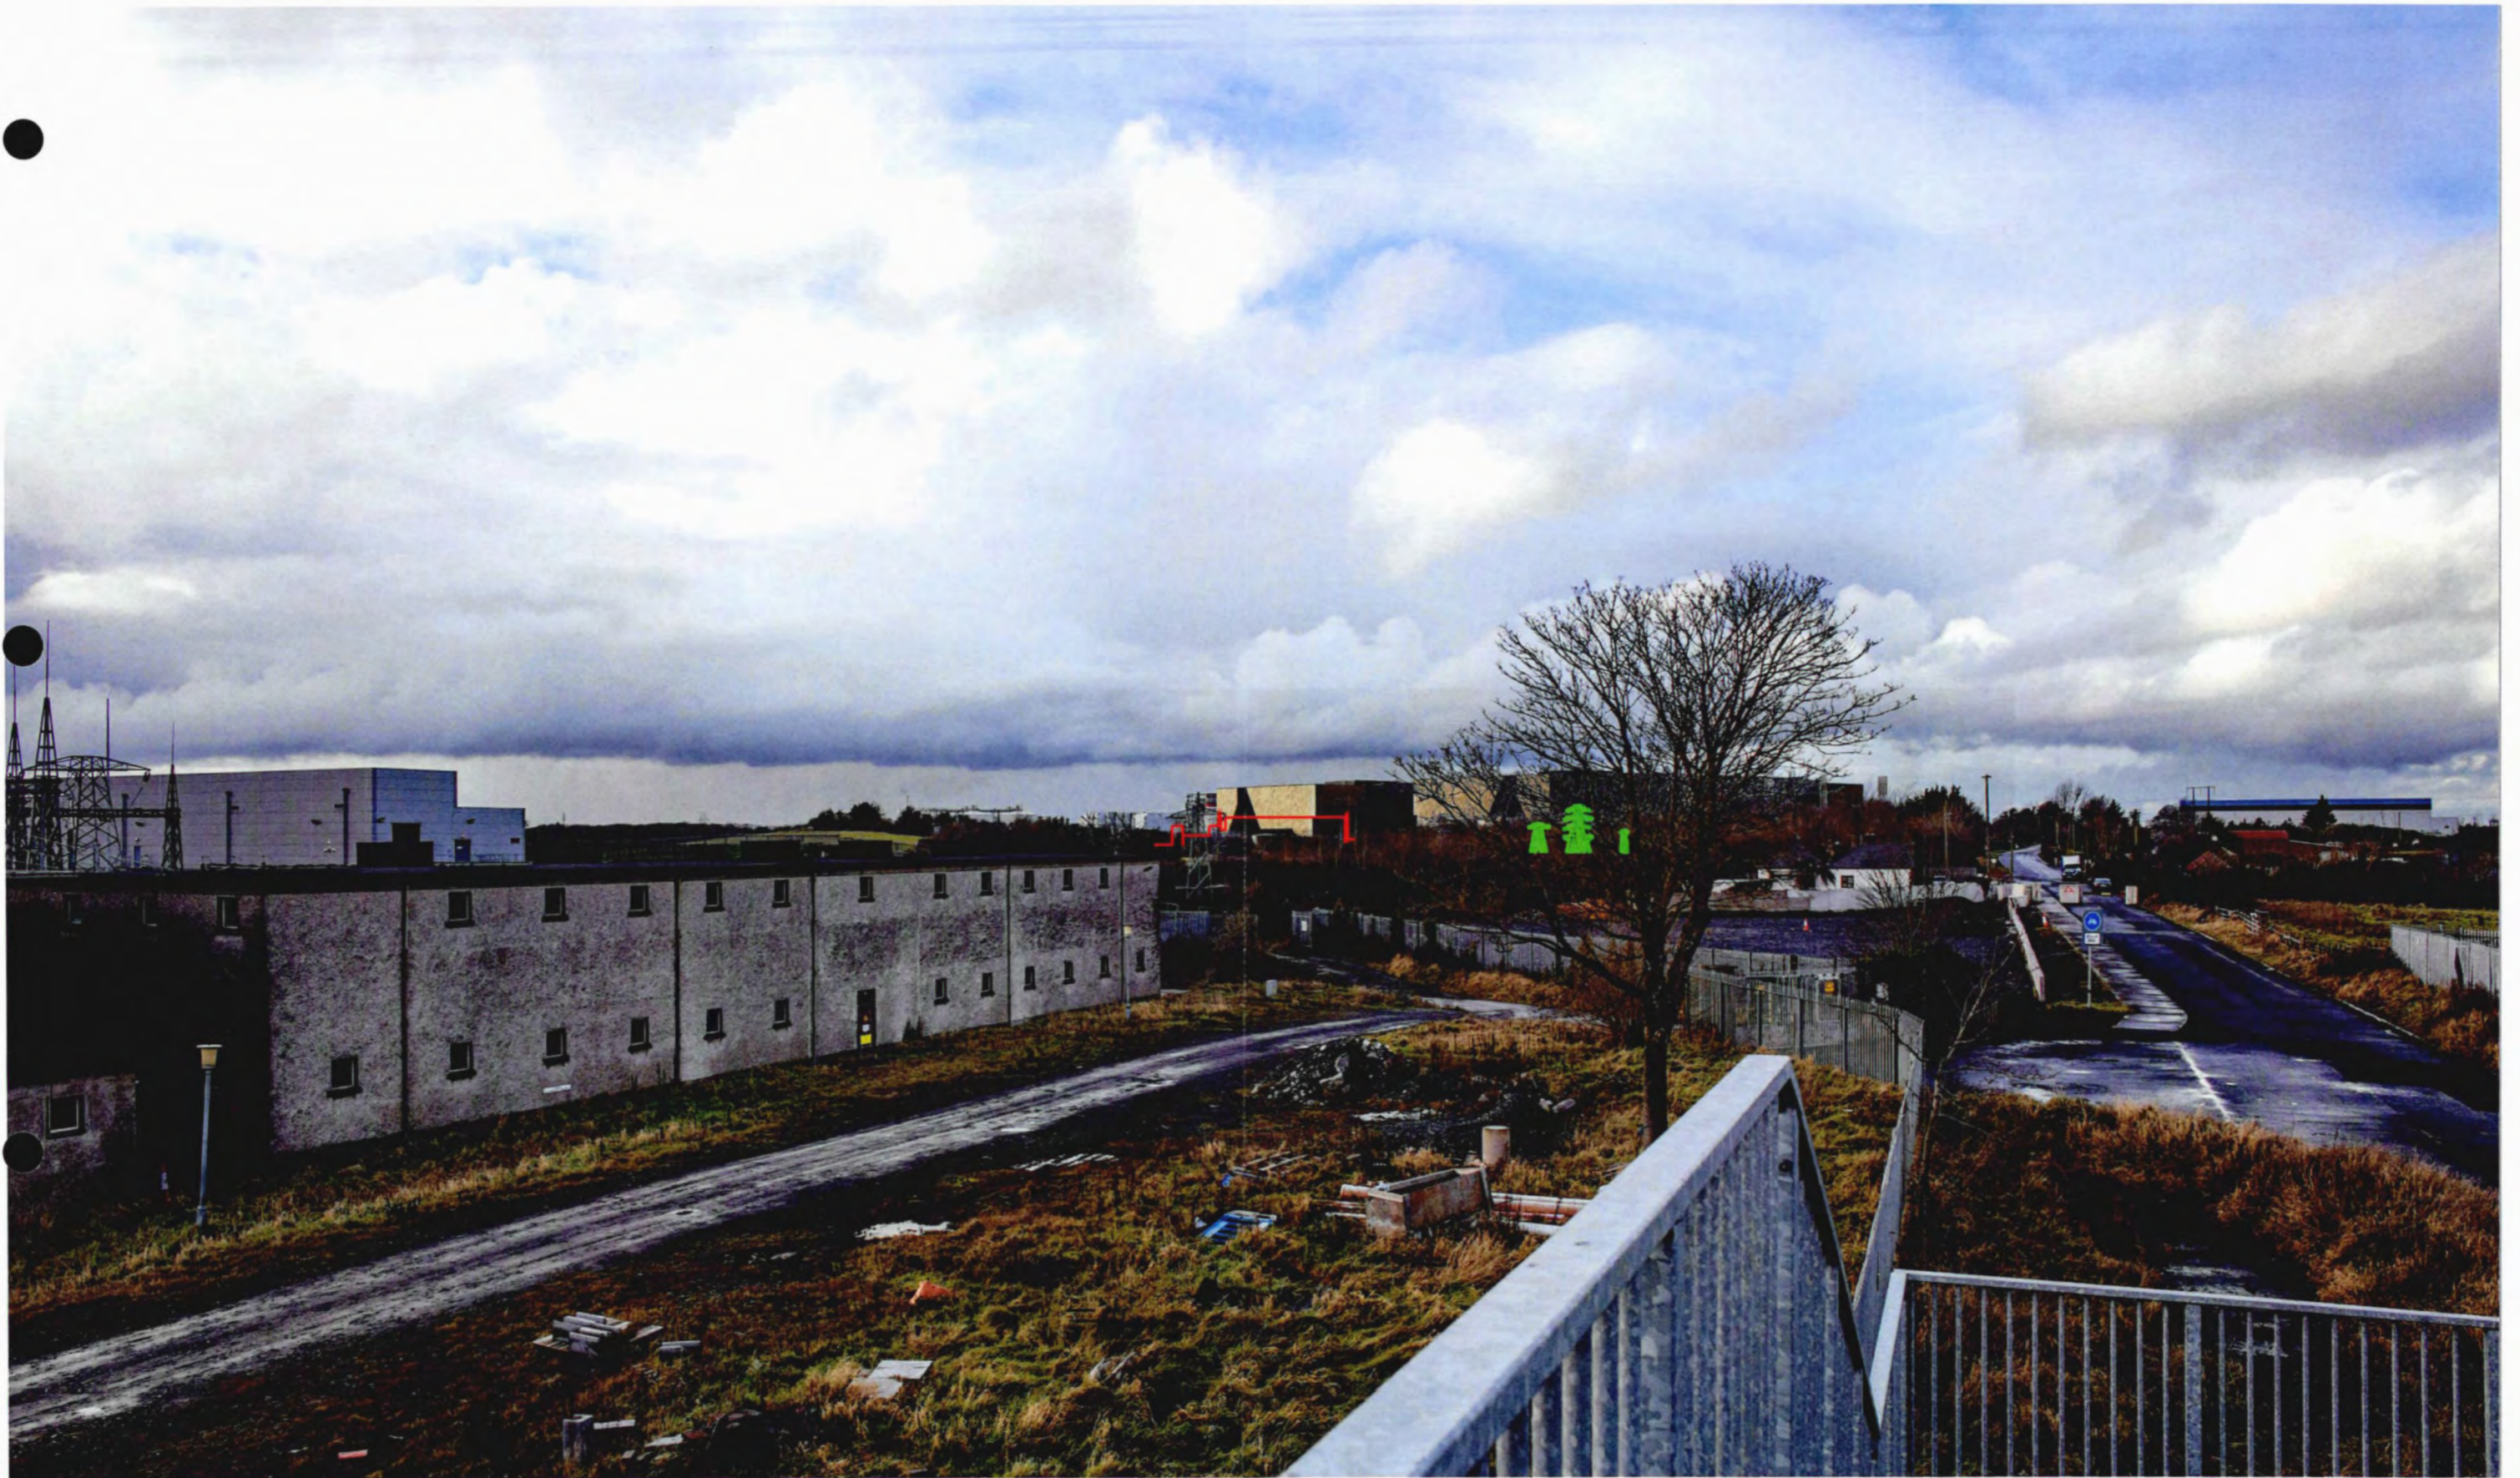
Location	Date	Field of view	35mm equivalent	Distance to site	Camera model
View 3 Proposed	04-02-2021	74°	24mm	468m	Canon EOS 5DS

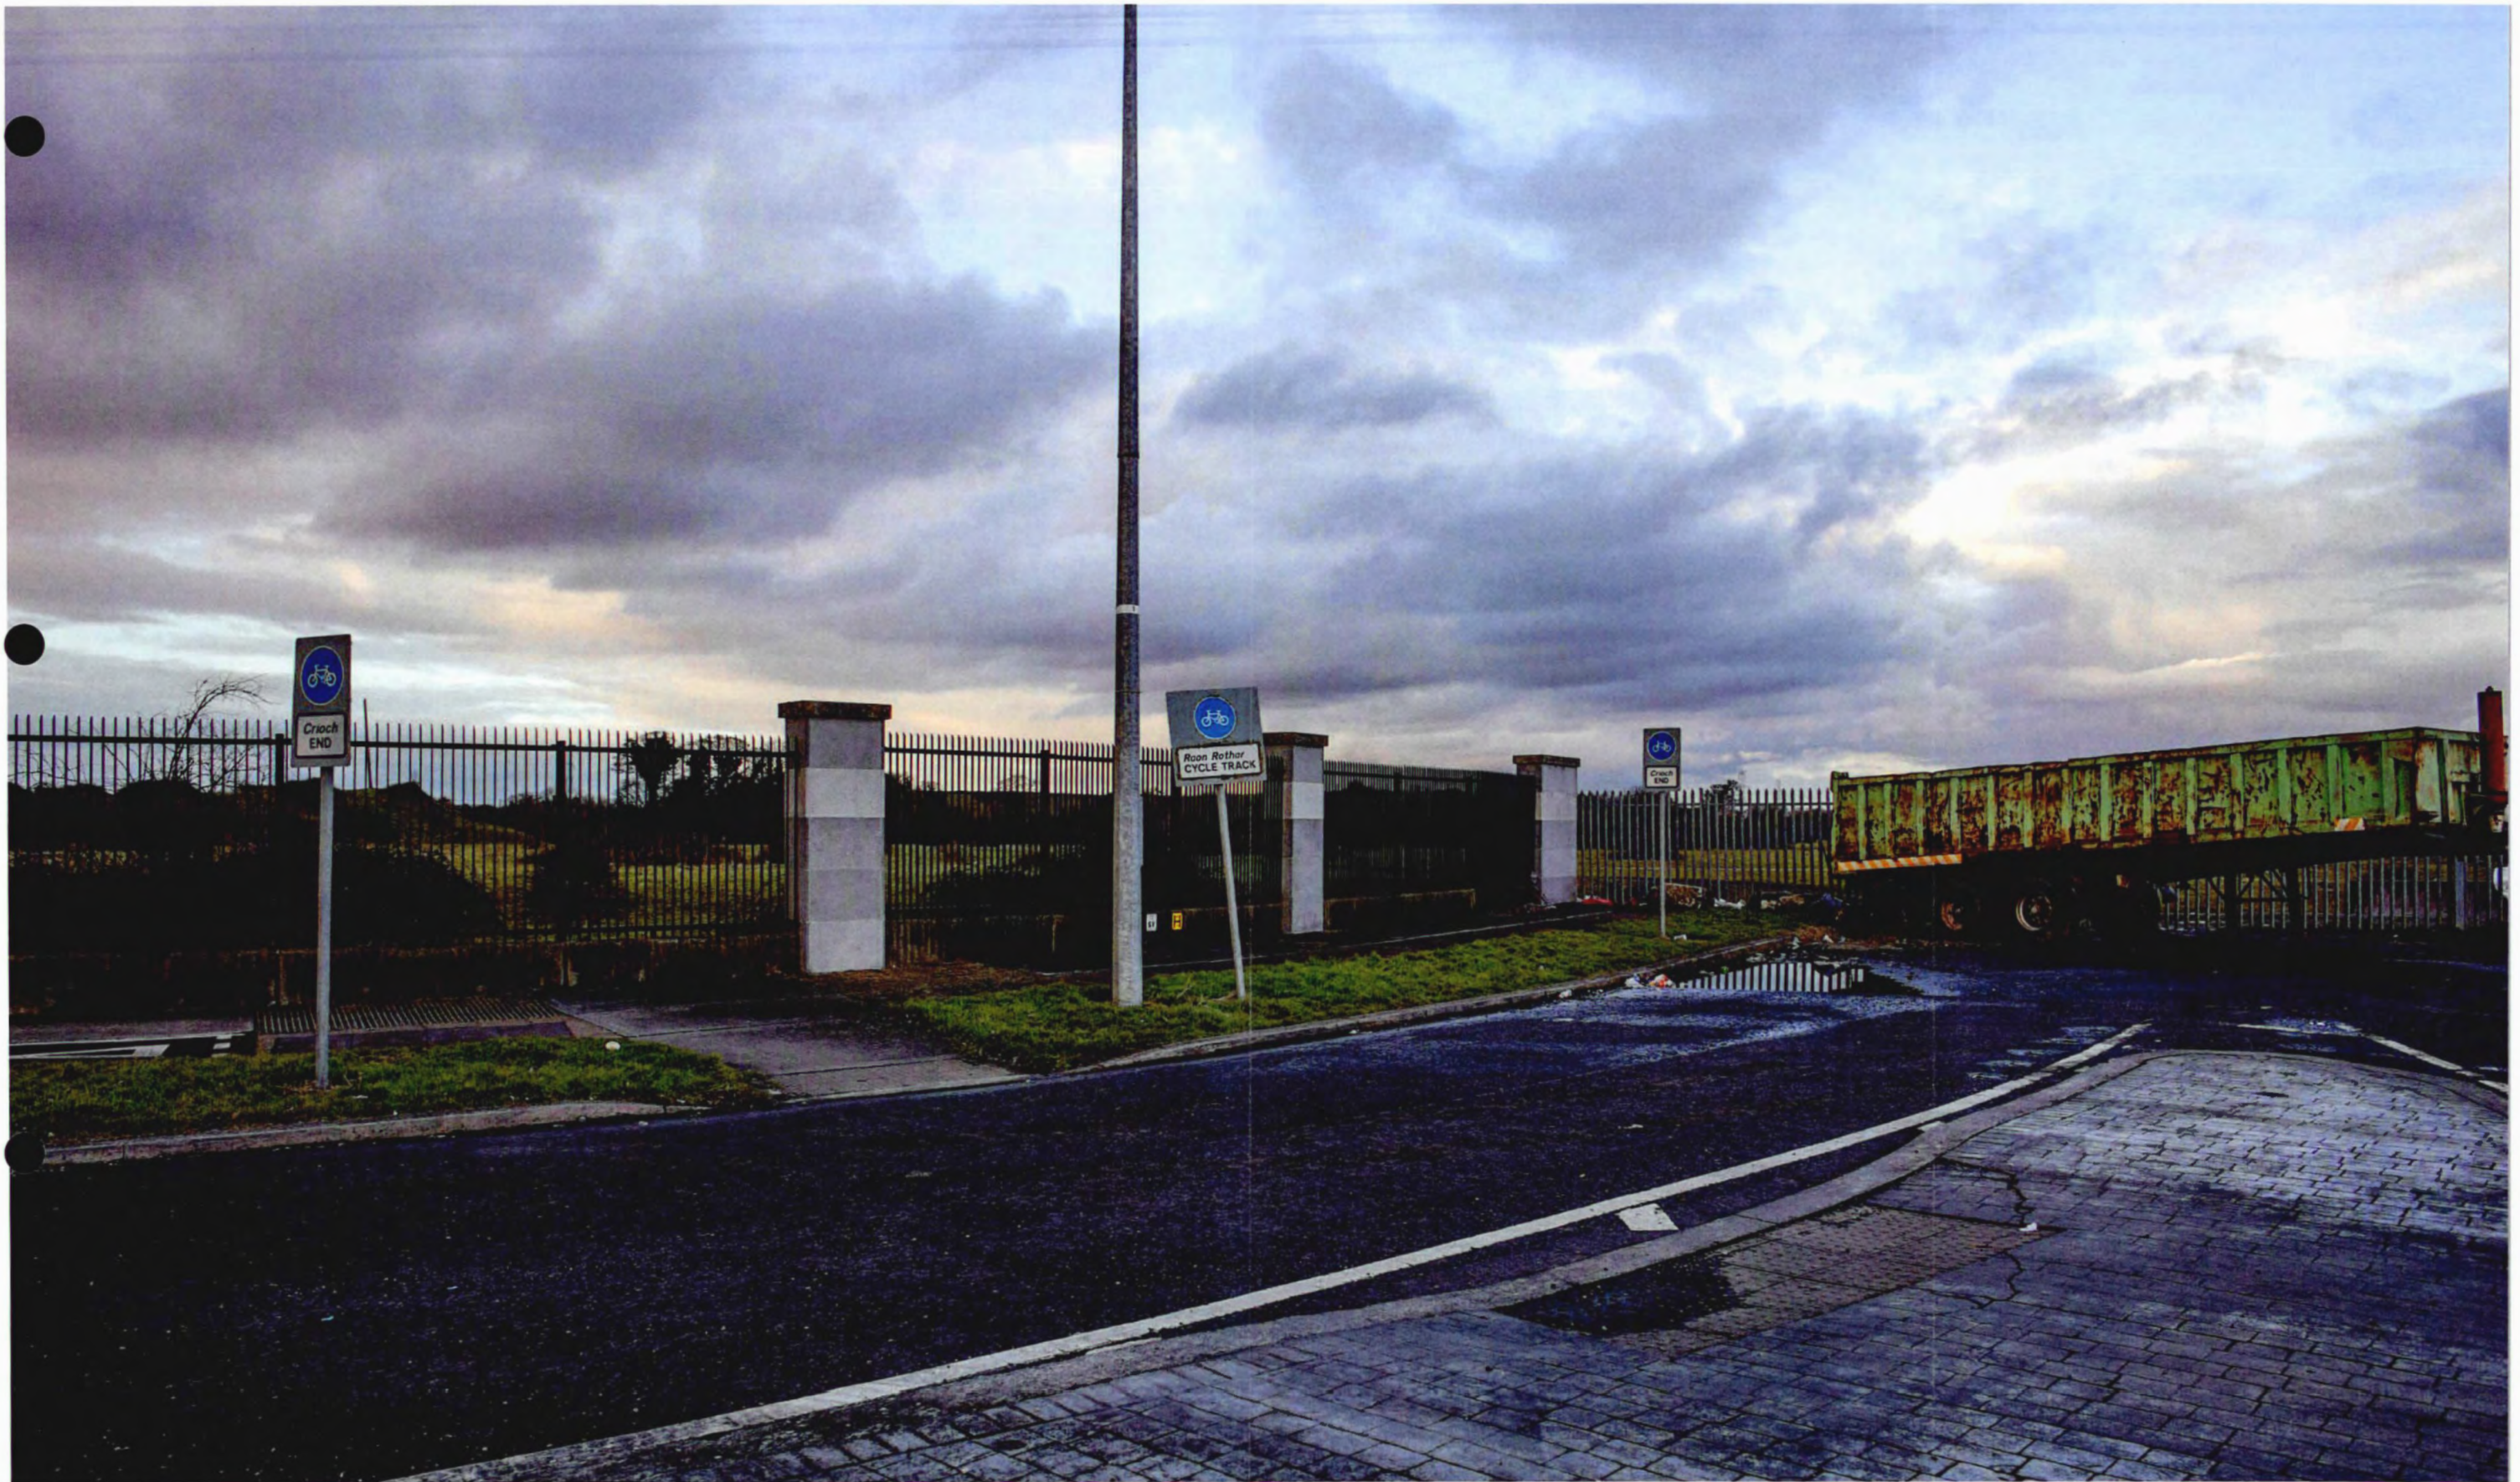
Location	Date	Field of view	35mm equivalent	Distance to site	Camera model
View 4 Existing	04-02-2021	74°	24mm	1414m	Canon EOS 5DS

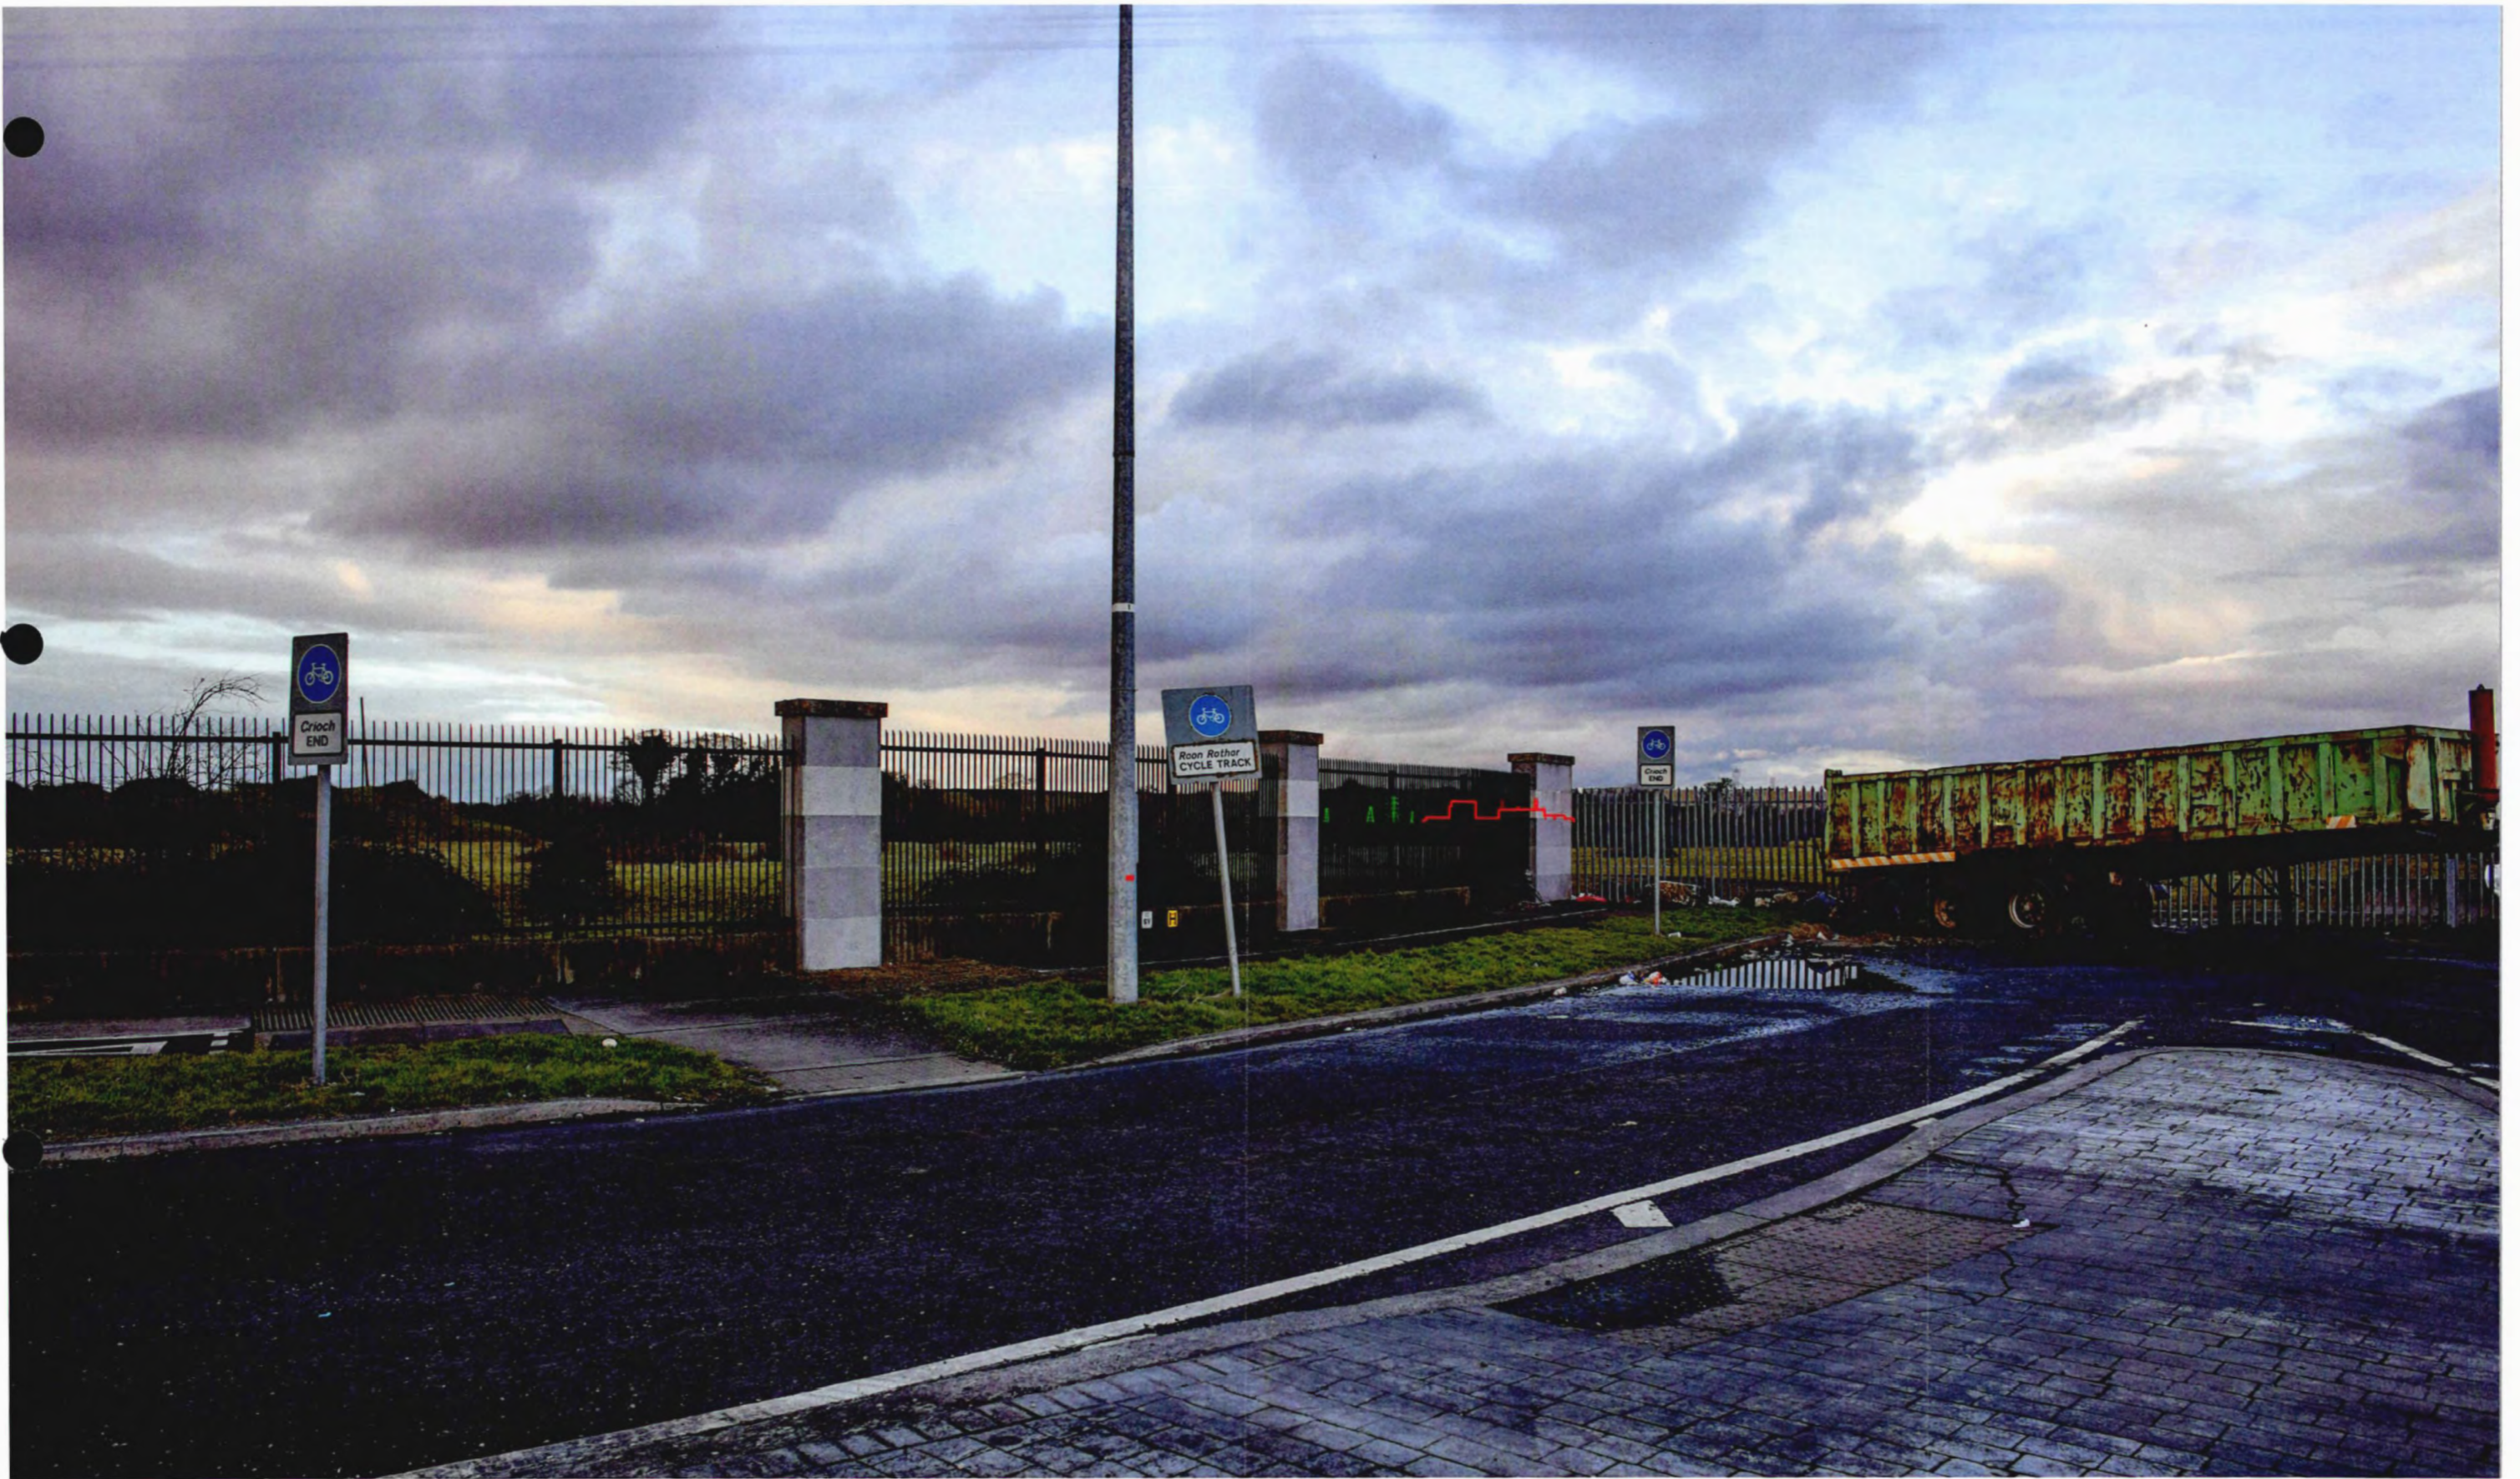
Location	Date	Field of view	35mm equivalent	Distance to site	Camera model
View 4 Proposed	04-02-2021	74°	24mm	1414m	Canon EOS 5DS

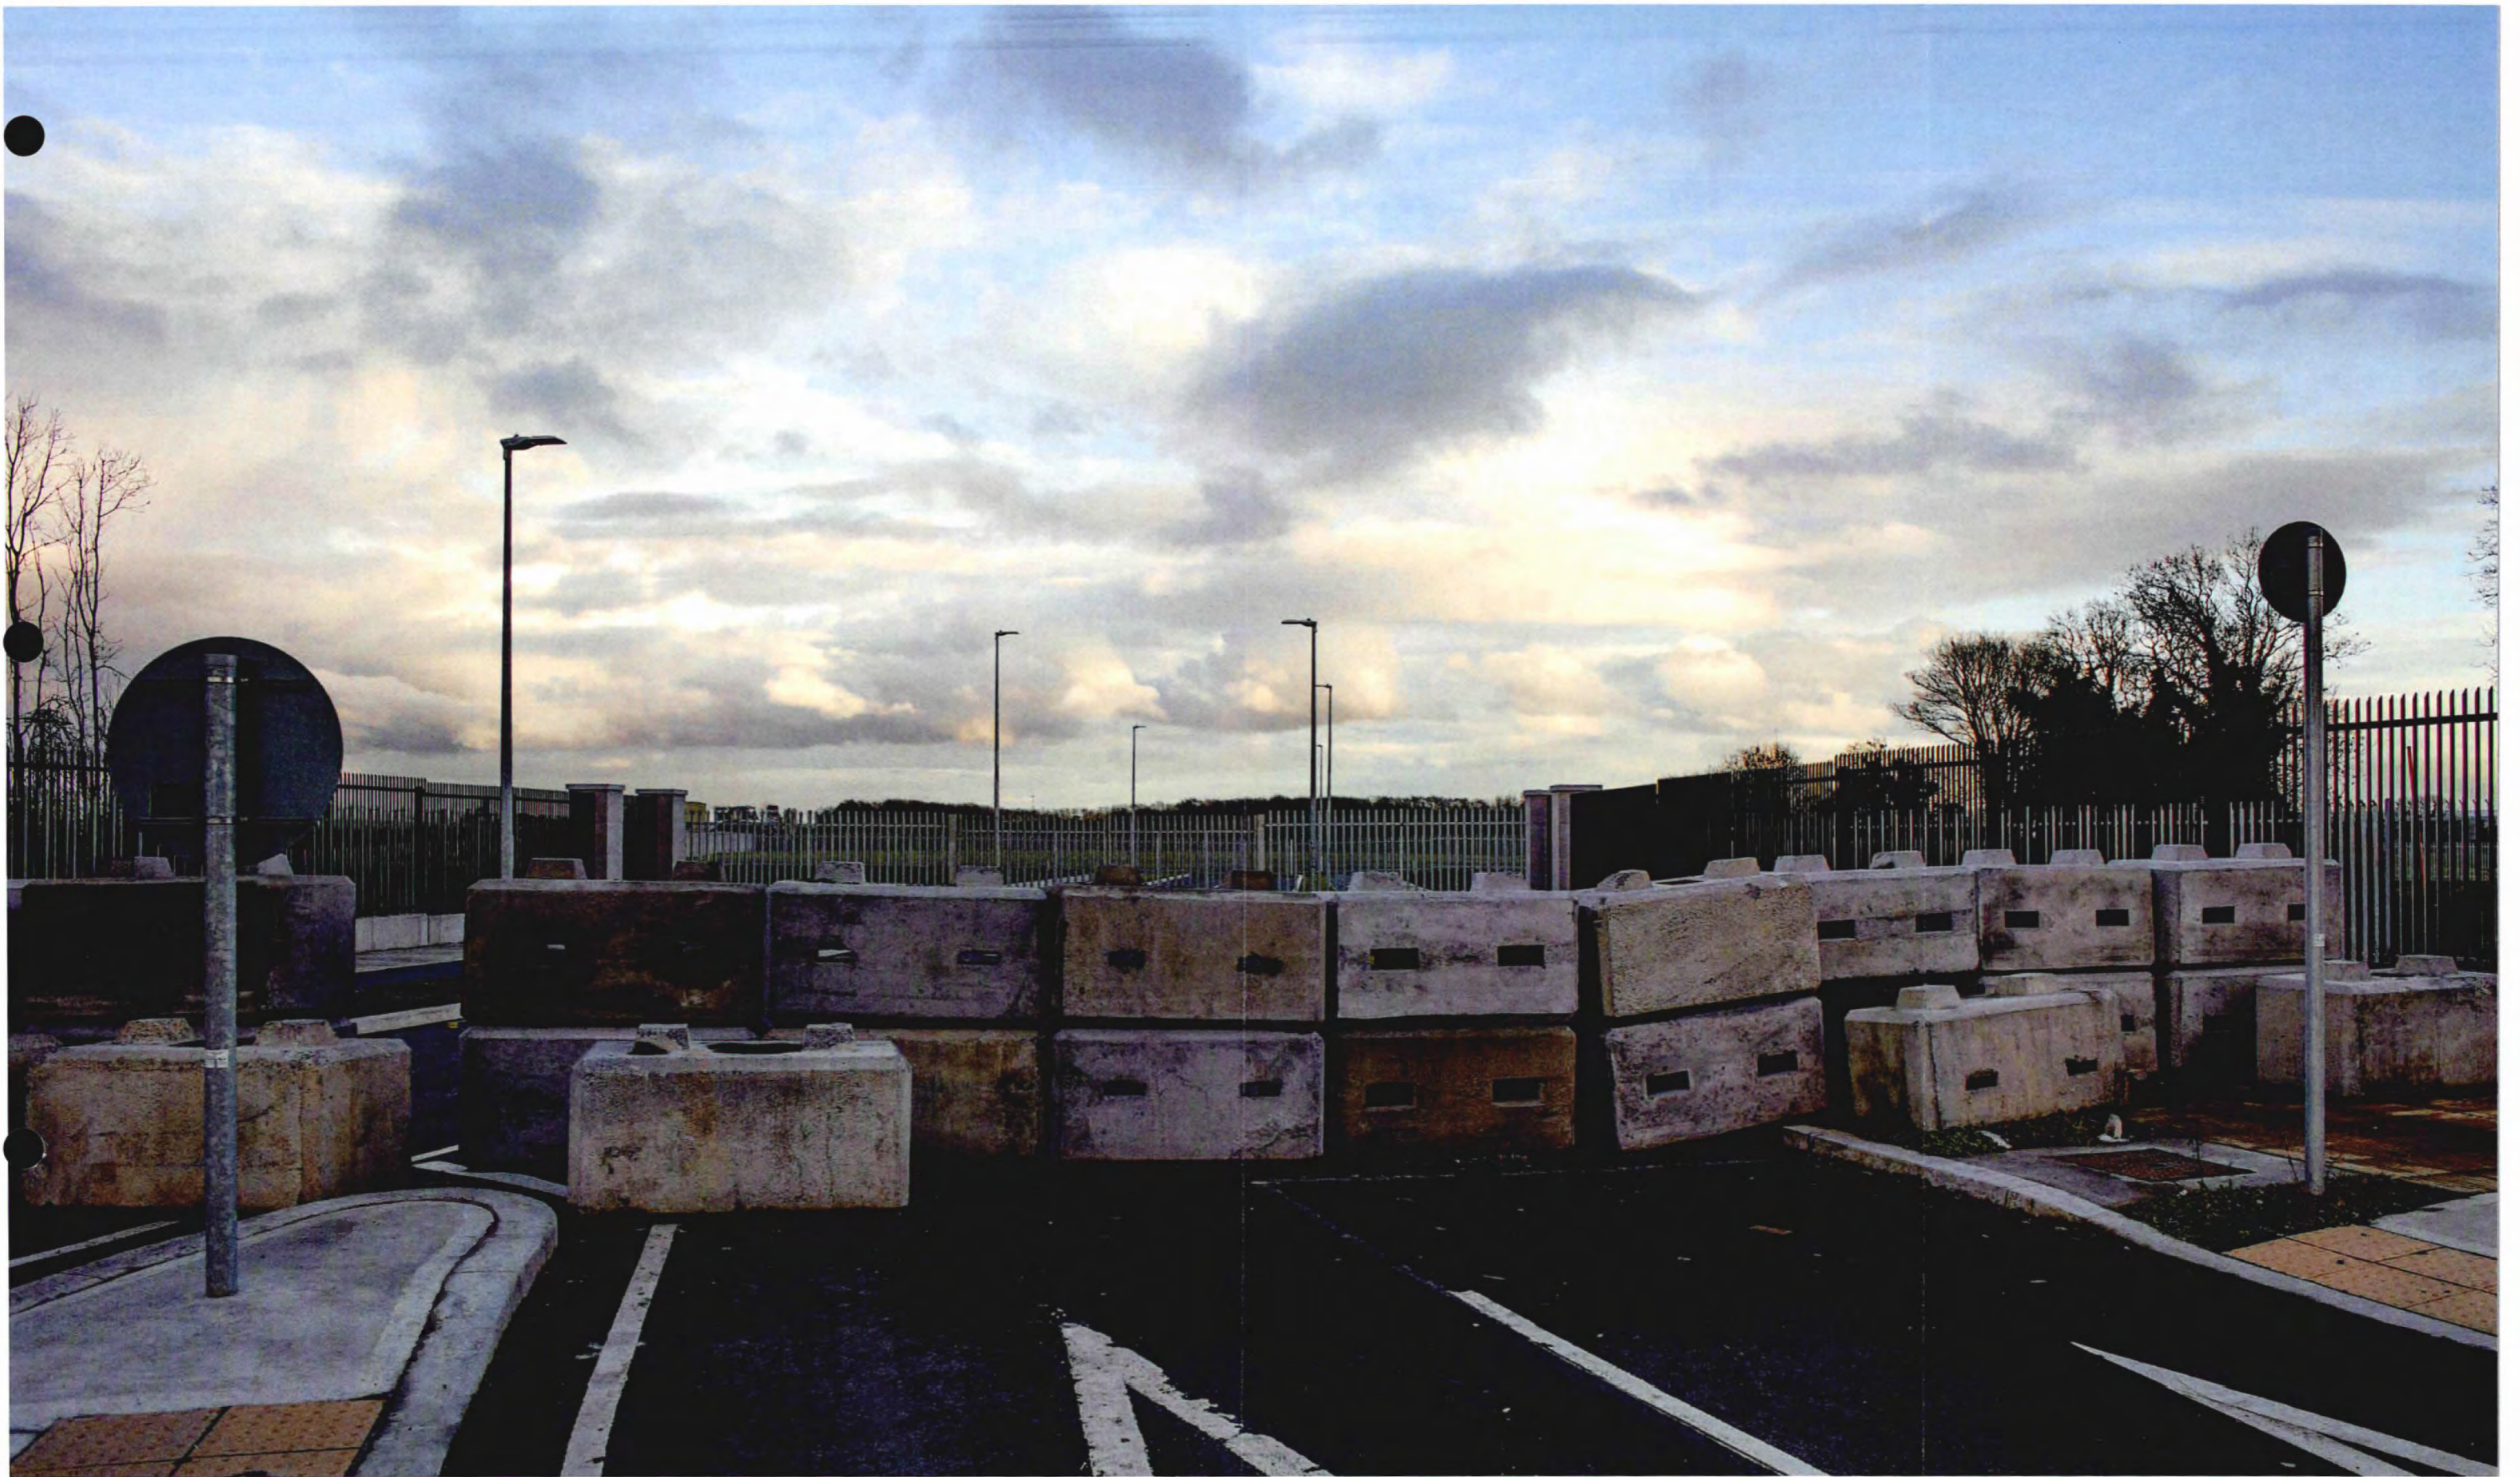
Location	Date	Field of view	35mm equivalent	Distance to site	Camera model
View 5 Existing	04-02-2021	74°	24mm	1361m	Canon EOS 5DS
