# Environmental Impact Assessment Report (Addendum)

## Development of Two Data Halls and Ancillary Structures

## Volume 4 – EIA Appendix II

**COMAH LAND USE  
PLANNING ASSESSMENT  
FOR PROPOSED  
SUBSTATION AND  
UNDERGROUND CABLE  
ROUTES, CO. DUBLIN**

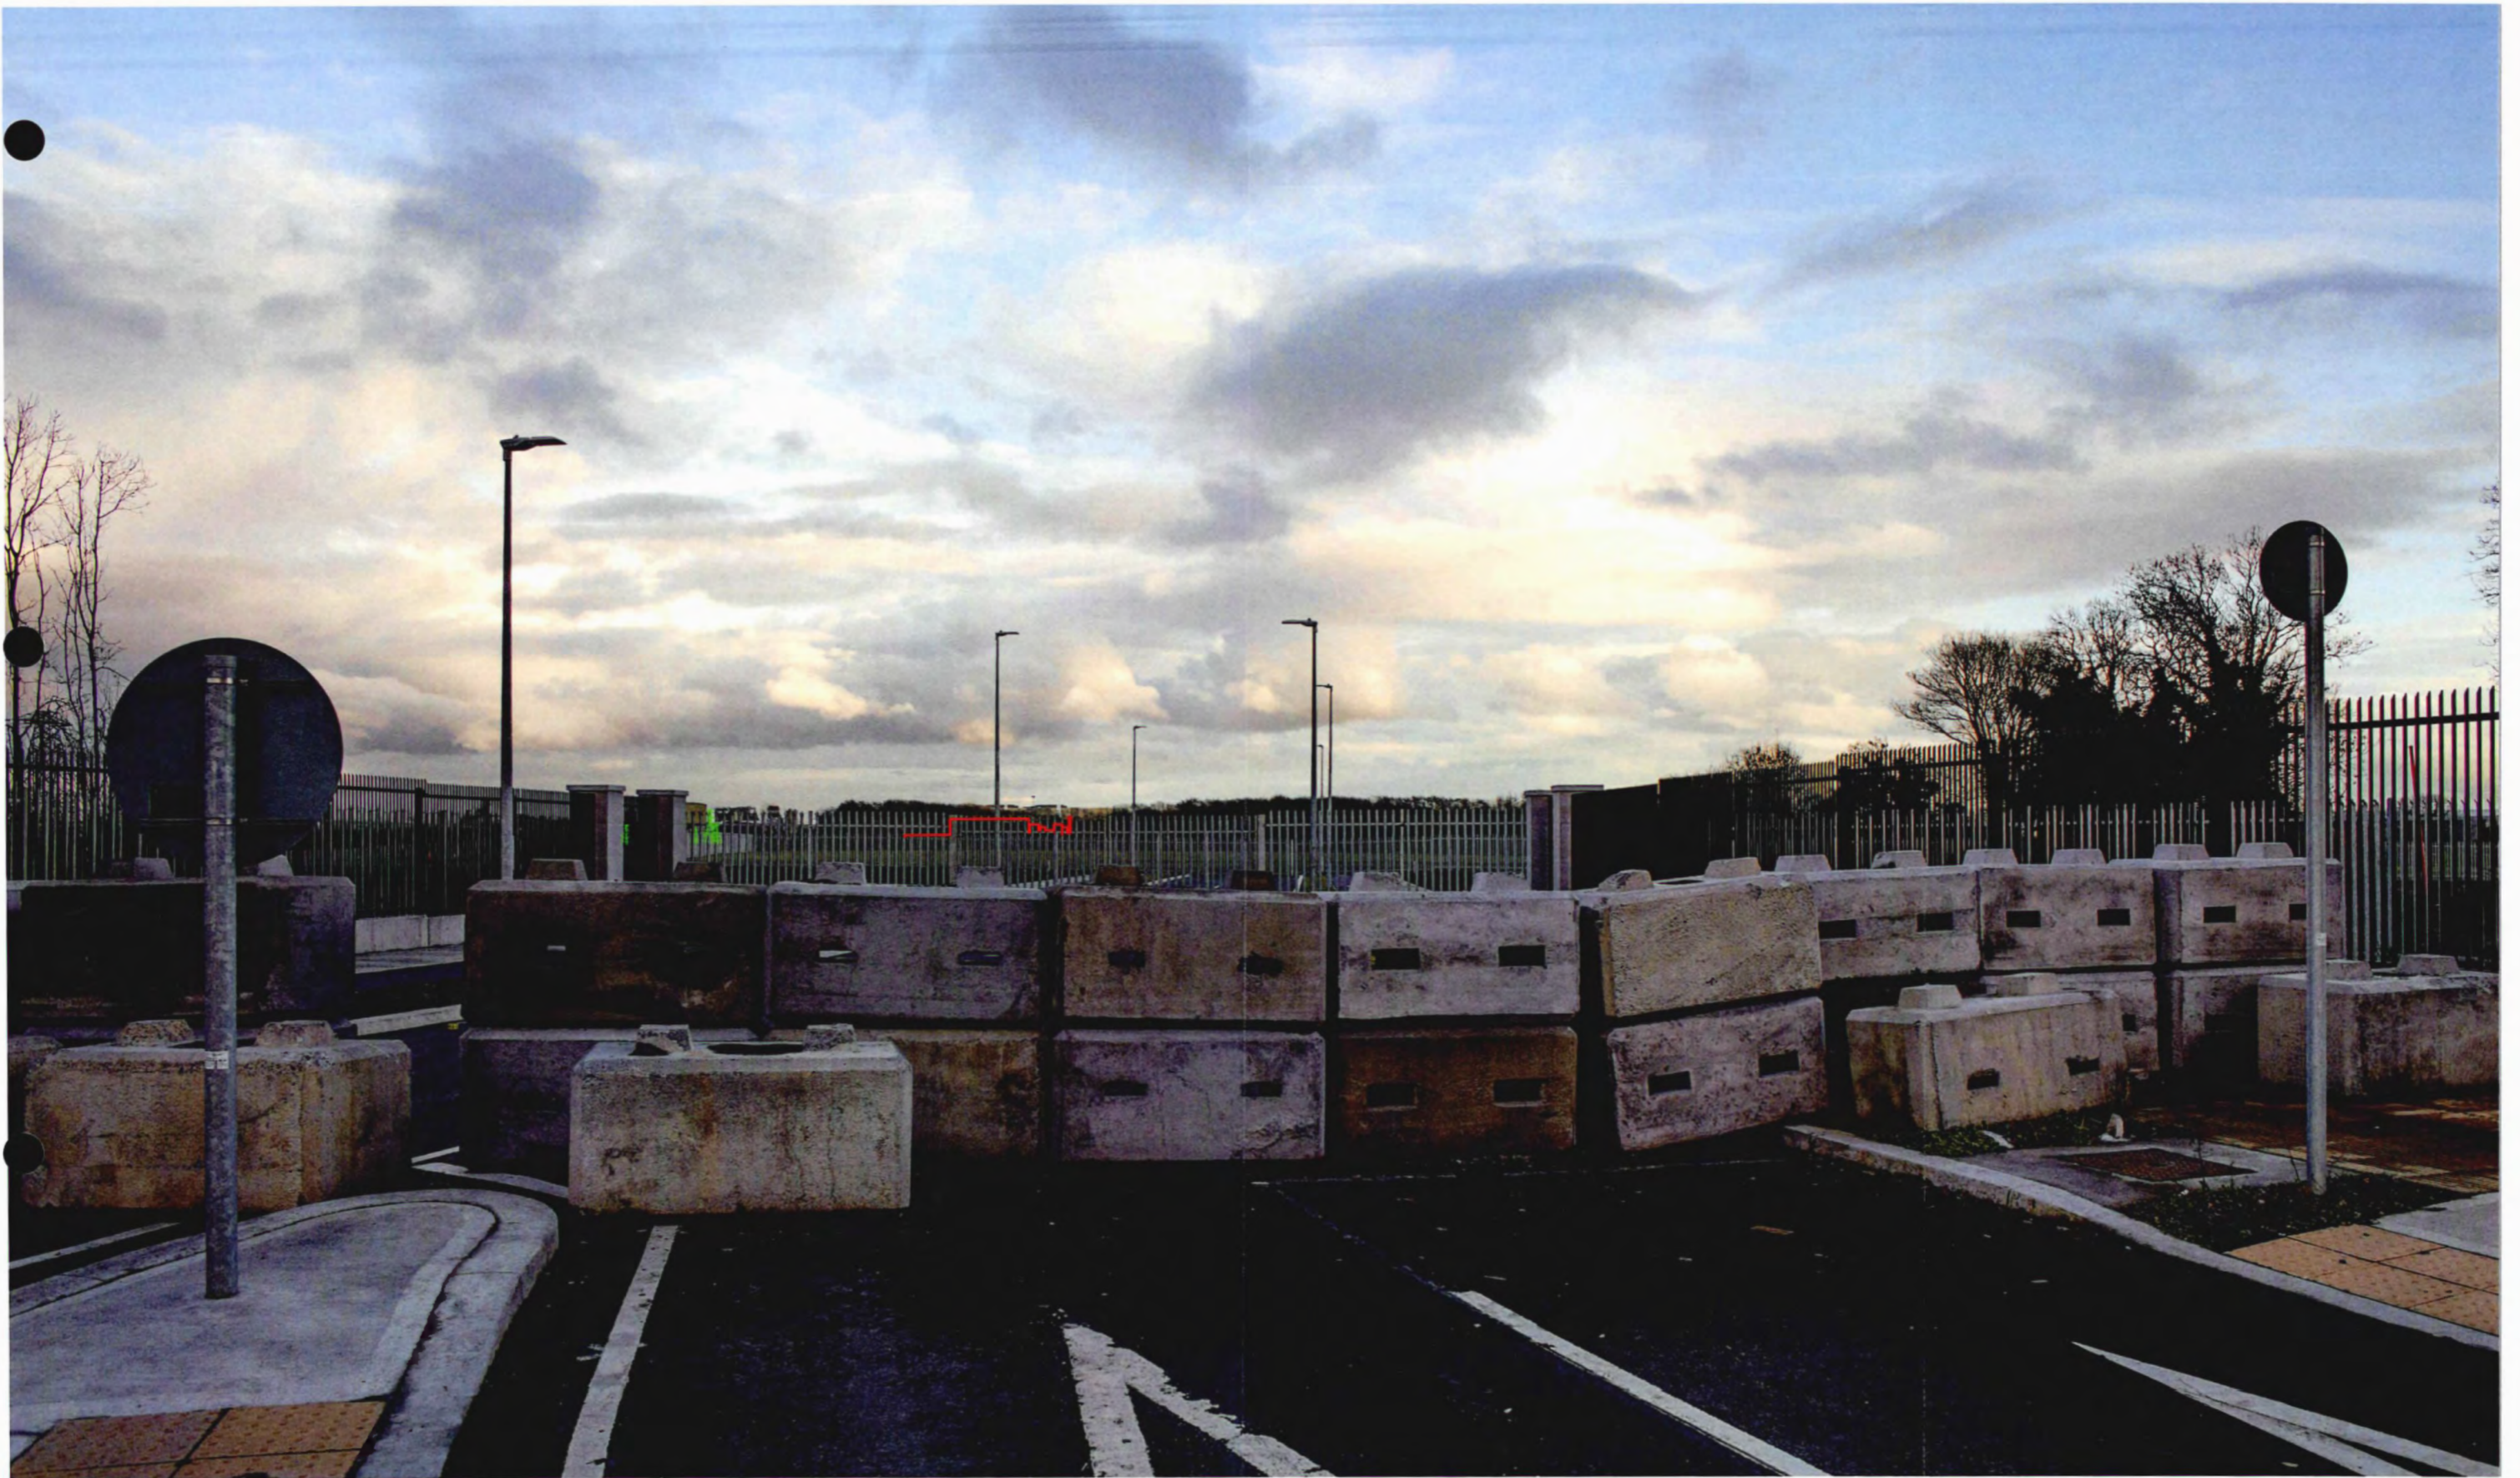
Location	Date	Field of view	35mm equivalent	Distance to site	Camera model
View 5 Proposed	04-02-2021	74°	24mm	1361m	Canon EOS 5DS

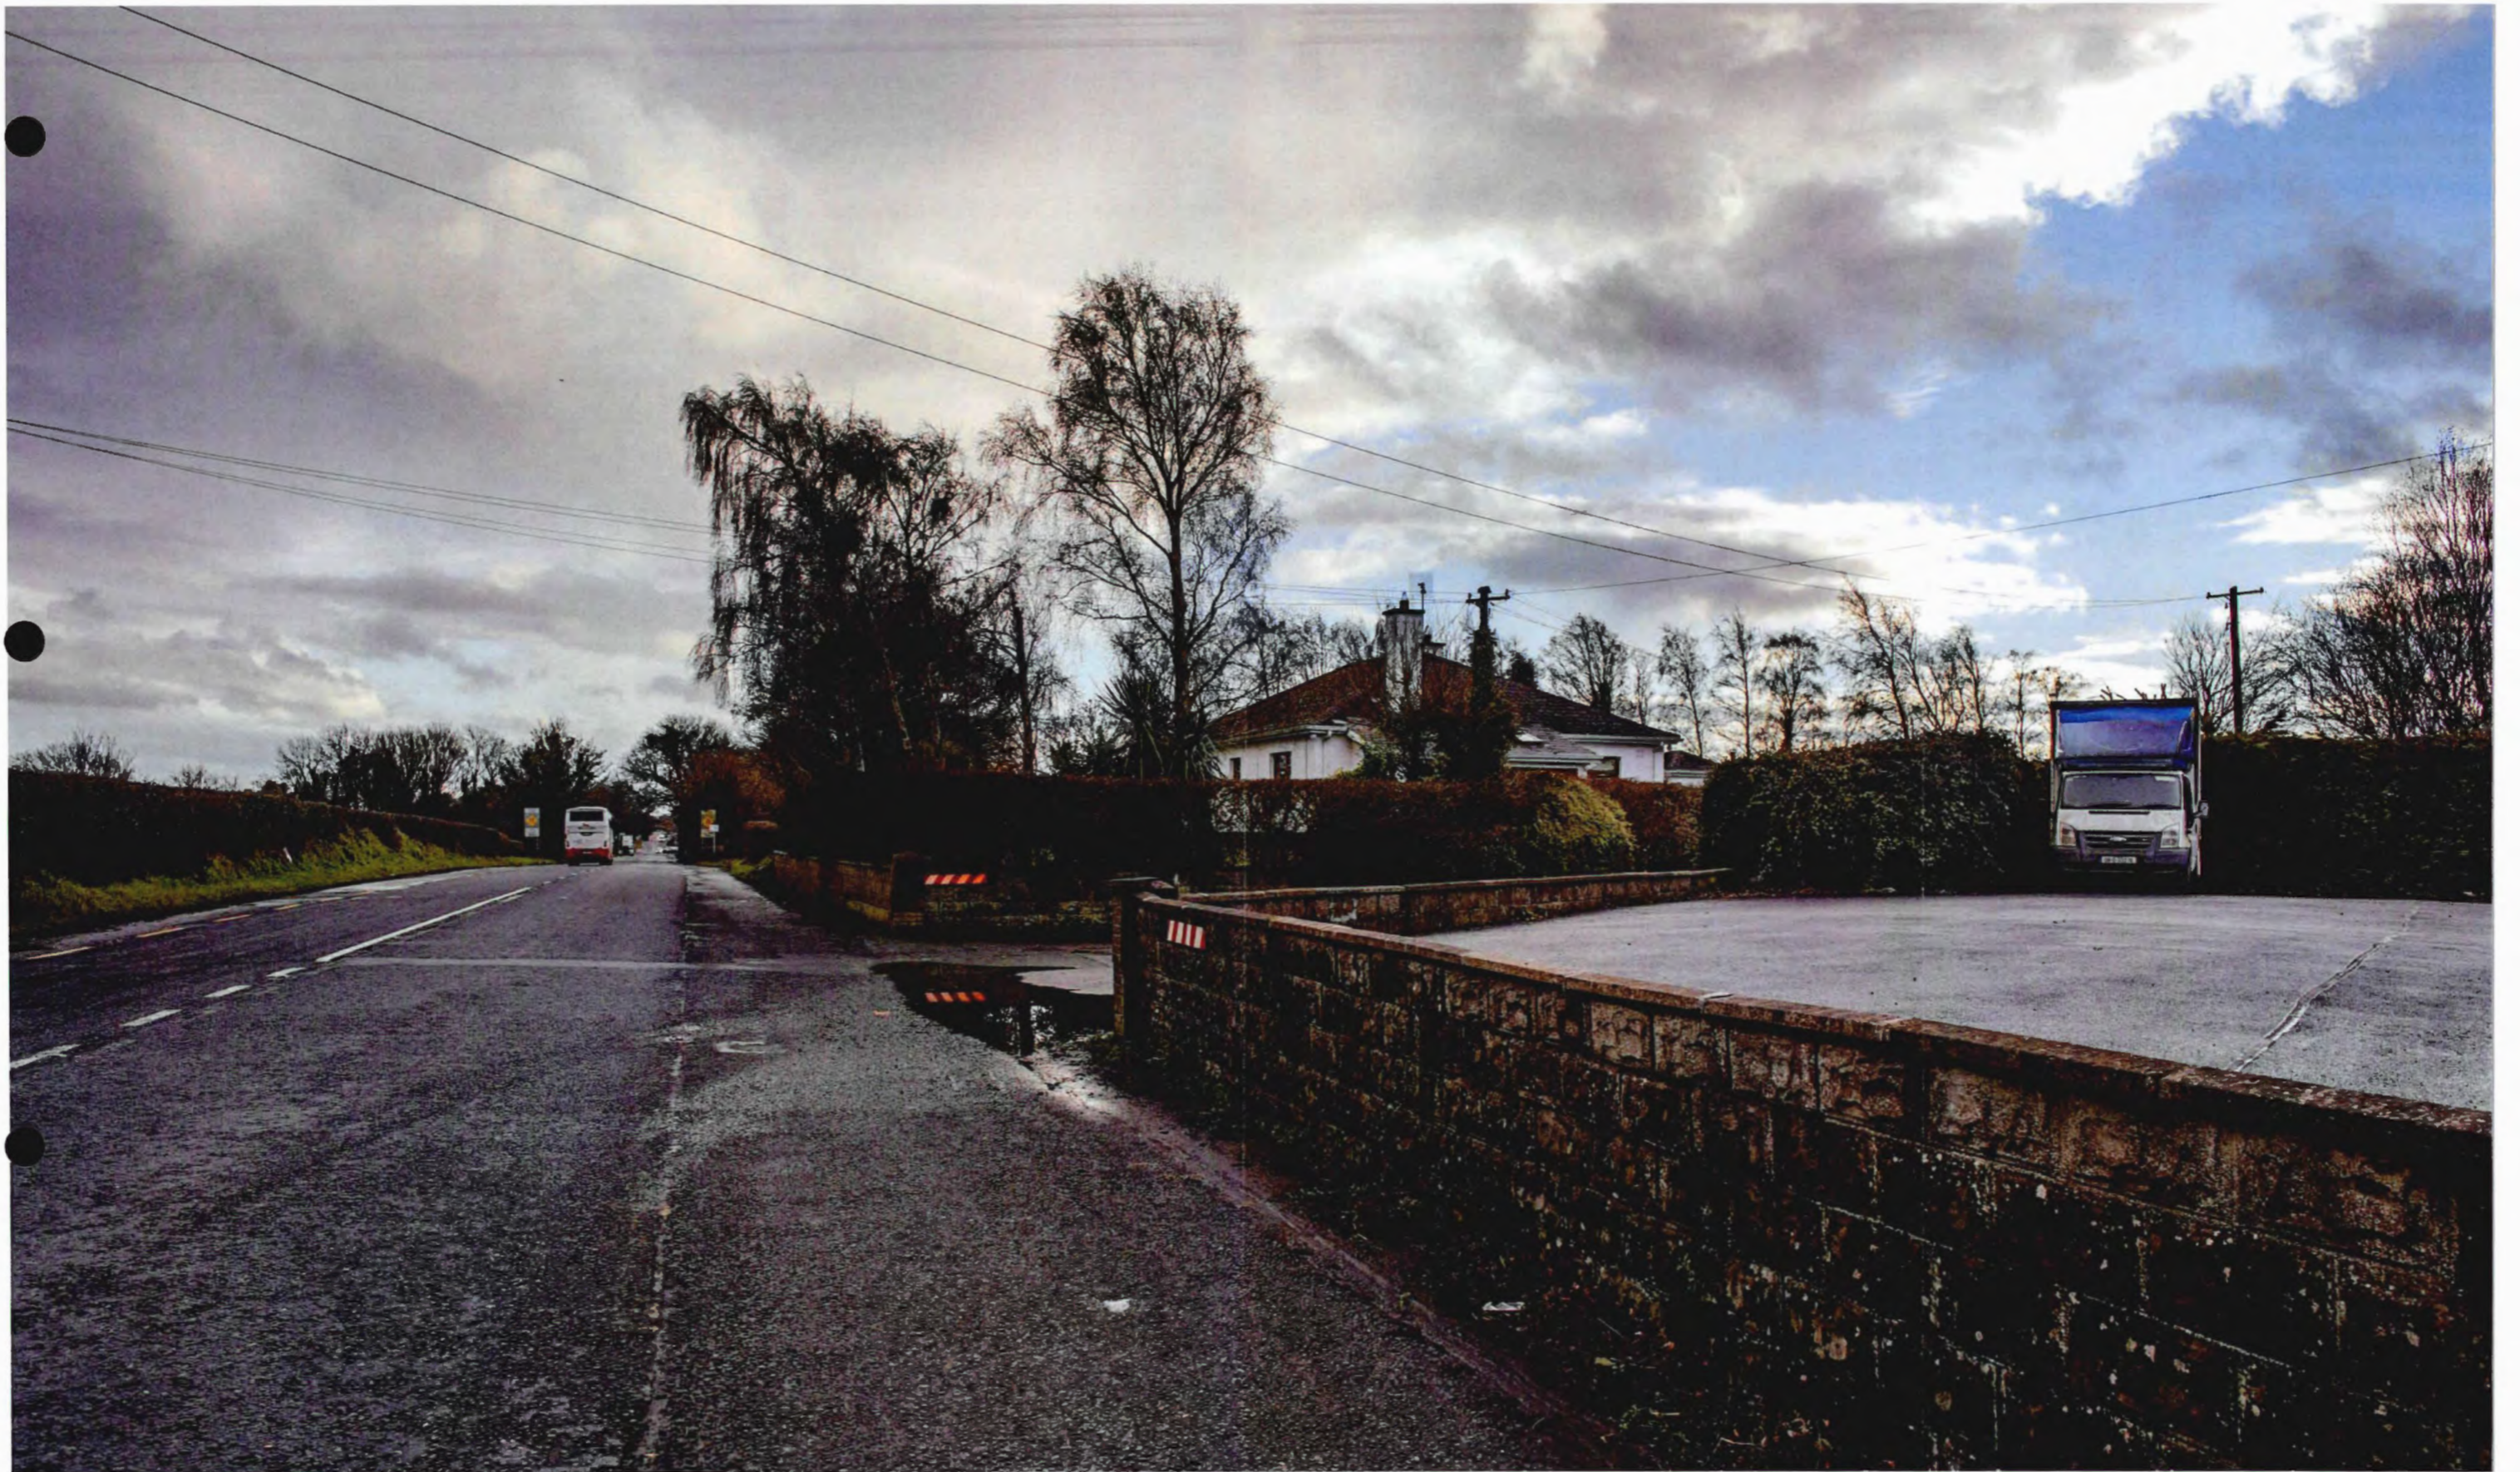
Location	Date	Field of view	35mm equivalent	Distance to site	Camera model
View 6 Existing	04-02-2021	74°	24mm	2171m	Canon EOS 5DS

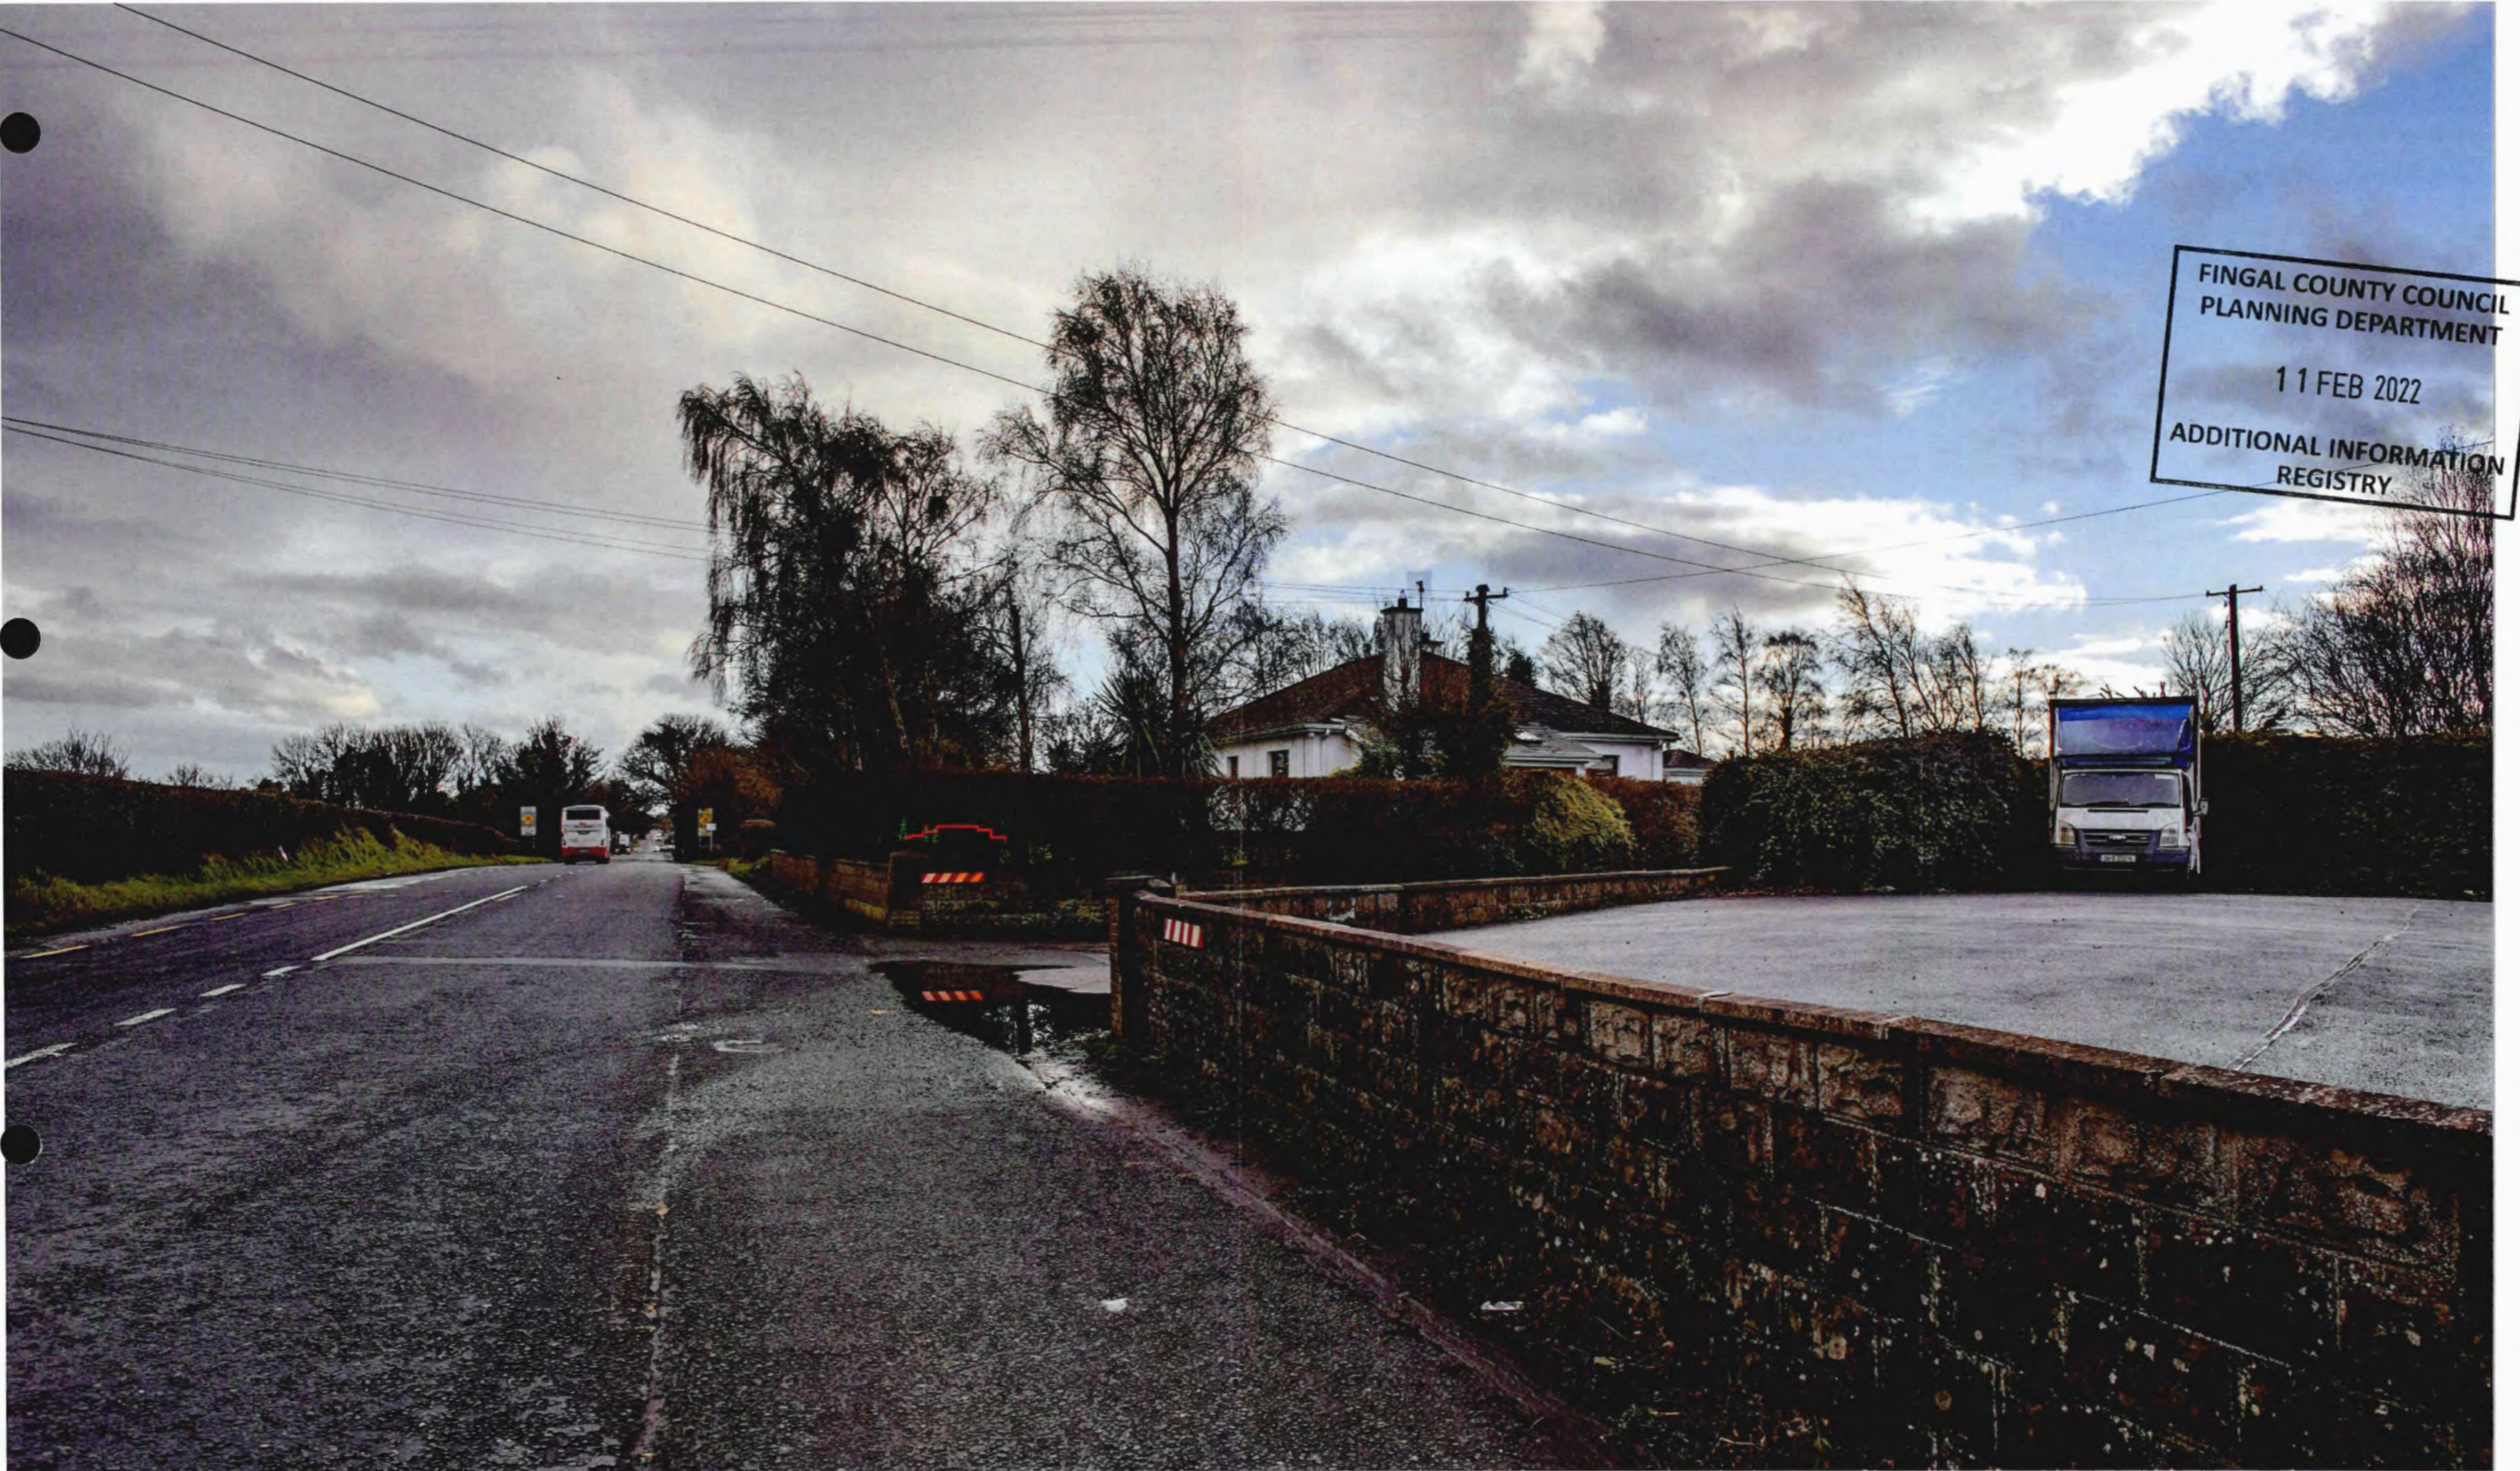
Location	Date	Field of view	35mm equivalent	Distance to site	Camera model
View 6 Proposed	04-02-2021	74°	24mm	2171m	Canon EOS 5DS

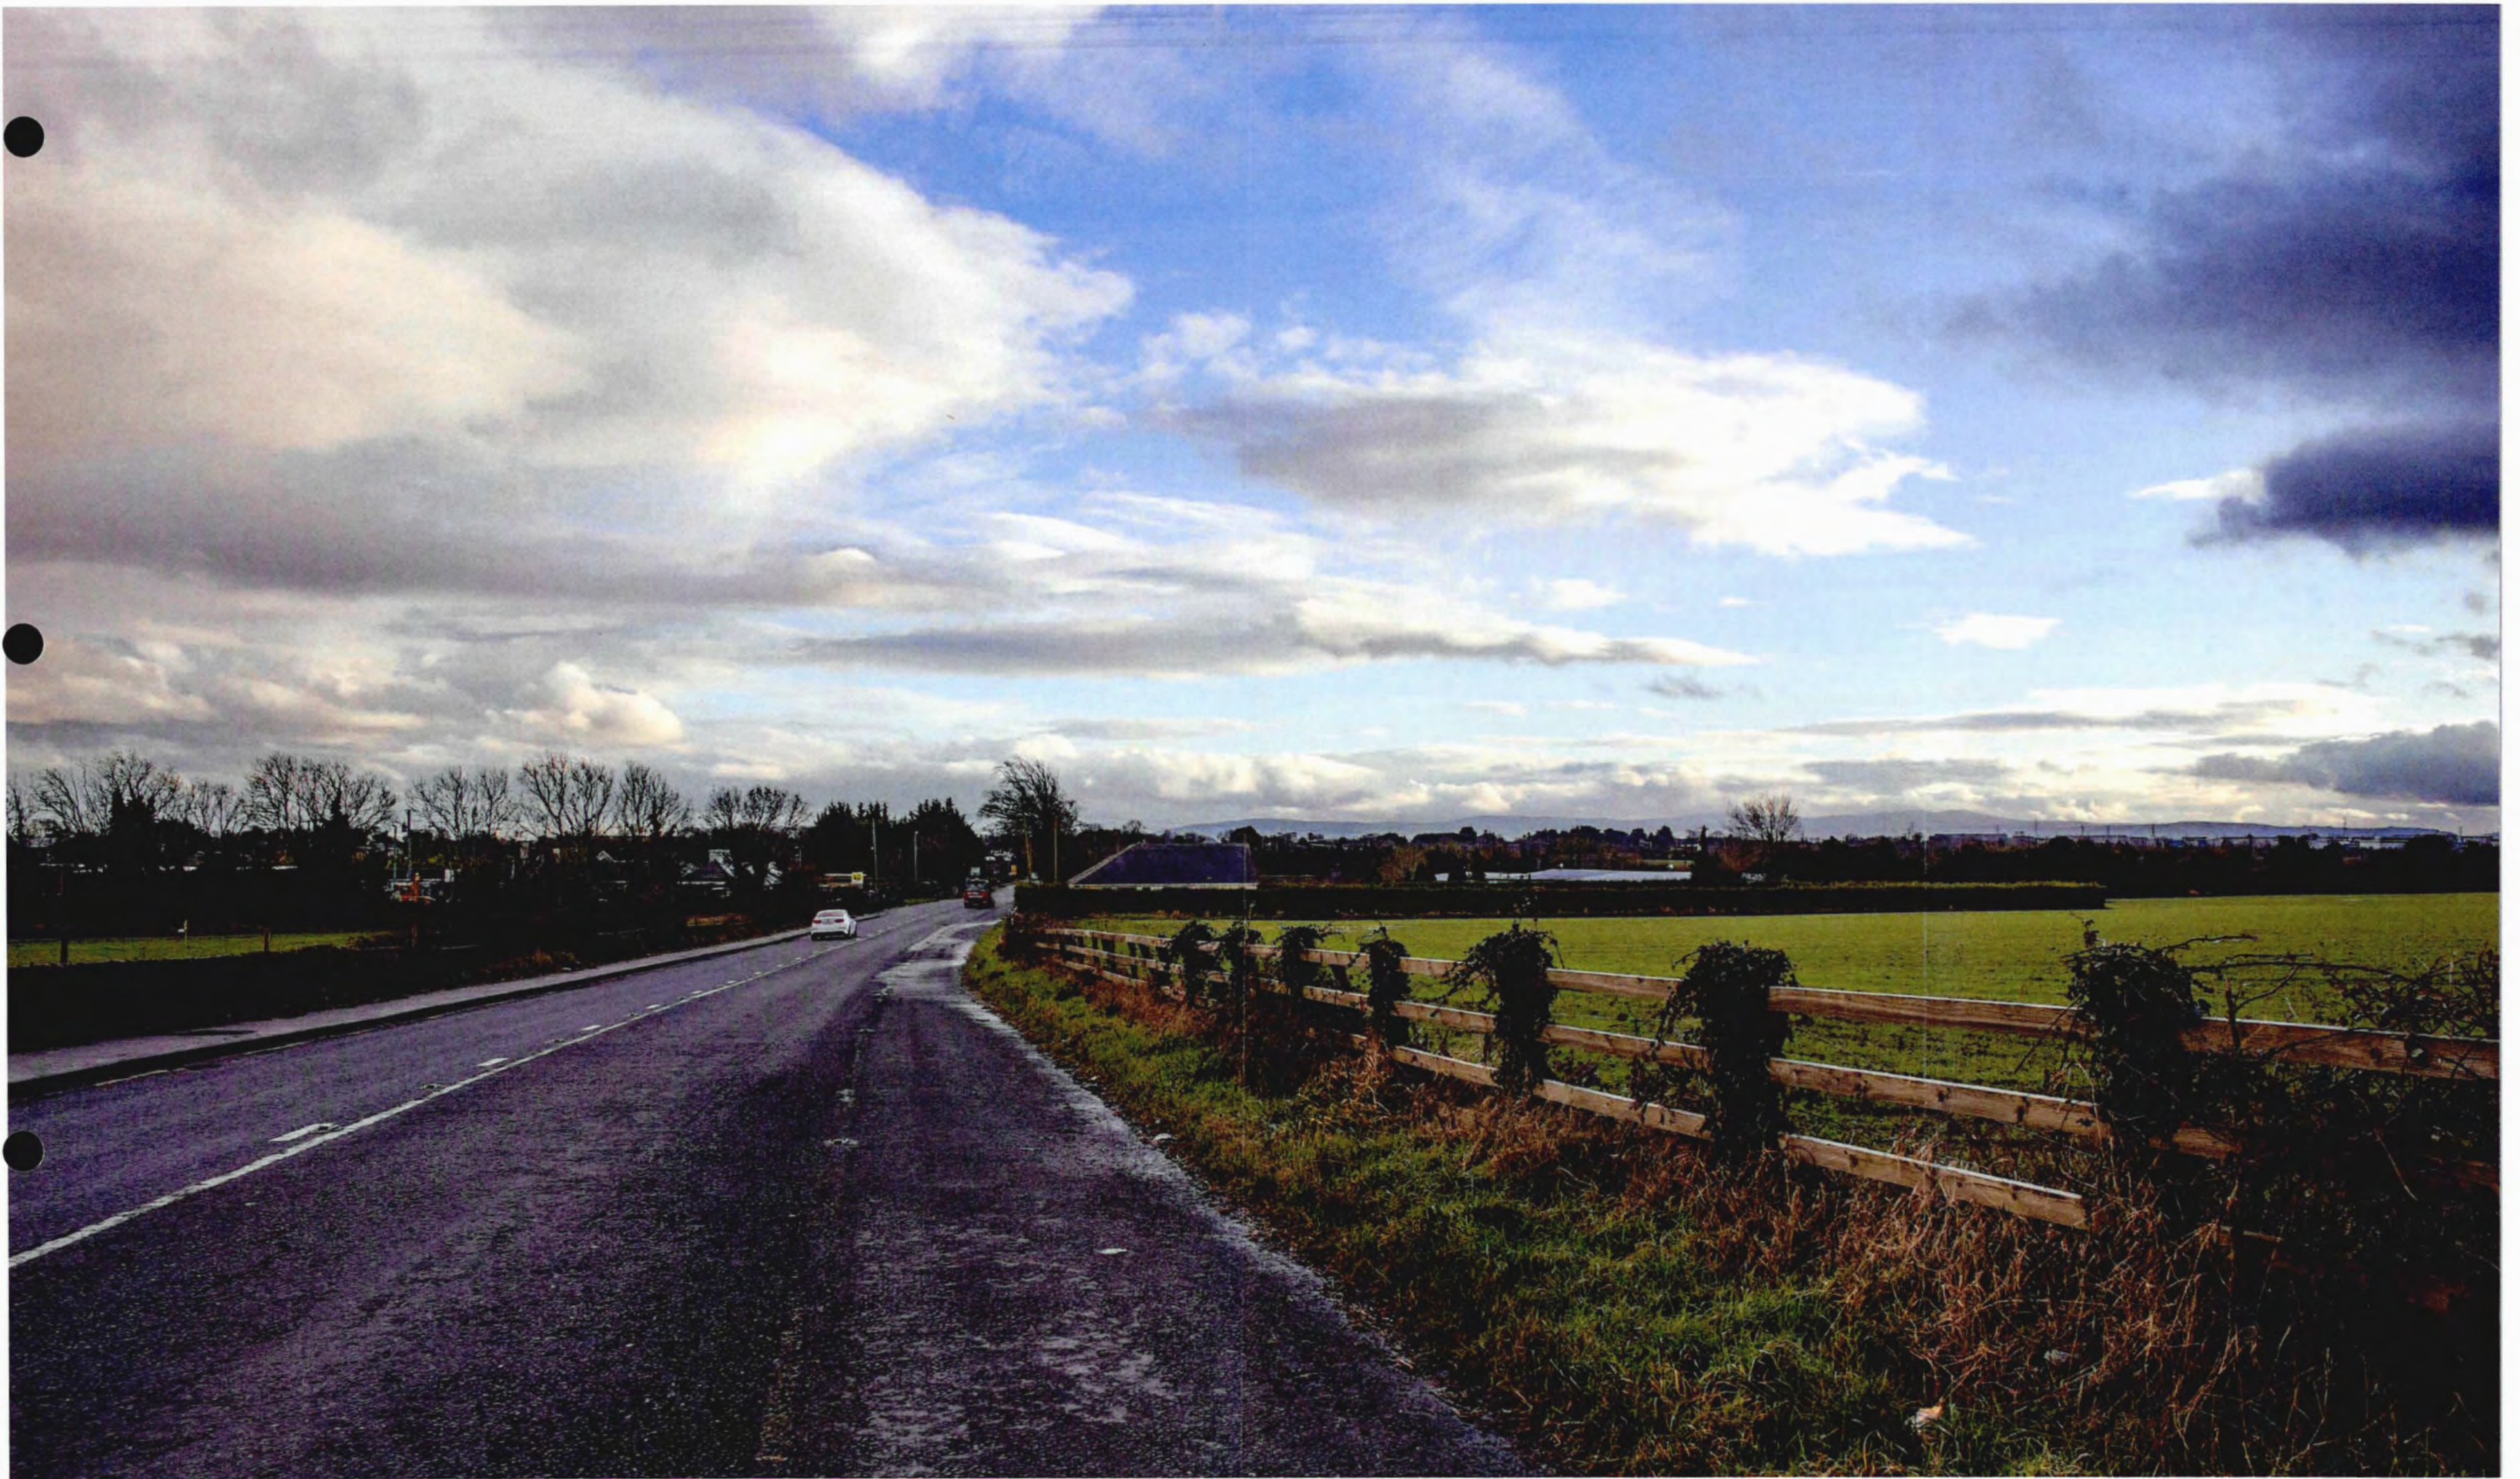
Location	Date	Field of view	35mm equivalent	Distance to site	Camera model
View 7 Existing	04-02-2021	74°	24mm	3188m	Canon EOS 5DS

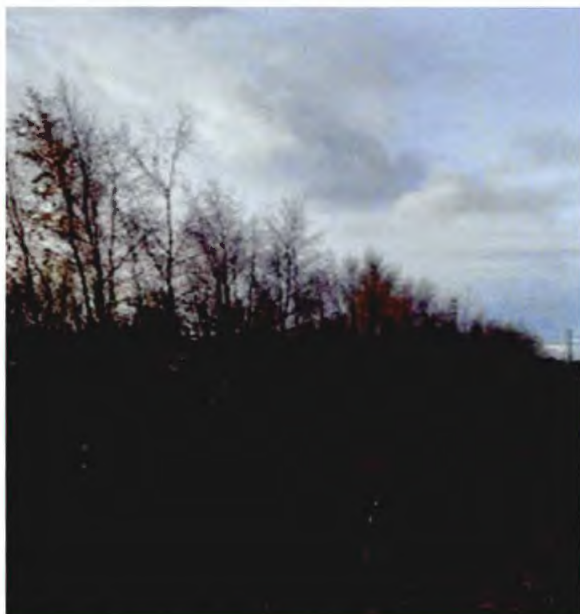
Fig 1. Shelter belt, South-Eastern corner

(*Rubus fruticosus*), Dog Rose (*Rosa canina*) and Ivy (*Hedera helix*) proliferate in the understorey, and the Ivy climbs high into the crowns of the overstorey trees., There is a shelter belt of Birch (Fig 1) (*Betula pendula*), Beech (*Fagus sylvatica*), and Rowan (*Sorbus aucuparia*) to the South-East, and to the South-West lies another shelter belt of Scots Pine (*Pinus sylvestris*), Oak (*Quercus petraea*), Beech, and Ash. The northern boundary is a hedgerow adjacent to arable land and to The Dogs Trust facility. The eastern extent is bordered by a public road and two dwelling houses. The southern boundary is a roadway which leads to Huntstown Power Station and Huntstown Quarry. The western boundary is adjacent to the Huntstown Power Station campus.

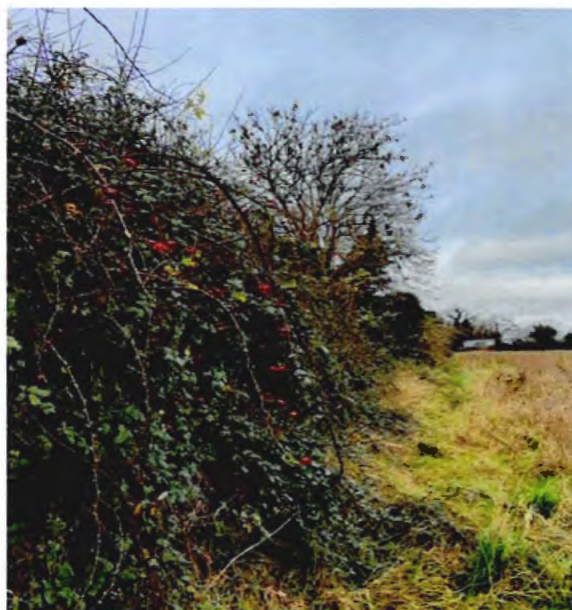
Fig 2. Hedgerow including ash T7

**3.1** The survey area comprises broadly level arable land bordered and intersected by drainage ditches (Fig 4) adjoined by hedgerows of varying character. There are a number of native hedgerows (Fig 2), comprising an overstorey of Ash (*Fraxinus excelsior*), Wych Elm (*Ulmus glabra*) and Sycamore (*Acer pseudoplatanus*), with an understorey of Hawthorn (*Crataegus monogyna*), Blackthorn (*Prunus spinosa*), and Elder (*Sambucus nigra*). Bramble

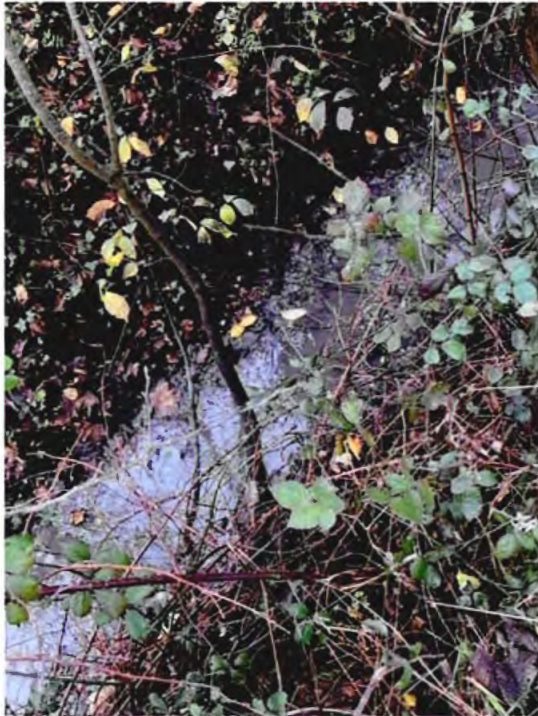
Fig 3. Drainage ditch

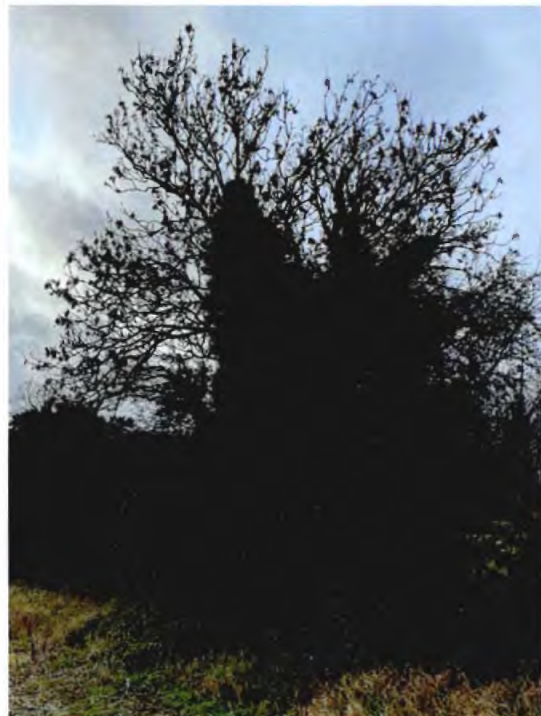
Fig 4. Ash, typical of many on site

There is limited visibility of the site from public roads. The trees are generally of small stature (Fig 4), and as such they offer minimal visual importance. The planned replanting of a wide variety of native trees and hedgerows will mitigate losses sustained during the development of the site as well as mitigating expected future losses due to ash dieback. The impact on retained trees, tree groups and hedgerows will be minimal if the development plans are carefully implemented according to the arboricultural method statement.

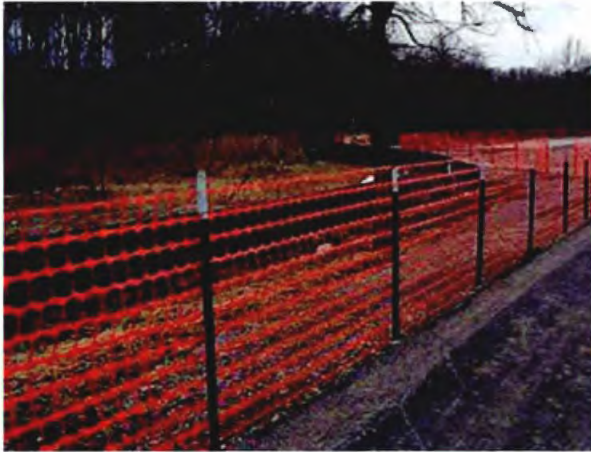
Fig. 6: Euromesh type fencing

On completion of the tree works, protective fencing should be erected where required, as specified in the tree protection plan, in accordance with BS5837:2012 (fig. 5). Fencing is intended as a precaution to prevent accidental damage to the rooting area of retained trees. Hedgerows, and trees remote from construction can be protected using a lower specification of barrier such as Euromesh (fig. 6). The positioning of any fencing at the edge of the RPA is shown in the TPP as a pink line.

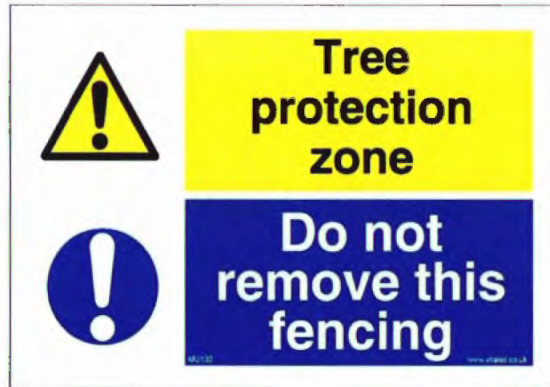
Fig. 7: signage to be affixed to fencing

- Erection of protective fencing should be completed before any materials or construction machinery are brought onto site and before any construction works commence.
- Signage (fig. 7) indicating 'tree protection area, no construction access' or similar must be affixed to the protective fencing.
- Fencing is not to be removed or repositioned without approval of the project arboriculturist.

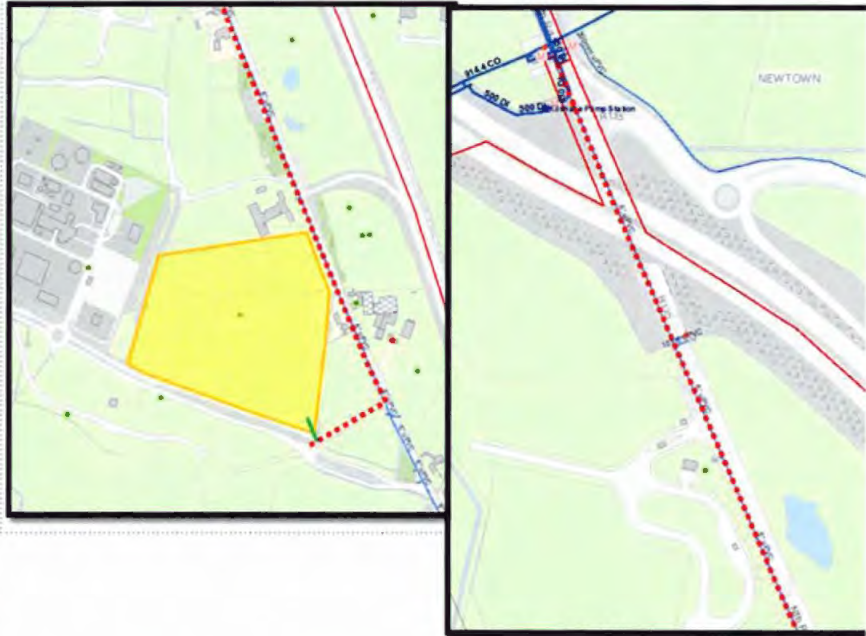
SERVICE	OUTCOME OF PRE-CONNECTION ENQUIRY <u>THIS IS NOT A CONNECTION OFFER. YOU MUST APPLY FOR A CONNECTION(S) TO THE IRISH WATER NETWORK(S) IF YOU WISH TO PROCEED.</u>
Water Connection	Feasible Subject to upgrades
Wastewater Connection	Feasible without infrastructure upgrade by Irish Water
<b>SITE SPECIFIC COMMENTS</b>	
Water Connection	Approx. 1500m of new 450mm ID pipe main to replace the existing 6" uPVC main as shown below (red dashed line) will be required. This new 450mm will be connected to the existing 450mm DI main.

Upgrade of pumps at Balleycoolen Highlands Tower will be required.
