Proposed Discharge, Dawn Meats Ireland, Navan, Co. Meath (P21/424)

Aquatic Habitat, Macroinvertebrate and Otter Surveys, River Boyne

Version (3-2-22) FINAL

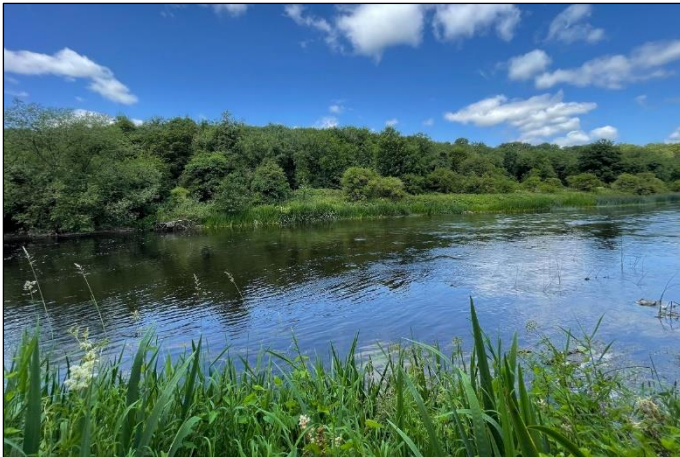
Plate 1 The River Boyne c.200m downstream of the proposed discharge location, July 2021. This is deep glide habitat with a predominantly rock / cobble substrate. This was kick sampling site 1.

Site 1 was deep glide habitat with a predominantly rock / cobble substrate. This site was located c. 200m downstream of the proposed discharge location.

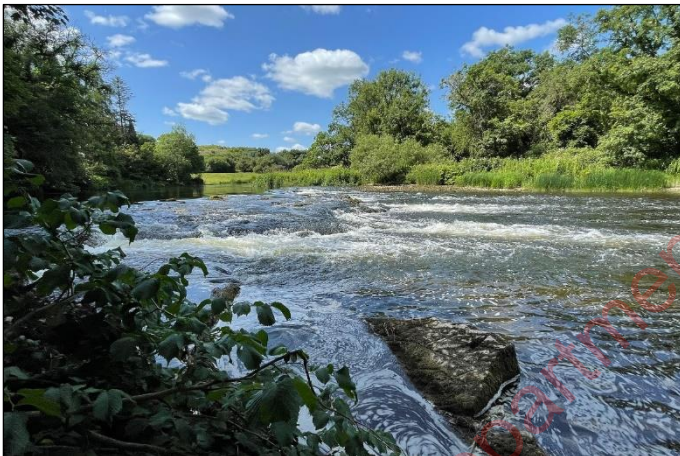
Plate 2 The River Boyne c.100m downstream of the proposed discharge location, July 2021. This is riffle / cascade habitat with a predominantly rock substrate.

Approximately 120m downstream from the proposed discharge location there is cascade habitat. The water in this area flows relatively fast for c. 30m and is cascade / riffle habitat with a predominantly rock substrate. On either bank here there is woodland. At this location the 2nd order River Dodderstown flows into the River Boyne. This stream runs adjacent to a historical quarry (as viewed on the GSI Quarry Directory maps). It also appears from viewing aerial photography that there is an active quarry c. 80m from the proposed discharge location. This quarry is not listed on the Active Quarry & Pits Ireland database. Due to this it appears that it is an unlicensed active quarry. The stream was visibly polluted during the survey.

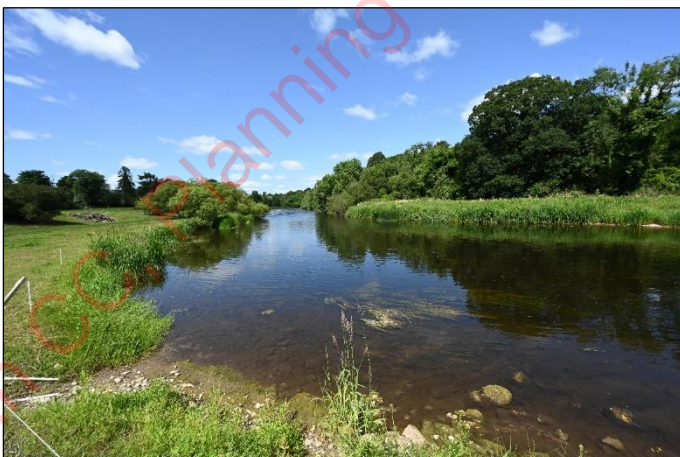
Plate 3 The River Boyne at the proposed discharge location, July 2021. This is pool habitat with a predominantly rock / cobble substrate.

At the proposed discharge location there is a 100m stretch of river which is deep pool habitat. The substrate here is rock/cobble. The woodland also encroaches on to these banks but there is a larger grassy area particularly on the northern bank. There then is a very large grassy area on the

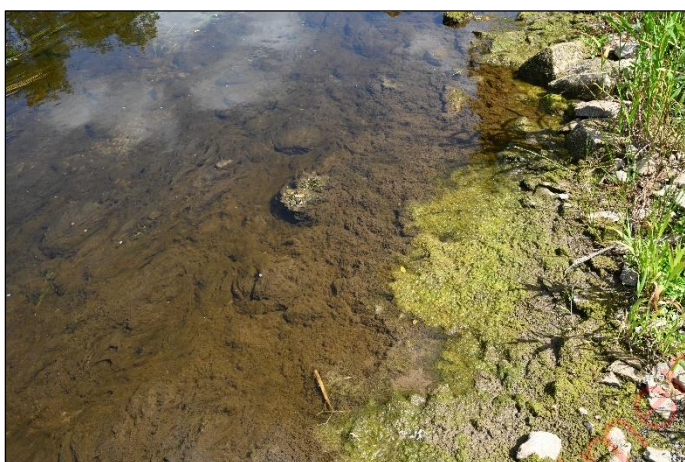
Plate 5 The River Boyne at the proposed discharge location showing signs of eutrophication (algal and bacterial growths, siltation).

south bank where the woodland ends. There were signs of eutrophication at the proposed discharge location with high levels of siltation in addition to algal and bacterial growths.

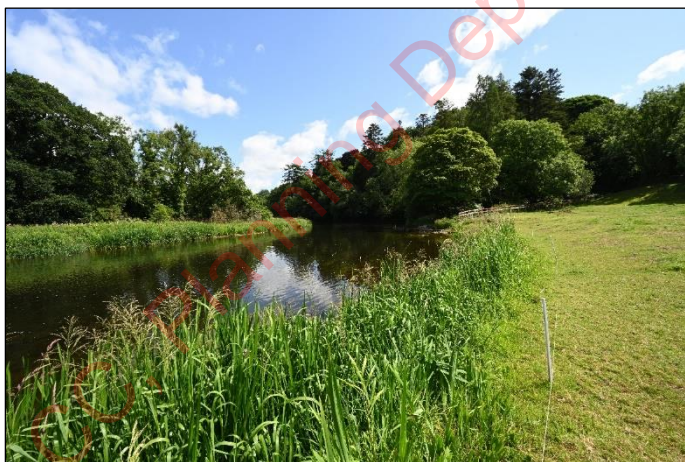
Plate 6 The River Boyne immediately upstream of the proposed discharge location, July 2021. This is pool habitat with a predominantly rock / cobble substrate. This was kick sampling Site 2.

Immediately upstream of the proposed discharge location was survey Site 2. This whole area is glide habitat with a predominantly rock / cobble substrate. The north bank in this location is broadleaved woodland. There is no woodland on the south bank here and it is an open grass area. Also present here is the beginning of the mill race which is a part of the former a mill building which is present just upstream. The mill race is glide habitat and is c. 178m in length. Approximately 50m upstream from Site 2 is a small section of riffle habitat. Directly upstream from here is again glide habitat and the mill race ends here. During the current survey there was a high proportion of submerged instream vegetation in this area. The mill race and the main channel of the River Boyne are separated by a long in stream island.

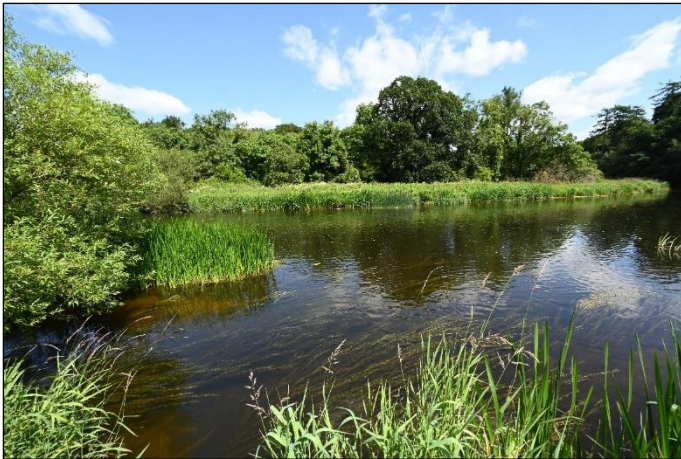
Plate 7 The River Boyne c.100m upstream of the proposed discharge location, July 2021. This is glide habitat with a predominantly rock / cobble substrate.

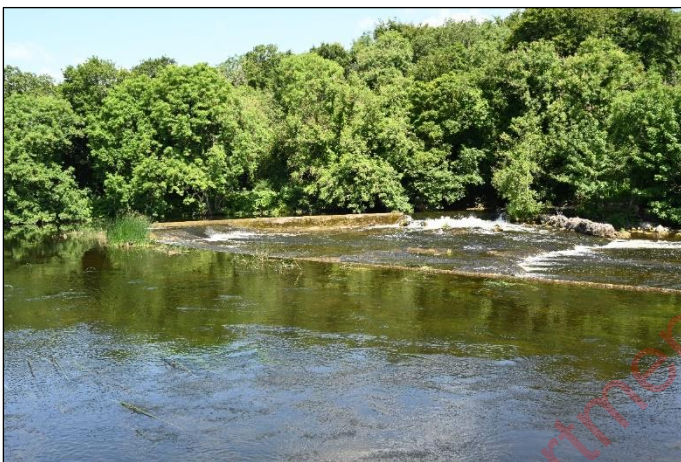
Plate 8 Lugaree Weir located on the River Boyne c.200m of the proposed discharge location. The substrate here is again dominated by rock / cobble.

Directly upstream of the mill building is Lugaree Weir. This is also where the Boyne navigation crosses from lock 16 to lock 14. This substrate here was again predominantly rock / cobble. This weir has resulted in the river directly upstream being pool habitat for c. 80m. On the southern bank of this area there is optimal juvenile lamprey habitat in the form of silt beds. On the north bank is the end of the woodland habitat in that area. The water here is quite deep and a new slipway has been constructed into the lamprey nursery habitat which has damaged some of the silt beds in this area.

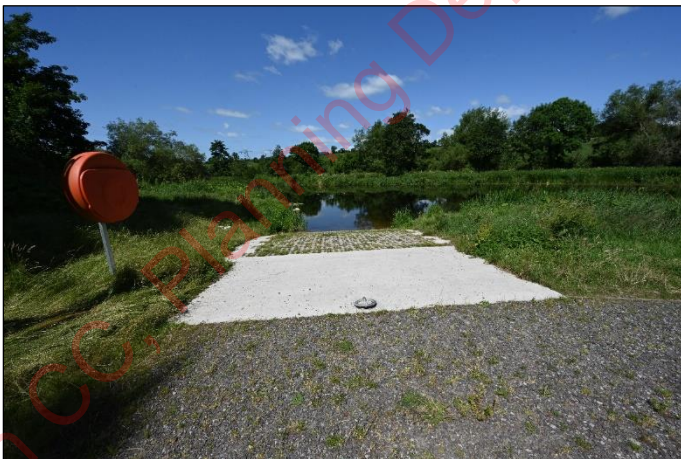
Plate 9 New slipway on the River Boyne c.250m upstream of the proposed discharge location, July 2021. This stretch of river has deep pool habitat impounded by the weir. Silt has built up in this area providing juvenile lamprey habitat. This was site B4 in the O'Connor (2006) lamprey survey of the River Boyne. Lamprey habitat at this site has been damaged by the construction of this slipway.
