**Road Safety Audit**  
**Stage 1/2**  
**for**  
**ACCESS TO PROPOSED MIXED USE DEVELOPMENT**  
**AT**  
**CARRIGALINE, CO CORK**

**Reference:** RSM/MOB/121021/CARRIGALINE RSA1-2

<b>Client</b>	HLCE Limited
<b>Project Title</b>	Access to Mixed Use Development, Carrigaline, Co Cork
<b>Document Title</b>	Stage 1/2 Road Safety Audit
<b>Document Ref.</b>	RSM/MOB/121021/CARRIGALINE RSA1-2
<b>Status</b>	FINAL

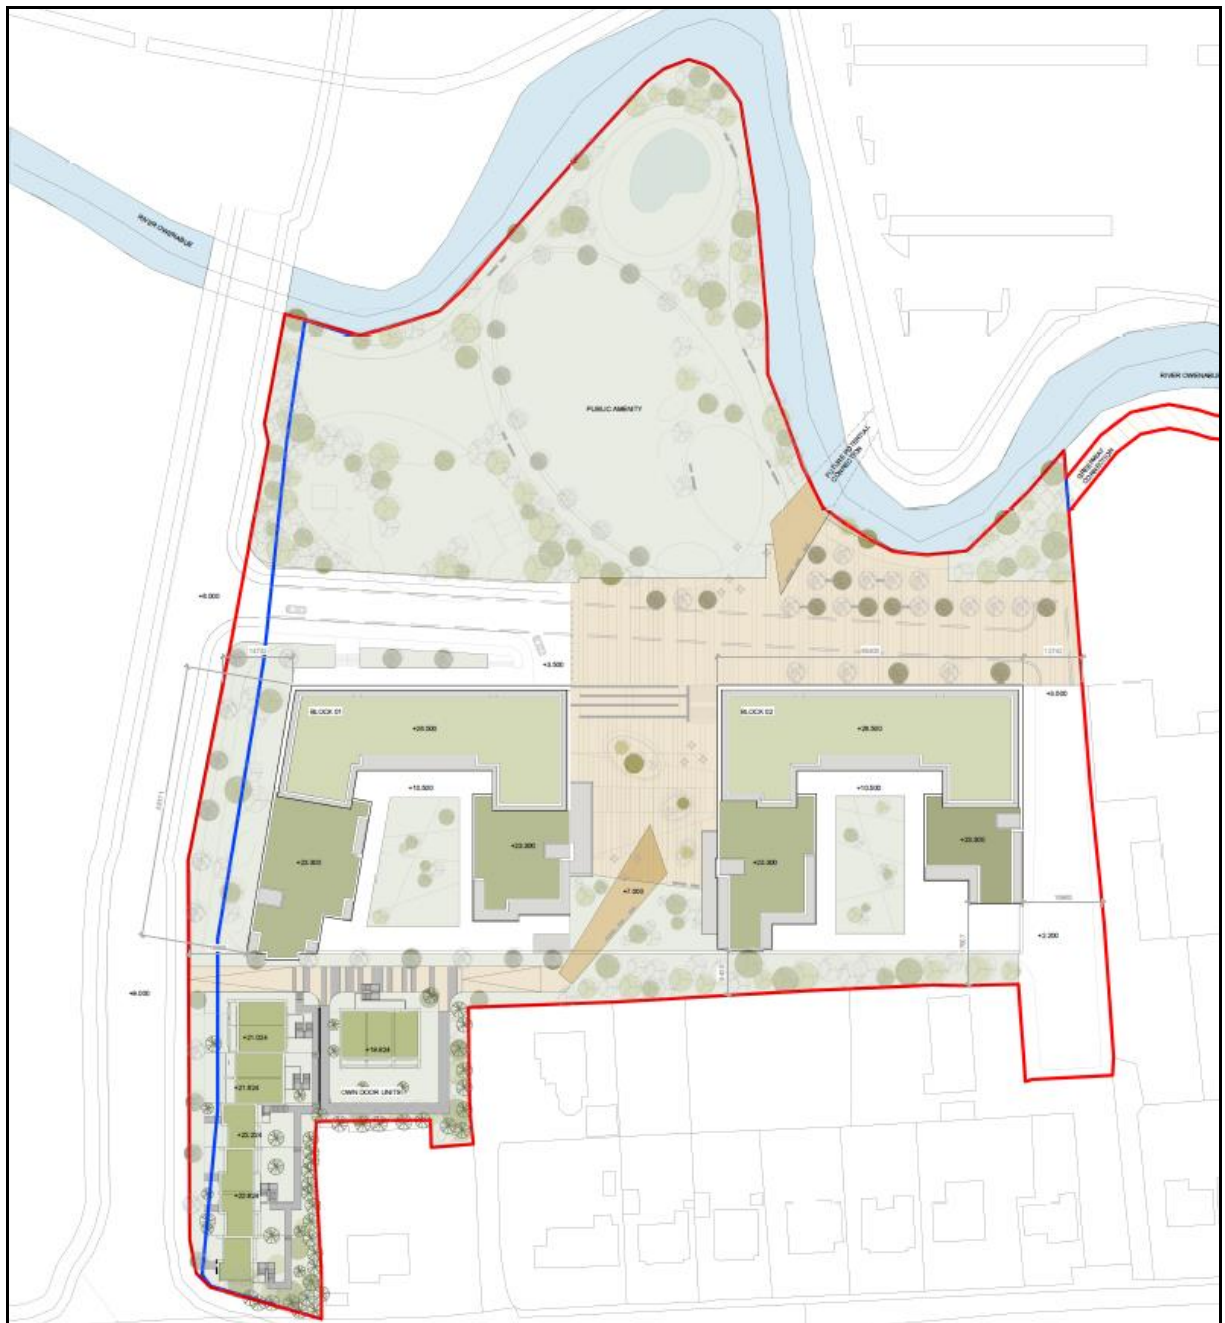
**Figure 2: Proposed Internal Site Layout**

1.1 This report results from a Combined Stage 1/2 Road Safety Audit (RSA) of the proposed access and internal road layout for a proposed mixed-use development site comprising 224 residential apartment dwellings, a large retail outlet and 2 No small retail units and a creche with associated parking both underground and at surface level. The site, at the location shown in figure 1, will be accessed via a priority-controlled T-junction off the eastern side of the new Carrigaline Western Relief Road (CWRR) which is currently under construction in Carrigaline, Co Cork, and shown indicatively in figure 1. This Stage 1/2 RSA has been carried out at the request of HLCE Limited, and comprises an examination of the design proposals within the red line boundary of the site only, which is shown in figure 2. This Audit examines the road safety implications associated with the proposed access to the development site and the internal road layout, and all associated ancillary works.

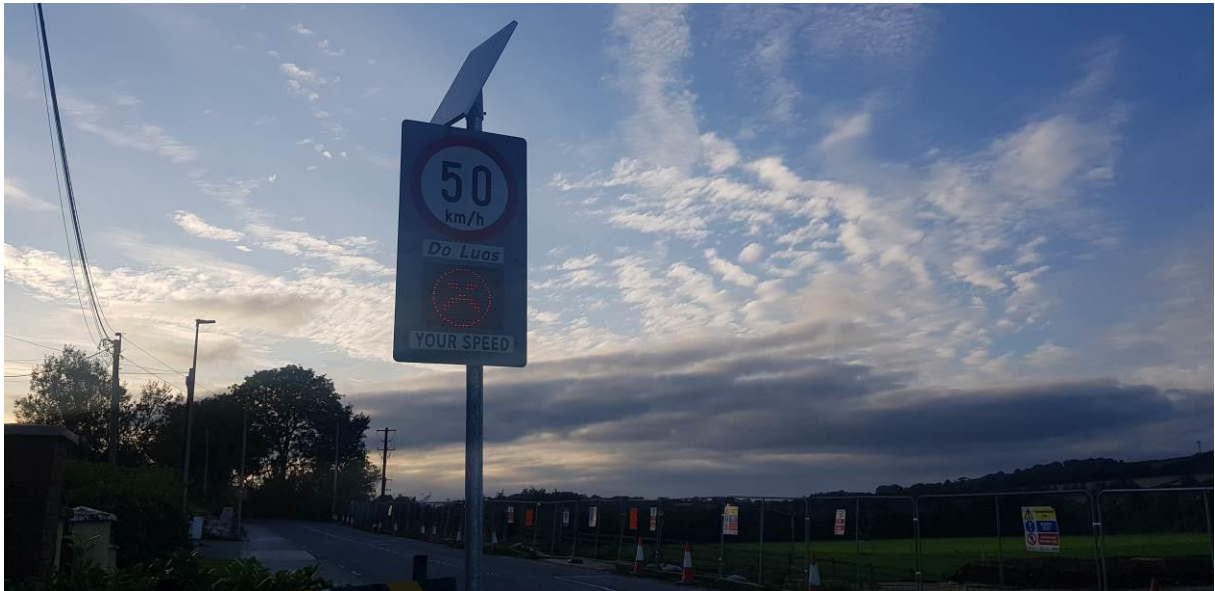
**Figure 4: VMS south of CWRR Junction**

The speed limit on the R611 to the south of the site is the 50 km/hr urban speed limit. The proposed speed limit on the CWRR is unknown. There is no provision for 30 km/hr reduced speed limit and slow zone signage within the site, which was noted at entry to other residential areas in the locality, and no provision for traffic calming within the site or for lower speed limits and associated signage on the access to the basement car parking area. There was no 85<sup>th</sup> percentile speed data provided for the external road network north and south of the site, however observations at the time of the site visit demonstrated that some vehicles were travelling at speeds in excess of the posted speed limit of 50 km/hr on the R611, as recorded by an existing VMS located just south of the proposed junction with the CWRR. Vehicle speeds on the R613 Ballea Road to the north of the site were lower, and traffic calming measures, including vertical deflection, were noted along this link.

1. A reduced speed limit and slow zone signage should be provided at a safe suitable location on entry to the site which does not obstruct footways, and at a suitable mounting height to prevent an overhead hazard. Suitable lower speed limits and associated signage should be applied to the car parking circulation areas within the site.

2. Provision should be made for suitable traffic calming and/or speed control measures as necessary within and on all approaches to the site.

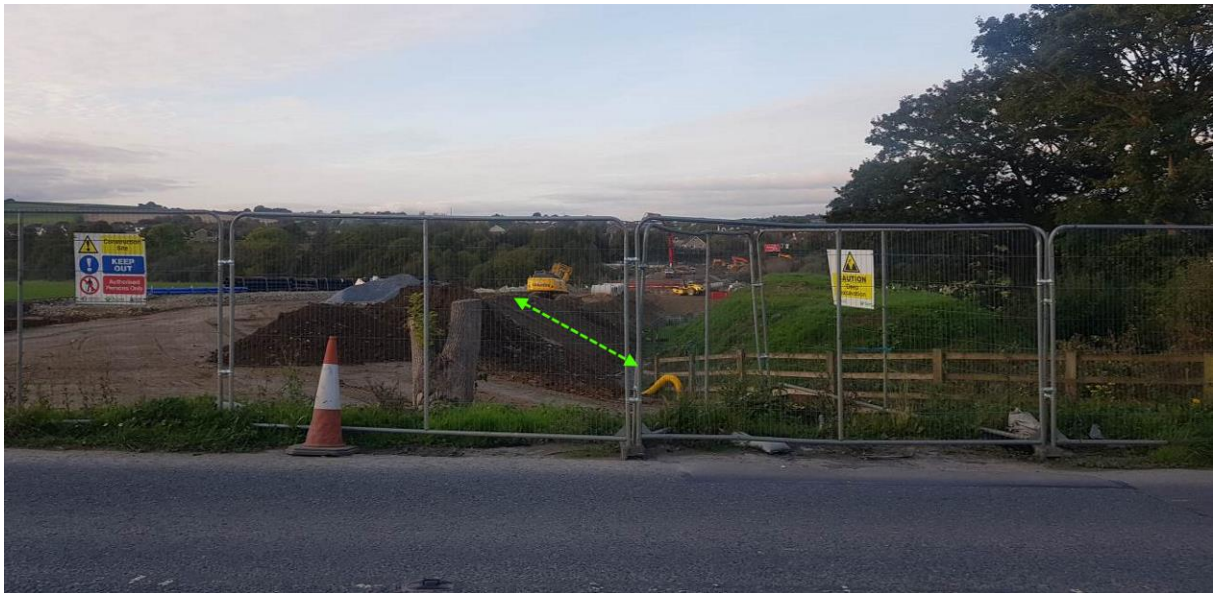
**Figure 6: Embankments at site**

There were no long or cross sections provided for the proposed roads. A large portion of the northern section of the site will be used for public amenity, adjacent to the River Owenabue, however there were no details provided for proposed surfaces and gradients on footways and VRU routes to determine suitability for all road users, including those who are mobility or visually impaired.

1. Detailed design should include vertical design and long and cross sections, and provision should be made for a relatively level dwell area at the proposed site access for a distance of 15m back from the channel line.
2. Detailed design should include details of any proposed embankments along the western site perimeter, and details of all gradients and crossfalls on roads and surfaces to be used by traffic and VRUs, including within the public amenity area at the north of the site.

3. A minimum crossfall of 2.5% should be provided on the access link, or the longitudinal profile should be a minimum 2% to minimise the risk of standing water. A minimum crossfall of 2.5% should also be provided on footways.
4. Detailed design should include kerb design to include detailed of all dropped kerbs and full height kerbs within and surrounding the site. All kerbs on pedestrian desire lines to be flush with the surrounding surface or have a maximum upstand of 6mm.

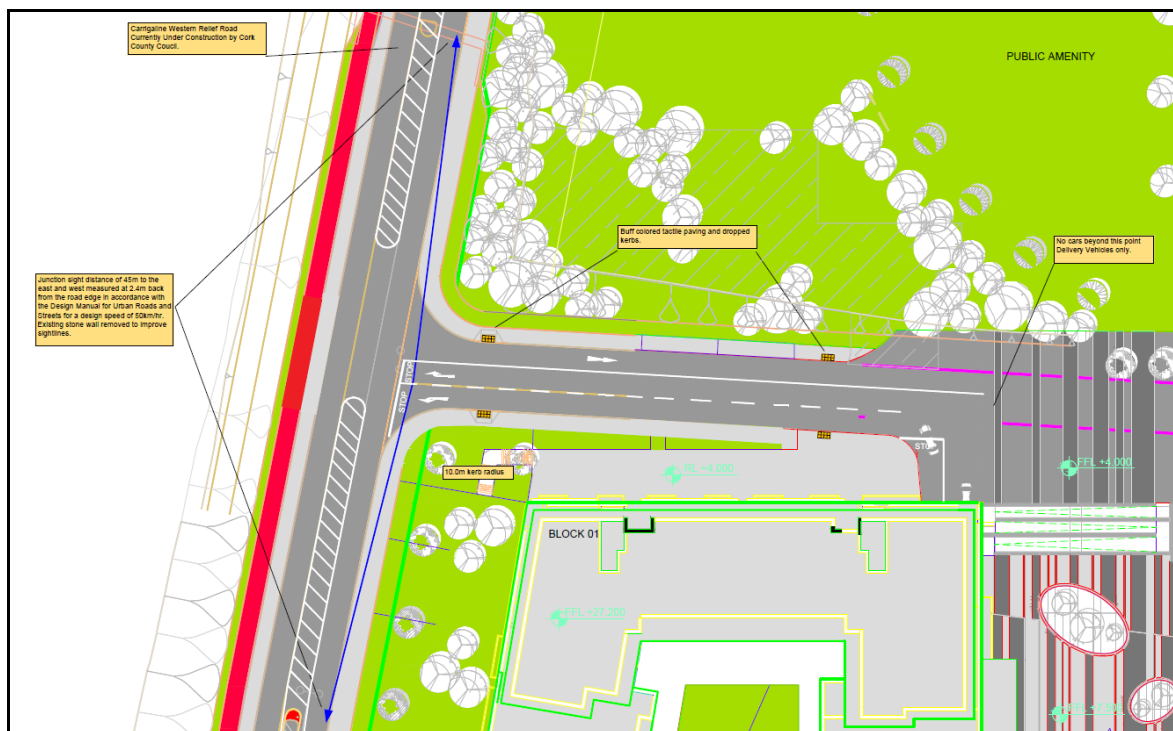
**Figure 8: Proposed Layout at Site Access**

The TTA for the site indicates turning movement proportions and anticipated Queues during AM and PM peak hours for the development site, and the layout plan indicates provision for a ghost island junction on the CWRR, however there is no provision for suitable reservoir length for queuing vehicles including deceleration length, to minimise obstruction to through traffic and potential for increased rear shunt collision risk. The junction has also been configured with two egress lanes at the proposed stop line on the minor road, which will increase the number of simultaneously turning traffic streams at the junction, and presents an increased risk of right-angled collisions and pulling out type incidents due to waiting vehicles in the adjacent lane on the minor road obstructing clear visibility to and from oncoming vehicles.

The swept path analysis provided for the proposed access junction showed right turning vehicles only entering. Left turning manoeuvres to and from the site have not been shown, which are typically the most constrained movement, particularly on a layout where there will be two lanes of egressing traffic waiting to turn out, which increases the likelihood of obstruction for entering vehicles.

1. The layout should ensure that the total demand for right turners into the site is satisfied by the proposed layout, with suitable right turn reservoir length, and that traffic queuing to enter the development site will not obstruct the movement of through traffic on the CWRR.

2. The minimum length of right turn reservoir should be provided in accordance with the relevant standards for ghost island junction design, to include queuing length, deceleration length, taper and turning length, taking into account approach speeds and forward visibility from each direction, with visibility to be clear and unobstructed at all times in accordance with traffic speeds.

3. The number of exit lanes should be reduced to one to minimise the number of conflicting movements and to minimise the crossing distance for pedestrians. Vehicles waiting to turn out of the minor road must not obstruct entry for other vehicles, including emergency access.

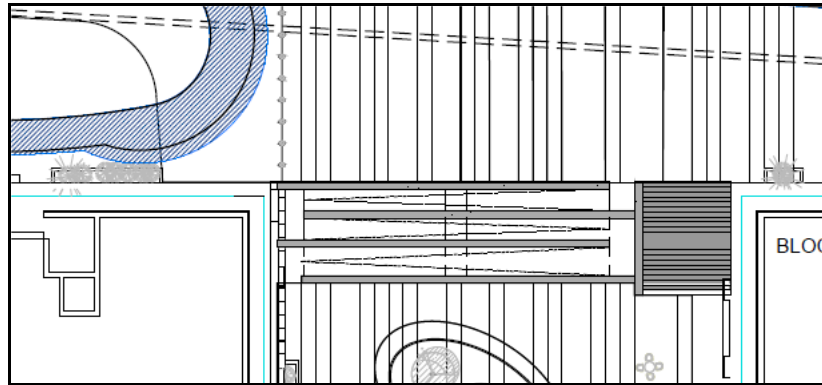
**Figure 10: Proposed Ramps and steps within Site**

**2.3.1.2** Ramps and steps have been shown at a number of locations within the site, however details have not been provided for ramps to ensure widths and gradients are suitable for all anticipated road users. Tactile paving has not been shown to the top and bottom of steps to alert visually impaired pedestrians to the presence of the hazard.

1. All ramps throughout the scheme should have a maximum gradient of 1:20 (preferable) or 1:12 (absolute maximum over short distances only) at all locations. An alternative means of access for wheelchair users must be provided in all locations where steps have

been provided and where there is no ramp, or where ramp gradients of 1:20 or greater are provided, with a total ramp rise greater than 2m.

2. Ramp widths and layout should comply with the requirement of Technical Guidance Document M, Access and Use (2010) with the minimum unobstructed width between handrails to be not less than 1200 mm, and 1500mm between the walls, with wider ramps to be provided for shared use with cyclists, or where a high demand for access by buggy/double buggy users may arise.
3. Corduroy tactile paving should be provided at the top and bottom of all steps throughout the site and configured in accordance with 'Guidance on the use of Tactile Paving Surfaces'.

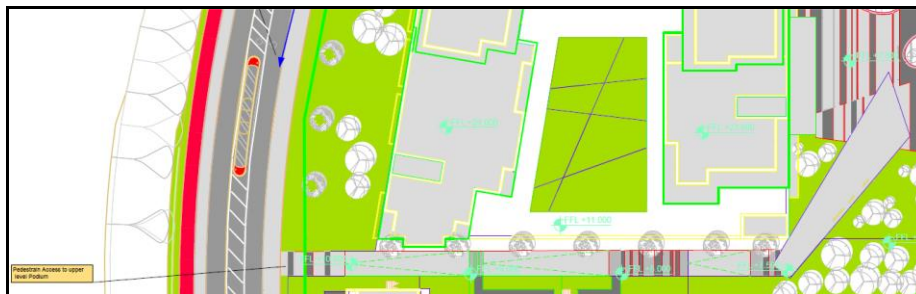
**Figure 12: Pedestrian Access to south of site**

**2.3.1.3** A pedestrian access has been shown at the southern section of the site which includes ramps and steps, however swept path analysis has been provided to demonstrate vehicular access at this location also, where conflict may arise. Pedestrians are also likely to be circulating within the access route to and from the delivery area to the east of the site, where conflicts may also arise, particularly as HGVs have limited visibility and blind spots.

1. Pedestrian movements should be segregated from HGV and vehicular movements where possible throughout the site.
2. All routes to be used by vehicles should have suitable gradients, and provision should be made for suitable dropped kerbs where necessary at all locations where vehicular access is required, including for emergency vehicle access, with clear signage for the latter to ensure routes are not obstructed by other vehicles.

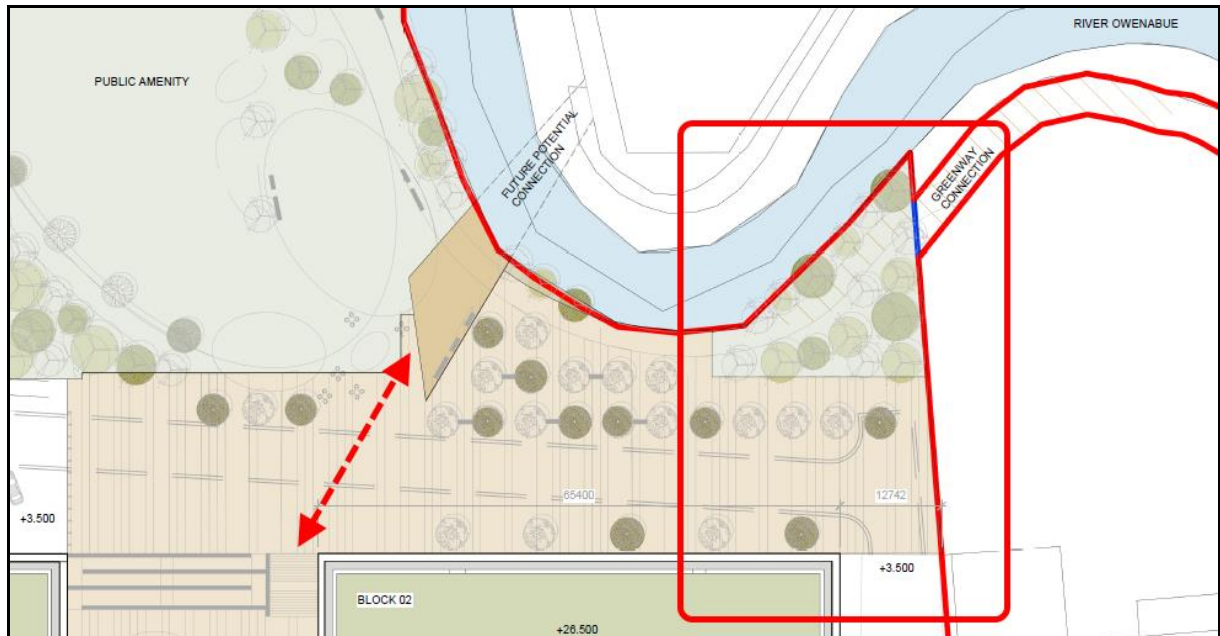
**Figure 14: Details for Greenway Connection & Cyclist Connectivity Not known**

No information has been provided on likely cyclist demand and activity to and from the site, and there was no cycling activity observed adjacent to the site at the time of the site visit. The design includes provision for a significant number of cycling parking spaces, however the proposed routes to and from the bicycle parking areas are unclear. There are no dedicated cycling routes or facilities shown, and cyclists would be expected to share road space with motorised vehicles where the risk of conflict is higher. The widths of the proposed footways throughout the site and surrounding the site are insufficiently wide for

shared use between cyclists and pedestrians. The layout plans show provision for a Greenway connection to the northeast side of the site along the southern bank of the river, however there is no provision for connectivity to the hard surface areas. Cyclists will also be brought out into an area where vehicles will be reversing and turning, as a turning head has been shown, as indicted on figure 14. Future potential connection over the river has also been shown, however it is unclear how cyclists will access the southern section of the site as the ramp width shown in figure 4 immediately west of the steps appears too narrow.

1. Likely cyclist demands, desire lines and volumes should be examined within and on all approaches to the site to take into account issues raised in this Stage 1/2 RSA report, with safe continuous and unobstructed facilities provided to cater for anticipated cycling demands, inclusive of shared off road facilities wherever possible, with a minimum 3m width, to minimise the risk of pedestrian and cyclist conflict.
2. Provision should be made for suitable transition kerbs to facilitate safe access between on and off-road facilities and proposed bicycle parking spaces within the site, and gradients on all routes to be used by cyclists should be a maximum 3%.

3. Detailed design should include provision for suitable connectivity to the Greenway and proposed cycling network long the CWRR. Cyclists should not be brought out into areas where vehicles will be turning and reversing.

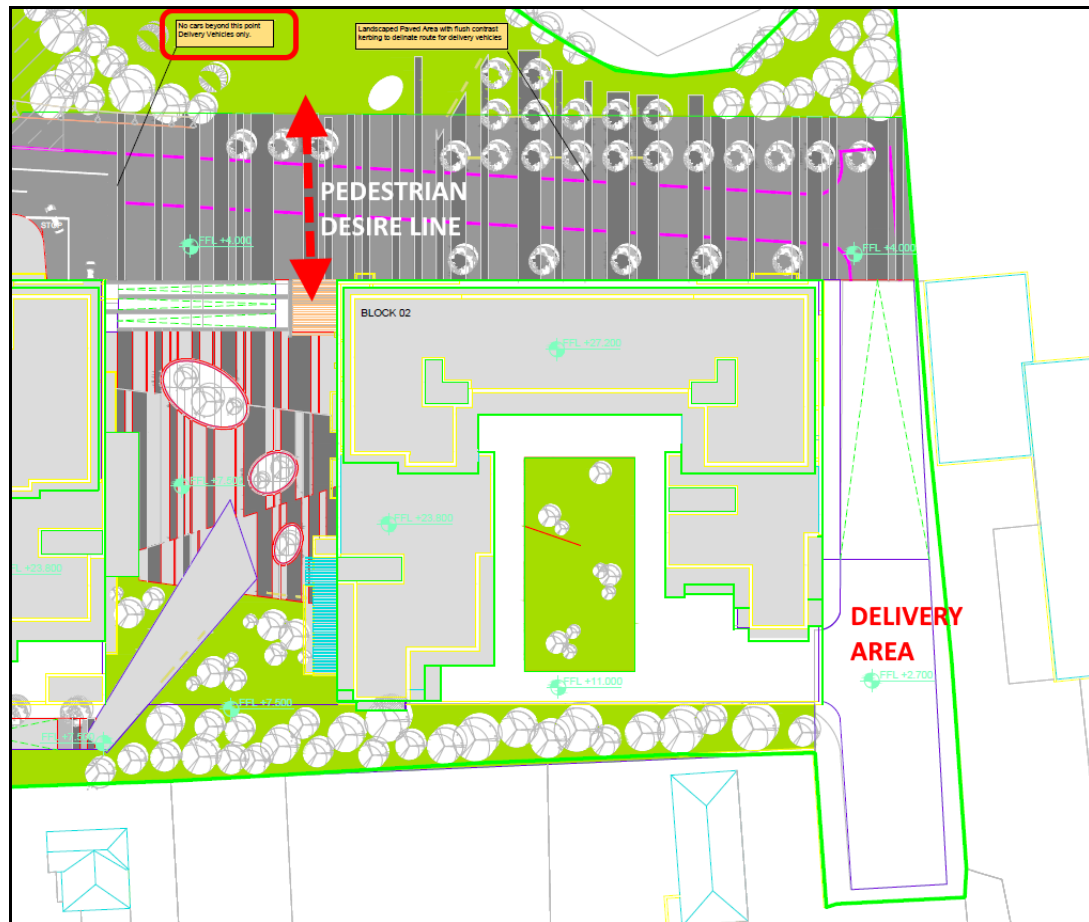
**Figure 15: No provision for signs to distinguish Service Vehicle Access**

There was no signing and lining schedule provided for the proposed signs and road markings, however the design layout includes for stop lines and markings at the proposed site access and at the access to the basement car parking area. No provision has been made for associated signage in accordance with the requirements of the Traffic Signs Manual. There is no provision for reduced speed limit and slow zone signage, parking restrictions and no signs or guidance regarding the restriction of access for delivery vehicles only to the eastern area of the site, where a high pedestrian desire line should be anticipated.

1. A signing and lining schedule should be produced at detailed design stage, to take into account all issues raised in this Stage 1/2 RSA report, to include provision for standardised road markings and signage in accordance with the Traffic Signs Manual.
2. All signs should be posted in full view of motorists in a safe location with a minimum offset of 450mm from the sign face to the carriageway edges. The lowest edge of all signs should be set at a height of 2.1m or higher over footway and at 2.4m or higher over a surface which may be used by cyclists.
3. All road markings and signage to be highly reflective material to ensure visibility during the hours of darkness.
