Mixed Use Development, Carrigaline, Co Cork.

Quality Audit

Client	Reside Investments Ltd.
Project Title	Mixed Use Development Carrigaline, Co Cork..
Document Title	Quality Audit – Access, Walking & Cycling
Document No.	21014-QA-D01
Job No.	21014TT
Date	30th April 2022
Status	Final Issue

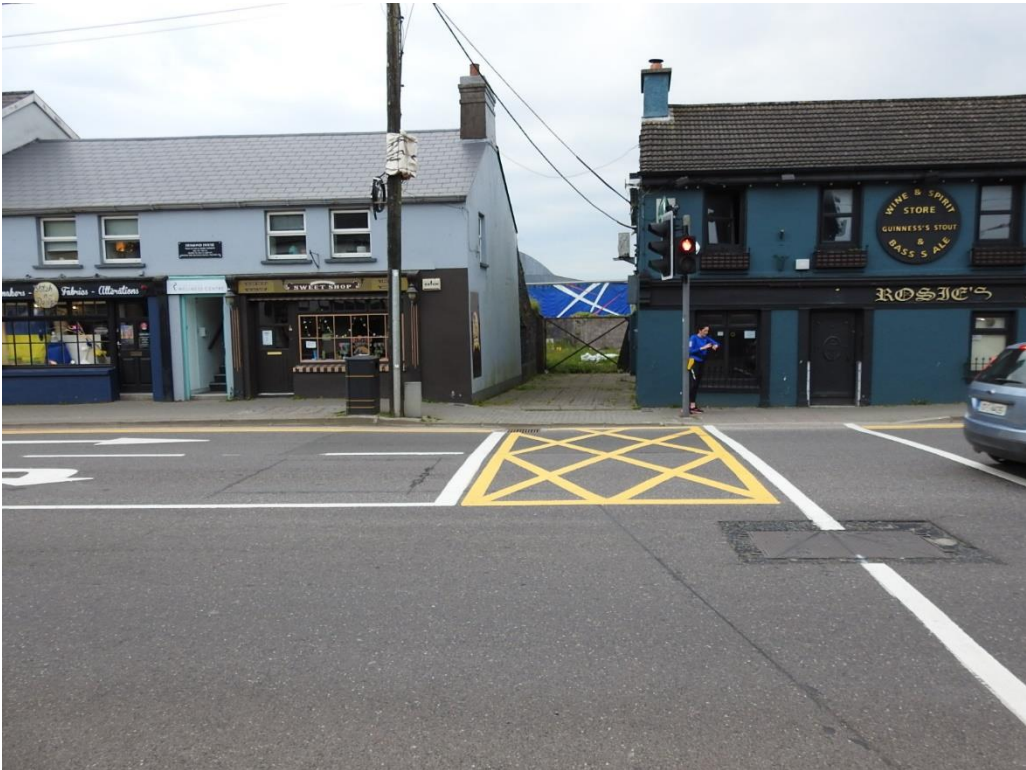
Photo 4: Access to Riverside Pedestrian / Cycle Link to Main Street

5.1.10 The combined cycle/pedestrian Riverside link terminates on Main Street Carrigaline. The connectivity of cycle facilities will be maintained by the provision of cycle facilities as part of the Carrigaline Transportation and Public Realm Enhancement Plan’ (CTRPEP)
