Title: QUALITY AUDIT

Road Safety Audit, Access Audit, Cycle Audit and Walking

Ballyoulster KDA SHD - Phase 1 Residential Development,

Celbridge, Co. Kildare

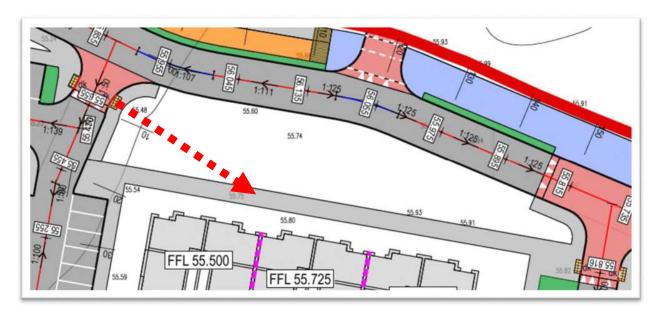
Drawing 180221-DBFL- Z0-SP-DR-C-2001 Rev P02, Main Access Road Ch 90 to 150.

The footpath does not follow the edge of the carriageway along the access road between Ch 90 and 150. There is a risk that pedestrians will take the most direct route from Shinkeen Road and will travel through the green area. This could lead to slips and falls.

It is recommended that the footpath network follows desire lines as much as practicable.

3.1	Yes	No	Hard standing with drop kerb provided to allow access to / from the cycle facility	Yes
3.2	Yes	No	The footpath has been aligned to respect drainage design requirements. Obstructions by way of planting will be provided in this area with the aim of making this route through the green area less convenient	Yes

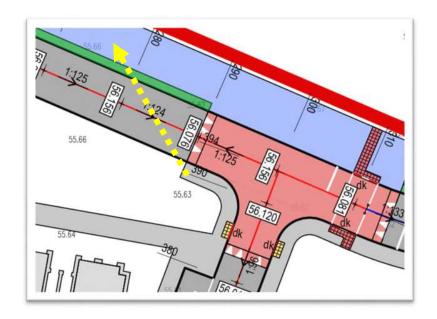
Drawing 180221-DBFL- Z0-SP-DR-C-2001 Rev P02, Main Access Road Ch 140 & 290.

There are short sections of footpath on the western side of the junctions at Ch 140 & 290. These footpaths terminate at the end of the raised tables. There is a risk that pedestrians will use these footpaths and take a diagonal route to the footpath /shared area on the northern side of the main access road rather than using the signalised crossing. This would increase the likelihood of a collision with a passing vehicle.

It is recommended that the section of footpath be removed after the uncontrolled pedestrian crossing on the side roads.

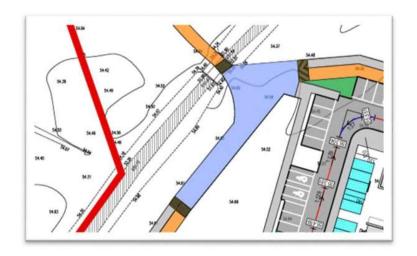
Drawing 180221-DBFL- ZO-SP-DR-C-2001 Rev P02, Shared use path at north eastern end of the site.

There is along section of shared use pedestrian/cyclist path at the north eastern side of the site. The reason for such a long length is unclear. Cyclists will pick up speed and if they collide with pedestrians the severity of the injuries could be higher.

It is recommended that the shared area be reduced to locally around the junction.

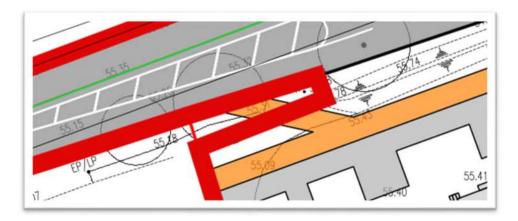
Drawing 180221-DBFL- Z0-SP-DR-C-2002 Rev P02, Dublin Road cycle track.

It is proposed to merge cyclist back onto the Dublin road at the western side of the development at an acute angle. There is a risk that cyclists may not check for oncoming traffic and drivers might not have sufficient visibility to merging cyclists given the berm and the vegetation.

It is recommended that the interim tie-in be perpendicular to the Dublin Road whereby cyclists will have to stop and look right. Suitable visibility splays should be provided to this temporary merge point.

Alternatively the temporary merge should be omitted and suitable fencing be placed along this boundary to ensure that pedestrian and cyclists use the signalised junction to access the Dublin Road.

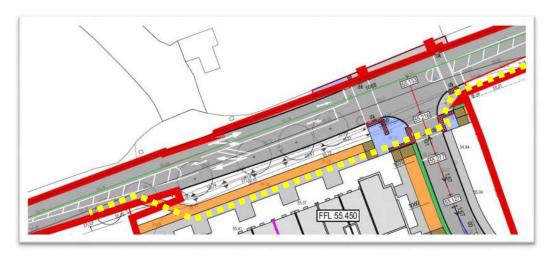
Drawing 180221-DBFL- ZO-SP-DR-C-2002 Rev P02, Dublin Road.

Pedestrians travelling along the southern side of Dublin Road towards Celbridge town centre may think that the footpath to the west of the site access continues towards the town centre and travel along it. When they realise that the footpath terminates they may use the cycle merge to regain access to the Dublin Road. There are poor facilities for pedestrian on the southern side of Dublin Road.

It is recommended that the temporary cycle merge be omitted and suitable fencing be placed along this boundary to ensure that pedestrians use the signalised junction to cross the Dublin Road to the continuous footpath on the northern side.

3.3	Yes	Yes		
3.4	Yes	Yes		
3.5	Yes	Yes		
3.6	Yes	Yes		
3.7	Yes	Yes		
3.8	Yes	Yes		
3.9	Yes	Yes		
3.10	Yes	Yes		
3.11	Yes	No	In the short term prior to continuous pedestrian facilities along the southern side of Dublin Road, pedestrians seeking access to the proposed residential units will be directed along this section of footpath. Celbridge bound pedestrians will be directed to the proposed traffic signals.	Yes
