# Kiltiernan SHD

## Lands at Wayside, Kiltiernan

Quality Audit

Liscove Ltd.

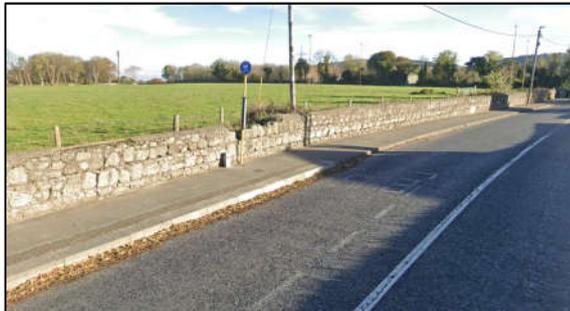
Figure 2-1 – Existing bus stop

Existing bust stop no. 3280 located on Enniskerry Road does not seem to be catered for within the proposed design. This is particularly relevant for those using a wheel chair as a revised location may be force a wheel chair user to take a long route to access and egress the scheme.

The Designer should ensure a suitable location for the existing bus stop, with regards to access and egress to the proposed scheme.

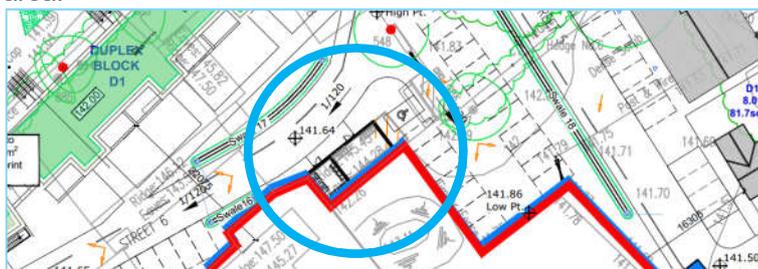
Figure 2-2 – Bin Store on Street 6

The proposed bin store is located in what appears to be remote of the proposed residential and commercial properties. This naturally increases the difficulty for people to access this area.

The Designer should assess the viability of having the bin store closer to the properties and reduce the need to cross the junctions and roads to access the store.

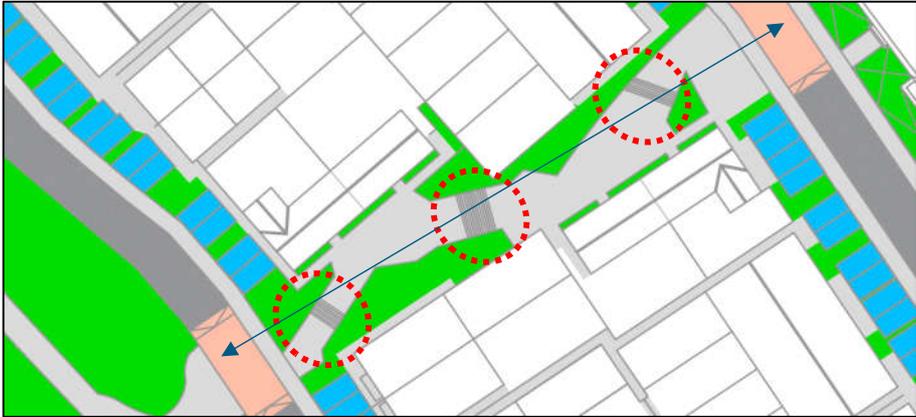
Figure 2-3 – Path between Cell 8 and 9

A series of stairs are indicated between housings cells 8 and 9. It is not apparent how wheelchair users would travel along this part of the scheme and between the adjacent roads.

The Designer should consider the movement of wheelchair users in the location described is adequately considered.

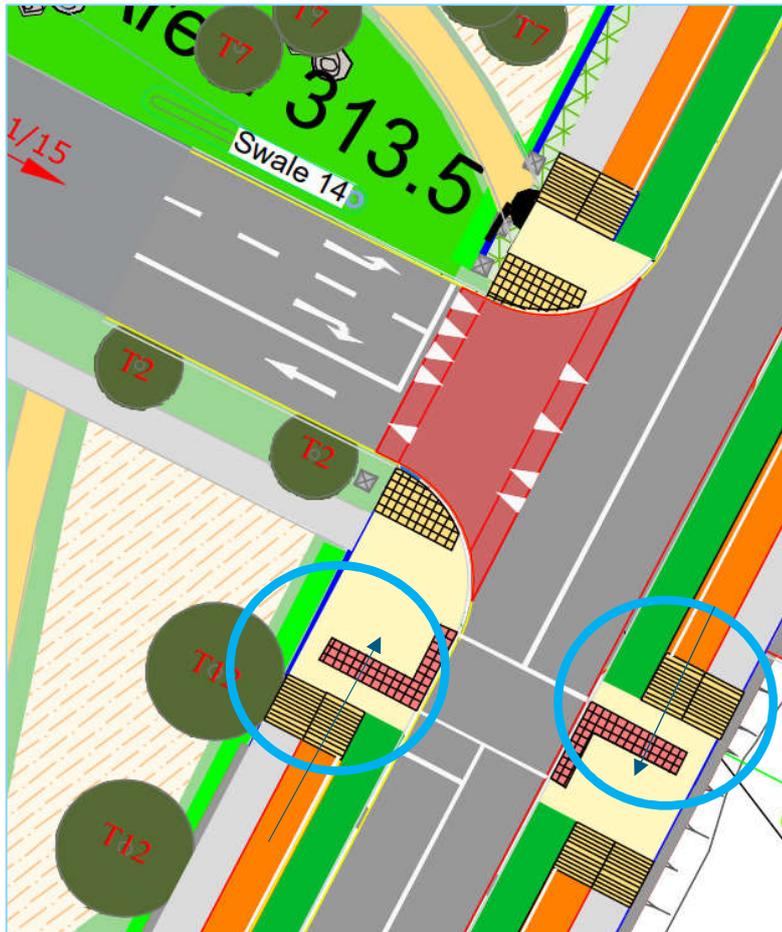
**Figure 3-1 – Signalised Pedestrian Crossing**

The drawings indicate that cyclists will be entering a shared area directly adjacent to the pedestrian waiting area of the signalised pedestrian crossing. There is a risk of conflict between cyclists and visually impaired pedestrians or people who may be pushing buggies as they have limited opportunity and space to avoid each other.

The Designer should increase the length of the shared area to ensure cyclists have enough time to slow down or dismount and account for pedestrians waiting in the areas highlighted.

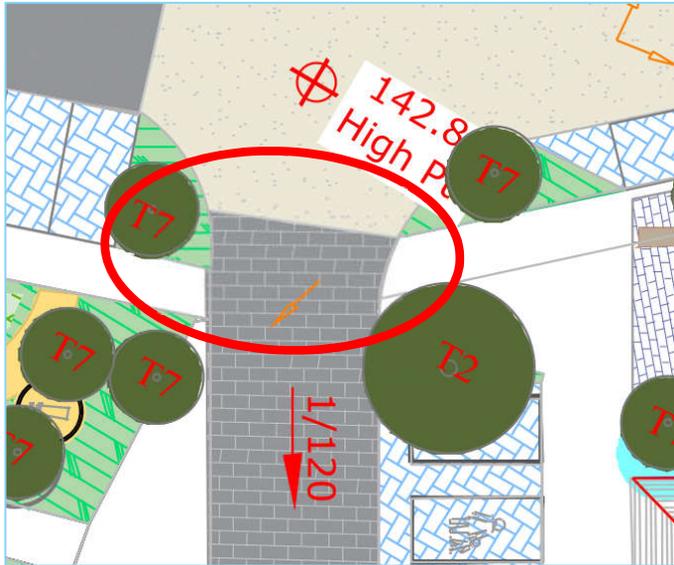
**Figure 3-2 – Internal Junction**

The design drawings do not indicate warning measures at various locations across the scheme. An example of this is the crossing point at the north-east corner of the Village Green. This may result in pedestrians entering the roadway without warning which may result in pedestrian / vehicle collisions.

There are multiple other locations where suitable guidance / warning has not been provided and may lead to conflict where less abled users / visually impaired are not suitably warned.

The Designer should ensure adequate warning features are provided on all desire lines, at the junction crossing points and interface between shared use zones and footpaths throughout the scheme.

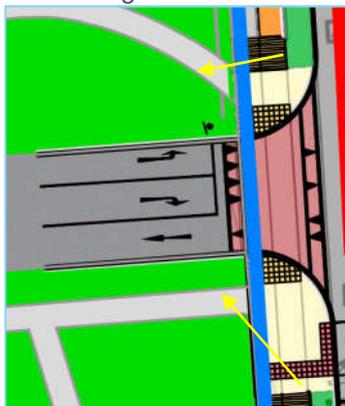
**Figure 3-3 – Cyclist access through junction 1**

The proposals do not indicate how cyclists will enter and exit the development on the east through Junction 1. This may lead to pedestrian / cycle conflict.

The Designer should ensure that cyclists can enter and exit the development while considering the movement of pedestrians across the junction.

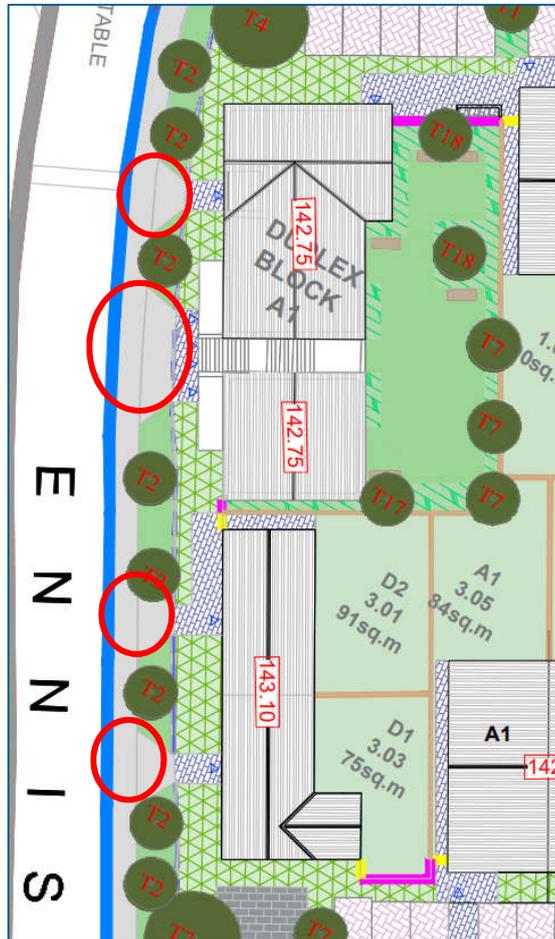
Figure 3-4 – Access points to buildings along west of scheme

The drawings detail pedestrian entrances into Duplex Block A1 opening directly onto the Enniskerry Road. There is potential for drivers to mount the kerb and park within these areas, leading to potential conflicts with pedestrians.

Consideration should be given to deliveries and visitors in and out of the complex. The designer should consider measures to deter vehicles from parking in these areas.

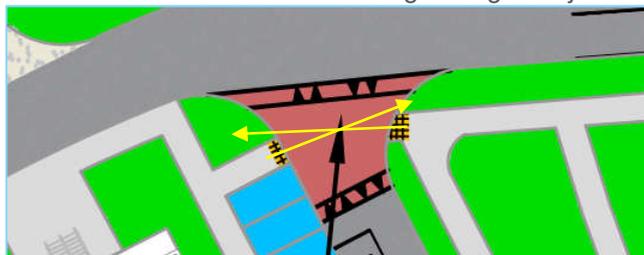
Figure 3-5 – Junction 16 Alignment

The angle of footpaths and tactile paving is such that users may be incorrectly directed across the junction and fail to reach the opposing footpath. This may lead to an increased risk of conflict with vehicles moving through the junction.

The layouts should be amended to have the crossing lining up directly on both sides of the junction.

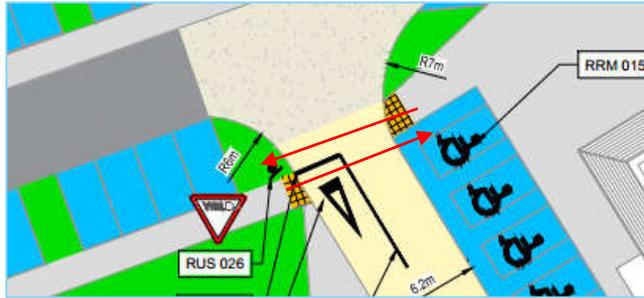
**Figure 3-6 – Junction 12 stagger on crossing**

A similar concern relates to Junction 12.

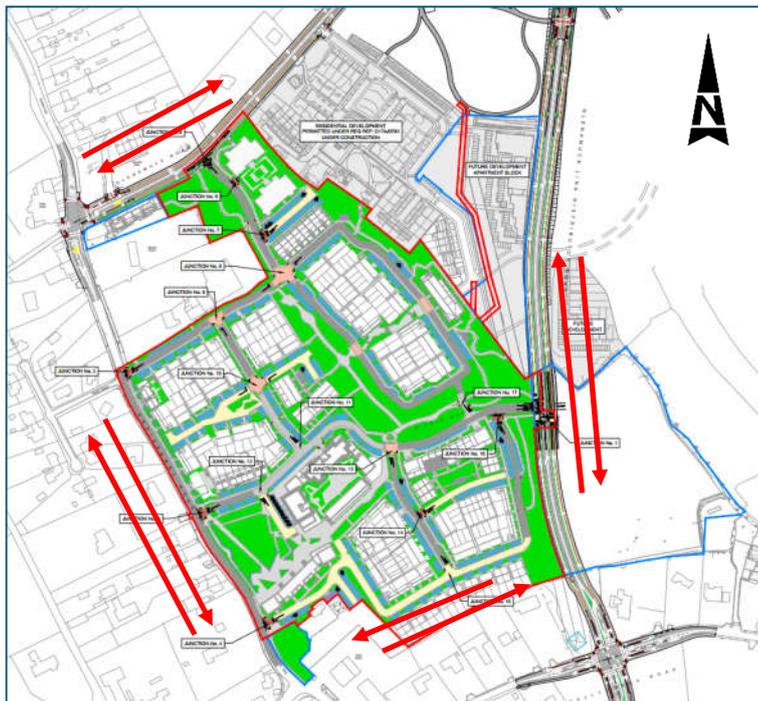
**Figure 2-1 – Loop around development**

The construction of the Glenamuck Link Distribution Road on the east and upgrade of the Glenamuck Road on the north would appear to create an attractive route for recreation and exercise where people can travel on a continuous loop around the development and area of Kiltarnan in general.

2.1	Y	Y	Junction has been designed with input from DLRCC) to reflect demand from all users including motorised vehicle and non-motorised users.	
2.2	Y	Y	A review of junction at detailed design will be undertaken and the optimum layout finalised considering concerns noted.

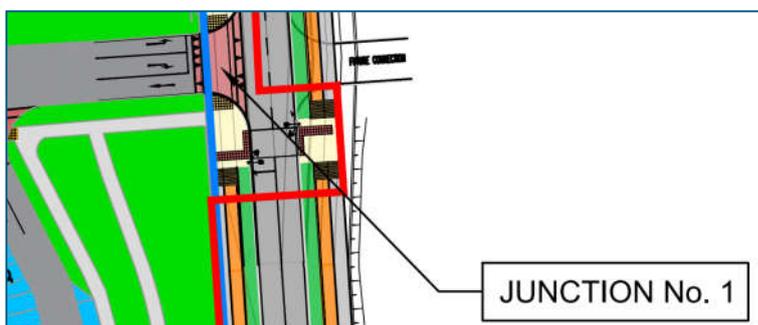
**Figure 2-2 – Junction 1 on East**

Junction 1 on the east is an uncontrolled 3 lane layout (on the western arm) serving the development. The movement of vehicles into and out of the development may conflict with pedestrian, runners and cyclists who are utilising the loop and those users may find it difficult to cross 3 streams of traffic as they travel north-south and through the junction.

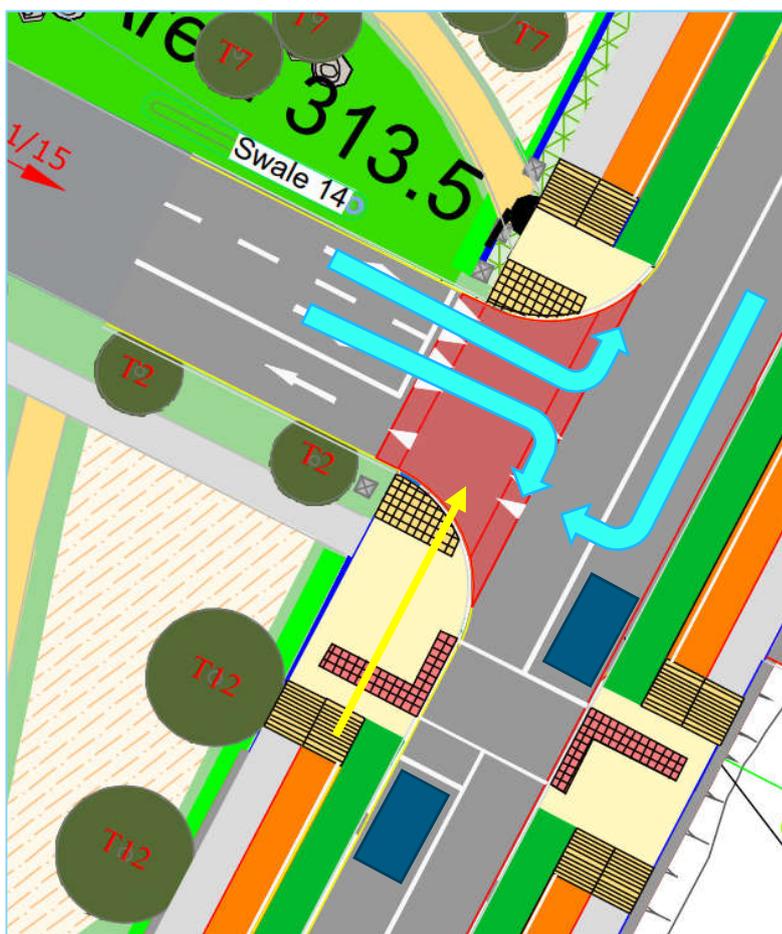
Figure 2-3 – Continuity of Cyclists at Junction 1

The drawings indicate cyclists will bypass the controlled pedestrian crossing and can continue through the junction while the lights may be on red. The presence of stopped vehicles at the pedestrian crossing may suggest it is safe / clear to continue however traffic may still be entering and existing the development at the same time which are unsighted/unexpected by the cyclists. This may lead to conflict between turning vehicles and cyclists.

The Designer should consider measures to address the risk of confusion and conflict noted.

2.3	Y	Y	A review of junction at detailed design will be undertaken and the optimum layout finalised considering concerns noted.	
2.4	Y	N	Traffic flows on Enniskerry Rd will significantly reduce when the GDRS is implemented with a bus gate restricting traffic flows travelling north south through Enniskerry Neighbourhood Centre. Road has been narrowed and footpath widened and landscape improvement. Proposal will provide opportunities for multiple crossings in low traffic low speed environment.	Yes. Shift of traffic and cross section changes noted to help address concerns noted. . Designer might consider crossing of this road by all road users during the detailed design stage to and from other developments including the church.

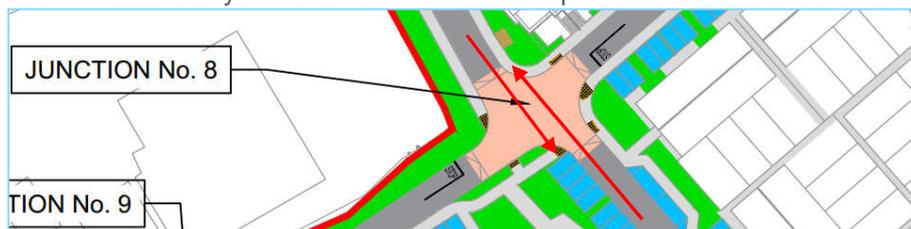
Figure 2-5 – Alignment Through Junction 8

The north-south alignment includes a relatively sharp change/kink. Drivers may find it challenging to negotiate the junction and opposing traffic with the degree of stagger indicated. This may lead to conflict such as swipe and head-on collisions.

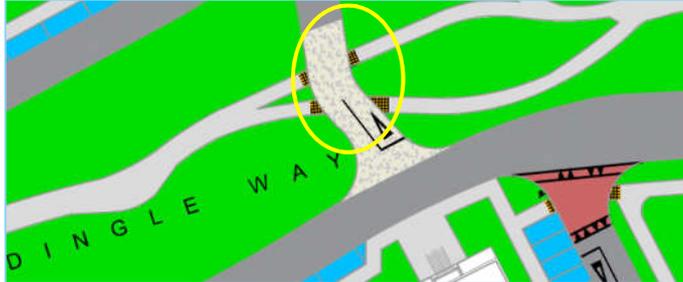
Figure 2-6 – Paths Crossing Dingle Way

Two paths are serving Dingle Way on the east of the development. This is proposed within an area of trees and landscaping which may be dark. Drivers may not be expecting users of the path to come from multiple locations in quick succession with the dark environment adding to the risk of confusion. This may lead to conflict between vehicles and path users.

2.6	Y	N	Location of paths are informed by landscaping including the location of existing mature trees. The overall design is to create a pleasant walking experience in a landscape environment. Vehicle flows and speeds through this environment at very low and design is appropriate for these conditions.	Yes, Layout to be reviewed with more detail at next design stage.

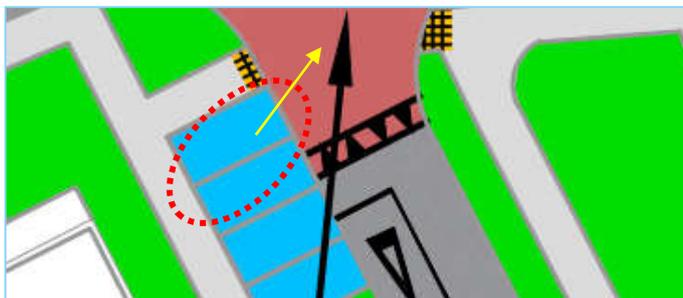
Figure 2-7 – Adjacent Junction 16

Parking is indicated directly adjacent to pedestrian crossings. This may result in vehicles restricting visibility of people wishing to cross the junction. Additionally parked vehicles may need to reverse across the junction while exiting the parking locations. This may also lead to conflict.

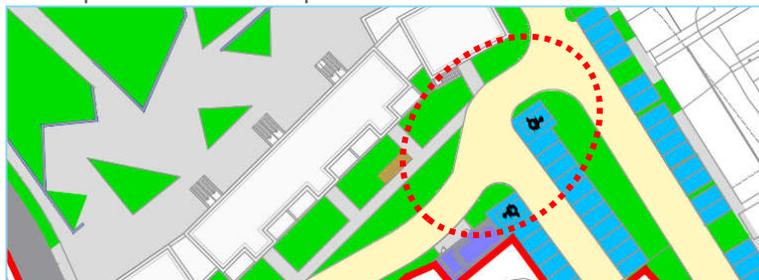
**Figure 2-9 – Curved alignment and junctions Street 6**

Street 6 is proposed to be a shared street for all road users. There are 2 junctions in proximity to each other which is combined with a series of curved alignments. The combination of junction proximity and curved alignment may increase the frequency and likelihood of vehicles crossing into the path of other vehicles and also across the zone where pedestrians are expected to walk.

The Designer undertake a check to ensure vehicles can move through this area without excessively needing to cross centre of the road or the area where pedestrians may need to walk. Where required the curved alignment through the junction may be straightened to address the concerns noted.

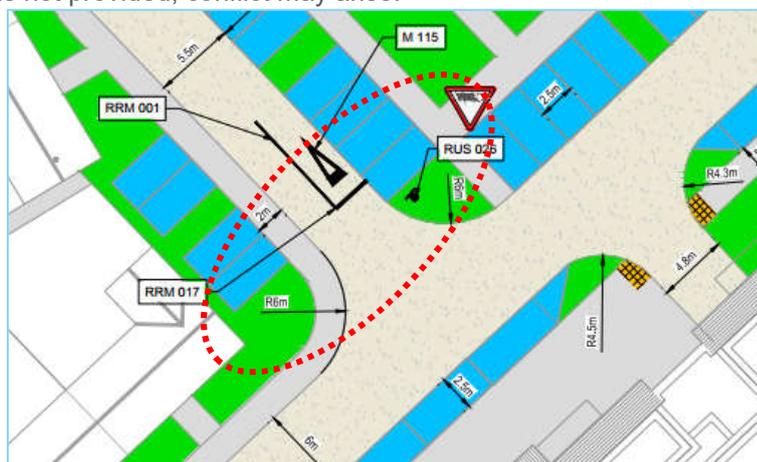
**Figure 2-10 – Likely desire line Junction 11**

Provision for pedestrians wishing to cross Junction 11 are not reflected in the proposals. This junction is located towards the centre of the scheme and a natural focal point and likely to have vulnerable road users wishing to cross east-west. Where adequate provision is not provided, conflict may arise.

2.9	Y	Y		
2.10	Y	Y		
2.11	Y	Y	Design provides adequate visibility given road alignment, design speed and vehicle flows both along the local street and in particular the homezone street where there is limited traffic expected as noted in DMURS (section 4.4.5 page 109 – <i>“Designers must also take a holistic view of the application of reduced forward visibility splays as this can provide traffic calming benefits“</i>	Yes. Designer confirms that adequate visibility has been provided.

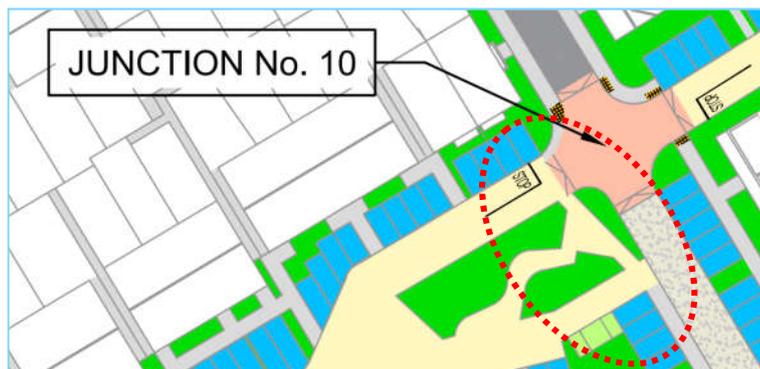
**Figure 2-11 – Likely desire line Junction 10**

A similar concern relates to Junction 10 where a clear dedicated path for pedestrians is not evident in the design drawings.

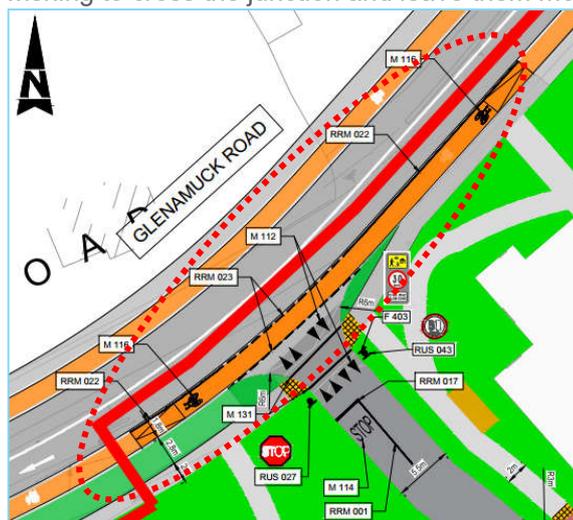
**Figure 2-12 – On road cycle track Junction 5**

Provision for cyclists across the Glenamuck Road at Junction 5 is proposed to be in the form of on-road painted cycle lane. This may not provide sufficient protection for cyclists wishing to cross the junction and leave them more vulnerable to conflict with traffic.

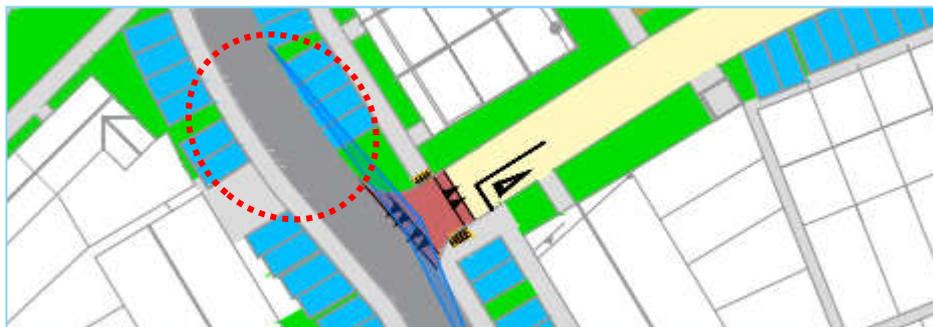
**Figure 2-13 – Parking Junction 14**

Parked vehicles are likely to compromise the visibility splay to the north of the junction. This may result in vehicles pulling out when it is unsafe to do so which may lead to conflict such as swipe, shunt and side-impact collisions.

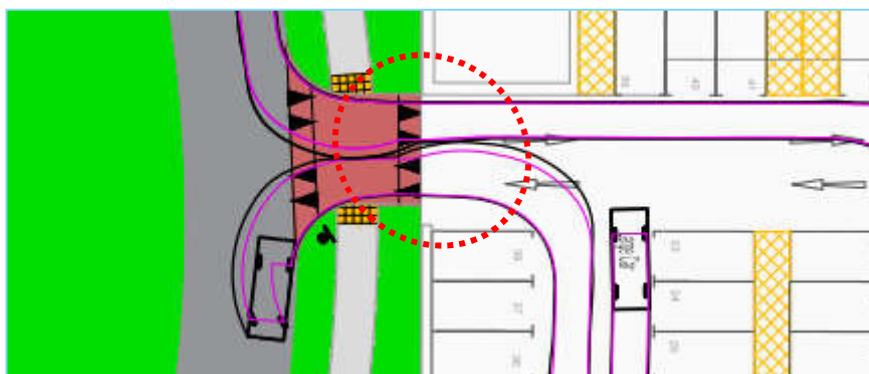
**Figure 2-14 – Parking Block C&D**

The walls serving the parking area of block C&D may compromise visibility to pedestrians crossing at the entrance / exit area. This may result in vehicle / pedestrian conflict.

2.12			Visibility given road alignment, design speed and vehicle flows both along the local street and in particular the homezone street where there is limited traffic expected as noted in DMURS (section 4.4.5 page 109 – <i>“Designers must also take a holistic view of the application of reduced forward visibility splays as this can provide traffic calming benefits“</i>	Yes. Designer confirms that adequate visibility has been provided.
