Environmental Impact Assessment Report (EIAR) Volume 4 of 4 Appendices

Appendix A14.1: Scheme Walkover Summary

Table 1: Scheme Walkover Summary

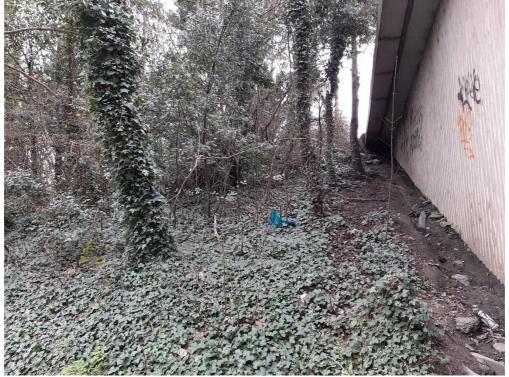
Photo ID	Caption	Date Taken	Coordinates	
Blanchardstown_Image01	Proposed Landtake area for Mill Road Bridge upgrade showing elevation change	25/02/2020	708232, 738731 (ITM)

Observation	General Arrangement Drawing Sheet Number*	Description	Possible Impact	Photo Number
Potential land take for proposed Mill Bridge upgrade works	Sheet 10	The variation in topography at this location could result in earthworks	To be considered for earthworks balance and waste assessment'	Blanchardstown_Image01
Pedestrian access Ramps and Steps	Sheet 10	The variation in topography at this location could result in earthworks being required to create a ramp.	To be considered for earthworks balance and waste assessment'	Blanchardstown 02.
Petrol Station	Sheet 17	Historic activities at petrol stations may have resulted in oil leaks into the surrounding soils and groundwater in the past.	To be considered for earthworks balance and waste assessment' and may mobilize contaminants into the groundwater.	Blanchardstown_Image06
New Development on the Navan Road	Sheet 17	There is a current development underway along the Navan Road	To be considered for earthworks balance and waste assessment'	Blanchardstown_Image 07

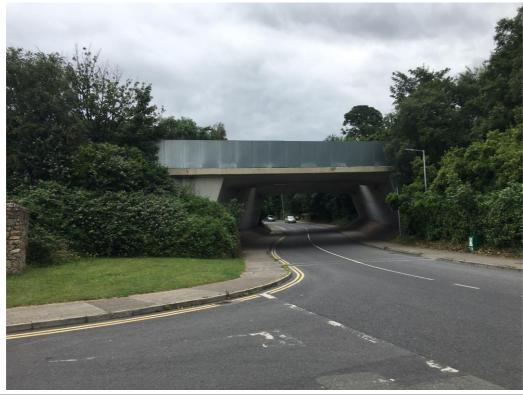
Photo ID	Caption	Date Taken	Coordinates
Blanchardstown_Image02	Area for development of pedestrian access steps/ramps	25/02/2020	708183, 738702 (ITM)

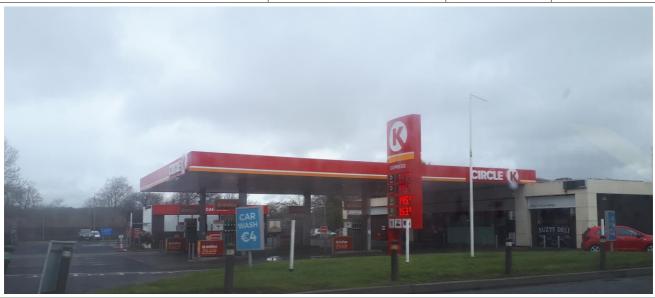
Photo ID	Caption	Date Taken	Coordinates
Blanchardstown_Image06	Petrol Station	25/02/2020	709484, 737828 (ITM)

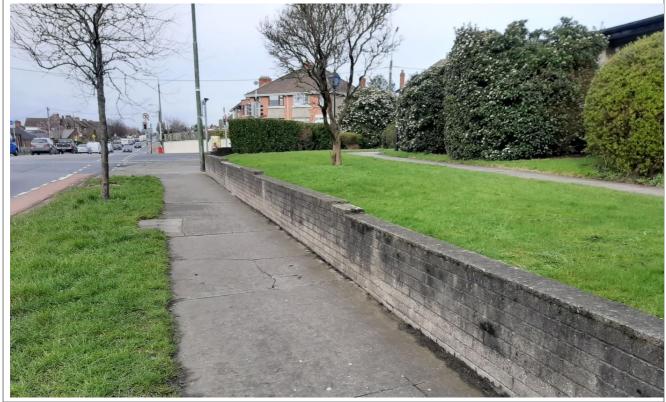
Photo IDCaptionDate TakenCoordinatesBlanchardstown_Image09Cabra Garda Station retaining wall25/02/2020712560, 736329 (ITM)

Road Widening Navan Road	Sheet 21 to 26	There is proposed residential land take due to Road widening along sections of the Navan Road. There are existing retaining walls, which form residential garden walls. There is a noted level change.	To be considered for earthworks balance and waste assessment'	Blanchardstown_Image08
Cabra Garda Station	Sheet 26	There is an existing retaining wall which separates the station grounds from the existing road level. Road widening is proposed along here. There is a noted level change.	To be considered for earthworks balance and waste assessment'	Blanchardstown_Image09
Cabra Car park	Sheet 27	There is an existing boundary wall which separates the carpark from the existing road level. There is proposed road widening in this area. There is a noted level change.	To be considered for earthworks balance and waste assessment'	Blanchardstown_Image10
Existing boundary wall (Navan Road)	Sheet 27	Proposed Road widening is required along the Navan Road which will require removal of this boundary wall .	To be considered for earthworks balance and waste assessment'	Blanchardstown_Image11

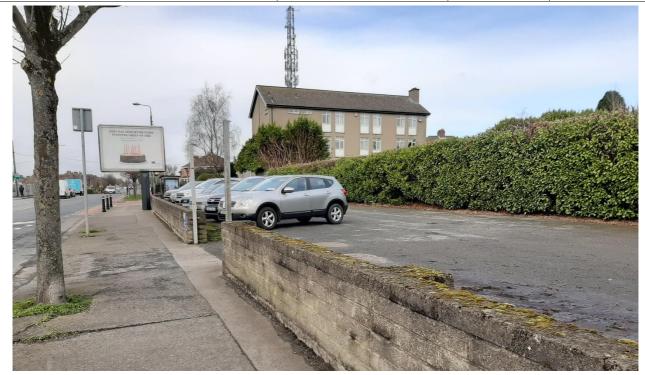
Photo ID	Caption	Date Taken	Coordinates
Blanchardstown_Image10	Cabra Car Park	25/02/2020	712644, 736286 (ITM)

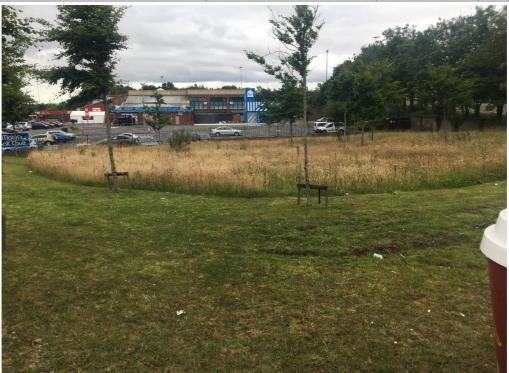
Photo ID	Caption	Date Taken	Coordinates
Blanchardstown_Image13	Image of proposed site for a construction compound at Junction 6 Castleknock – West of M50	09/07/2021	708728, 738392 (ITM)

Potential Construction Compound Junction 6, Castleknock	Sheets 12	A potential Construction compound is to be located at Junction 6, Castleknock, west of the M50. Minor level changes were noted in the green area and is likely to require minor earthworks to accommodate the works	To be considered for earthworks balance and waste assessment'.	Blanchardstown_Image13
Potential Construction Compound – R147 East of the M50 (South & North)	Sheets 14	Potential Construction compounds are to be located at the R147 East of the M50. Minor level changes along with vegetation were noted in the green area and is likely to require minor earthworks to accommodate the works	To be considered for earthworks balance and waste assessment'.	Blanchardstown_Image 14

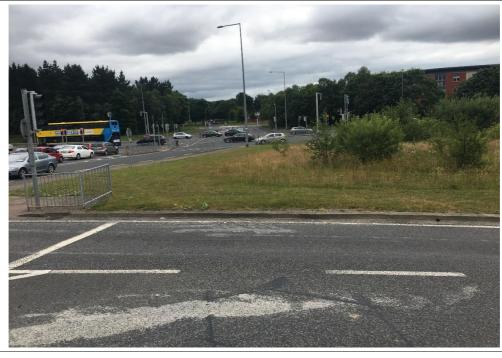
Photo ID	Caption	Date Taken	Coordinates
Blanchardstown_Image14	Image of proposed location for a construction compound at the R147 East of the M50 South	09/07/2021	709255, 738040 (ITM)
