# Aquatic baseline report for the BusConnects Dublin – Core Bus Corridor Infrastructure Works

Prepared by Triturus Environmental Ltd. for Scott Cawley

**December 2020**

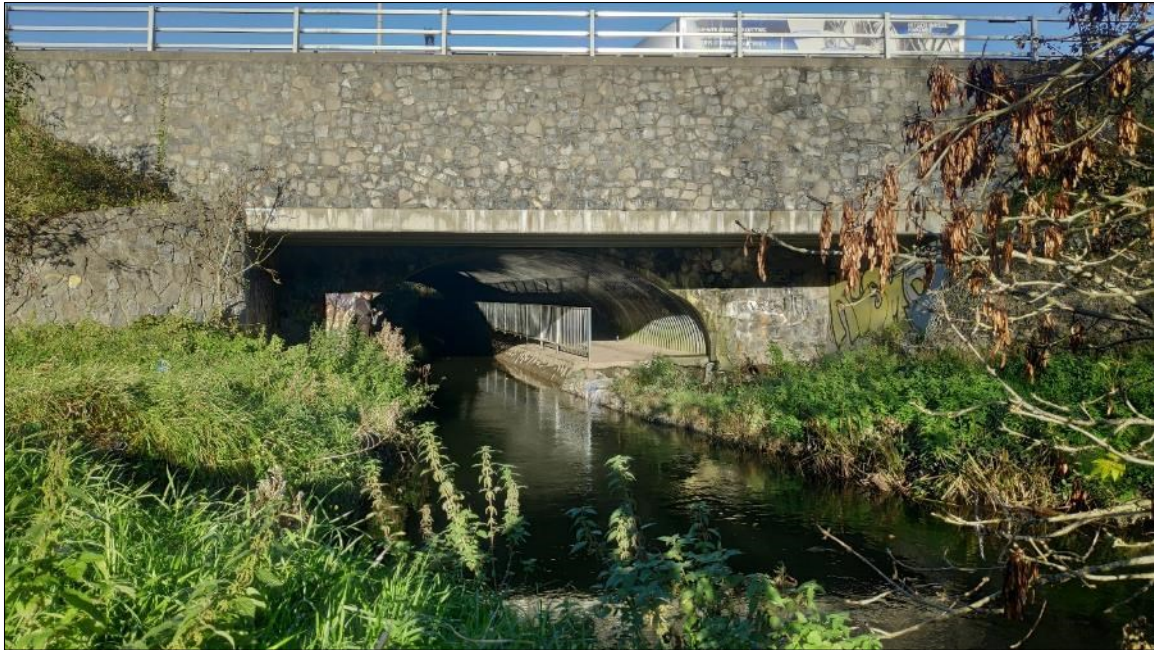
The River Tolka at site T1 was a semi-natural lowland depositing watercourse (FW2) with evident historical deepening and bank modification works. These included gabion basket scour protections and a concrete culverted bed at the N3 road crossing. The river profile mainly comprised of deep glide (60% area) and pool (30%) with more localised riffle (10%). The channel averaged 5-8m wide, with a variable depth of 0.3-1.5m deep. The channel bed comprised rendered concrete under the road crossing. However, downstream of the culvert, the substrata were dominated by boulder and cobble with pockets of very localised medium and fine gravels. The substrata were heavily bedded with 30% cover of filamentous green algae, indicating enrichment. The bed suffered from heavily siltation, albeit swift flows reduced the visible deposition levels on instream substrata. The macrophyte community was limited to small patches of emergent branched-bur reed (*Sparganium erectum*) and watercress (*Rorripa nasturtium-aquaticum* agg.). The coarse substrata on the bed also supported the aquatic moss species *Cinclidotus fontinaloides* and *Platyhypnidium riparoides* locally. The riparian habitats supported mainly scrub habitat (WS1) and rank grassy areas (GS2) with frequent nettle (*Urtica dioica*), butterbur (*Petasites hybridus*), thistles (*Cirsium* spp.) and red osier dog wood (*Cornus cericea*). Riparian trees were scattered along the banks with crack willow (*Salix fragilis*) and sycamore (*Acer pseudoplatanus*) being the most frequent species.

The river was considered a moderate quality brown trout nursery, with some localised deeper pools (including immediately downstream of the culvert) providing good holding habitat. Spawning habitat for both salmonids and lamprey was locally good (c.110m downstream of the culvert in the tailing of a pool where mobile gravel was identified, ITM 707825, 738930). The site offered poor lamprey ammocoete habitat given the high flow rates and predominance of hard substrata. European eel habitat was moderate overall. The deeper pool areas locally would support European eel (*Anguilla anguilla*). White-clawed crayfish are not present in the River Tolka (no known records) and were not recorded during the survey. Otter spraint (1 site (3 spraints)) was recorded under the culvert in a muddy area of the west bank (ITM 707817, 739019).

**Plate 3.1** Representative image of site T1 on the River Tolka (facing upstream towards culvert)

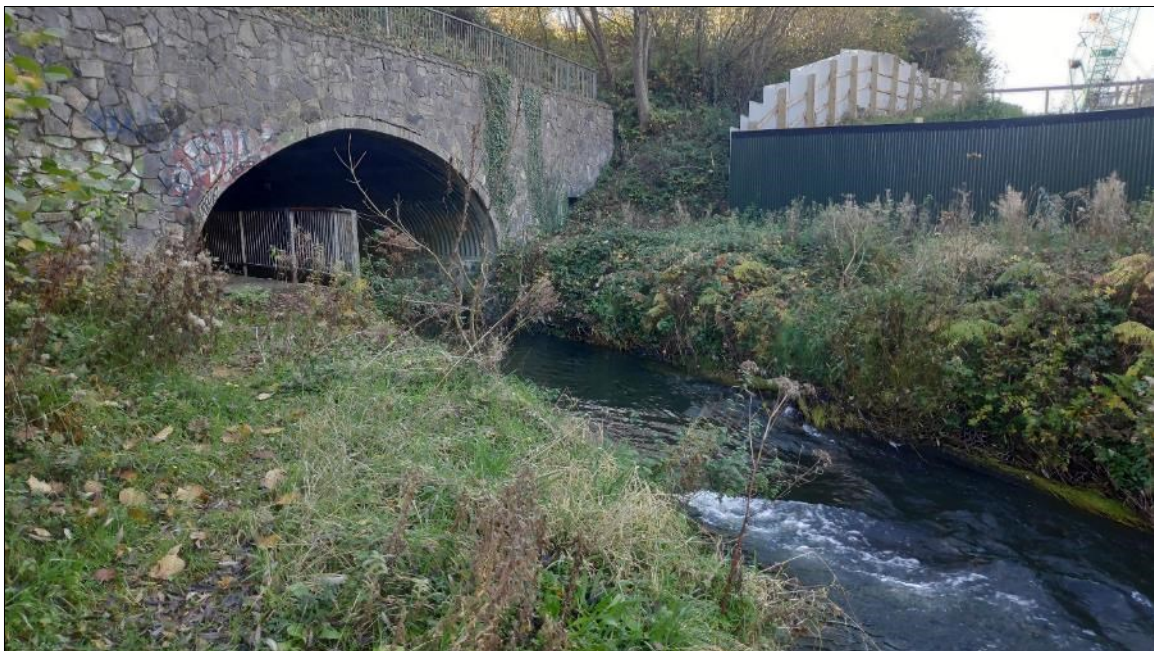
The River Tolka at site T2 was a semi-natural lowland depositing watercourse (FW2) with a swift flow and a well-defined thalweg downstream of the bridge crossing and associated culvert. Located approx. 0.5km downstream of site T1, the river profile was dominated by glide (50%) and riffle (40% area) with more localised pool 10%. The channel width was variable between 6m and 14m wide. The depth was also variable and recorded between 0.4m and 1.0m deep. The good semi-natural character for an urban river, however, was diminished by riverine substrata that were in poor condition due to siltation pressures. Furthermore, hydro-morphologically the river had been altered at the N3 crossing with the channel bed comprising of rendered concrete with little gravel or cobble deposition under the road crossing. Downstream of the culvert, the bed comprised bedrock, boulder and cobble with very localised pockets of medium and fine gravels. The substrata were very however, heavily bedded and covered by filamentous green algae (205 surface area cover, indicating enrichment). While the bed suffered from heavily siltation, the swift flows reduced the visible deposition levels on the visible instream substrata (as with other areas on the River Tolka). The macrophyte community comprised locally frequent watercress (*Rorippa nasturtium-aquaticum* agg.) and lesser water parsnip (*Berula erecta*) in the margins. The coarse substrata on the bed also supported *Cinclidotus fontinaloides* and *Platyhipnidium riparoides* locally. The riparian habitats supported mainly scrub habitat and rank grassy areas with frequent winter heliotrope, nettle, bramble (*Rubus fruticosus* agg.), bracken (*Pteridium aquilinum*), buddleja (*Buddleja davidii*), hemp agrimony (*Eupatorium cannabinum*), spear thistle (*Cirsium vulgare*) and hogweed (*Heracleum sphondylium*). The banks supported a few scattered mature crack willow (*Salix fragilis*), with a more mature treeline downstream of the survey area. The river upstream of the culvert was narrower, very fast flowing and heavily overgrown with scrub. Historical bank works were evident with gabion baskets present.

The river was considered a moderate brown trout nursery, with some localised deeper pools providing good holding habitat. Spawning habitat for both salmonids and lamprey was poor given substrata compaction and bedding. Swift flows largely precluded sediment deposition but some superficial silts were present marginally which provided some limited suitability for *Lampetra* sp. ammocoetes. European eel habitat was moderate overall albeit compaction of the bed and swift flows provided for less optimal refugia. White-clawed crayfish are not present in the River Tolka (no known records) and were not recorded during the survey. Regular otter spraint sites were recorded on the concrete path on the downstream side (ITM 708122, 738814) and upstream side of the culvert (ITM 708095, 738790).

**Plate 3.2** Representative image of site T2 on the River Tolka (facing upstream towards culvert)

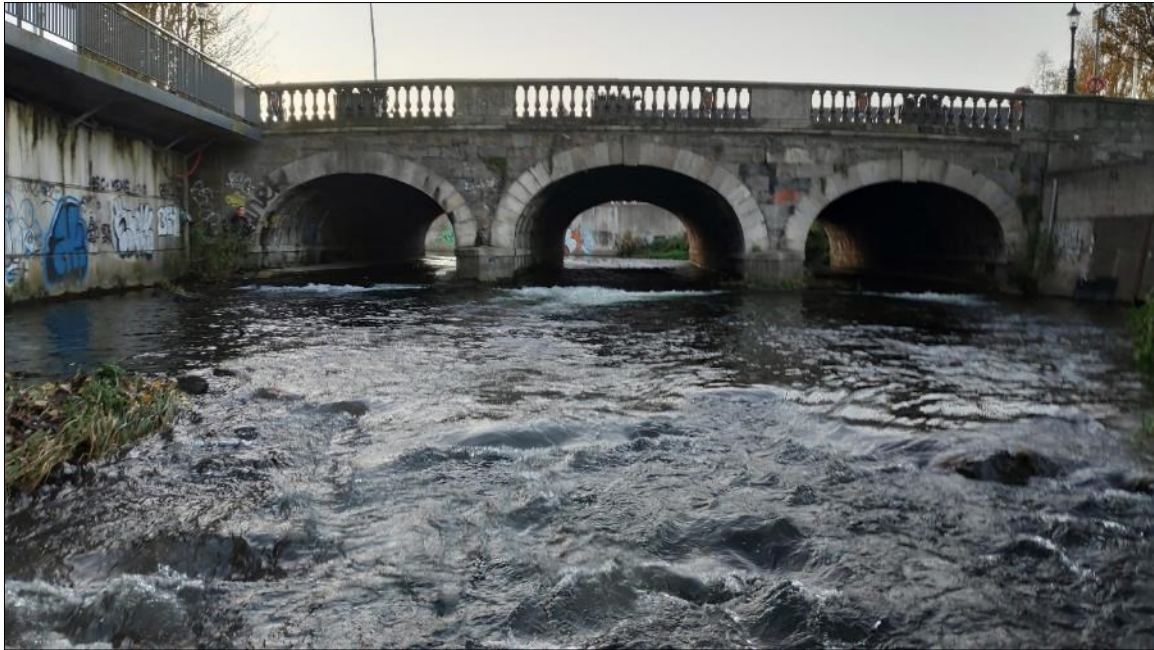
The River Tolka at site T3 was a semi-natural lowland depositing watercourse (FW2) with a swift flow. Despite being located in a heavily urbanised area with high retaining walls, the river profile was surprisingly natural downstream of the bridge (upstream being glide dominated, held between retaining walls and with less natural character). The river profile was dominated by glide (30%) and riffle (50%) with more localised pool 20% (the largest of which was located immediately downstream of the bridge apron/weir). The channel width was variable between 15m and 20m wide, being narrower downstream where marginal riparian stands of osier (*Salix viminalis*), grey

Downstream of the bridge, the river was considered a good brown trout nursery and good holding area for adult fish. Spawning for both salmonids and lamprey was considered locally good, despite siltation pressures. Upstream of the bridge the river was mainly a holding area for salmonids with deeper glide habitat held between retaining walls. Lamprey ammocoete habitat was sparse given the high energy nature of the site. European eel habitat was good downstream of the bridge owing to ample boulder refugia and deeper pool areas. White-clawed crayfish are not present in the River Tolka as previously described for other survey areas and none were recorded during the survey. A regular otter spraint site (1(6), mixed age) was recorded on the bridge apron downstream of the bridge (south bank) (ITM 716124, 736756).

**Plate 3.3** Representative image of site T3 on the River Tolka at Frank Flood Bridge (facing upstream)

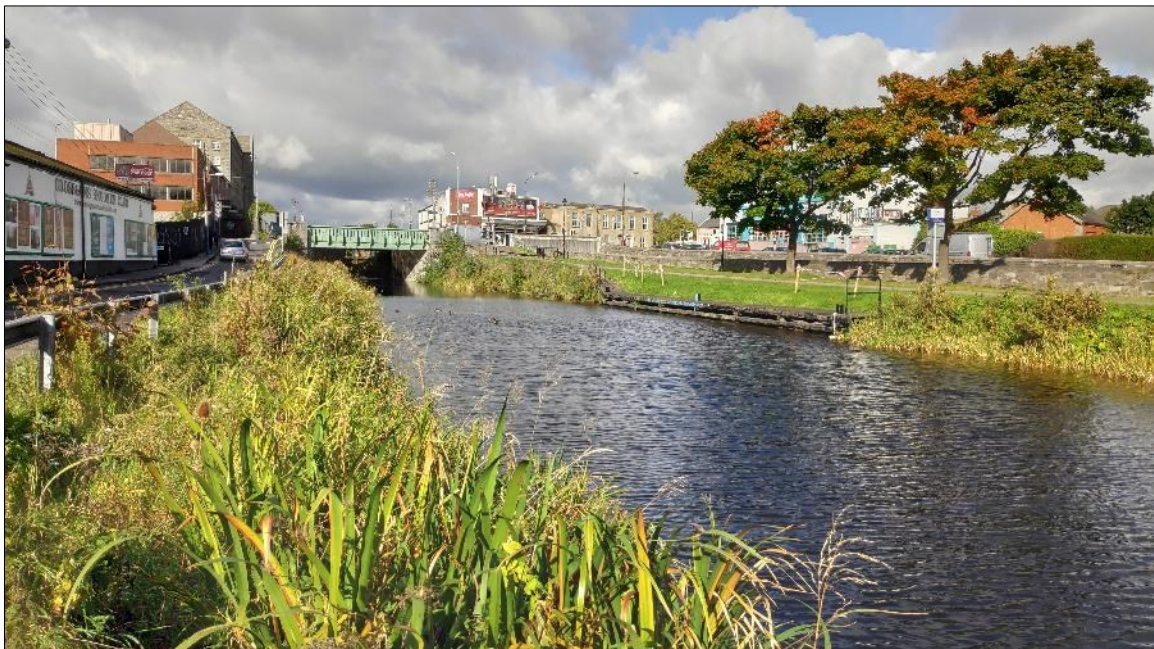
The Royal Canal between the 4<sup>th</sup> and 5<sup>th</sup> lock (level 4, Phibsborough) was a uniform 10-12m wide and 1.5-2.5m deep, with a centrally deeper navigation channel in most areas. The substrata were dominated by silt with high clay fractions (often >0.3m in depth), with scattered boulder and localised marginal cobble/gravel areas (e.g. along boat gangway). The 300m section of canal (between the 4<sup>th</sup> and 5<sup>th</sup> locks) was typified by narrow riparian fringes bordered by urban areas and built land (BL3). The riparian zones supported a range of common species such as great willowherb (*Epilobium hirsutum*), nettle, meadowsweet, yarrow (*Achillea millefolium*), marsh ragwort (*Jacobaea aquatica*), hedge bindweed (*Calystegia sepium*), creeping thistle, hogweed and occasional teasel (*Dipsacus fullonum*). Non-native Canadian fleabane (*Conyza canadensis*) and buddleja were both occasional. Intermittent planted treelines of sycamore and cherry (*Prunus* sp.) were present in maintained grassland strips (WD5 parkland habitat). The canal margins were lined by narrow linear strips dominated by reed sweet grass (*Glyceria maxima*) with frequent stands of iris (*Iris pseudacorus*) and occasional reed canary grass. Instream, the macrophyte community was dominated by yellow lily (*Nuphar lutea*) (both submerged and emergent forms), with common duckweed (*Lemna minor*) and ivy-leaved duckweed (*Lemna trisulca*) being frequent. Also frequent was Canadian pondweed (*Elodea canadensis*), Nuttall's pondweed (*Elodea nuttallii*), whorled-water milfoil (*Myriophyllum verticillatum*) and stonewort species *Chara* sp. Amphibious bistort (*Persicaria amphibia*) was occasional on bank and in margins. The rare and protected opposite-leaved pondweed (*Groenlandia densa*) is known from this area of the Royal Canal (BEC, 2011; NPWS data) but no stands were observed during the survey (October 2020). It is considered likely that the species is still present but given it is a dark green, submerged pondweed that often sprawls along the bottom, its detection can be difficult.

Overall, site RC1 offered excellent coarse fish habitat for a range of common species including roach (*Rutilus rutilus*), bream (*Abramis brama*), perch (*Perca fluviatilis*) and pike (*Esox lucius*). Well-vegetated canal sections such as this provide valuable nursery habitat for numerous fish species, in addition to good spawning substrata in the spring/early summer months. European eel are known from this section of canal and habitat was considered good. No white-clawed crayfish are known from the eastern extent of the Royal Canal in Dublin City (NBDC, NPWS data, pers. obs.), despite some good physical habitat and physiochemical suitability. No otter signs were recorded during the site visit although suitable marking areas were largely absent.

**Plate 3.4** Representative image of site RC1 on the Royal Canal at Phibsborough (5<sup>th</sup> lock)

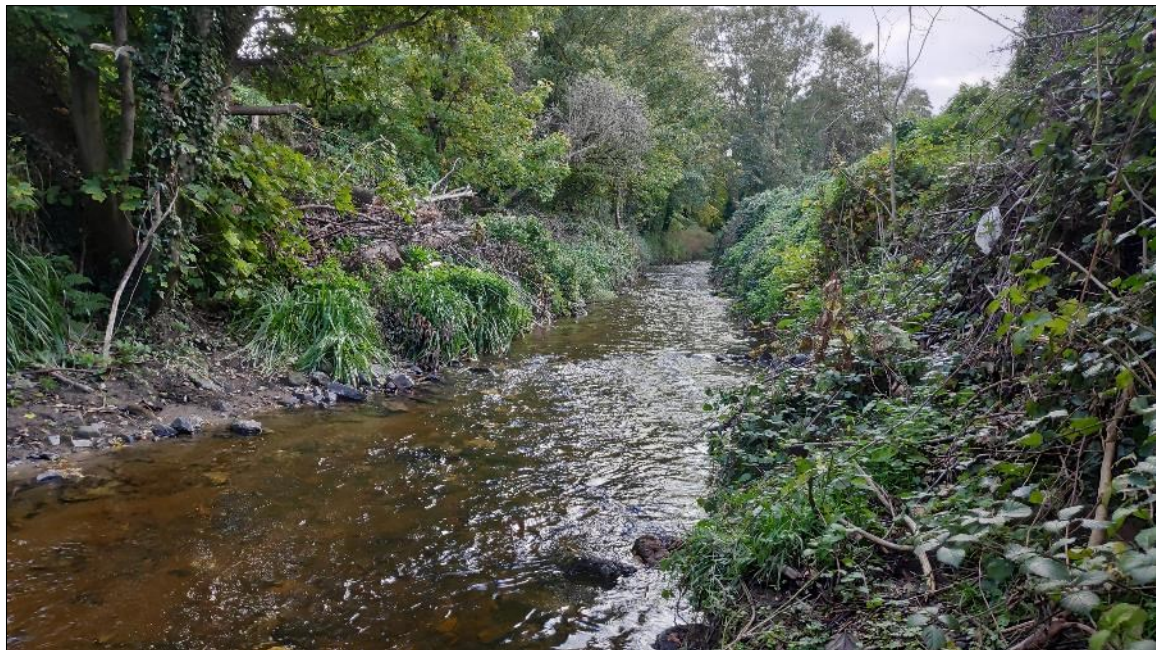
The Owendoher River at site O1 was located approx. 100m upstream of the R114 road bridge (site O2). The upland eroding watercourse (FW1) was swift flowing and averaged 6-7m wide and 0.2-0.5m deep, with localised deeper pool and glide areas to 1m. The river flowed through a semi-natural V-shaped incised valley with bankfull heights of 7-8m (steep sided). The site was characterised by shallow glide (30%) and riffle (60%) with occasional pool areas, usually associated with large instream boulders. The substrata were dominated by partially bedded cobble (40%) with clean sand and fine to medium gravels atop (40% overall). Large boulder was frequent (20%). Siltation was very low with any accumulations of finer substrata dominated by sand. Erosion from floods and human access was evident along both banks. Although adjoined by urban areas (BL3, GA2 etc.), the river was isolated from human activity with poor access via steep

Overall, site O1 offered excellent salmonid habitat, with particularly good spawning opportunities given abundant clean substrata. Whilst limited in extent (site was typically shallow riffle), some very good holding habitat was present in localised small pools (with brown trout evidently plentiful). The site was also a good salmonid nursery. Whilst the site offered some good physical suitability for lamprey spawning, the swift flows and general eroding/spate nature precluded fine sediment deposition and larval habitat was largely absent. European eel habitat was moderate. White-clawed crayfish are not known in the Owendoher, despite some good physical suitability. Otter suitability was very high given low disturbance and good prey resources (but no signs were recorded at this site).

**Plate 3.5** Representative image of site O1 on the Owendoher River (facing upstream)

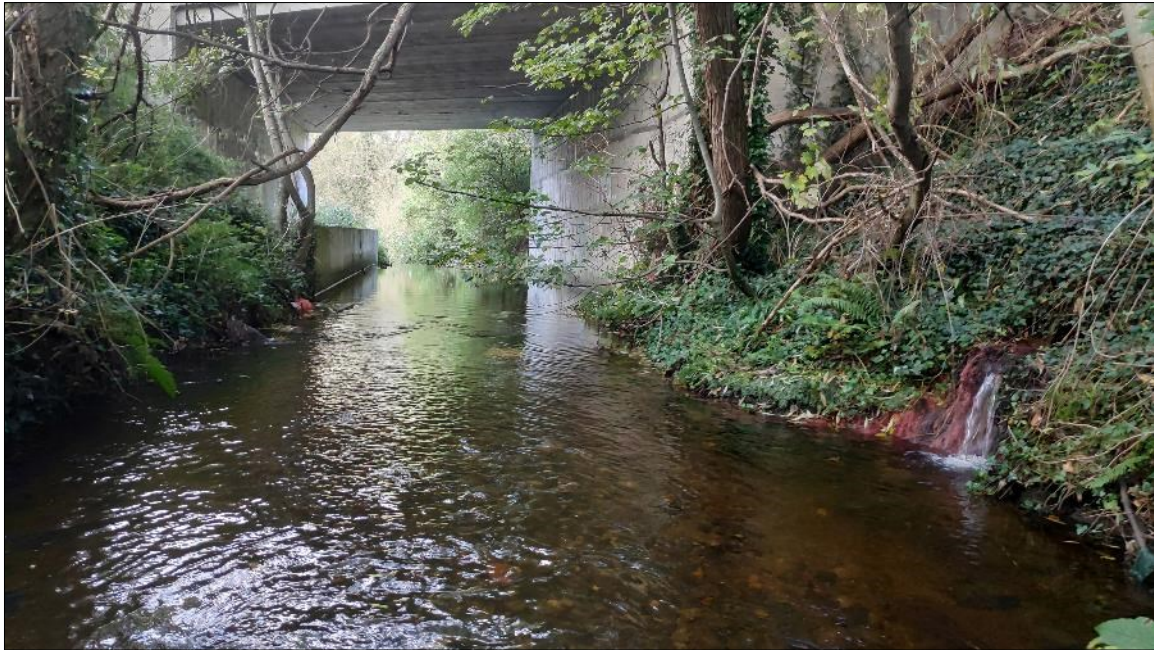
The Owendoher at site O2 was located at the R114 road bridge/culvert, approx. 100m downstream from site O1. Here, the river averaged 6-7m wide and 0.3-0.6m deep, with localised deeper pool and glide areas to 1.2m. The river flowed through a semi-natural V-shaped valley with bankfull heights of 7-8m (steep sided) and was bound by masonry retaining walls under the bridge. In contrast to site O1 upstream, the site was characterised by slower, deeper glide and pool. Downstream of the weir, riffle predominated. The substrata were dominated by partially bedded cobble (30%) with clean sand (30%) and well-sorted gravels (20% overall). There were extensive beds of coarse sand locally. Large boulder was frequent (20%). Siltation was low with any accumulations of finer substrata dominated by sand. Erosion from floods and human interference was evident along both banks. As per site O1, the river was isolated from human activity with poor access via steep banks. The banks supported mature treelines dominated by sycamore, crack willow, ash and elder (*Alnus glutinosa*), with occasional cherry laurel. Buddleja was present downstream of the bridge. The scrubby escarpments supported bramble and ivy with angelica and hedge bindweed. Japanese knotweed and winter heliotrope was scattered throughout the site (but more prevalent upstream). Riparian shading was relatively high and macrophytes were absent. The aquatic moss layer was poorly developed with only localised *Platyhypnidium riparoides* present, with *Hygroamblystegium tenax* on the weir face. The bridge retaining walls did not support vegetation.

Site O2 offered excellent salmonid habitat, with particularly good spawning opportunities given abundant clean substrata. Holding habitat was also excellent (particularly underneath the bridge) although the weir was a significant barrier to fish migration (no fish pass present). Brown trout were plentiful. The site was also a good salmonid nursery (likely brown trout only given known migration barriers downstream). Whilst the site offered some good physical suitability for lamprey spawning, the swift flows and general eroding/spate nature precluded fine sediment deposition and larval habitat was largely absent. European eel habitat was moderate. White-clawed crayfish are not known in the Owendoher. Old otter spraint (1(2)) was recorded under the bridge structure on the west bank (ITM 714179, 728878).

**Plate 3.6** Representative image of site O2 on the Owendoher River (facing downstream towards road bridge with point source evident in right foreground)

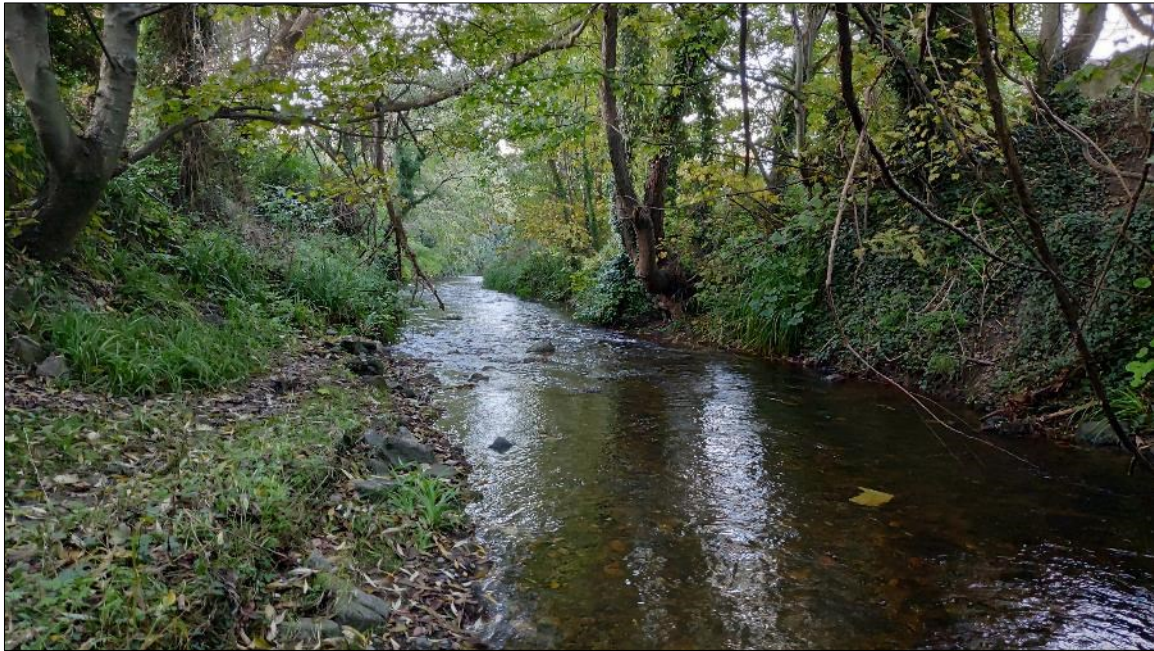
In summary, site O3 showed excellent salmonid habitat with good habitat in particular. Additionally, habitat with high otter potential (including a possible breeding area) was also noted.

**Plate 3.7** Representative image of site O3 on the Owendoher River (facing downstream)

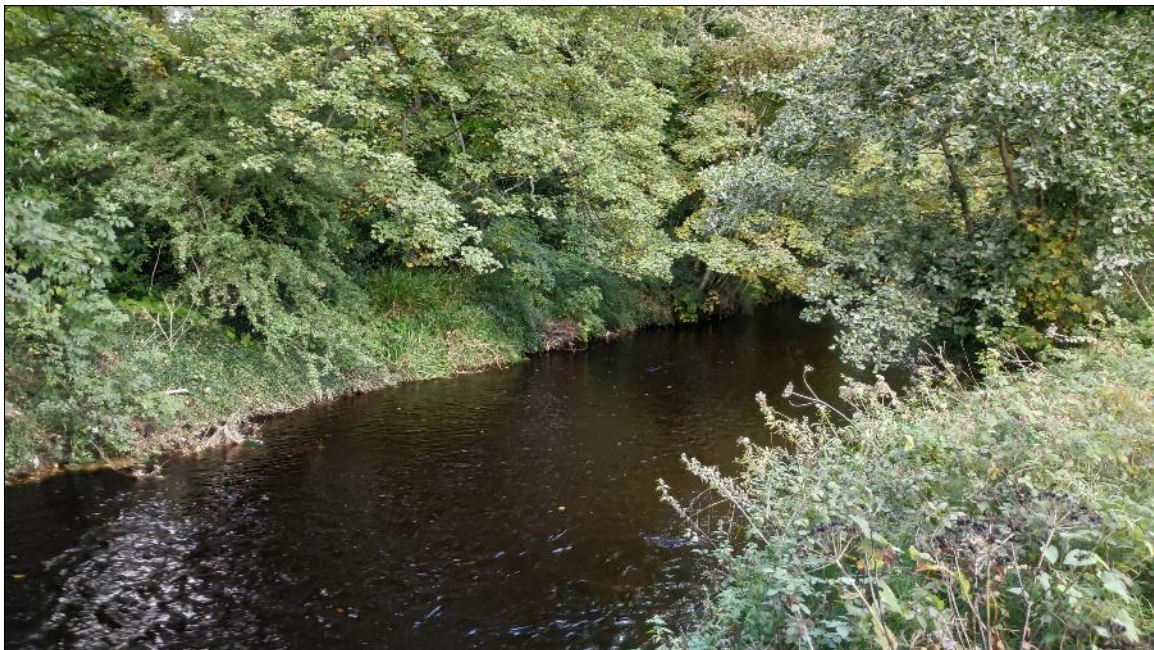
In summary, given the excellent salmonid habitat - in particular spawning gravel, with other areas of good quality nursery and holding habitat observed at this site. Otter activity was not seen at this site during survey, but it is thought that habitat potential at this site was high for this species.

**Plate 3.8** Representative image of site D1 on the River Dodder at Rathdown Park

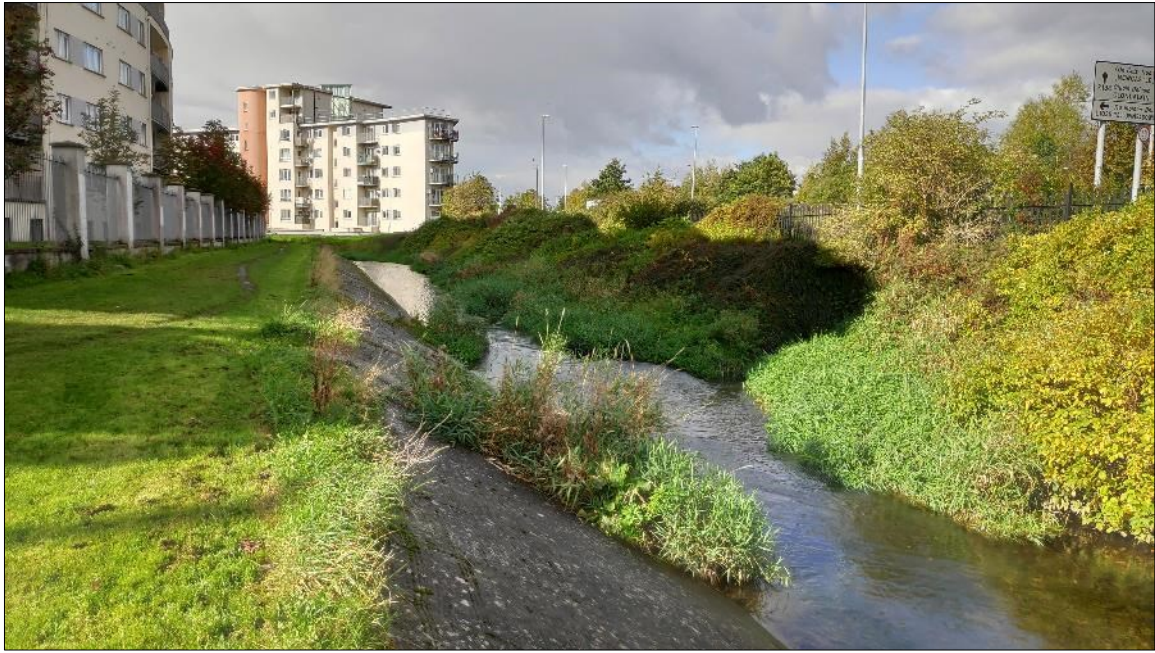
In summary, salmonid habitat was found to be of moderate quality, with moderate quality lamprey habitat and low densities of Annex II white-clawed crayfish at this site.

**Plate 3.9** Representative image of site C1 on the River Camac (facing upstream)

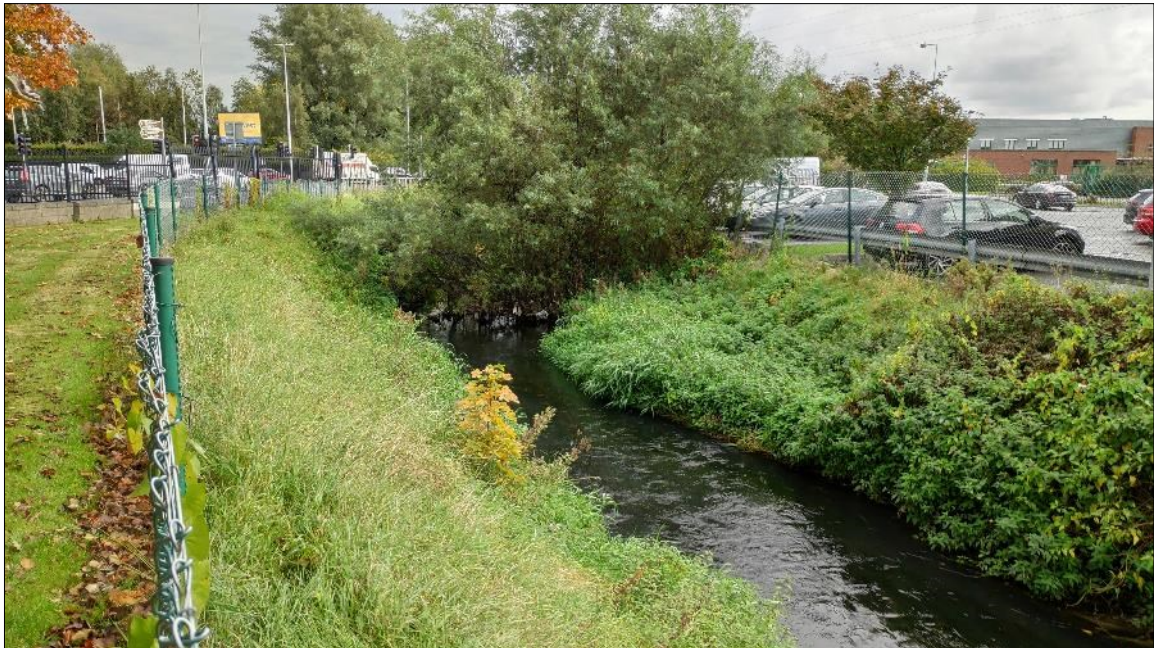
Site C2 offered some very good salmonid habitat (brown trout only). Upstream of the culvert provided excellent quality spawning and nursery habitat (among the best on the entire river) with very good holding habitat for abundant adult trout in undercut banks/under overhanging reed canary grass. A single mature crack willow immediately upstream of the culvert also provided an excellent deep holding pool for adult salmonids. Downstream, whilst spawning and nursery value was somewhat reduced, adult holding habitat was very good given undercut banks and prominent submerged tree roots (willow and sycamore). These also offered excellent refugia for white-clawed crayfish, which were recorded at 'moderate' densities ( $\geq 1$  to  $< 3$  per 10 refugia; Peay, 2003). A total of  $n=8$  crayfish were recorded via sweep netting, with males, females and juveniles present, ranging from 19-41mm carapace length. Lamprey ammocoete habitat was present both upstream and downstream of the culvert, usually in association with instream macrophyte beds. European eel habitat was good throughout but better upstream. Despite known utilisation of the river and abundant prey resource, no otter signs were recorded during the site visit (few suitable marking sites present).

**Plate 3.10** Representative image of site C2 on the River Camac (upstream of the culvert)

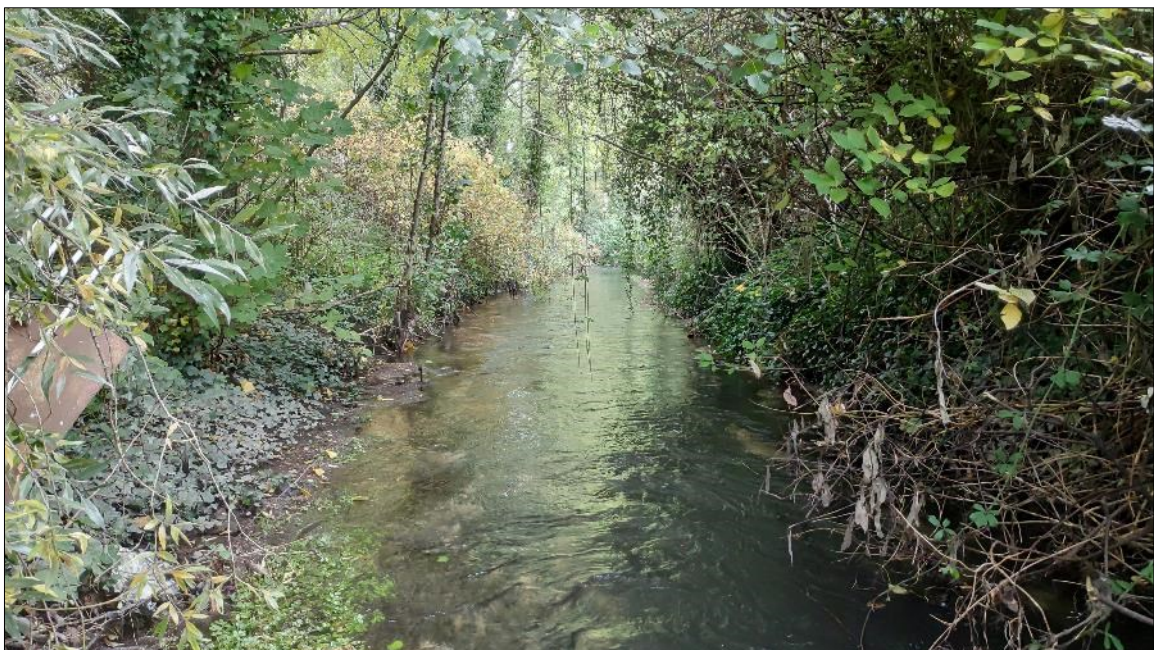
**Plate 3.11** Representative image of site C2 on the River Camac (downstream of the culvert)

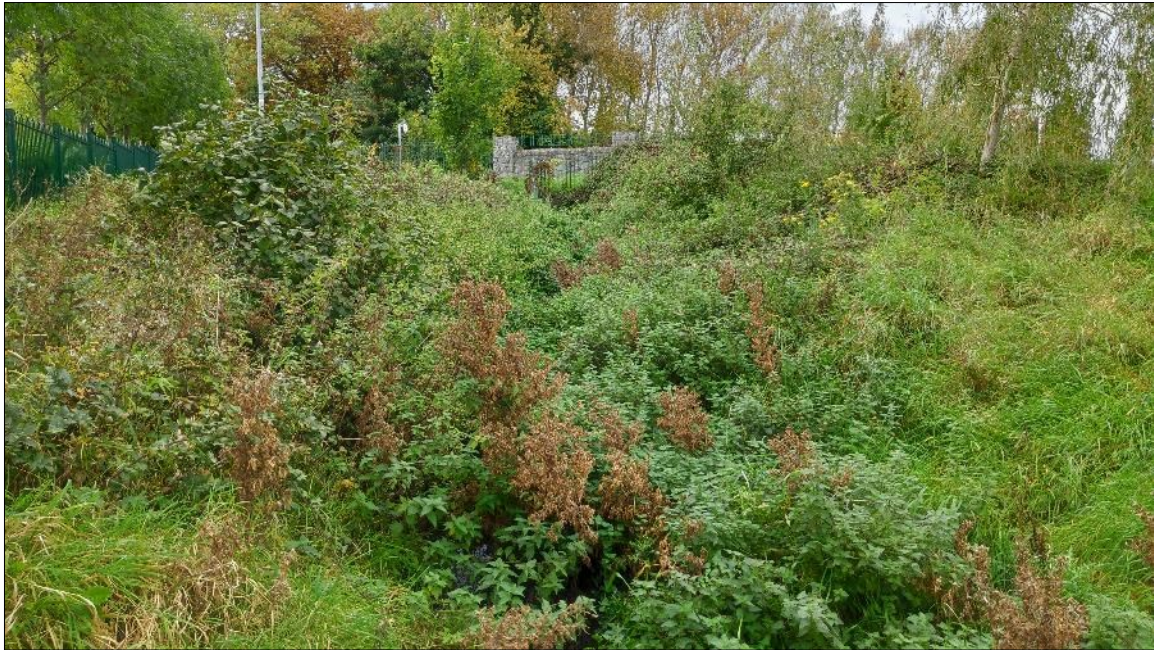
Site P1 was found to have low fisheries value and poor water quality, and of low overall aquatic ecological value.

**Plate 3.12** Representative image of site P1 on the upper reaches of the River Poddle (heavily scrubbed-over, facing upstream to road crossing)
