Ballysheedy Quarry

Substitute Consent Application

Remedial EIAR

Document Control Sheet	
Document Reference	R01 Remedial EIAR
Report Status	Final
Report Date	June 2022
Current Revision	A01
Client:	John Madden & Sons
Client Address:	Kilmaine, Co. Mayo
Project Number	10925

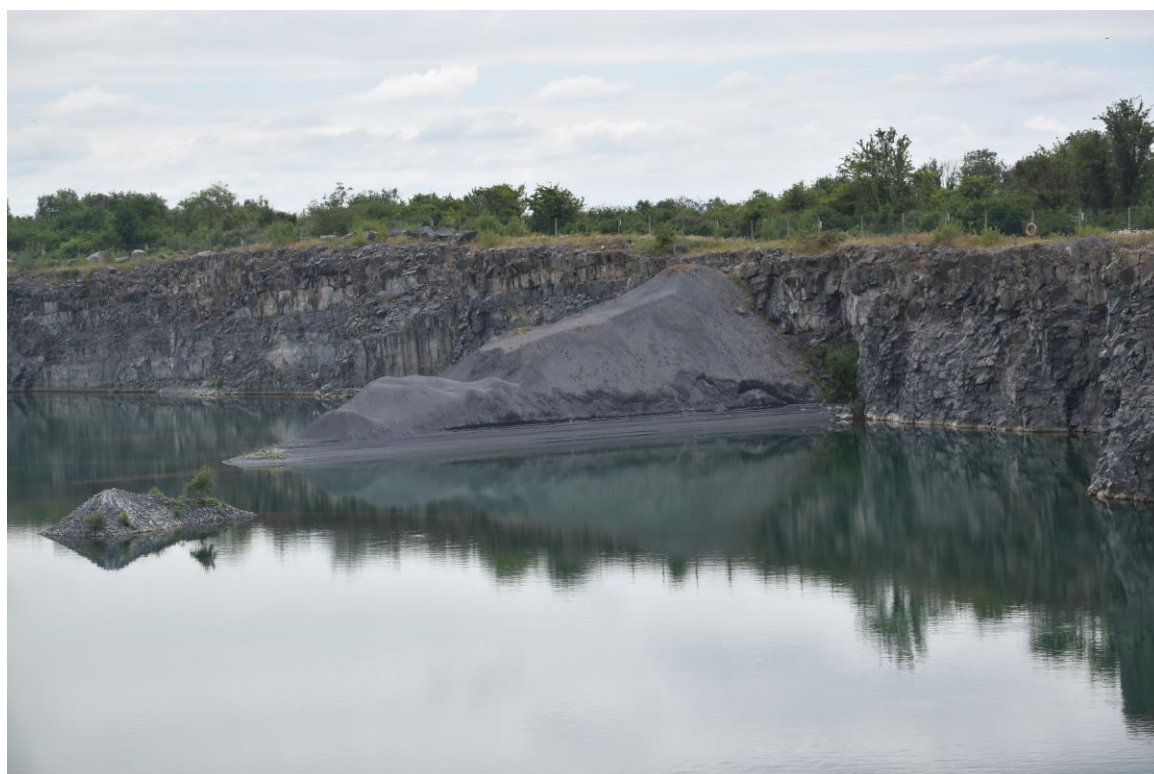
Photo 1 - View of western quarry face

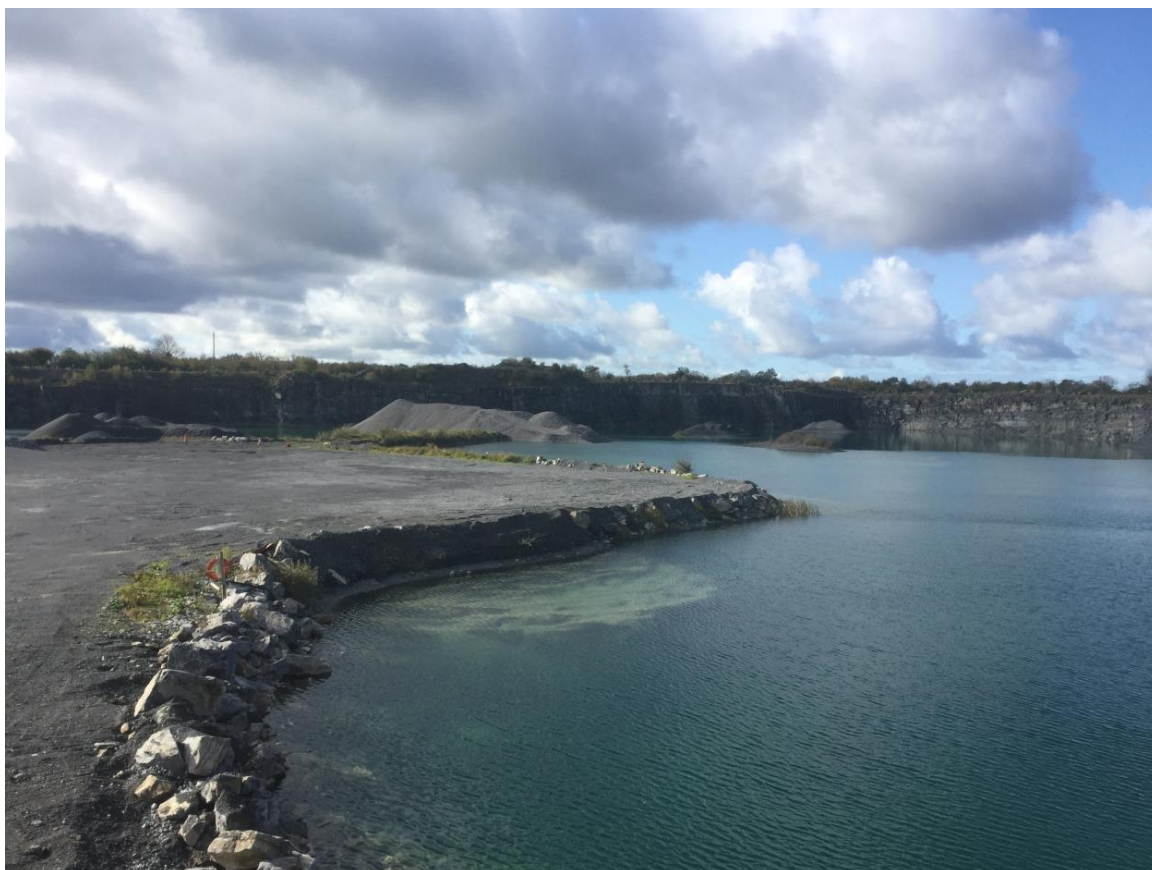
Photo 2- View across quarry looking southwest

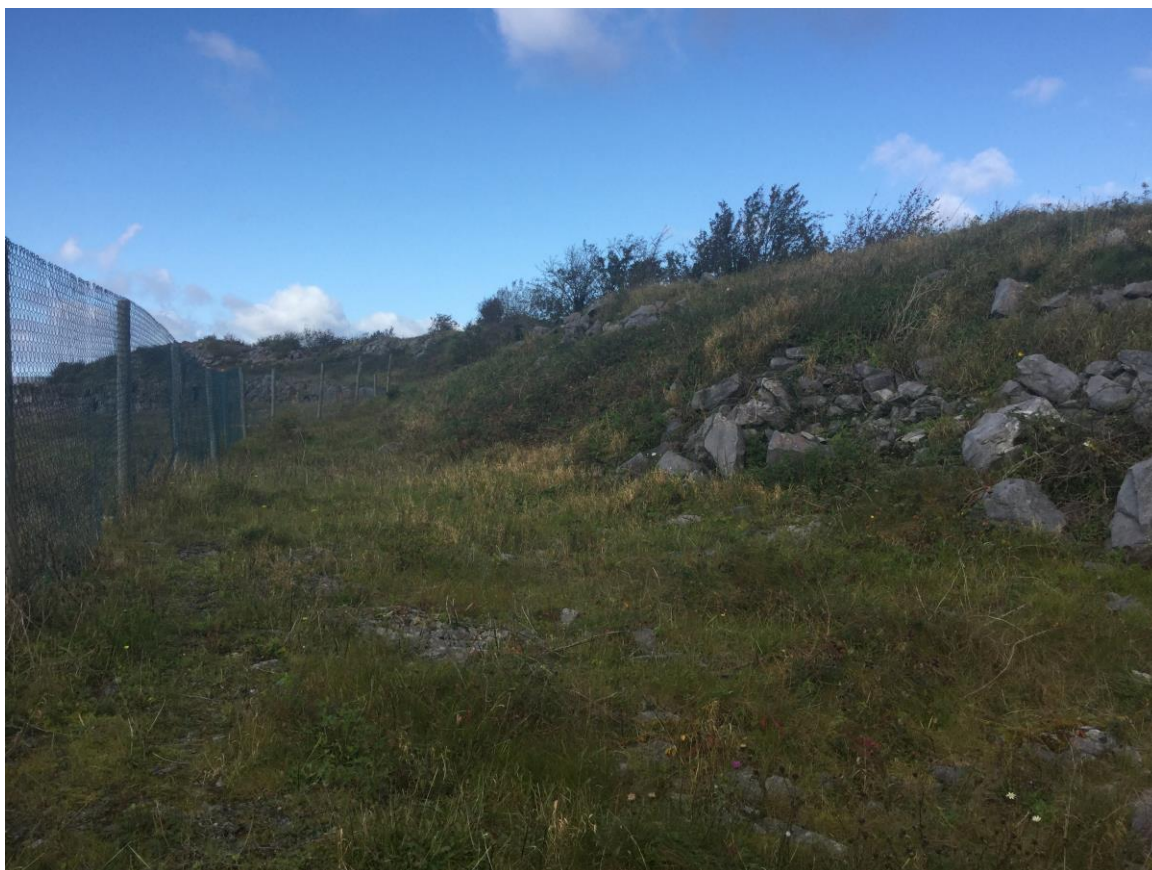
Photo 3 - View of northern quarry fence and stockpile

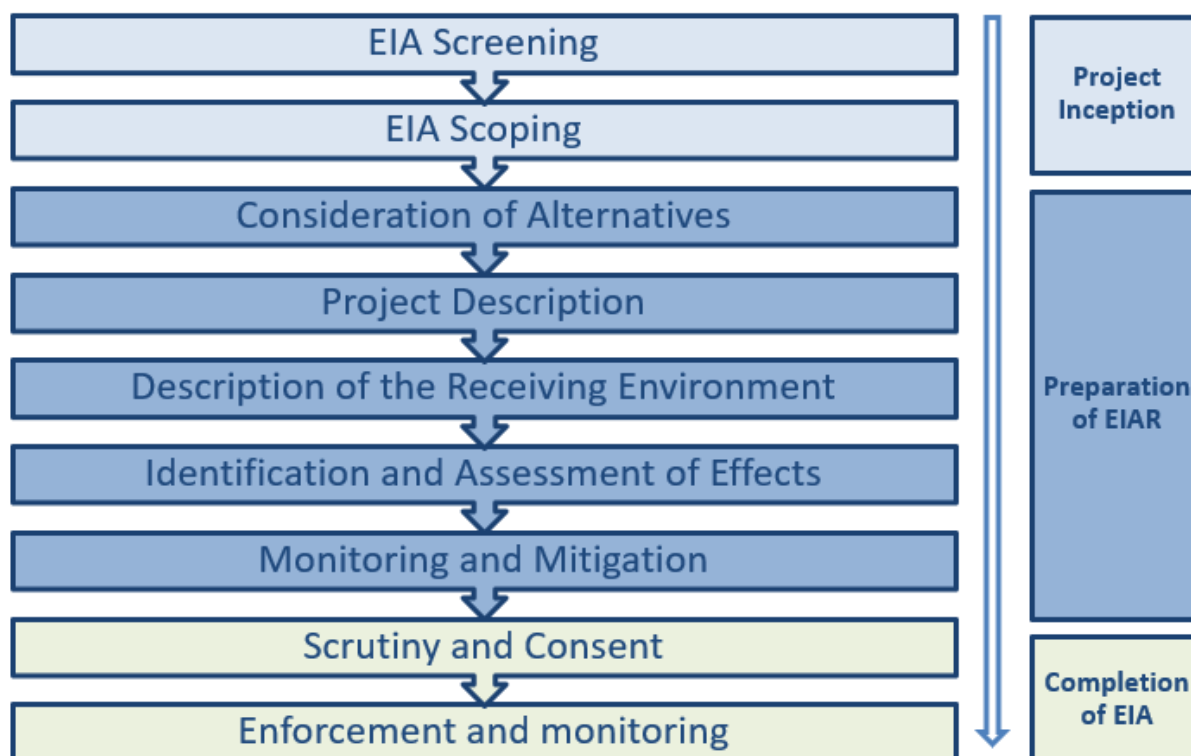
Diagram 1.1: EIA Process

The following Diagram 1.1 illustrates the EIA Process as outlined in the EPA Draft Guidelines (2017).

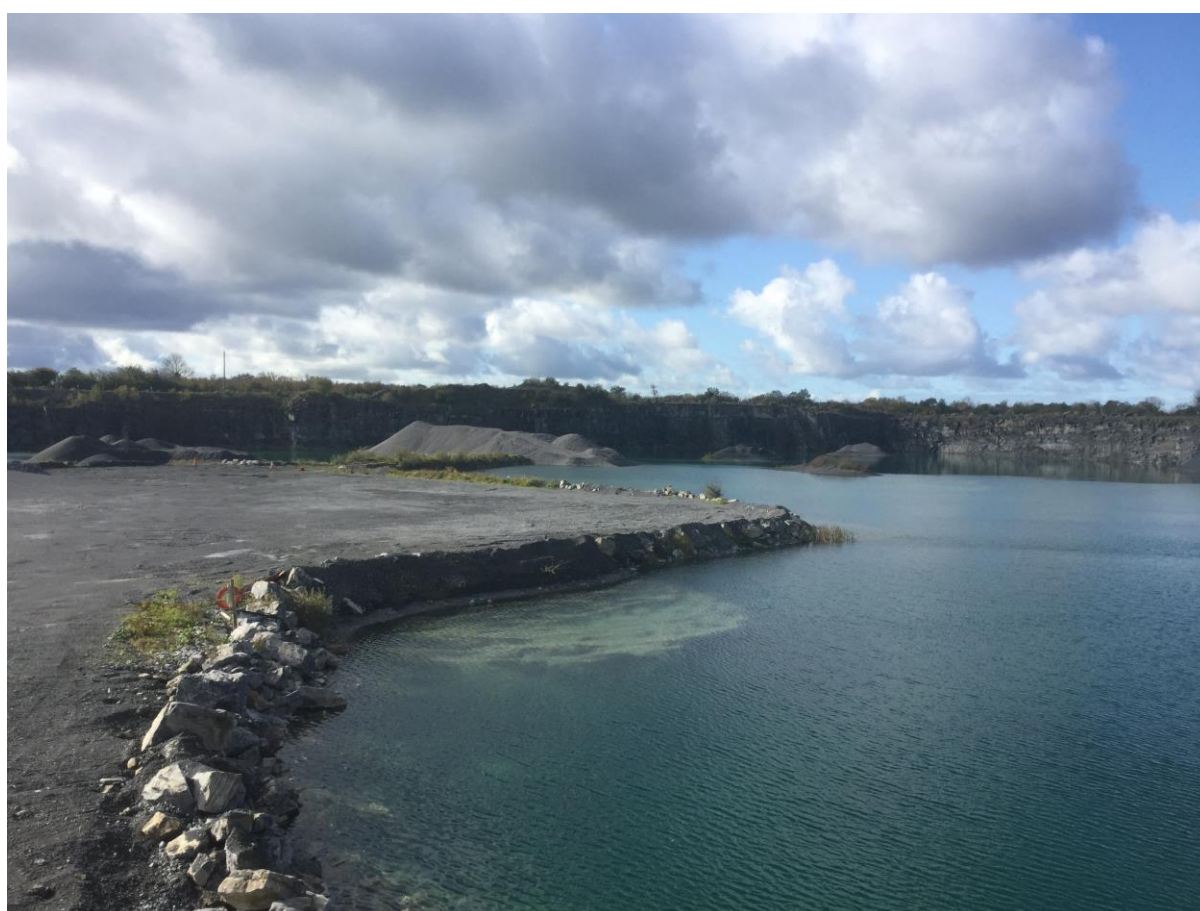
Plate 5.1: Dormant Quarry is largely non-vegetated – view looking south-west across quarry.

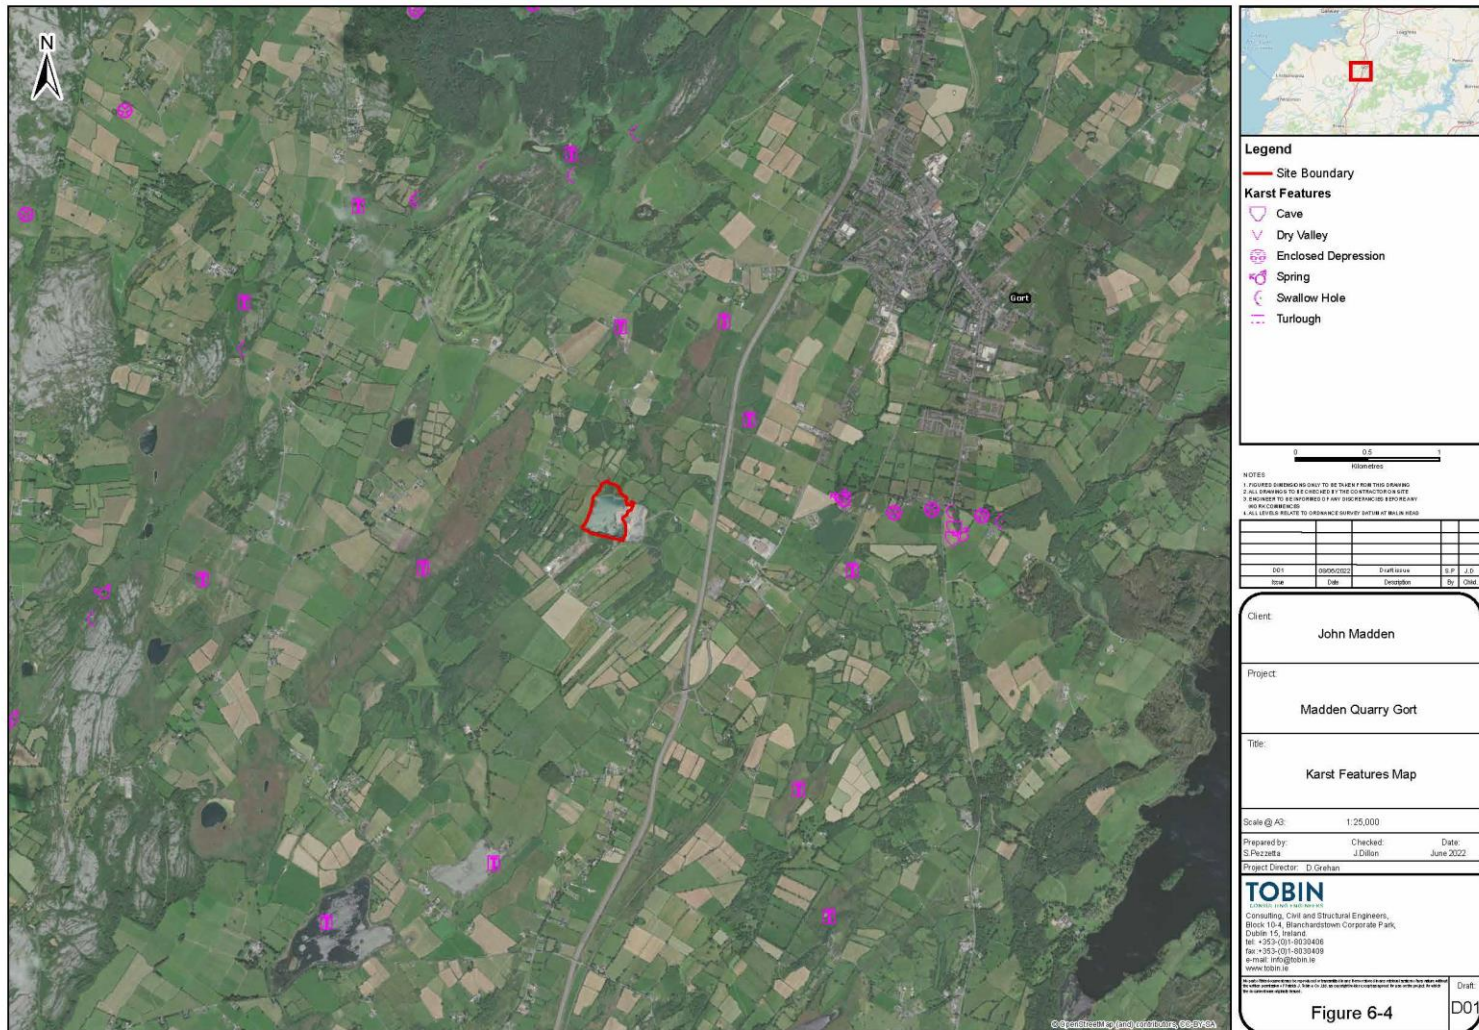
Figure 6-4 Karst Features Map

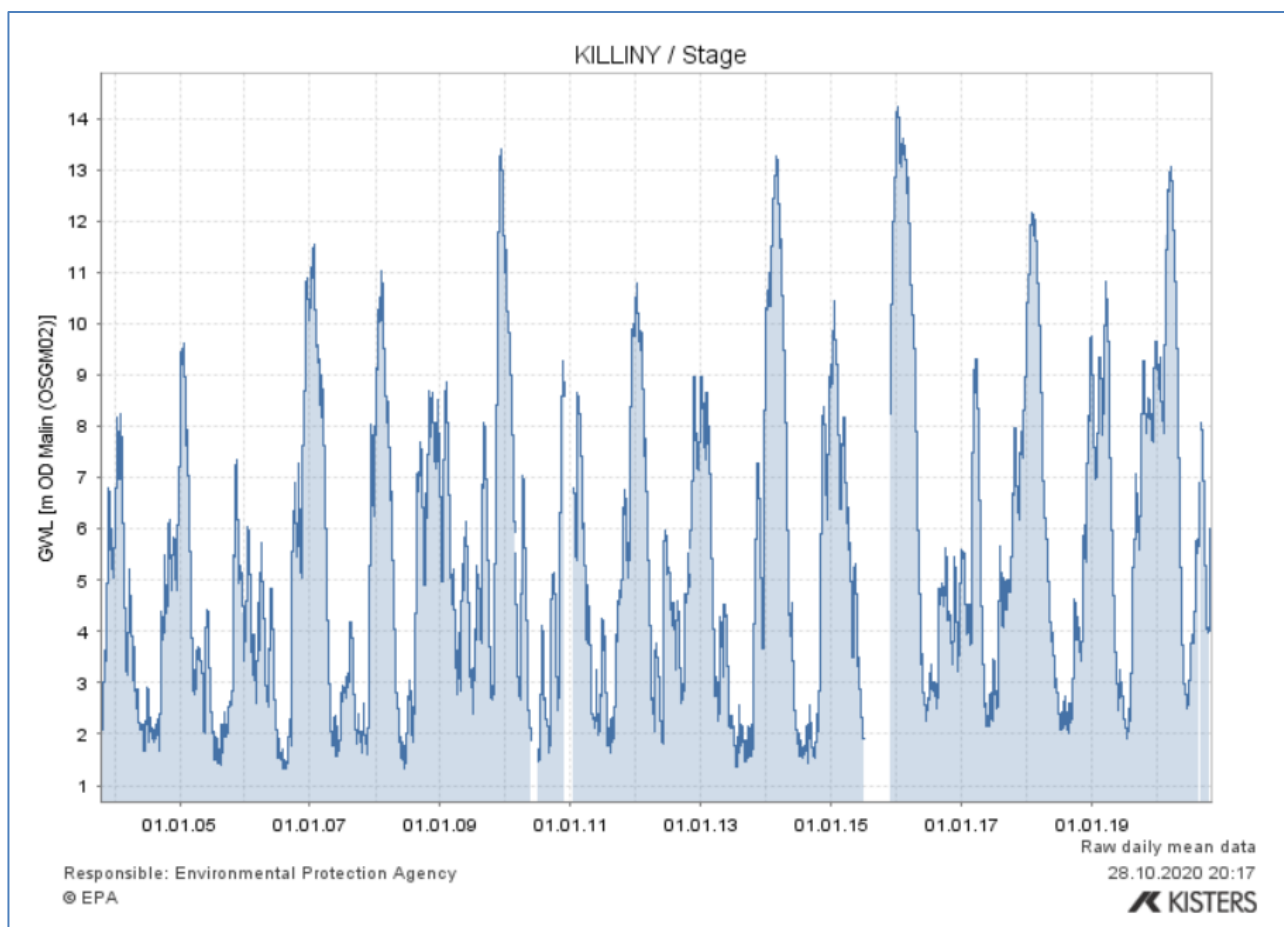
Figure 7-4 Killiny BH – 2km west of the site

The water level (29.5 to 30.1m) in the flooded quarry floor is stable and at a significant level above the regional groundwater level. Groundwater and surface water levels in the regional Gort lowlands area vary from 4 to 15mOD to the east and north of the site (based on M18 groundwater data and recent flood data) and 1.8 to 14m to the west (Killiny BH – EPA groundwater monitoring point), see Figure 5.

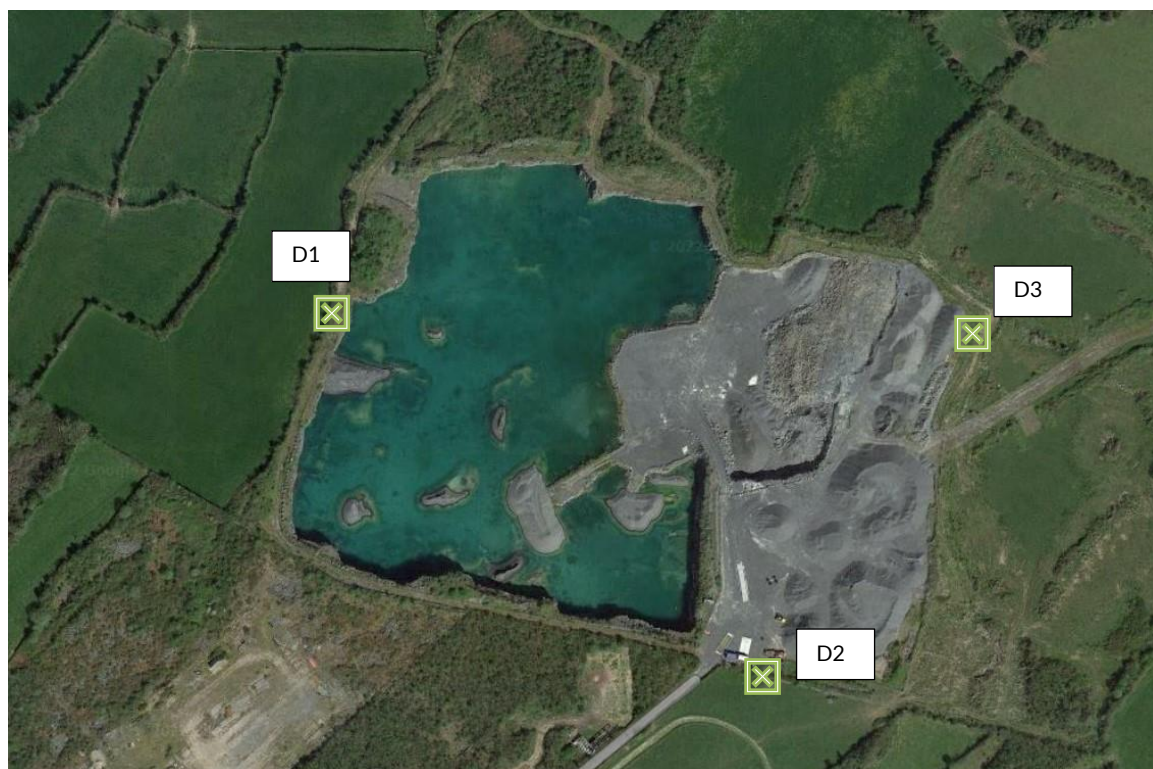
Figure 9-1 Dust Monitoring Locations

These existing dust monitoring locations are illustrated on Figure 9-1.
