## APPENDIX 16.1 SUMMARY OF NATIONAL MONUMENTS LEGISLATION

**APPENDIX 16.2****DUBLIN CITY DEVELOPMENT PLAN 2016 – 2022 – ARCHAEOLOGY**

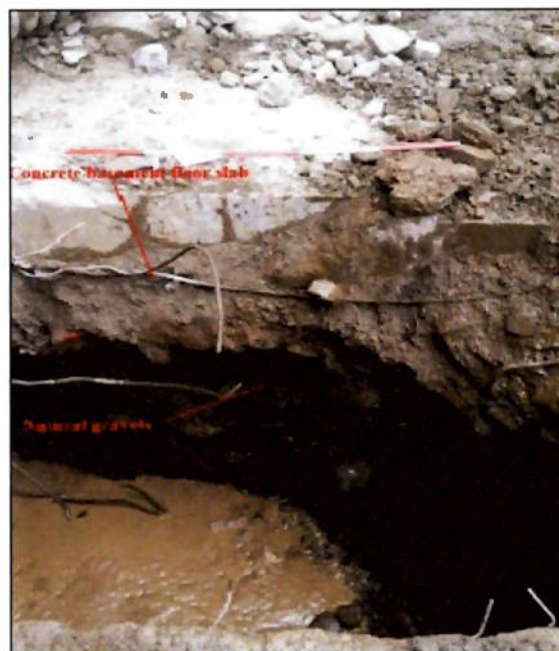
Figure 25 Trench B, concrete and natural gravels

The monitoring programme established that the original concrete floor of the basement of the hotel was very substantial and still in position, made of reinforced concrete and measuring over 1m in depth (Figs 24-26). This basement was cut into deep gravel and silt deposits, presumably originally riverine deposits associated with the River Liffey, before it was reclaimed between 1678 and 1728. The gravels were carefully examined but no archaeological features or artefacts found. In April 2009, three (nos 1-3) additional engineering test-trenches were excavated in the basement area of no. 40 and this was followed in May, after the complete demolition of the hotel (nos 40-41), by the casting of a temporary crane base (no. 4) (Fig. 27). In early June, the remaining trenches (nos 5-9) were excavated, with most of the excavation works taking place in the eastern half of the site close to the O'Connell street frontage. The basement floor slab was located at approximately 3m below (2.40m O.D) below present road level of O'Connell Street (5.40m O.D.).

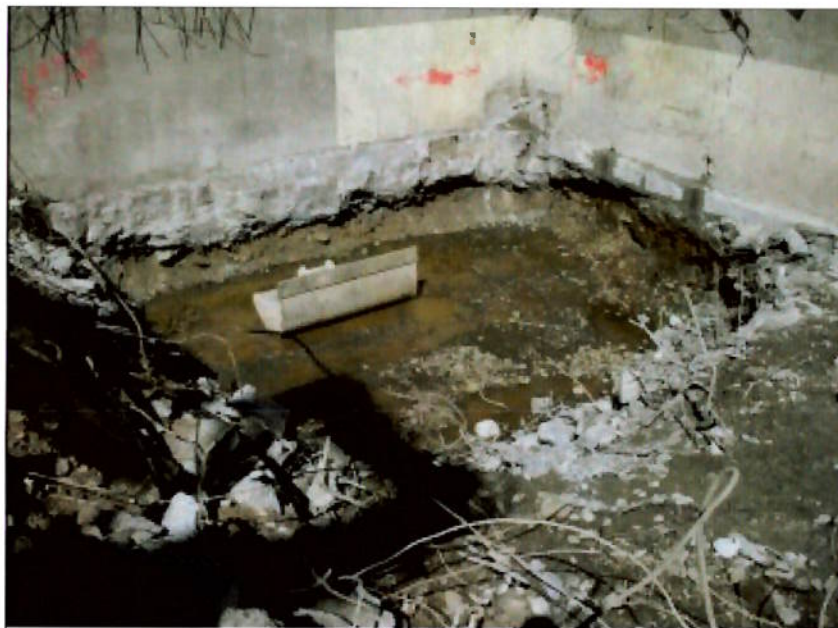
Figure 27 Trench 4, temporary crane base

The archaeological testing in Site A revealed it is unlikely any archaeological levels survive in this site, the substantial slab extending to at least 1m in depth cut into the natural gravels. The previous hotel had had a deep basement that extended across the plot and this is likely to have removed any deposits. Much of this slab is still in position. However, it should be noted there was a dump of organic infill material, which may have originated somewhere in the site, perhaps under the ramp. This material was dumped across the crane-base, installed in 2009.

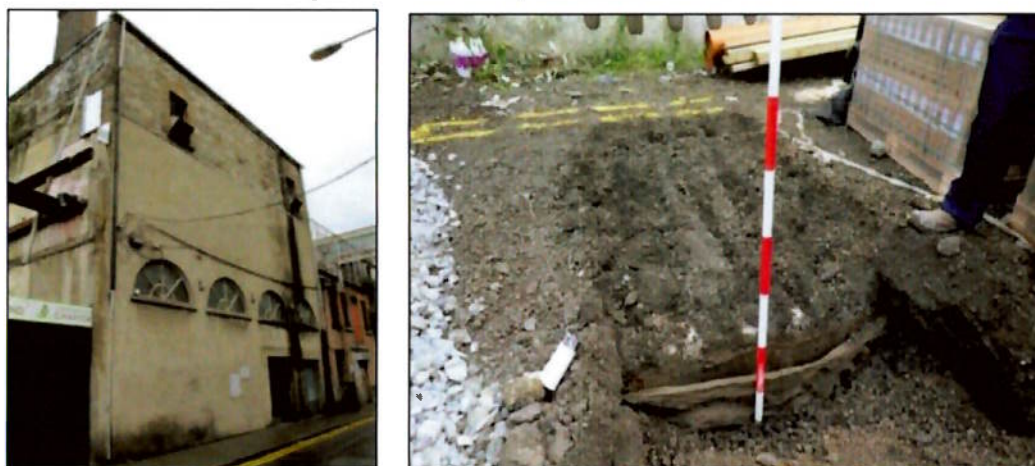
Trench 1 was located on the southern side of the site, close to the southern boundary wall and this also exposed the same slab found to extend across the site. This concrete slab is part of the floor of the original hotel, along with an additional concrete level laid in 2009.

Figure 34 The building on Moore Street  
Figure 35 Trench 1, from the north: concrete slab

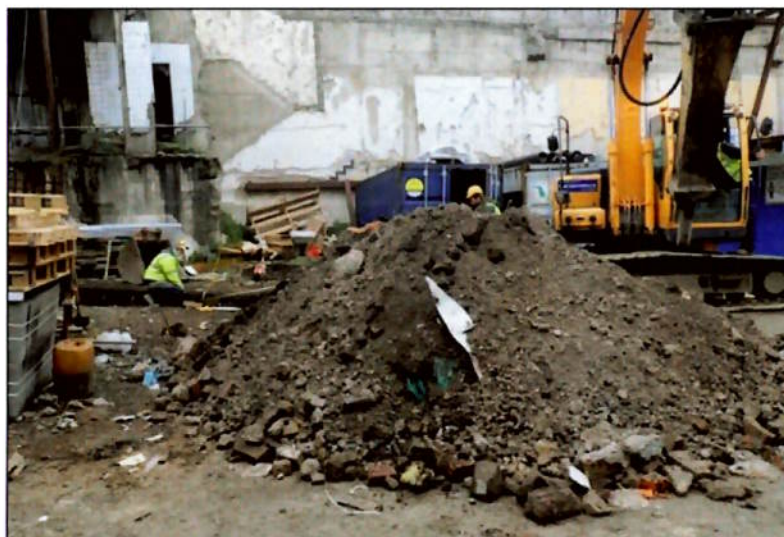
At the northern-western end of the site, at 0.90m below present ground level, a modern smooth slab was found beneath the brown organic infill deposit and an edge was found on the eastern side, which extended to at least 1.40m in depth: the base was not exposed. This can be identified as the temporary crane base, constructed in 2009, the exposed section measuring 3.58m east-west by 1.80m north-south. The base appears to have been inserted through the existing slab, which is likely to be part of the basement of the hotel, as a cut-line was identified on the eastern side of the pad, extending for 1.10m in width (east-west). The cut was filled with two deposits of mortar/gravel, the lower level of which was a dark grey gravel mortar. This was sealed by a loose deposit of light grey gravelly mortar mix, extending at least 1.40m in depth.

Figure 42 The infill from Trench 4

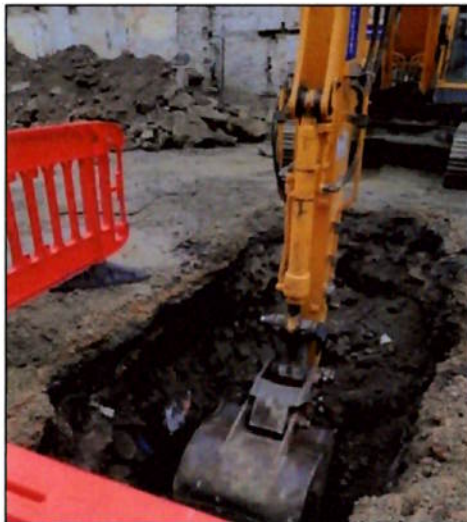
This trench was excavated after Trench 3 at the eastern end of the site. It was orientated north-south and measured 6m long by 0.80m north-south by 4m in depth (Figs 51-54). It was positioned across the projected line of the wall/structure found in Trench 3 (see below), which was orientated east-west. However, the continuation of this wall foundation was not found further east in Trench 3 (see below).

Figure 51 Trench 2 from the south

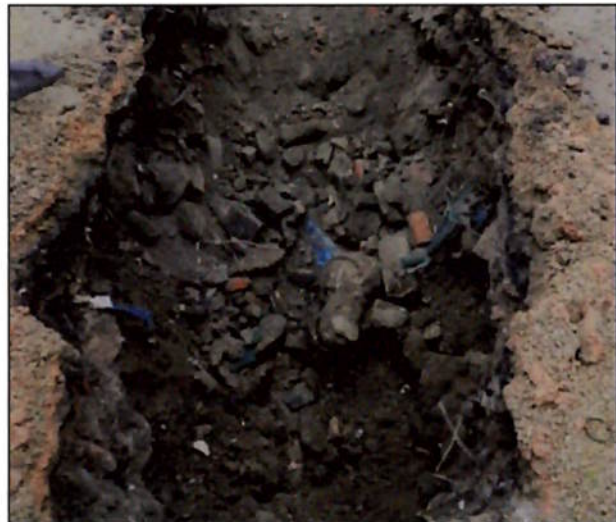
| 0.15m - 2.80m: | Rubble infill similar to Trench 3, with bricks, grey clay, wires and blue tiles found in Trench 3. This infill included concrete blocks. |

Figure 52 Trench 2 from the south: infill deposits

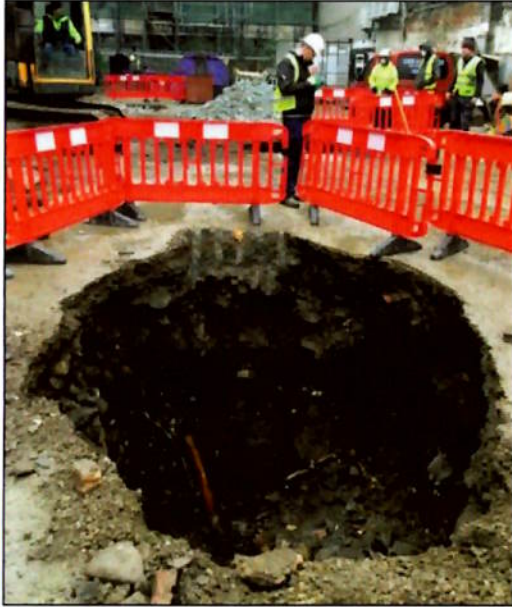
Figure 53 The expanding trench

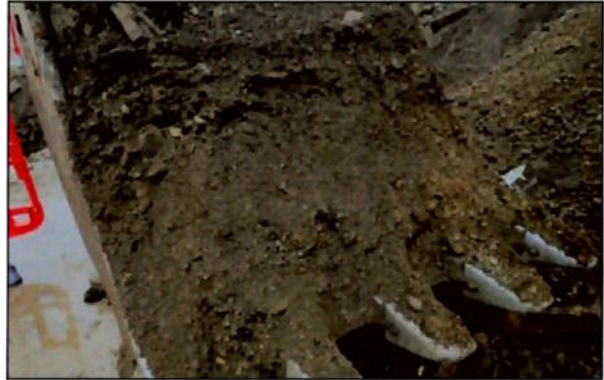
This trench was designed to establish whether or not the wall structure found in Trench 3 to the west extended eastwards. However, no trace of the wall was found. In addition to this, the trench did not expose any walls foundations, floor or structures that could be associated with the standing walls. The infill deposits were similar to those found in the other two trenches with natural deposits at approximately 4m below present ground level.

Figure 54 The gravels at 4m below present ground level

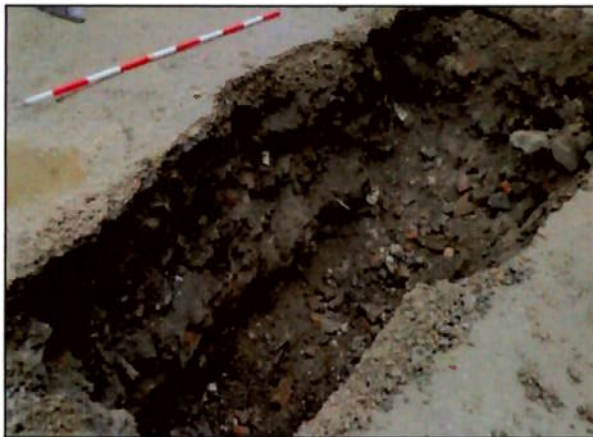
This trench measured 6m east-west by 0.80m in width by 4m in depth, located in the western side of the site, in area thought to contain a cellar (Figs 55-60). The trench located deep infill deposits, sealing a substantial limestone build, orientated north-south, which was at least 1m in width. This appears to be a wall foundation, perhaps of the basement recorded in 1893.

Figure 55 Trench 3, from the east

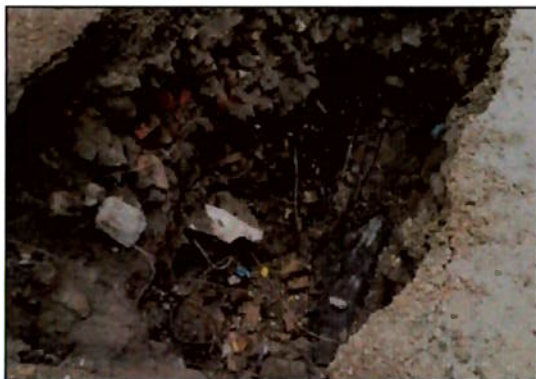
Figure 57 The floor abutting the wall foundation

The cartographic sources in 1893 indicates that the building at the western end of the site (Building no. 1) was two stories in height but with a basement, which was relatively unusual for a rear building. Rocque's map, dated 1756, does show a stable/coach-house, which is unlikely to have a basement but which might have been integrated into Building 1. Trench 3 was positioned at this end of the plot to try and locate the basement and the wall foundation and floor found is likely to be related to this structure. Thus, the evidence suggests that the basement was demolished but the foundations of the wall and possibly the floor are still *in situ*.

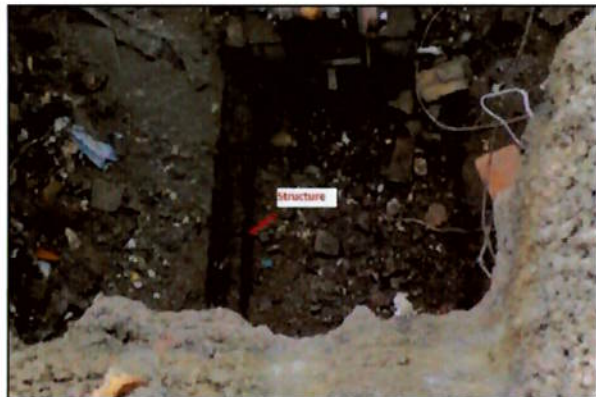
Figure 58 Foundation from the east

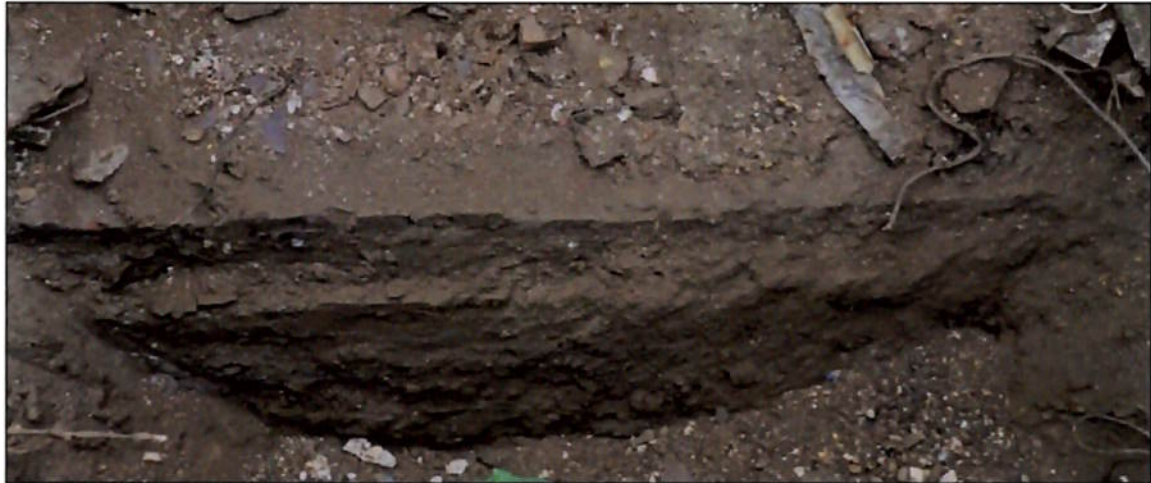
Figure 59 The northern face: note modern debris

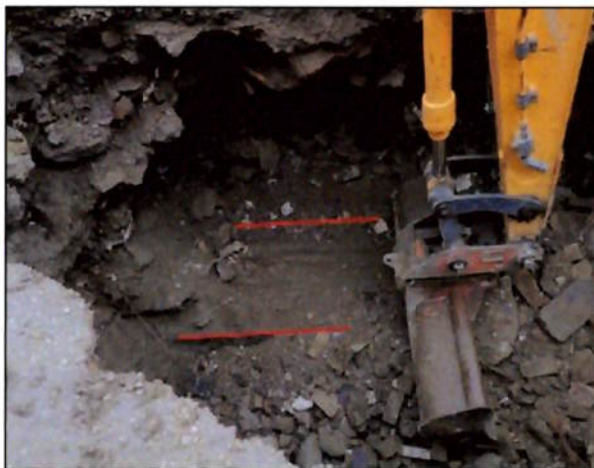
Figure 60 The structure from the north

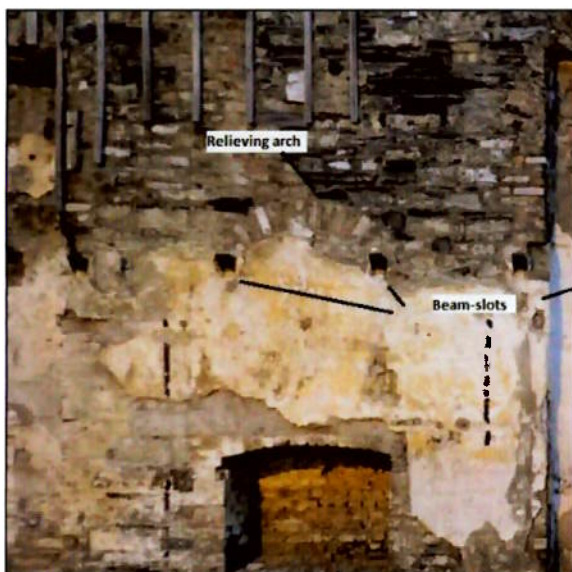
An additional floor had also been added in the grand room but this was more crudely done than Building 1, with large beam-slots inserted roughly into the chimney breast. This floor was positioned 0.55m lower than the inserted floor found in Building 1, an indication that both rooms were not linked at first floor level (Fig. 78).

Figure 78 The relieving arch and beam-slots
