Environmental Impact Assessment Report (EIAR)

Strategic Housing Development at
Kilbarry on the Old Whitechurch Road, Cork City

Volume III - Appendices

Appendix 13.3 Malachy Walsh & Partners Ltd. Report on Ground Conditions

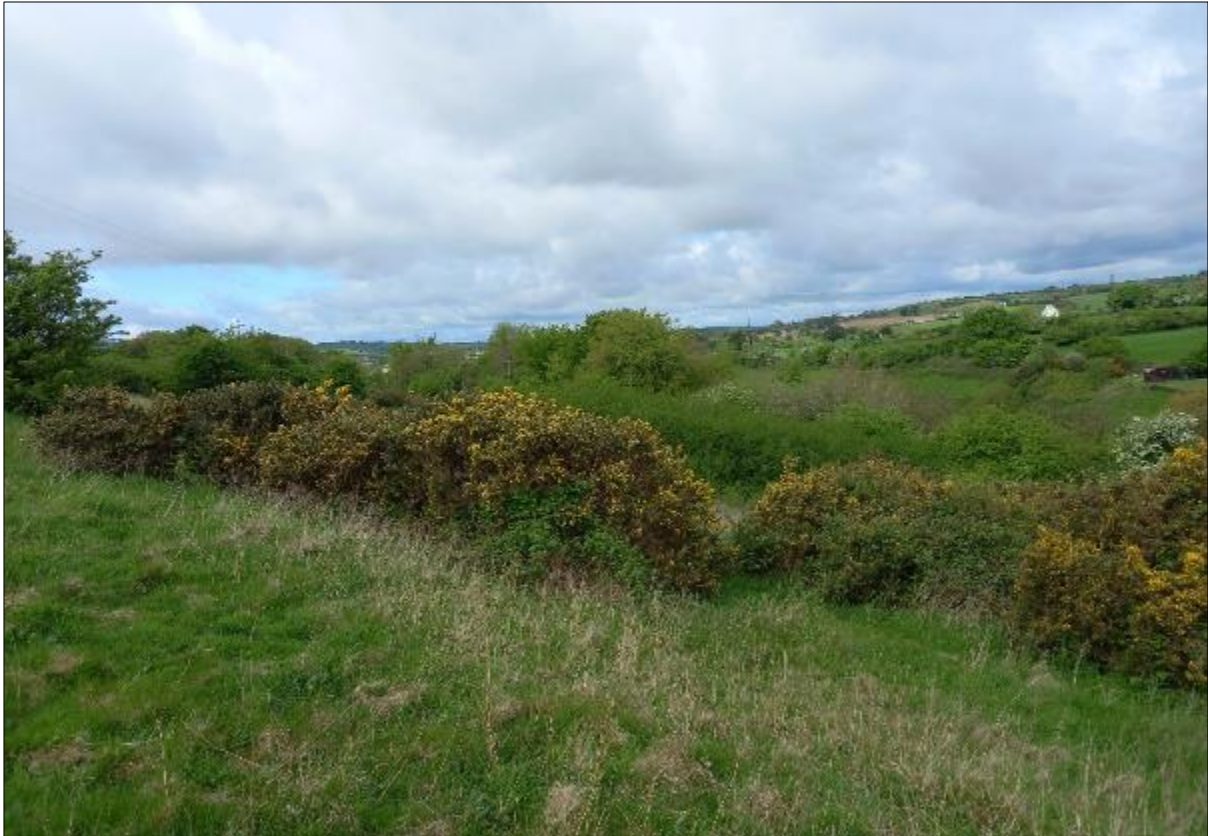
Plate 11.13: View of ground conditions within Field 4, facing west

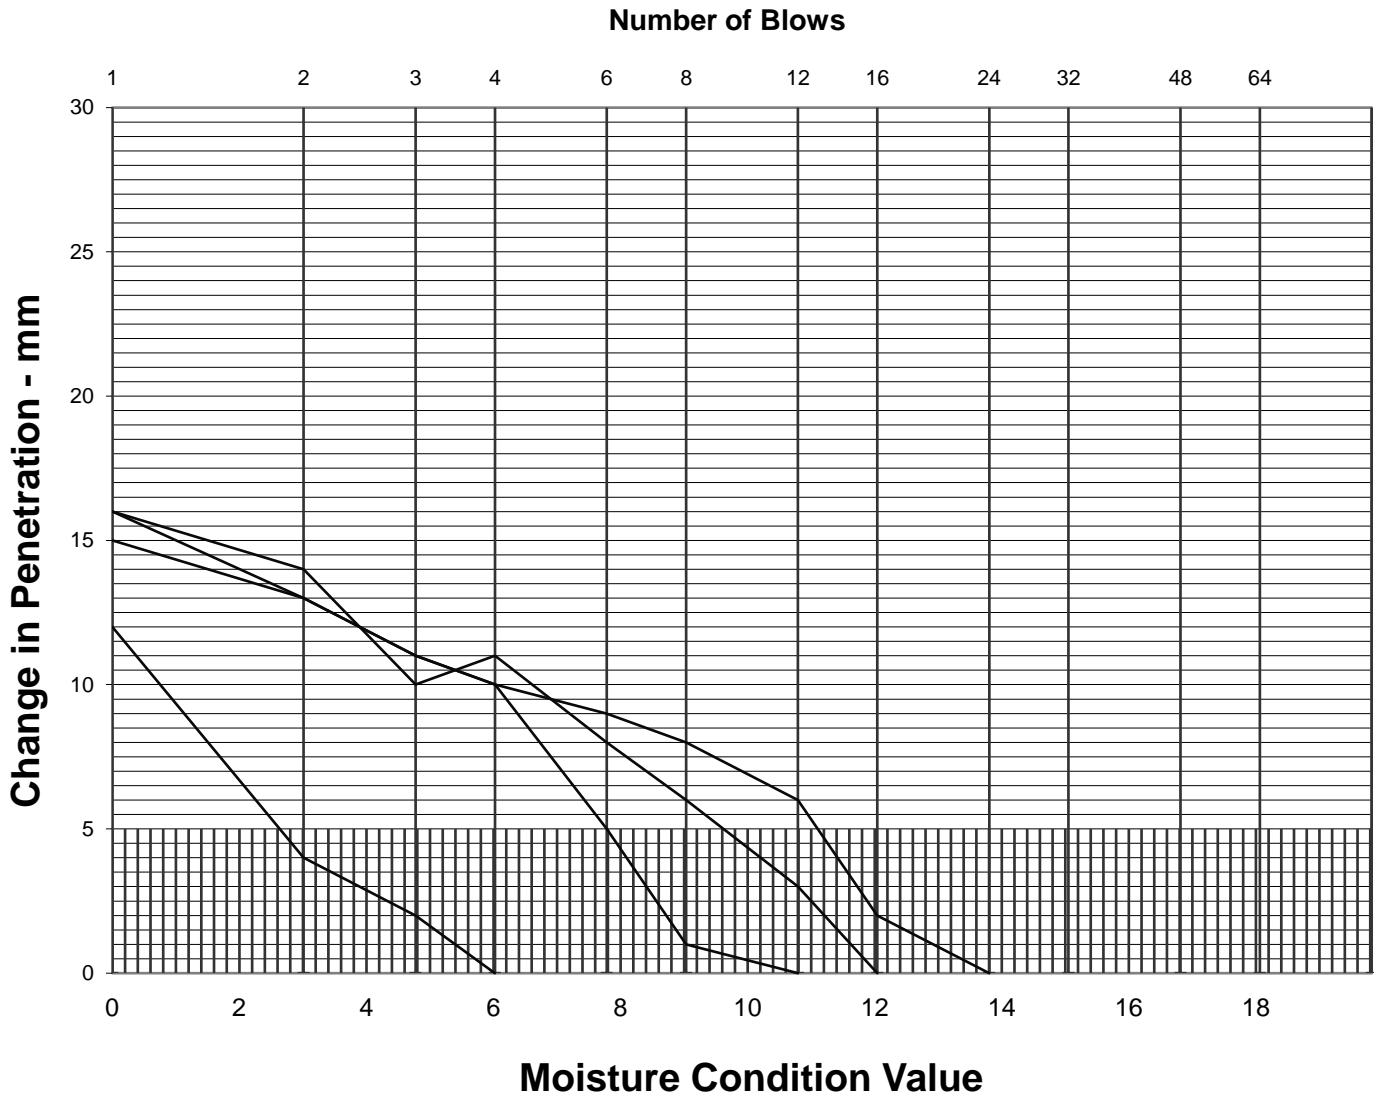
Very silty very sandy GRAVEL

Specimen No	1	2	3	4	5	6
Moisture Condition Value	7.8	10.0	11.1	2.6		
Moisture Content %	21.54	20.61	17.51	23.75		
Bulk density after compaction Mg/m ³	2.01	2.01	1.93	1.93		
Dry density after compaction Mg/m ³	1.65	1.67	1.64	1.56		
Hand vane strength kPa						
Method of determining MCV	Steepest fit line	Steepest fit line	Steepest fit line	Steepest fit line	Steepest fit line	
Mass retained on 20mm sieve %	12.3

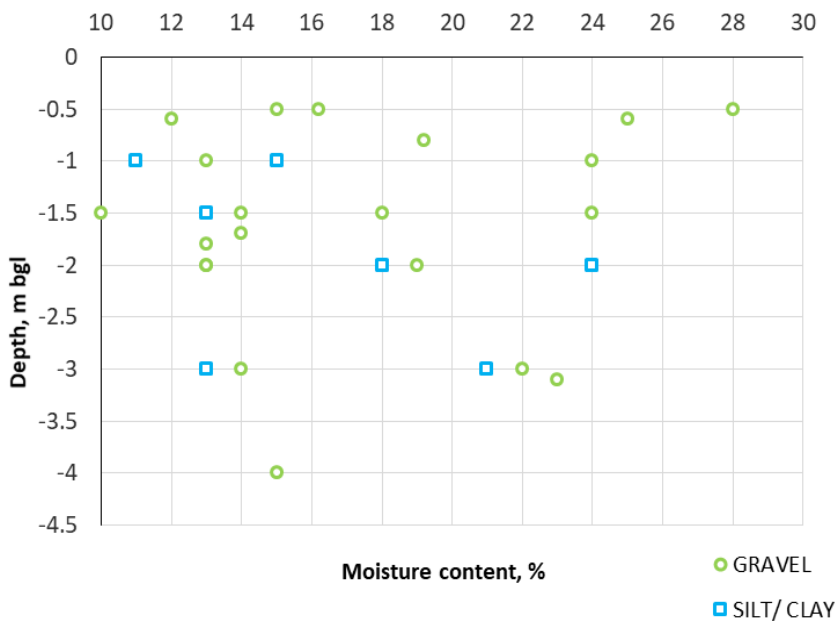
Moisture content profile

The more elevated moisture content >20% were associated with higher fines fractions.

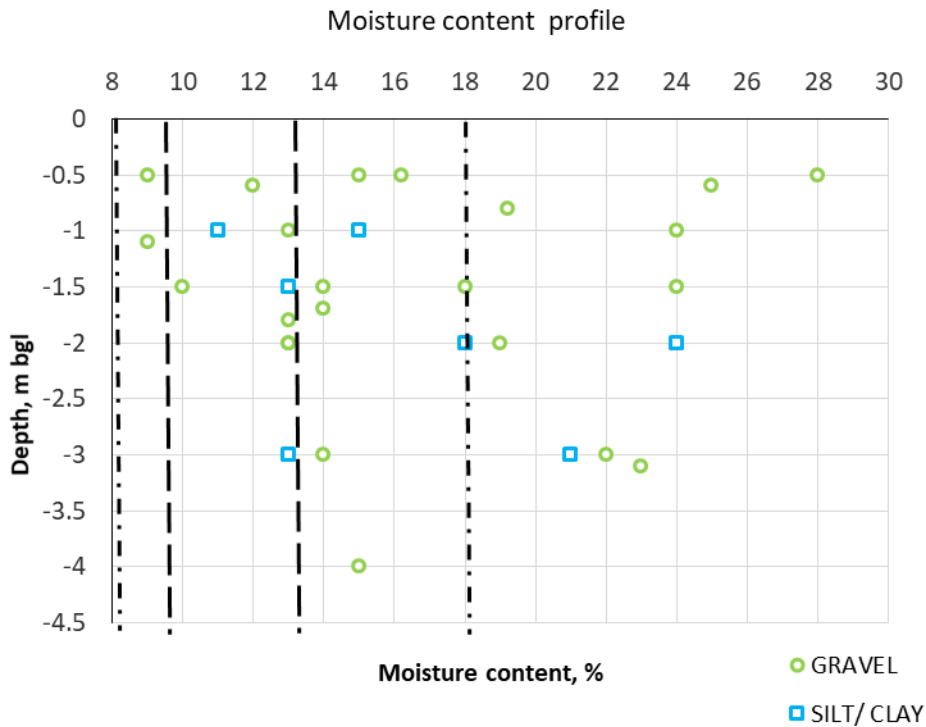
With maximum dry density 9.5% to 13.3% natural moisture content typically lies ‘wet’ of the optimum for maximum dry densities 1.90Mgm⁻³ to 2.00Mgm⁻³.Compaction levels of 95% maximum dry density can be achieved at moisture content 7% to 18%. Deposits are expected to be suitable for re-compaction at natural moisture content(s).

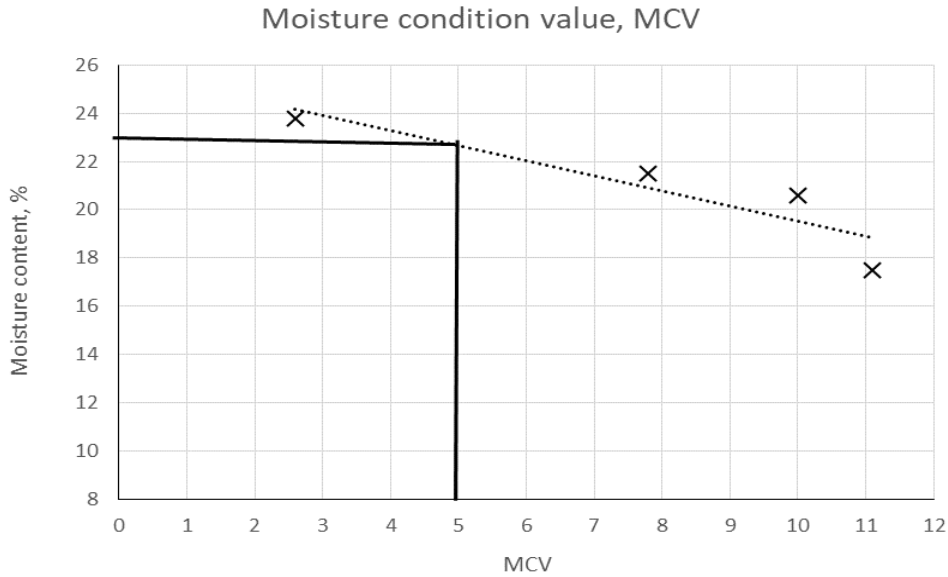
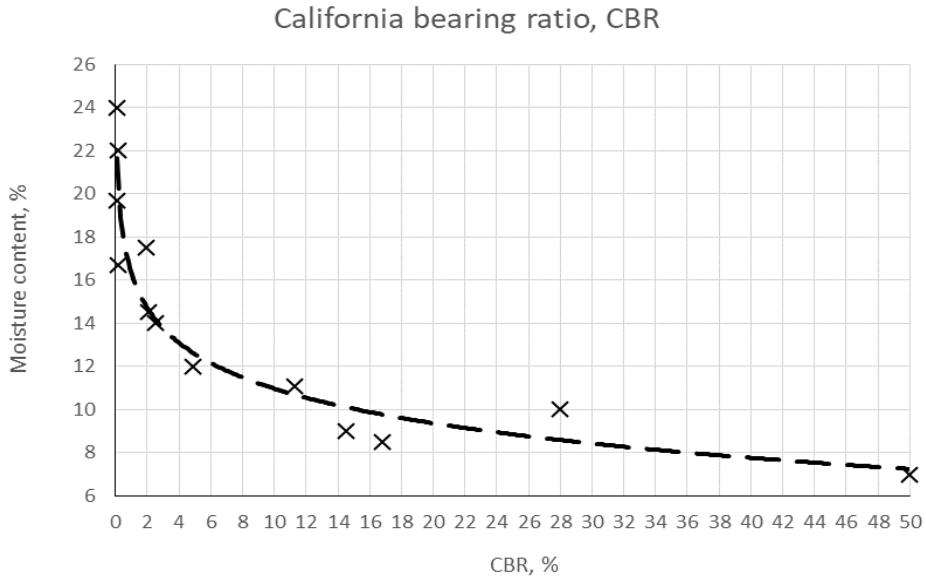
At moisture content <23% a MCV5 is expected identifying deposits as suitable for re-use as general landscaping fill. Some drying -1% to -5% is required for the upper 1.0m of SILT deposits.

Plasticity data suggested a design equilibrium CBR4% to CBR5% (TRRL 889, Road note 29, Black and Lister 1979).

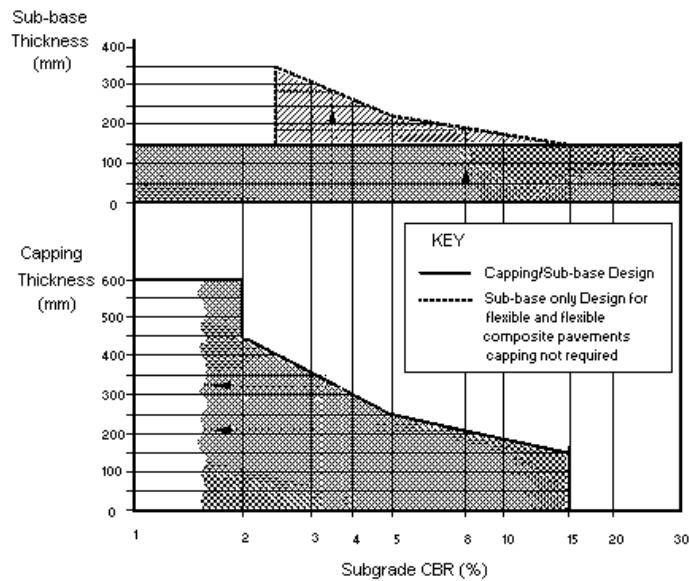
A CBR5% is achieved at natural moisture content <12%. With natural moisture contents ranging from 9% to 28% in the upper 1.0m bgl, varied CBR values of CBR0.2% to CBR16% are expected. At natural moisture content CBR0.2% was measured; capping 6F1/ 6F2 600mm thick with 150mm sub base is recommended for pavement construction in accordance with Tii DMRB Vol 7 Pt 2A, TD25-26/1- Figure 4.1.

A drainage system shall be provided a minimum of 600mm below formation (underside of capping).
