# Proposed Residential Development at Kilbarry, Cork

## Flood Risk Assessment

June 2022

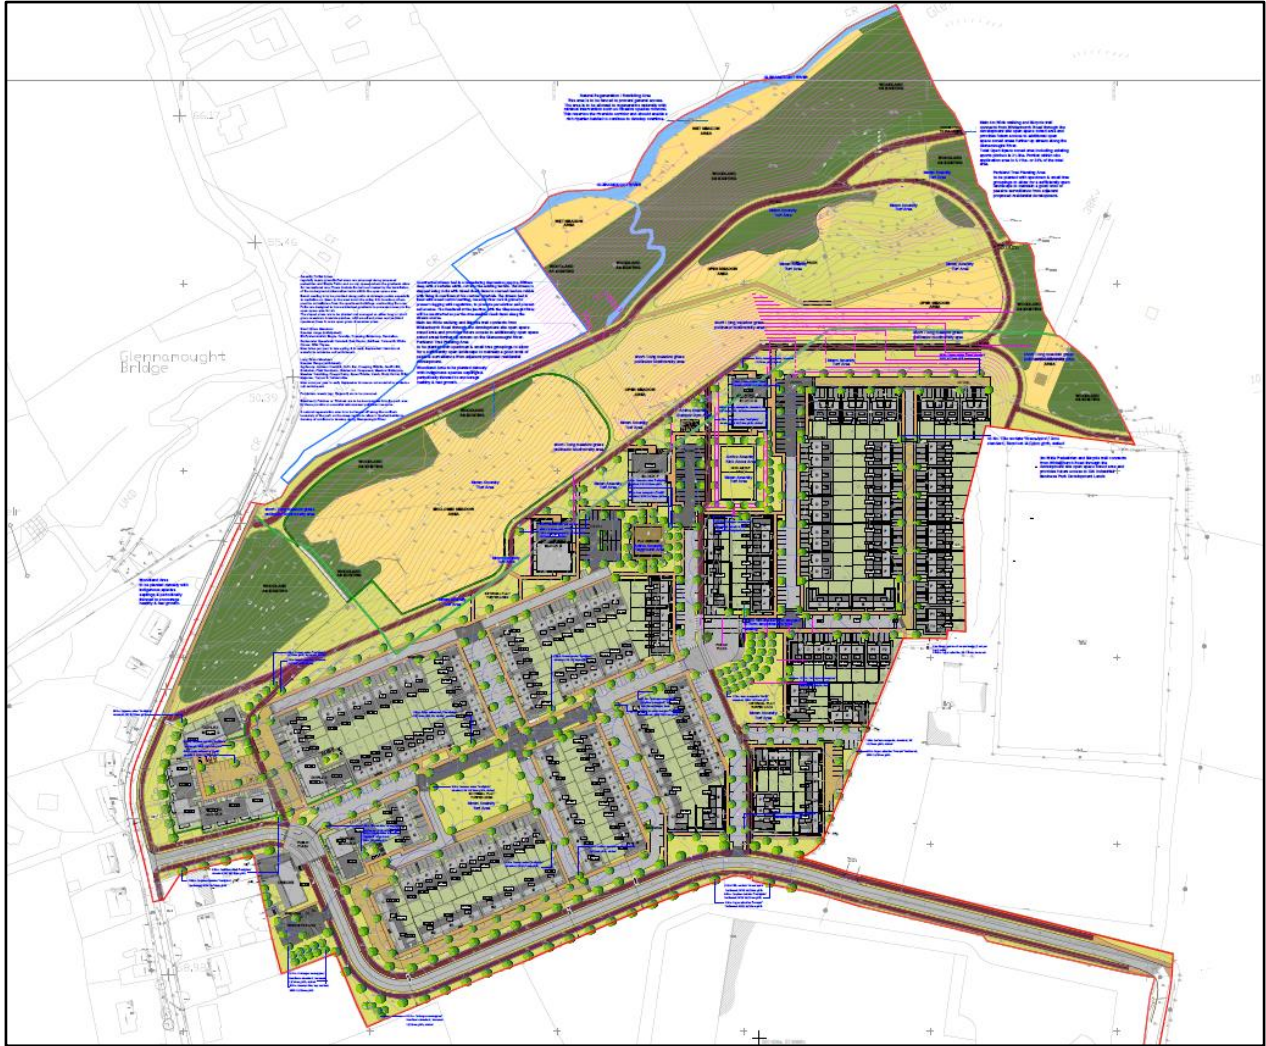
**Figure 1-2: Proposed Development Site Layout**

The proposed development will consist of the construction of 319 No. residential units and associated ancillary site works. *Figure 1-2* below shows the proposed development site layout. The site falls significantly from south to north.

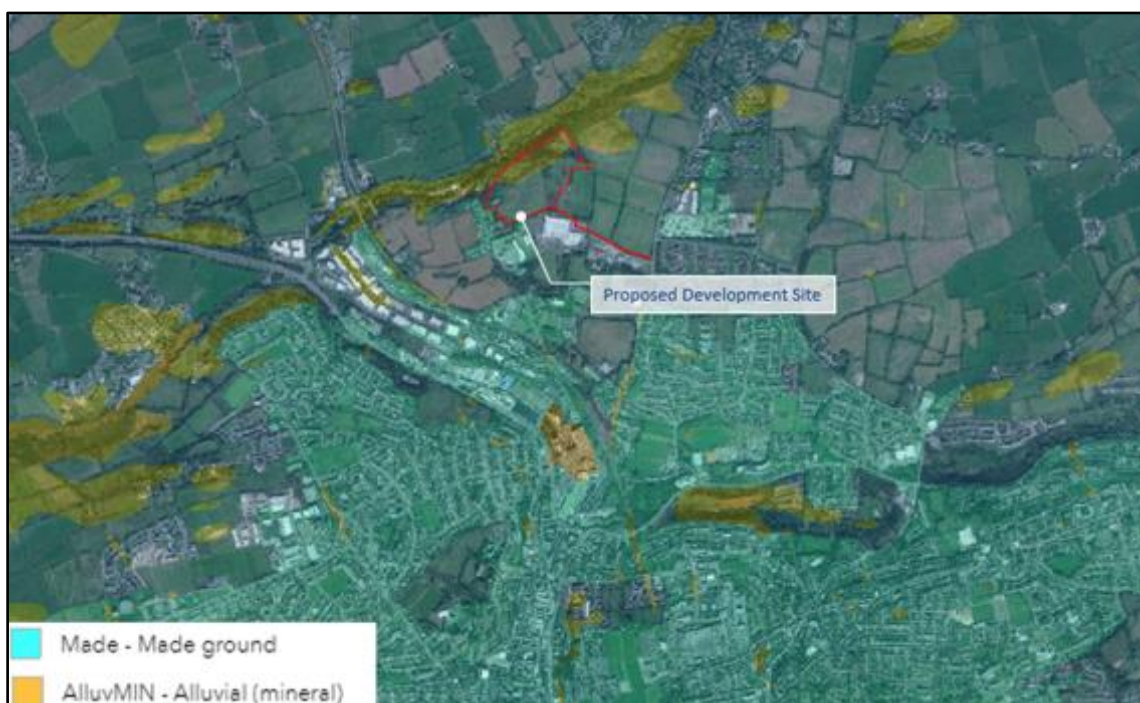
**Figure 3-2: GSI Subsoil Mapping (Source: [www.gsi.ie](http://www.gsi.ie), annotation by J.B. Barry & Partners)**

The Geological Survey of Ireland (GSI) website provides information on their public online mapping service at [www.gsi.ie](http://www.gsi.ie) on subsoil type and aquifer vulnerability. The maps presented in *Figure 3-2* and *Figure 3-3* depict the subsoil type and aquifer vulnerability for the proposed development site. The GSI subsoil mapping (*Figure 3-2*) indicates that made ground is the dominant ground condition within the environs of the proposed development site due to the urban nature of the site. There are also traces of alluvium located at the River Bride.

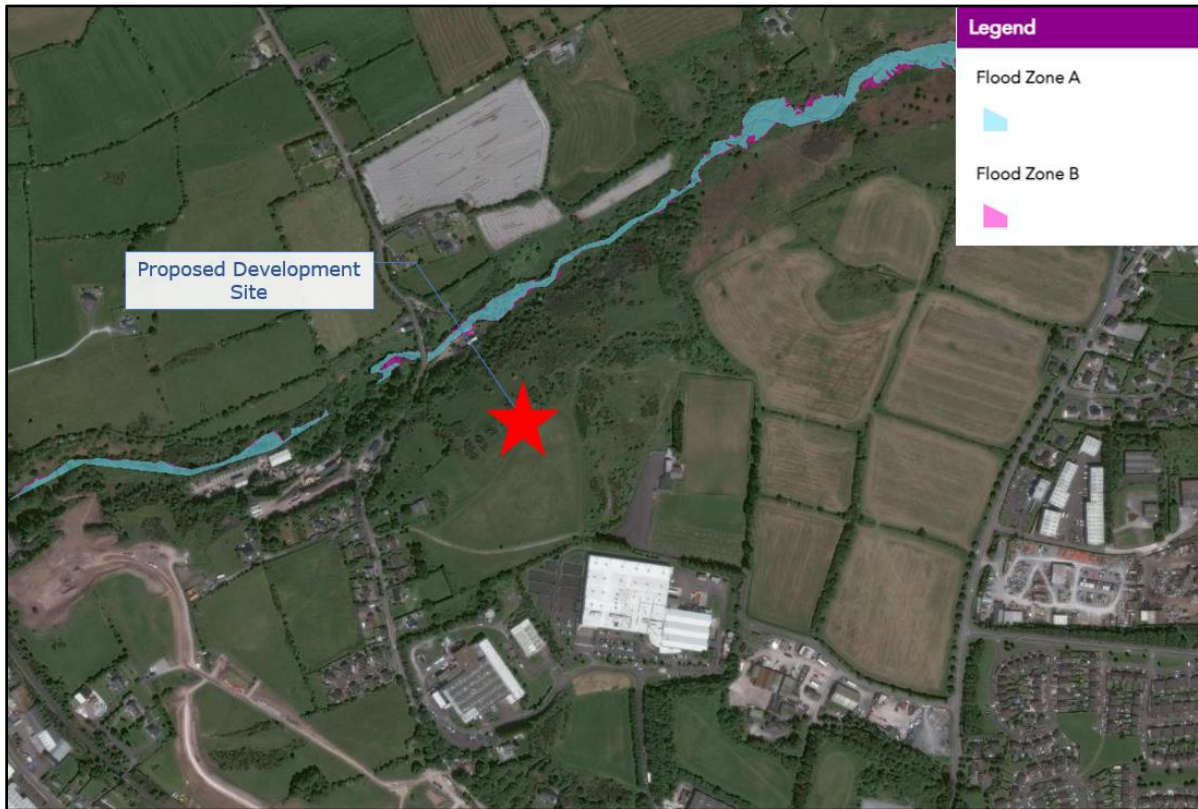
**Figure 3-6: Extract from the Interactive Cork City Council Flood Risk Mapping (Source: [www.corkcoco.com](http://www.corkcoco.com), annotation by J.B. Barry & Partners)**

An extract from the flood risk map prepared for Kilbarry is shown below in Figure 3-6. Observation of Figure 3-6 demonstrates that the northern portion of the proposed development site lies within the 1% AEP flood plain of the River Bride. This is consistent with the CFRAM flood mapping. As discussed previously, no development will occur in this portion of the proposed development site and there is a steep rise from the river to the remainder of the site. As such the development site is considered to be located within **Flood Zone C** where the risk of flooding is lowest.

The CFRAMS Map in *Figure 3-5* and Cork City Council flood maps in *Figure 3-6* both indicate that the proposed development site lies outside of the 0.1% AEP coastal flood event and hence is located within **Flood Zone C** for Coastal flood risk, where the risk of flooding is low.

The CFRAMS Map in *Figure 3-5* and Cork City Council flood maps in *Figure 3-6* both indicate that the northern portion of the proposed development site is at risk to flooding from the River Bride. However, no development will take place at this portion of the site. All development including highly vulnerable development will occur outside of any fluvial flood extent. Therefore, the proposed development site lies within Fluvial **Flood Zone C** – low flood risk. The OPW Summary Local Area Report shows no indication of previous fluvial related flooding at the proposed site, however, there has been instances of fluvial flooding nearby and downstream to the site caused by the River Bride.

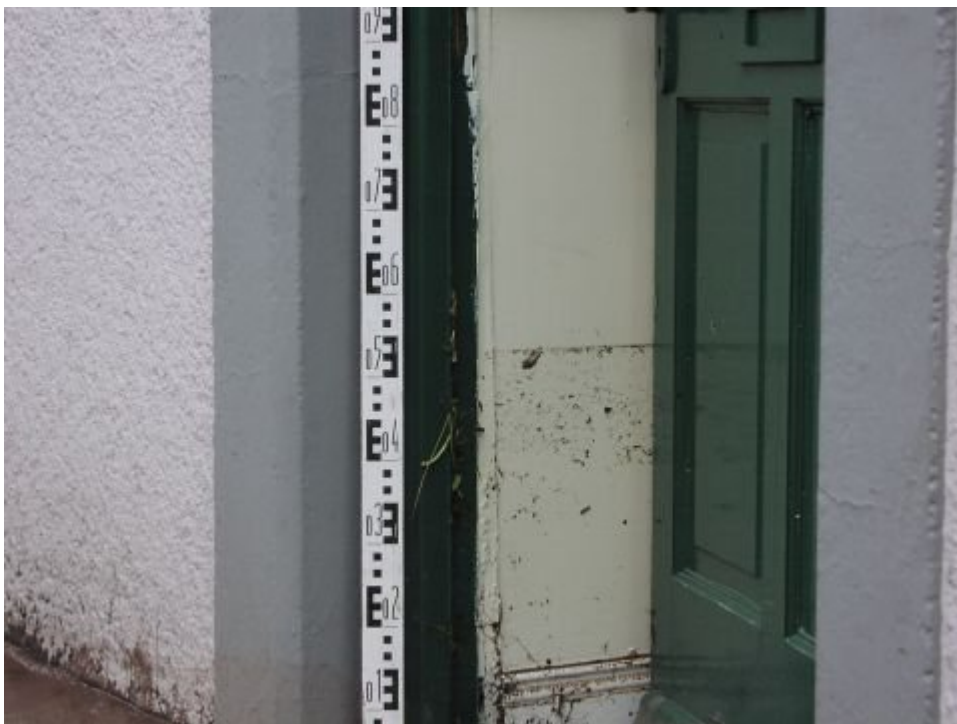
View showing depth of flooding in a house in Thomas Davis Street, (just over 0.5m).

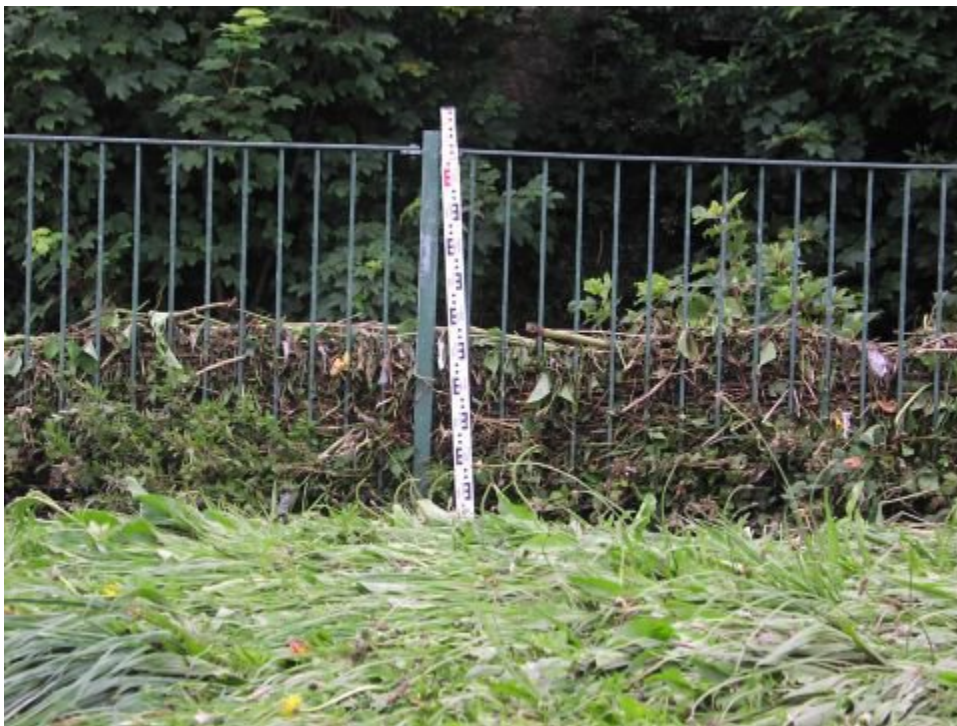
View showing depth of flood debris caught in railing along River Bride in Orchard Court (about 0.6m)

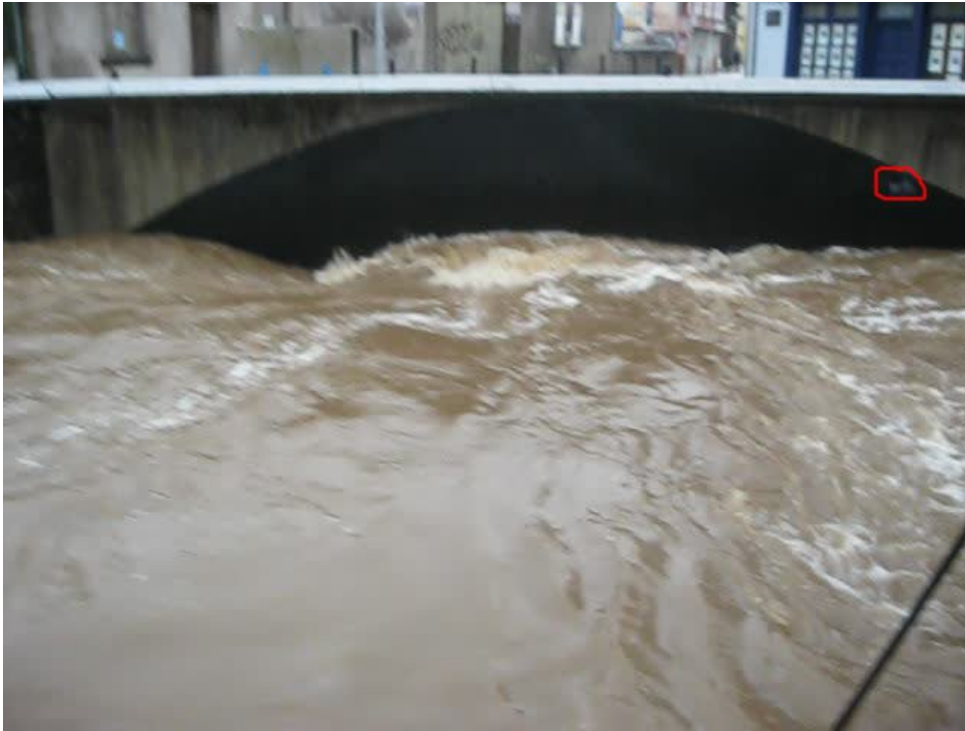
Entrance to Culvert adjacent to Blackpool Church. This view is a still from a video taken about 5.00 am. I was advised by a Senior Engineer from Cork City Council that the flood at this location was observed earlier at the level of the graffiti on the headwall of the culvert (ringed in red). This would be about 1.2m above the soffit level of the culvert, or at a level of about 8.7m O.D. Malin, based on Lee CFRAMS Channel & Cross Section Survey (7BRI\_0). See following photo for clarification.

- **Blackpool Village.** Flooding was from the River Bride. The cause of flooding is considered to be culverts both at Orchard Court and south of Blackpool Church that were not capable of conveying the flood waters in the Bride River. It is not considered that there were any blockages in these culverts during the flood. This opinion is based on video footage of the flood at both culverts that was made available to me by a member of the public as well as a discussion with senior engineer who witnessed the floods at these locations at what is believed to be about the time of the peak flood level. The video footage was recorded about 5.00am to 5.20 am while the engineer witnessed the flooding at about 4.00am to 4.30am. (It is possible that flooding here could have been contributed to by the flow from Spring Lane along Thomas Davis Street.)

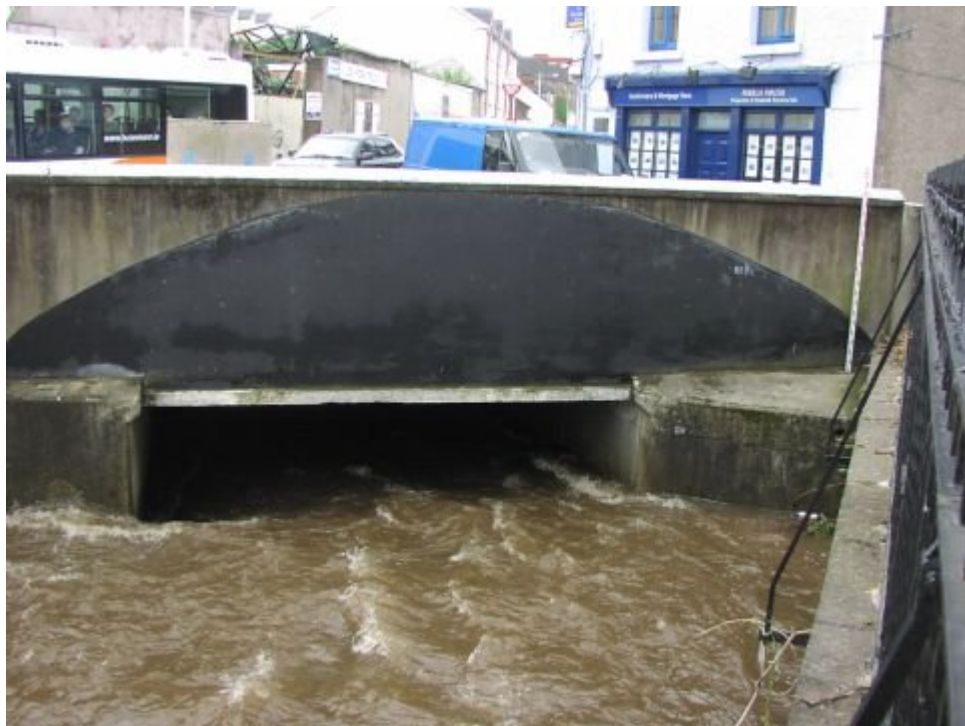
View of culvert at Blackpool Church with flood level reduced. Note staff in right of photos used to give estimation of height of Graffiti mark above soffit.

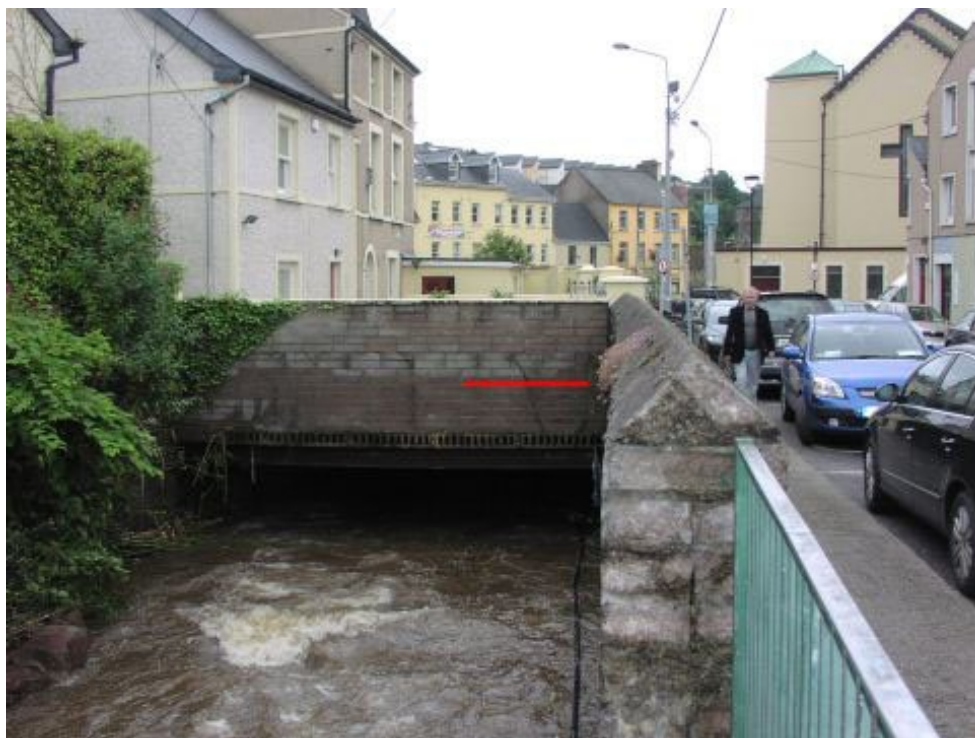
View of entrance to Orchard Court cuvlert after flood level reduced. Red line indicates level described as observed earlier. Based on Lee CFRAMS (7BRI\_93) survey drawing this approximates to a level of about 9.4m OD Malin, and it is about 1.1m higher than the soffit level of the culvert entrance.

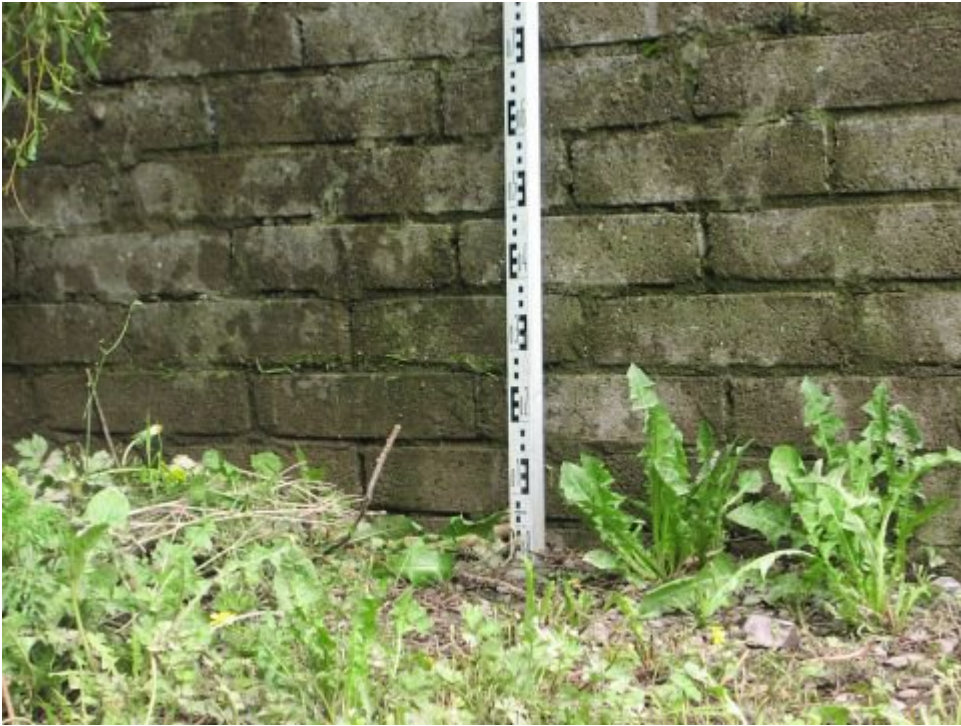
Photo showing tide line at about 0.27m on staff on inside of wall at exit from hotel grounds near north end of flood extent

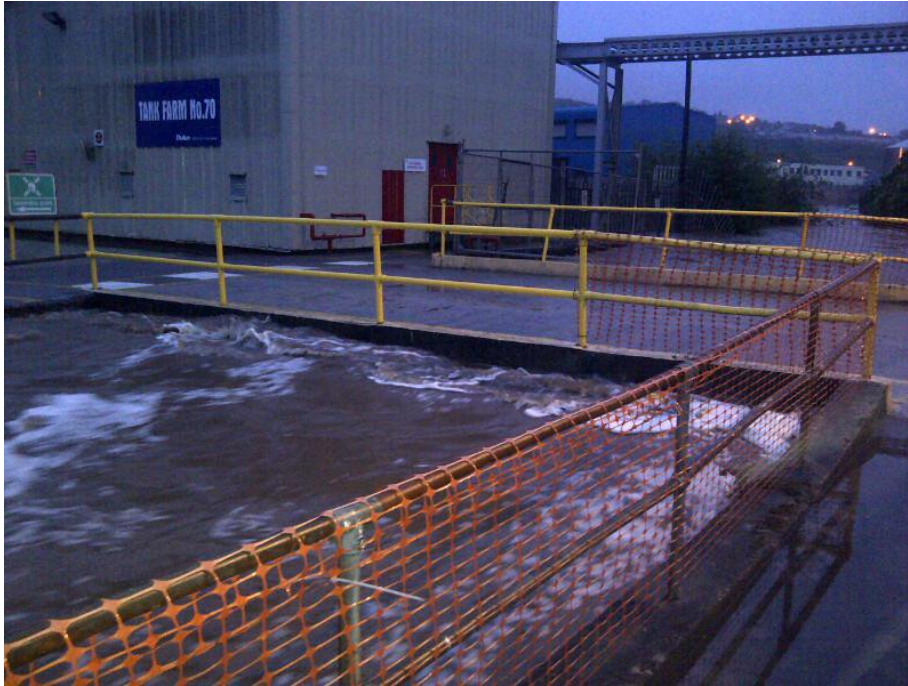
Photo given to me by a member of the public showing flood level shortly after 4.30 am. This bridge is located about 260m downstream from Fitz's Boreen. Based on the Lee CFRAMS Channel and Cross Section Survey (7BRI\_1175), the flood level here at this time is about 15.85m OD Malin

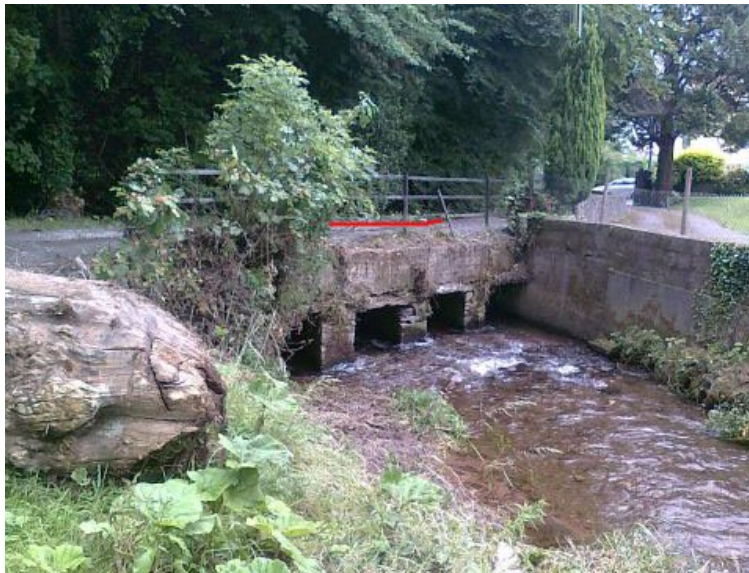
Photo showing upstream side of culvert on private access road on Glenamought River. Based on debris observed in the area and the Lee CFRAM Structure survey (7BR1\_91), the estimated flood level, indicated by the red line is about 25.3m OD Malin. This may be conservative, (low) as there was considerable debris evident upstream along the road to the left of the picture
